the **play inspection** company

Annual Inspection

Winchester City Council

Recreation Ground (Cheriton PC)

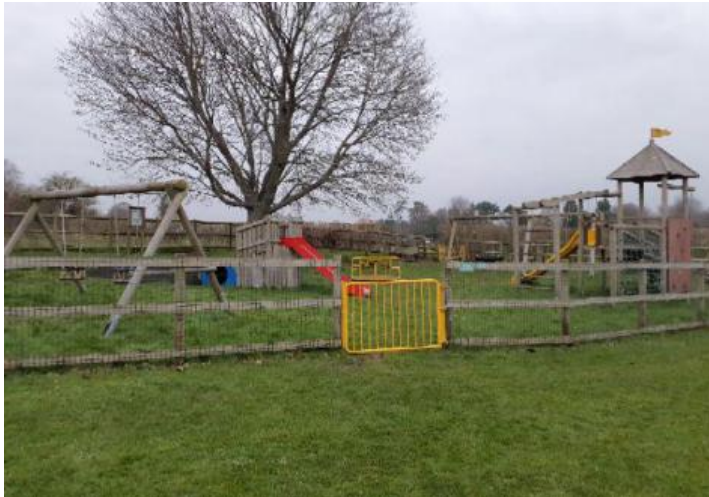
Finding: It is recommended that signage, with information including the site address, contact information for maintenance issues and emergency contact details are provided for the facility

Action: Provide in accordance with the recommendations

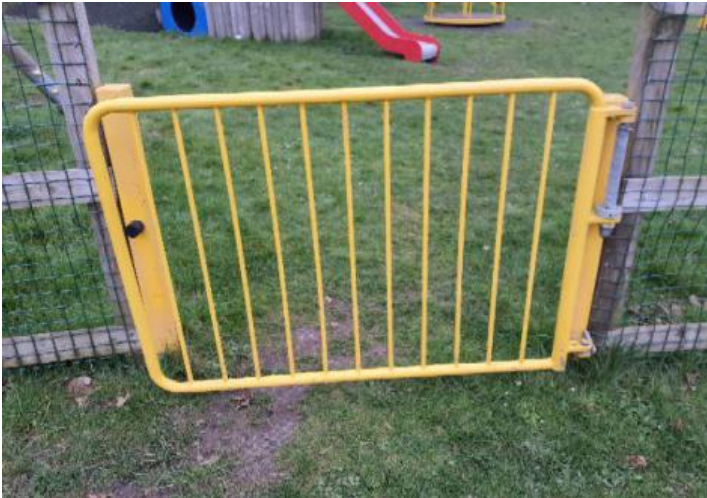
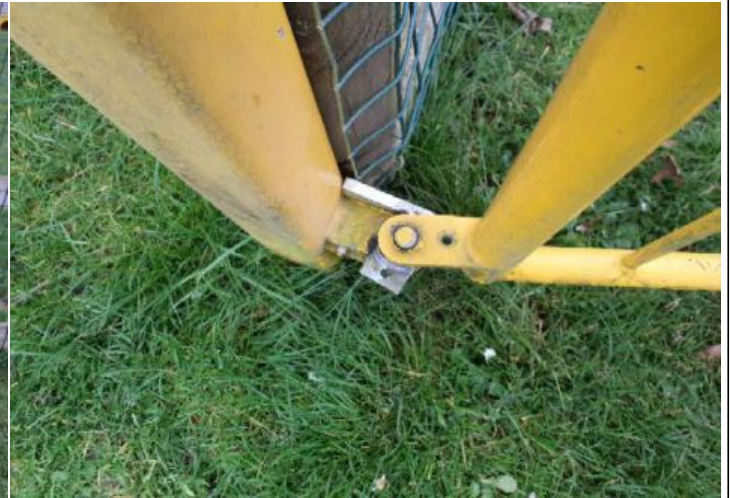
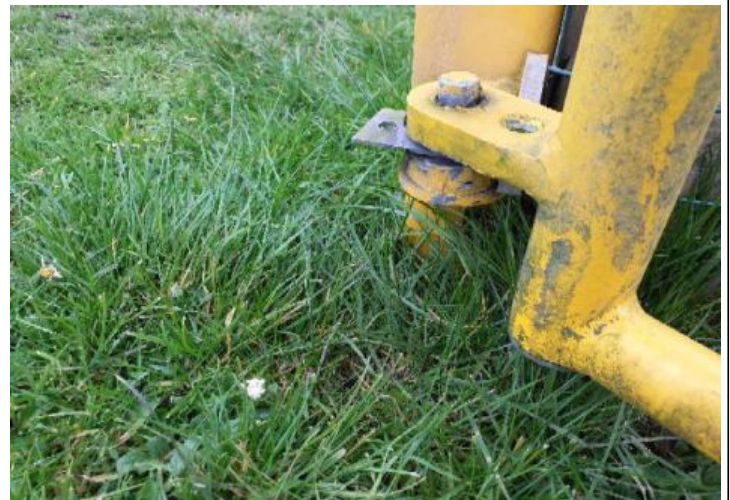
Finding: There is a missing fixing and a bracket has slipped out of place with sharp edges **Action:** Repair

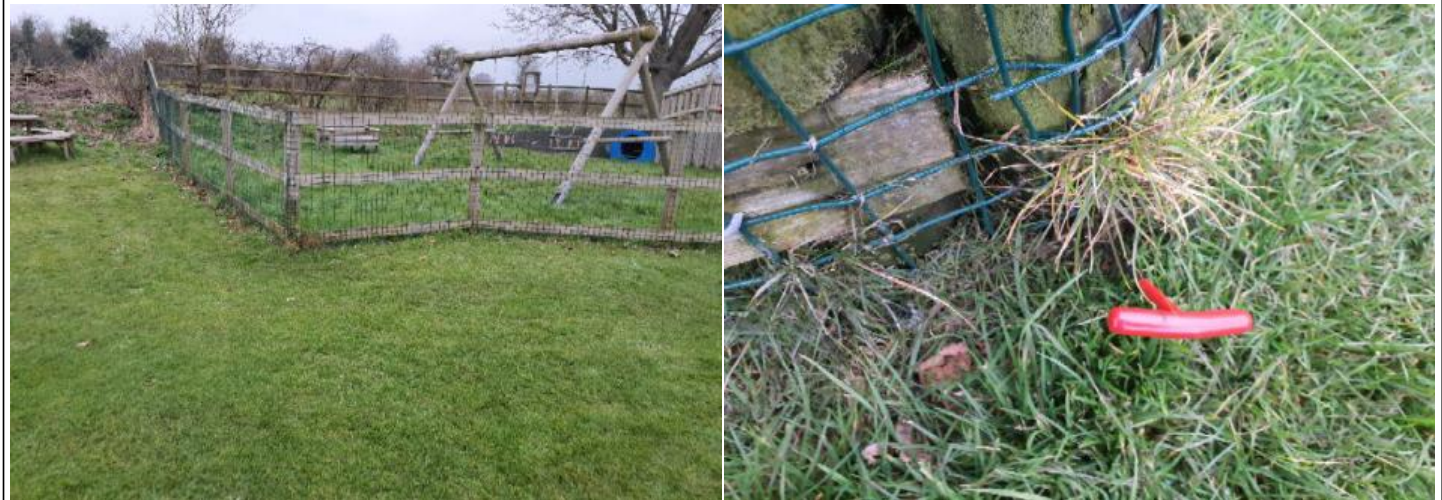
Finding: There is some evidence of rot in the timber	Action: Monitor for any further deterioration and replace as required
---	--

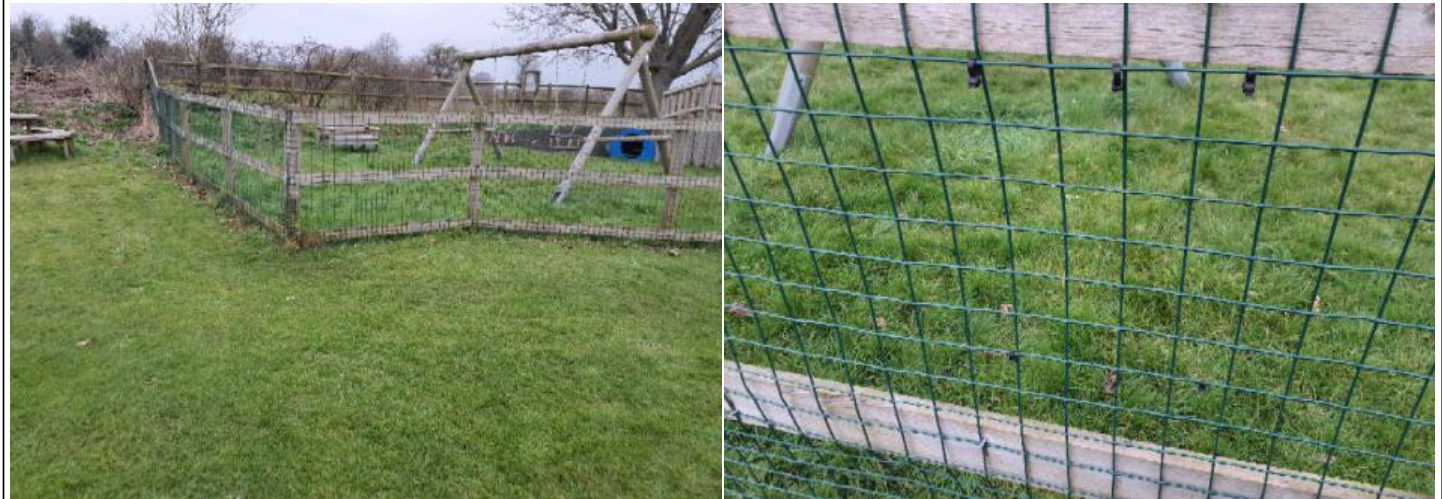
Finding: Cable ties have been used on the item and there are sharp projecting ends	Action: Remove if not required or replace with a more appropriate alternative fixing method if used as a fixing
---	--

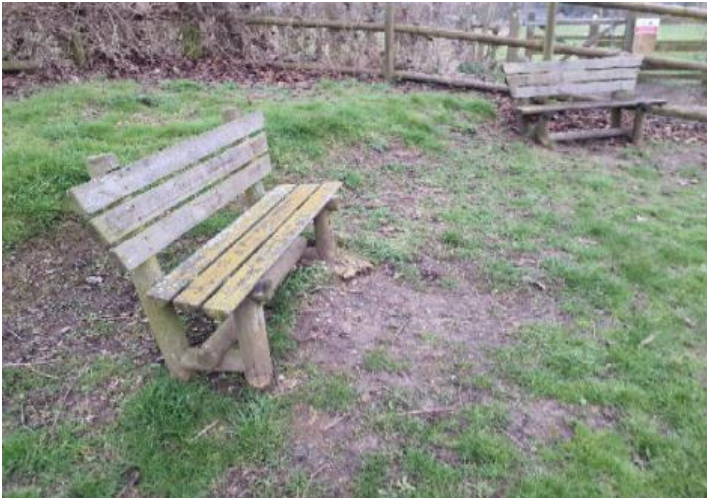
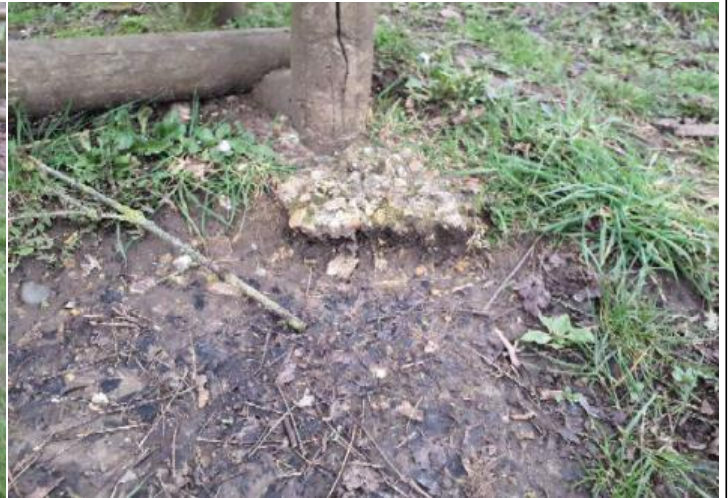
Finding: The surface has eroded and the foundations are exposed

Action: Reinstate surrounding surfaces to cover the foundations

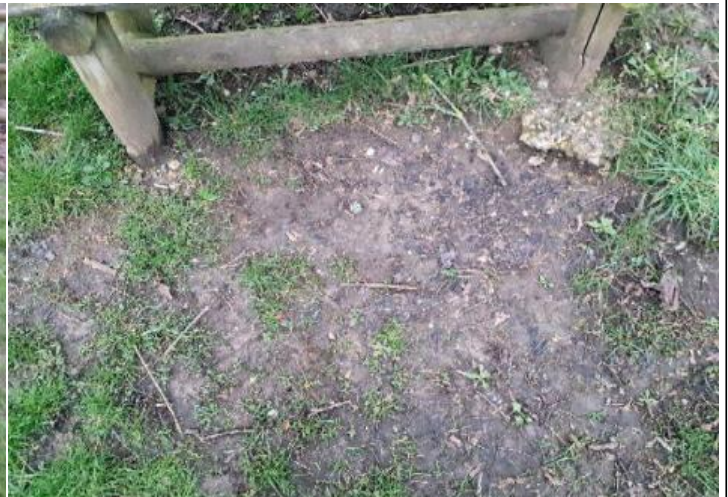
Finding: The area around the item has eroded and may become slippery

Action: Reinstate eroded area

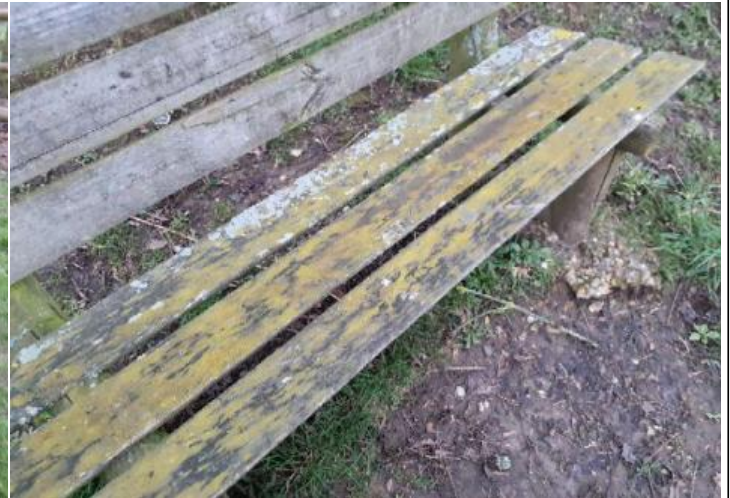
Finding: There is algae or moss on the surface of the equipment

Action: Clean and treat appropriately

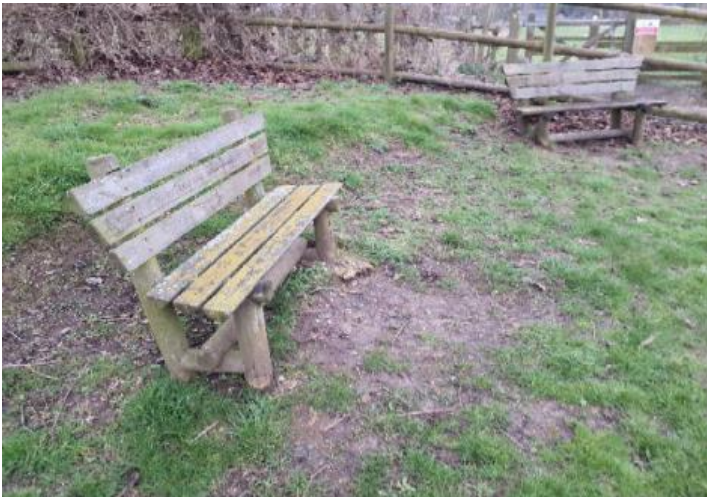
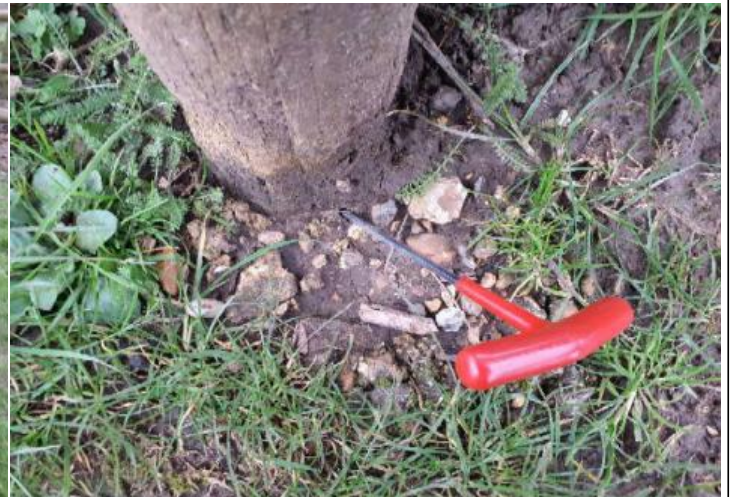
Finding: There is some evidence of rot in the timber

Action: Monitor for any further deterioration and replace as required

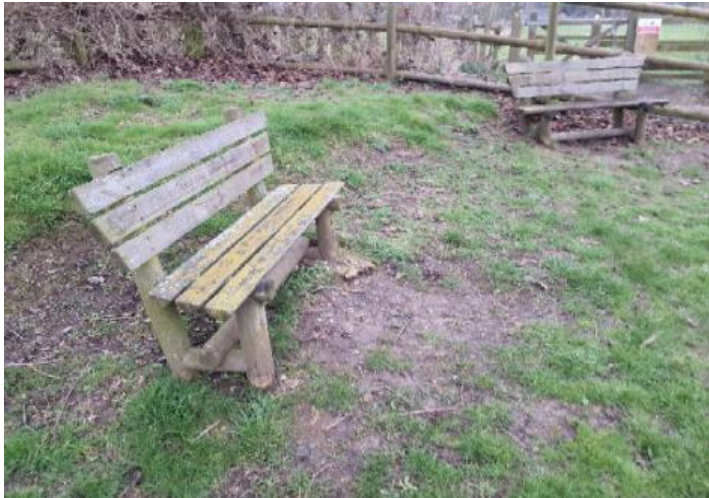
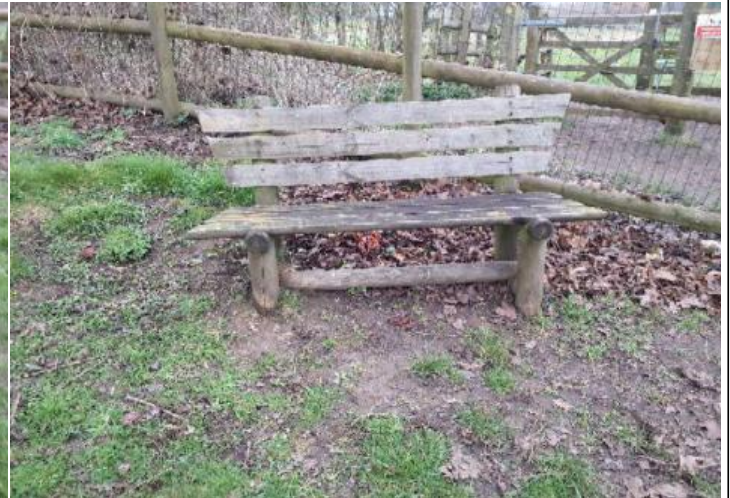
Finding: The seat is not level

Action: Adjust as required

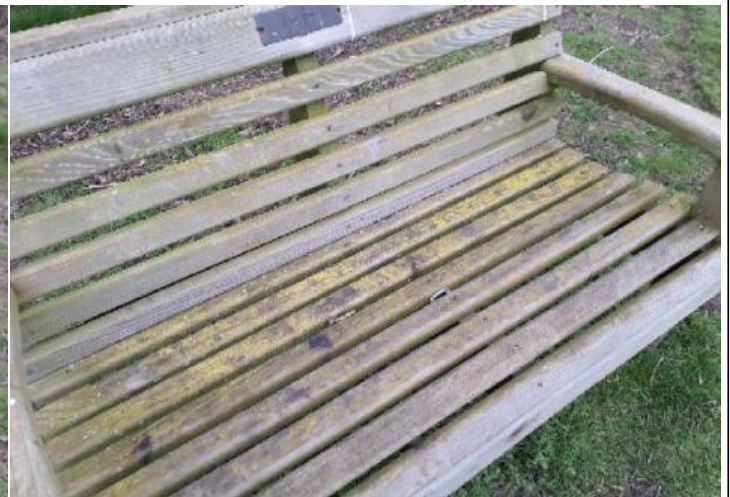
Finding: There is algae or moss on the surface of the equipment

Action: Clean and treat appropriately

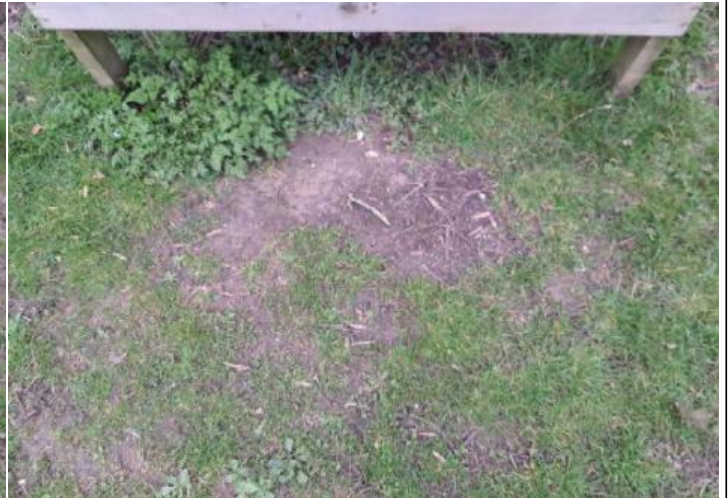
Finding: The area around the item has eroded and may become slippery

Action: Reinststate eroded area

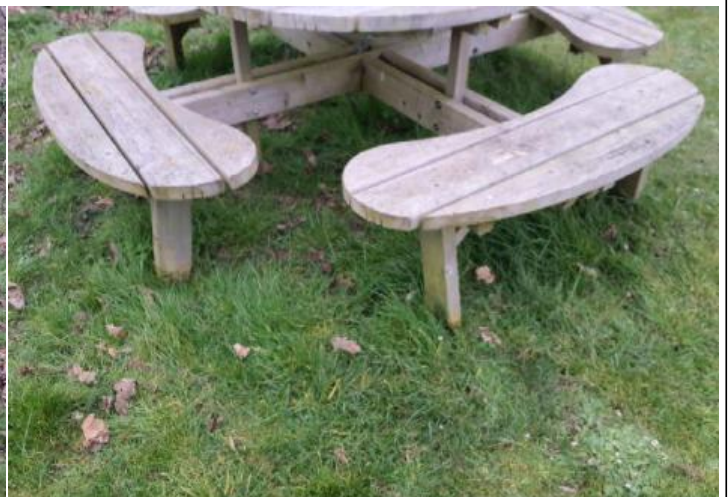
Finding: The table/s is/are not secured to the ground and there is some potential for the item/s to be moved within falling spaces of equipment

Action: Secure to the ground

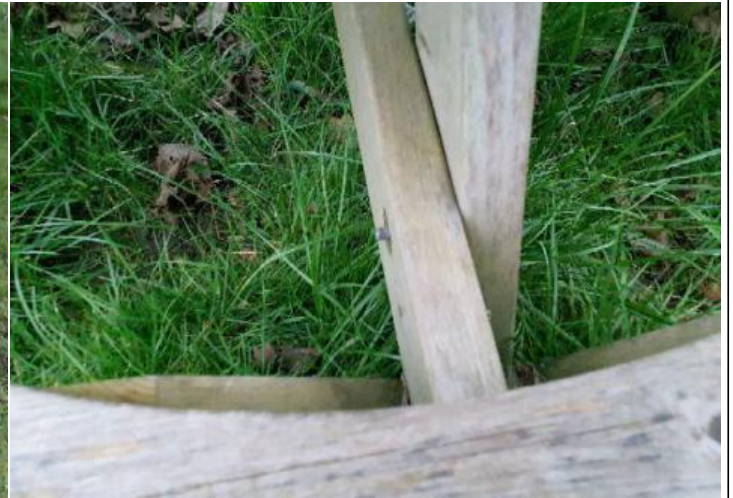
Finding: There are projecting bolt thread(s) present

Action: Remove excess thread length and deburr or provide cap

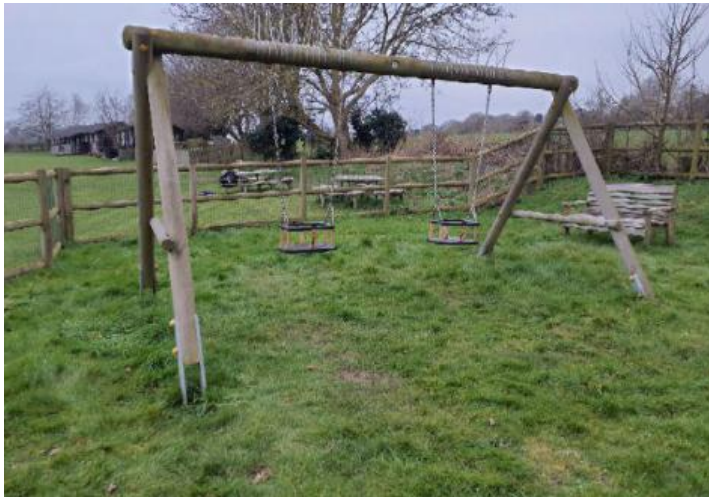
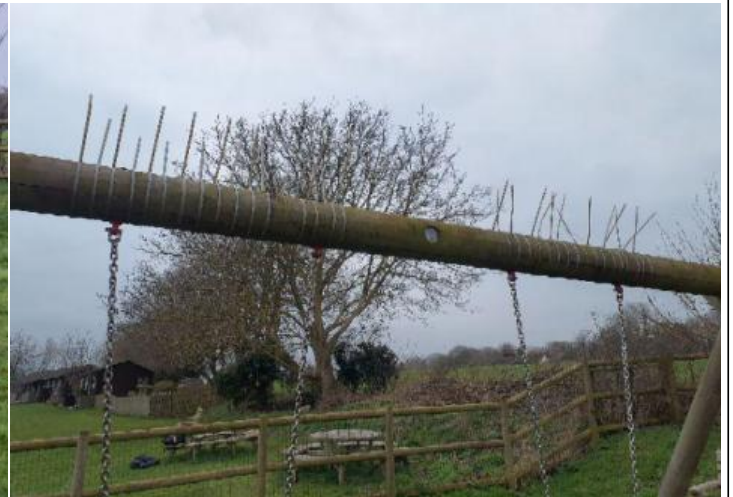
Finding: The timber has a number of splits/shakes or air cracks and this may affect the stability or allow water ingress which will accelerate the rotting process

Action: Monitor to ensure the splits do not cross through fixing points of the structure and/or cause any instability

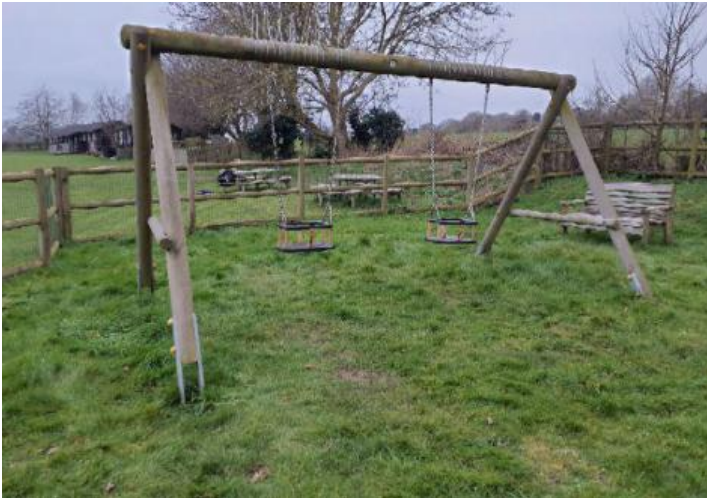
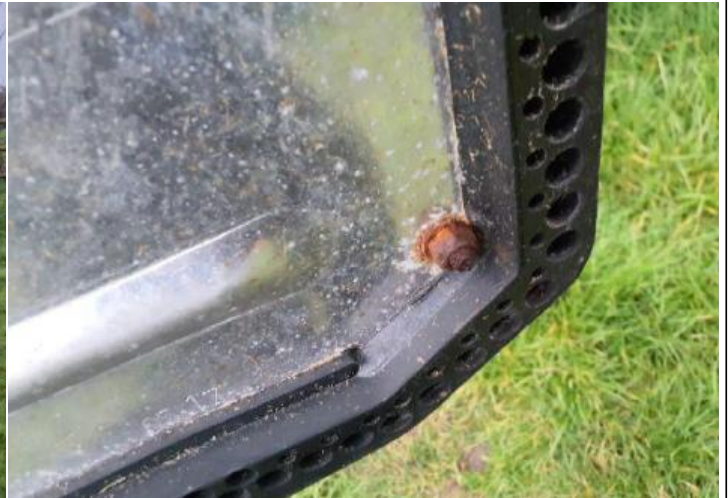
Finding: The fixings have corroded excessively

Action: Replace all corroded fixings

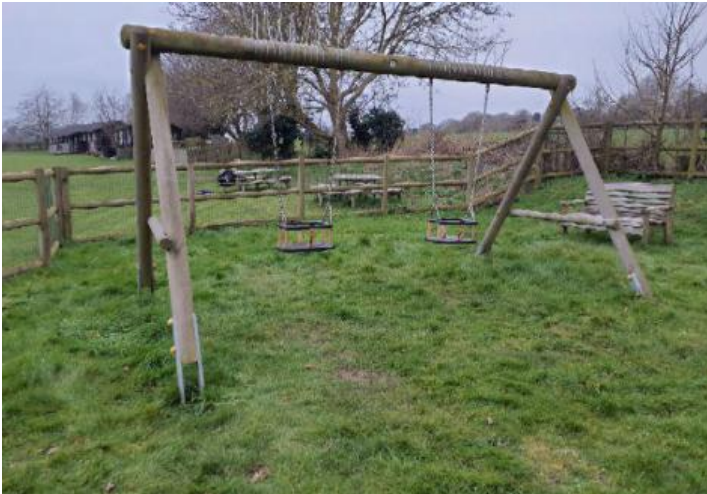
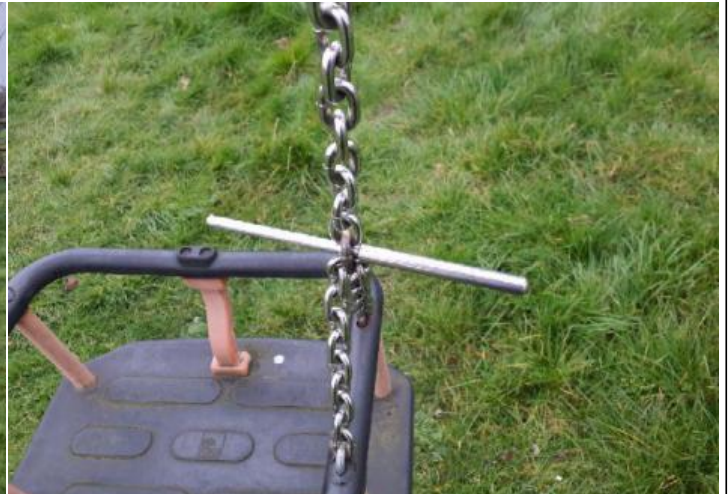
Finding: The chain openings are in excess of the 8.6mm as recommended by BS EN 1176

Action: Monitor - No remedial work recommended

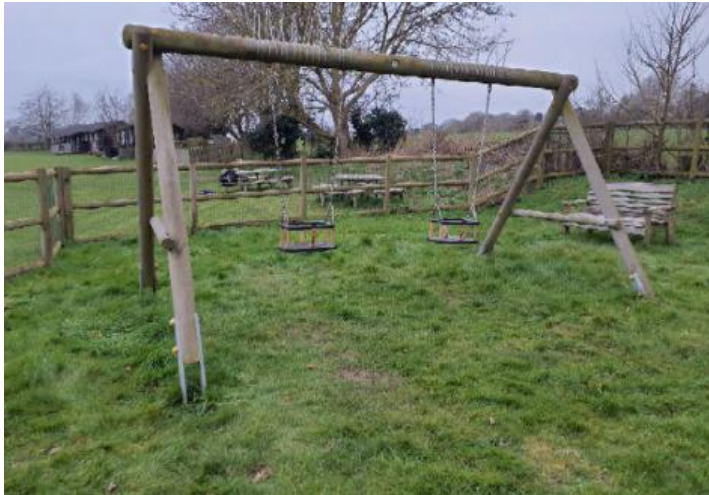
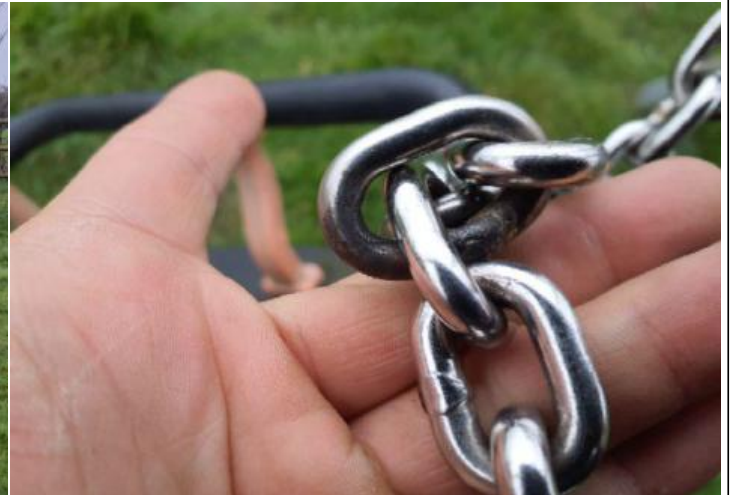
Finding: There is some notable evidence of chain wear

Action: Monitor for any further deterioration and replace when 40% worn

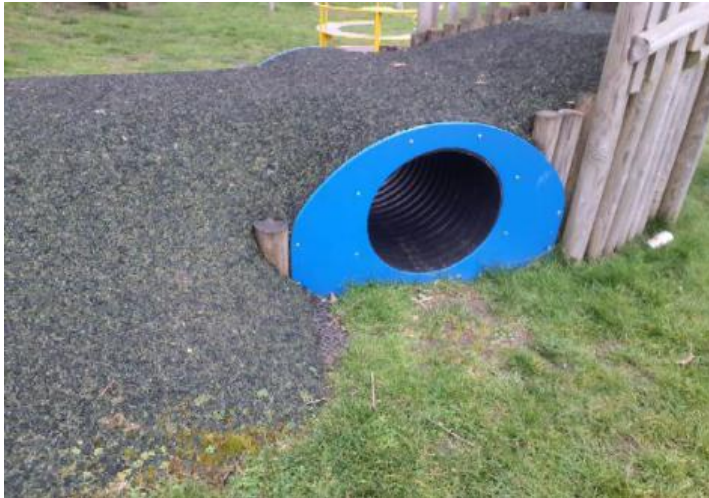
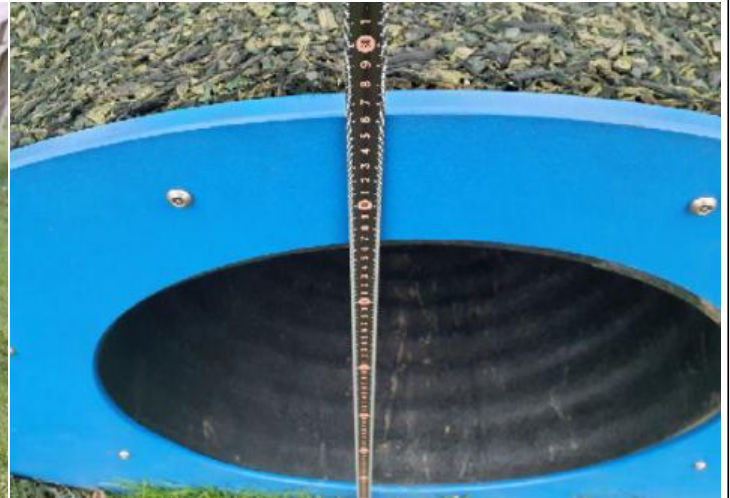
Finding: This design / configuration of tunnel mound is well established and has been successfully included in large quantities of playgrounds throughout the UK. Whilst the design does not fully meet the requirements of BS EN 1176 with regards to falls in excess of 600mm over the edge of the tunnel to the surface below, it has been risk assessed as fit for purpose in this regard and no changes are recommended to the design unless otherwise stated in additional findings

Action: Monitor - No remedial work recommended

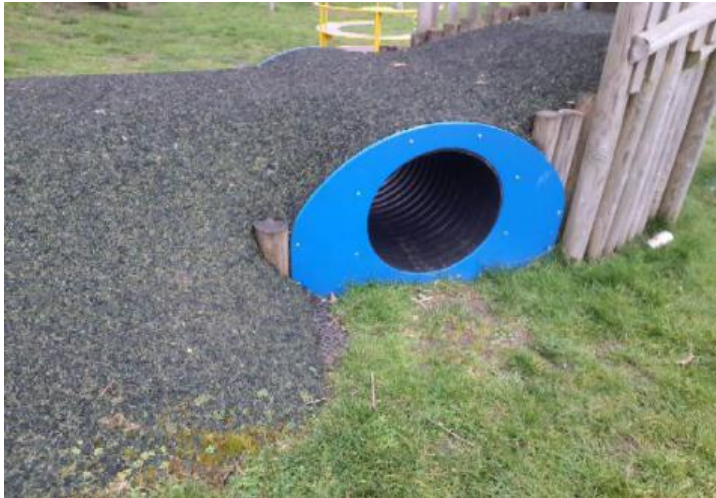
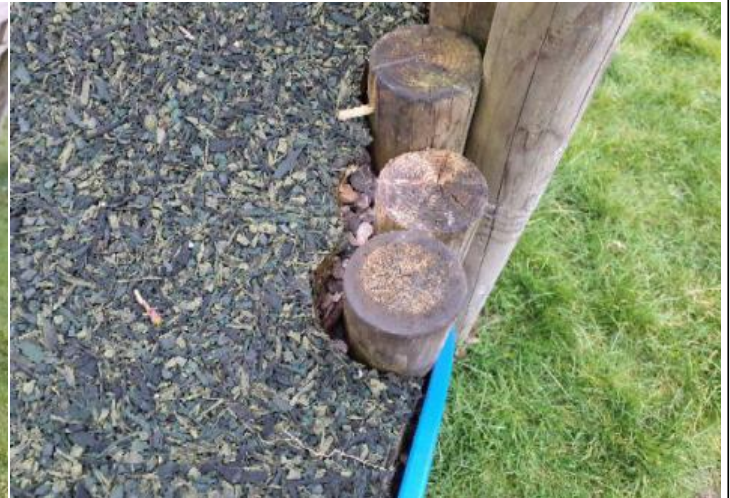
Finding: There are significant gaps (over 30mm) between the surface and the edging or between the joints in the surface; these are large enough for a small foot to enter

Action: Repair surfacing

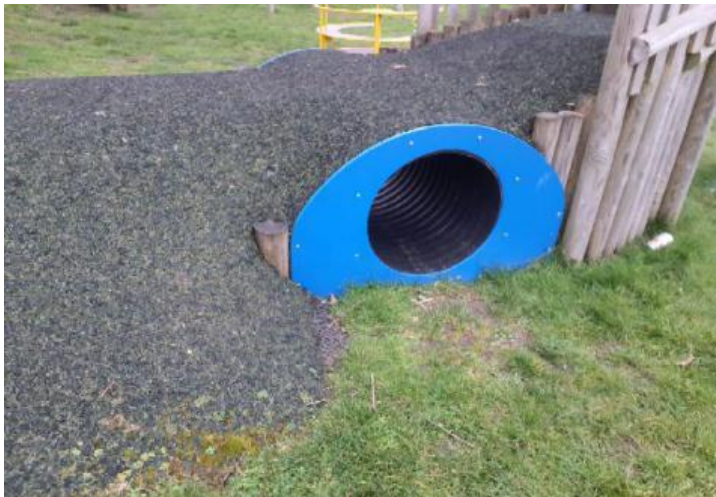
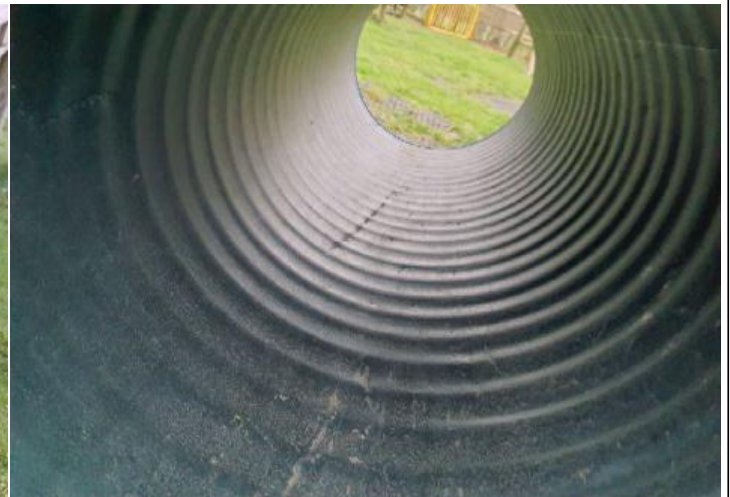
Finding: There is some damage to the item

Action: Monitor for any further deterioration and repair as required

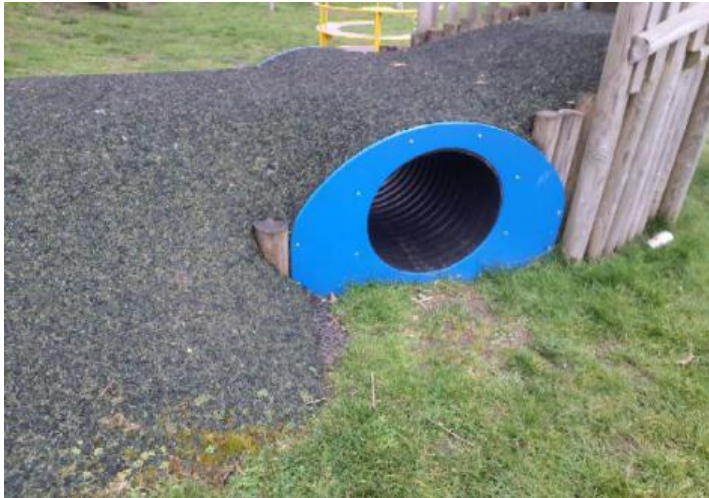
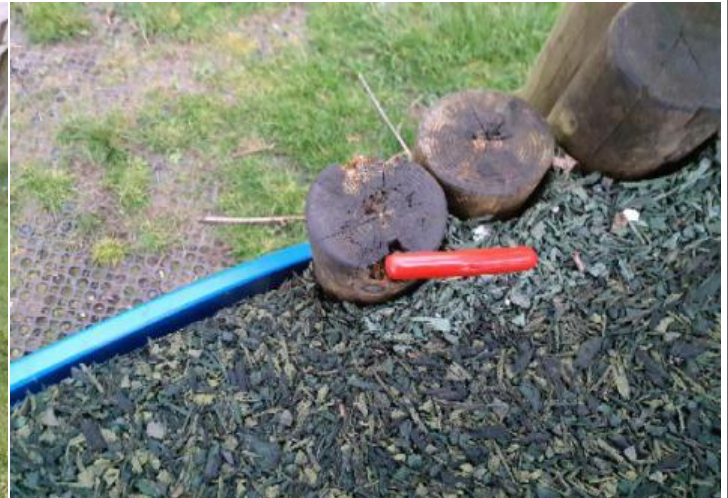
Finding: There is some evidence of rot in the timber
Action: Monitor for any further deterioration and replace as required

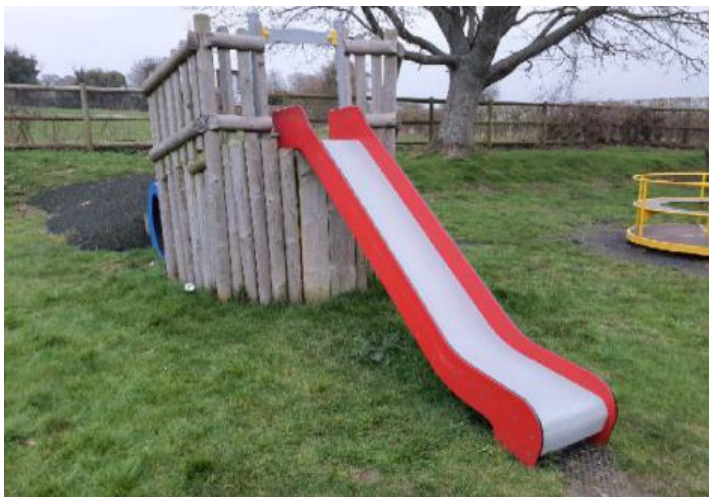
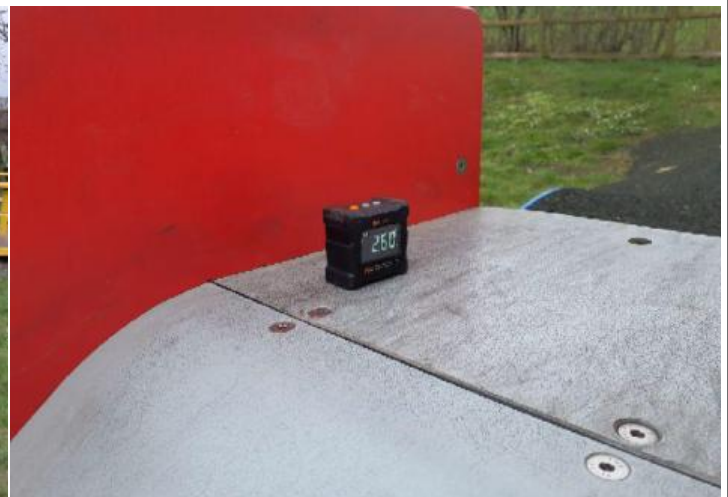
Finding: The slide start section incline is not in the direction of travel; it should slope towards the direction of the sliding surface to meet the requirements of BS EN 1176 Part 3
Action: Monitor - No remedial work recommended

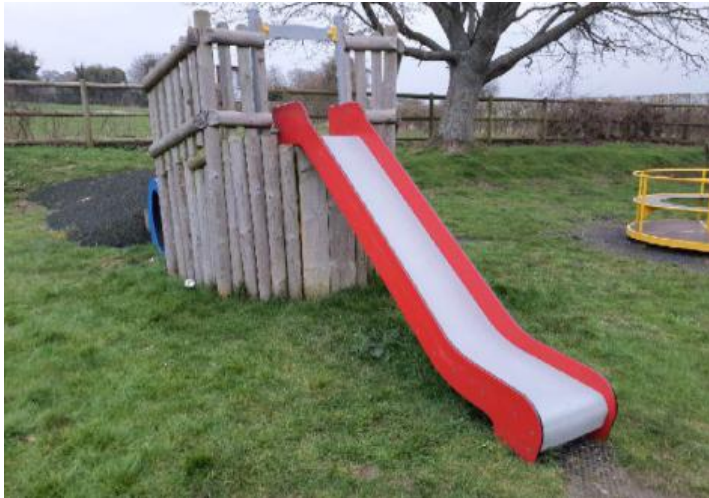
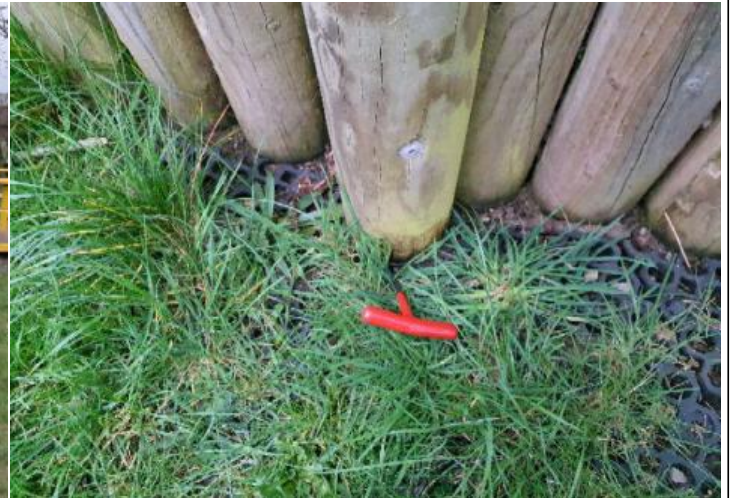
Finding: There is some evidence of rot in the timber

Action: Monitor for any further deterioration and replace as required

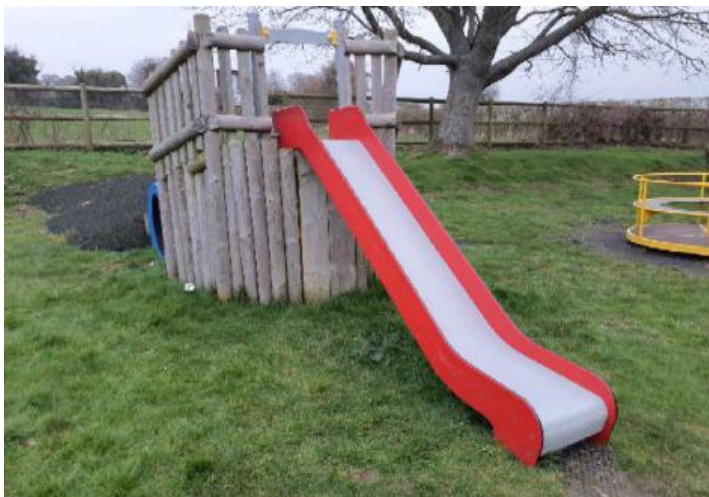
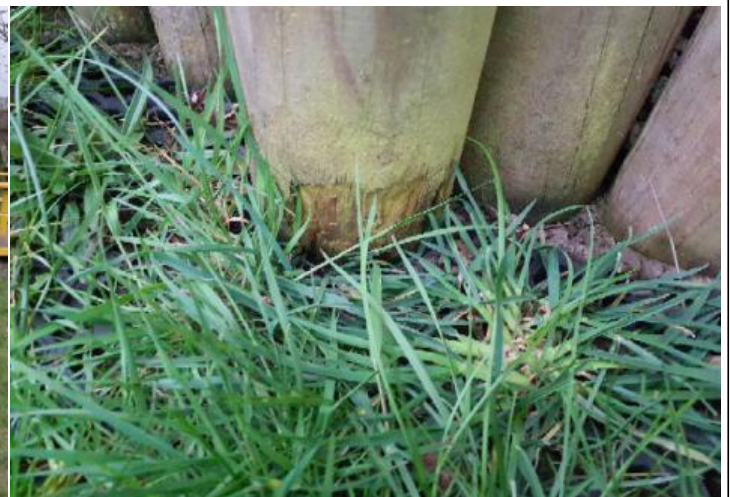
Finding: There is some strimmer / machinery damage apparent on the posts, this can penetrate the preservative applied to the timber and accelerate the rotting process

Action: Monitor for any deterioration (rot) and replace as required

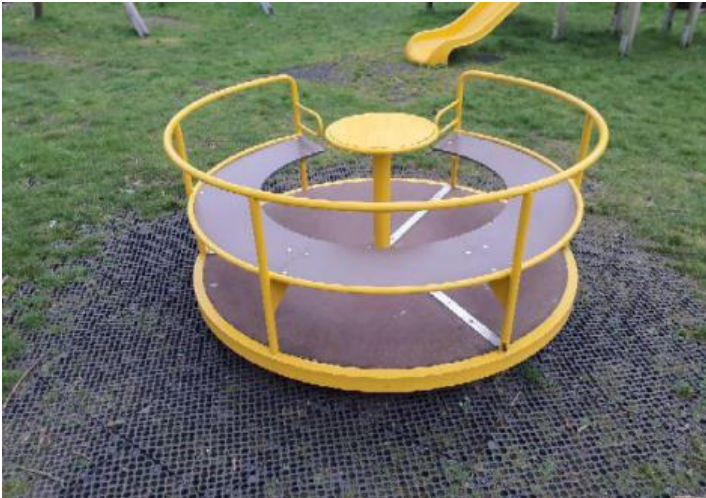
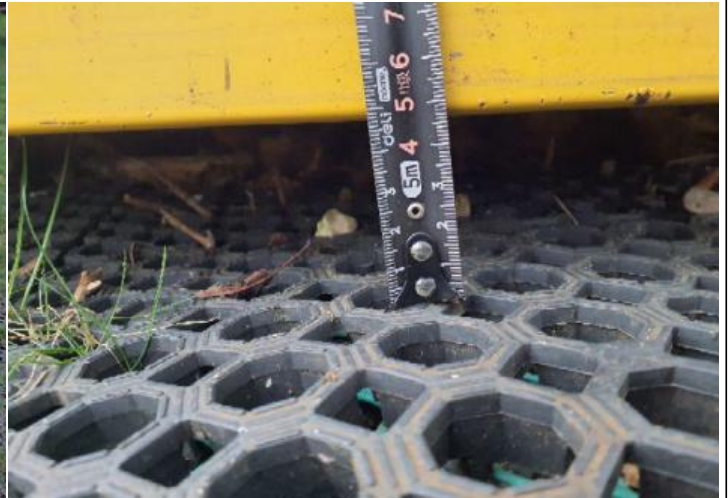
Finding: The distance between the underside of the roundabout platform and the playing surface is less than 60mm and contravenes the requirements of BS EN 1176 Part 5 which requires that the distance be maintained between 60mm-110mm for the entire circumference of the roundabout

Action: Monitor - No remedial work recommended

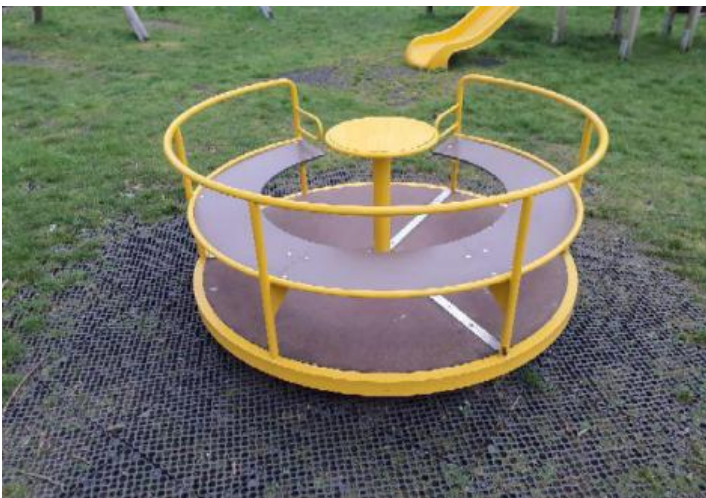
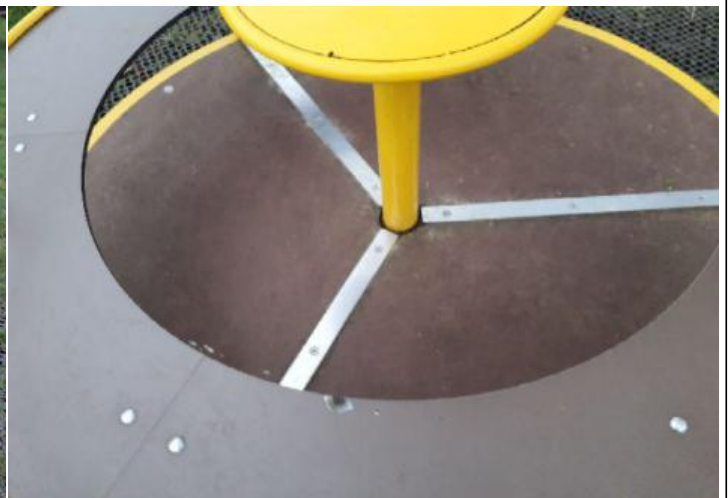
Finding: The bearing is showing signs of wear

Action: Monitor for any further deterioration and replace as required

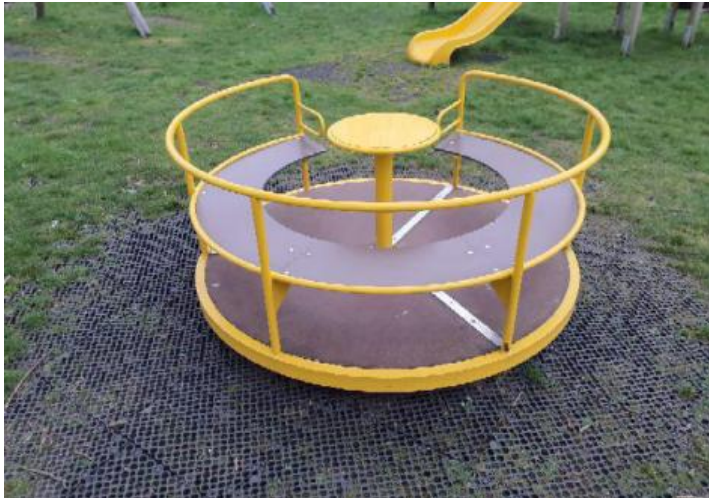
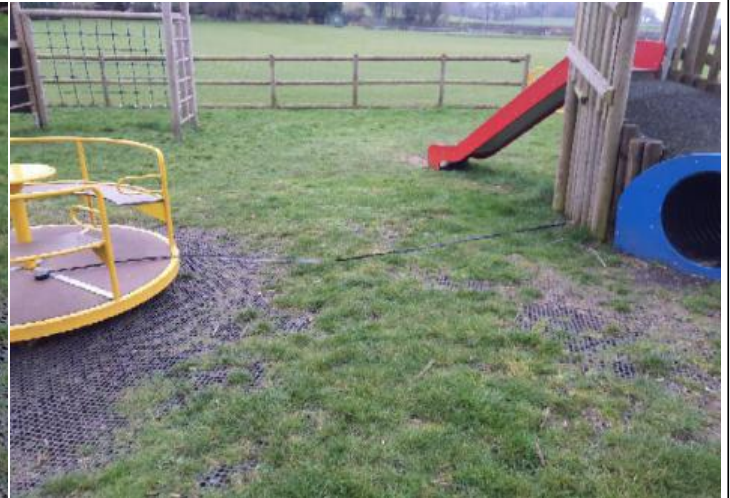
Finding: The falling space overlaps the free space between the embankment slide/crawling tunnel and the roundabout in contravention of the requirements of BS EN 1176:2017 Part 1

Action: Monitor - No remedial work recommended

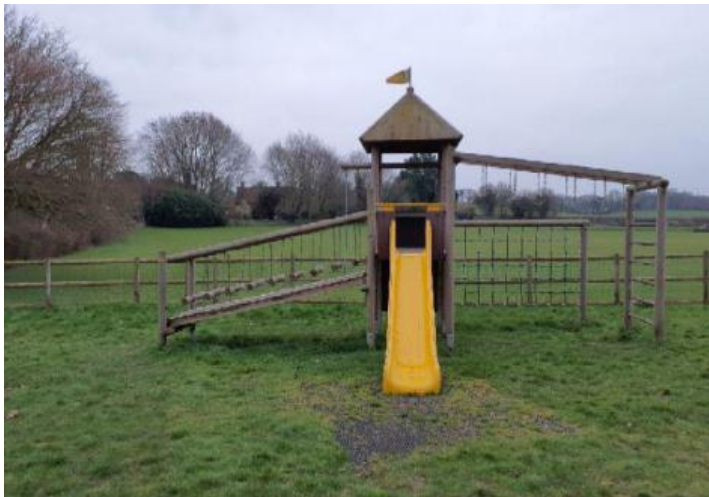
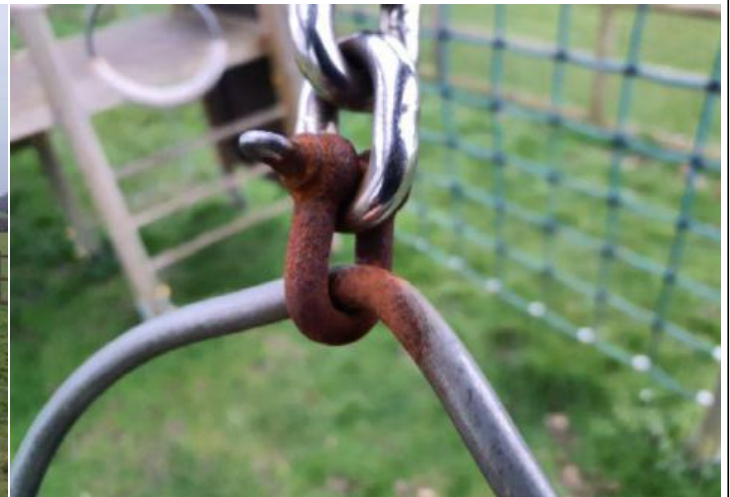
Finding: The fixings have corroded excessively

Action: Replace all corroded fixings

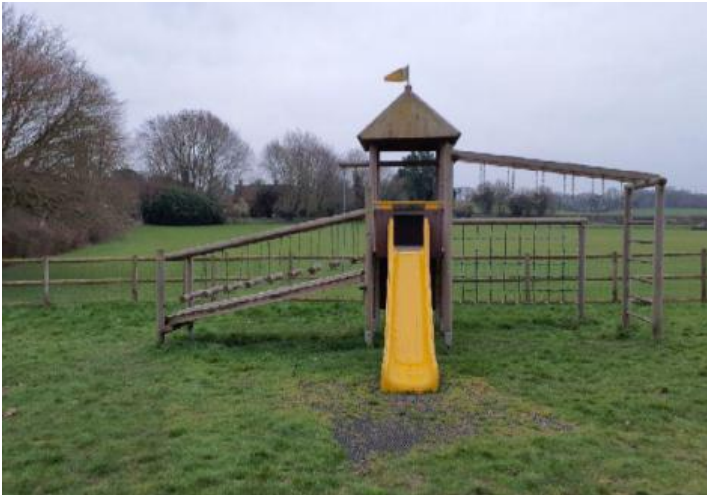
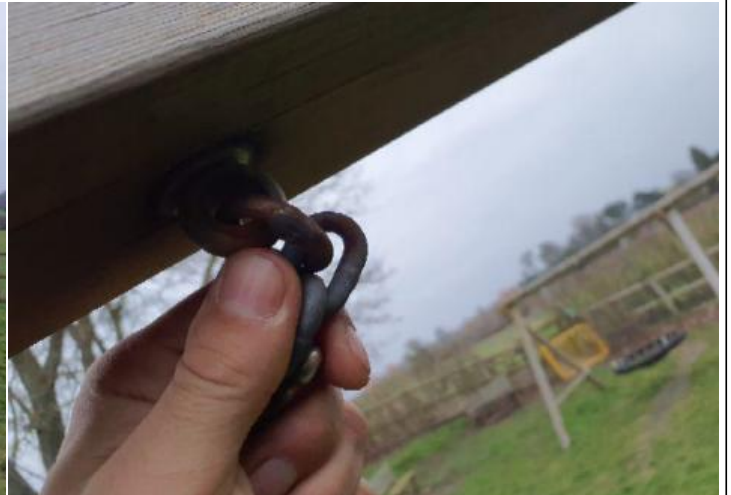
Finding: There is some notable evidence of chain wear

Action: Monitor for any further deterioration and replace when 40% worn

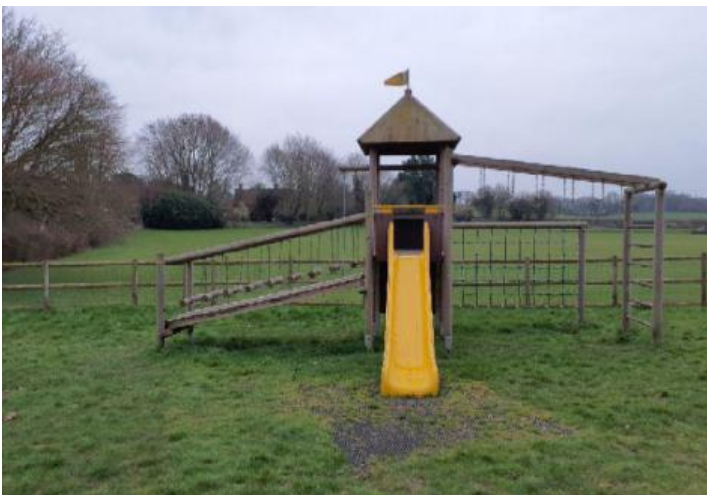
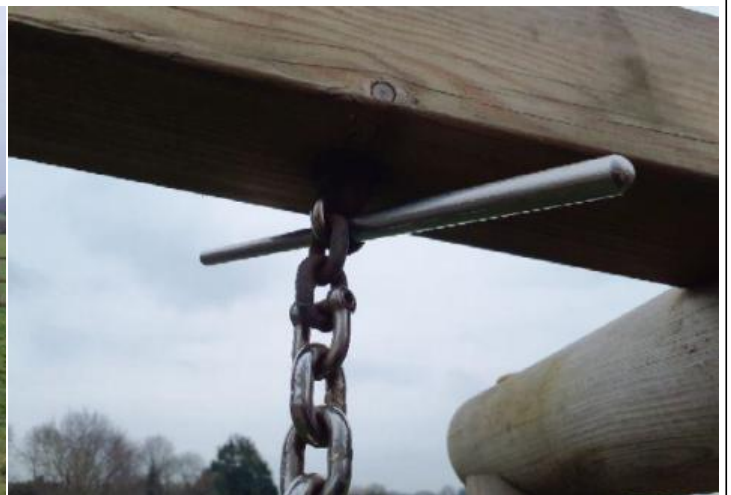
Finding: The connecting links are in excess of 8.6mm and less than 12mm and fail the requirements of BS EN 1176 Part 1; clause 4.2.13, Chains

Action: Monitor - No remedial work recommended

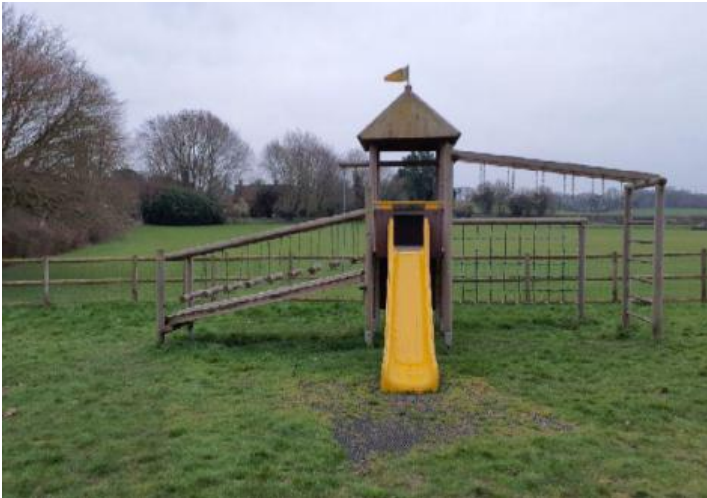
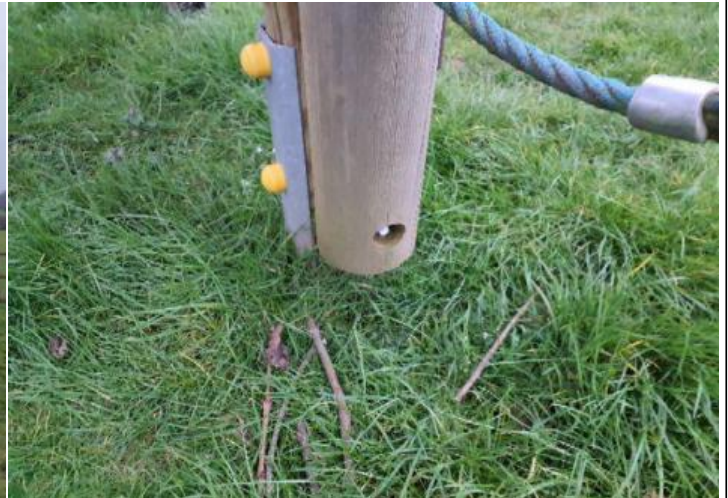
Finding: There is/are bolt cap covers missing or damaged on the item

Action: Replace missing or damaged bolt cap covers

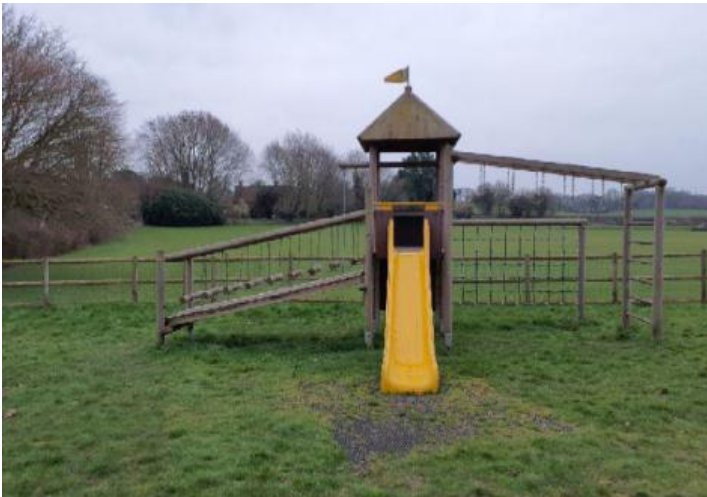
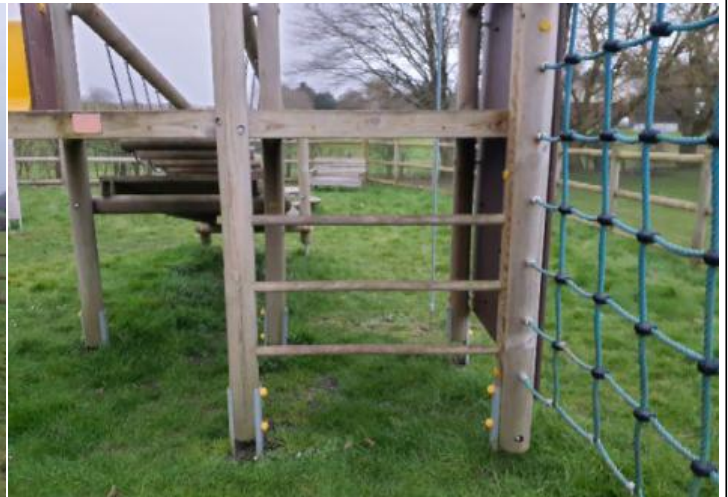
Finding: There are openings leading from platforms in excess of 1.0m in height to steep play elements and no hand supports complying with grip or grasp are provided, in contravention of BS EN 1176 Part 1: 4.2.9.4

Action: Monitor - No remedial work recommended

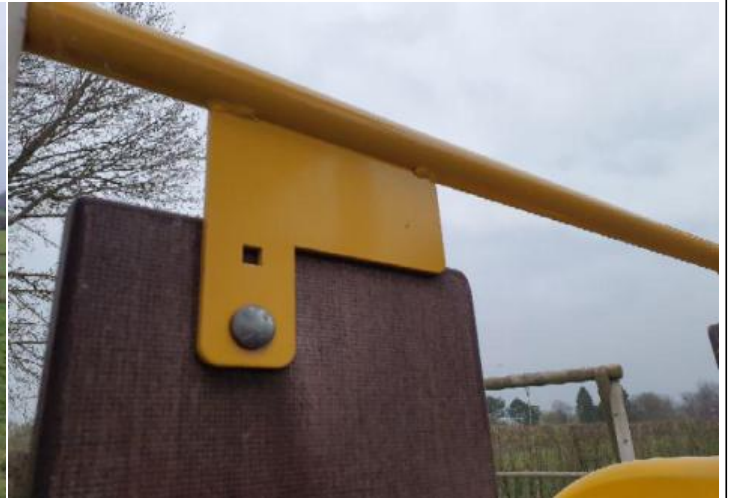
Finding: There are unused fixing holes

Action: Refer to manufacturer
