the **play inspection** company

Annual Inspection

Winchester City Council

Recreation Ground (Cheriton PC)

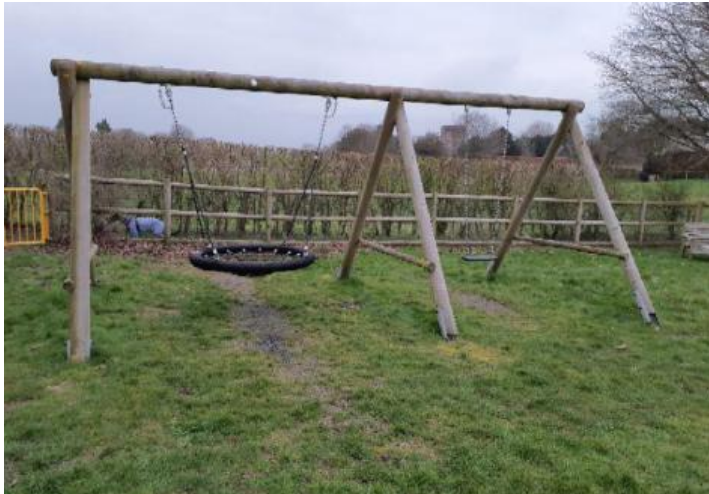
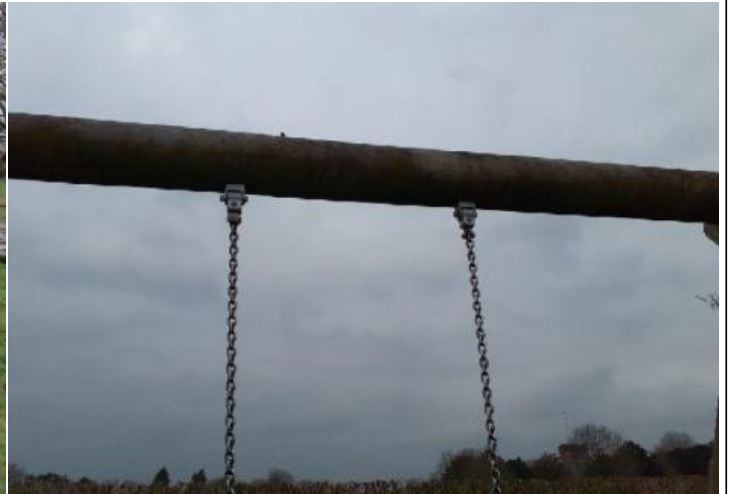
Finding: This design of swing joint has been known to fail on the weld connecting the joint to the threaded stud

Action: We would recommend that the joint be dismantled and checked on a regular basis or consulting with manufacturer on whether a Secondary Safety Device can be fitted

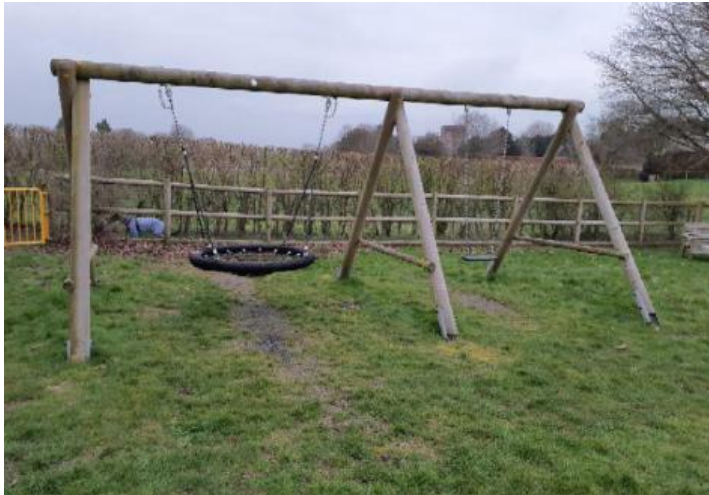
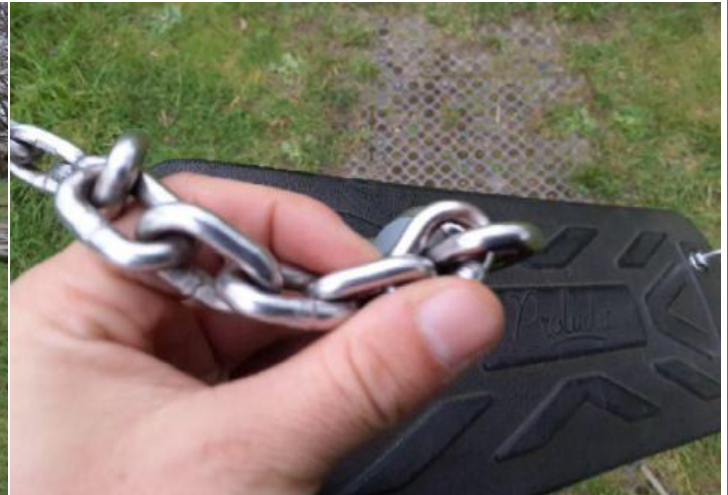
Finding: There is some notable evidence of chain wear
Action: Monitor for any further deterioration and replace when 40% worn

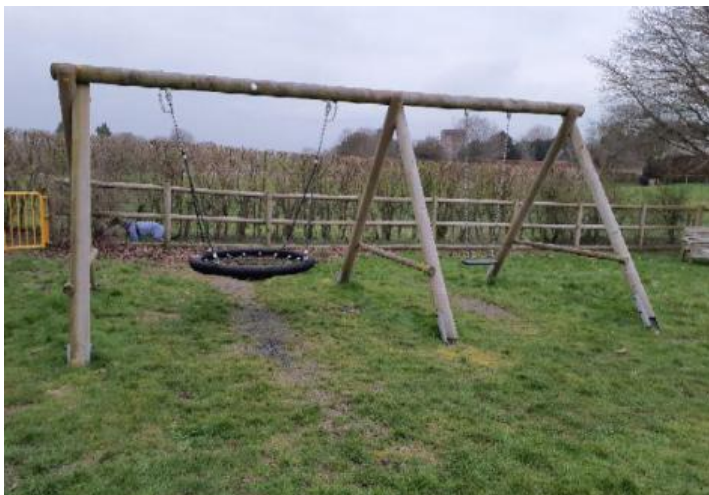
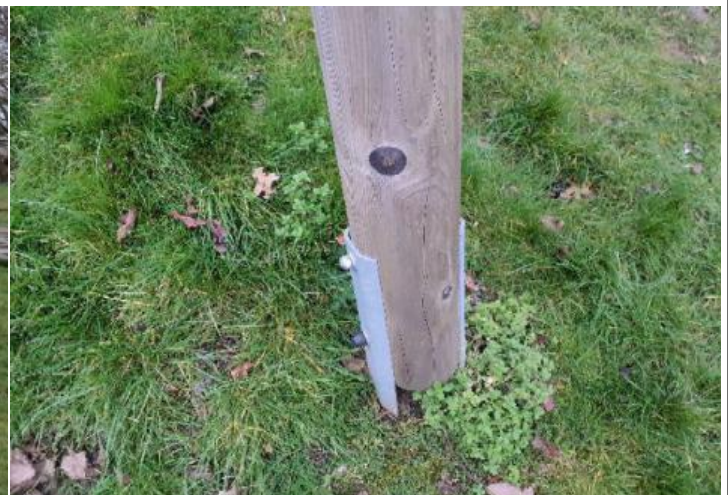
Finding: There is/are bolt cap covers missing or damaged on the item
Action: Replace missing or damaged bolt cap covers
