## Annual Inspection

Winchester City Council

Meonwara PA (West Meon PC)

Meonwara Crescent, West Meon, Winchester, Hampshire

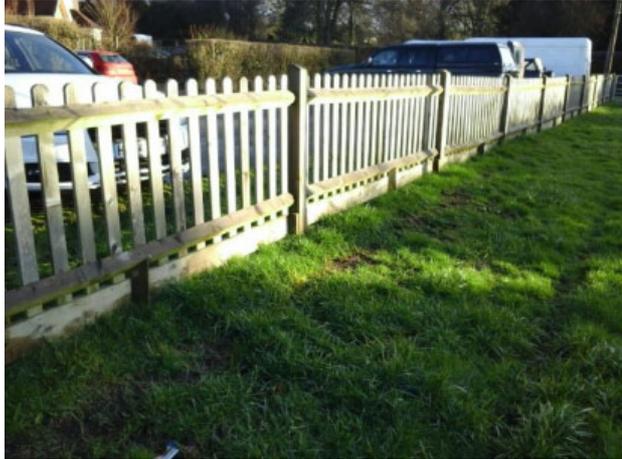
**Item:** Ancillary Items - Fencing - Timber  
**Manufacturer:** Owner/Operator  
**Surface Type:** Grass  
**Equipment Compliance:** N/A  
**Surface Area Compliance:** N/A  
**Ref/Part Number:**  
**Total Findings:** 1

This item is satisfactory - no work required

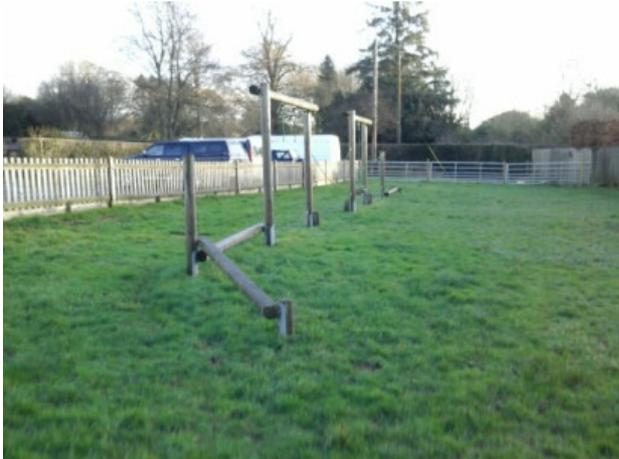
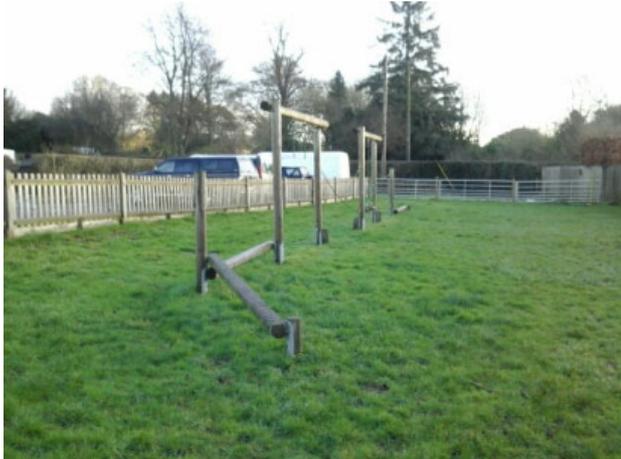
**2 - Very Low Risk (Finding 1)**

It is recommended that information signs with emergency contact details are installed at each entrance/exit point to the playground - Provide in accordance with the recommendations set out in BS EN 1176

<b>Finding:</b>	It is recommended that information signs with emergency contact details are installed at each entrance/exit point to the playground	<b>Action:</b>	Provide in accordance with the recommendations set out in BS EN 1176
-----------------	---	----------------	--

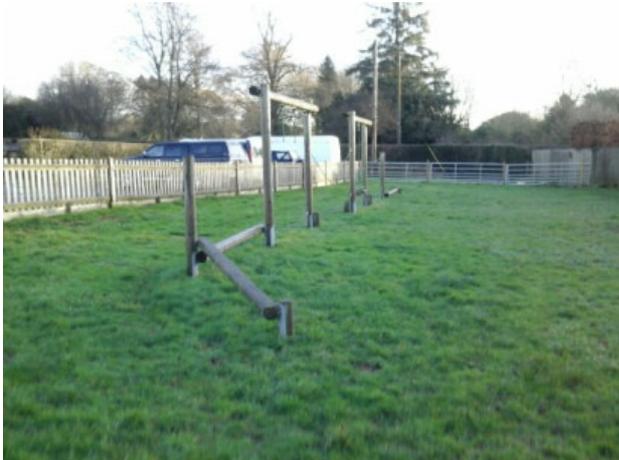
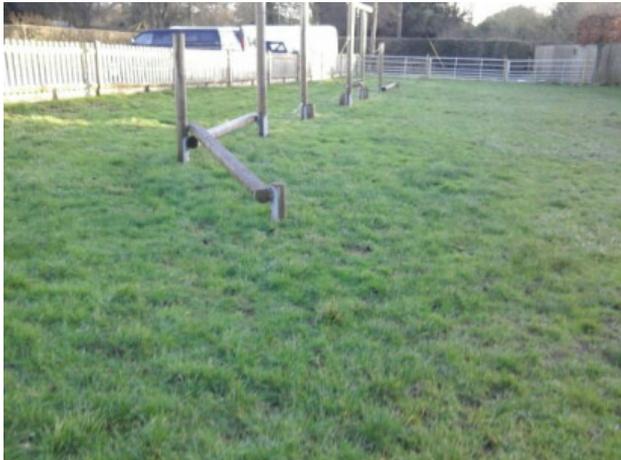
**6 - Low Risk (Finding 2)**

The grass is overgrown within the play area and may hide hazards - Reduce the length of grass to an acceptable height and maintain

<b>Finding:</b>	The grass is overgrown within the play area and may hide hazards	<b>Action:</b>	Reduce the length of grass to an acceptable height and maintain
-----------------	--	----------------	---

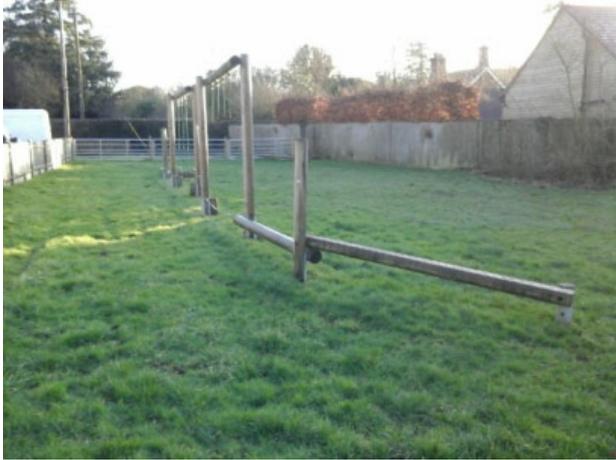
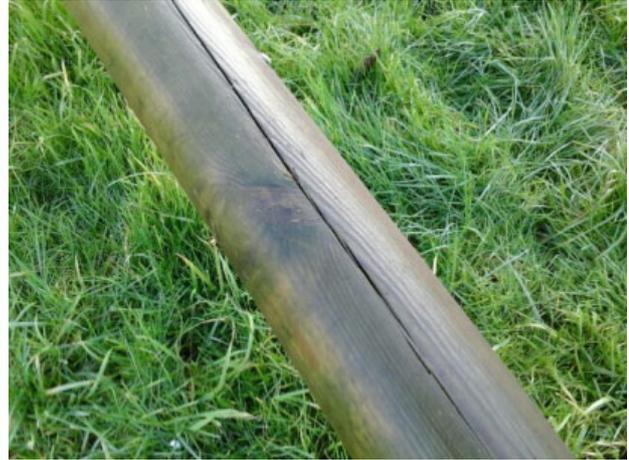
6 - Low Risk (Finding 1)

The timber has a number of air cracks apparent, the splits will have penetrated the preservative applied to the timber and allow water ingress to the unprotected areas - Monitor for any deterioration (rot) and replace as required

**Finding:** The timber has a number of air cracks apparent, the splits will have penetrated the preservative applied to the timber and allow water ingress to the unprotected areas

**Action:** Monitor for any deterioration (rot) and replace as required

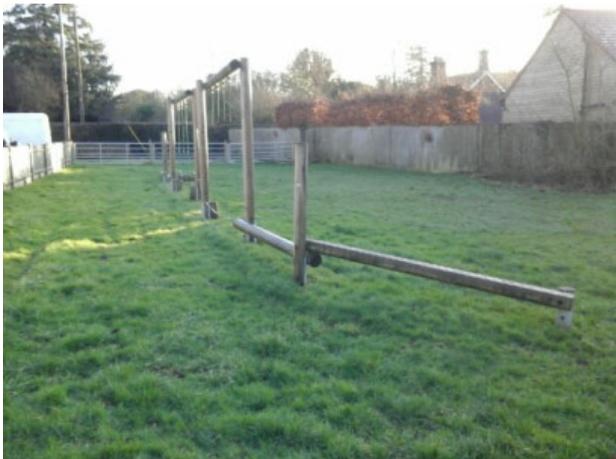
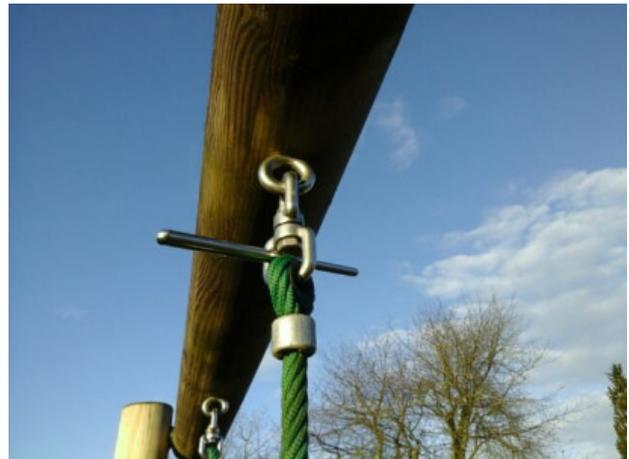
5 - Very Low Risk (Finding 2)

The connecting links are in excess of 8.6mm and less than 12mm and fail the requirements of BS EN 1176:2008 Part 1; clause 4.2.13, Chains - Monitor use and replace with compliant links at the next maintenance cycle

**Finding:** The connecting links are in excess of 8.6mm and less than 12mm and fail the requirements of BS EN 1176:2008 Part 1; clause 4.2.13, Chains

**Action:** Monitor use and replace with compliant links at the next maintenance cycle

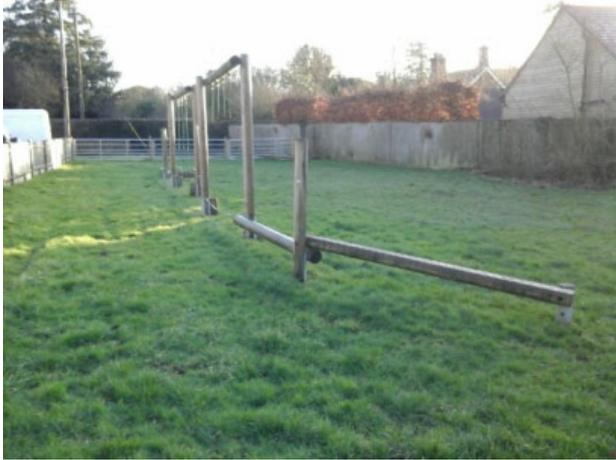
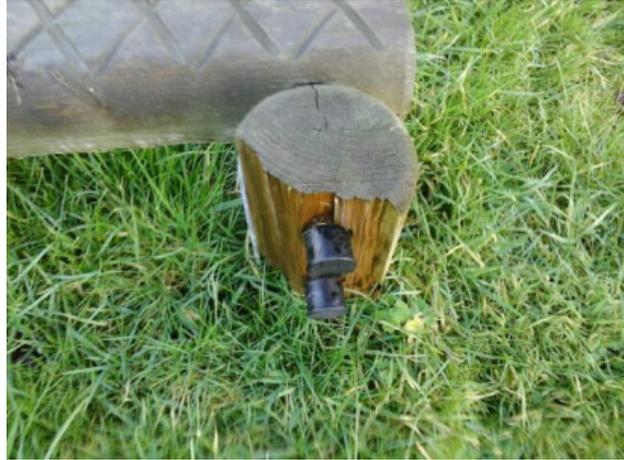
6 - Low Risk (Finding 3)

Parts of the timber are rough or splintered - Remove all rough or sharp edges

**Finding:** Parts of the timber are rough or splintered

**Action:** Remove all rough or sharp edges

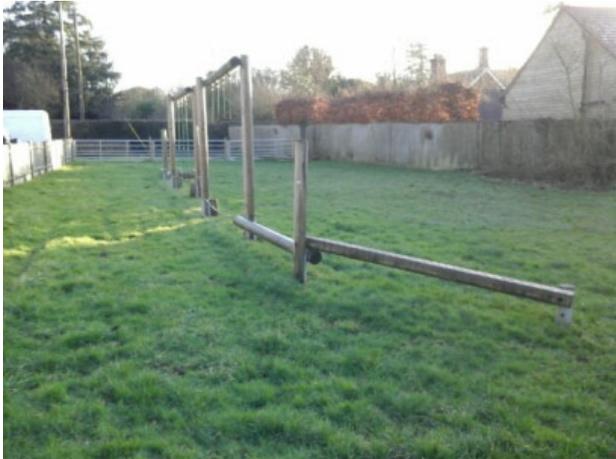
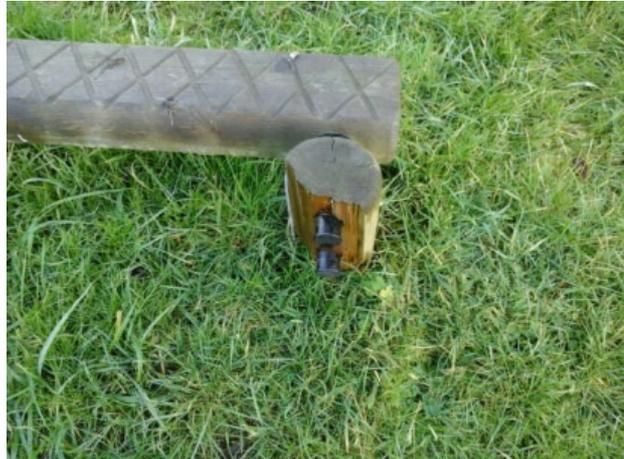
6 - Low Risk (Finding 4)

The timber is damaged - Monitor use and replace if required

**Finding:** The timber is damaged

**Action:** Monitor use and replace if required
