## Annual Inspection

Winchester City Council

West Meon Village Hall RG (West Meon PC)

Annual Inspection - 16 January 2018 at 09:20 Inspector: Matt Clay (RPII Annual Inspector)

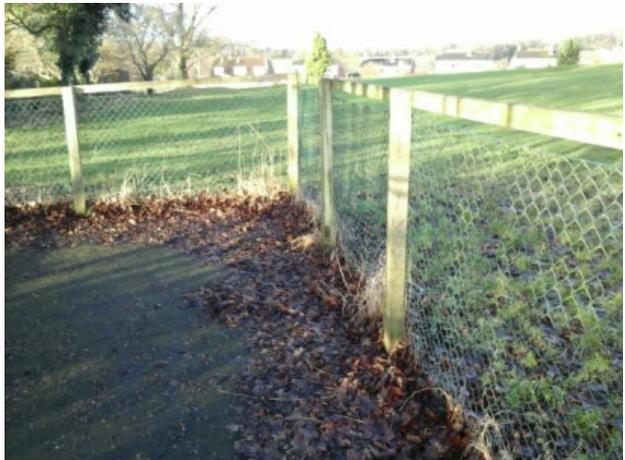
There are areas or parts of the timber on the structure that have rotted - Replace all affected timbers

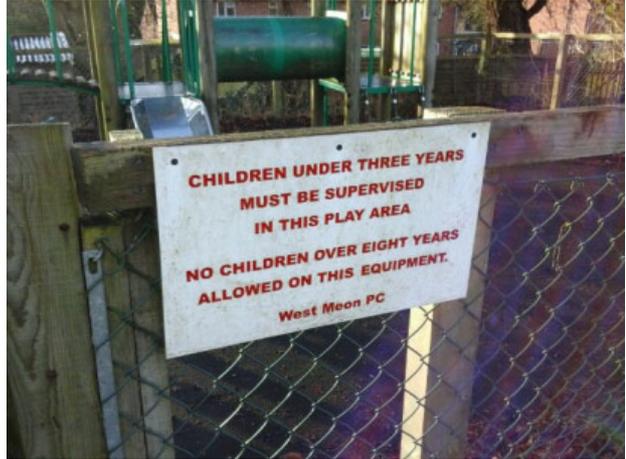
It is recommended that information signs with emergency contact details are installed at each entrance/exit point to the playground - Provide in accordance with the recommendations set out in BS EN 1176

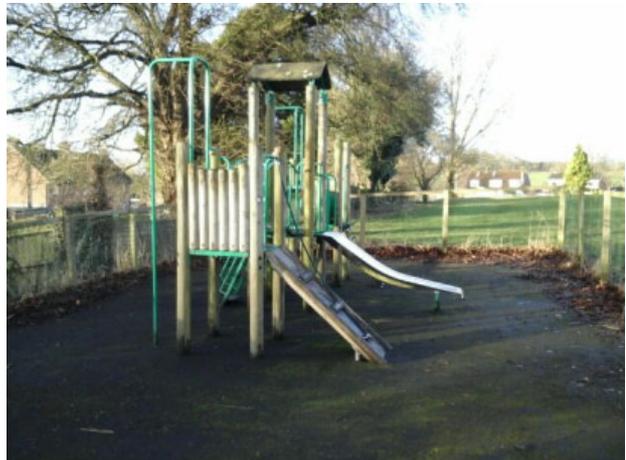
There is algae or moss growth on the surface resulting in slippery conditions - Clean and treat appropriately

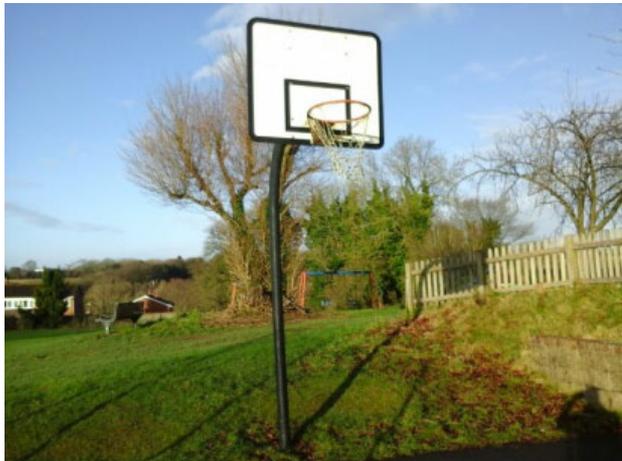
The net is damaged - Replace

The paintwork on this item has been damaged or worn exposing the metal underneath which is rusting - Treat any rusting components and repaint

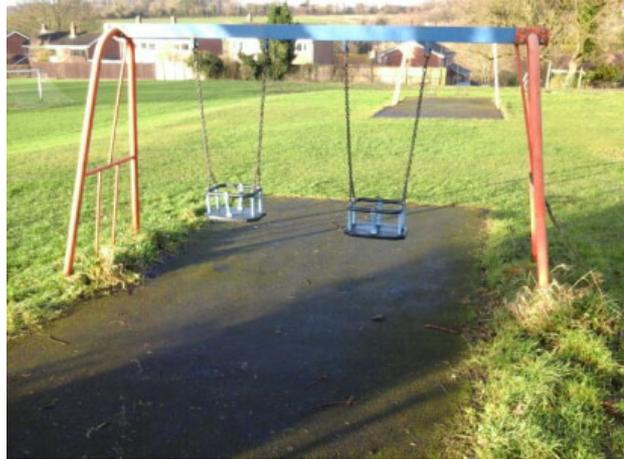
The paintwork on this item has been damaged or worn exposing the metal underneath which is rusting - Treat any rusting components and repaint

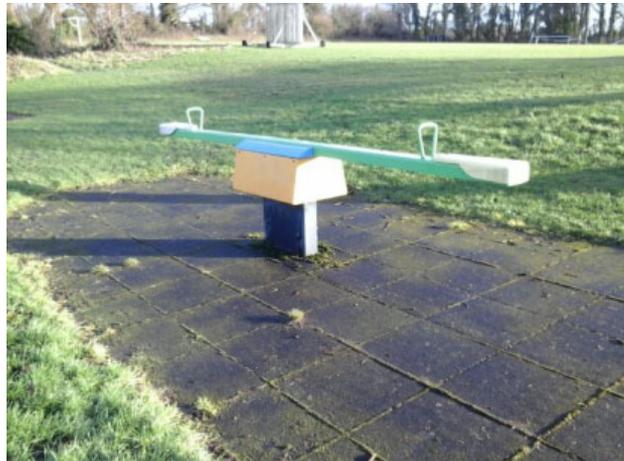
Parts of the steel on this item have corroded excessively and the metal has perforated in places - Ensure all affected areas are treated and repaired

The seat has minor damage or wear - Monitor for any further deterioration and replace as required

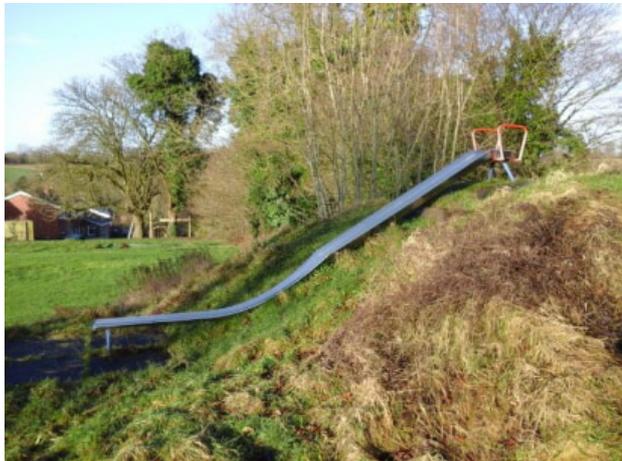
The grass is overgrown within the play area and may hide hazards - Reduce the length of grass to an acceptable height and maintain

The slide start section incline is not in the direction of travel; it should slope towards the direction of the sliding surface - Monitor use

The paintwork on this item has been damaged or worn exposing the metal underneath which is rusting - Treat any rusting components and repaint

There is a toggle entrapment at the top of the slide - Monitor Use

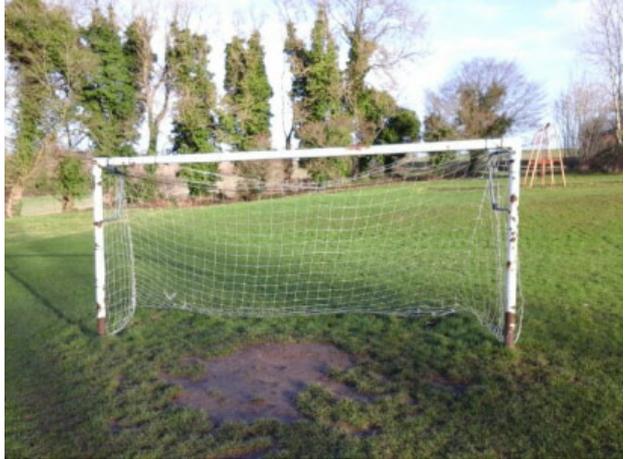
The surface is worn around the item - Reinststate surface levels as required

The paintwork on this item has been damaged or worn exposing the metal underneath which is rusting - Treat any rusting components and repaint

The net is loose / damaged - Repair / secure

The item is slightly loose in its foundations - Monitor for any further deterioration and repair as required

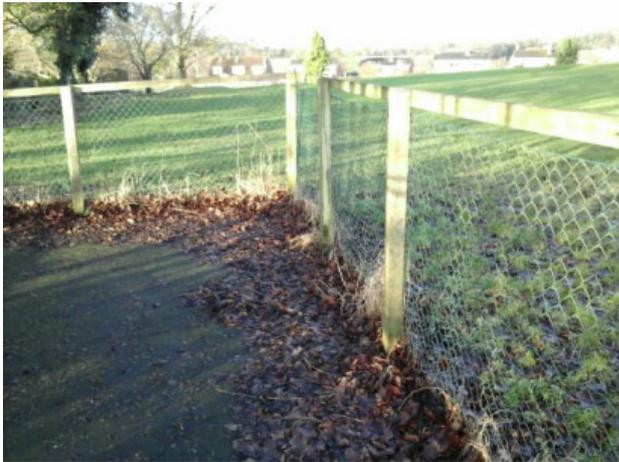
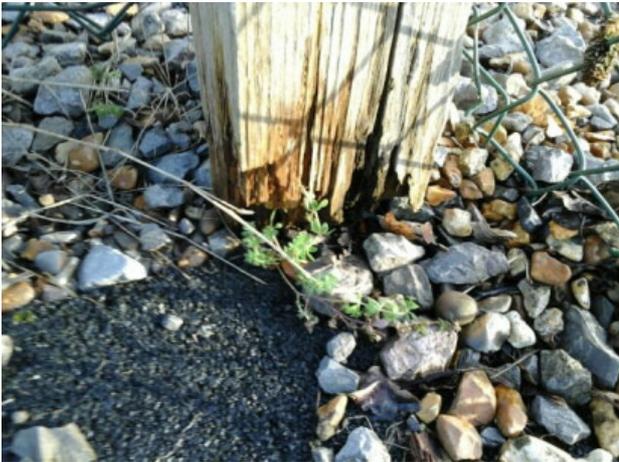
<b>8 - Low Risk (Finding 1)</b>			
<b>Item:</b>	Ancillary Items - Fence - Timber & Mesh Infill	<b>Risk Level:</b>	L - Low Risk
<b>Manufacturer:</b>	Owner/Operator	<b>Surface:</b>	Grass

<b>Finding:</b>	There are areas or parts of the timber on the structure that have rotted		<b>Action:</b> Replace all affected timbers

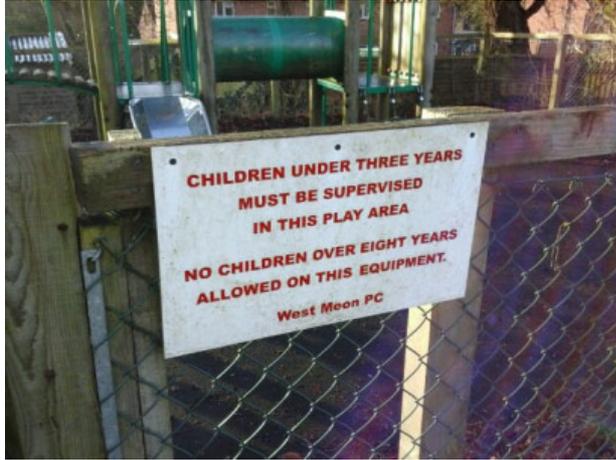
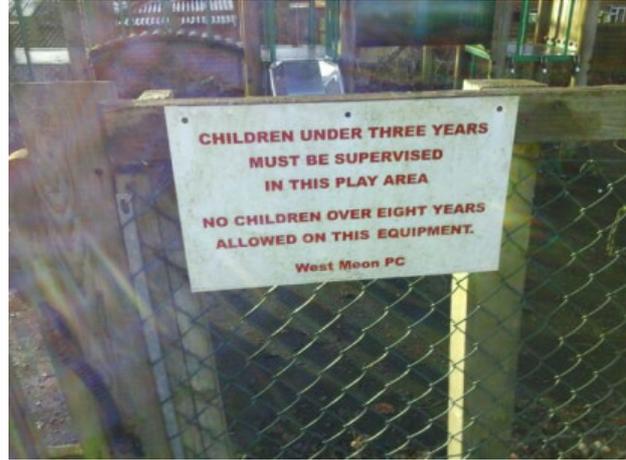
2 - Very Low Risk (Finding 1)

**Finding:** It is recommended that information signs with emergency contact details are installed at each entrance/exit point to the playground

**Action:** Provide in accordance with the recommendations set out in BS EN 1176

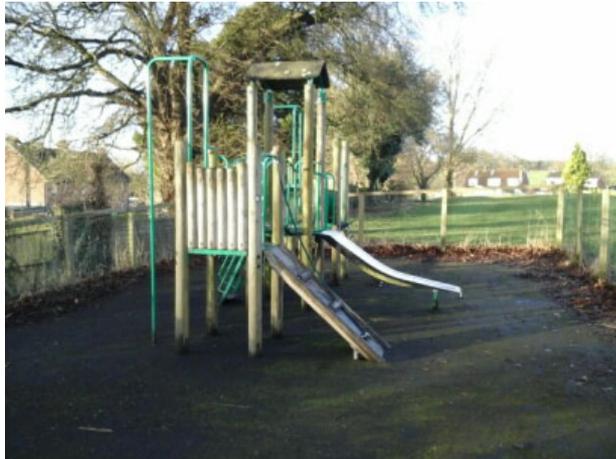
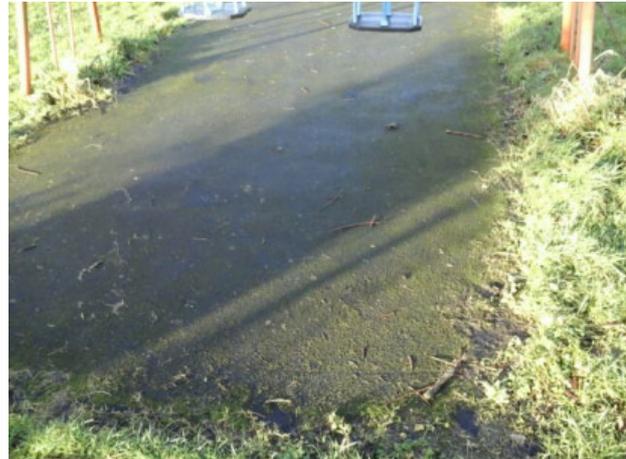
8 - Low Risk (Finding 1)

**Finding:** There is algae or moss growth on the surface resulting in slippery conditions

**Action:** Clean and treat appropriately

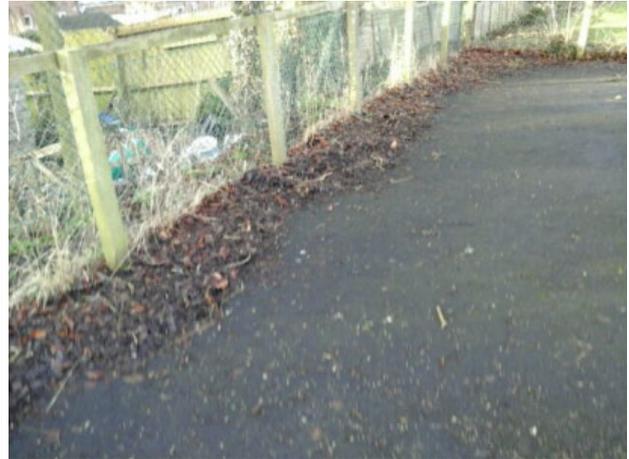
6 - Low Risk (Finding 1)

**Finding:** There is some tree debris on the surfacing

**Action:** Remove and maintain

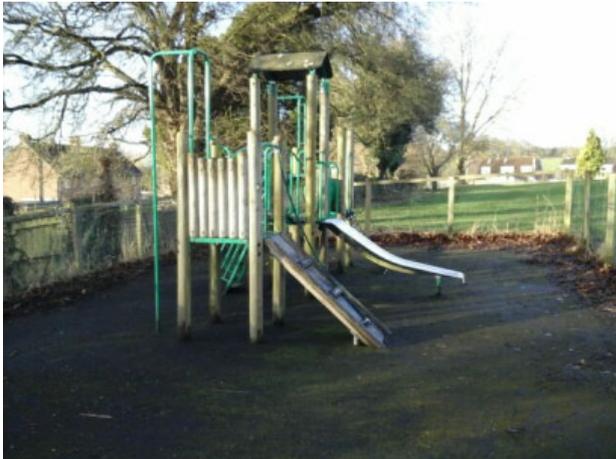
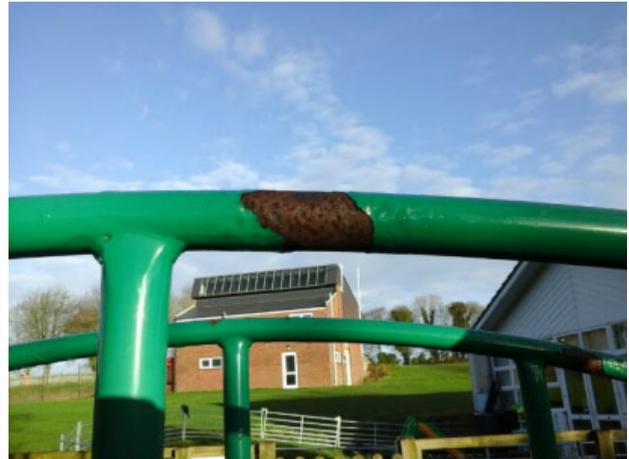
6 - Low Risk (Finding 2)

**Finding:** The paintwork on this item has been damaged or worn exposing the metal underneath which is rusting

**Action:** Treat any rusting components and repaint

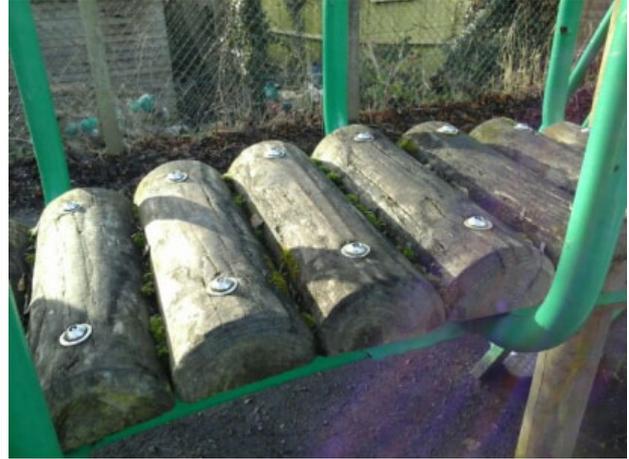
8 - Low Risk (Finding 3)

**Finding:** There is algae or moss on the surface of the equipment

**Action:** Clean and treat appropriately

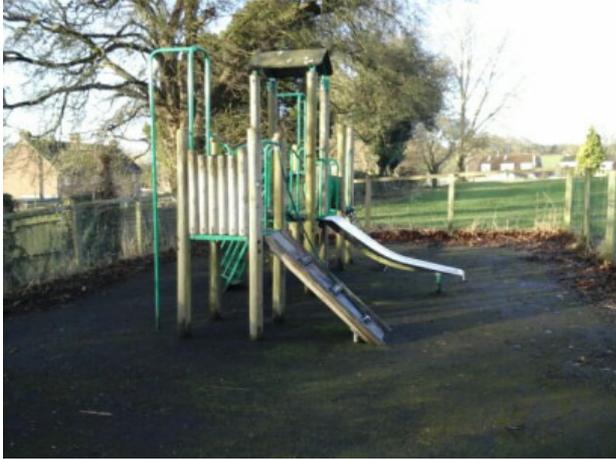
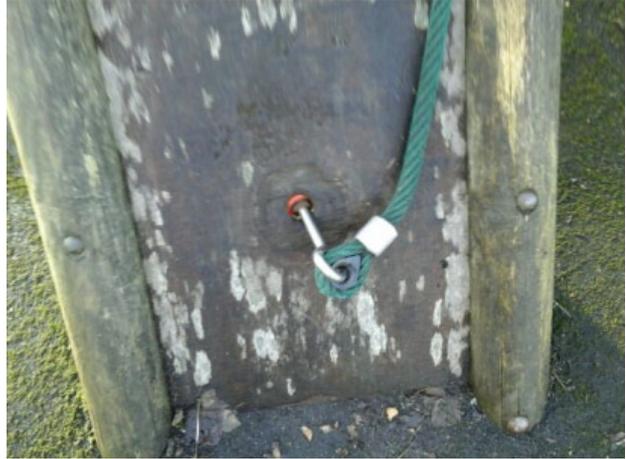
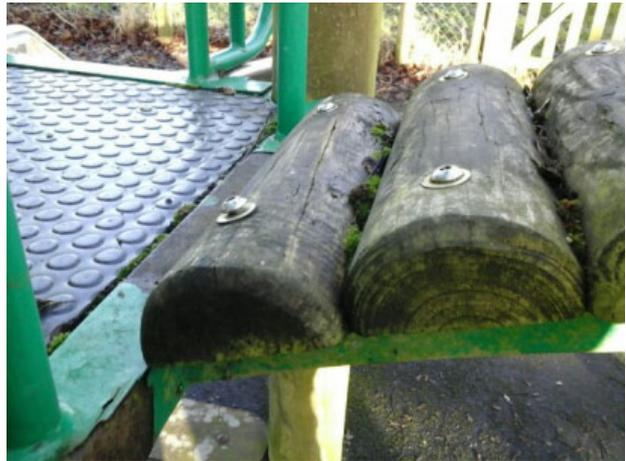
6 - Low Risk (Finding 4)

**Finding:** A number of fixing(s) have worked loose

**Action:** Secure all loose fixings

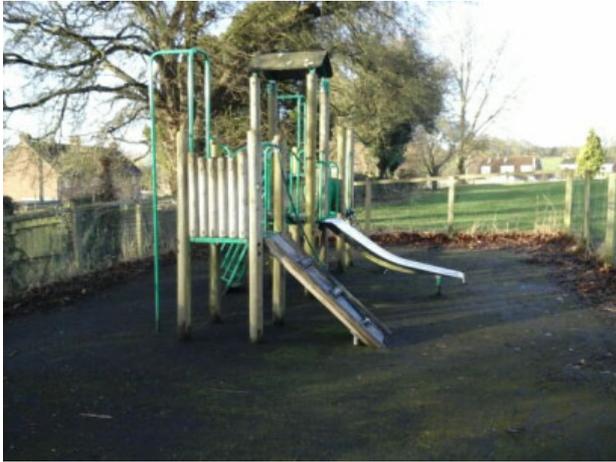
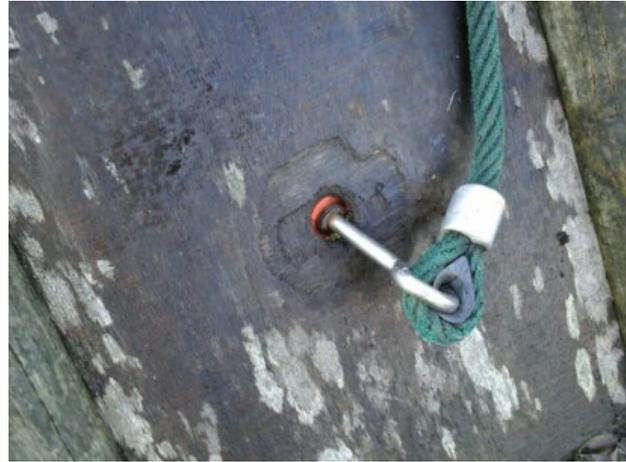
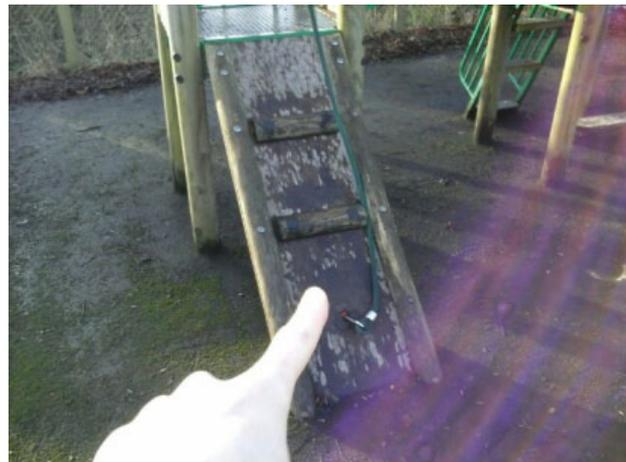
12 - Moderate Risk (Finding 5)

**Finding:** There are areas or parts of the timber on the ramp that have rotted

**Action:** Replace all affected timbers

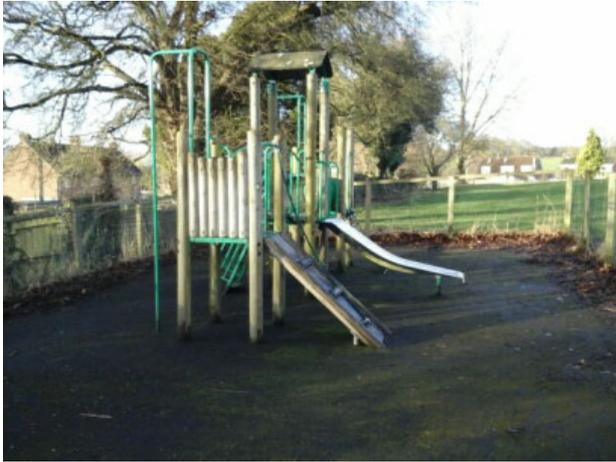
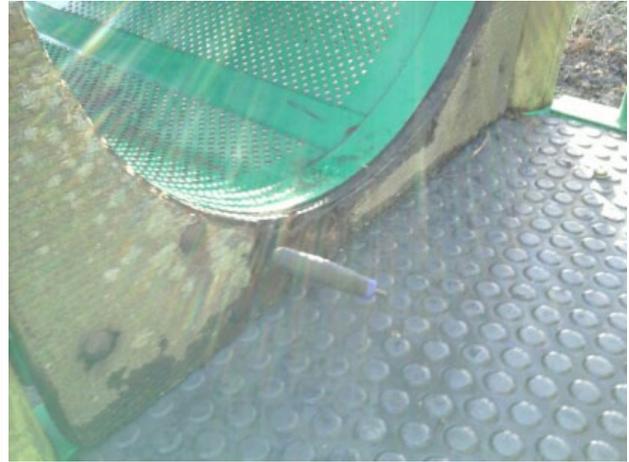
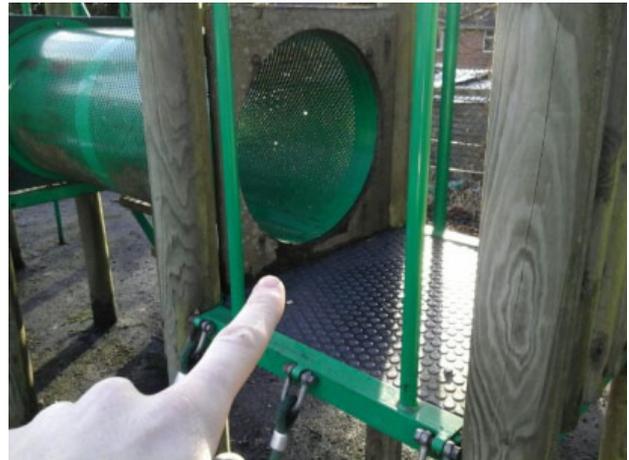
12 - Moderate Risk (Finding 6)

**Finding:** There are areas or parts of the timber on the tunnel that have rotted

**Action:** Replace all affected timbers

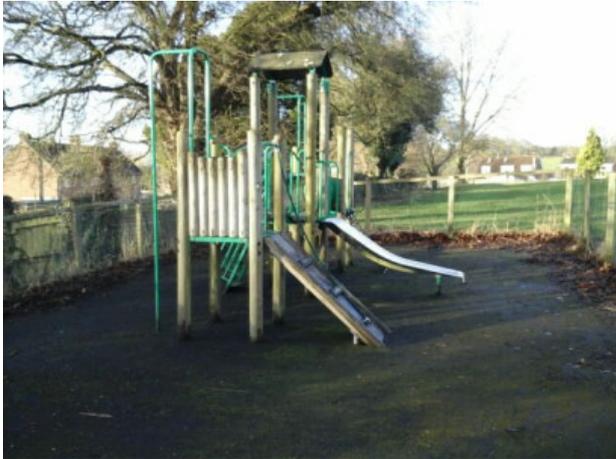
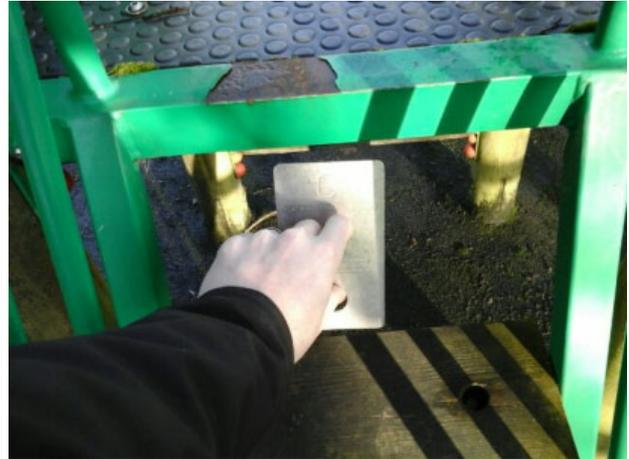
5 - Very Low Risk (Finding 7)

**Finding:** The item fails to meet the requirements of BS EN 1176:2008 Part 1 4.2.7.2 head and neck entrapment in the barriers and/or steps

**Action:** Monitor use

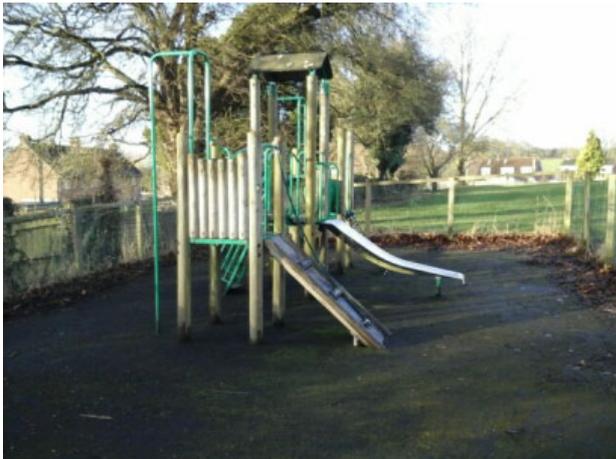
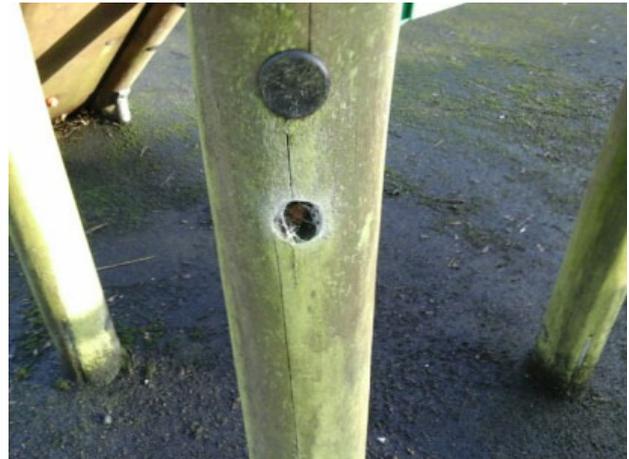
6 - Low Risk (Finding 8)

**Finding:** There is/are several inserts missing

**Action:** Replace missing inserts

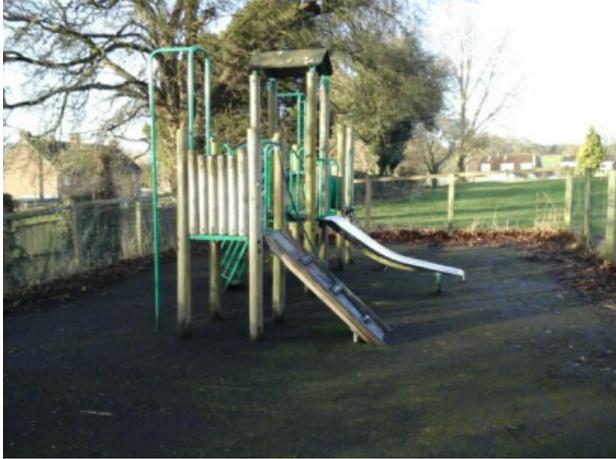
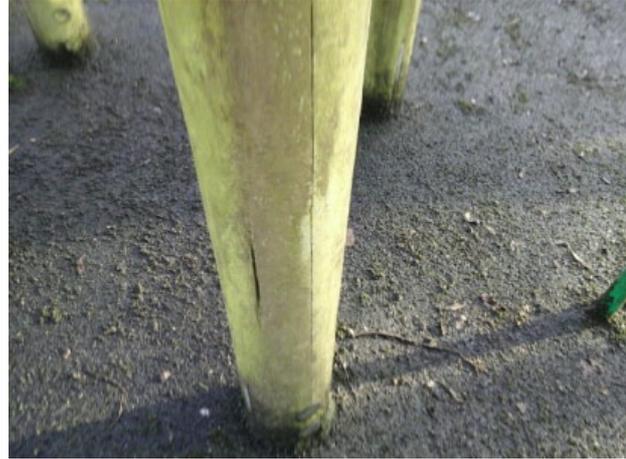
6 - Low Risk (Finding 9)

**Finding:** The timber has a number of air cracks apparent, the splits will have penetrated the preservative applied to the timber and allow water ingress to the unprotected areas

**Action:** Monitor for any deterioration (rot) and replace as required

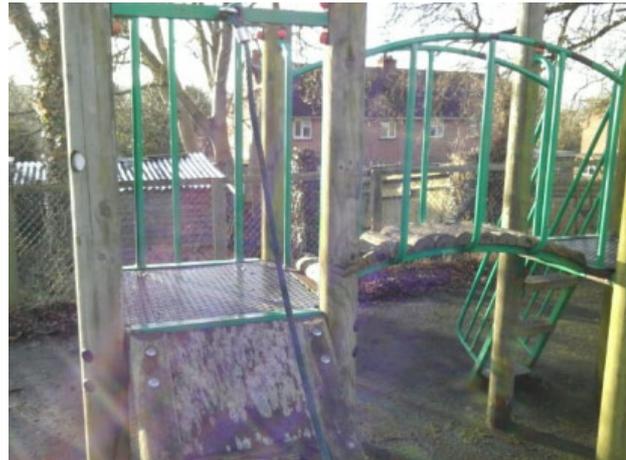
8 - Low Risk (Finding 10)

**Finding:** The unit is easily accessible and should have the appropriate barriers installed as the height of the unit exceeds 600mm

**Action:** Monitor use

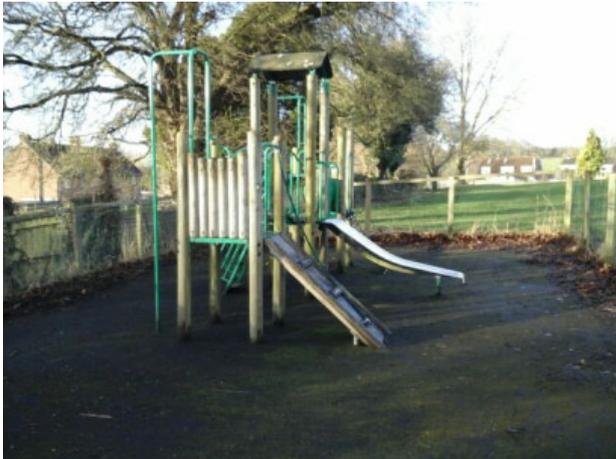
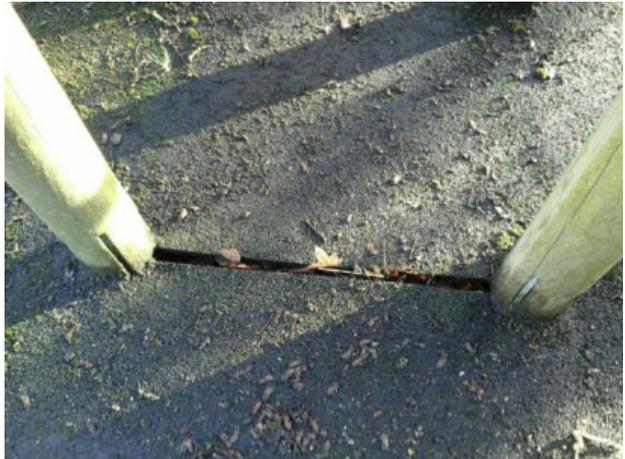
6 - Low Risk (Finding 12)

**Finding:** There are gaps opening between the surfacing and the edging surround or between the joints in the surfacing

**Action:** Monitor for any further deterioration and repair as required

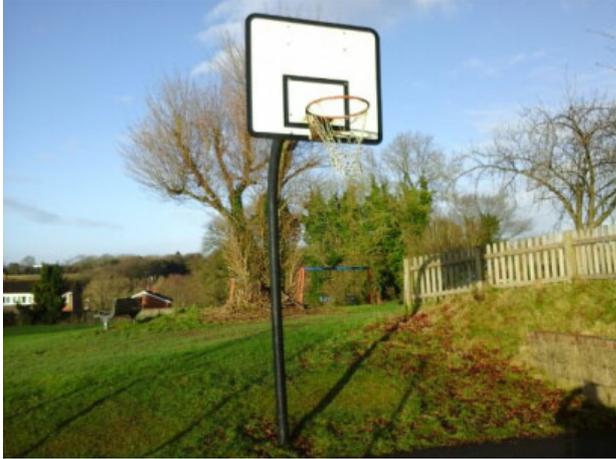
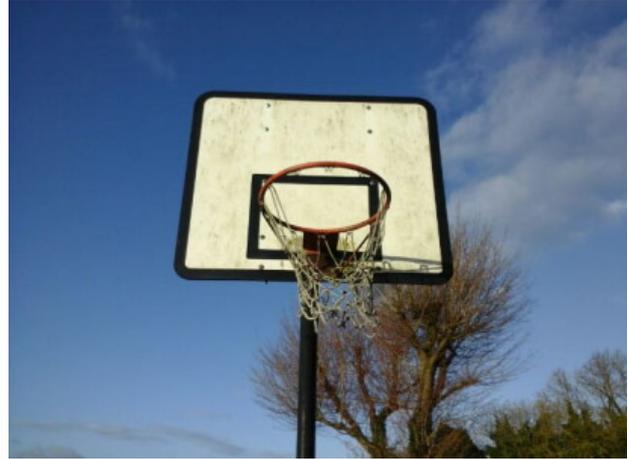
6 - Low Risk (Finding 1)

**Finding:** The net is damaged

**Action:** Replace

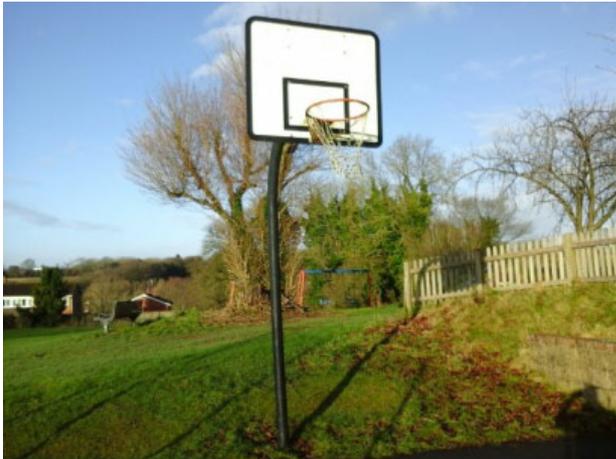
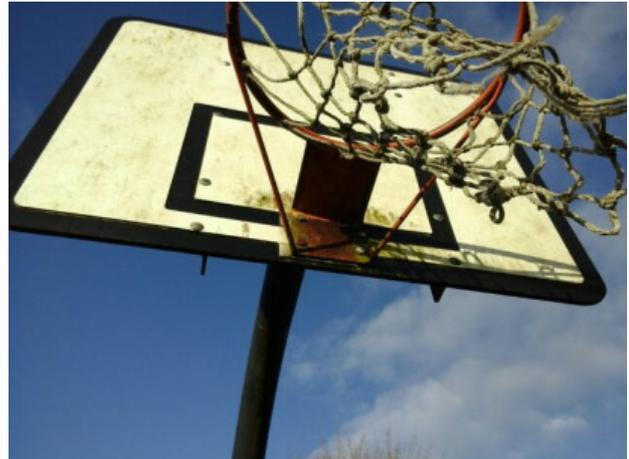
6 - Low Risk (Finding 2)

**Finding:** The paintwork on this item has been damaged or worn exposing the metal underneath which is rusting

**Action:** Treat any rusting components and repaint

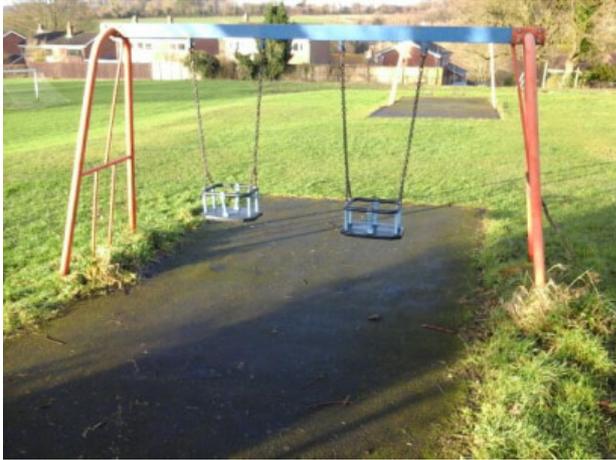
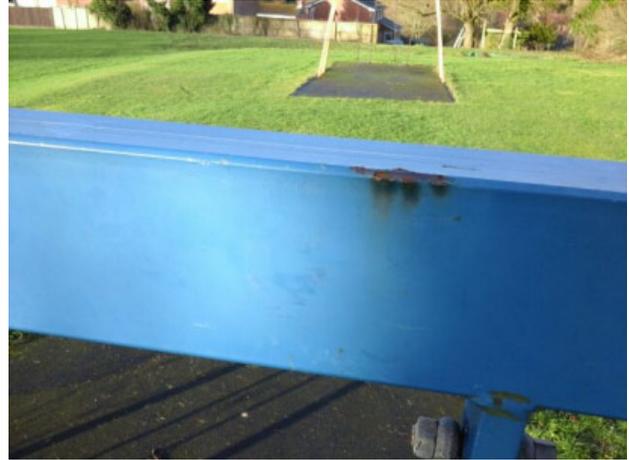
6 - Low Risk (Finding 1)

**Finding:** The paintwork on this item has been damaged or worn exposing the metal underneath which is rusting

**Action:** Treat any rusting components and repaint

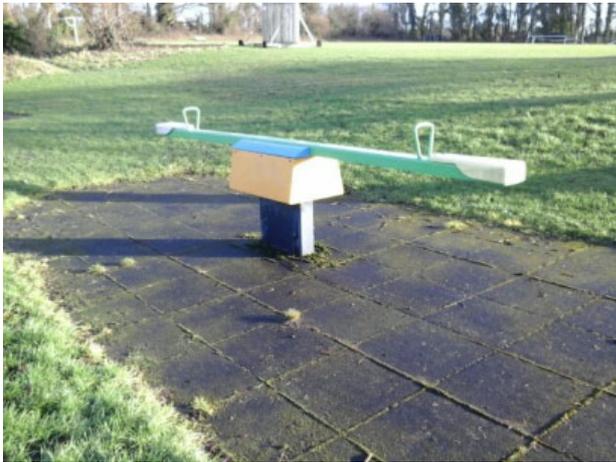
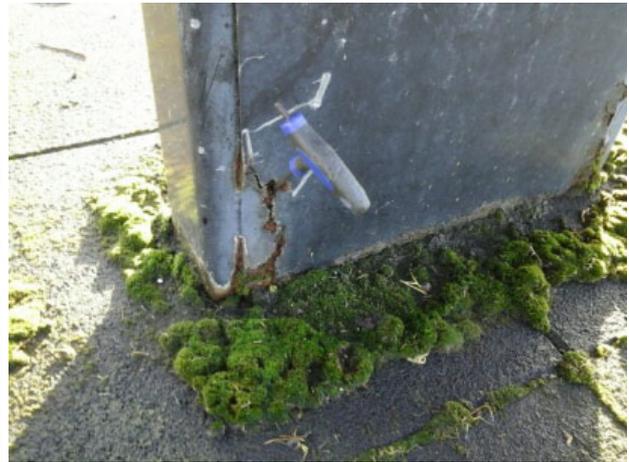
12 - Moderate Risk (Finding 1)

**Finding:** Parts of the steel on this item have corroded excessively and the metal has perforated in places

**Action:** Ensure all affected areas are treated and repaired

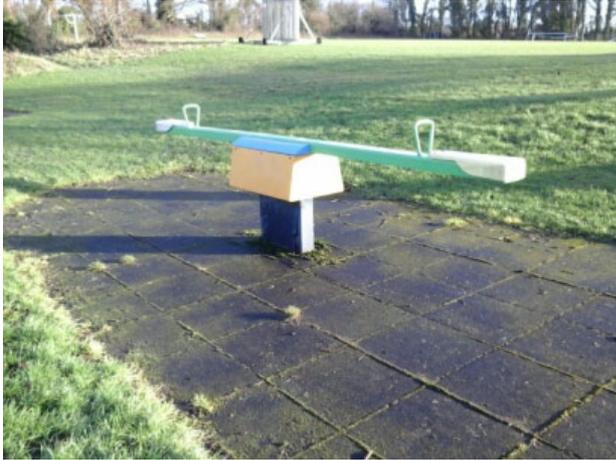
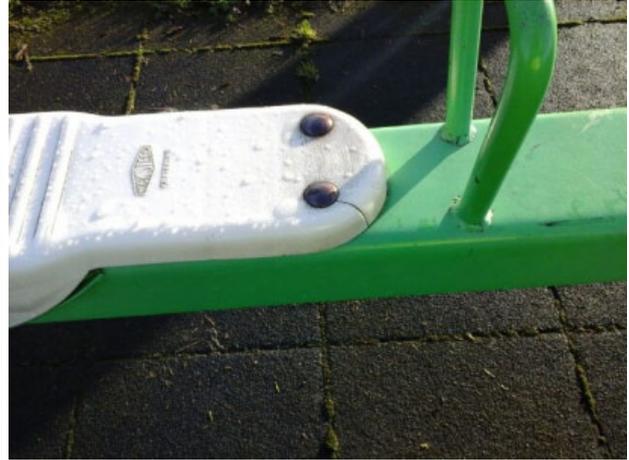
6 - Low Risk (Finding 2)

**Finding:** The seat has minor damage or wear

**Action:** Monitor for any further deterioration and replace as required

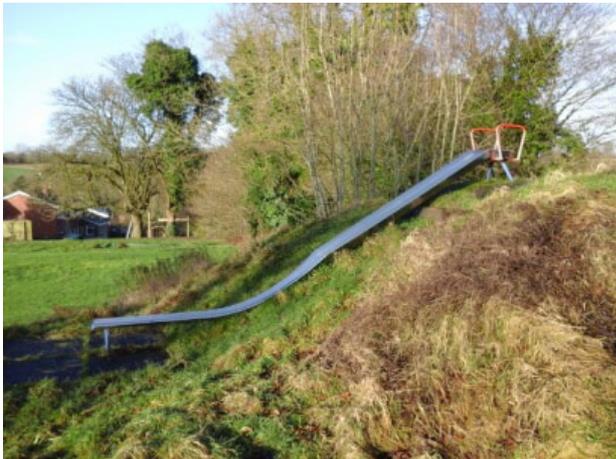
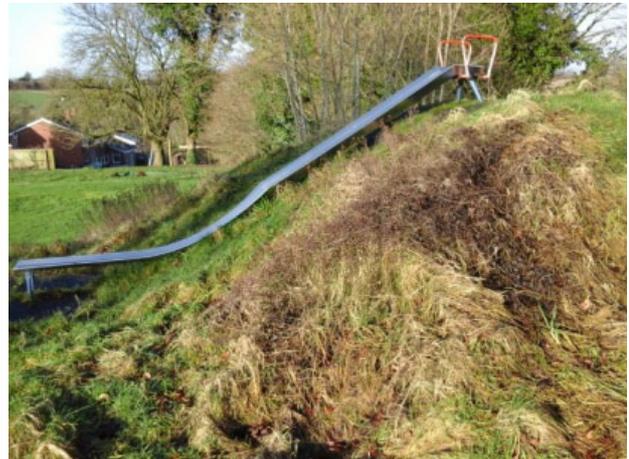
6 - Low Risk (Finding 1)

**Finding:** The grass is overgrown within the play area and may hide hazards

**Action:** Reduce the length of grass to an acceptable height and maintain

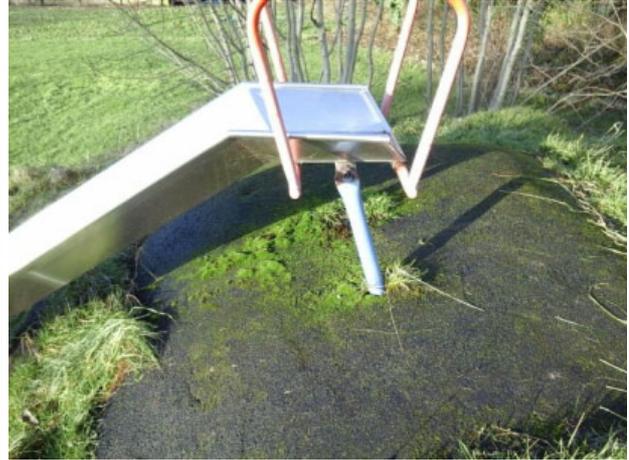
4 - Very Low Risk (Finding 2)

**Finding:** The slide start section incline is not in the direction of travel; it should slope towards the direction of the sliding surface

**Action:** Monitor use

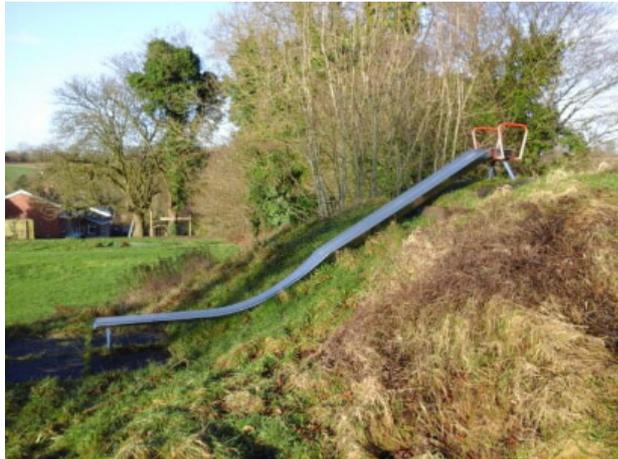
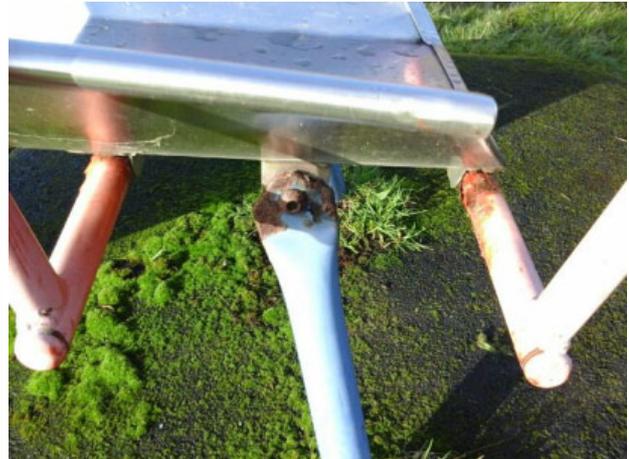
6 - Low Risk (Finding 3)

**Finding:** The paintwork on this item has been damaged or worn exposing the metal underneath which is rusting

**Action:** Treat any rusting components and repaint

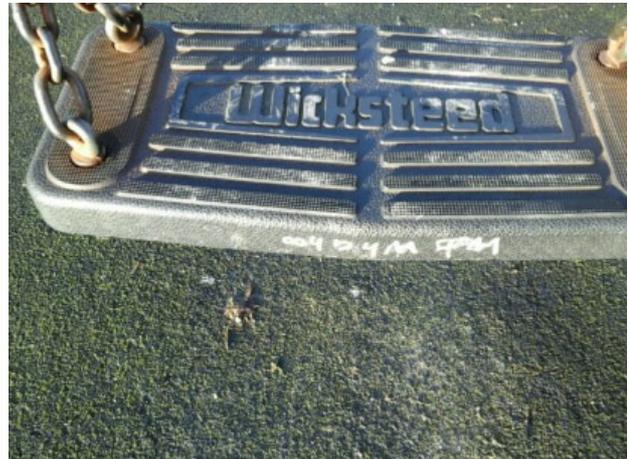
2 - Very Low Risk (Finding 1)

**Finding:** There is some graffiti present

**Action:** Remove the graffiti

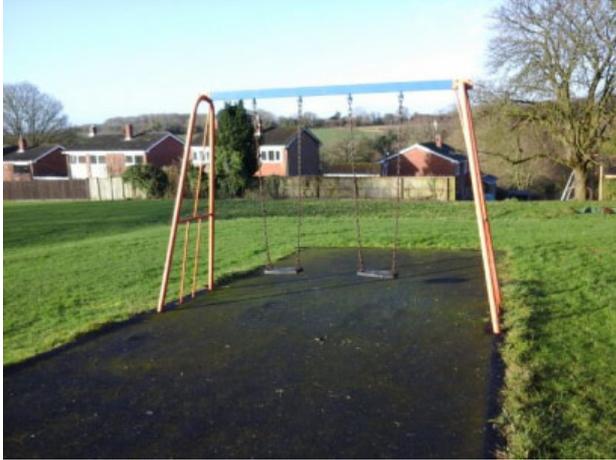
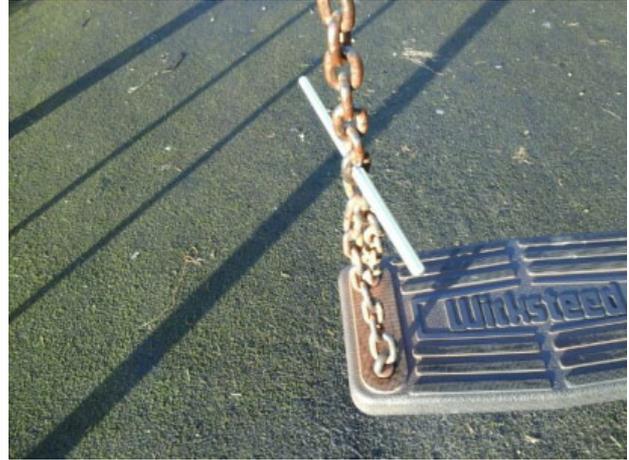
5 - Very Low Risk (Finding 2)

**Finding:** The chain openings are in excess of the 8.6mm as recommended by BS EN 1176

**Action:** Monitor use

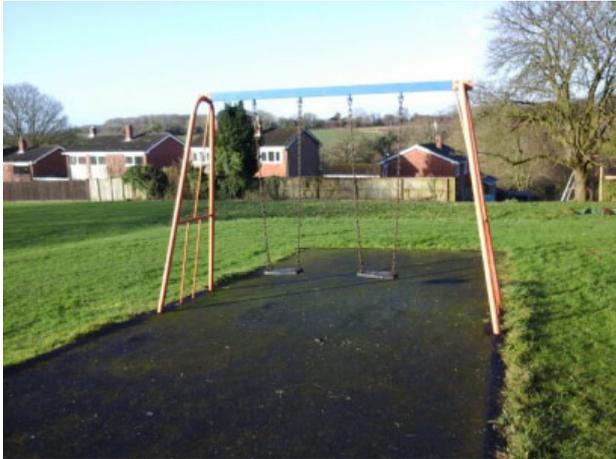
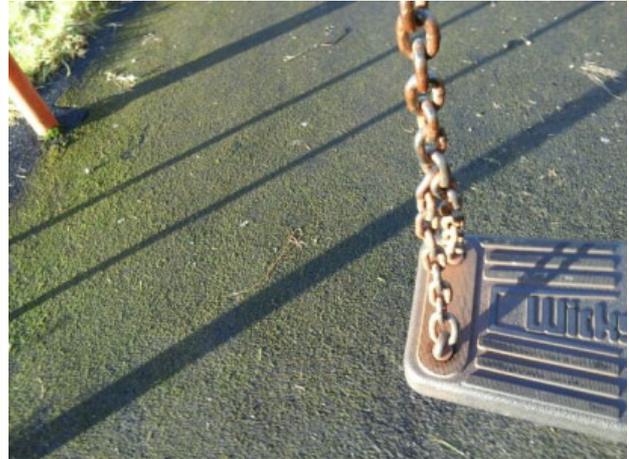
6 - Low Risk (Finding 3)

**Finding:** There is some notable evidence of chain wear

**Action:** Monitor for any further deterioration and replace when 40% worn

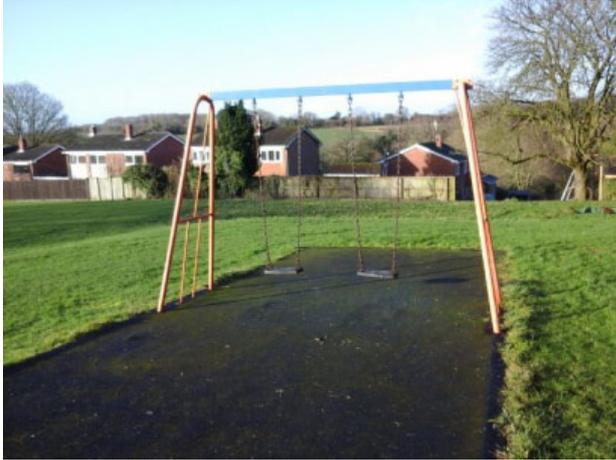
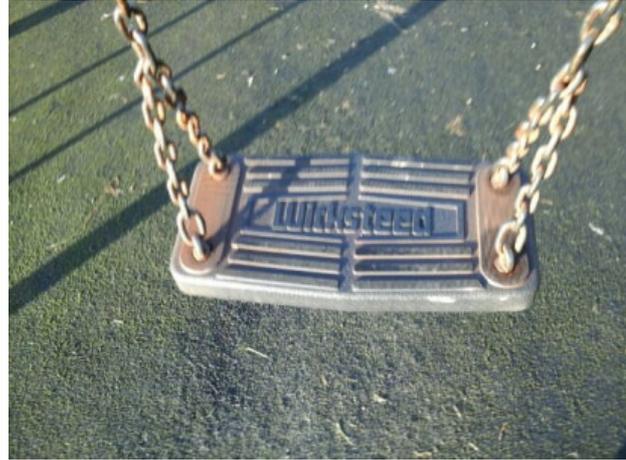
6 - Low Risk (Finding 4)

**Finding:** The swing seat connectors are loose

**Action:** Tighten to secure

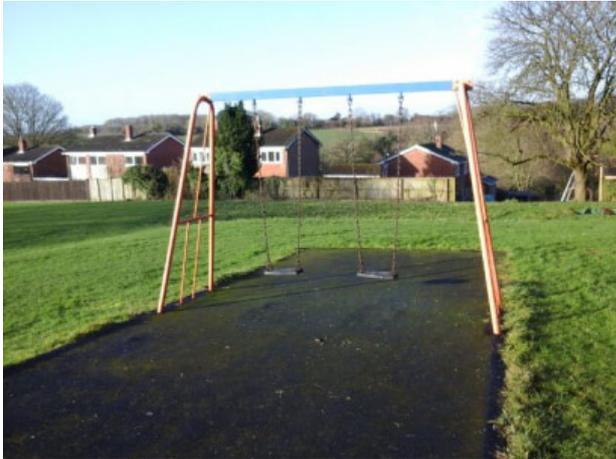
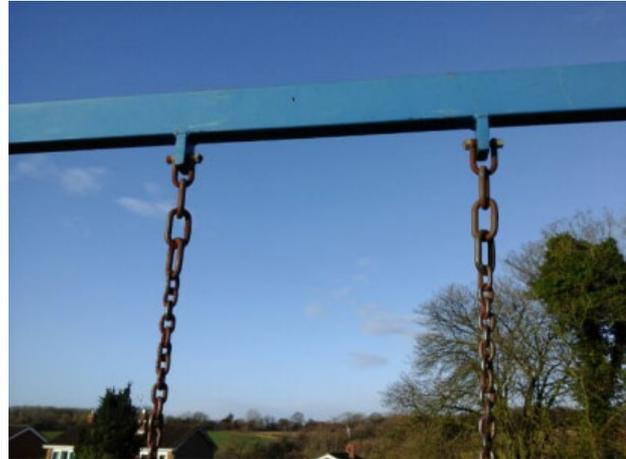
4 - Very Low Risk (Finding 5)

**Finding:** The bushes are showing signs of wear

**Action:** Monitor for any further deterioration and replace as required

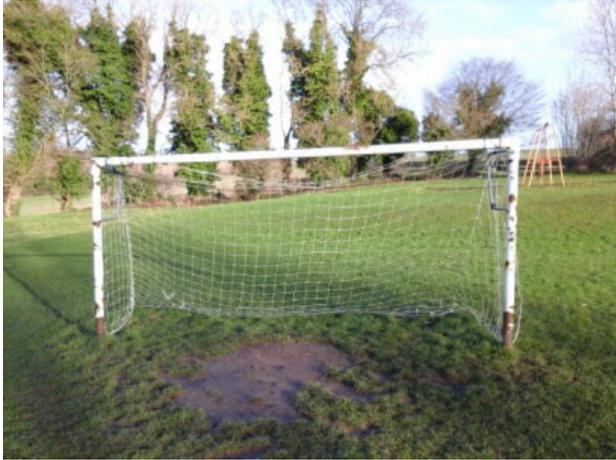
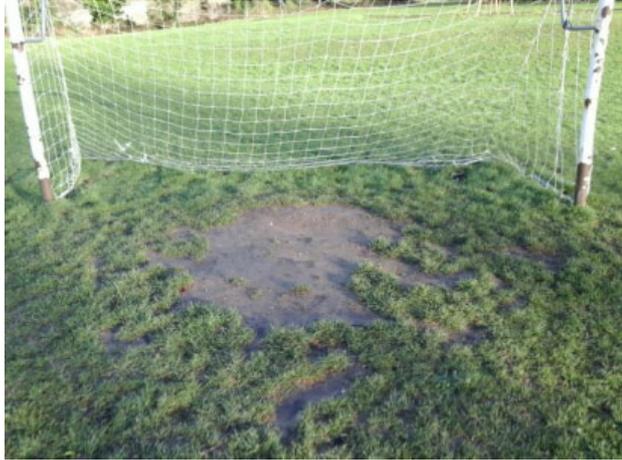
6 - Low Risk (Finding 1)

**Finding:** The surface is worn around the item **Action:** Reinstate surface levels as required

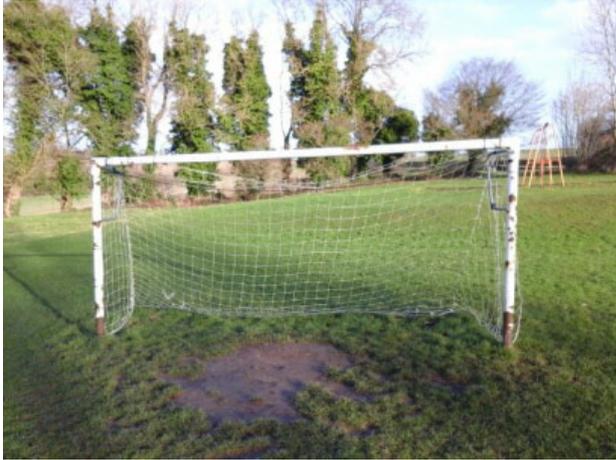
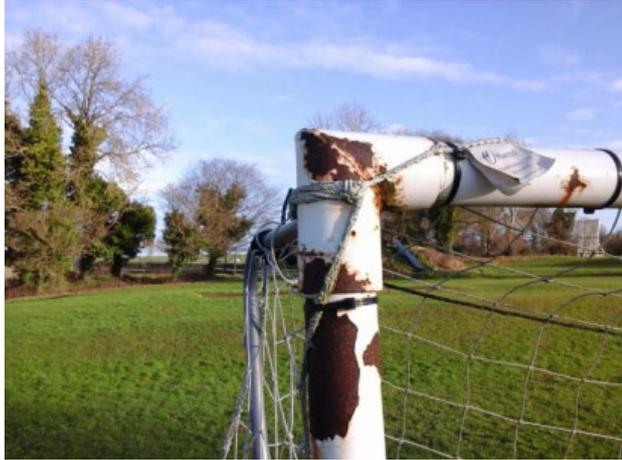
6 - Low Risk (Finding 3)

**Finding:** The paintwork on this item has been damaged or worn exposing the metal underneath which is rusting

**Action:** Treat any rusting components and repaint

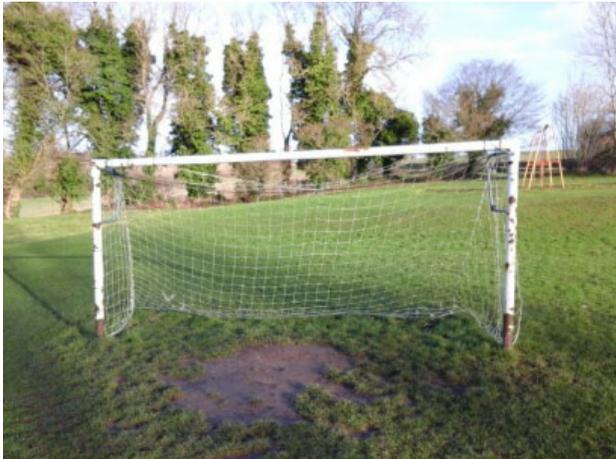
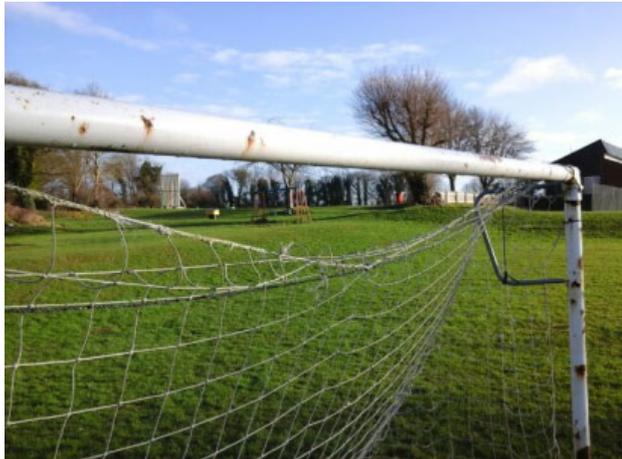
6 - Low Risk (Finding 4)

**Finding:** The net is loose / damaged

**Action:** Repair / secure

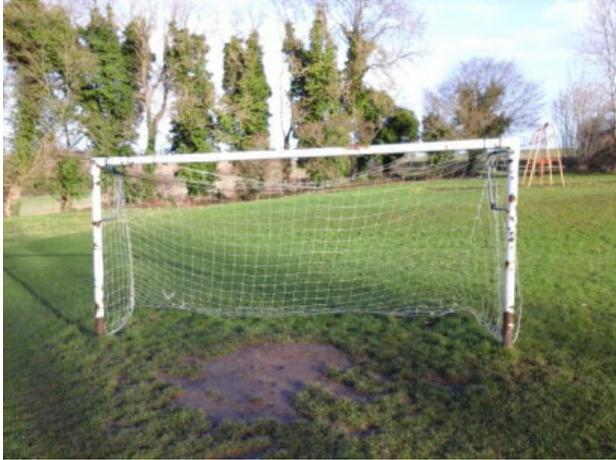
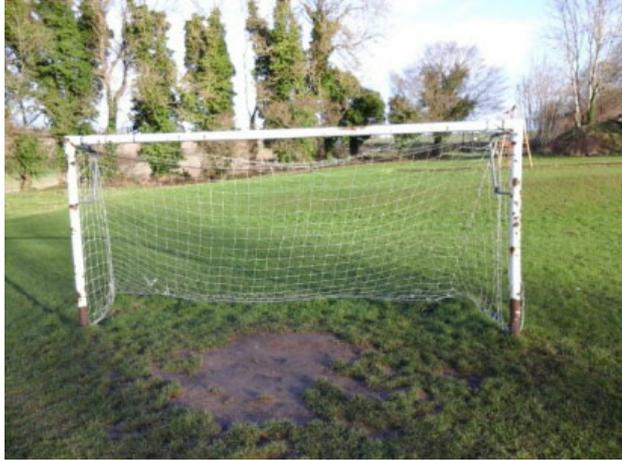
6 - Low Risk (Finding 5)

**Finding:** The item is slightly loose in its foundations

**Action:** Monitor for any further deterioration and repair as required
