Children's Play Area Annual Inspection Report

Doddington Parish Council

The Playing Field

19th July, 2018

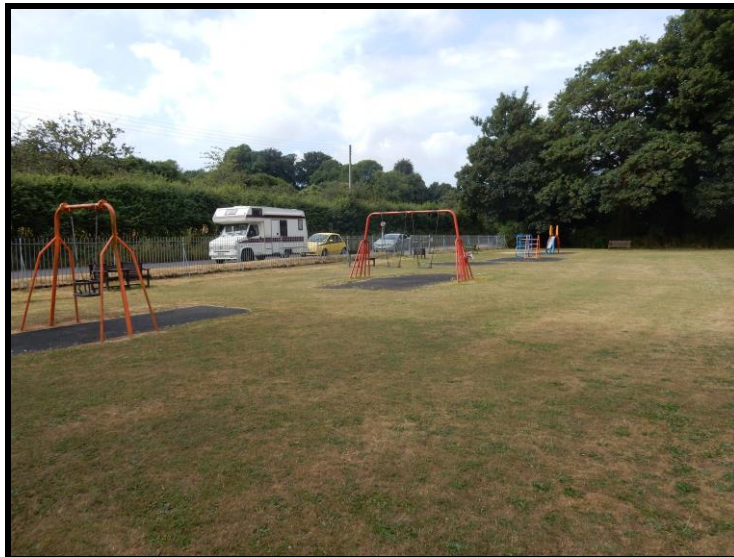
The play area is in good conditions and has improved since last year's inspection.

The site is adjacent a 'B' road. Road signs are in place and the play area is clearly visible from the road. However, parking may restrict visibility to the gates. ***Moderate Risk***

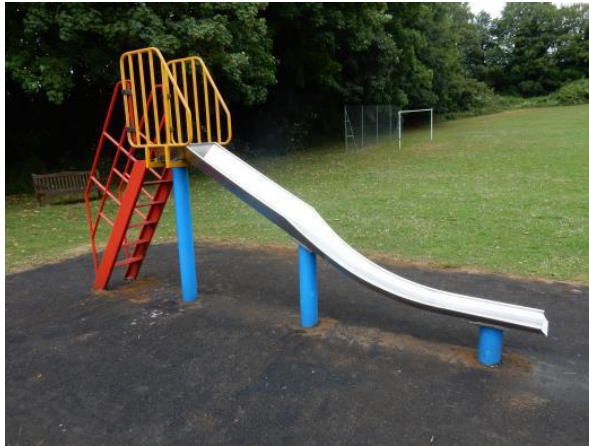
Slide & Steps

BS EN 1176 Compliance: No

1. The spacing to the barrier bars is in excess of 89mm. **Low Risk**
2. A slide barrier rail is not fitted across the access to the slide. **Low Risk**
3. There is a toggle entrapment at slide entry **Low Risk**

1. There is shrinkage to the edges. **Monitor** **Low Risk**

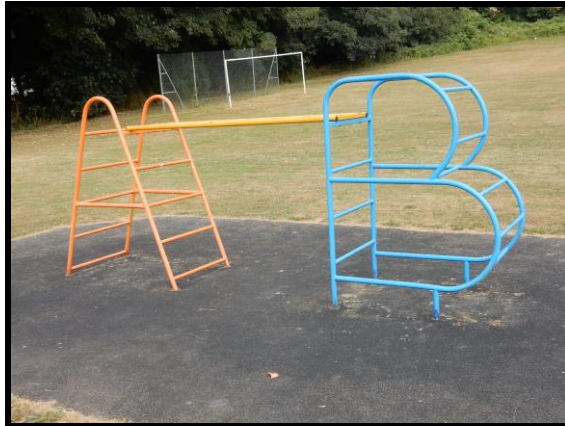
A & B Climber

1. There is a head/torso entrapment between the overhead ladder rungs. **Low Risk**

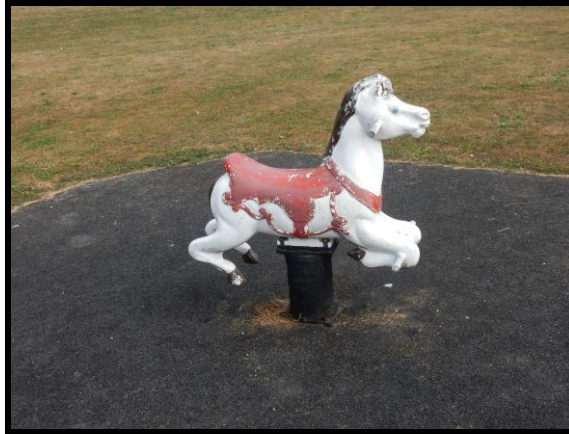
Spring Horse

1. The peg-type hand/foot grips fail BS EN 1176. A ball or similar should have a diameter of 15cm area on the end. (If circular the diameter should be over 22mm minimum). **Low Risk**

1. There is algae growth on the surface giving slippery conditions. ***It is recommended that the surface is cleaned and treated with an appropriate non-toxic weed killer.*** **Low Risk**

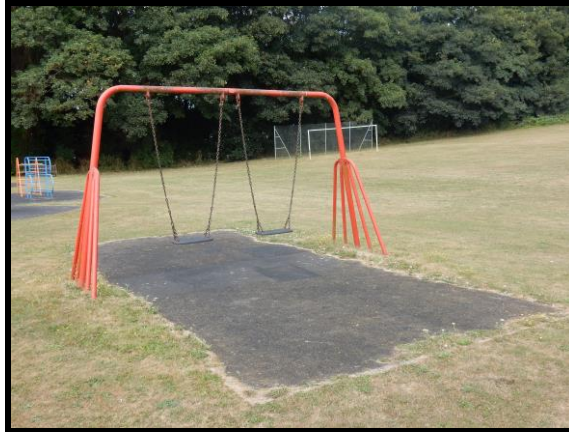
1 Bay, 2 Flat seats

1. There is some chain wear. **Monitor and replace at 40% wear.**
2. Remove the shackle bolt and check the bushes and shackle pins for wear. **Replace bushes/shackle pins if necessary.**
3. There are rusty areas to the frame and the paint is peeling and the frame is rusting **Repainting the swing frame with a lead free paint, or one that contains less than 0.25% in dry lead film, is recommended in the future.**

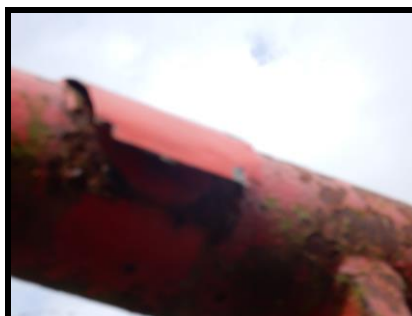
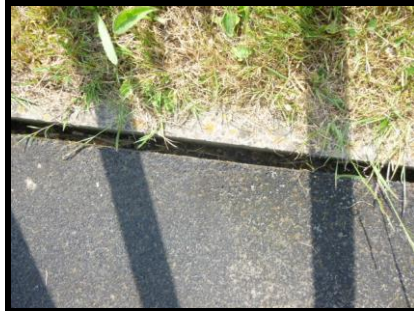
1. There is shrinkage to the edges at the side and under one seat.

Monitor

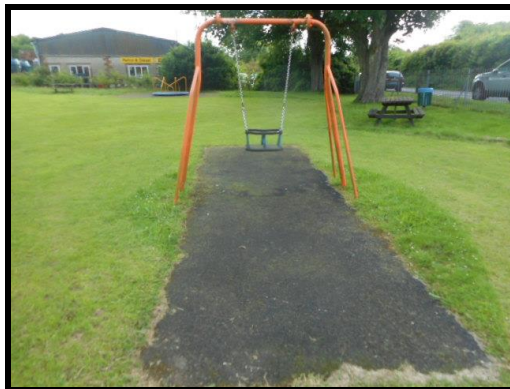
1 Bay 1 Cradle seat

1. There is some chain wear. **Monitor and replace at 40% wear.**

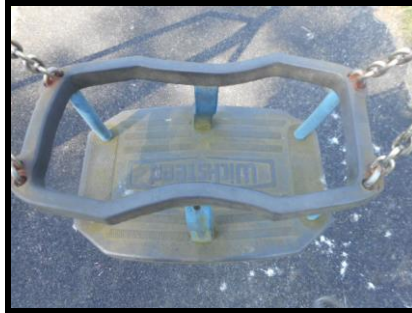
- 2 The seat frame is bent and corroding at the fixings. ***The seat should be replaced within 3 months.*** ***Low/Moderate Risk***

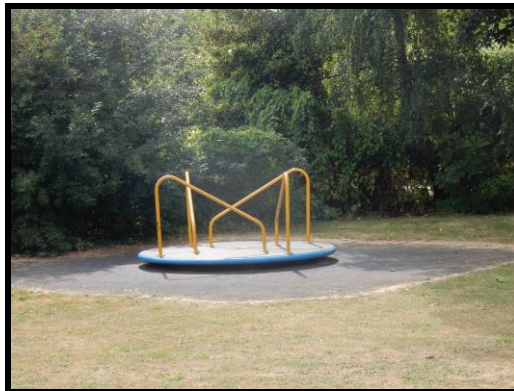
Roundabout

Note: The speed of the roundabout may fail BS EN 1176 when a test becomes available. ***Low/Moderate Risk***

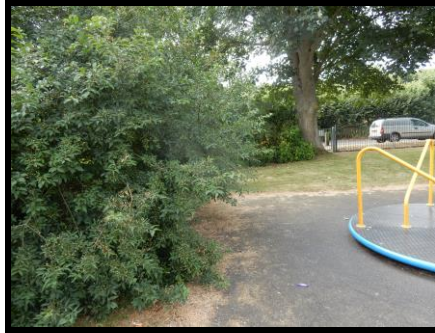
The hedge to the side is encroaching the safer surface area and requires cutting back.

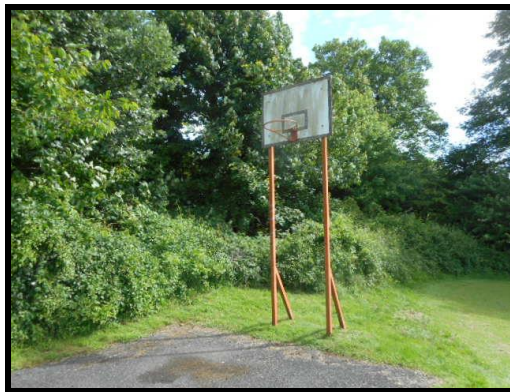
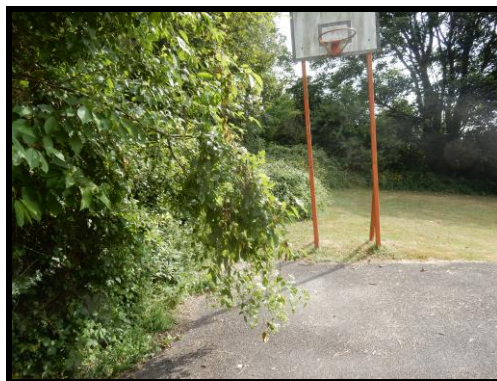
Basketball Post

Overgrowth to the side requires cutting back.
