# Tree Survey for Abbots Ann Parish Council

Health and Safety Tree Survey September 2023

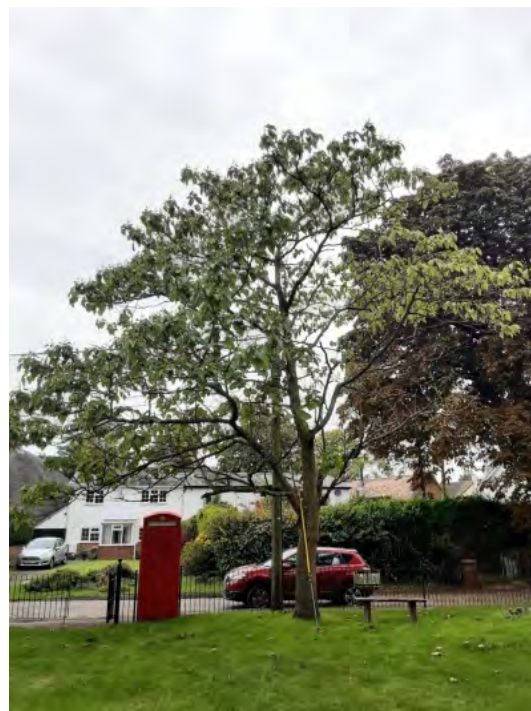
**Seq No:** 1

**Condition:** Fair

**Failure:** Potentially

- Bark damage - to branches rubbing on the overhead cables
- Bleeding canker - on lower trunk to West with black new exudate
- Die back - around 30% - 40% of the crown has died back and is dead with limited live growth
- Epicormic growth - upright epicormic growth rafting along the branches on the Southern side of the crown
- Major dead wood >50mm
- Minor dead wood <50mm
- Roots strimmer damaged - root to the North West bark damaged and potential for infection

**Remove dead wood (>50mm )** - within 3 months for reasons of health and safety

**Prune clear of overhead wires** -prune clear of overhead wires, one limb rubbing so sensitive selective branches to be pruned to achieve 0.5m clearance from wires within 3 months to ensure clearance of the overhead power and phone lines and to prevent further bark damage by rubbing on the wires

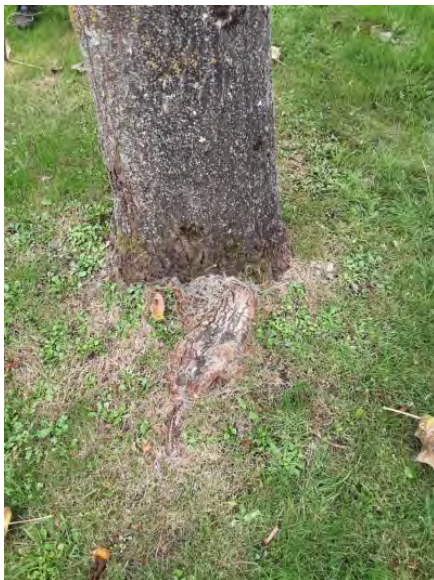
Roots strimmer damaged

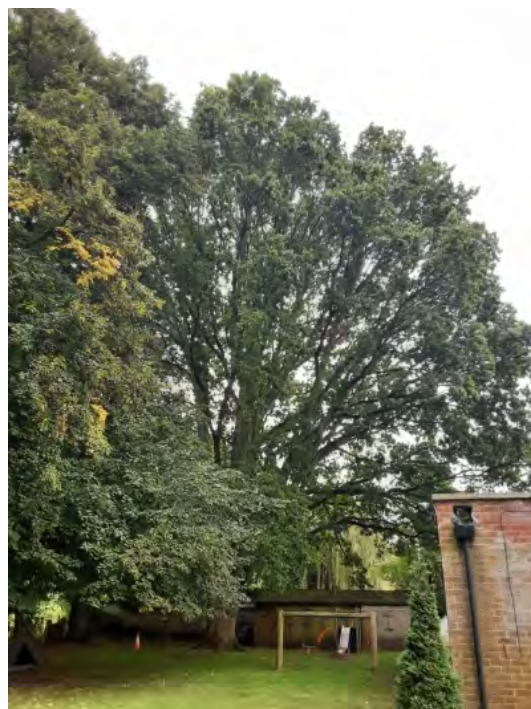
**Seq No:** 2**Position:** War Memorial Hall rear garden  
play area**Species:** Quercus robur ( English Oak)**Grid Ref:** SU 32900 43638**OS X/Y:** 432899.43, 143637.12**Lat Long:** 51.191016, -1.530602**what3words:** ///ledge.suffer.hours

**Notes:** Veteran tree characteristics include a large girth minimum of 25% of species age equating to around 177 - 216 years of age circa 1800's. With potential for internal heartwood decay, large quantities of deadwood, habitat holes and epiphytic plants including Lichens and Ferns. This is an important tree locally as well as historically, culturally, ecologically and environmentally.

**Risk:** Slight (200)

**Lift canopy to 2.5m** - Crown lift over flat roof to West to achieve 1.5m clearance over the roof within 3 months to prevent any damage to the roof of the building

**Sever climbing plant** - This will prevent a build-up of ivy obscuring any potential defects in addition to reducing the build-up of ivy on the stem and in the crown adding additional weight.

**Management of the land around the tree** - Over time look to convert the land underneath the crown of the Oak tree from grass over to wood chip mulch and leaf litter. Reduce the grass-cutting regime to avoid damage to surface roots. Add composted bark chips (ideally from an Oak tree) over the area evenly to a depth of 5-7cm in stages starting with the current areas used for the play equipment in year 1, then expand the area out to the second half in year 2. This will aid in providing a natural source of organic matter to the tree over a period of time while it breaks down aiding in maintaining a healthy rooting environment for the tree.

**Target management** - If possible seek to move the targets from underneath the canopy of the Oak tree. This would include the two sets of swings and the slide. If possible do not disturb the ground when moving the play equipment to avoid any further root damage and move them to a more suitable location away from underneath the canopy of the trees. This will reduce the risk as the fixed targets beneath the tree will be moved.

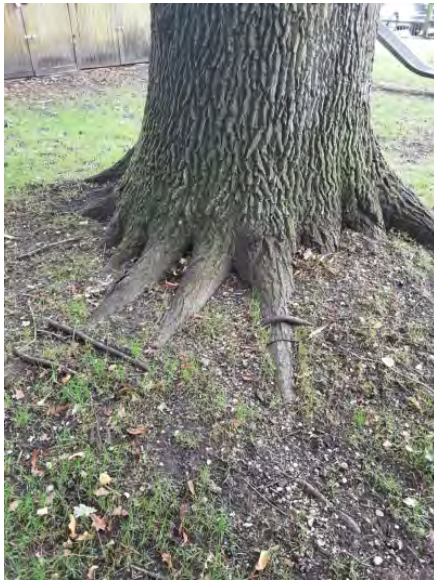
Girdling roots

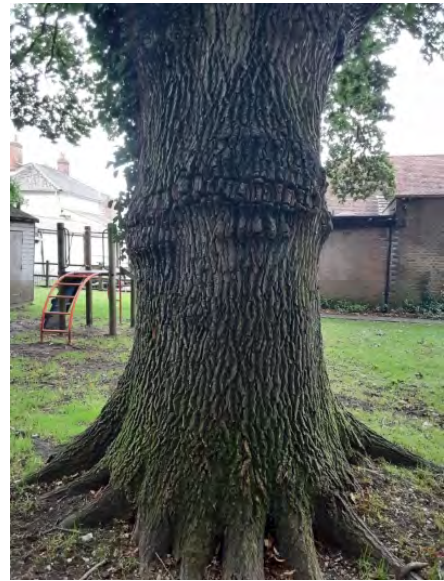
Stem issues or observations

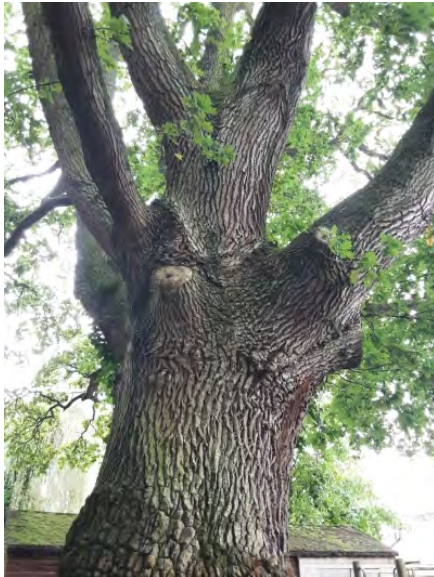
Multiple old pruning wounds

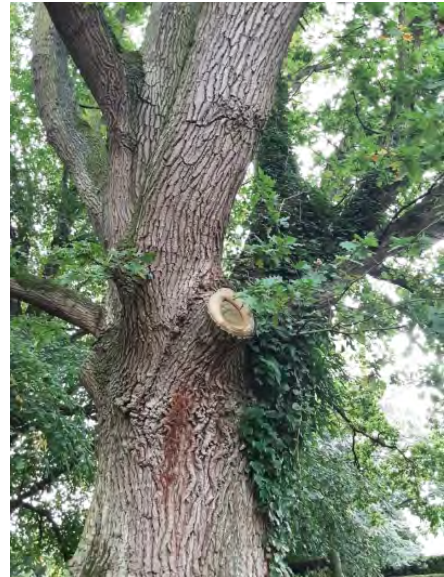
Occluding pruning wounds

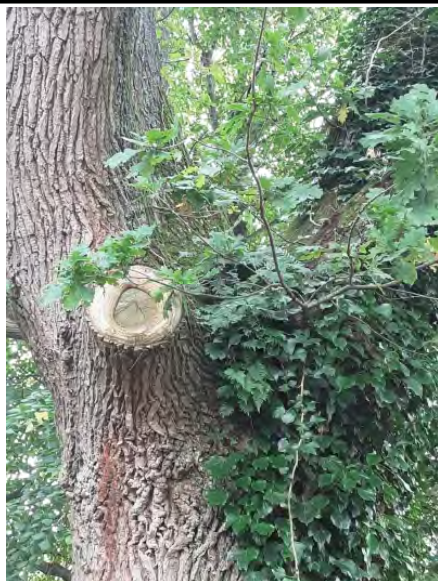
Epiphytic plants (Ferns)

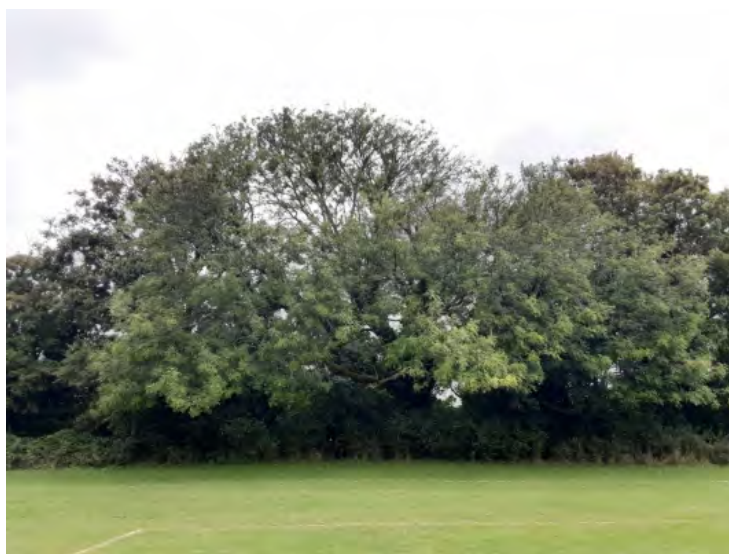
**Seq No:** 3

Ash dieback  
Ash stage 1 = 76-100% canopy remaining  
Ash stage 2 = 51-75% canopy remaining - In the upper crown Bat potential Branch stubs present  
Crown issues or observations -lapsed historic pollard  
Compacted roots - bare earth for the route of the footpath with compacted ground to the North and exposed bark-damaged surface roots visible  
End weighted branches  
Epiphytic plants (Lichens)  
Epicormic growth  
Historical branch loss  
Ivy or climbing plants  
Ivy covered tree  
Live epicormic growth rafting  
Low hanging branches  
Major dead wood >50mm  
Minor dead wood <50mm  
Multiple old pruning wounds Occluded pruning wounds Occluding pruning wounds  
Surface roots  
Thinning crown  
Veteran tree  
Wildlife habitat

- Lateral reduction of 2 - 3m to prune canopy back to edge of the football pitch to the South leaving 11 metre crown spread to the South.
- 2m end weight reduction of over-extended lower limbs to the East and West leaving 10 to 11 m crown spread in each direction.
- 1m height reduction to prune out dying tips down to around 18 metres.
- 2m reduction of lower limbs over the footpath to the North leaving an 11m spread.
- Works to be carried out during the dormant season and within 3 months.
- Check for bats prior to work.
- Works are to aid with the prevention of end-weighted branch failure and to aid with crown management in light of Ash dieback to aid with the overall retention of the Ash tree as an important wildlife habitat tree.

**Sever climbing plant** - to aid with further assessment at the next inspection of the main stem to assess for decay and fungi as currently limited observations are able to be made with the dense ivy present. Within 3 months allow it to die off naturally.

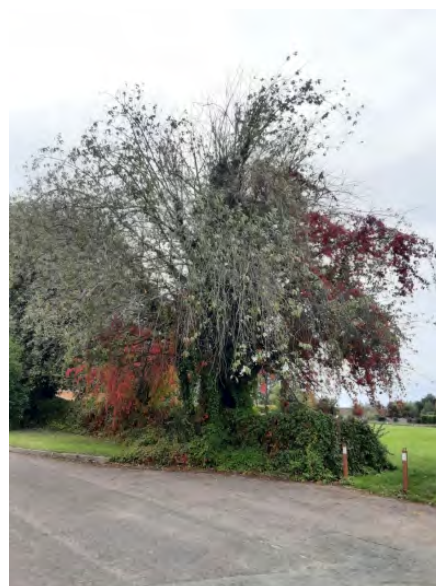
**Seq No:** 4

**Condition:** Very poor

**Failure:** Likely

**Fell Broadleaves** - within 3 months for reasons of health and safety as the tree is nearly dead.

**Stump - Grind out stump** - within 3 months to facilitate space for replacement tree planting in this location.

**Plant New Tree** - 8-10 -Recommend a Wild Service tree (*Sorbus torminalis*) as a replacement or a Whitebeam (*Sorbus majestica*) planted in Winter 2023/ 2024) to aid with maintaining the existing tree stock and canopy cover for the site.

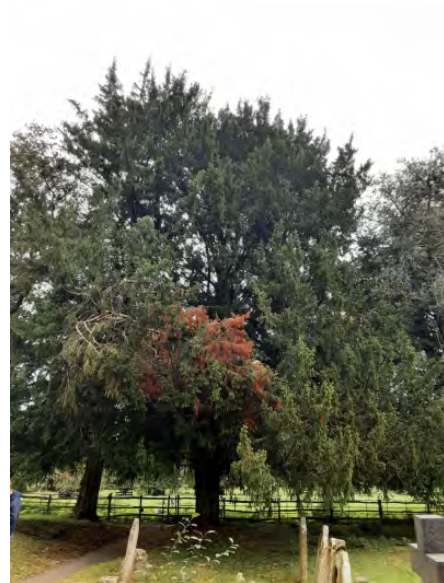
- Branch stubs present
- Crown shape distorted due to group pressure
- Epicormic growth
- Hanging broken branches - failed hazard beam
- Ivy or climbing plants
- Low hanging branches
- Major dead wood >50mm
- Minor dead wood <50mm

**Remove hanging/broken limb** -over footpath within the churchyard, snapped out hazard beam, browning foliage within 1 month for reasons of health and safety

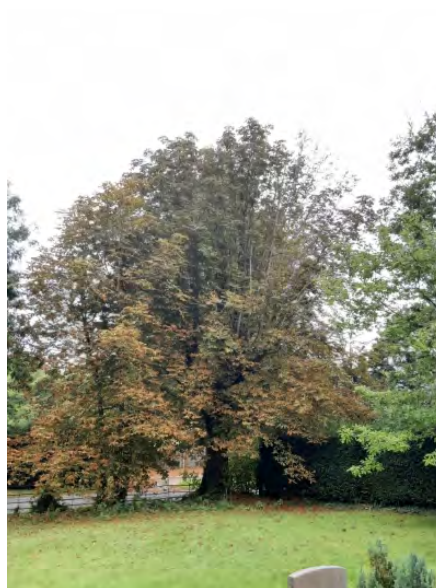
**Seq No:** 7

Basal decay - decayed heartwood visible at bark wounds on lower trunk  
 Bird box - plus natural bird nest on trunk in ivy  
 Bleeding canker  
 Bat potential  
 Basal suckers  
 Branch stubs present  
 Cankers on branches  
 Cankers on trunk  
 Cavities present - decay present in the old pollard heads  
 Crossing branches  
 Crown issues or observations - Leaf blotch and leaf miner  
 Epicormic growth  
 Fluted buttresses  
 Ivy or climbing plants - around buttresses  
 Minor dead wood <50mm  
 Multiple old pruning wounds Occluded pruning wounds Occluding pruning wounds  
 Pollarded  
 Stem issues or observations -flaking and delamination bark  
 Veteran tree potential  
 Wildlife habitat

**Reduce crown by 4m** - Reduce crown down by 4m but not to the original pollard points.

- Retain a smaller crown above the pollard points.
  - Thin out each pollard head to retain the smaller stems and remove the two largest diameter stems on each pollard head back to the pollard head at around 6m to reduce the weight on the pollard heads.
  - Works to be carried out within 3 months during the dormant season and bat check prior to work.
  - Works to prevent pollard head collapse under the weight of the new regrowth that has lapsed and to retain a smaller managed crown due to the proximity to the roadside.
-

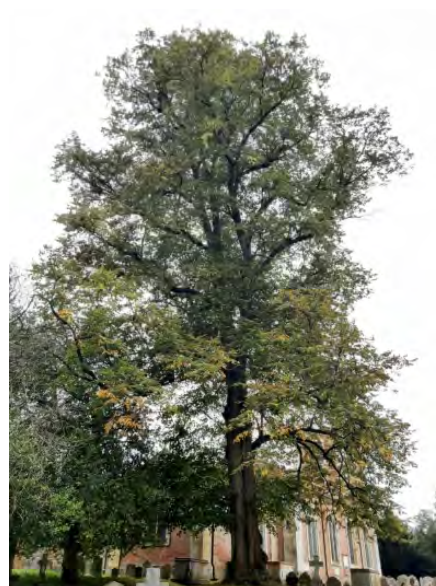
**Seq No:** 8

Bat potential  
 Basal suckers  
 Cavities present  
 Epicormic growth  
 Fluted buttresses  
 Ivy or climbing plants - starting up the trunk and around the buttresses  
 Live epicormic growth rafting  
 Major dead wood >50mm  
 Minor dead wood <50mm  
 Multiple old pruning wounds  
 Occluded pruning wounds  
 Occluding pruning wounds  
 Surface roots - lifting tarmac path and visible in the grass bank,  
 bark damage to some exposed roots and decay present

**Lift canopy to 3m** - over the footpath within 3 months for reasons of health and safety

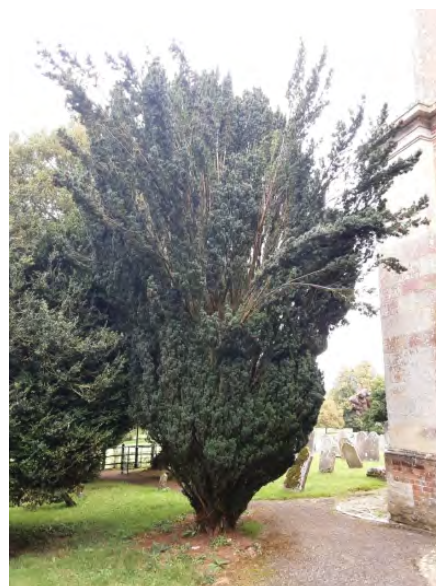
**Seq No:** 9

Bark damage - from wire cutting into branches

Crown issues or observations -Branches collapsed out of the crown and are hanging down. Fastigate form opening up. Previously supported by wire which in places is now imbedded wire cables which are now causing bark and branch damage.
