# St Giles Church, Boundary Walls

## Condition Report

**VISUAL STRUCTURAL INSPECTION  
ST GILES CHURCH, BALDERTON  
SOUL ARCHITECTS**

**12783-WMS-XX-XX-T-S-20001-S2-P2**

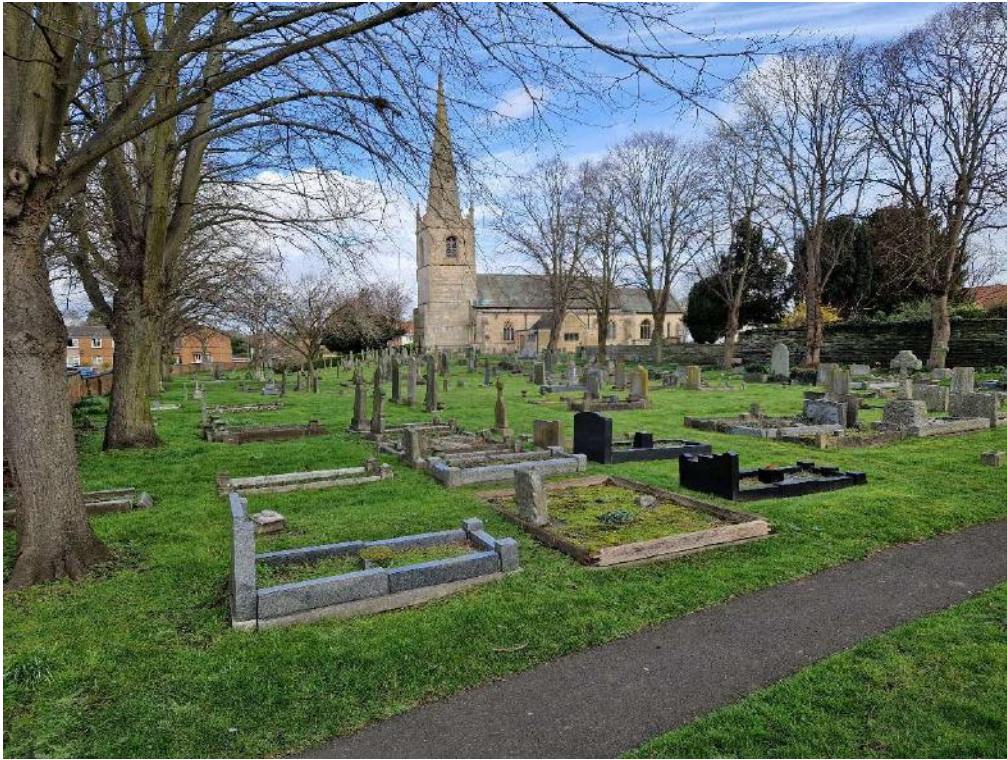
2.1.1 The boundary wall encapsulates the grounds of St Giles Church; a Grade I listed building (list entry: 1369963) constructed circa 1200 (Photograph 1). The inspected wall is constructed using a variety of materials and techniques with some elements forming retaining structures and other lengths being freestanding walls.

Photograph No. 1 – General View of Site with Boundary Wall to Far Left and Right

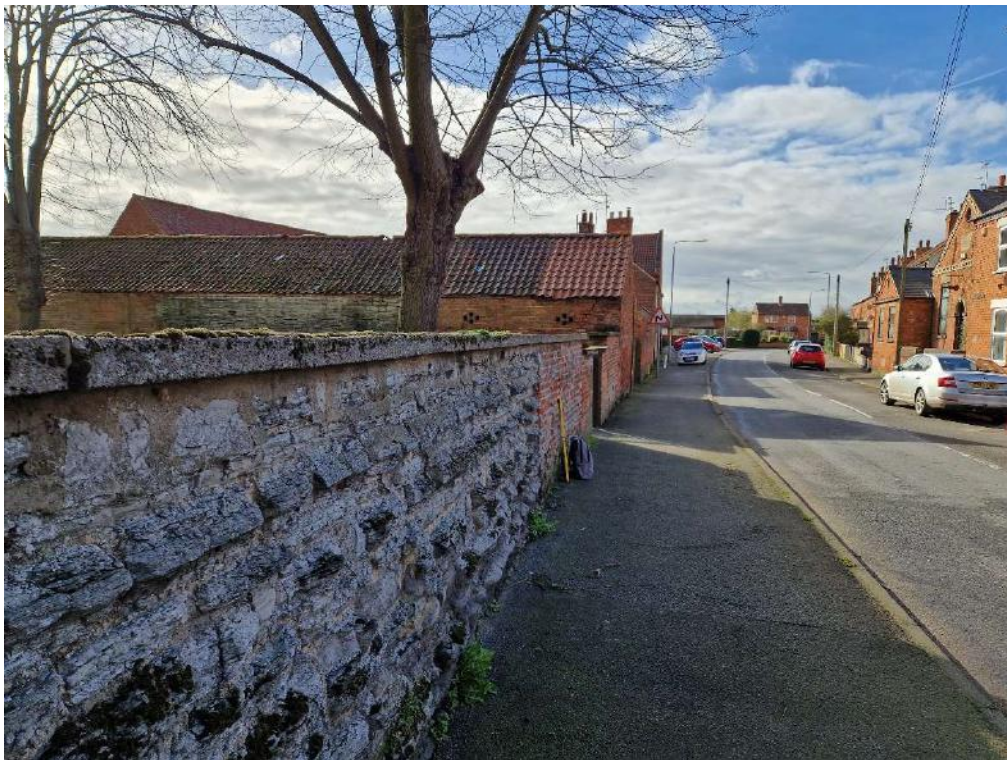
- c. The initial 3.5m of wall is of solid 230mm thick brickwork construction with piers at either end measuring 480x350mm.
- d. The wall is partially retaining as indicated by the efflorescence on the lower third of the wall.
- e. In general, the wall is free from significant defects. Nominal masonry spawling is present along with friable mortar, but for a structure of this age the current condition is reasonable.

- a. The brickwork reduces in width slightly to 230mm thick and has a gate positioned at mid span.
- b. The wall is not retaining and is in good condition.

- a. Span 3 is also of brick construction. It steps back out to 380mm thick with a full height of approximately 1.5m and retained height of earth averaging approximately 0.5m.
- b. Again, minimal defects are present although a slight deflection inward can be seen to the end of the panel (starting at approximately 8m) as it meets the Blue Lias section.

Photograph No. 2 – West – Spans 1-4 with Blue Lias Section in Foreground

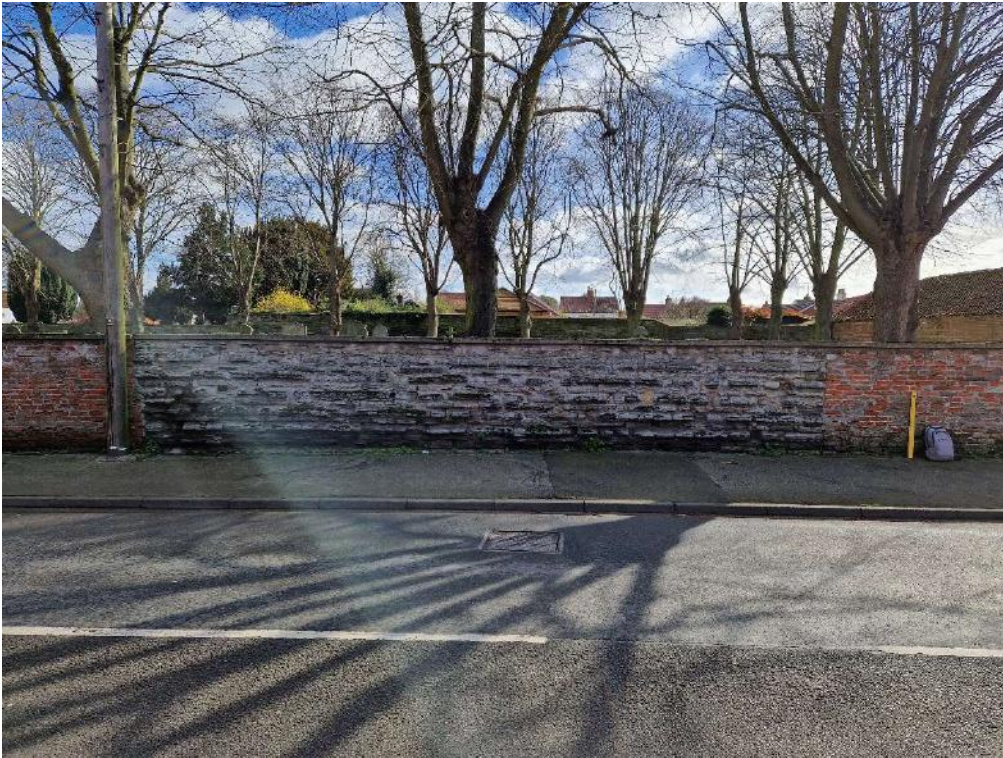
- a. Noted as 'A' on the sketch plan. Span 4 is constructed from Blue Lias and steps out further still to approximately 530mm. It measures approximately 1.5m tall with a retained height of 0.5m.

Photograph No. 3 – West – Span 4

- 3.1 The length of wall identified as Span 4 is currently structural stable although the extent of lean should be visually monitored to ensure it does not reach a point that could pose a risk to the public or users of the church grounds. The retained earth to the rear is likely acting as a prop preventing significant lean, furthermore the significant mass of the section is likely adding to the stability. Strengthening works would likely have minimal impact on the stability of the structure due to the general deteriorated nature of the facing brickwork and mortar.

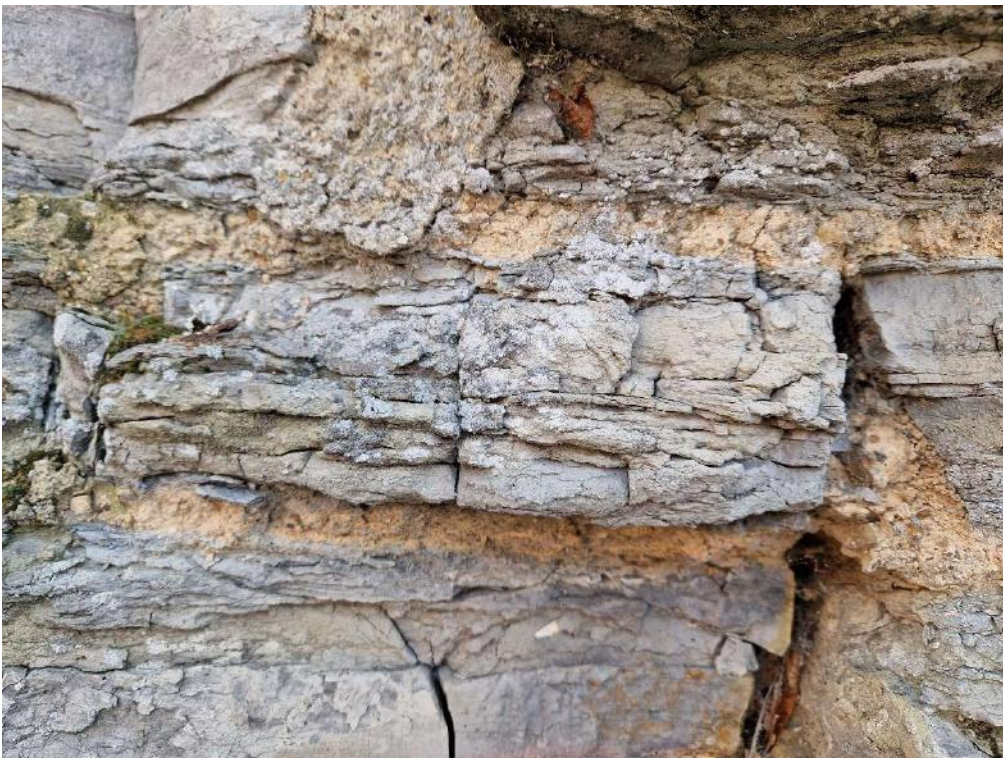
- b. The panel is in poor condition overall, with significant spawling masonry which is friable and crumbled to the touch (Photograph 4).
- c. The bottom third of the wall appeared noticeably discoloured suggesting an accumulation of water behind the structure (Photograph 5). The lack of weepholes will only compound this issue further.

Photograph No. 4 – West – Heavily Deteriorated Masonry and Mortar

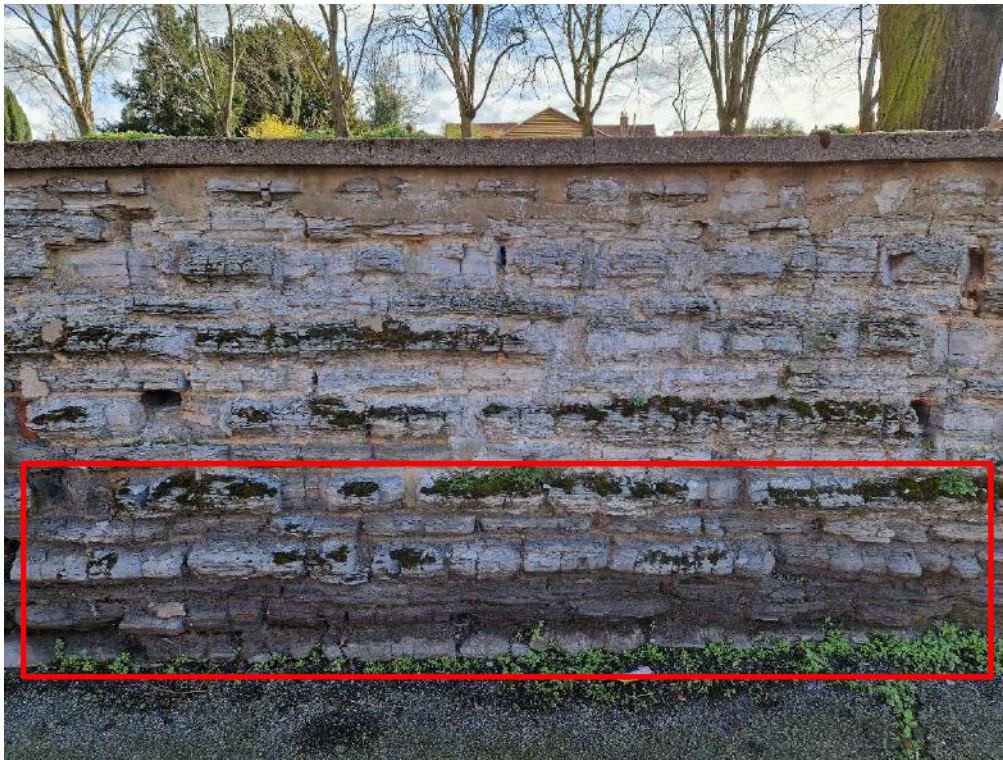
Photograph No. 5 – West – Noticeable Change in Colour at Low Level

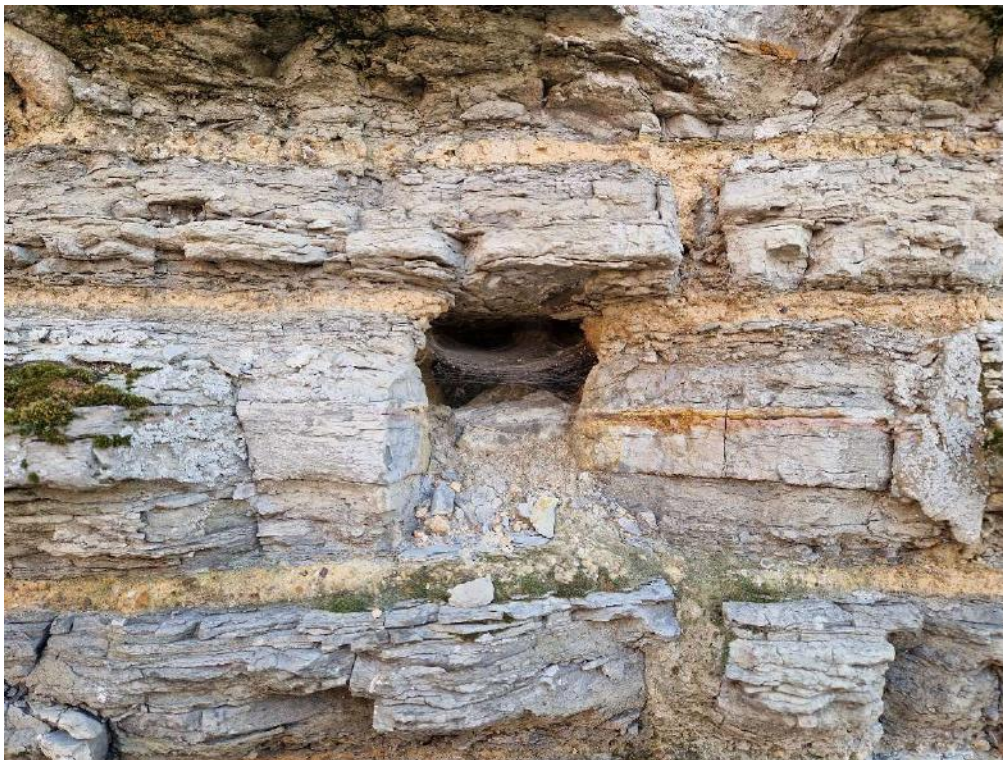
- d. Significant areas of missing masonry/mortar are present along the length of the structure both on the front and rear (Photographs 6).
- e. The wall is also noticeably out of plumb (Photographs 7 - 8), as indicated on the sketch in appendix B, with the wall leaning into the grounds of the church by up to 150mm in places. The coping stone is also significantly misaligned when compared to the previous section of wall (Photograph 9).

Photograph No. 6 – West – Areas of Missing Masonry and Mortar

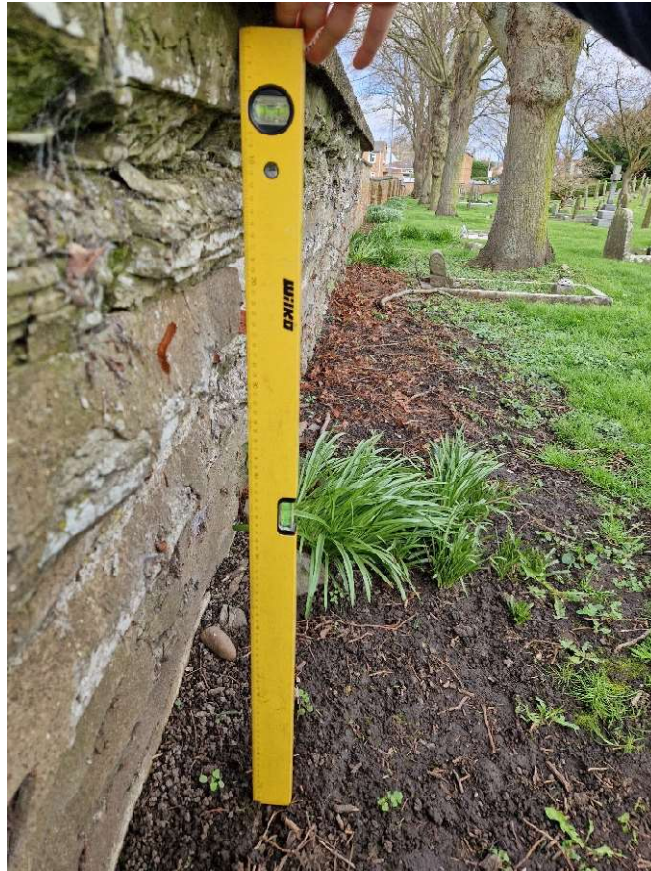
Photograph No. 7 – West – Lean to Rear Face of Wall

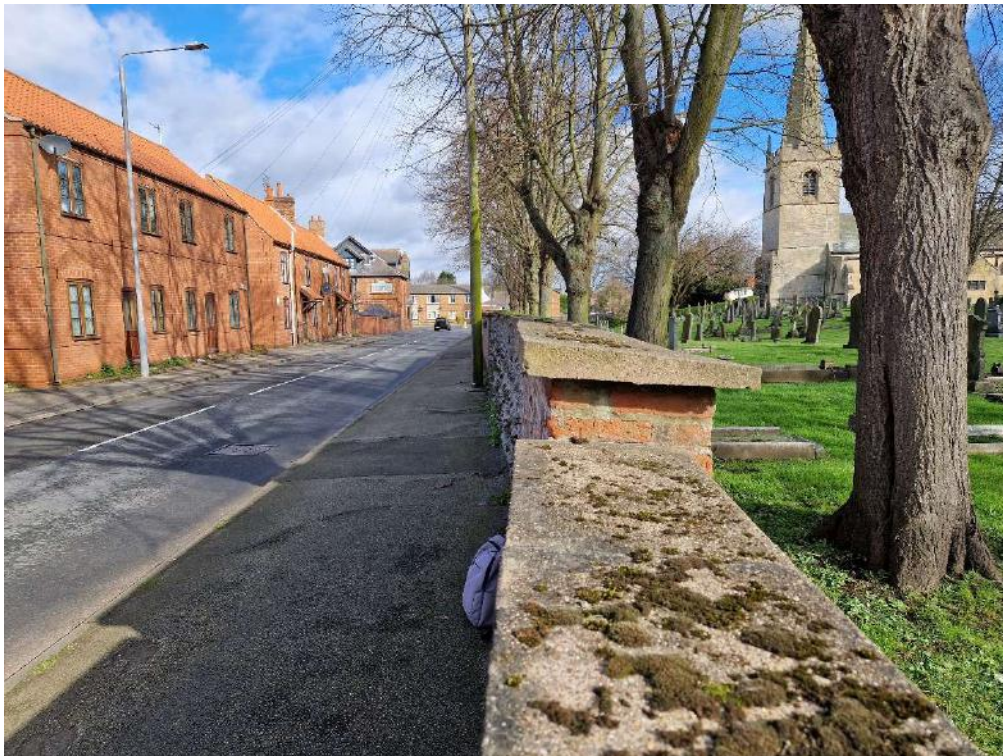
Photograph No. 8 – West – General View of Lean to Front Face of Wall

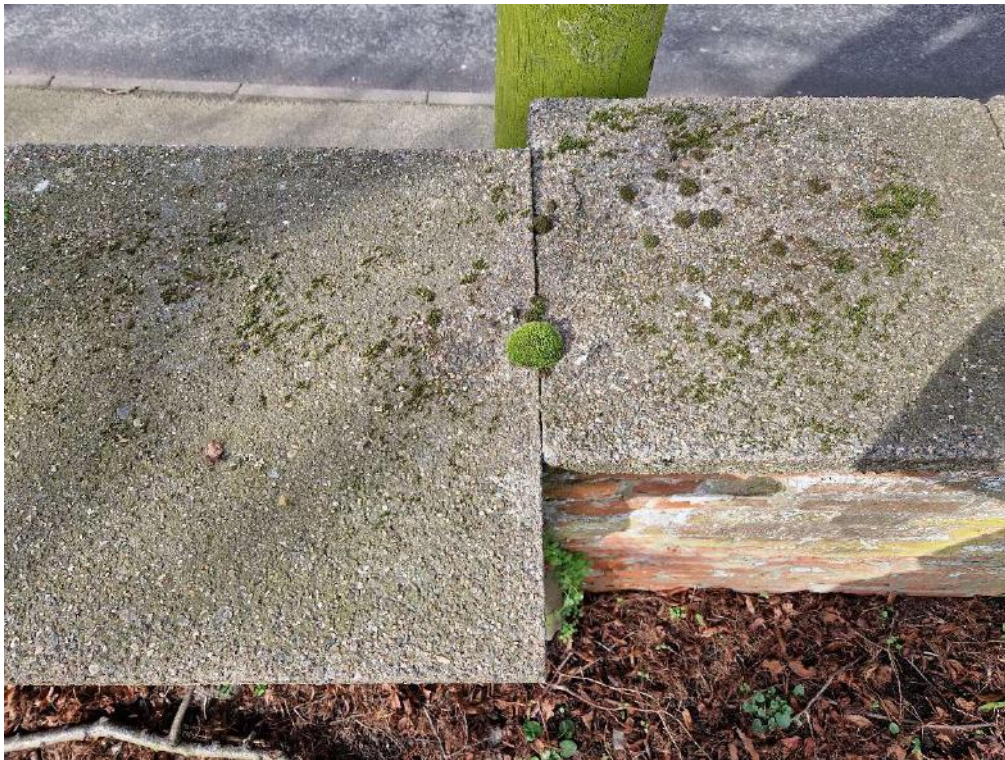
Photograph No. 9 – West – Misaligned Coping Stone Between Span 4 and 5

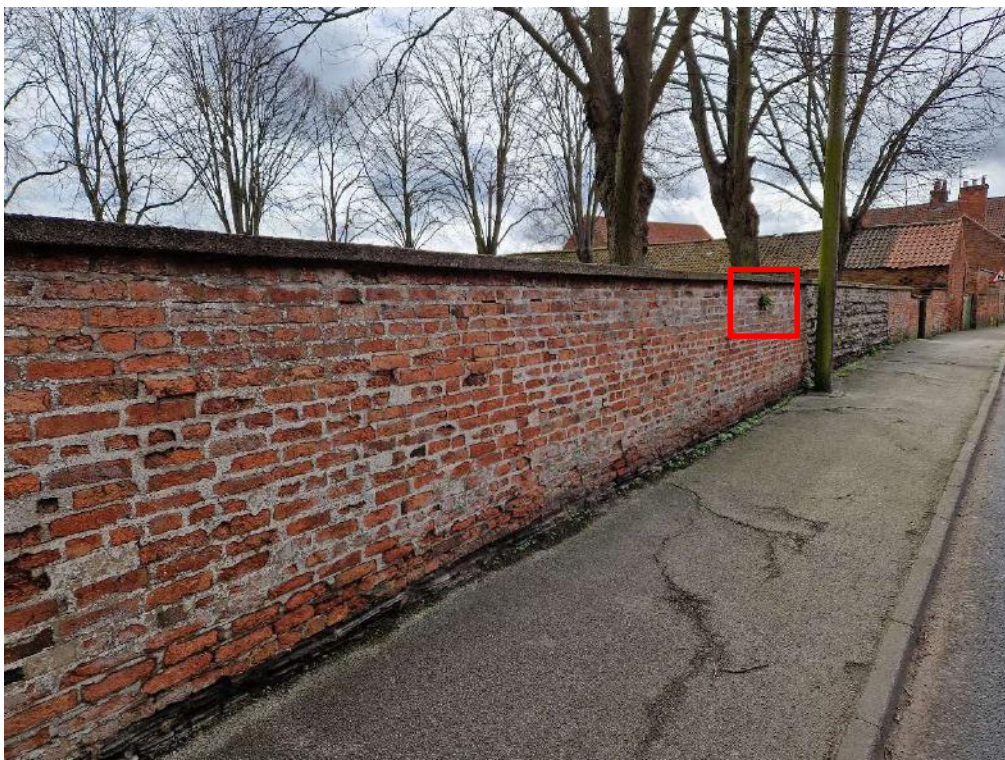
- a. The wall steps back in to 380mm thick reverting to a brickwork construction, similar to that of span 3. The full height again measures approximately 1.5m and the retained height averages 0.4m.
- b. The wall is in relatively good condition; however, a noticeable scour is present at ground level running the length of the wall (Photograph 11).
- c. The wall is of new construction when compared with span 4, although it appears as if the new wall has been constructed atop the old footing as can be seen at the base of the wall (Photograph 11).

Photograph No. 10 – West – Span 5, Highlighted Foliage Growth

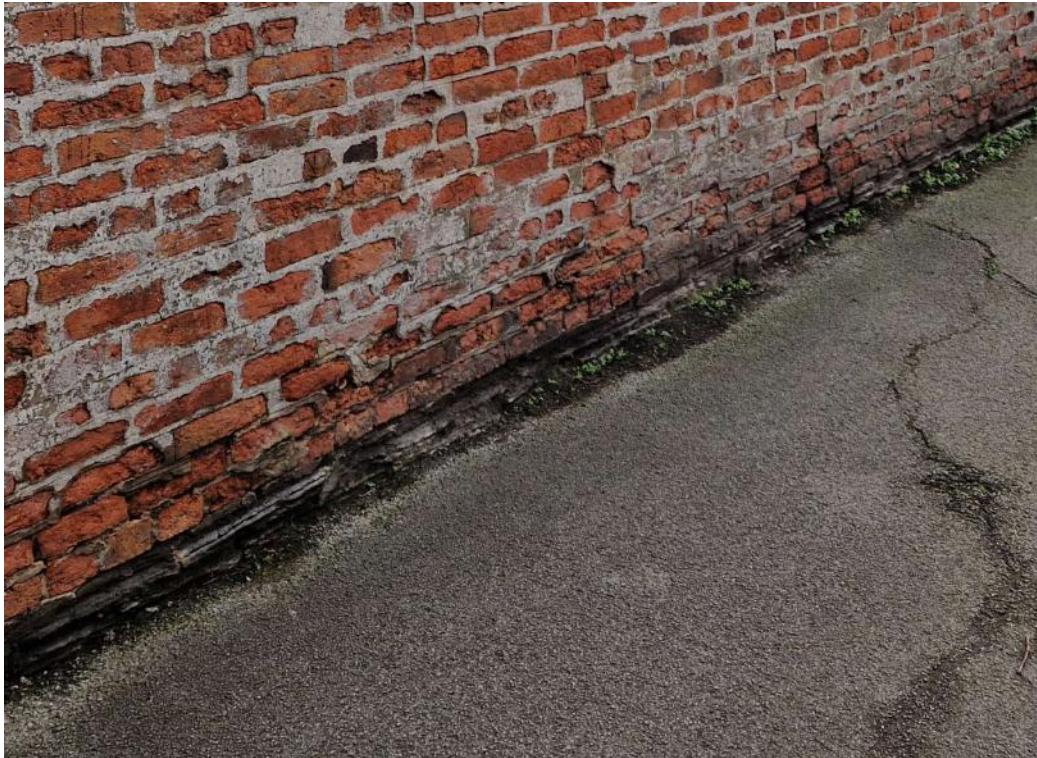
Photograph No. 11 – West – Scour at Base of Wall and Blue Lias Used as Base

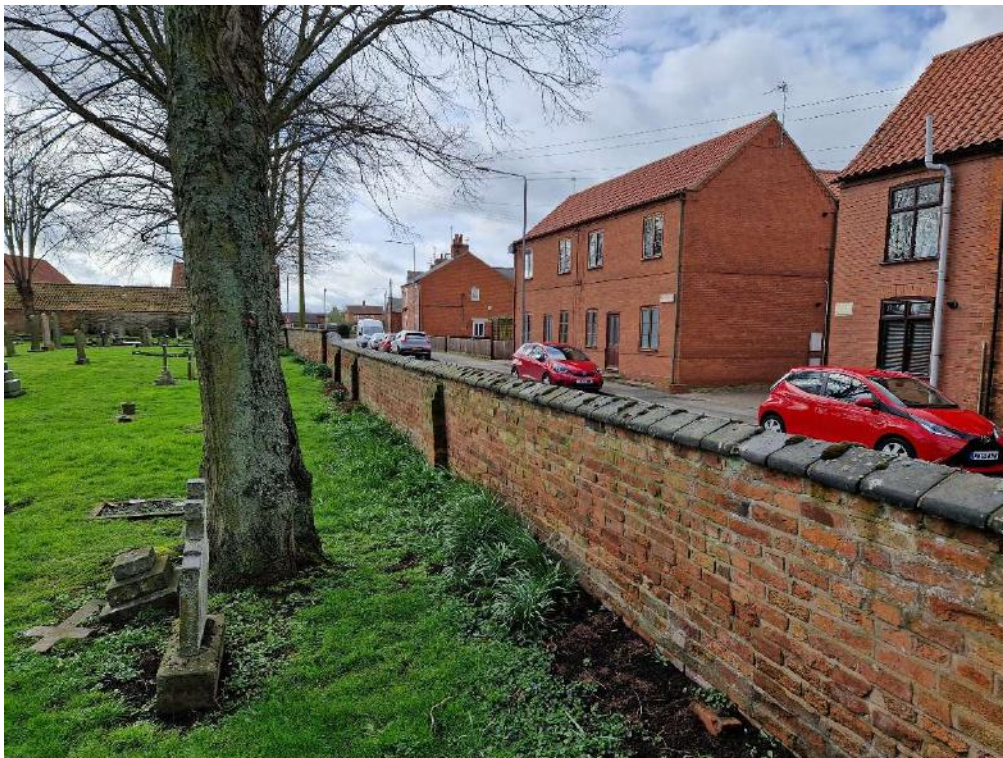
- a. Span 6 maintains the brickwork construction and measures 230mm thick. It steps down at various locations to average an approximate height of 1.35m. Piers are located at approximately 7m c/c.

Photograph No. 12 – West – General View of Span 6

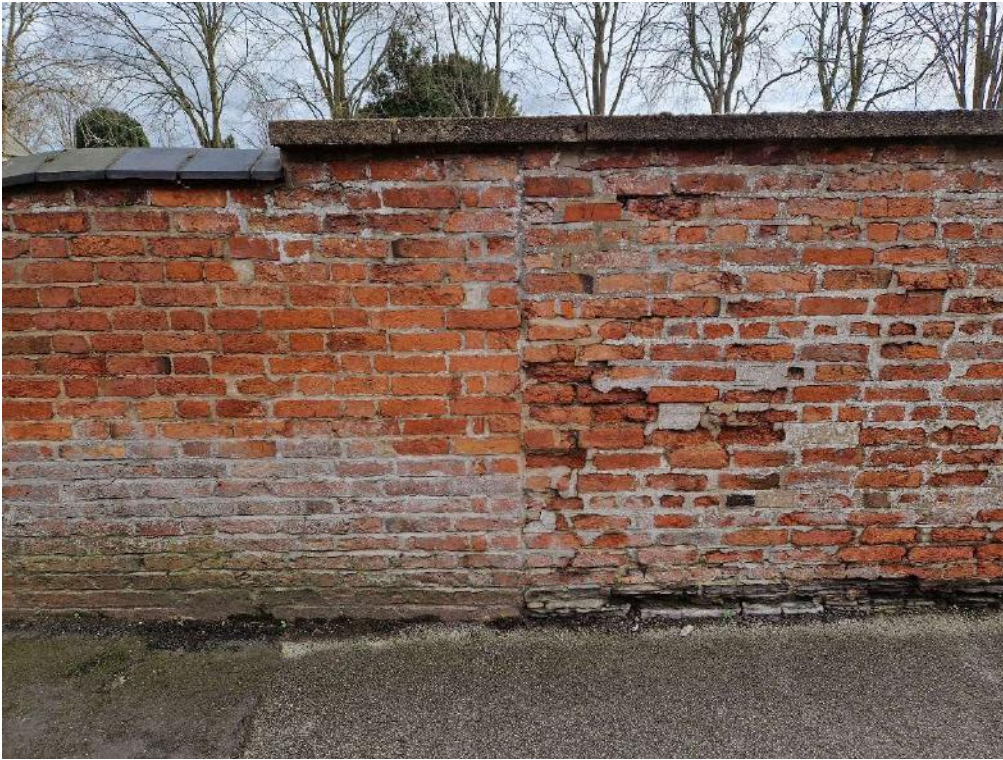
- b. The interface between Span 5 and 6 is poor (Photograph 13). There is no evidence of toothed masonry. It is likely the two sections are simply abutting one another and can be considered a point of weakness. It should be noted that the above is present to most sections where a change in construction/material occurs.

Photograph No. 13 – West – Interface Between Span 5 and 6

- 3.6 It would be advisable to retrofit wall ties / restraint at the junction between the various wall sections. HeliFix (or other) bars can be installed across the junction to strengthen the joint causing it to act as one homogenous structure as opposed to various independent sections of wall. Any provided solution should be installed as per the manufacturer's guidance.

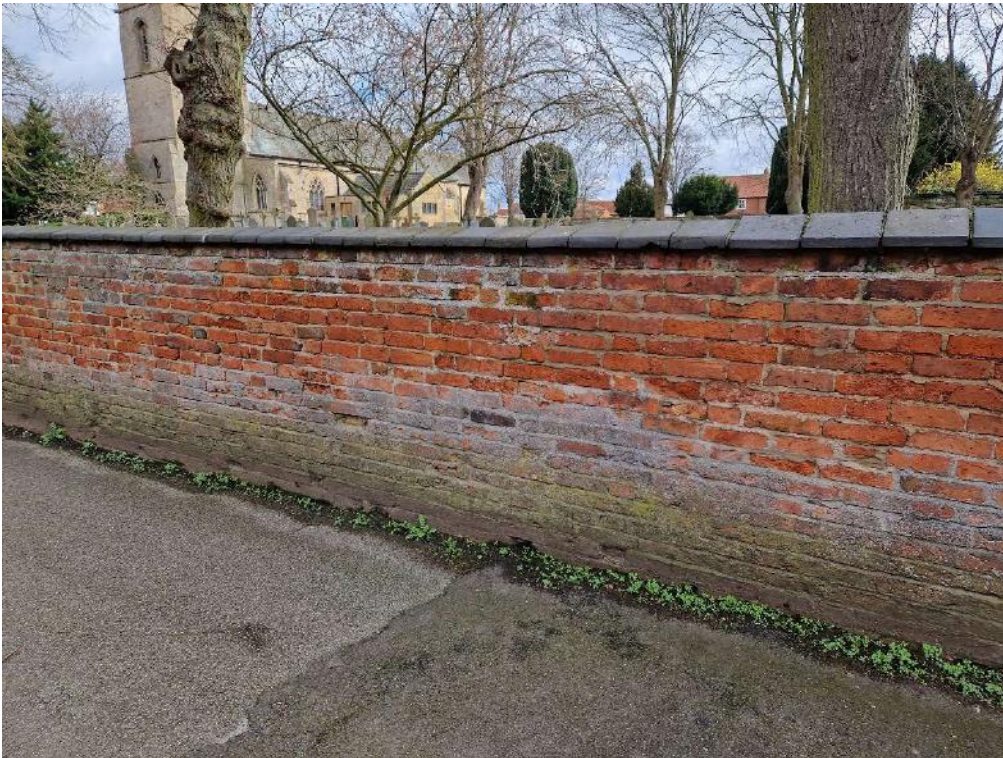
- d. Similar efflorescence to that observed on other sections of the wall is present at low level, and bar localised pockets of moss growth on the surface of the wall, the overall condition is reasonable (Photograph 14).

Photograph No. 14 – West – General Condition of Wall Section and Efflorescence to Lower Half

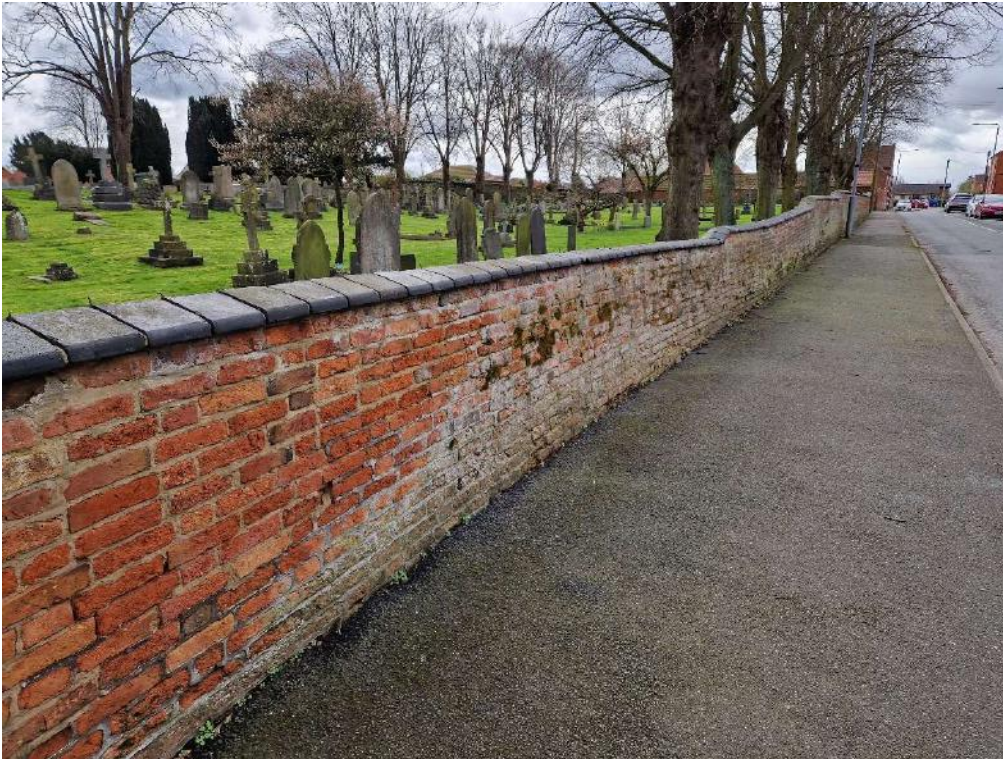
- a. Noted as B on the sketch plan, span 7 appears heavily deflected with a lean of up to 200mm in places (Photograph 16 + 17). The wall itself is relatively low, with a height of only 1100mm. It is non-retaining and of brick construction. See the sketch in Appendix B for details.
- b. The wall construction is the same as that of the previous sections and maintains regular piers, several of which appear to have sheared at the base (Photograph 18).

Photograph No. 15 – West – Span 7

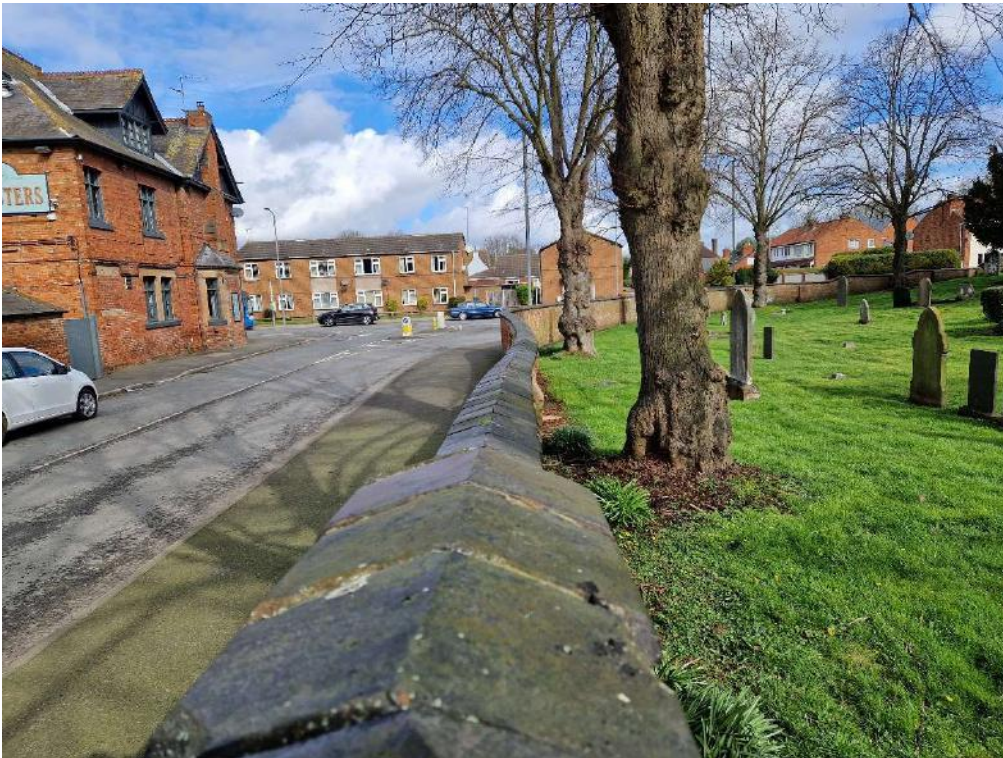
Photograph No. 16 – West – Deflection to Span 7

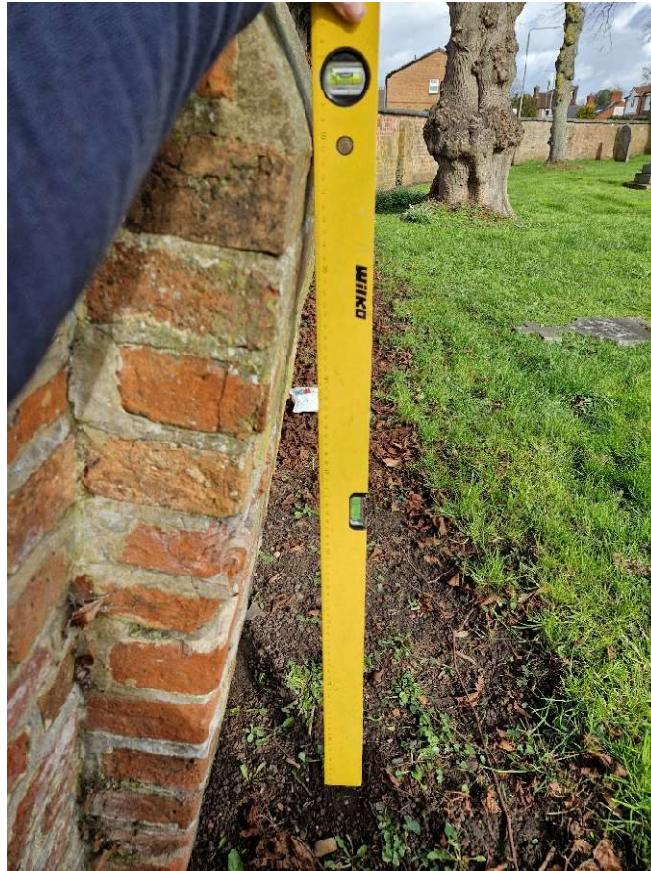
Photograph No. 17 – West – Lean to Rear Face of Span 7

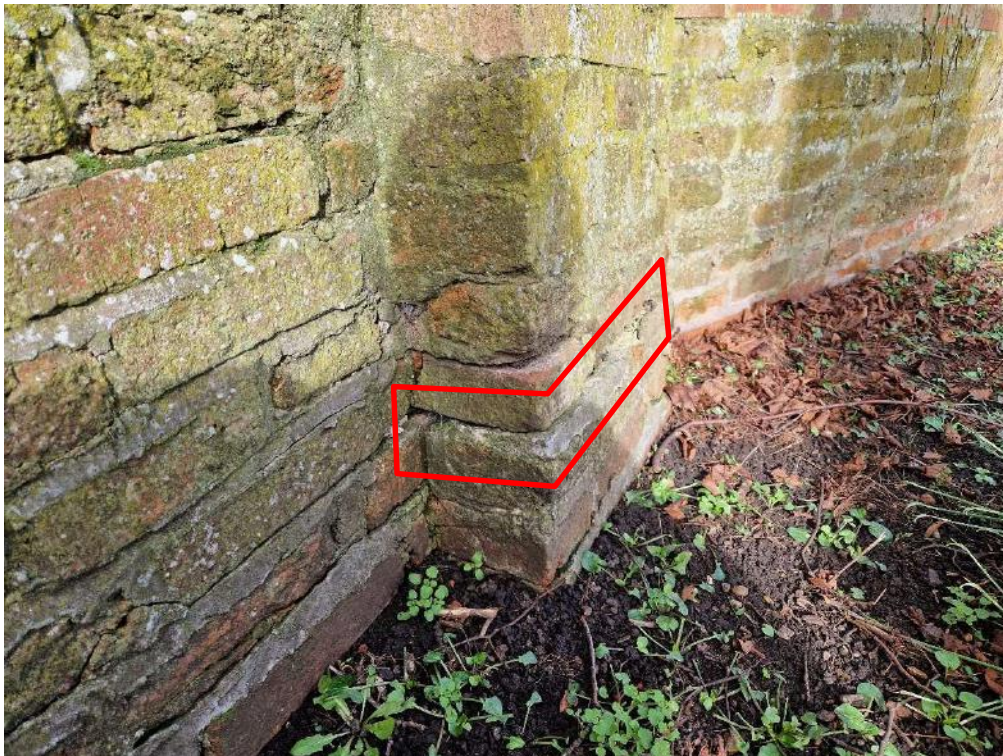
Photograph No. 18 – West – Deteriorated Pier with Lateral Movement at Base

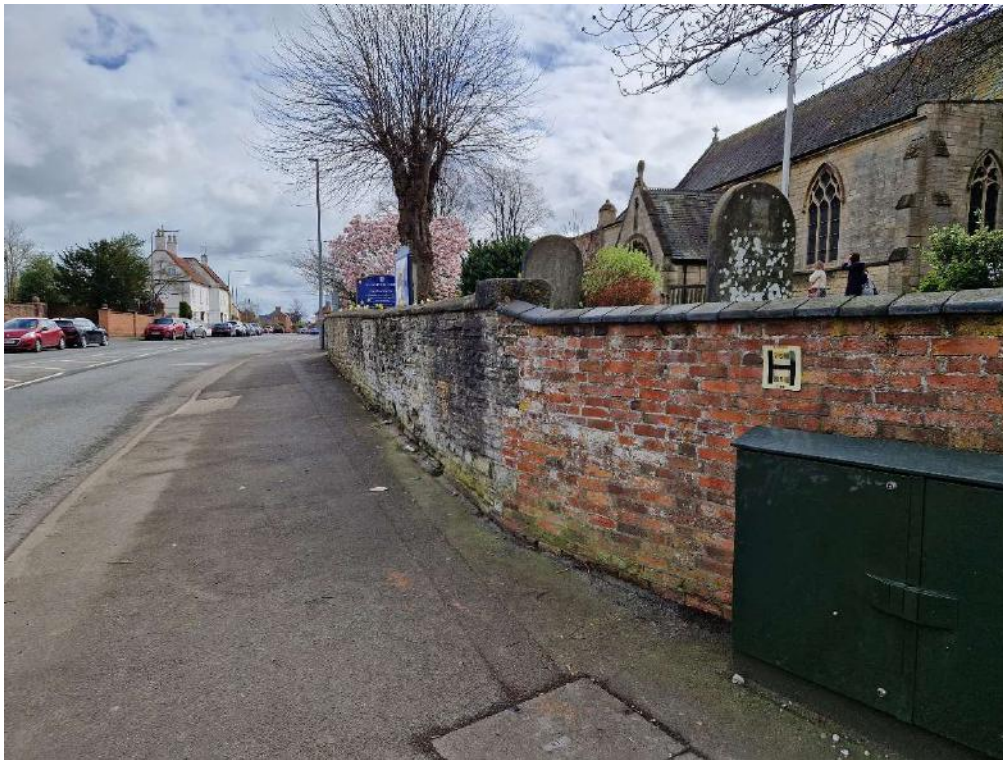
2.2.9 The brick boundary continues around the northwest corner of the site abutting another section of Blue Lias retaining wall which continues along the length of the northern boundary (Photograph 19). The wall is generally free from significant defects; however, there are still areas of undulation, but relatively minor when compared to that of previous sections (Photograph 20). Foliage growth is also present along the length of the structure as well as general areas of deterioration and weathering due to age (Photographs 21 - 22).

Photograph No. 19 – North – Continuation of Boundary Wall to Northern Edge of Site

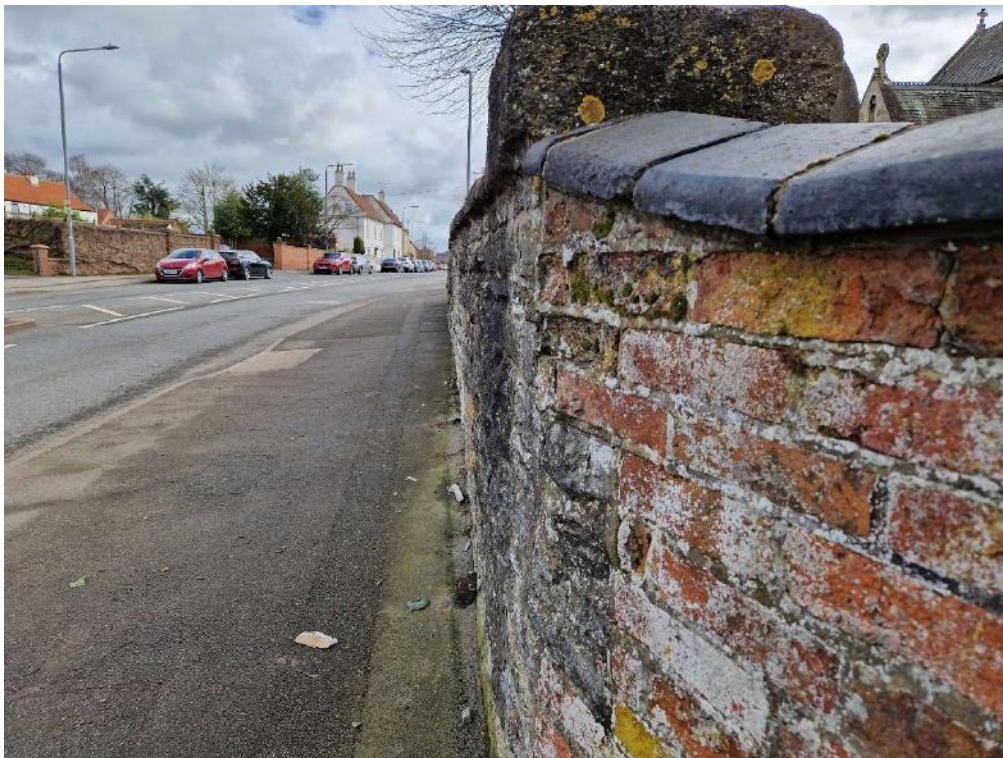
Photograph No. 20 – North – Observed Undulations and Minor Lean

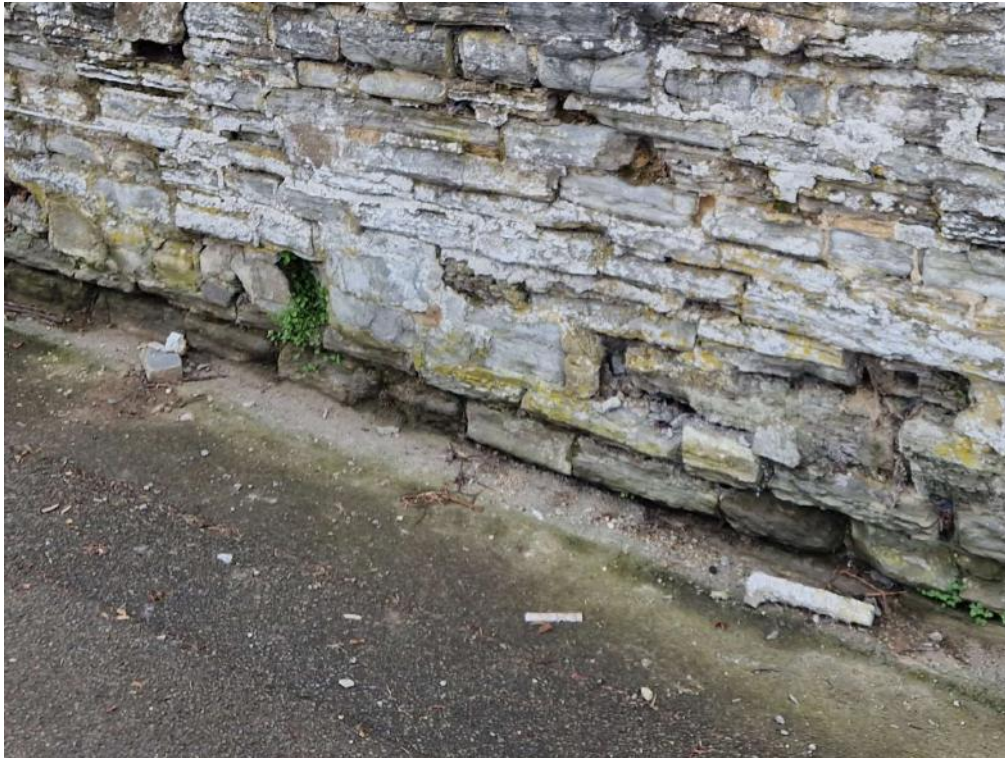
Photograph No. 21 – North – Scour at Base of Wall

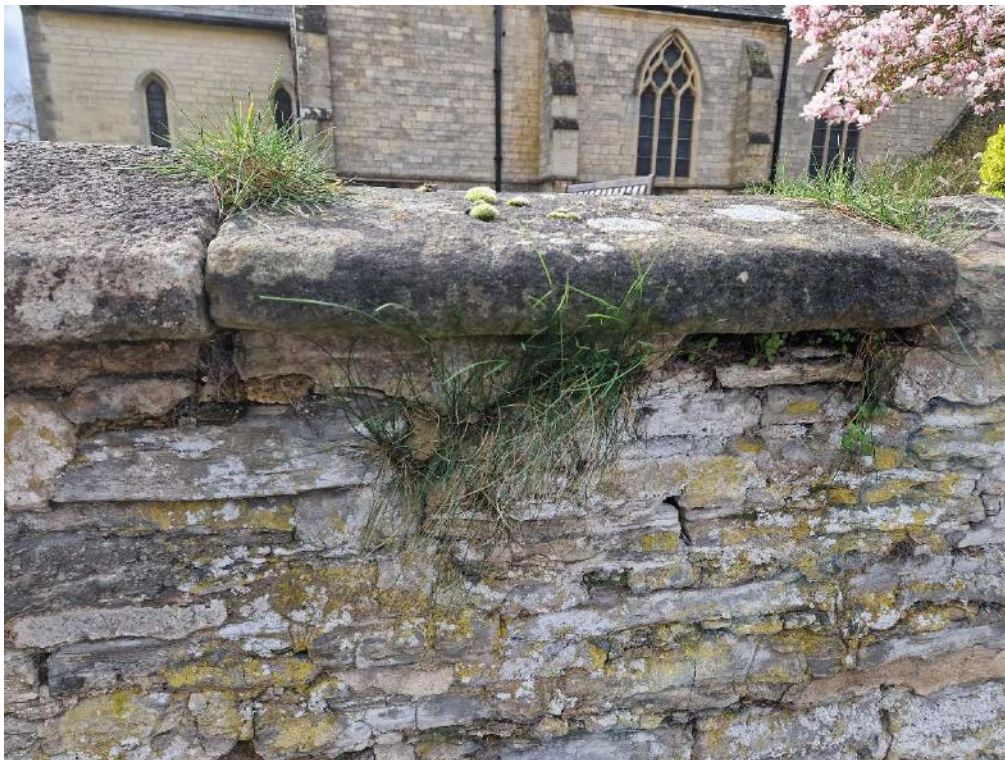
Photograph No. 22 – North – Foliage Growth on Wall

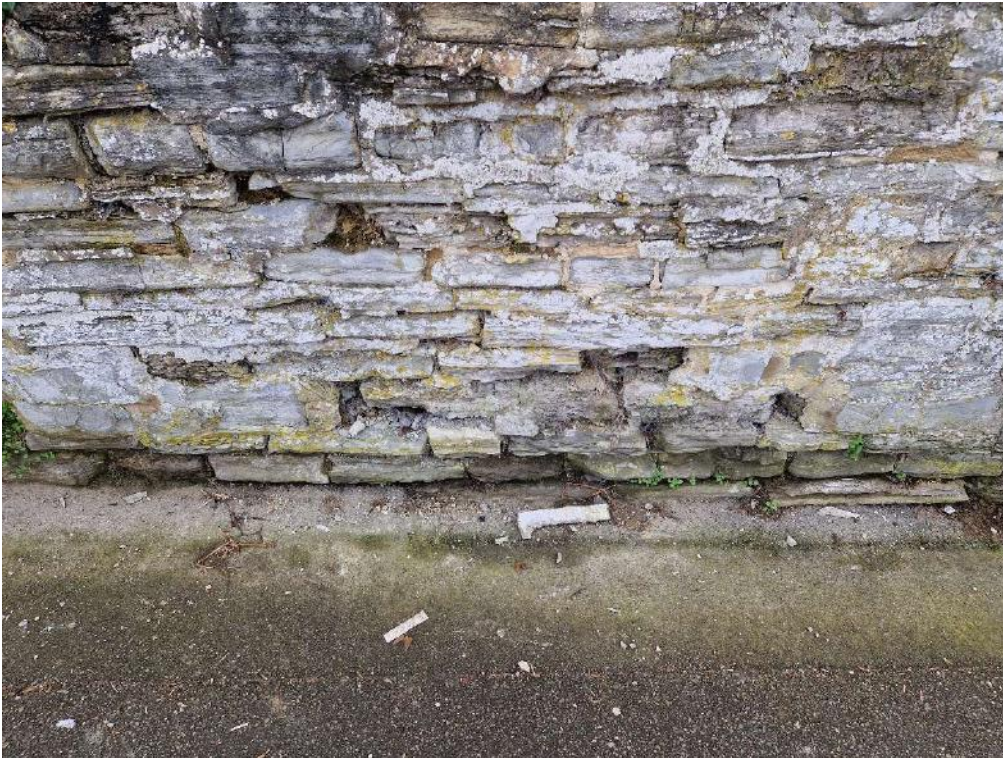
Photograph No. 23 – North – General Areas of Deterioration Due to Age

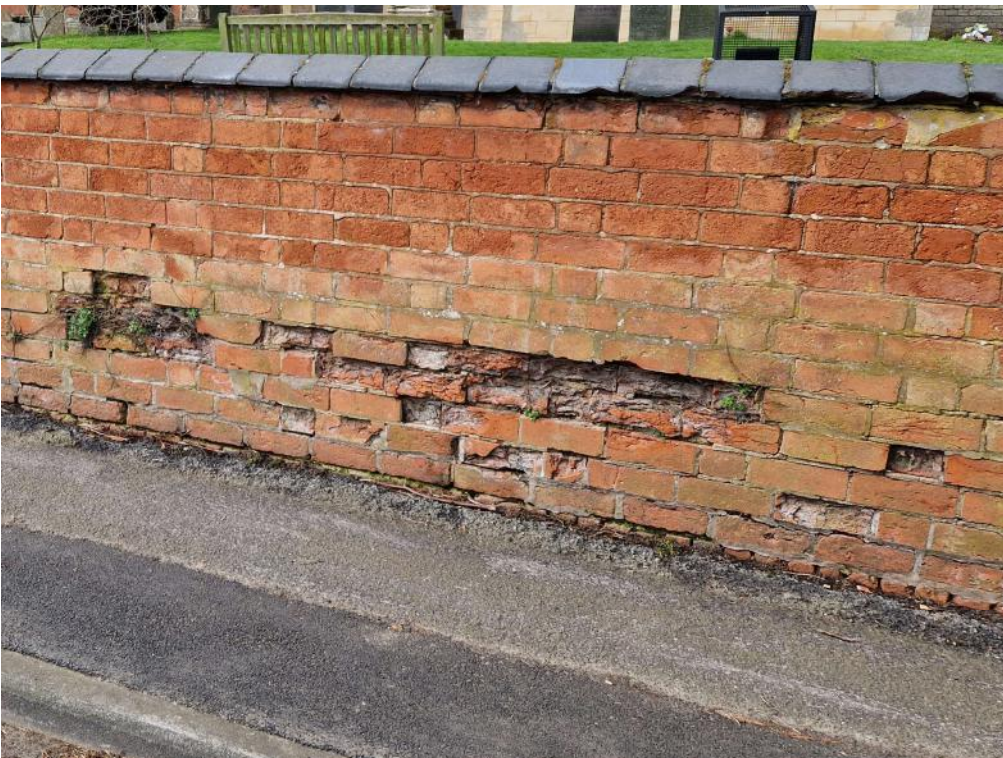
- a. A significant area of deteriorated masonry (noted as 'C' on the sketch plan) is present, located approximately 20m from the northeast corner, as well as smaller pockets of deteriorated brickwork along the wall's length (Photograph 24).
- b. The wall appears to have sheared at low level along a length of 1m, located approximately 21m from the northeast corner (noted as 'C' on the sketch plan) (Photograph 25).
- c. A slight concave appearance is present to the wall near the southeast corner of the site with a mortar infill to hide the step (Photograph 26).

Photograph No. 24 – East – Deteriorated Masonry at Low Level

- 3.4 Areas of heavily deteriorated masonry, such as that identified on the east boundary wall, should be replaced/repared. This can be done on a brick-by-brick basis with individual units being removed and replaced. Where the wall is retaining, it would be unadvisable to remove several bricks at a given time, as the overall integrity of the section will need to be retained throughout any repairs.

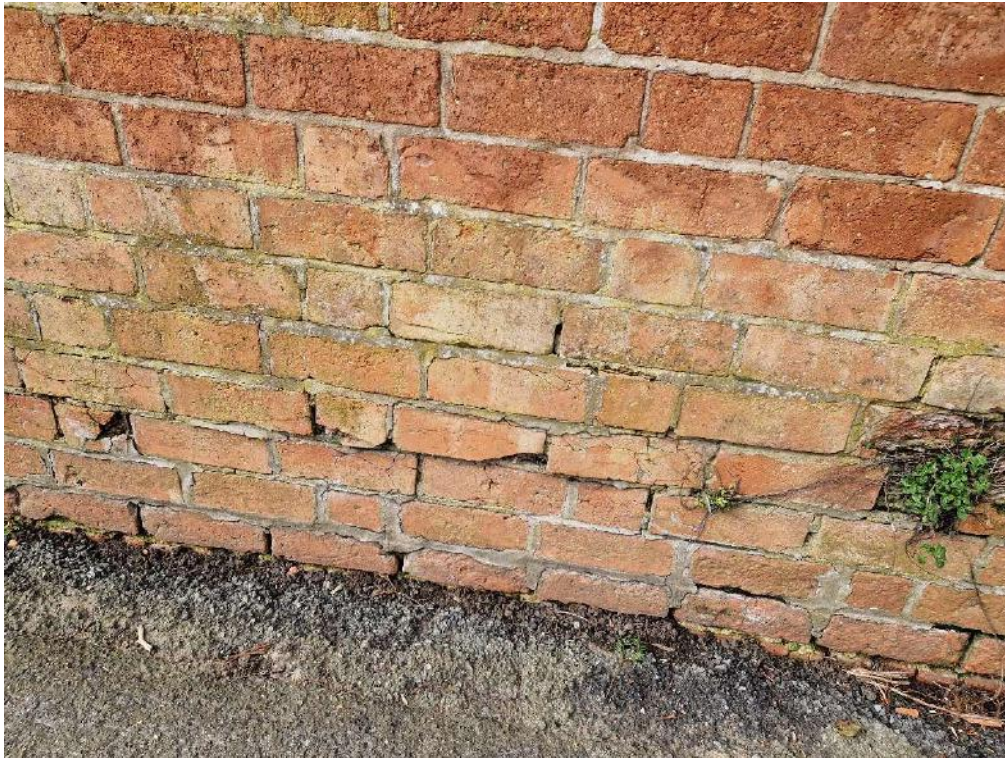
Photograph No. 25 – East – Sheared Wall at Low Level

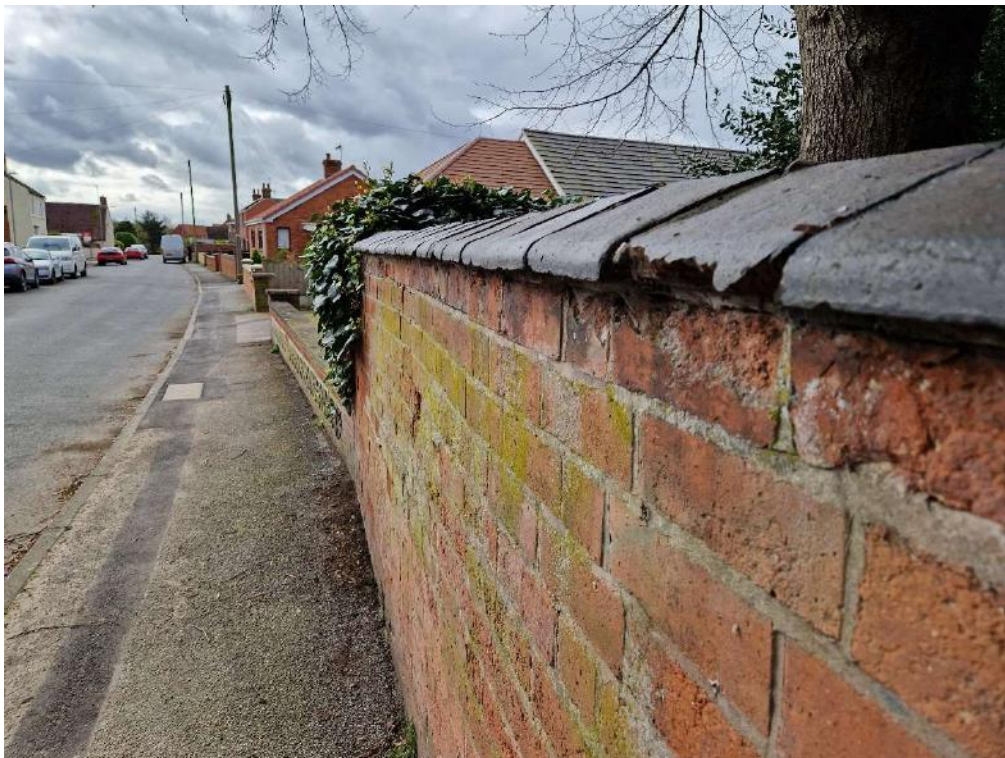
Photograph No. 26 – East – Minor Concave Shape to Wall at Southeast Corner

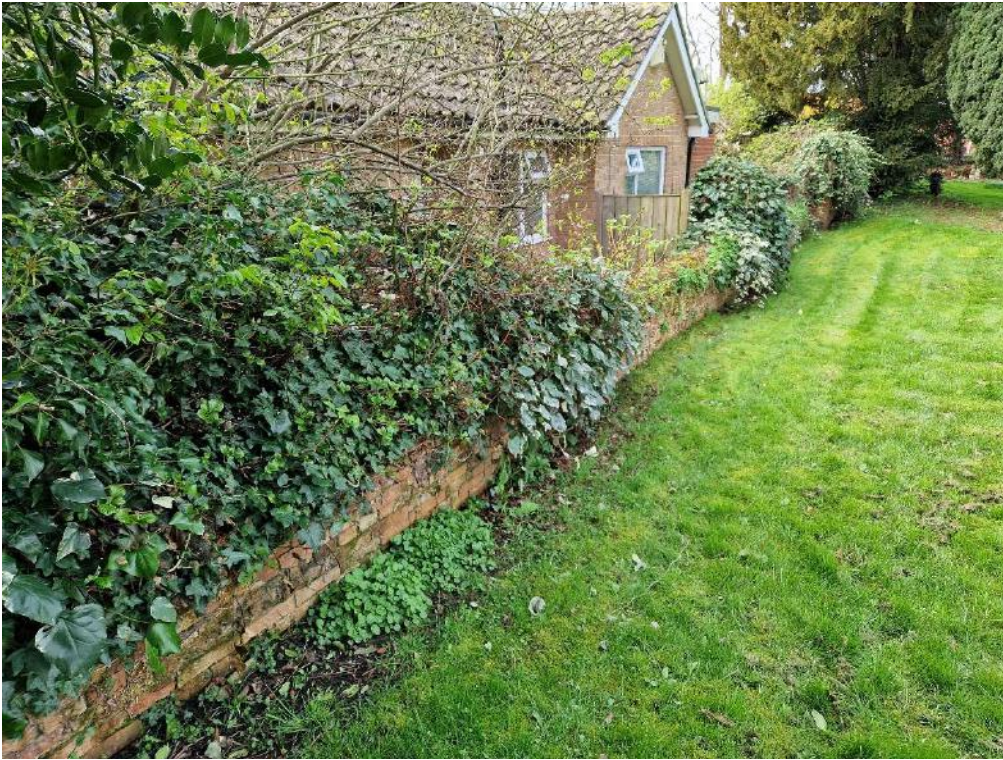
- a. Noted as 'D' on the sketch plan. Significant foliage growth is present to roughly the first 20m of the wall when measured from the southeast corner (Photograph 27). Additional areas of deteriorated masonry are present beneath the foliage (Photograph 28).
- b. A collapsed section of wall is present at approximately 40m from the southeast corner of the site (Photograph 29, noted as section 'E' on the sketch plan). The remainder of the boundary wall continues south at this location with an additional stretch of wall progressing into the site and forming a further retaining structure.
- c. Further pockets of missing masonry and mortar can be seen along the boundary wall running between the near and far south boundary of the site (Photograph 30).

Photograph No. 27 – South – Foliage Growth Along Wall
