# St Giles Church, Boundary Walls

## Condition Report

**VISUAL STRUCTURAL INSPECTION  
ST GILES CHURCH, BALDERTON  
SOUL ARCHITECTS**

**12783-WMS-XX-XX-T-S-20001-S2-P2**

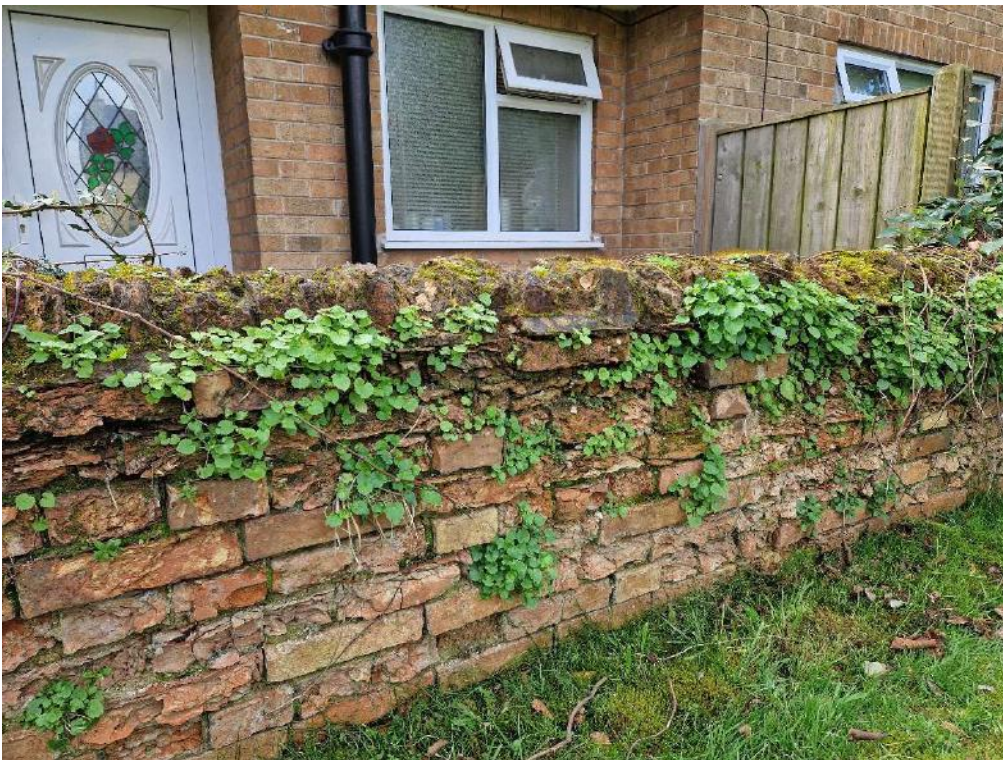
- a. Noted as 'D' on the sketch plan. Significant foliage growth is present to roughly the first 20m of the wall when measured from the southeast corner (Photograph 27). Additional areas of deteriorated masonry are present beneath the foliage (Photograph 28).
- b. A collapsed section of wall is present at approximately 40m from the southeast corner of the site (Photograph 29, noted as section 'E' on the sketch plan). The remainder of the boundary wall continues south at this location with an additional stretch of wall progressing into the site and forming a further retaining structure.
- c. Further pockets of missing masonry and mortar can be seen along the boundary wall running between the near and far south boundary of the site (Photograph 30).

Photograph No. 28 – South – Deteriorated Masonry Throughout Wall

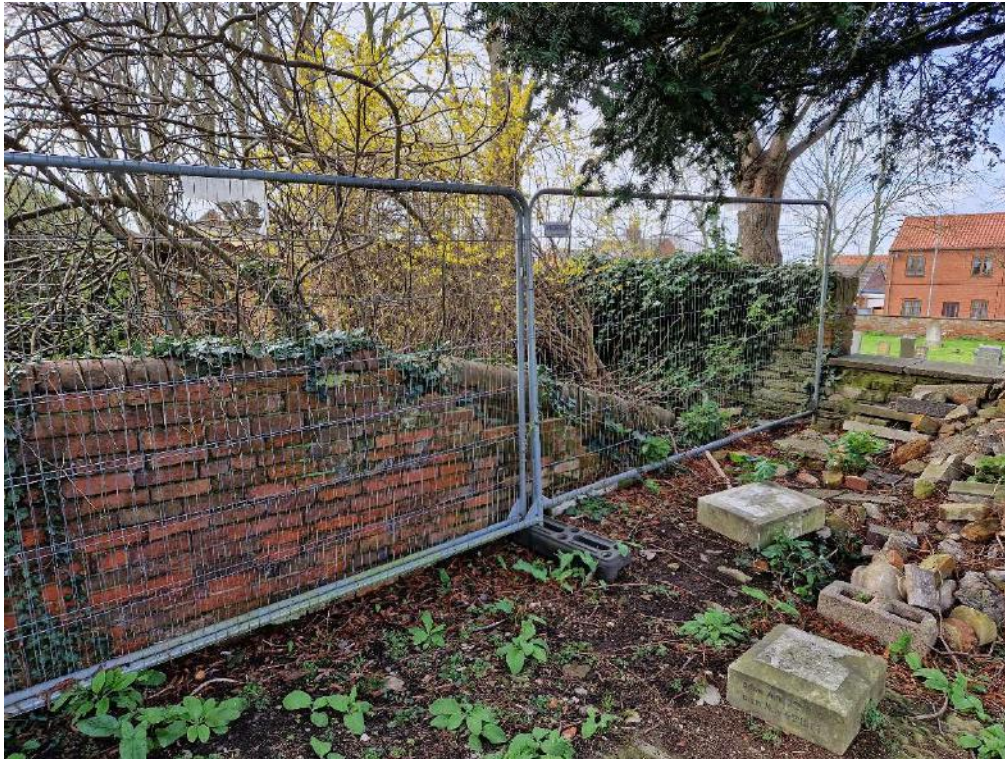
Photograph No. 29 – South – Collapsed Section of Wall

- 3.3 In addition to the above, the collapsed section of wall on the southern side of the site will require replacement. Any areas of reconstruction will have to be in keeping with the special historic nature of the site. Bricks should be reused wherever possible and where not, reclaimed bricks, to match the existing, should be used. Furthermore, a suitable lime mortar mix should be used to bed all masonry units. Any feature units should also be retained and reused, coping stones for example.

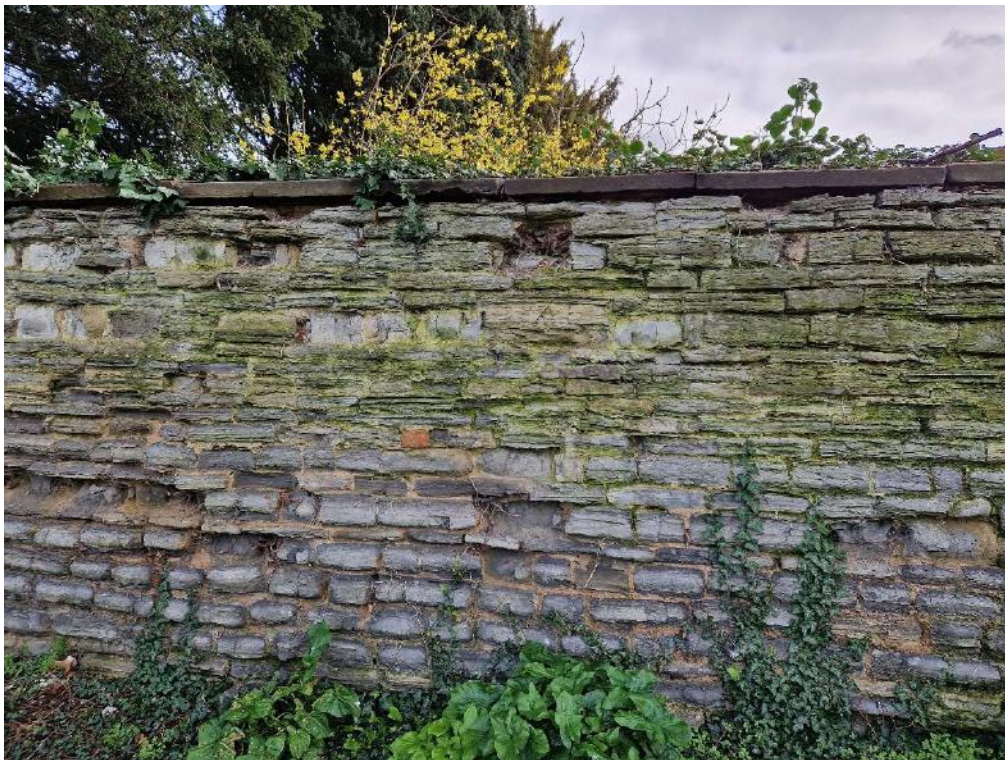
Photograph No. 30 – South – Deteriorated Masonry/Mortar Along Wall Length

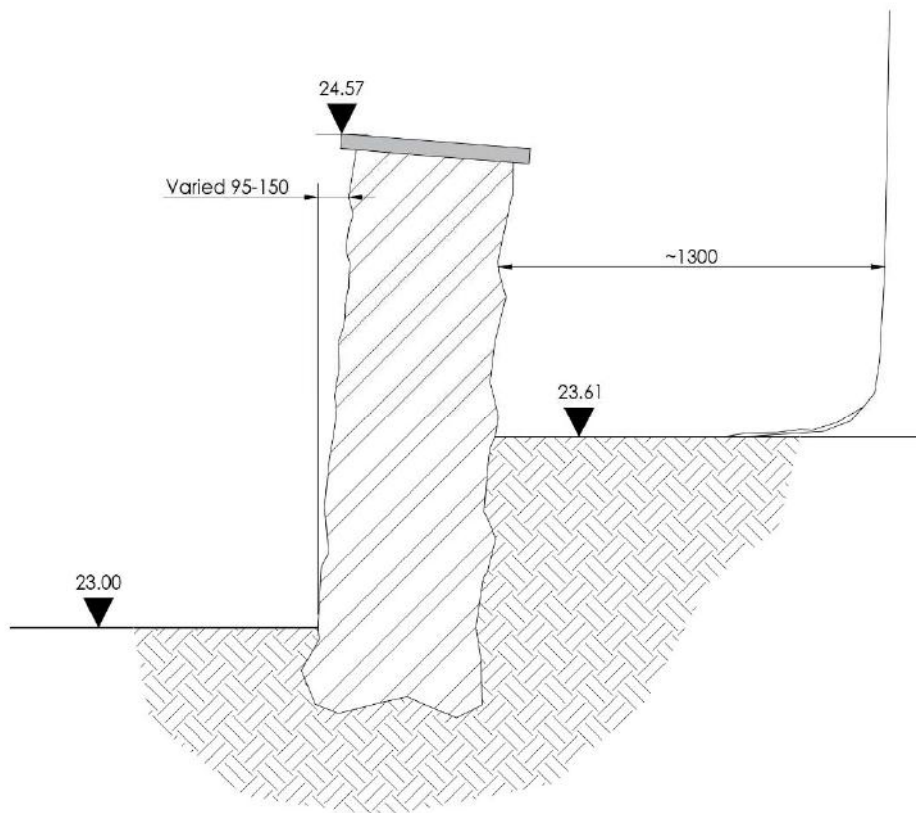
## Indicative Section of Leaning Blue Lias Wall

*Noted as section A on the sketch plan.*

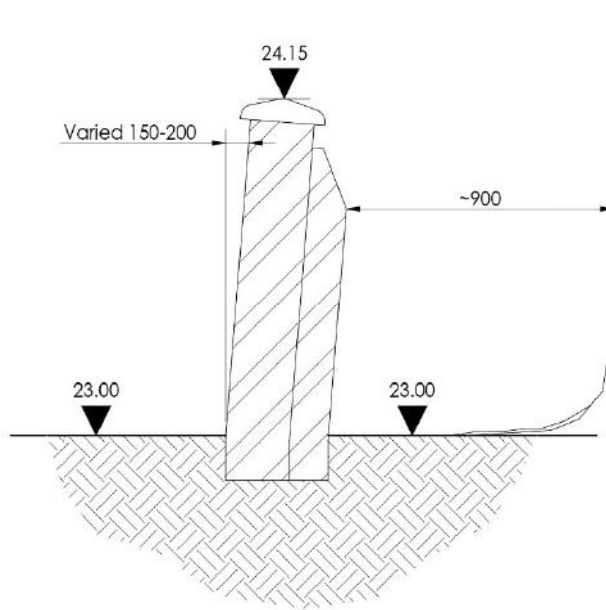
## Indicative Section of Leaning Masonry Wall

*Noted as section B on the sketch plan.*
