## Donhead St Andrew Cemetery War Memorial

A report on our activities on 8th November 2017:

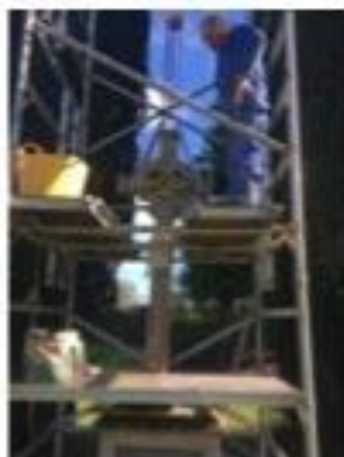
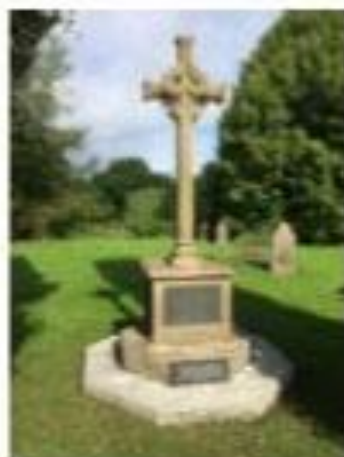
Concern had been raised as there was movement of the shaft and cross emanating from the joint above lower sockle. This joint showed a hair line break.

We established there are ferrous dowels pinning the top section of the cross and bottom shaft to sockle .

We quickly established that the grouting around this ferrous dowel was neat cement and being careful not to damage the joints or rupture the surrounding stone, we tried to hit it at its centre so we could break the joint to reveal the pin. We ground down a chisel for this purpose to avoid spalling the joint. Unfortunately, try as we may, even hoisting the cross top to put upward pressure on the joint, it would not give way. After consideration, we decided that pursuing this would cause too much damage to the cross. I did not want to be responsible for a massive diagonal spall where the dowel terminated. There is no sign of any rusting and subsequent exfoliation of the iron dowel. We decided at length not to force it.

While lifting, all three stones came up as one. We again carefully tried to separate the sockle stone, but met very stiff resistance. We decided not to force the stones as this would have resulted in serious damage. We opened the lower joint as with the top .

There is no lower dowel in the sockle base. We refixed the base on a hydraulic lime mortar and raked out and repointed the shaft base and the joint below the cross.

The ferrous dowels for now are safe from water ingress and will not present a problem for at least ten years. They will need to be monitored.
