## **Hamble-le- Rice Parish Council**

**Asset Management Committee of the Parish Council will be held on  
Tuesday 29<sup>th</sup> August 2017 4.00pm at Hamble Village Memorial Hall, High  
Street, Hamble-le-Rice  
AGENDA**

**Tree Survey Report  
Hamble Le Rice Parish Council**

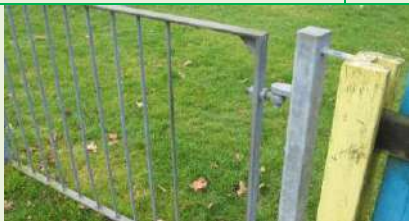
<p>SITE, SIGNS, FENCE AND GATES</p>		<p>FAULT(S) AND/ OR STANDARD FAILURE(S) FOUND, SEE BELOW</p>
VEHICLE GATE	SECTION MISSING AND DOGS CAN ENTER	RISK ASSESSMENT 2 X 2 LOW RISK

REPLACE MISSING SECTION
BOTH GATES	FINGER CRUSHING POINT WHERE GATES COME TOO CLOSE TO POST (S) SHOULD BE MIN 12 MM GAPS	RISK ASSESSMENT 1 X 3 LOW RISK

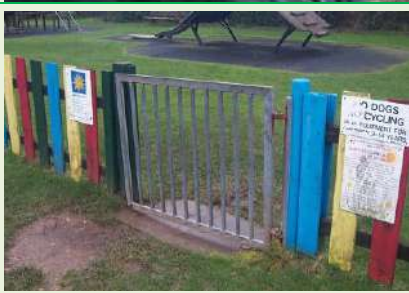
ADJUST CLEARANCES, THERE SHOULD BE A MINIMUM OF 12 MM BETWEEN GATE AND POST(S)
GATES	BOTH GATES GATE CLOSES FAST ON REBOUND WHEN PUSHED OPEN  BACK GATE CLOSES FAST FROM 90°	RISK ASSESSMENT 2 X 3 MEDIUM RISK

ADJUST SPEED OF CLOSING - GATES SHOULD SELF-CLOSE IN NO LESS THAN 3 SECONDS AND NO MORE THAN 8 SECONDS, INCLUDING ON REBOUND

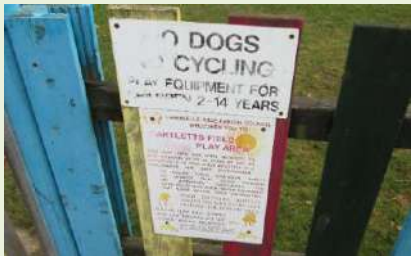
SIGNS	WEARING/DAMAGED AND BECOMING HARD TO READ  ALSO NO TELEPHONE NUMBER PROVIDED TO REPORT ACCIDENT OR FAULT	RISK ASSESSMENT 2 X 2 LOW RISK

RENEW SIGNS AND ADD TELEPHONE NUMBERS
SURFACE	TRIPPING HAZARD WHERE REMAINS OF SPRING PROTRUDE	RISK ASSESSMENT 2 X 2 LOW RISK	 	REMOVE REMAIN OR COVER

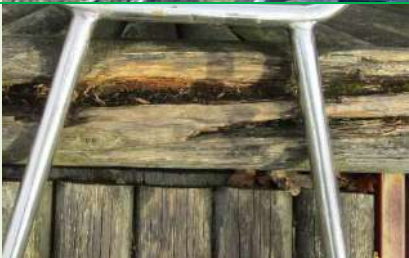
REPAIR
CABIN	ROTTING AT SLIDE ENTRANCE	RISK ASSESSMENT 1 X 3 LOW RISK

MONITOR FOR FURTHER DETERIORATION
CABIN	FIXINGS BEGINNING TO PROTRUDE IN ENTRANCE AREA	RISK ASSESSMENT 1 X 2 LOW RISK

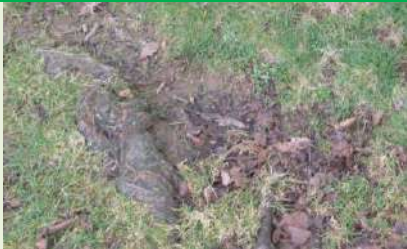
BENCH AT SLIDE	TRIPPING HAZARD DEVELOPING WHERE ROOT PROTRUDES	RISK ASSESSMENT 2 X 2 LOW RISK

ELIMINATE TRIPS
BENCH AT SIDE	ROTTING	RISK ASSESSMENT 2 X 2 LOW RISK

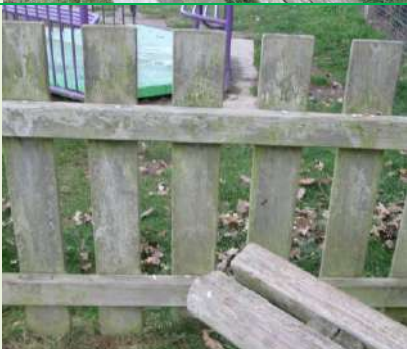
RENEW
BENCH AT END	LOCATION ENTICES CLIMBING OVER AND HEAD TRAPS IN FENCE ARE PRESENT	RISK ASSESSMENT 1 X 3 LOW RISK

CONSIDER RELOCATING BENCH

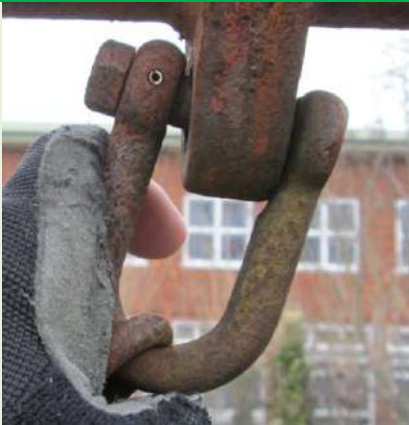
SHACKLES AND BUSHES	BADLY WORN	RISK ASSESSMENT 2 X 3 MEDIUM RISK

<p>PHOTO SHOWS EXAMPLE</p>	SERVICE SHACKLES AND BUSHES
SURFACE	SURFACE PULLING APART AT JOINTS/EDGES AND HAS WEED GROWTH	RISK ASSESSMENT 2 X 2 LOW RISK

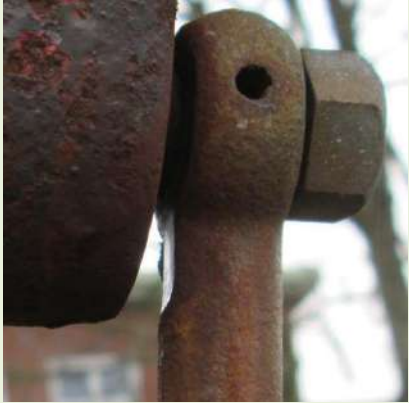
REMOVE WEEDS AND MONITOR FOR FURTHER DETERIORATION
SHACKLES	WEARING AS THEY CONNECT WITH LUGS	RISK ASSESSMENT 2 X 3 MEDIUM RISK

<p>PHOTO SHOWS EXAMPLE</p>	RENEW SHACKLES
SHACKLE	ONE SHACKLE HAS NO ROLLER PIN AND IS LOOSE	RISK ASSESSMENT 3 X 3 HIGH RISK

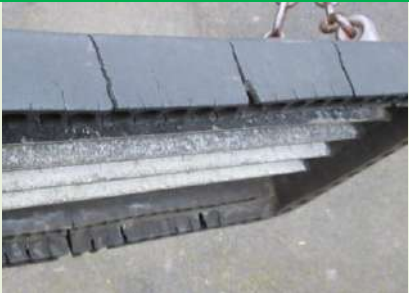
JUNIOR SEAT	SLIGHT DAMAGE	RISK ASSESSMENT 1 X 3 LOW RISK

MONITOR FOR FURTHER DETERIORATION
FRAME	CONSIDERABLE RUST ON FRAME RISKS WEAKENING OF STRUCTURE	RISK ASSESSMENT 1 X 4 LOW RISK

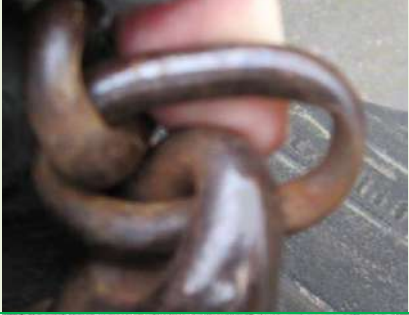
DE RUST AND REPAINT
CHAINS	CHAIN LINK WEAR IS CLOSE TO 10% AND/OR LINKS ARE NOTCHED AND THEREFORE MORE THAN 50% OF THEIR STRENGTH MAY BE LOST	RISK ASSESSMENT 2 X 3 MEDIUM RISK

RENEW CHAINS
ADVISORY NOTE	CONSIDER REPLACING JUNIOR SEATS WITH TODDLER SEATS TO INCREASE TODDLER PROVISION ON SITE

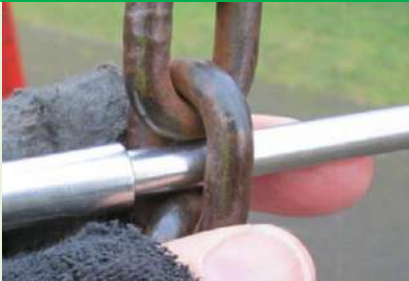
CHAINS	TWO SETS OF CHAINS HAVE AN OPENING GREATER THAN 8.6 MM	RISK ASSESSMENT 1 X 3 LOW RISK

REMEDY WHEN CHAINS RENEWED
SEATS	SLIGHT DAMAGE	RISK ASSESSMENT 2 X 2 LOW RISK

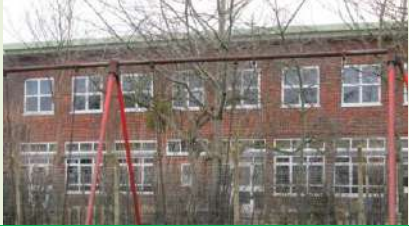
MONITOR FOR FURTHER DETERIORATION
FRAME	CONSIDERABLE RUST ON CROSSBAR WEAKENING OF STRUCTURE	RISK ASSESSMENT 1 X 4 LOW RISK

DE RUST AND REPAINT

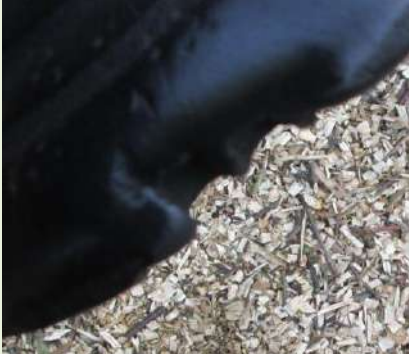
SEAT	SLIGHT DAMAGE	RISK ASSESSMENT 1 X 3 LOW RISK

MONITOR FOR FURTHER DETERIORATION
------	---------------	--------------------------------	--	-----------------------------------

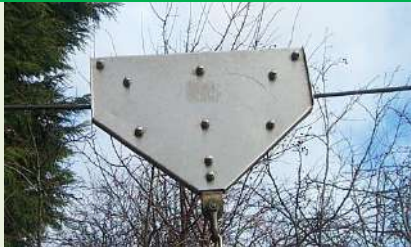
TRAVELLER	THIS IS JUDDERING WHEN LOADED AND IN MOTION	RISK ASSESSMENT 2 X 3 MEDIUM RISK

SERVICE THE TRAVELLER
SURFACING	THERE IS INSUFFICIENT DEPTH OF LOOSE FILL  THE MATERIAL IS DEPLETED, COMPACTED AND DISBURSED  AND AS THE PARTICULATE SIZE IS OUTSIDE THE RANGE USED IN BS EN 1176 TABLE 4 TO ESTABLISH A SUITABLE DEPTH OF SURFACE, THE RISK LEVEL GIVEN HERE CAN THEREFORE ONLY BE AN ESTIMATE	RISK ASSESSMENT 2 X 3 MEDIUM RISK

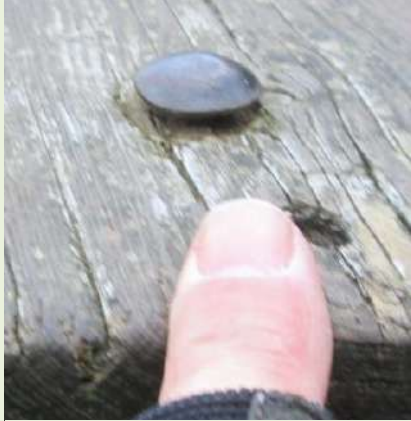
INVESTIGATE FOR LOOSE CONNECTIONS AND TIGHTEN ALL FIXINGS
RAMPS	FIXING HEADS PROTRUDING ON RAMPS	RISK ASSESSMENT 2 X 3 MEDIUM RISK

PHOTO SHOWS EXAMPLE	FULLY COUNTERSINK

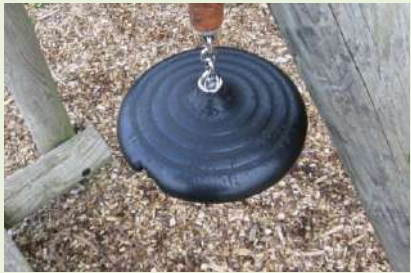
SEAT	COMES TOO CLOSE TO THE POSTS AT EACH END, SHOULD BE AT LEAST 2M CLEARANCE TO MEET BS EN STANDARD WHEN SEAT IS PITCHED FORWARD AT 45°	RISK ASSESSMENT 2 X 3 MEDIUM RISK

ADJUST STOPPING POSITION TO ACHIEVE REQUIRED CLEARANCE
BARK PIT	TIMBER EDGE DAMAGED AND ROTTING IN PLACES AND SECTIONS MISSING	RISK ASSESSMENT 1 X 3 LOW RISK

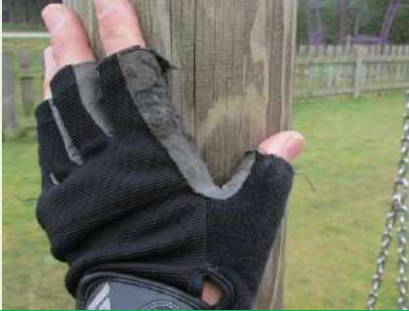
<p>ADVENTURE TRAIL</p> <p>PLAYDALE</p> <p>GRASS</p>		<p>FAULT(S) AND/ OR STANDARD FAILURE(S) FOUND, SEE BELOW</p>
<p>POST AT SWINGING LOGS</p>	<p>POST IS SLIGHTLY LOOSE</p>	<p>RISK ASSESSMENT 1 X 3 LOW RISK</p>

<p>EXCAVATE DOWN TO FOUNDATIONS TO DETERMINE THE CONDITION OF THE POLE</p>	
<p>POSTS</p>	<p>SPLITS ARE PRESENT IN TIMBERS</p> <p>THESE CAN PERMIT WATER TO REACH THE WOOD INSIDE ITS PRESERVATIVE ENVELOPE AND ROT AND/OR DECAY MAY FOLLOW</p>	<p>NO RISK ASSESSMENT</p>	 	<p>REGULAR INSPECTIONS, INCLUDING, SHOULD PAY PARTICULAR ATTENTION TO CONDITION AND STABILITY PARTICULARLY CHECKING FOR ROT AND DECAY AT POINTS OF GROUND CONTACT AND IN ALSO IN TIMBER COMPONENTS WHERE FIXINGS AND FITTINGS ARE ATTACHED</p>

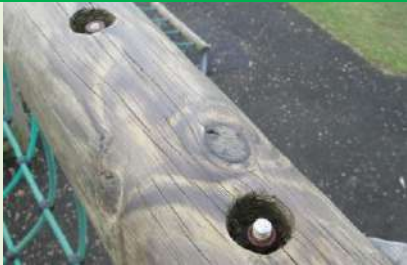
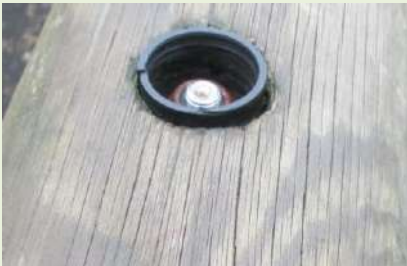
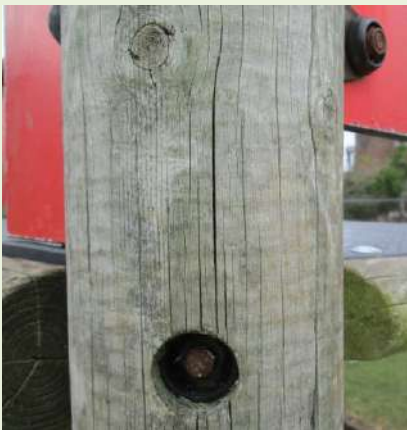
COVER CAPS	SOME ARE MISSING AND WATER WILL PENETRATE (SEE ABOVE)	RISK ASSESSMENT 2 X 3 MEDIUM RISK

REPLACE MISSING CAPS  SEE RECOMMENDED ACTION ABOVE RE TIMBERS
BOLTS	SHARP BOLTS PROTRUDE, INCLUDING BENEATH RAMP, PLATFORM AND BRIDGE	RISK ASSESSMENT 2 X 3 MEDIUM RISK

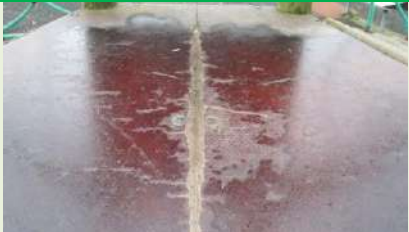
PLATFORM TIMBERS	WEARING	RISK ASSESSMENT 2 X 2 LOW RISK

PROGRAMME FOR RENEWAL
NET	NET WEARING	RISK ASSESSMENT 2 X 2 LOW RISK

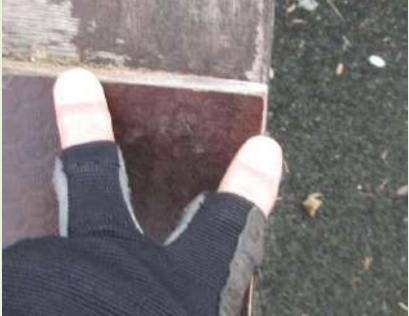
MONITOR FOR FURTHER DETERIORATION/D AMAGE
RAMP	ACCESSIBLE EDGES ARE NOT ROUNDED TO THE MINIMUM REQUIRED RADIUS OF 3 MM AND CORNERS ARE SHARP	RISK ASSESSMENT 1 X 3 LOW RISK

ROUND CORNERS AND CHAMFER EDGES
