Annual Inspection

Battle Town Council - WPS

Telham Recreation Ground

Inspection Ref: 1238930

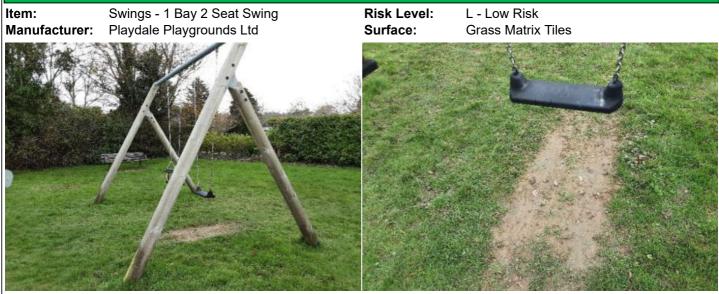
Finding: The surface has eroded in some areas

Action: Reinstate the surface

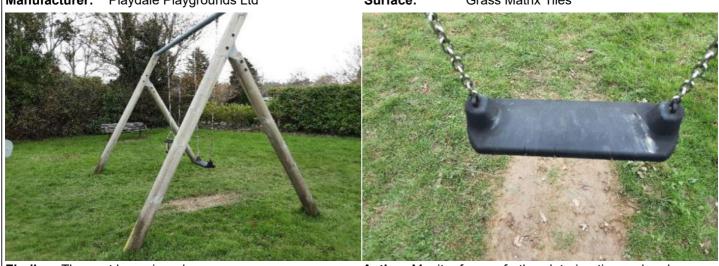
Finding: The seat has minor damage or wear

Action: Monitor for any further deterioration and replace as required

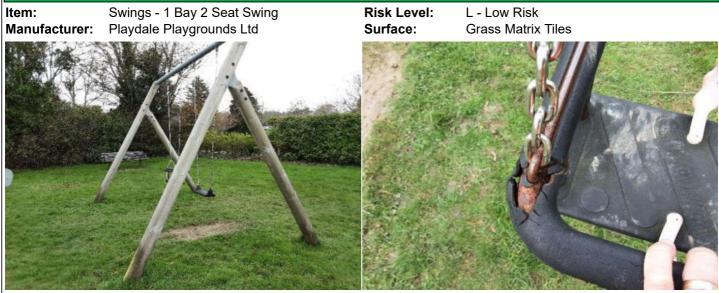
Finding: The swing seat frame is severely corroded and requires replacement

Action: Replace seat

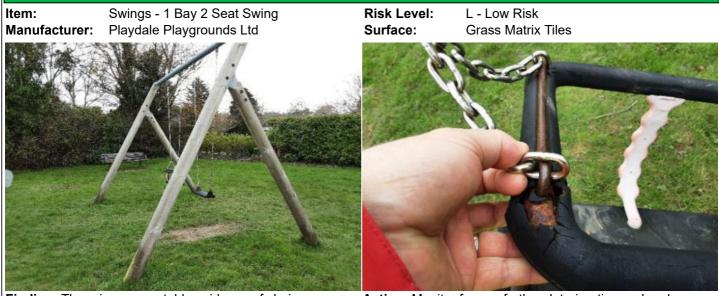
Finding: There is some notable evidence of chain wear

Action: Monitor for any further deterioration and replace when 40% worn

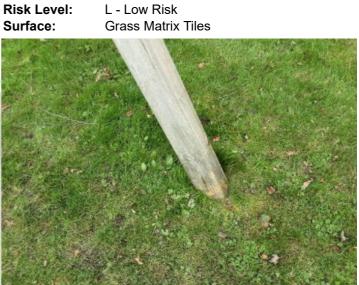
Finding: There is some strimmer / machinery damage apparent on the posts, this can penetrate the preservative applied to the timber and accelerate the rotting process

Action: Monitor for any deterioration (rot) and replace as required

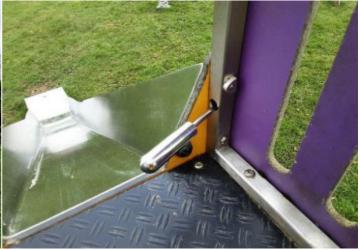
Finding: There is/are finger entrapment/s in the frame due to missing inserts and the item fails to meet the requirements of BS EN 1176 Part 1 4.2.7.6 Entrapment of fingers

Action: Replace all missing inserts

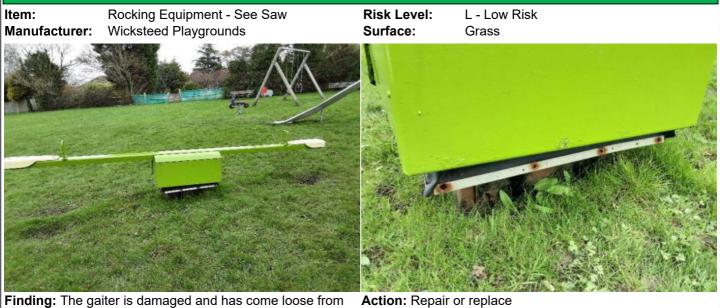
Finding: The gaiter is damaged and has come loose from its fixings

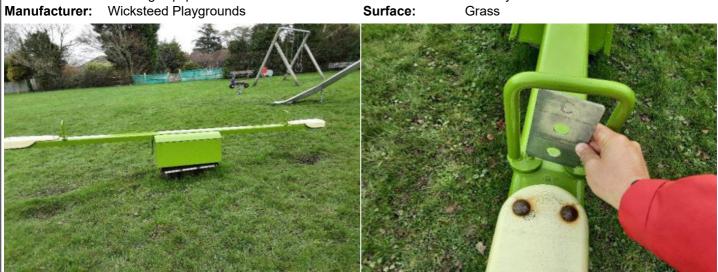
Finding: The item fails to meet the requirements of BS EN Action: Monitor - No remedial work recommended 1176 Part 1 4.2.7.2 for head and neck entrapment in the handles

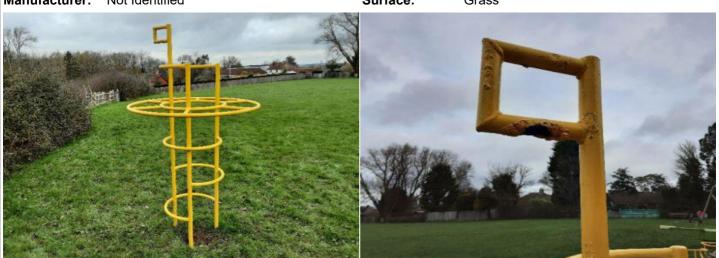
Finding: Parts of the steel on this item have corroded excessively and the metal has perforated in places

Action: Ensure all affected areas are treated and repaired
