# Operational Inspection Report – Play Equipment

**Site:** Merryweather Road Play Area, Swaffham

**Date of Inspection:** Tuesday 9<sup>th</sup> June 2020

**On Behalf Of:** Swaffham Town Council

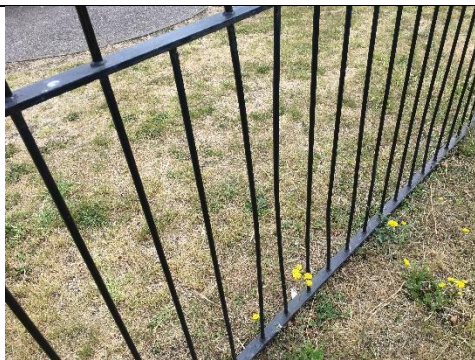
Minor damage to fencing panels in a number of places

Monitor only at this stage

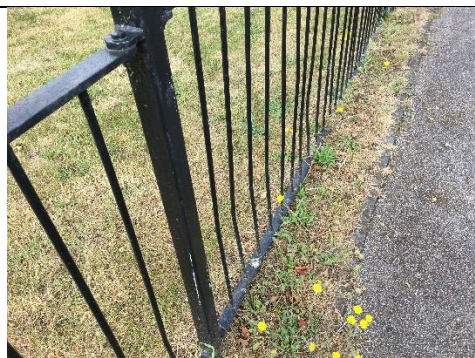
See comment above

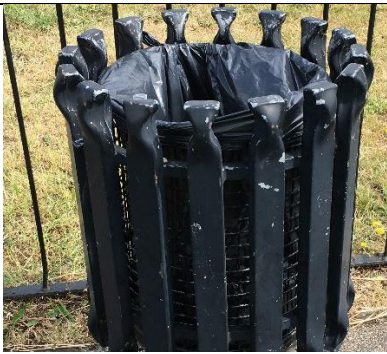
Paintwork poor in places

Consider re-painting

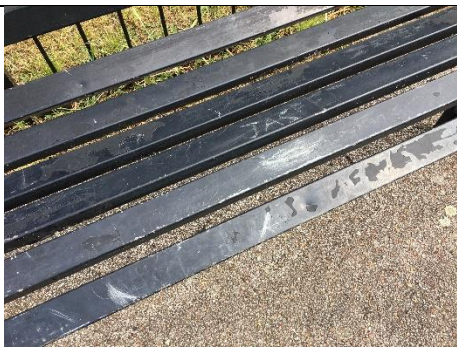
Paintwork poor in places and has been etched with graffiti

Monitor and consider re-painting

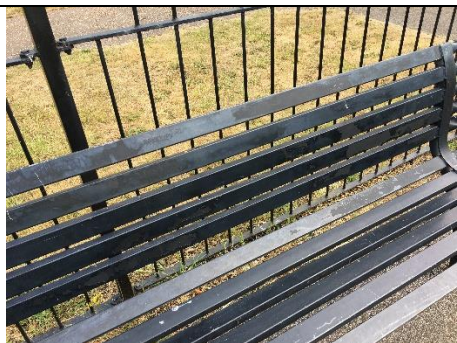
See comment above

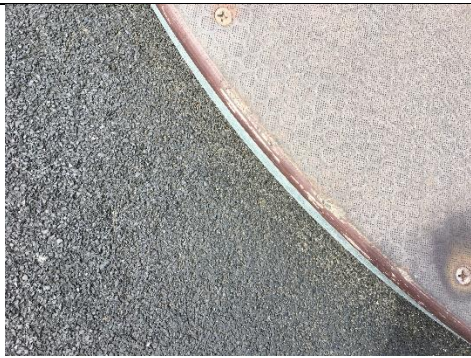
**Minor wear to platform edge**

**Monitor only at this stage**

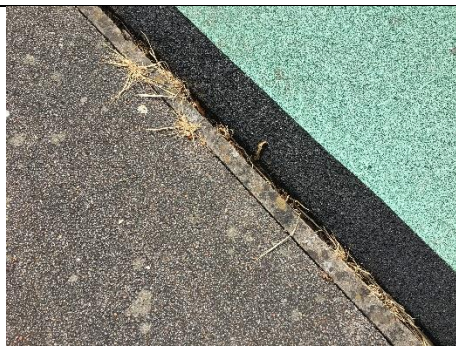
Some shrinkage of the wetpour surfacing

Monitor and consider repair if potential trip hazard arises

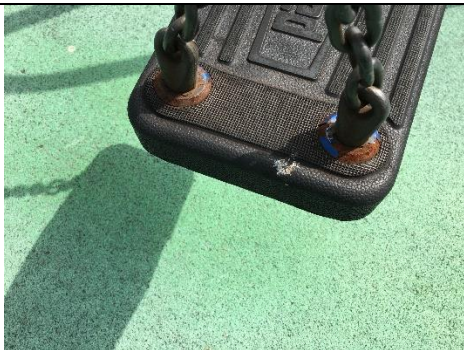
Minor corrosion on flat seat fixings

Monitor at this stage

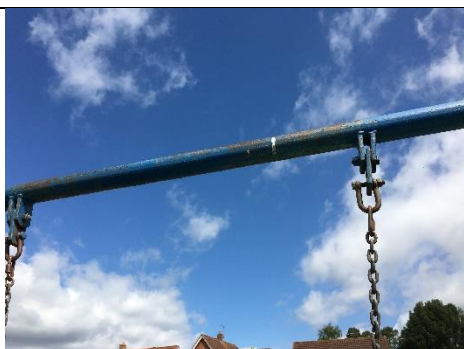
Corrosion on frame

Monitor at this stage

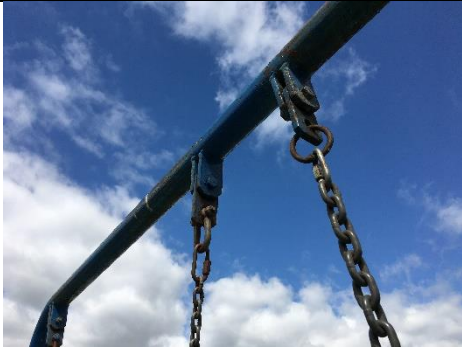
Some surface corrosion and wear on shackles and connectors

Monitor only at this stage

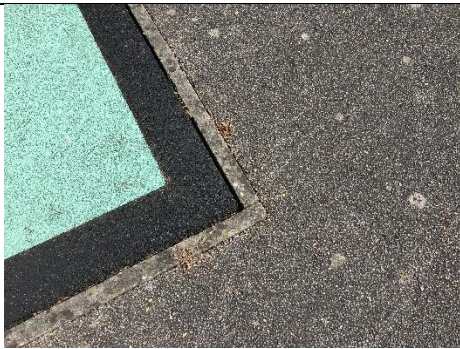
Minor shrinkage to the wetpour edging

Monitor

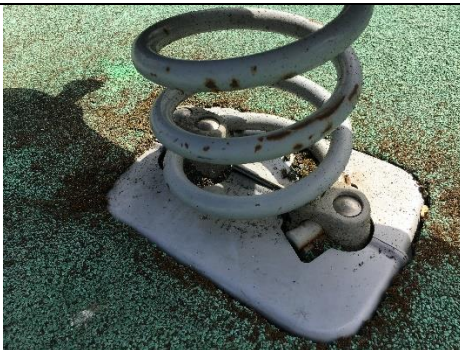
Corrosion on spring

Monitor and consider re-painting

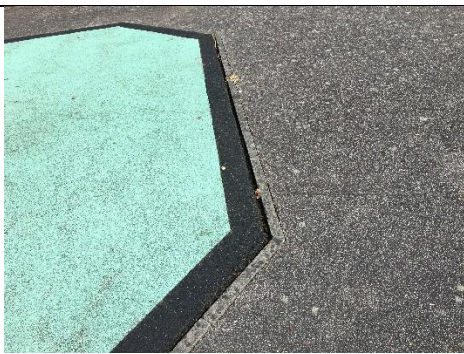
Some shrinkage of Wetpour surfacing

Monitor and consider repair if potential trip hazard arises

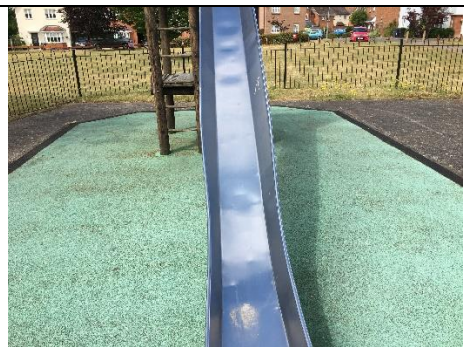
Minor dents to slide surface

Monitor

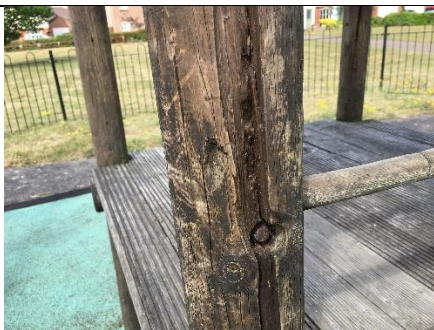
Some rough and snagged areas to timber components

Smooth/sand down

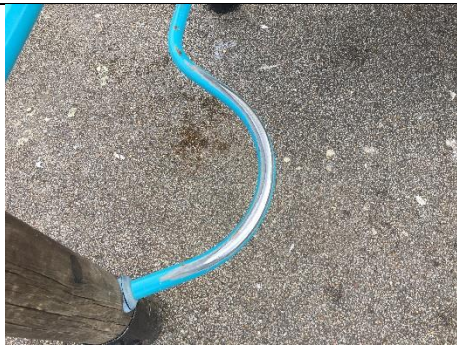
**Paintwork worn in places**

**Monitor and consider touching the panting**

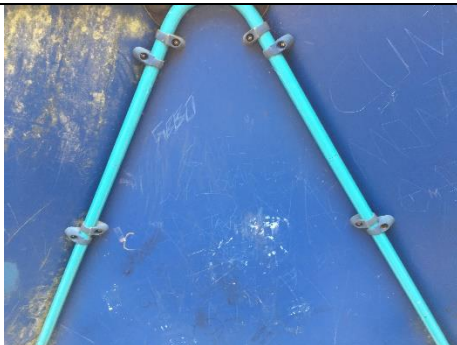
**Offensive graffiti present**

**Remove**

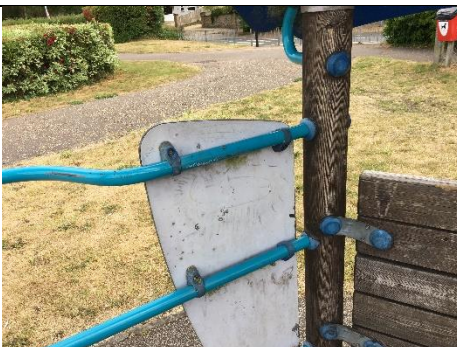
**See comment above**

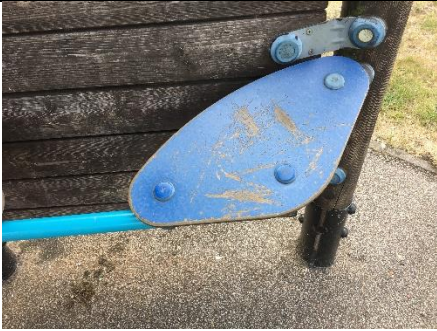
**Seats worn and etched**

**Monitor for any further deterioration**
