# Safety Inspection Report

## Widdrington Station Play Area

Widdrington Station and Stobswood Parish Council

22 June 2026

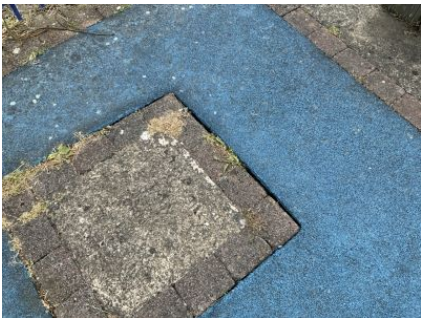
Shrinkage / separation of the surface. This may give a trip hazard.

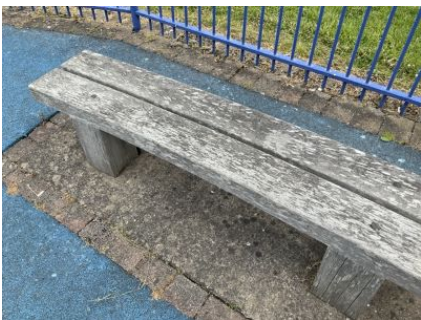
Timber preservation is in poor condition.

Stain with appropriate preservative. Most preservatives sold as child friendly by major DIY chains meet these standards (see advice in <https://www.rosaplaysafety.co.uk/advice-information/wooden-play-equipment/>).

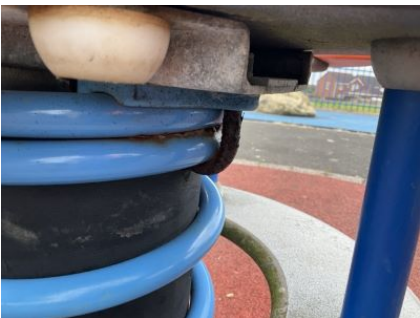
The spring is rusty. These have been known to fail without warning, leading to a collapse of the unit.

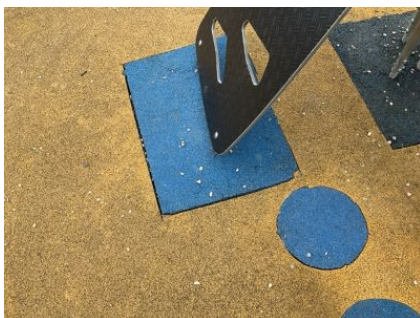
Shrinkage / separation of the surface. This may give a trip hazard.

## Repair.

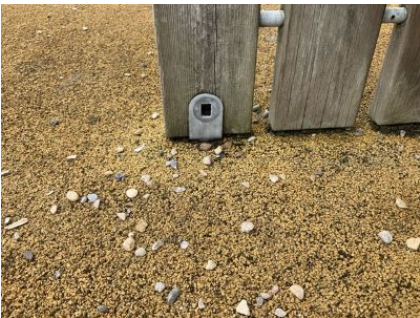
Bolt(s) missing.

Replace missing bolt(s).

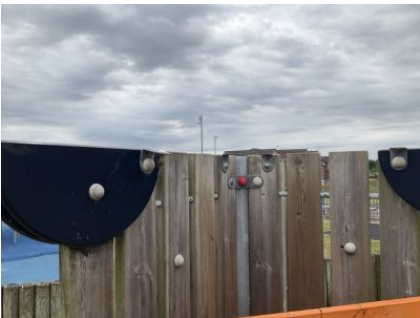
Item has some parts missing.

Replace the missing parts.

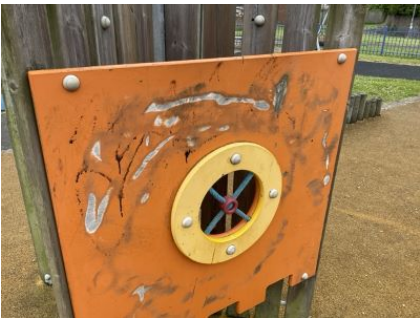
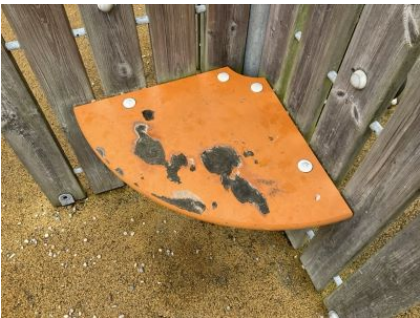
Item is damaged.

Repair.

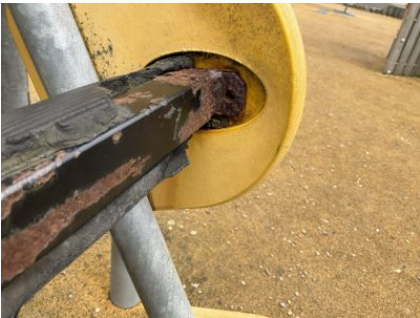
Bolt(s) missing.

Replace missing bolt(s).

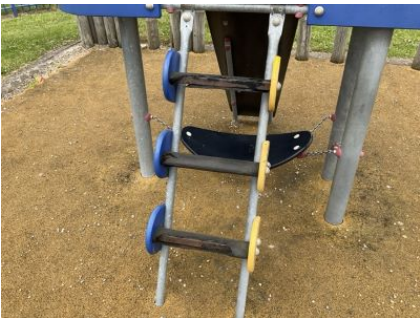
Item is damaged.

Risk score:  
 8

Repair.

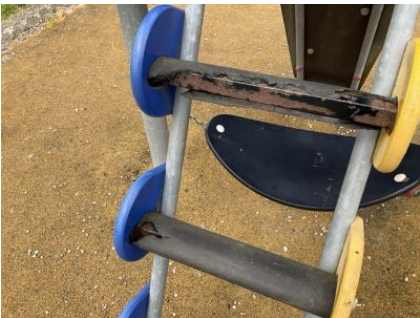
Item is rusting in places.

Risk score:  
 8

Repair.

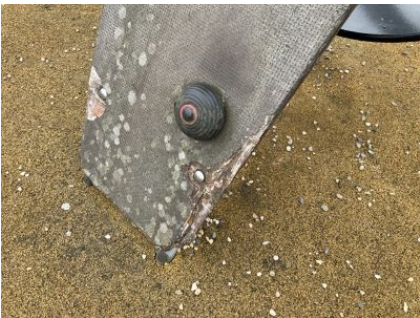
Item is damaged.

Risk score:  
 6

Repair.

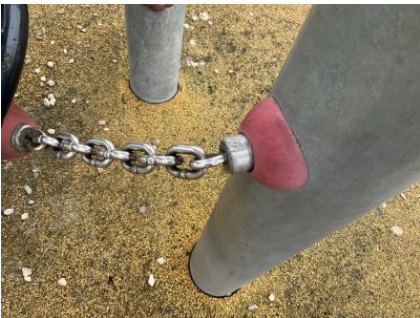
Some chain wear.

Risk score:  
 6

Monitor for further deterioration and replace before 40% wear.

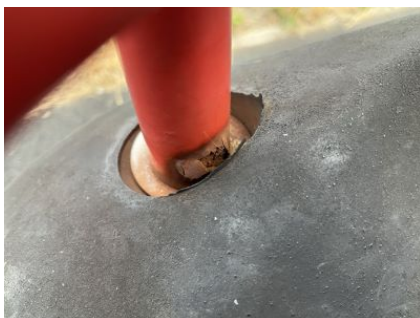
Corrosion in cradle seat top frame could lead to sudden failure of the seat.

Investigate and replace as necessary.

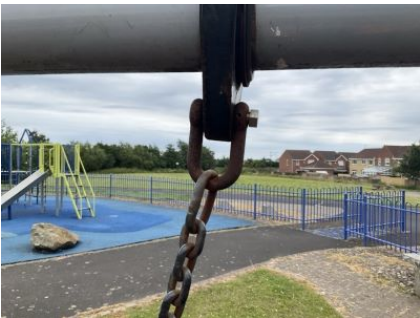
Fittings are rusty.

Replace.

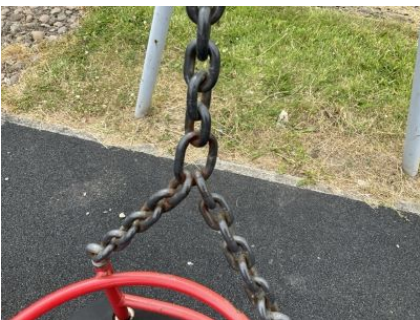
Some chain wear.

Monitor for further deterioration and replace before 40% wear.

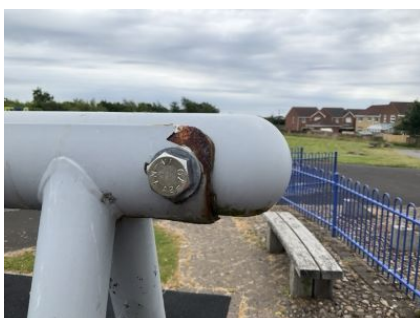
Item is rusting in places.

Repair.

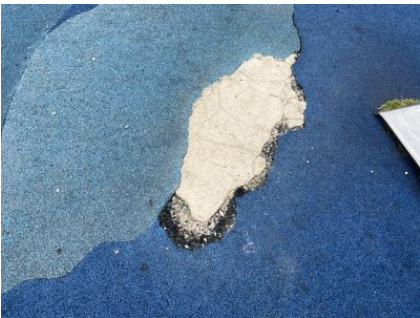
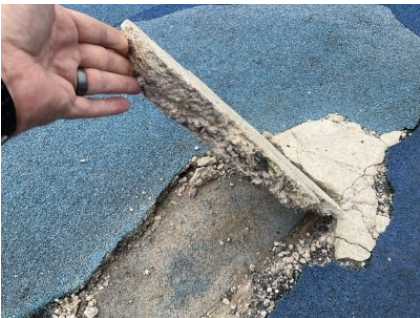
Hole in wet pour has been repaired with concrete. Remove and repair with wet pour.

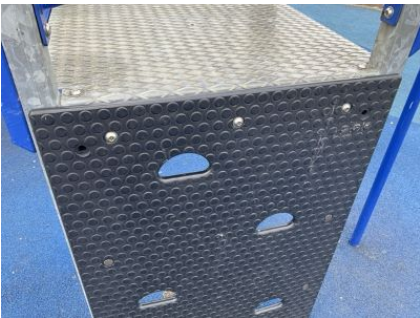
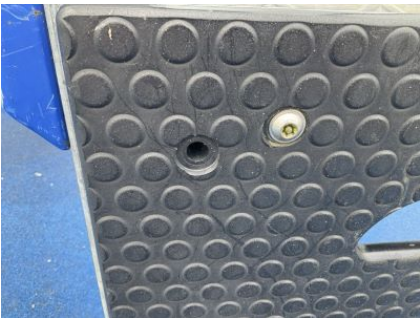
Bolt(s) missing.

Replace missing bolt(s).

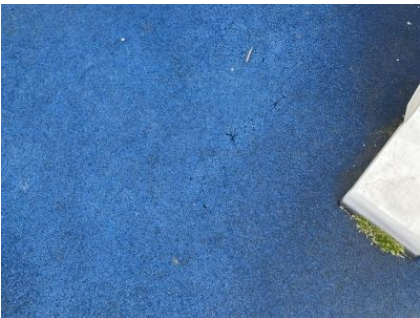
The surface is cracking.

Repair.

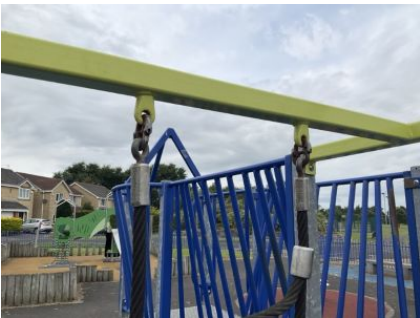
Some chain wear.

Risk score:  
 6

Monitor for further deterioration and replace before 40% wear.

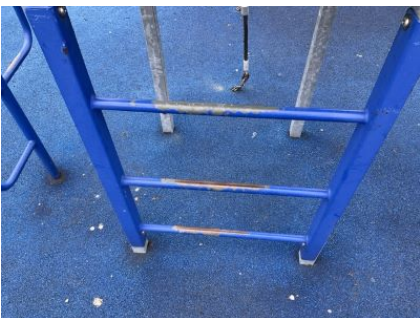
Paintwork is in poor condition.

Risk score:  
 5

De-scale back to good base material and coat with lead free paint, using appropriate precautions. Repairs may be necessary where corrosion is severe.

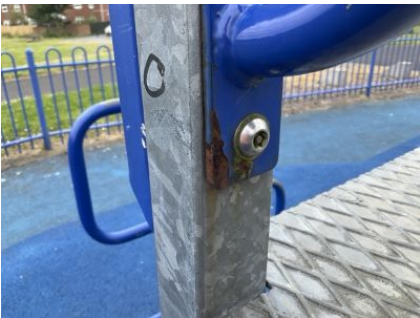
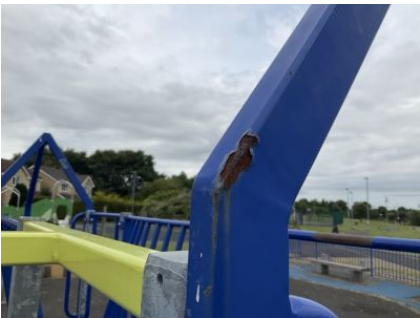
Item is rusting in places.

Repair.

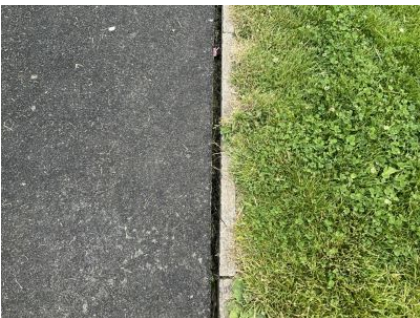
Shrinkage / separation of the surface. This may give a trip hazard.

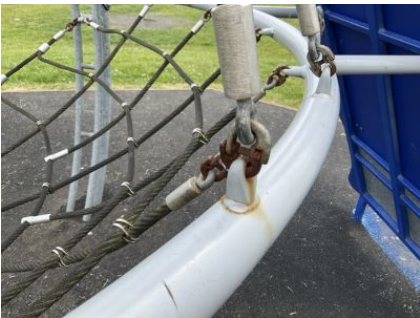
Fittings are rusty.

Risk score:  
 6

Replace.

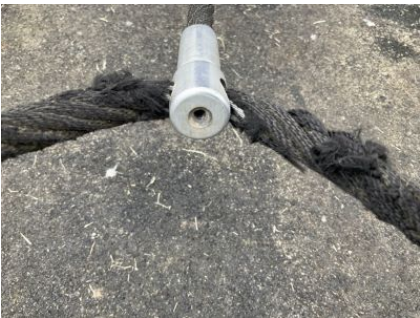
Screw is missing.

Risk score:  
 6

Replace.

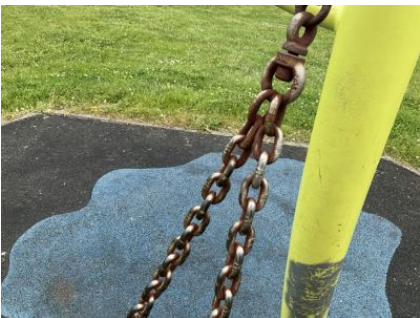
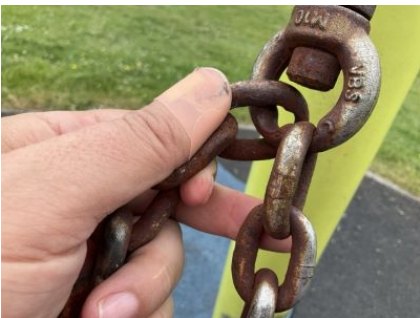
There is considerable wear to the chains.

Replace the worn chains or links.

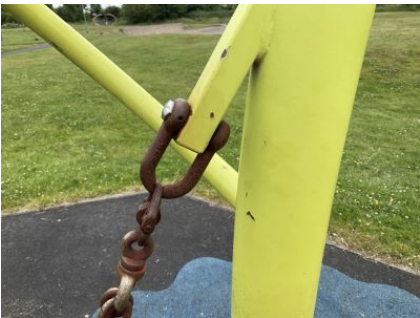
There is wear in the bushes.

Risk score:  
 10

Remove shackle bolt and check bush and shackle pin wear, replacing as necessary.

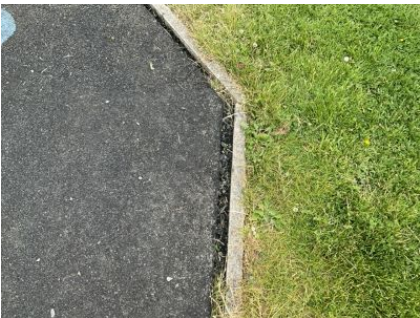
Shrinkage / separation of the surface. This may give a trip hazard.
