3.7.3. Site Description

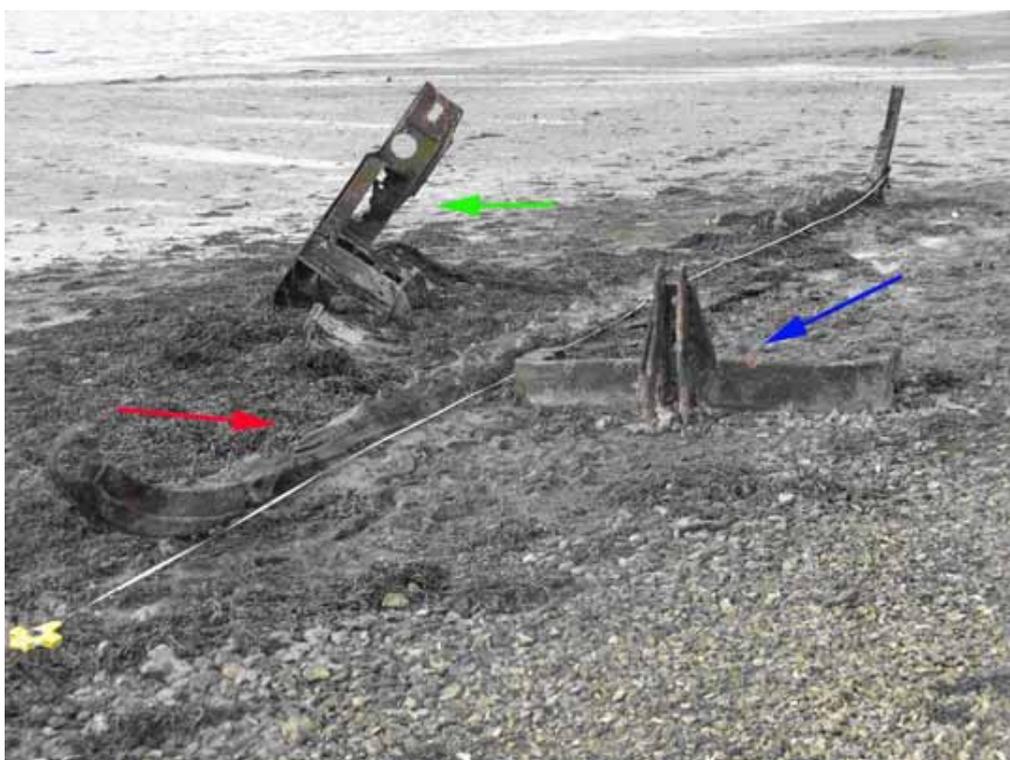
Through the centre of the site there is a keel from a carvel built hull (Figure HAM043-3). It has a composite keel of wood with an iron casing. Iron pins and bolts protrude down the centre of the keel. Towards midships the pins are in pairs. Not attached to the keel are two sections of collapsed steel structure. One section is the remains of the superstructure, which has been constructed using metal riveting (Figure HAM043-3). The other disarticulated structure is the remains of a tabernacle and deck coaming (Figure HAM043-3). The tabernacle lies forward of the coaming.

Figure HAM043- 3 The vessel comprises of the keel (red arrow), the tabernacle (blue arrow) and a section of superstructure (green arrow)

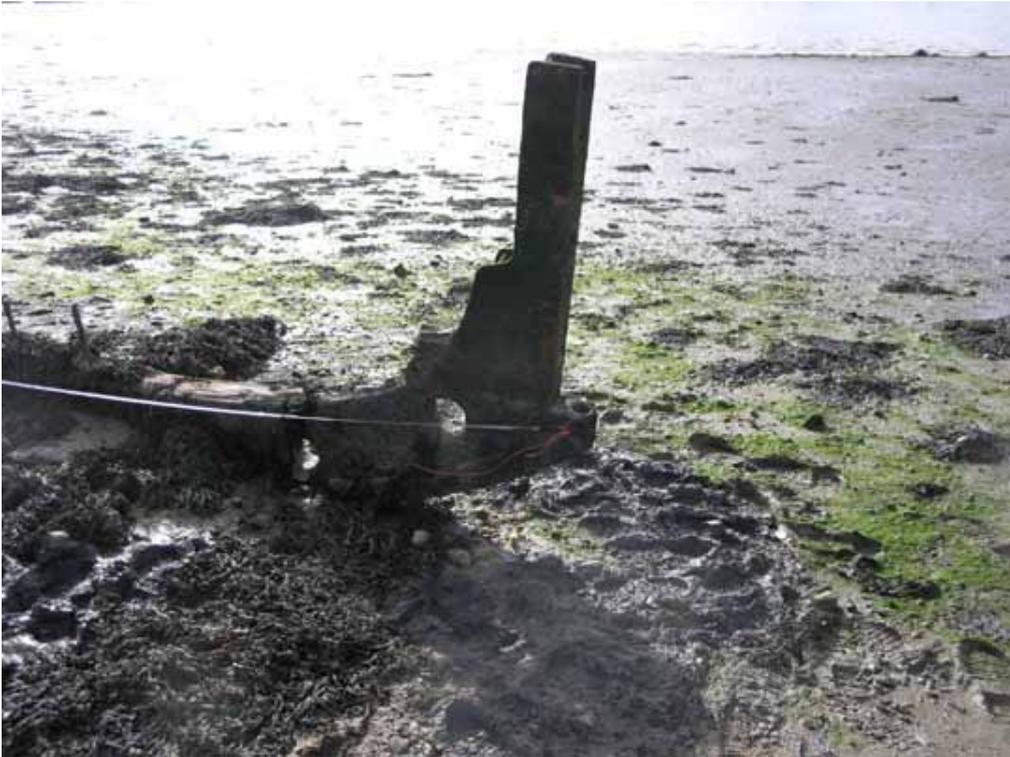
It is possible to define the stern and the stem of this vessel. On the sternpost there are the remains of a gudgeon, which would have held the rudder (Figure HAM043-4). Towards the stern there two round holes through the keel, these are 20cm in diameter. A similar, although slightly smaller hole can be found near the bow.

Figure HAM043- 4 At the stern of the hulk a gudgeon and two circular holes are located

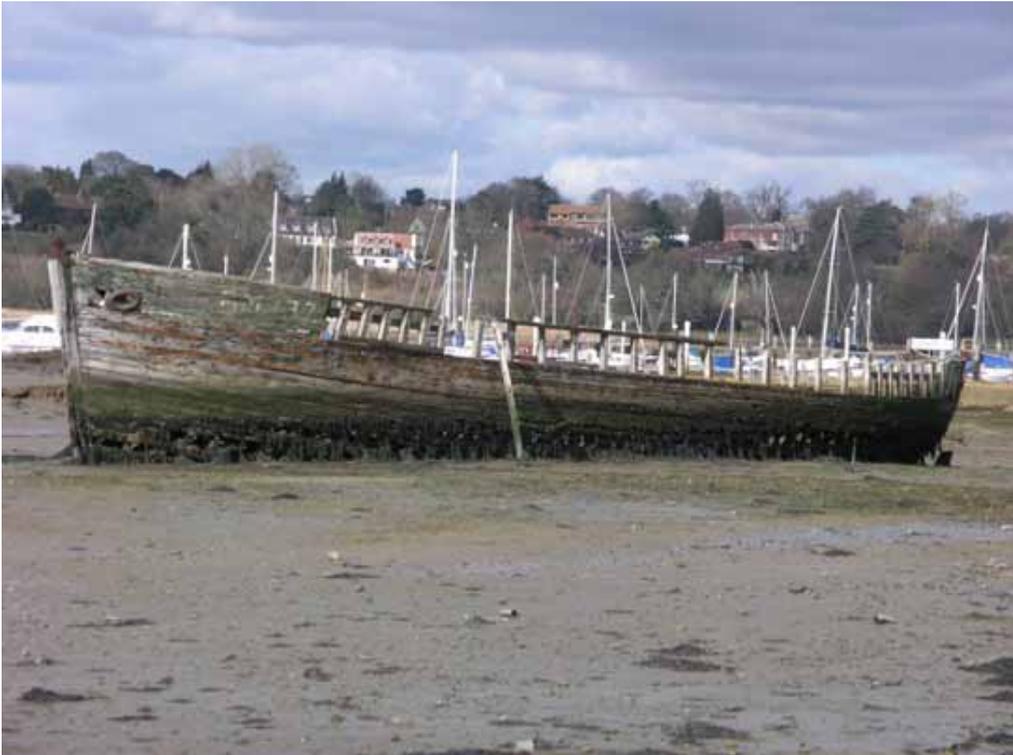
Near Crableck Quay on the eastern bank of the Hamble River lies the hulked remains of a large timber boat (Figure HAM044-1). The bows are pointing in a south-southwest direction and the stern is north-northeast. Most of the vessel's hull is present and no superstructure or masts remain. The vessel hull has been breeched and it is stranded in the inter-tidal zone of the river. The hulk is located about 30m from the shore, in an area of deep tidal sediments, making access very hazardous.

Figure HAM044-1 The hulk of a timber carvel constructed vessel in the inter-tidal zone near to Crableck Quay, looking towards the west

As previously mentioned this vessel is located in the intertidal zone about 30m from the shore and therefore, due to health and safety, a drawn record of these remains was not possible. It is recommended to record this vessel, if a safe method of accessing HAM044 can be found. It is advised that only the outside of the vessel be recorded, as the integrity of the vessel's structure is unknown, but it is likely to be unstable and potentially liable to collapse.

HAM044 lies within a very dynamic intertidal environment and is subject to natural erosion which can affect its preservation. It is recommended that HAM044 be monitored periodically with a photographic survey. This can be conducted from the shore, and will give an indication of how quickly these types of vessels degrade.

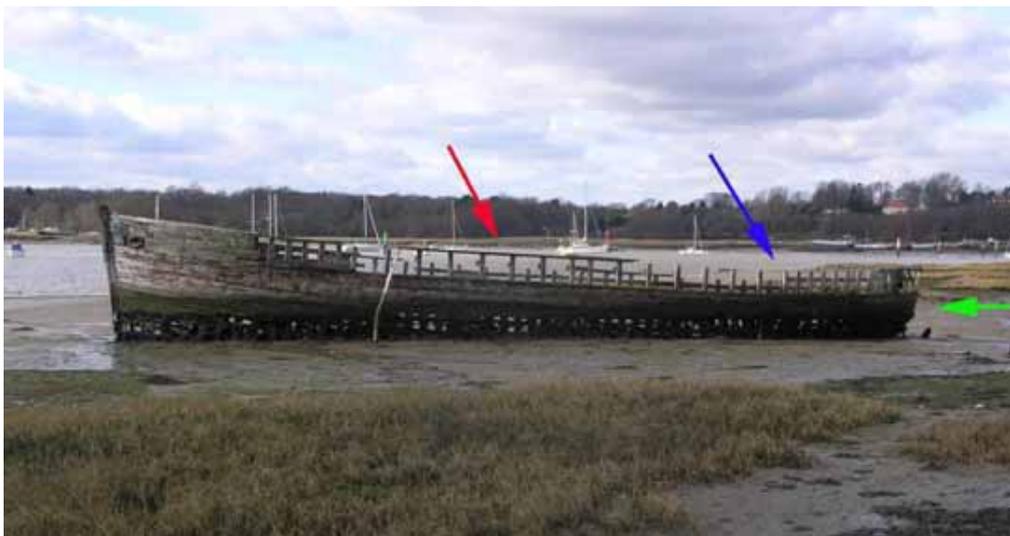
The vessel appears to be approximately 30m long and about 2.5m high at the stem post. The wooden hull is carvel built, and is fastened with metal nails. Above the high-water mark the majority of the hull strakes remain. Beneath this level though little hull planking is present, revealing the frame timbers. The frame timbers look slightly eroded probably due to the dynamic inter-tidal environment, and therefore being regularly drowned and exposed.

Figure HAM044-32The bulwark rail remains in sections (red arrow), and is missing in others (blue arrow), and HAM044 has a cruiser stern (green arrow) (looking north-northwest)

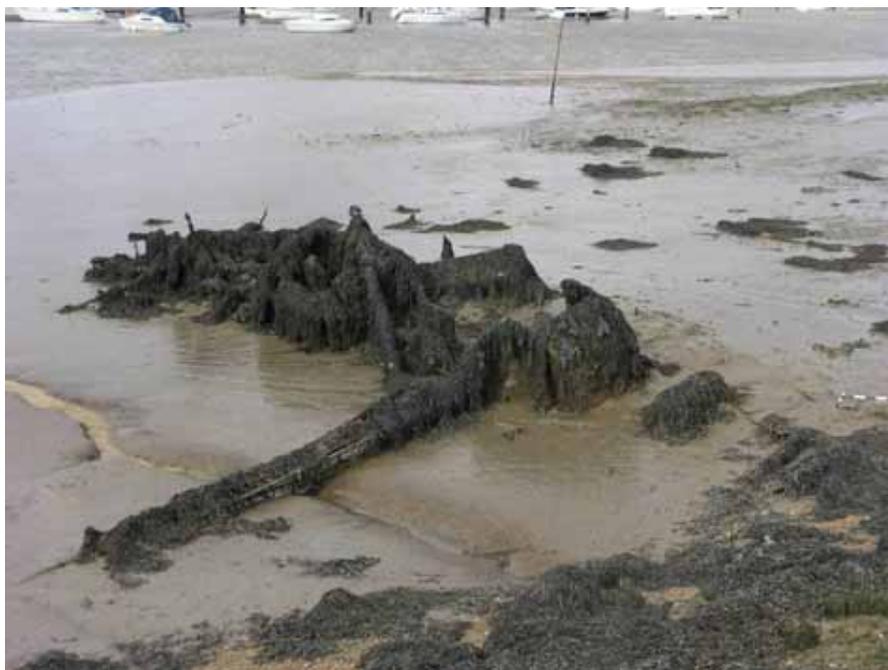
Figure HAM046- 1 Near to a sluice at Bunny Meadows is the remains of vessel buried in the sediments (looking northwest)

Comparing the photograph taken for this project (Figure HAM046-1) with the 1980 photograph (Figure HAM046-2) shows this vessel has suffered extensively from erosion, and has degraded considerably. This is indicative of a dynamic environment such as tidal area. This site is an excellent example of how quickly vessels can collapse within these environments. Further degradation will occur as erosion continues to affect this hulk. At its current rate of decay it is possible that nothing diagnostic will remain within the next decade or two.

Due to the environmental conditions an archaeological drawn survey may not be possible, however, it is recommended that a regular photographic survey be collected every six months to a year. This will allow monitoring of the condition of the vessel and gauge its rate of decay.

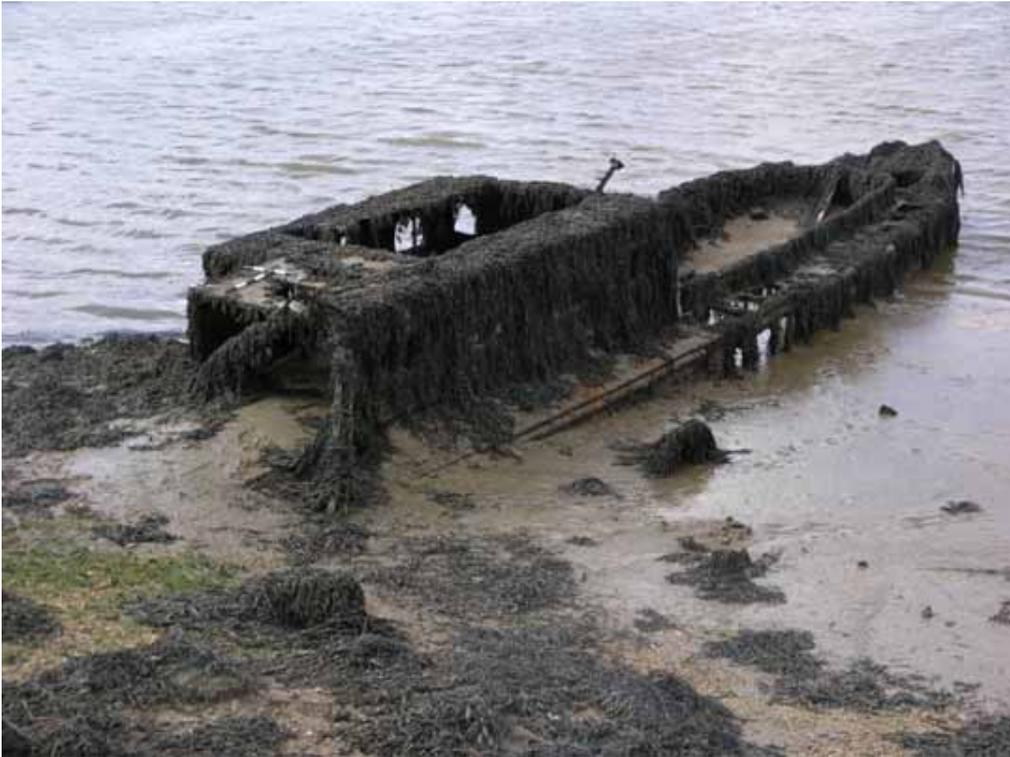
Access to the vessel was deemed dangerous as it lies in an area of potentially deep intertidal sediments, especially at the offshore end of the hulk. The remains are highly corroded, leaving the vessel with many sharp edges and liable to collapse (Figure HAM047-1). HAM047 was recorded through a digital and photographic survey instead of a drawn survey.

Figure HAM047- 1 Viewed from the northeast it can be seen that this is the remains of a highly degraded modern motor vessel

As this vessel is modern and of low archaeological significance there are no recommendations for further archaeological work.

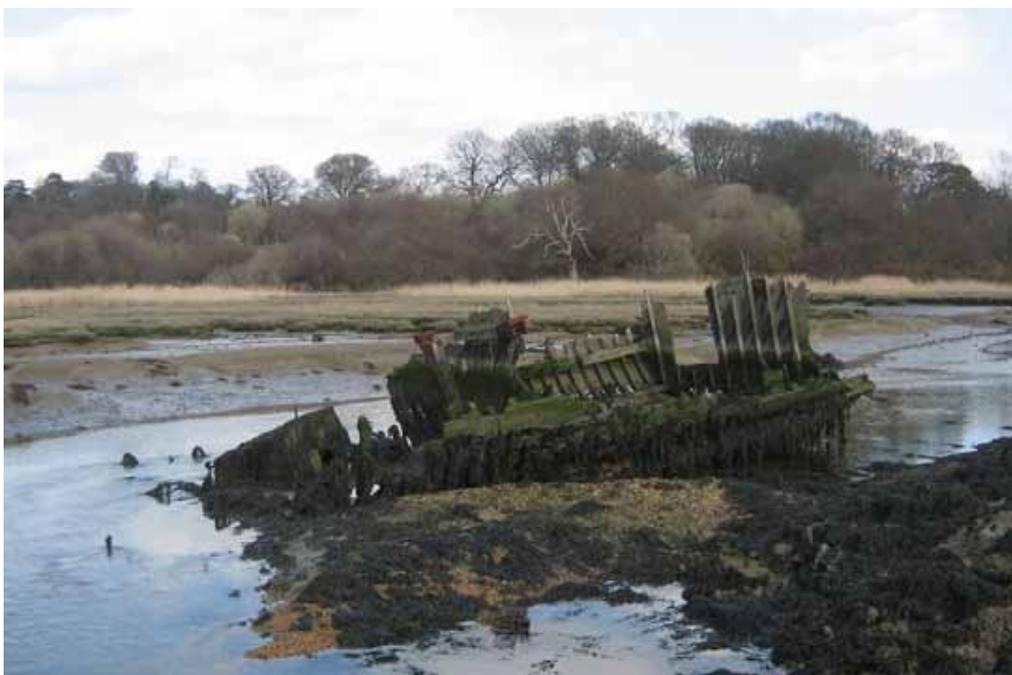
From initial observations it is apparent that this hulk is the remains of an incomplete wooden vessel (Figure HAM050-1). It is lying upright, with a list towards the starboard quarter. The bow and stern sections have been cleanly cut and removed, leaving a central section of about 13m in length (Figure HAM050-30). Remains of this vessel are severely degraded and comprise of part of the starboard and port hull, and three sections of bulkhead; further details are given below. Orientation of the vessel is 90° to the Hamble River, with the forward bulkhead towards the east. The tidal sediments that surround the vessel restrict access in some areas, especially along the port side.

Figure HAM050- 1 The partial structural remains of a vessel, located in the tidal area of Bunny Meadows

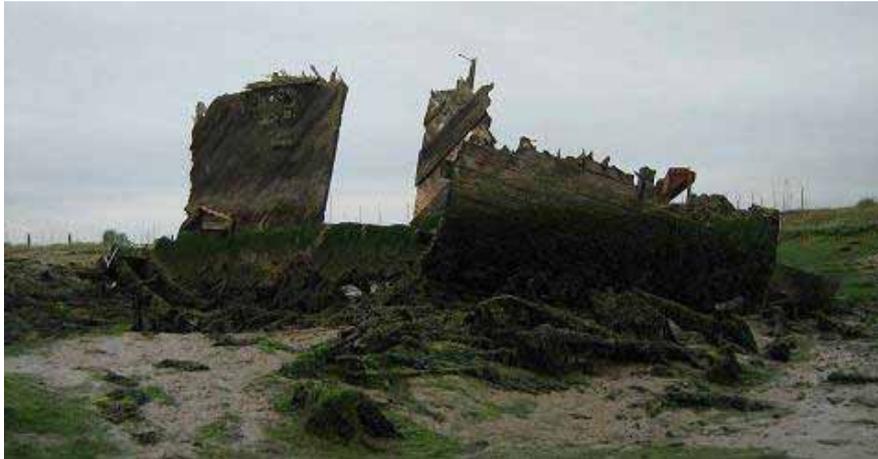
The ship remains have heeled over to the port side and sits lower at the stern, showing a varied level of preservation within the remaining structure. The lower sections of timber below the mean high water mark are the most degraded.

Figure HAM050- 4 In this photograph looking aft the more complete port side can be seen

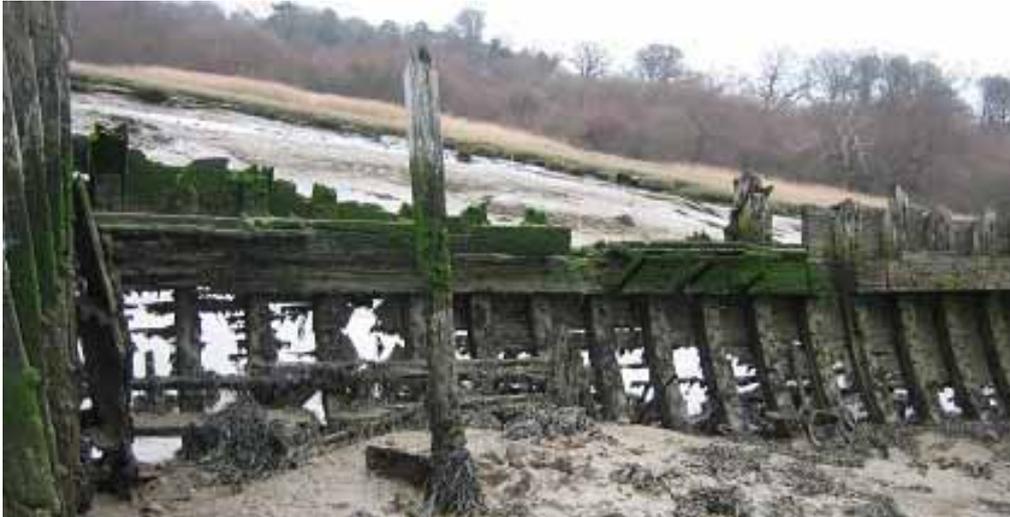
Along the port side there is a section of complete frames that measure 0.14m by 0.12m and are spaced 0.39m apart (HAM050 Figure 7). Planking still exists here, although the level of mud in the interior of the hulk restricted access to this area and survey was difficult. Towards the aft, the port planking and frames had collapsed outwards into the water, these are difficult to access.

Figure HAM050- 7 The internal structure of the port side

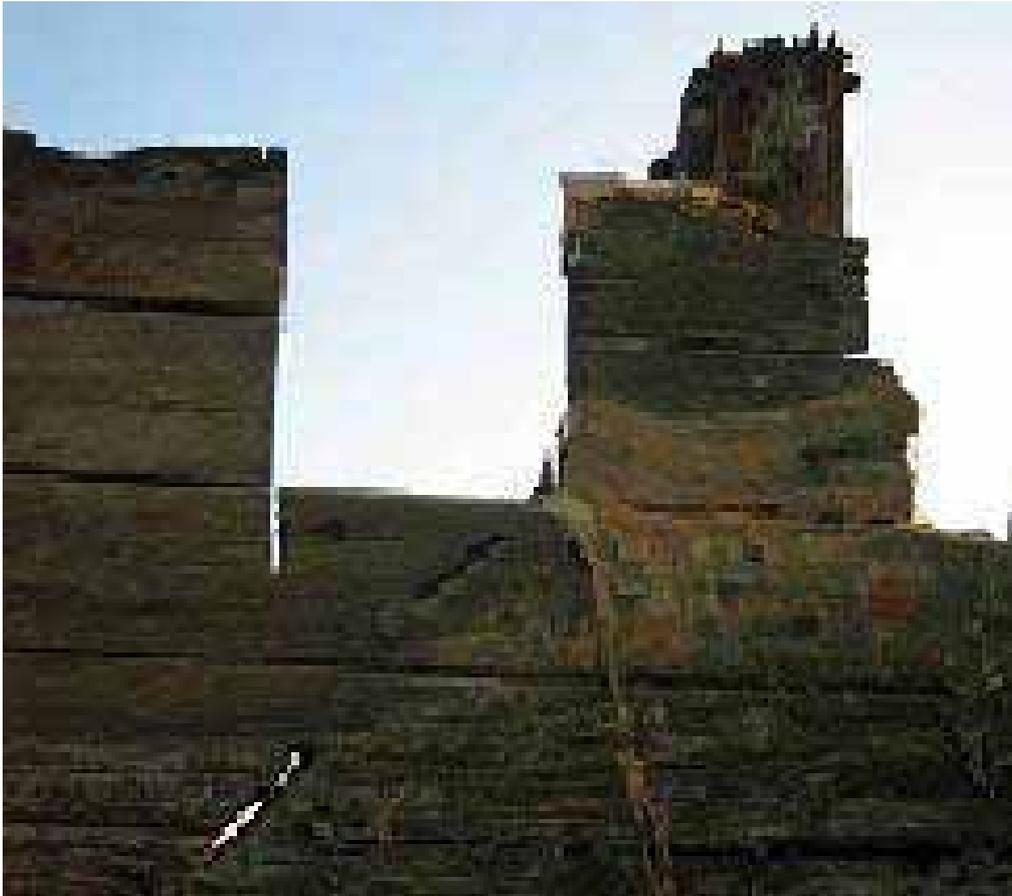
Figure HAM050- 8 Photograph showing the countersunk bolts with covering wooden plugs, and two saw marks probably from the salvage

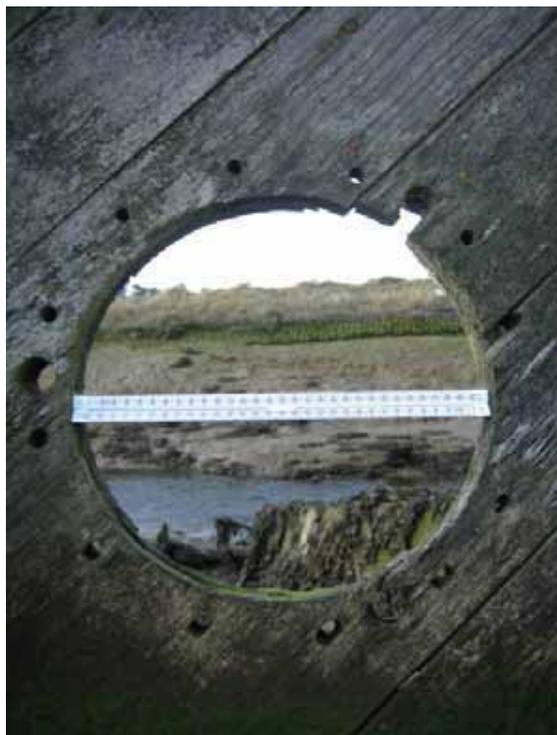
In the central bulkhead there is a circular hole, with rivet holes around it (Figure HAM050-11). A porthole may have been positioned here that would have enabled visual inspection of what may have been an engine bay. A rectangular section has been cut into the portside of the forward bulkhead. Rough cut marks and saw damage can be seen around this, which indicates that it is contemporaneous with salvage activity. On the uppermost part there is a metal plate with a number of circular holes of varying diameters. This is a conduit which would have enabled wires and pipes to pass through the bulkhead (Figure HAM050-12).

Figure HAM050- 11 Photograph of the circular feature in the central bulkhead

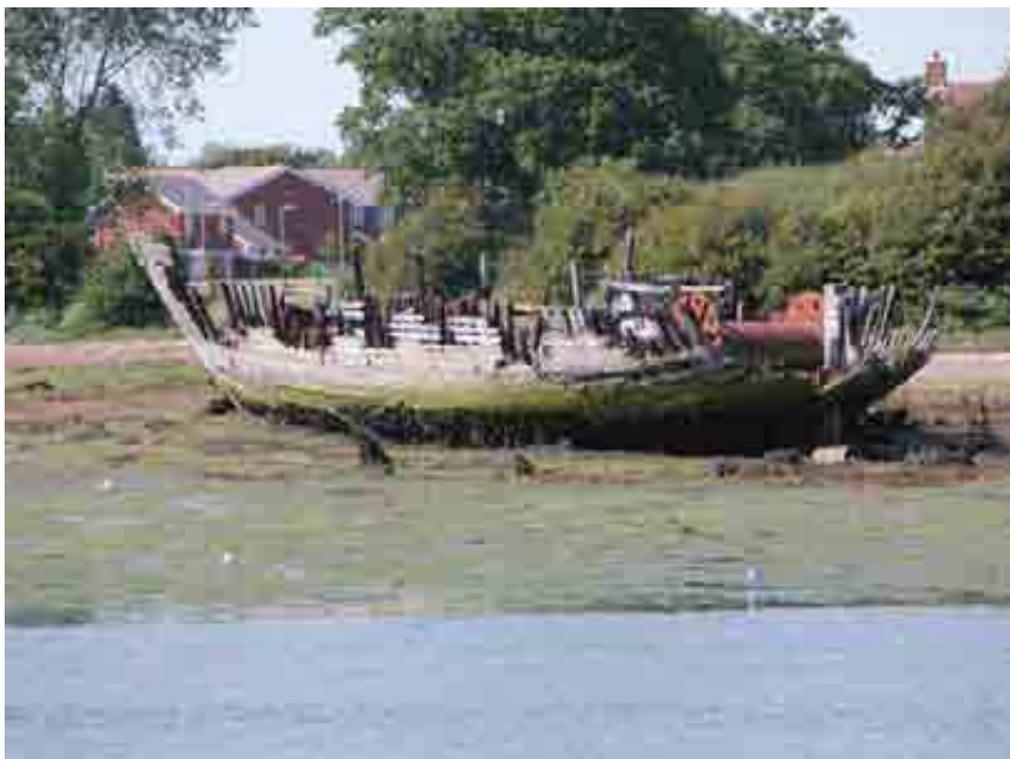
Figure HAM050- 28 The remains of MMS293 located at Forton Lake is in a poor condition, but substantially more remains compared to HAM050

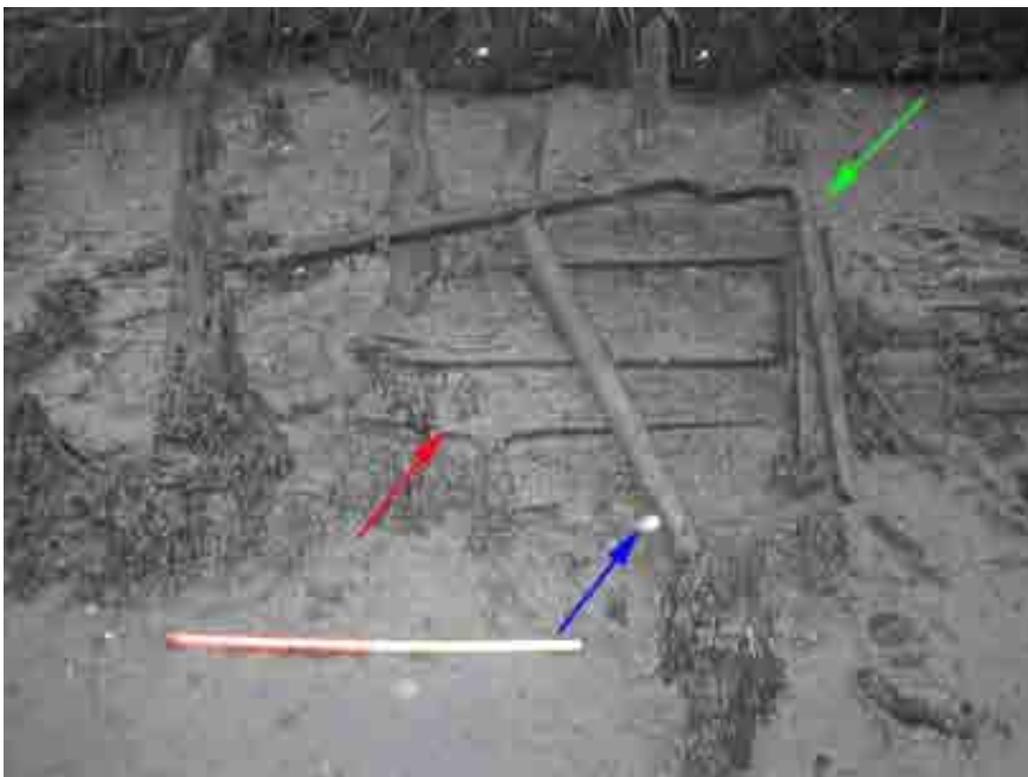
Figure HAM098- 10 An image of the hull on the port side, with the planking (red arrow), the pipe (blue arrow) and a collapsed knee (green arrow) clearly visible

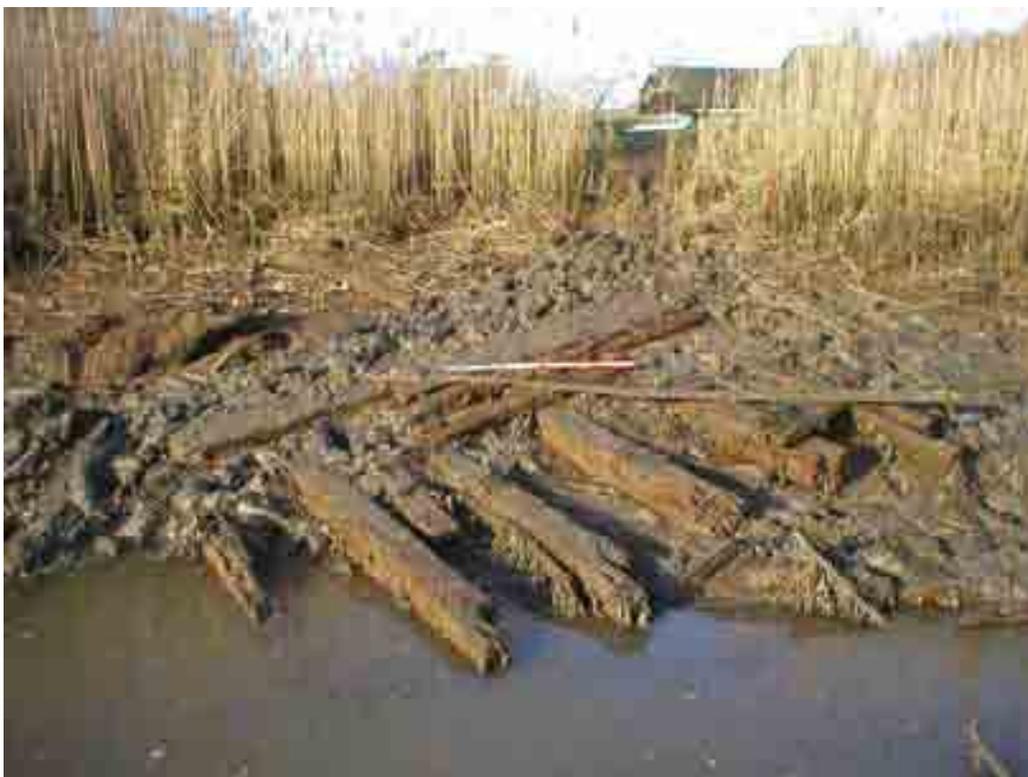
Figure HAM098- 11 The collapsed section of hull to the north, the joint can be seen on the foot of the frame closest to the camera, at the top of the image is the sheer strake

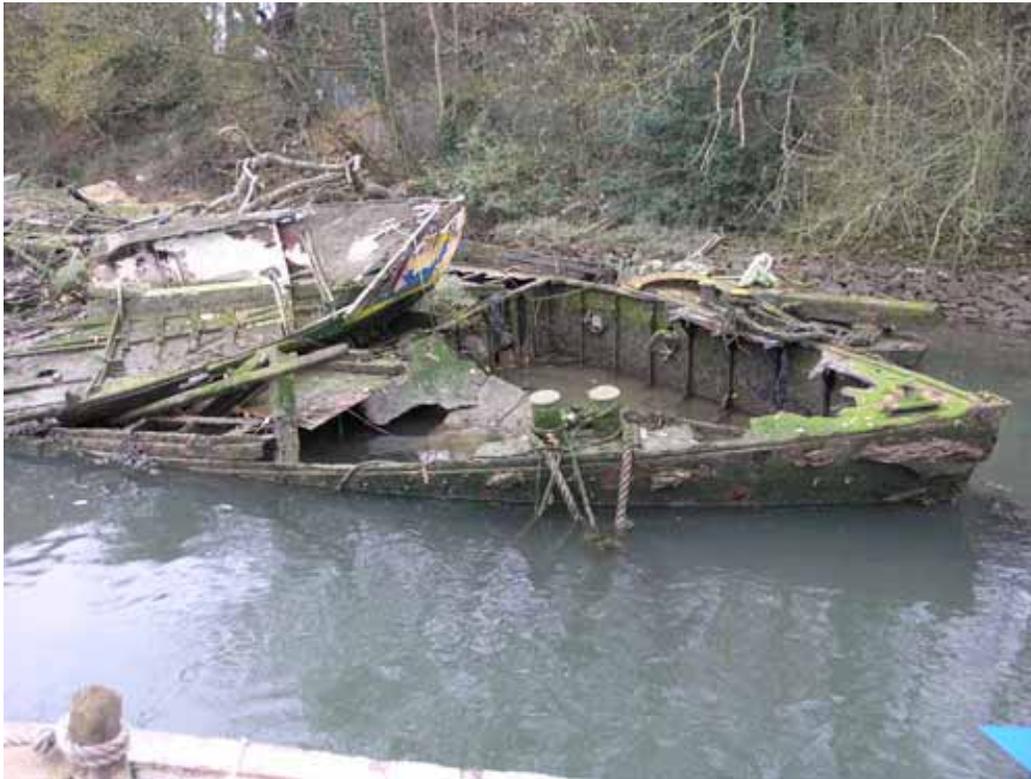
Figure HAM153- 4 The collapsed foredeck of the lighter with non-associated boat debris
