the play inspection company

Annual Inspection

Ninfield Parish Council

The Recreation Ground

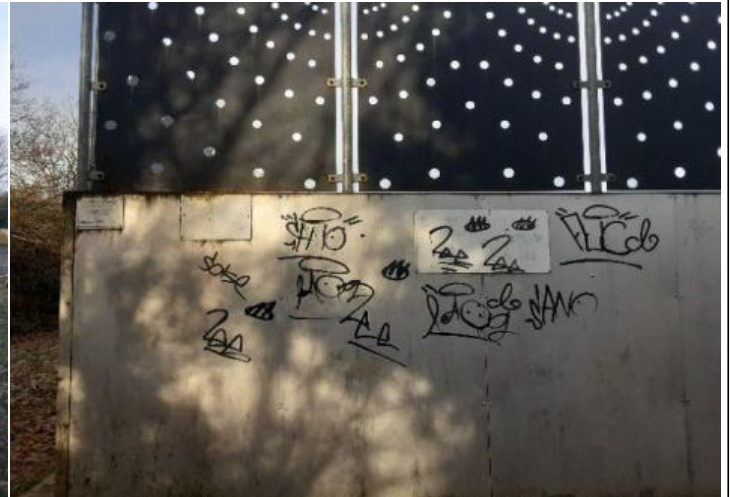
Risk Level: V - Very Low Risk
Surface: N/A

Finding: Signage of the wheeled sports area should be provided as recommended in BS EN 14974; this will include, but not exclusively, the use of the area, a recommendation to wear protective equipment, emergency contact details etc.

Action: Provide signage as recommended by BS EN 14974 for wheeled sports areas

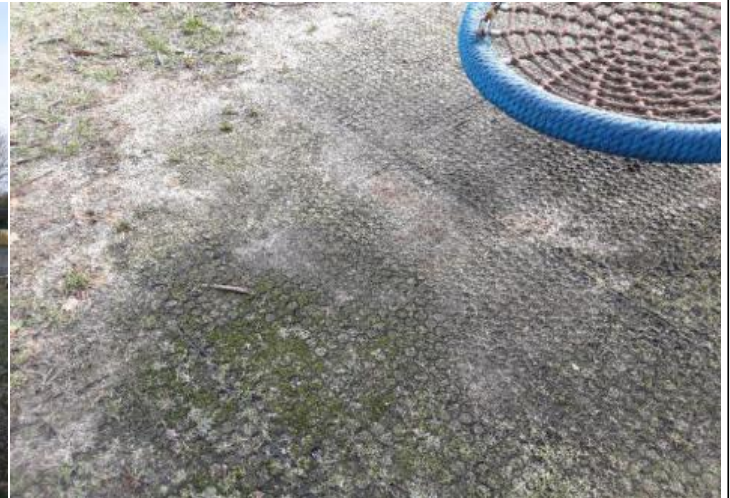
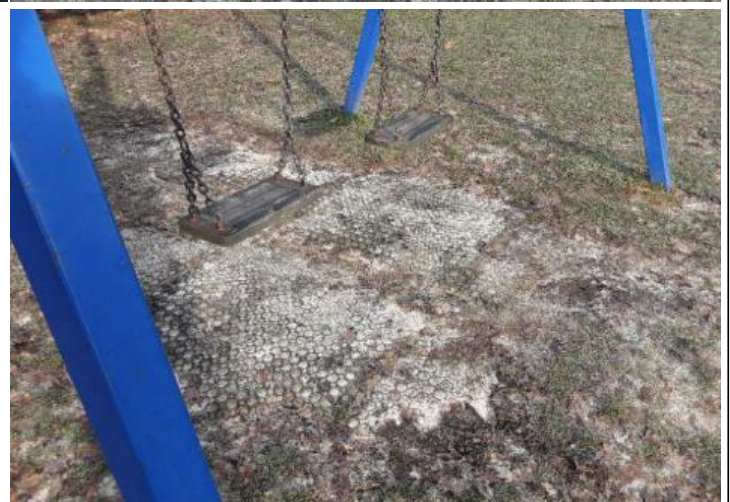
Risk Level: L - Low Risk
Surface: N/A

Finding: The grass mats are silted up and the soil is compacted; this may have an effect on the impact absorbing properties of the surface

Action: Consider HIC testing impact absorbing properties to ensure the correct surface qualities are maintained for the equipment and replace as required

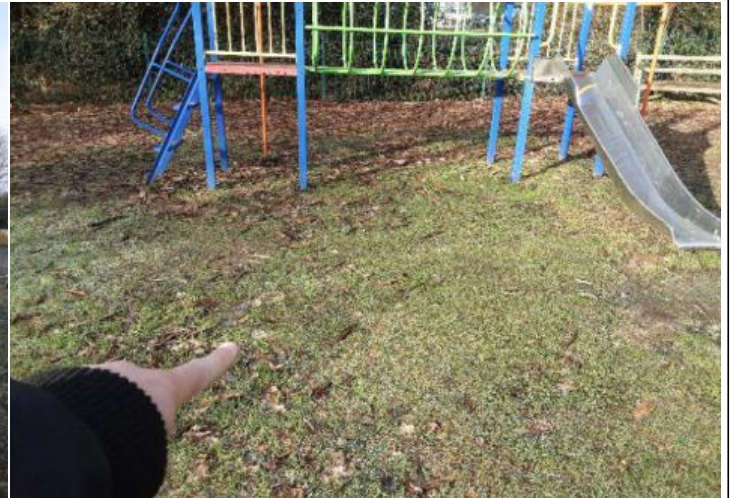
Risk Level: L - Low Risk
Surface: N/A

Finding: The surface has eroded and old foundations are exposed

Action: Reinstall surrounding surfaces to cover the foundations

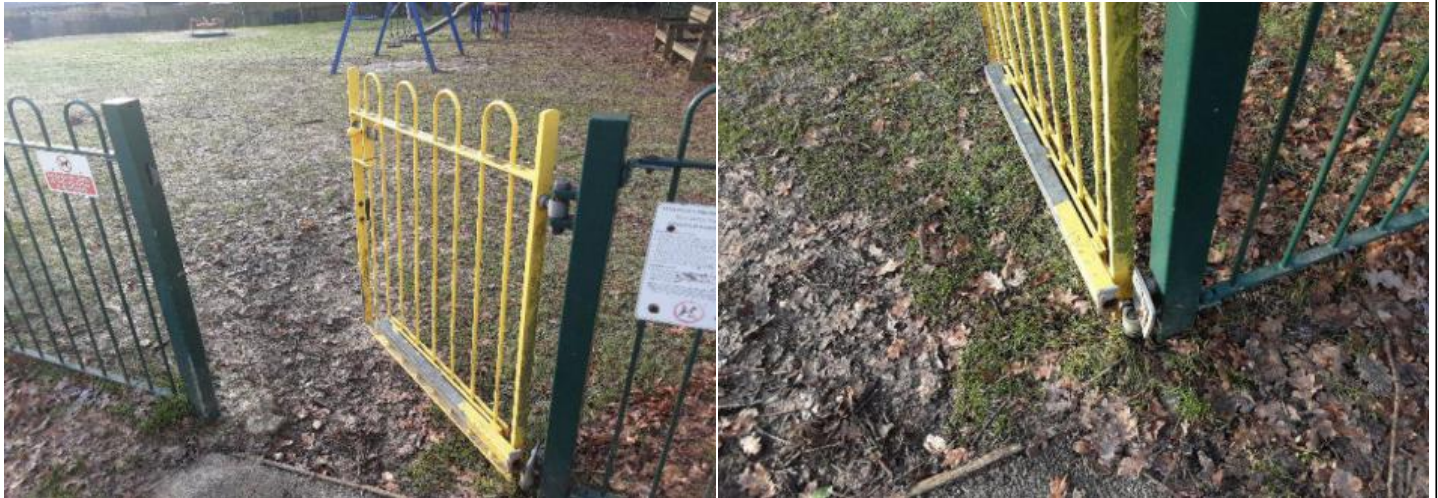
Risk Level: L - Low Risk
Surface: Grass

Finding: The self closing mechanism is missing

Action: Replace all missing components

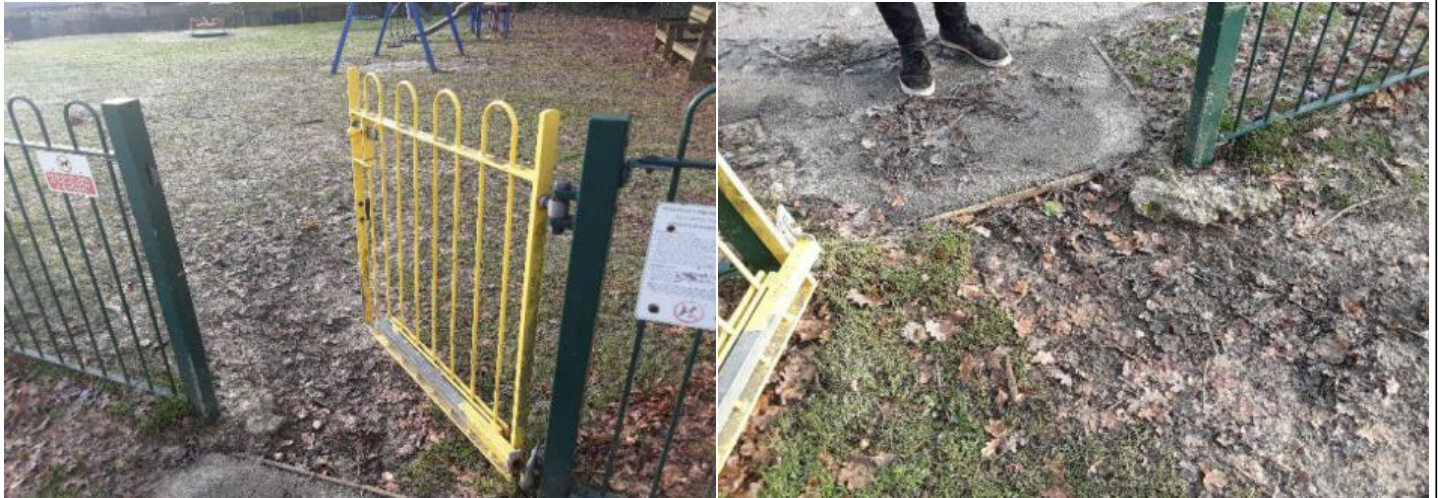
Risk Level: L - Low Risk
Surface: Grass

Finding: The area under the gate has eroded leaving uneven areas, or the concrete foundations exposed, resulting in trip hazards at the entrance/exit to the playground

Action: Reinststate to level with surrounding surfaces

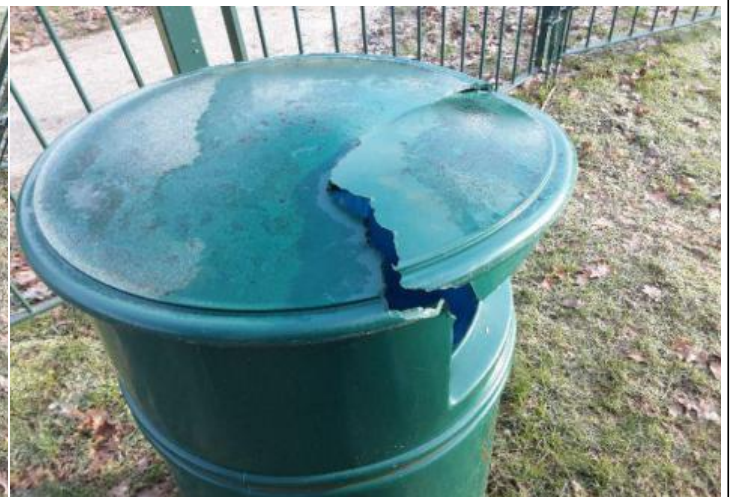
Risk Level: L - Low Risk
Surface: Grass

Finding: The item has been severely damaged

Action: Repair or replace the item

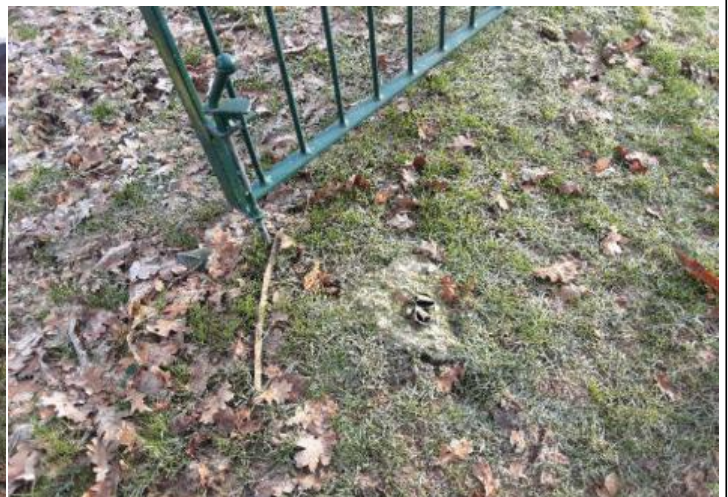
Risk Level: V - Very Low Risk
Surface: Grass

Finding: The dropbolt sleeves are damaged

Action: Repair or replace as required

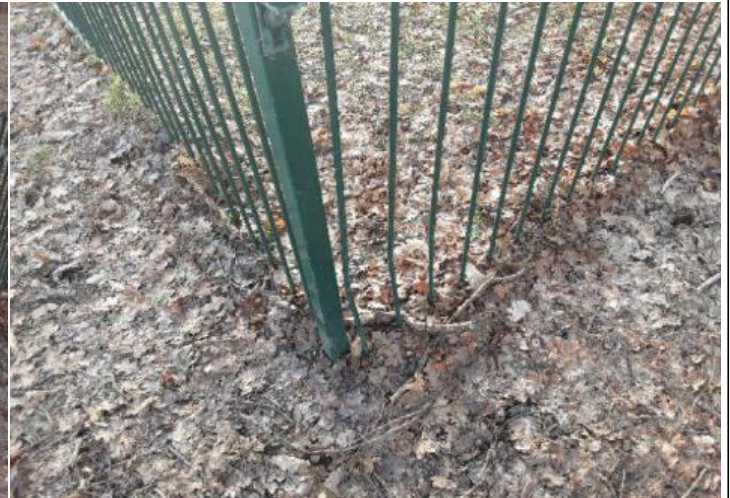
Risk Level: L - Low Risk
Surface: Grass

Finding: There is some damage to the fence sections

Action: Monitor for any further deterioration and repair as required

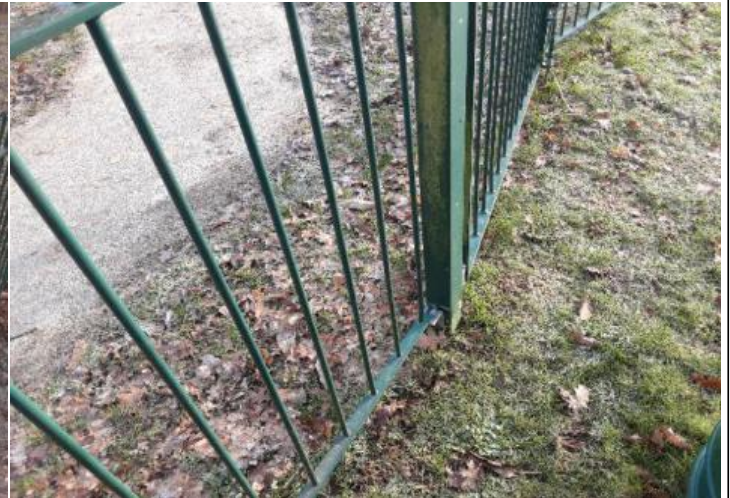
Risk Level: L - Low Risk
Surface: Grass

Finding: There are a number of fixings missing from the fence

Action: Replace missing fixings

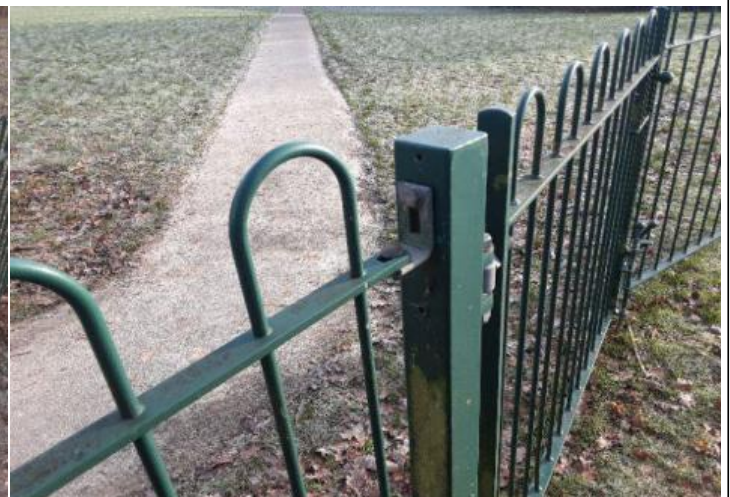
Risk Level: L - Low Risk
Surface: Grass

Finding: A number of fixings have worked loose around the fencing

Action: Secure all loose fixings

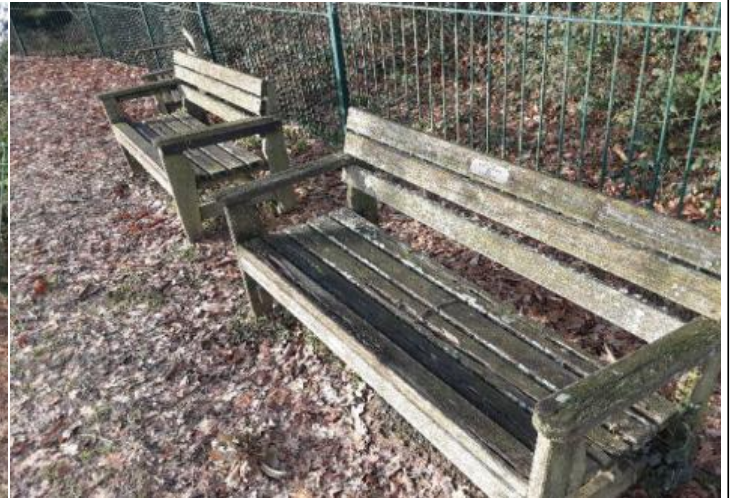
Risk Level: L - Low Risk
Surface: Grass

Finding: There are areas or parts of the timber on the structure that have rotted

Action: Replace all affected timbers

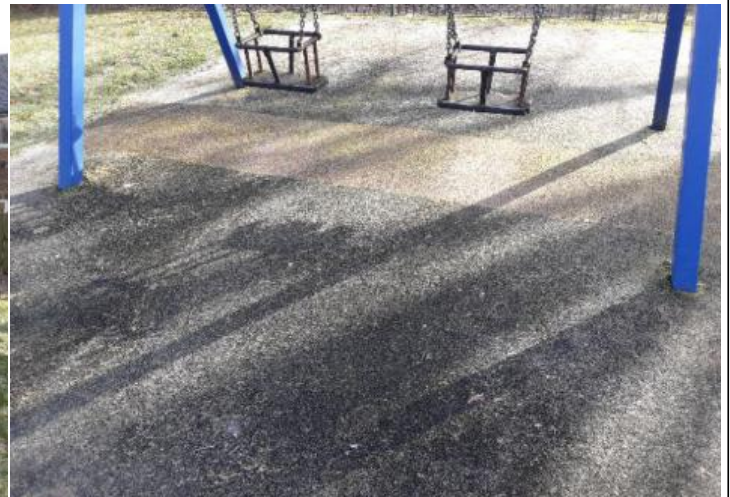
Risk Level: L - Low Risk
Surface: Wet Pour

Finding: The safety surface around the area is beginning to wear

Action: Monitor for any further deterioration and repair as required

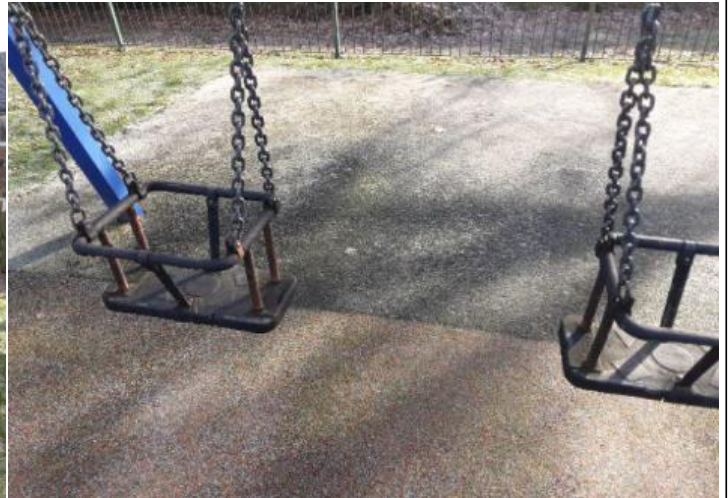
Risk Level: L - Low Risk
Surface: Wet Pour

Finding: There is algae, silt or moss growth on the surface resulting in slippery conditions

Action: Clean and treat appropriately

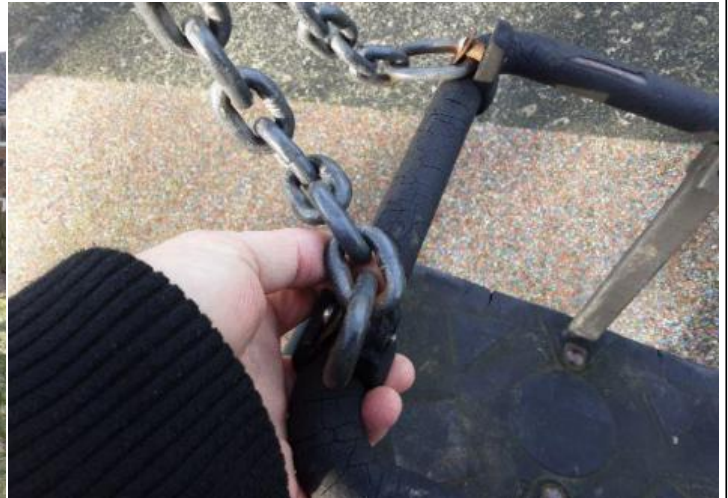
Risk Level: L - Low Risk
Surface: Wet Pour

Finding: There is some notable evidence of chain wear

Action: Monitor for any further deterioration and replace when 40% worn

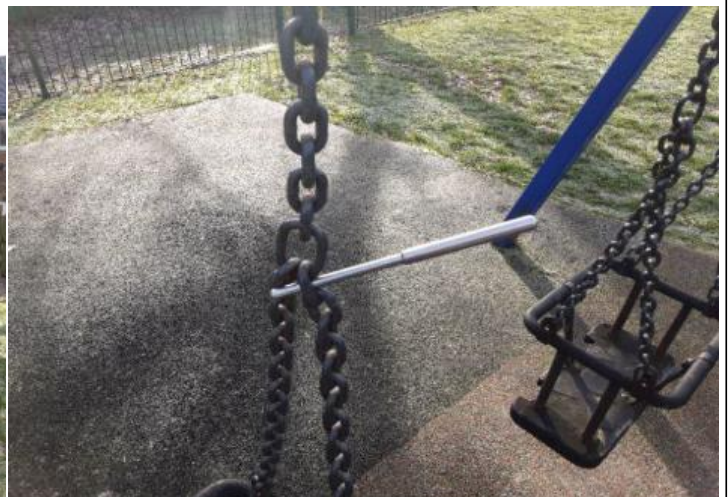
Risk Level: V - Very Low Risk
Surface: Wet Pour

Finding: The chain openings are in excess of the 8.6mm as recommended by BS EN 1176

Action: Monitor - No remedial work recommended

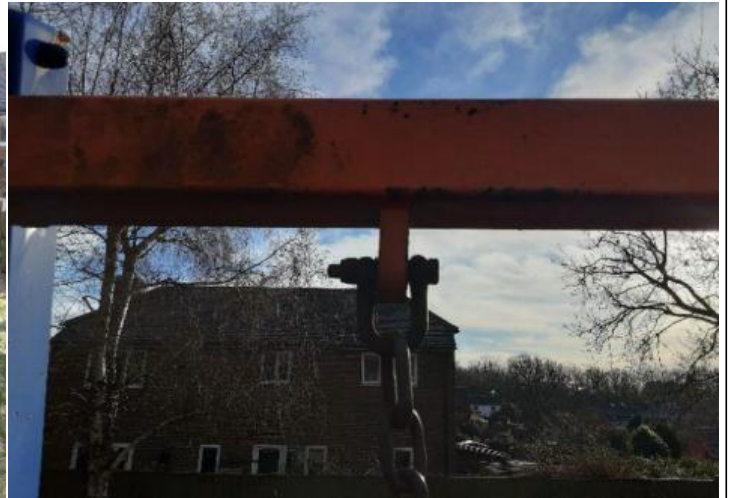
Risk Level: L - Low Risk
Surface: Wet Pour

Finding: There is some wear to the shackles.

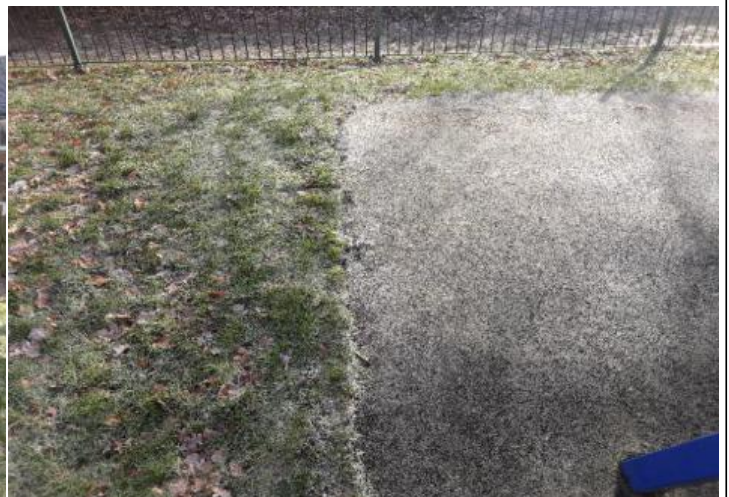
Risk Level: L - Low Risk
Surface: Wet Pour

Finding: There is moderate damage to the surface

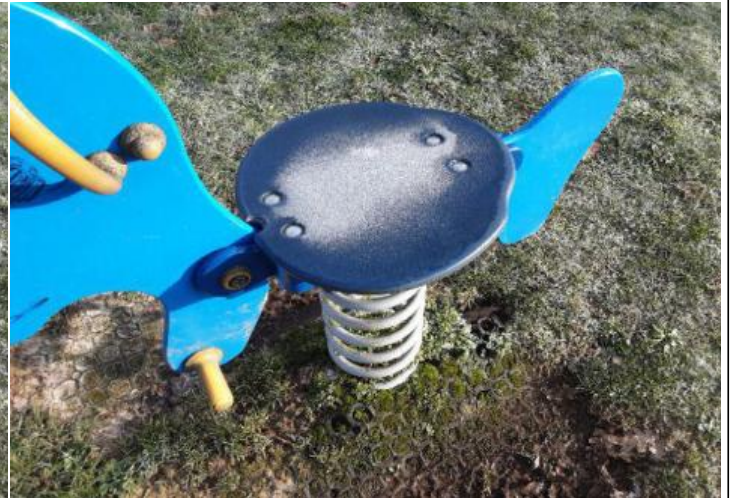
Risk Level: L - Low Risk
Surface: Grass Matrix Tiles

Finding: The item has been damaged

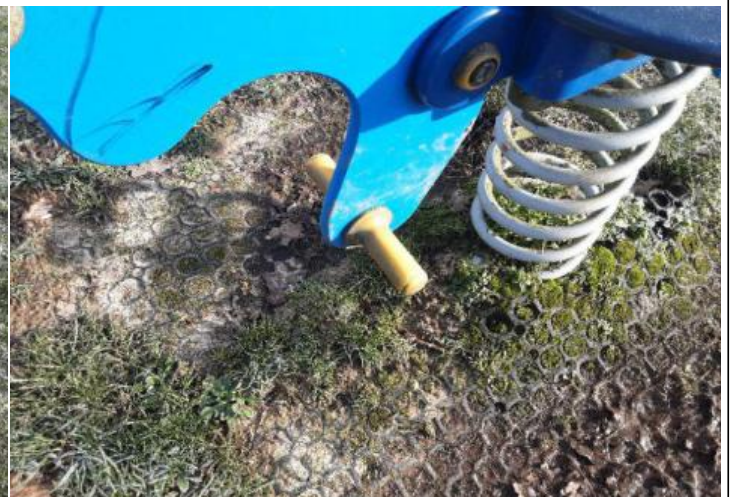
Risk Level: L - Low Risk
Surface: Grass Matrix Tiles

Finding: The end of handgrips and/or footrests have a cross section of less than 15cm² and fail to meet the requirements of BS EN 1176 Part 6

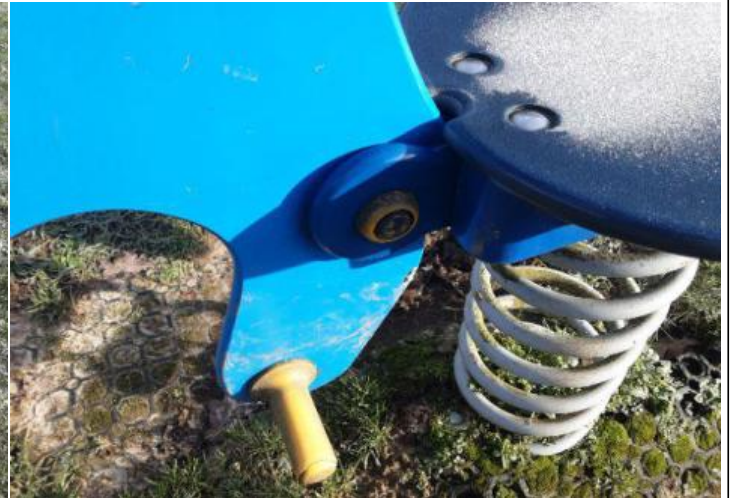
Risk Level: V - Very Low Risk
Surface: Grass Matrix Tiles

Finding: There is/are bolt cap covers missing or damaged on the item

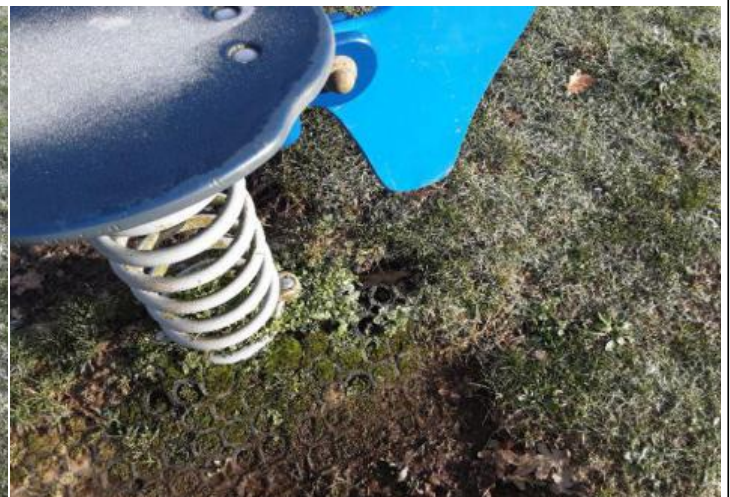
Risk Level: L - Low Risk
Surface: Grass Matrix Tiles

Finding: There is moderate damage to the surface

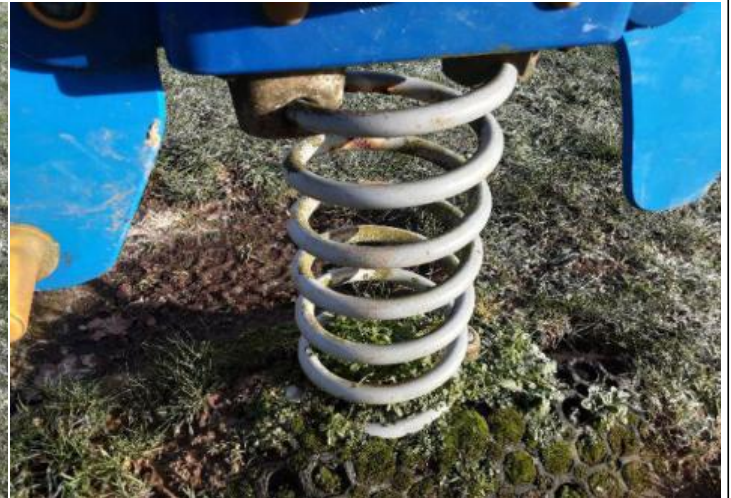
Risk Level: L - Low Risk
Surface: Grass Matrix Tiles

Finding: The paintwork on the spring has been damaged or worn exposing the metal underneath which is rusting
Action: Treat any rusting components and repaint

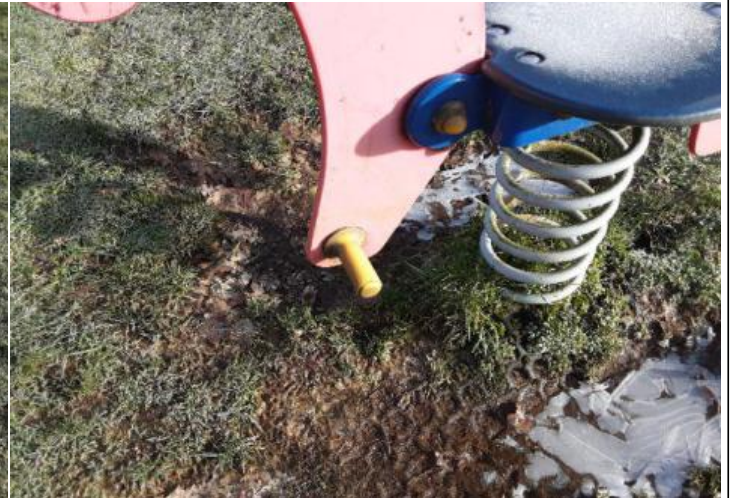
Risk Level: L - Low Risk
Surface: Grass Matrix Tiles

Finding: The end of handgrips and/or footrests have a cross section of less than 15cm² and fail to meet the requirements of BS EN 1176 Part 6
Action: Monitor - No remedial work recommended

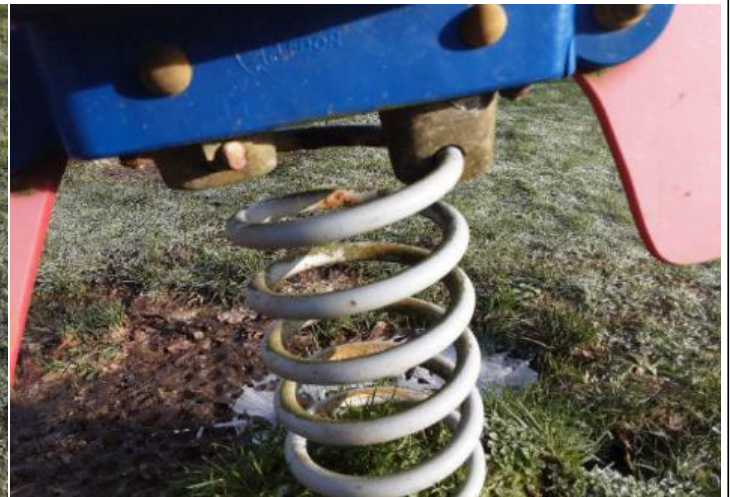
Risk Level: L - Low Risk
Surface: Grass Matrix Tiles

Finding: The paintwork on the spring has been damaged or worn exposing the metal underneath which is rusting
Action: Treat any rusting components and repaint

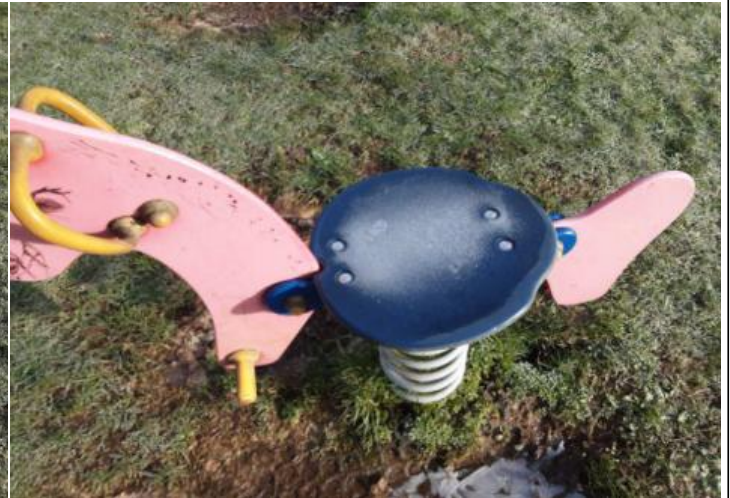
Risk Level: L - Low Risk
Surface: Grass Matrix Tiles

Finding: The item has been damaged

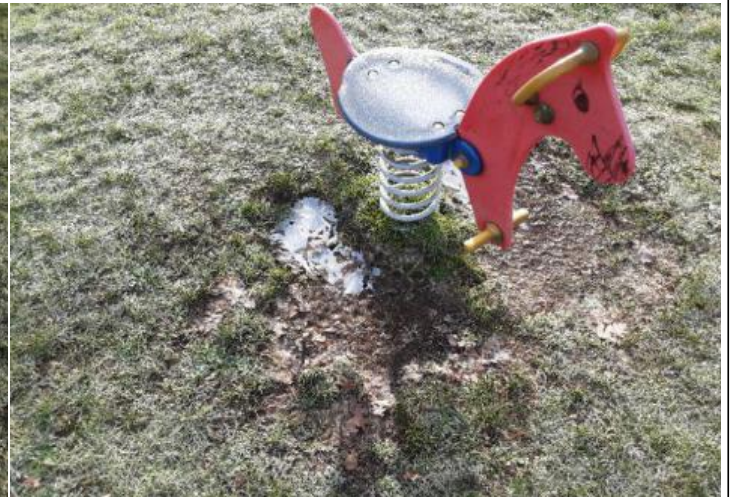
Risk Level: V - Very Low Risk
Surface: Grass Matrix Tiles

Finding: There is some minor damage to the surface

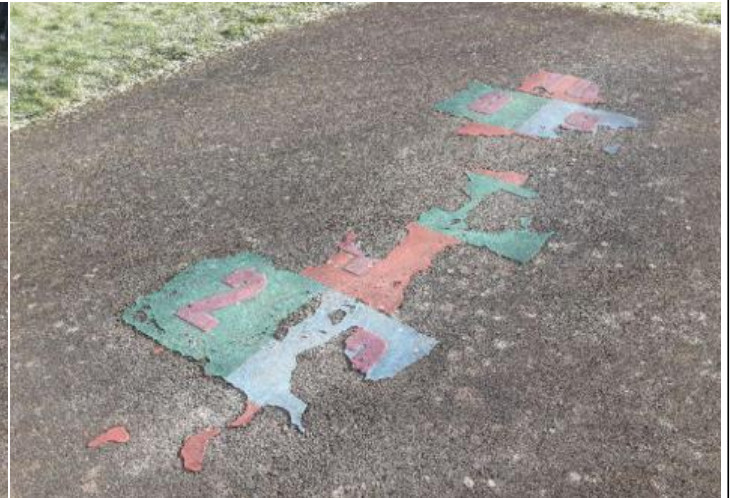
Risk Level: V - Very Low Risk
Surface: Bitmac

Finding: The item is damaged

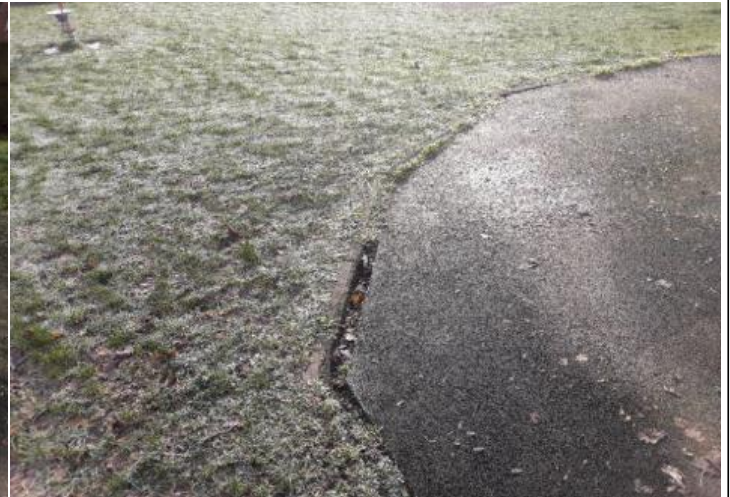
Risk Level: L - Low Risk
Surface: Wet Pour

Finding: There are significant gaps (over 30mm) between the surface and the edging or between the joints in the surface; these are large enough for a small foot to enter

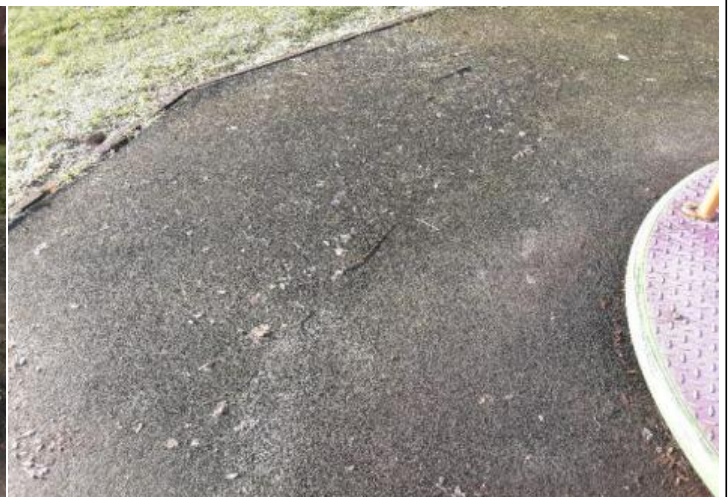
Risk Level: L - Low Risk
Surface: Wet Pour

Finding: The safety surface around the area is beginning to wear
Action: Monitor for any further deterioration and repair as required

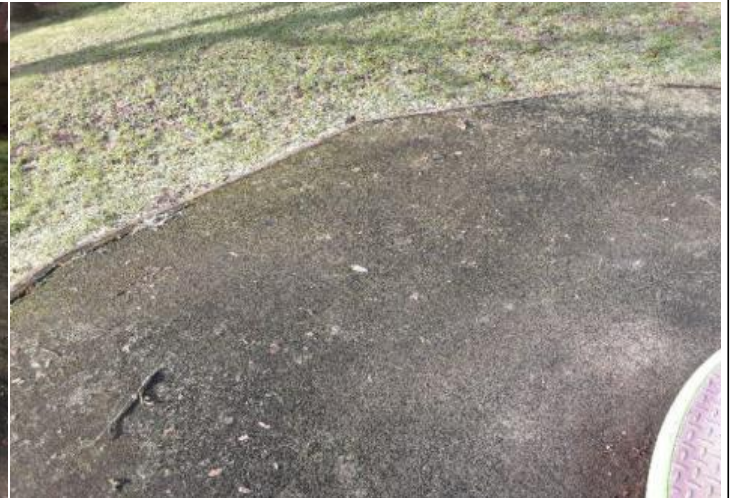
Risk Level: L - Low Risk
Surface: Wet Pour

Finding: There is algae, silt or moss growth on the surface resulting in slippery conditions

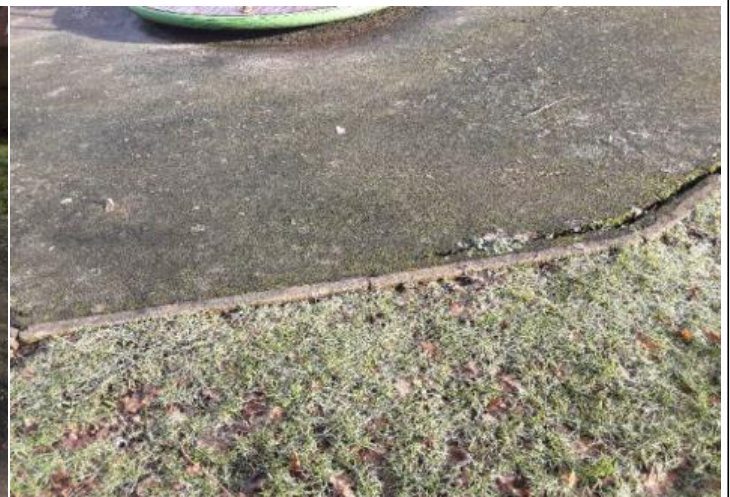
Risk Level: L - Low Risk
Surface: Wet Pour

Finding: There are trip hazards at the edges of the surface

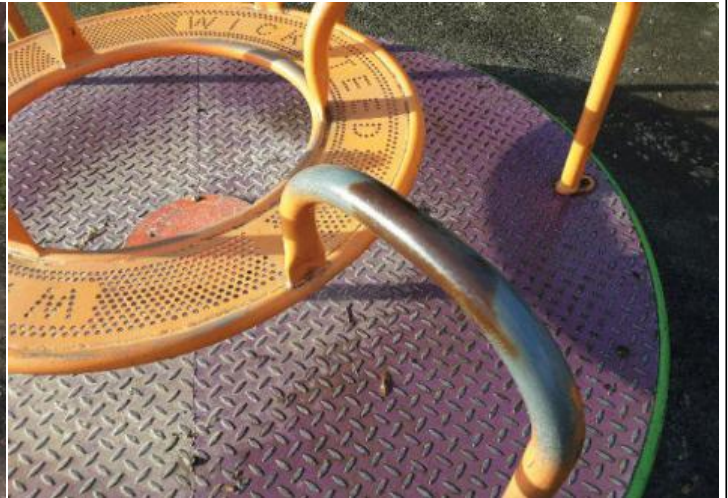
Risk Level: L - Low Risk
Surface: Wet Pour

Finding: The paintwork on this item has been damaged or worn exposing the metal underneath which is rusting

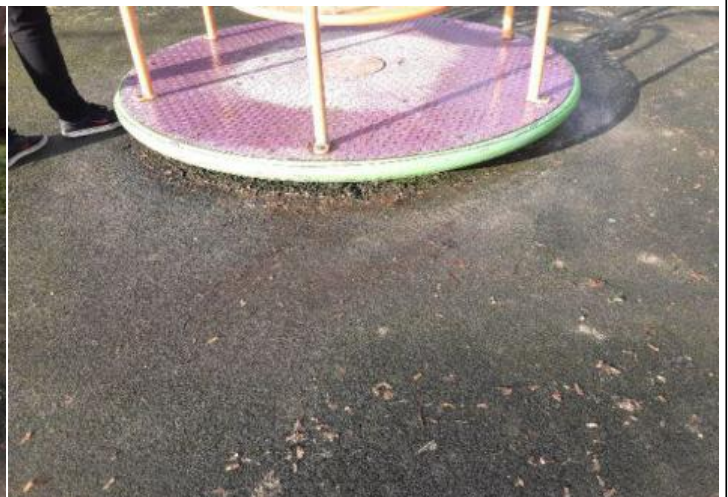
Risk Level: L - Low Risk
Surface: Wet Pour

Finding: The distance between the underside of the roundabout platform and the playing surface is in excess of 110mm and contravenes the requirements of BS EN 1176 Part 5 which requires that the distance be maintained between 60mm-110mm - for the entire circumference of the roundabout

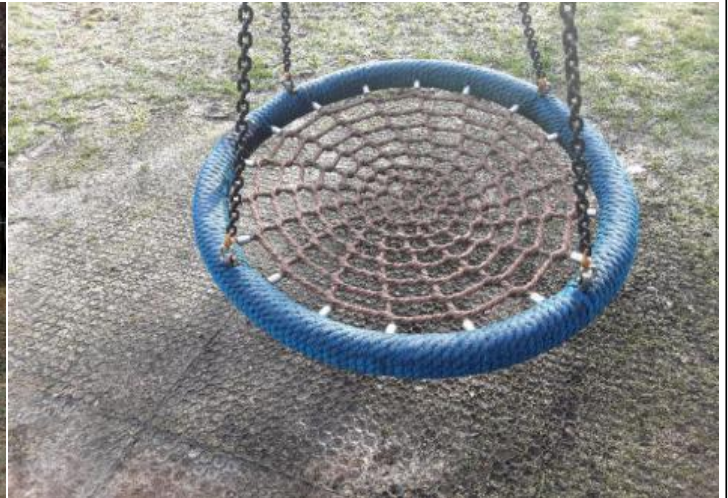
Risk Level: L - Low Risk
Surface: Grass Matrix Tiles

Finding: The incorrect seat design has been installed on this swing; there are unique designs for Type 1 and Type 3 swings that provide differing impact attenuating properties to the leading edges of the seat and/or has incorrectly aligned seat eye fixings which will lead to accelerated wear.

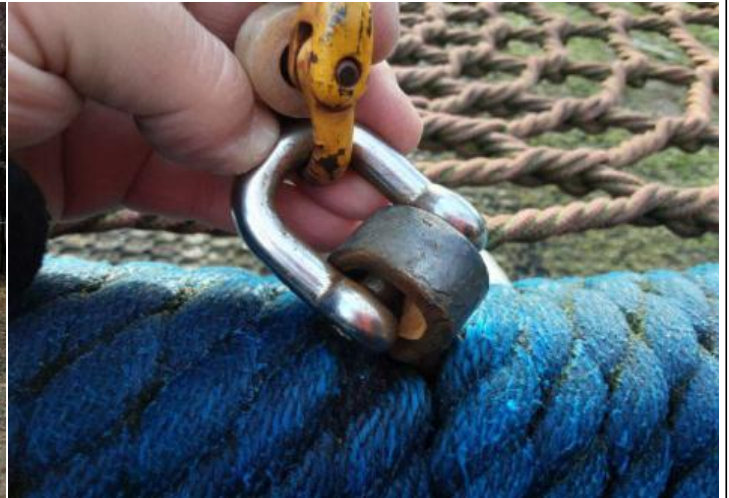
Risk Level: L - Low Risk
Surface: Grass Matrix Tiles

Finding: The swing seat connectors have some wear present

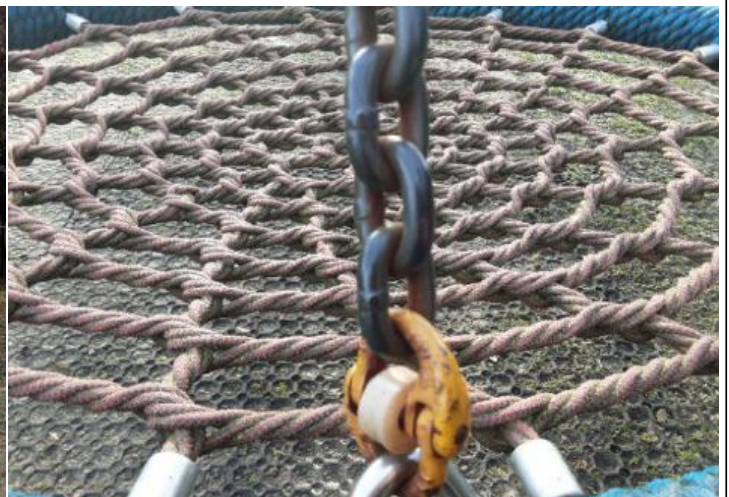
Risk Level: L - Low Risk
Surface: Grass Matrix Tiles

Finding: There is some notable evidence of chain wear

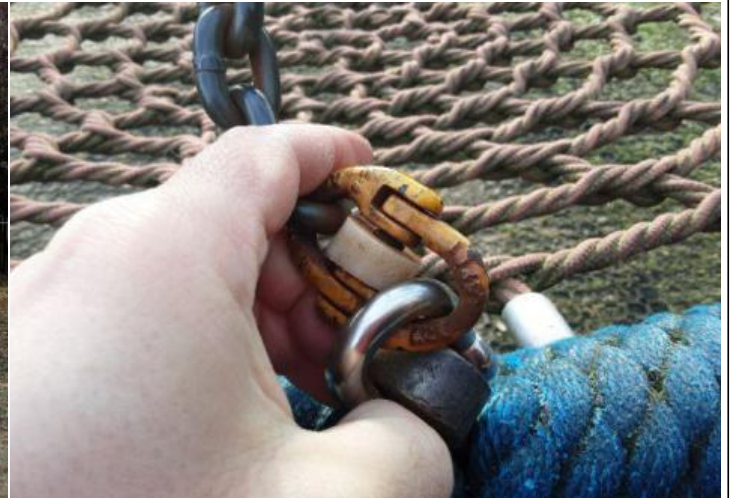
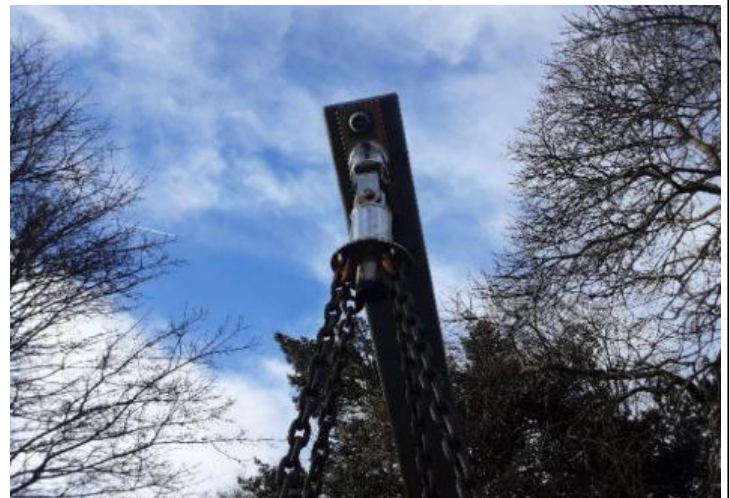
Risk Level: L - Low Risk
Surface: Grass Matrix Tiles

Finding: There is some wear to the shackles.

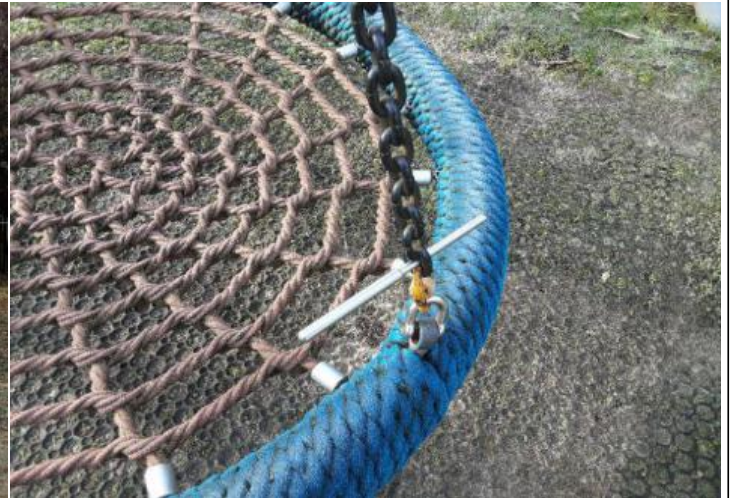
Risk Level: V - Very Low Risk
Surface: Grass Matrix Tiles

Finding: The chain openings are in excess of the 8.6mm as recommended by BS EN 1176 **Action:** Monitor - No remedial work recommended

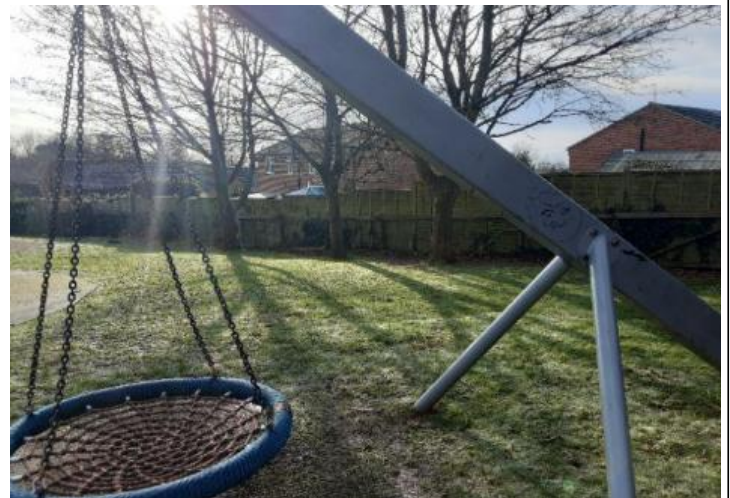
Finding: The beam buffer is missing and there are projecting fixings present

Action: Remove the projecting fixings and replace all missing components

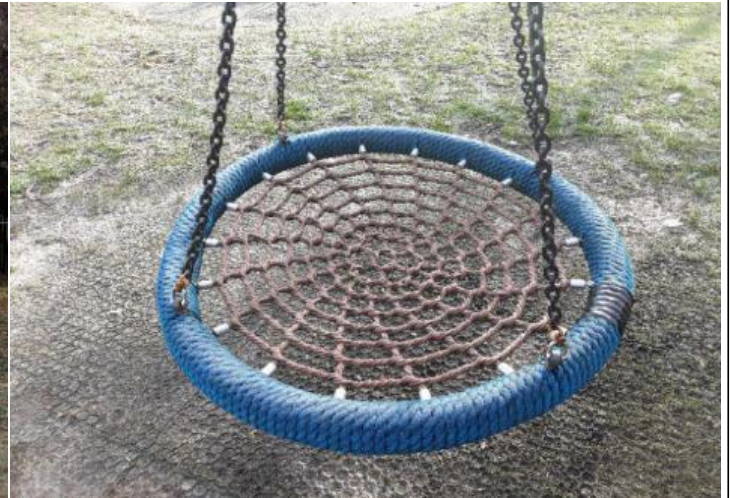
Risk Level: L - Low Risk
Surface: Grass Matrix Tiles

Finding: The seat has minor damage or wear

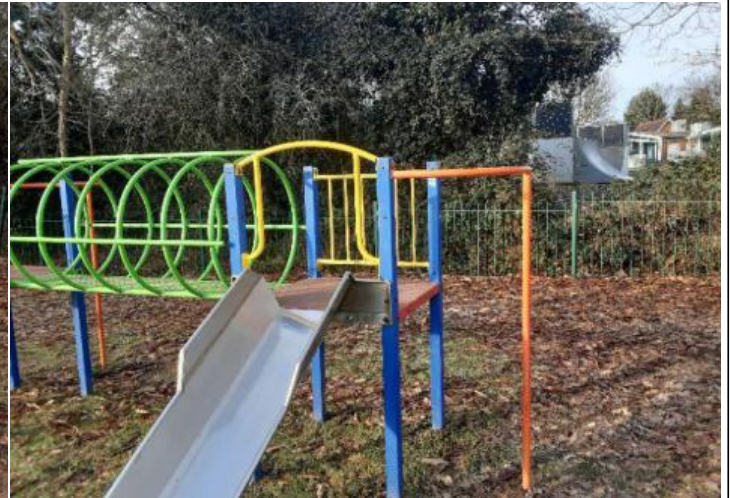
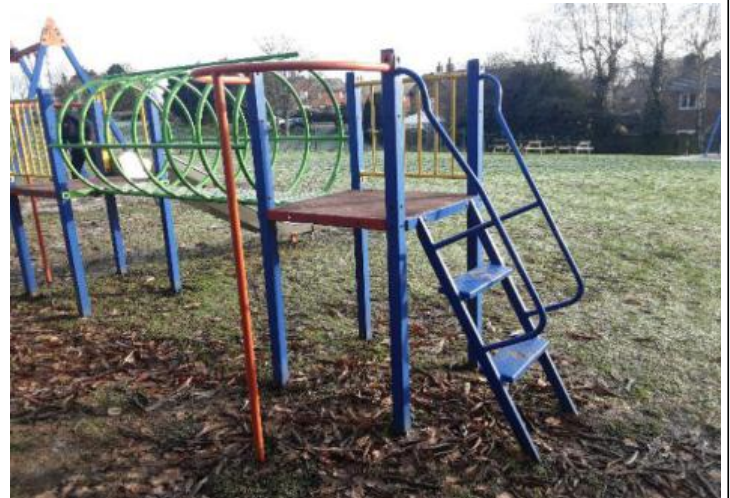
Risk Level: L - Low Risk
Surface: Grass Matrix Tiles

Finding: The unit is easily accessible and has an opening in the barrier to steep play elements in excess of 500mm in contravention of BS EN 1176 Part 1
Action: Monitor - No remedial work recommended

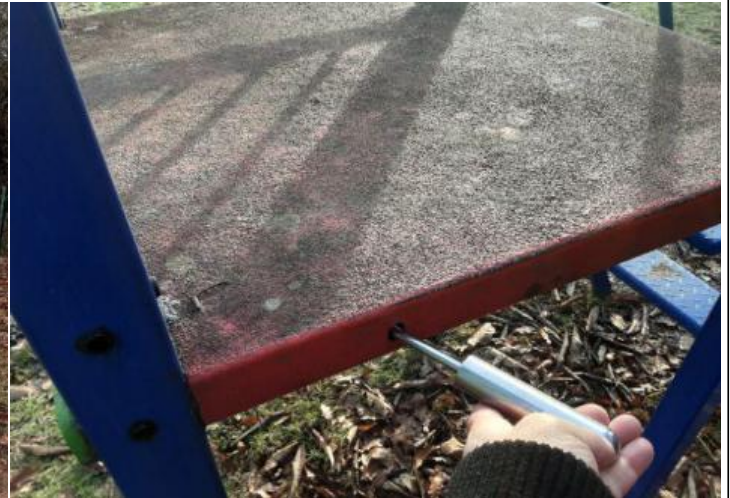
Risk Level: V - Very Low Risk
Surface: Grass Matrix Tiles

Finding: There is/are finger entrapment/s in the frame and the item fails to meet the requirements of BS EN 1176 Part 1 4.2.7.6 Entrapment of fingers

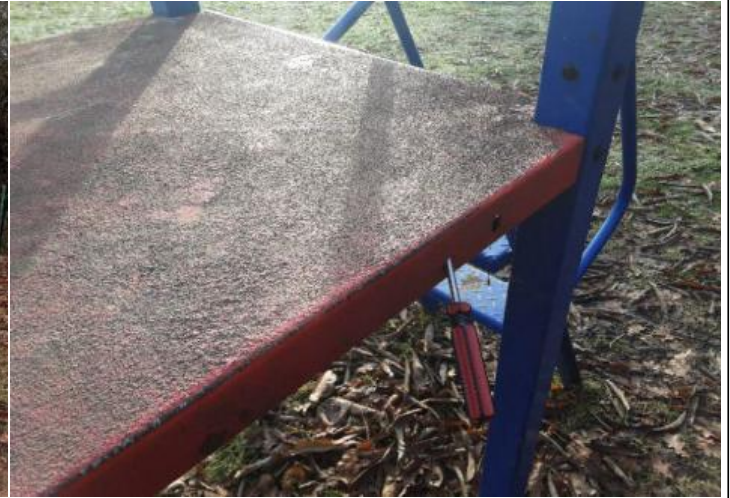
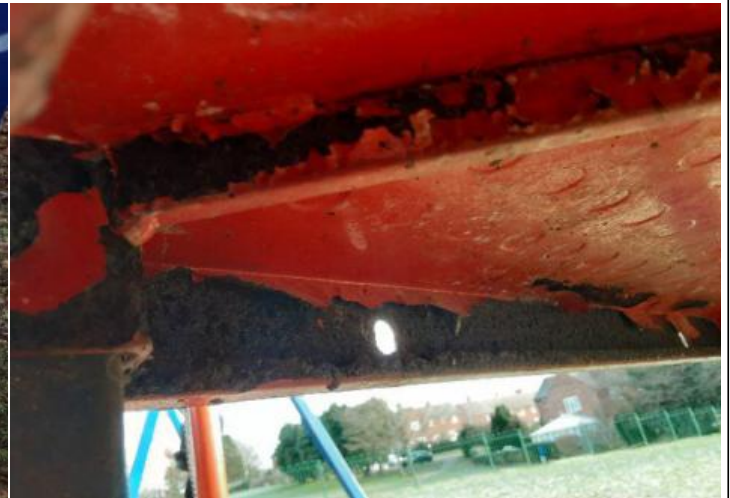
Risk Level: M - Moderate Risk
Surface: Grass Matrix Tiles

Finding: Parts of the steel on this item have corroded excessively and the metal has perforated in places

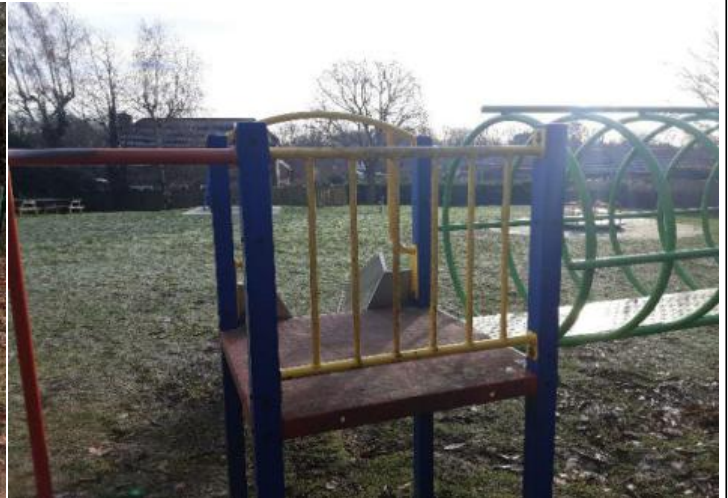
Risk Level: V - Very Low Risk
Surface: Grass Matrix Tiles

Finding: The height of the barrier(s) is insufficient and fails to meet the requirements of BS EN 1176 Part 1

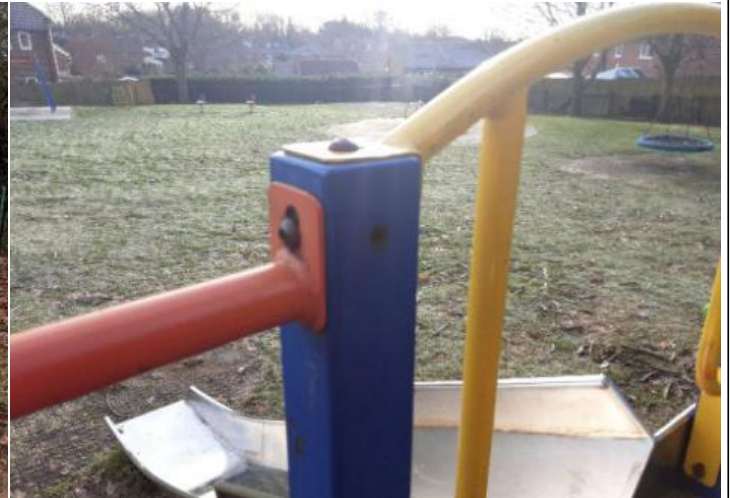
Risk Level: V - Very Low Risk
Surface: Grass Matrix Tiles

Finding: There is/are several inserts missing

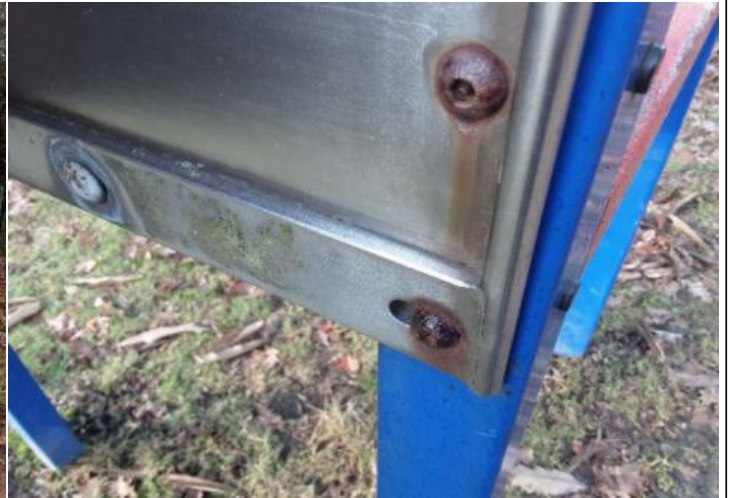
Risk Level: L - Low Risk
Surface: Grass Matrix Tiles

Finding: The fixings have corroded excessively

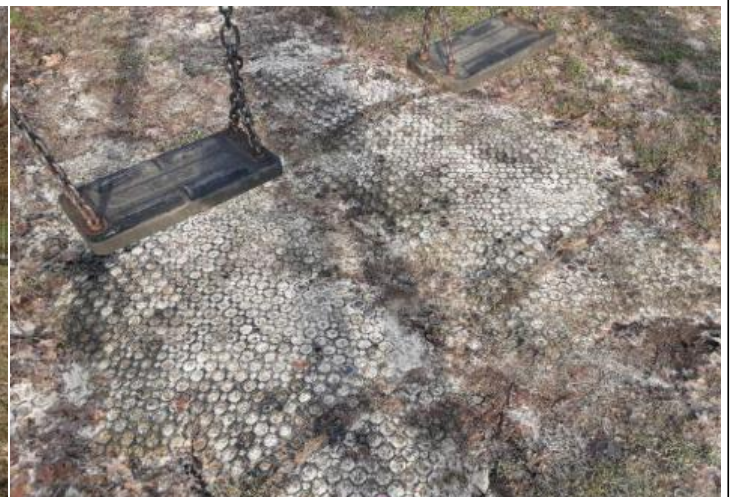
Risk Level: L - Low Risk
Surface: Grass Matrix Tiles

Finding: There is moderate damage to the surface **Action:** Repair the damaged areas of surfacing

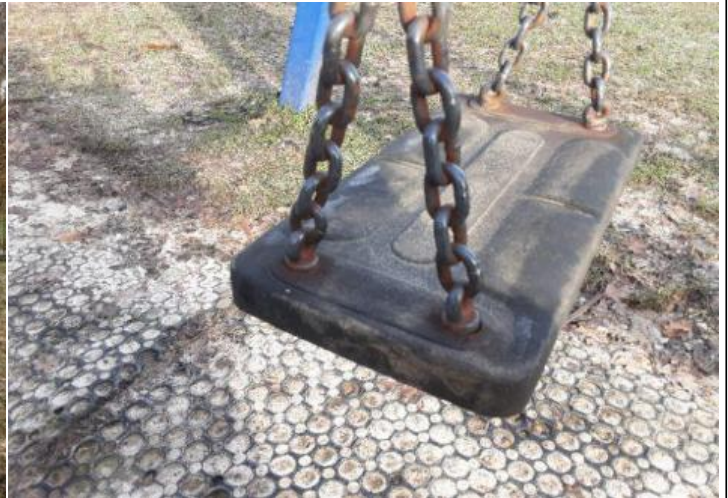
Risk Level: L - Low Risk
Surface: Grass Matrix Tiles

Finding: The swing seat connectors are loose

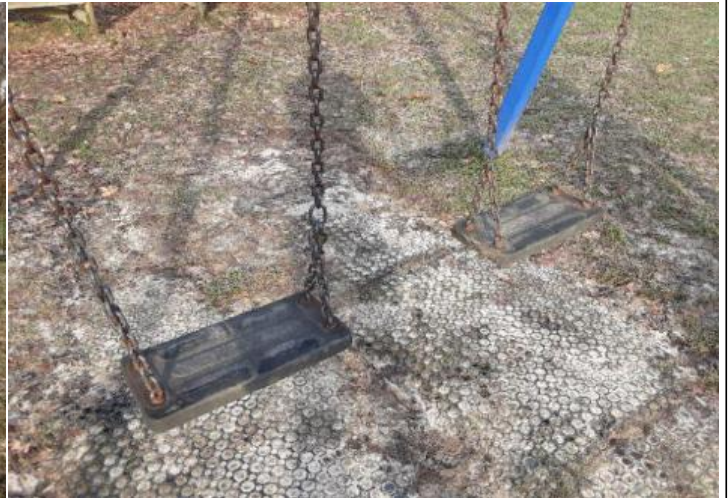
Risk Level: V - Very Low Risk
Surface: Grass Matrix Tiles

Finding: The seats are too close to each other as defined in BS EN 1176 Part 2; this is a low risk failure and no remedial action is required
Action: Monitor - No remedial work recommended

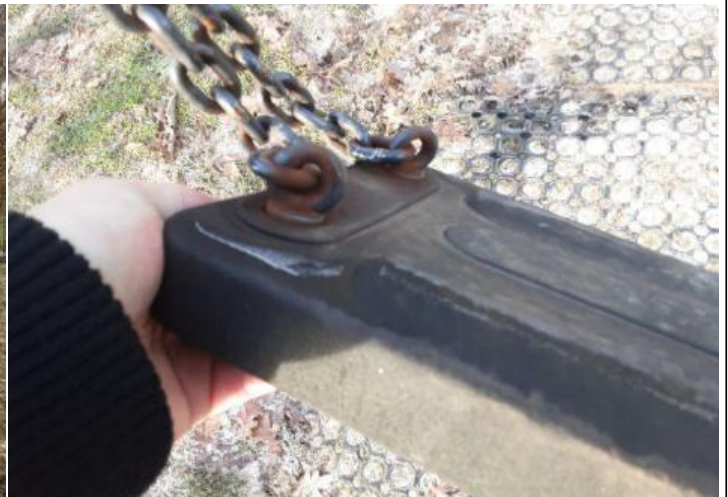
Risk Level: L - Low Risk
Surface: Grass Matrix Tiles

Finding: The swing seat connectors have some wear present

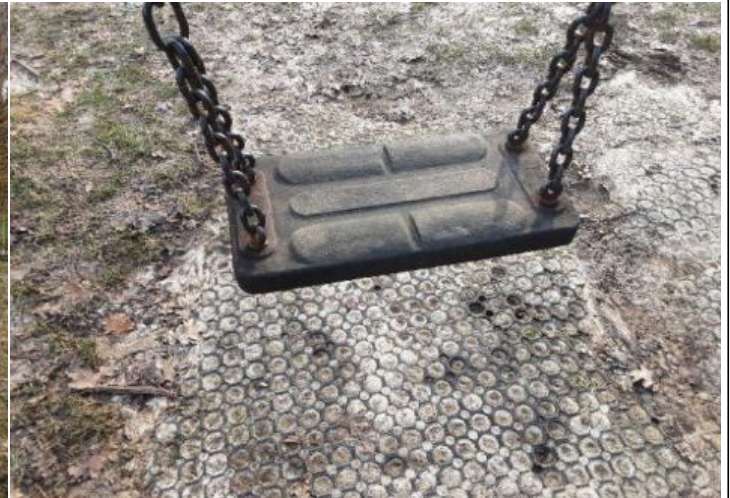
Risk Level: L - Low Risk
Surface: Grass Matrix Tiles

Finding: The seat has minor damage or wear
