the play inspection company

Annual Inspection

Ninfield Parish Council

The Recreation Ground

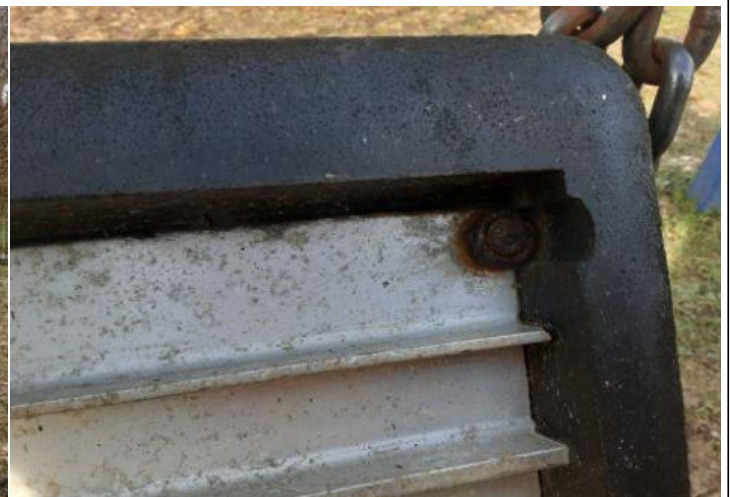
Risk Level: L - Low Risk
Surface: Grass Matrix Tiles

Finding: The fixings have corroded excessively

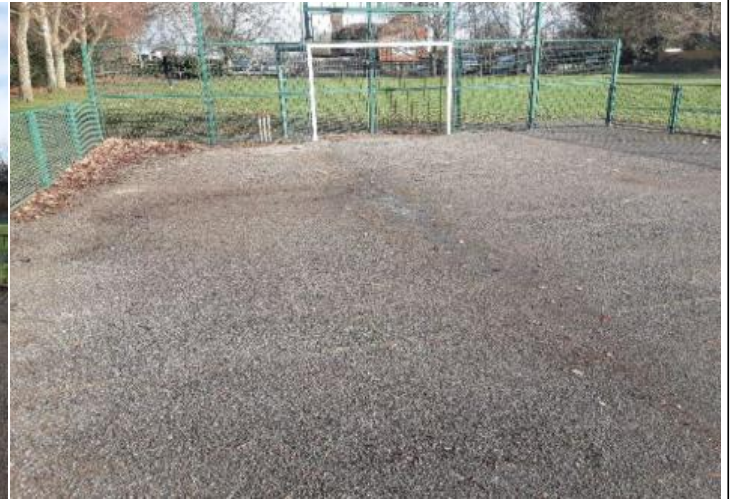
Risk Level: L - Low Risk
Surface: Bitmac

Finding: The surface is crumbing in areas creating slippery conditions

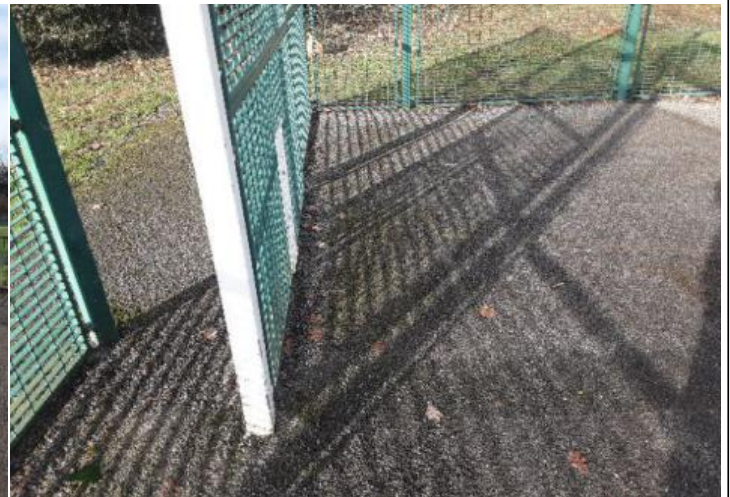
Risk Level: L - Low Risk
Surface: Bitmac

Finding: There is algae, silt or moss growth on the surface resulting in slippery conditions

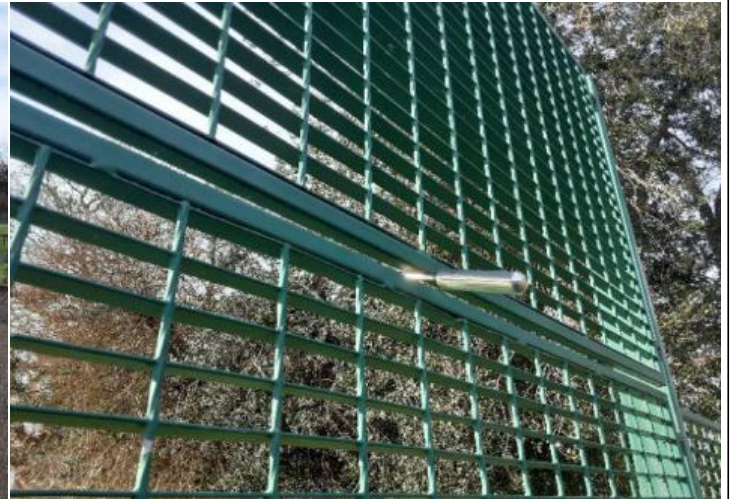
Finding: There is/are finger entrapments in the frame and the item fails to meet the requirements of BS EN 15312 Clause 4.4.2.2 Entrapment of fingers

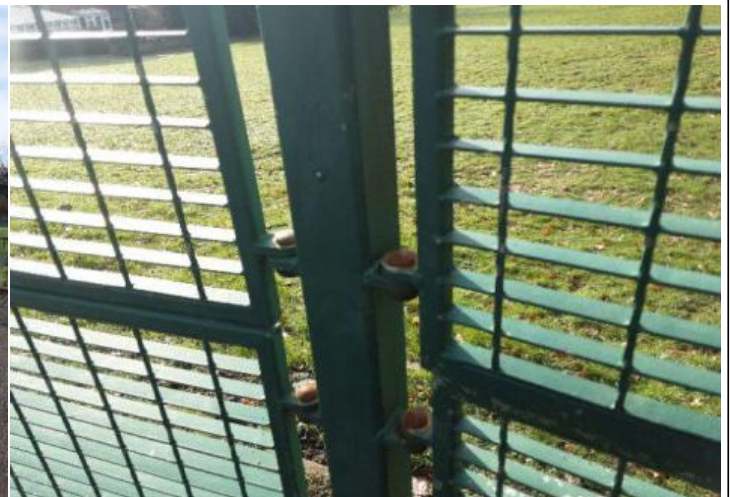
Finding: A number of fixing(s) have worked loose

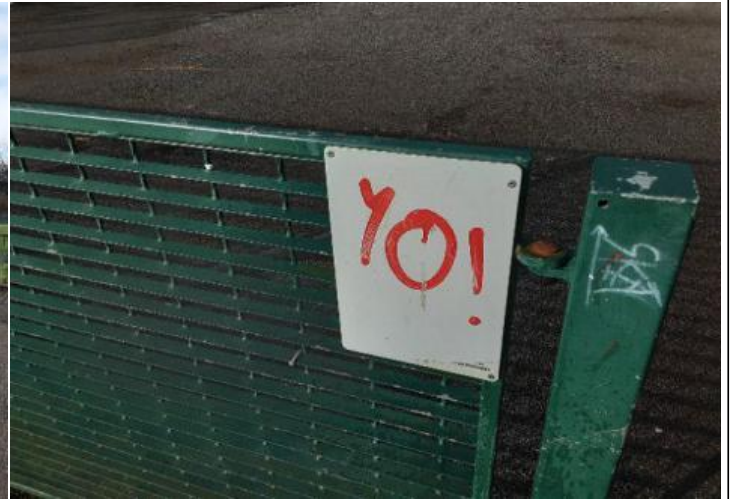
Finding: A clearly visible facility sign should be provided in a prominent position with the wording as detailed BS EN 15312- the equipment is not intended for children less than 3 years old- the warning - Do not climb on the framework or nets- the warning - Do not hang on the ring (if provided)- the warning - Do not wear rings or other jewellery- name and telephone number of the administrator- number to call in case of accident

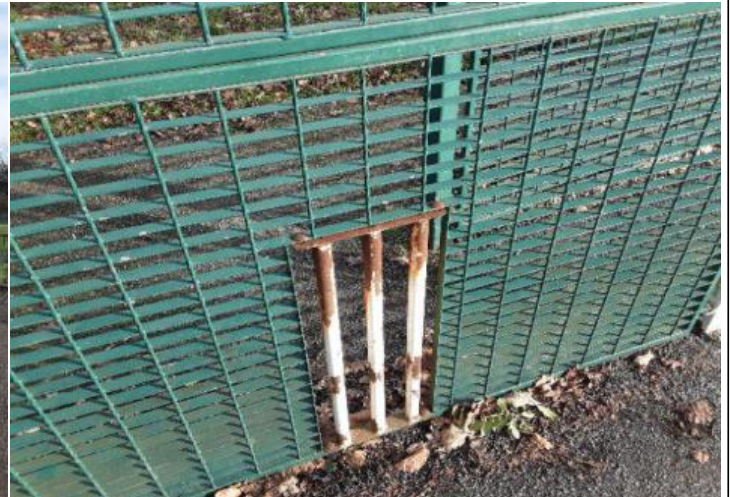
Finding: The paintwork on this item has been damaged or worn exposing the metal underneath which is rusting

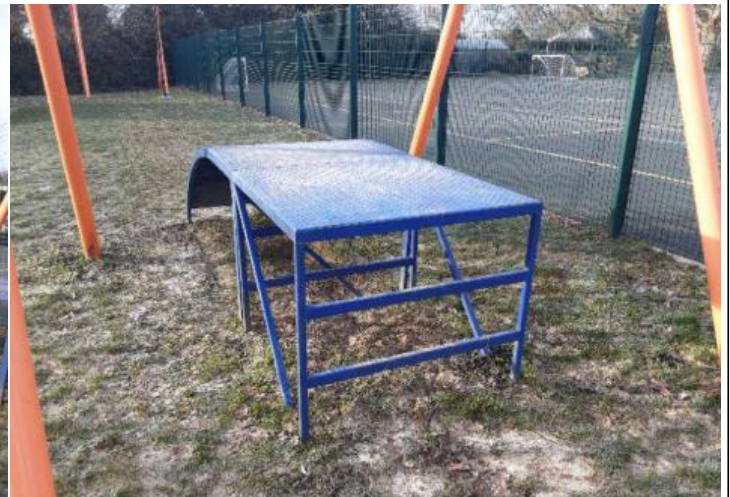
Finding: The unit is easily accessible and should have the appropriate barriers installed to meet the requirements of BS EN 1176 Part 1 as the height of the unit exceeds 600mm

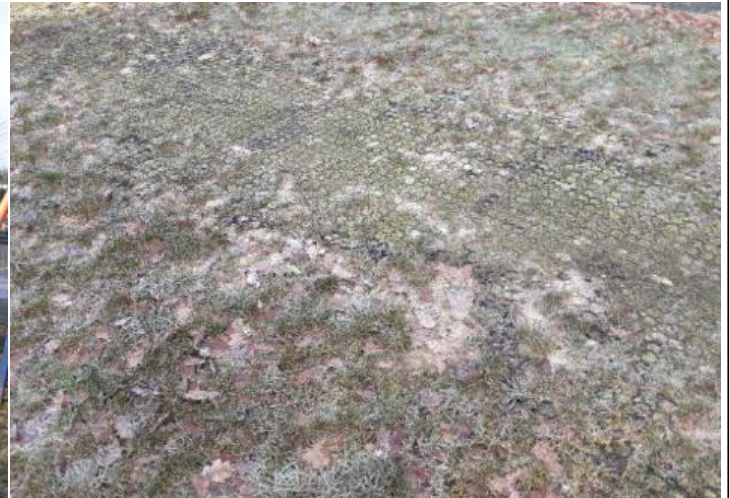
Risk Level: L - Low Risk
Surface: Grass Matrix Tiles

Finding: There is moderate damage to the surface

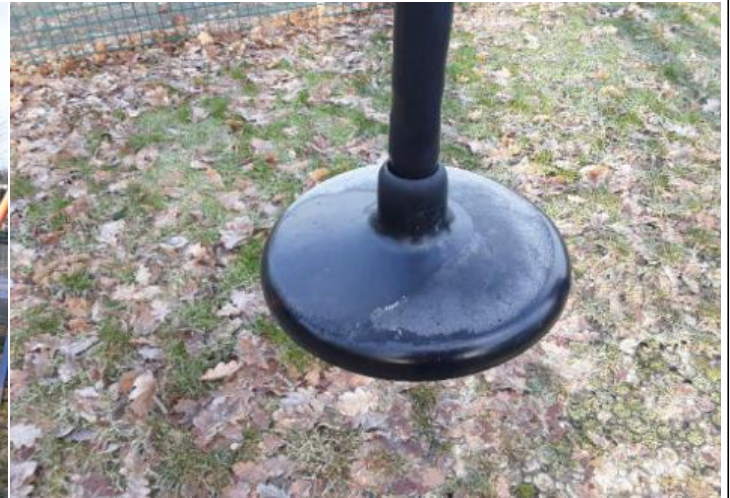
Risk Level: L - Low Risk
Surface: Grass Matrix Tiles

Finding: The cableway seat has been damaged

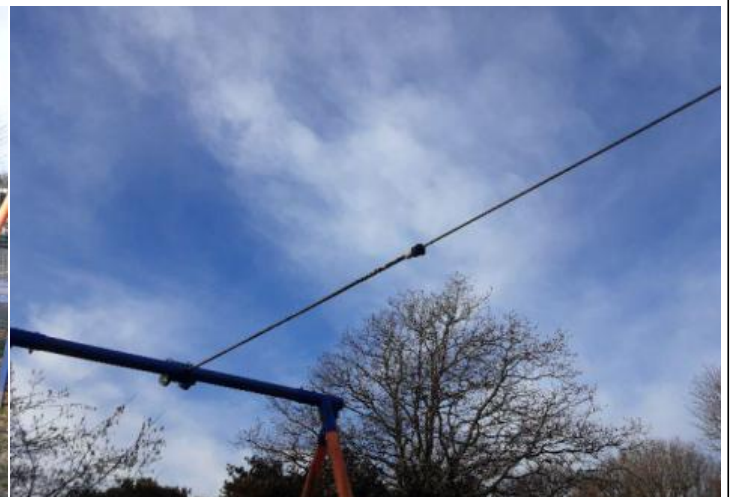
Risk Level: L - Low Risk
Surface: Grass Matrix Tiles

Finding: The dampening spring or tyre is damaged or broken on the item

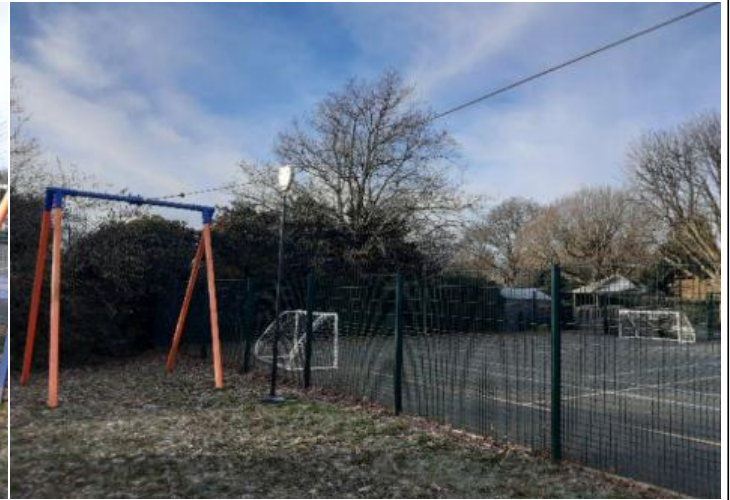
Risk Level: N - Risk Assessment not Undertaken
Surface: Grass Matrix Tiles

Finding: We have completed a visual inspection of the suspension links, cable and fixing points from ground level, however it is not possible to fully inspect these areas without either hiring equipment to gain access or removing the cable and suspension and inspecting at ground level. We recommend that the main cable and fixing security is thoroughly inspected at least in accordance with the manufacturers recommendations to check for wear, damage, security or internal rusting; this will help to ensure the continued safe use of the equipment

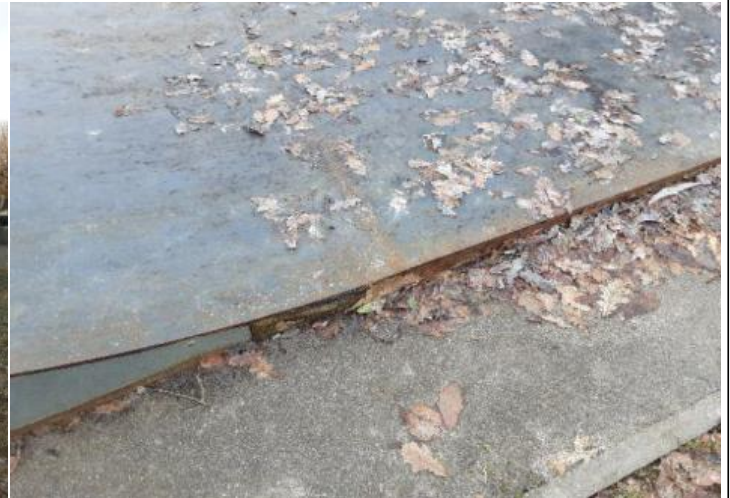
Risk Level: L - Low Risk
Surface: Bitmac

Finding: The paintwork on this item has been damaged or worn exposing the metal underneath which is rusting

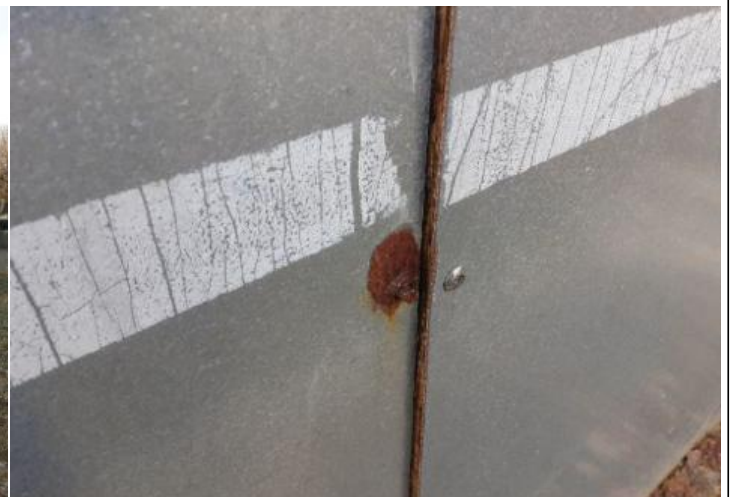
Risk Level: L - Low Risk
Surface: Bitmac

Finding: There is or are fixings missing on the item

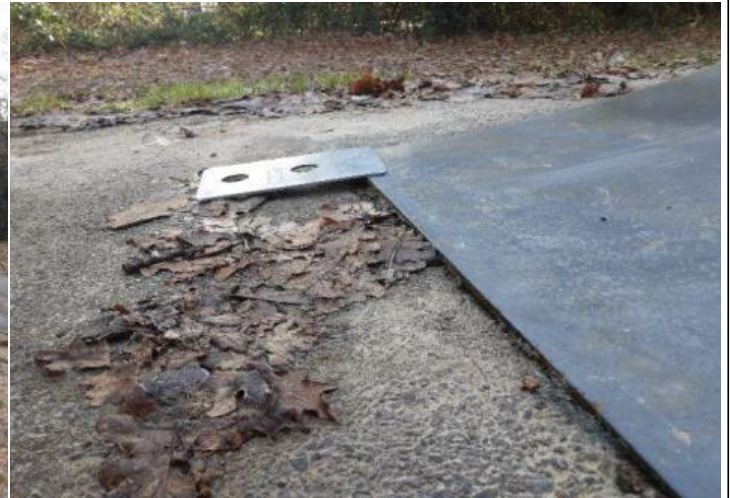
Risk Level: L - Low Risk
Surface: Bitmac

Finding: The kicker plate protrudes more than 5mm above the surrounding surface level, BS EN 14974 recommends a maximum of 5mm with 3mm preferred
Action: Adjust height to ensure a maximum of 5mm change in level
