Stage 1 ROAD SAFETY AUDIT REPORT.

Traffic Calming & Shared Space Scheme Ivinghoe Village

Date: 05/12/2016

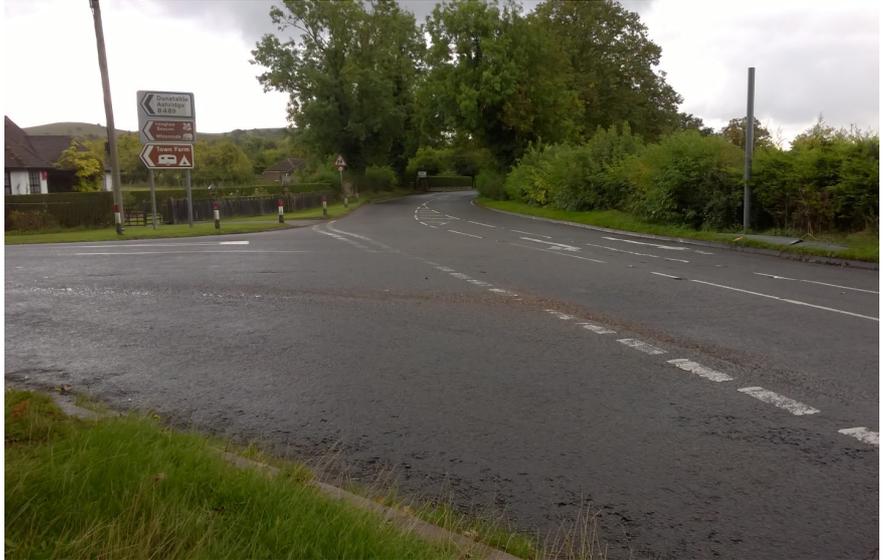
Curve of bend at proposed junction priority modification.

1. View of junction from the north.

The existing junction layout between the B488 Church Road and the B489 Tring Road, presents the B488 Church Road as the major road, with the B489 Tring Road joining from the northeast, at a downhill gradient. Approach speeds of vehicles travelling southwest to give way at the junction were observed to be high. A resident who lives at the property named 'The Warren', on the junction, explained their concern at the number of vehicles which approach at speed, fail to stop at the junction and crash into the direction sign and vegetation opposite.

Should the junction priorities be modified to change the section of B488 Church Road north of the junction into the minor road, the angle of the bend will be very sharp. This, in addition to the adverse camber of the carriageway at this location increases the likelihood of loss of control collisions, or sudden braking and loss of control.

Retain the existing junction priority and reposition the proposed village entrance feature to a point further north on B488 Church Road.

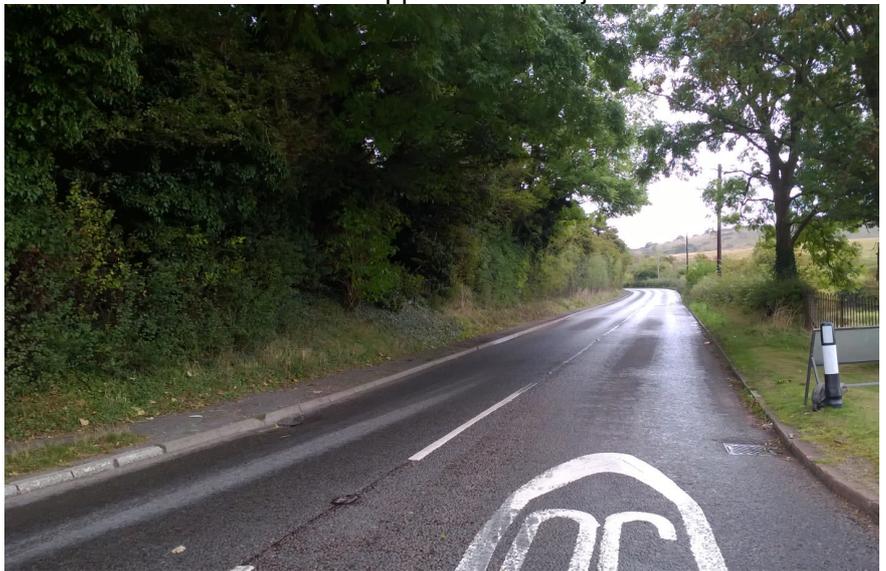
2. View of B489 westbound approach to the junction.

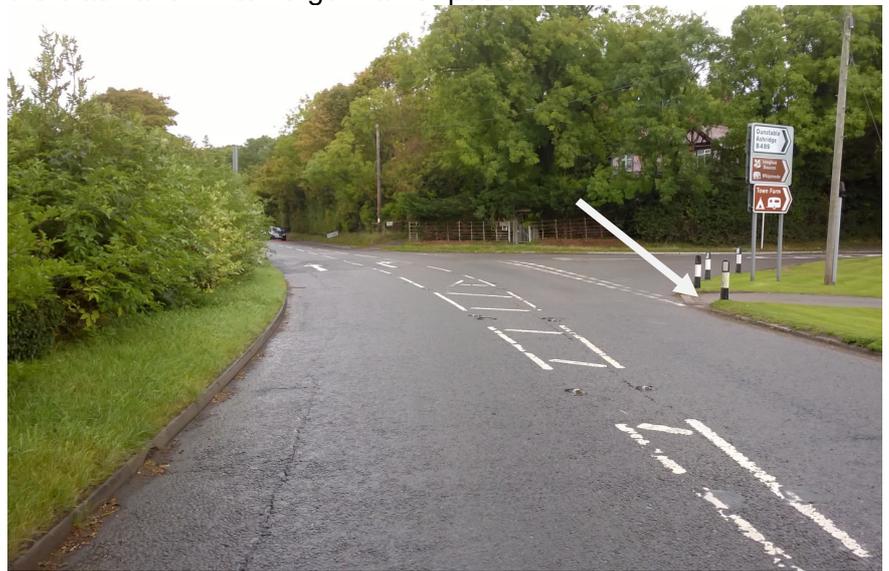
The vehicular access to property named 'The Warren' will be located on the exit of the bend.

3. View of junction from the south, showing the vehicular access to 'The Warren' on the right of the photograph, in between 2 of the black and white verge marker posts.

The vehicular access to 'The Warren' is currently located at a point where traffic stopping at the give way marking of the junction of B489 Tring Road, allows entrance and exit of the property easily. If the junction priorities are changed, the vehicular access will be located on the exit of the bend. This increases the risk of collisions involving vehicles exiting the property and being hit by vehicles travelling south around the bend. It also increases the risk of shunt collisions involving a vehicle waiting to turn left into 'The Warren' being hit by a vehicle travelling south around the bend.

Retain the existing junction priority and reposition the proposed village entrance feature to a point further north on B488 Church Road.

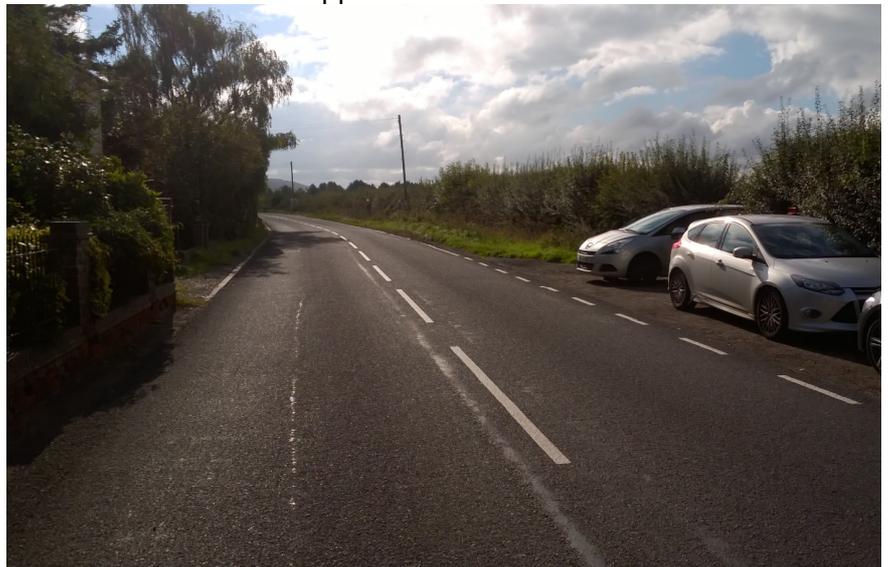
Vehicles entering a bend in the centre of the carriageway.

4. Southbound view of approach to the bend.

The proposed surface treatment and the removal of the centre lines, both intended to visually narrow the road, encourage vehicles to drive in the centre of the carriageway. There is a risk of head-on or side swipe collisions as vehicles enter the bend. The removal of the centre lines also increases the risk of vehicles cutting the across the curve of the bend, entering the opposing carriageway and being involved in a collision with a vehicle travelling in the opposite direction

Retain the centre line around the bend.

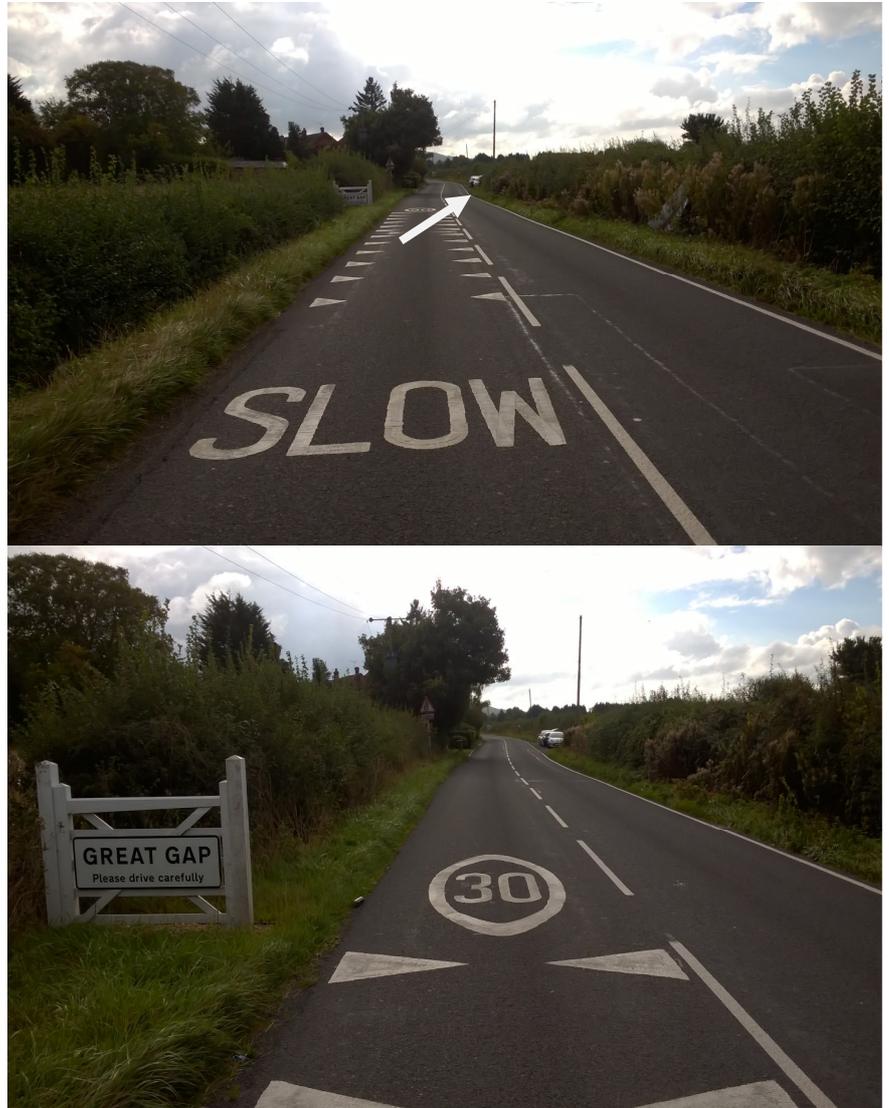
New trees planted at the extents of parking area.

5a & 5b. Southbound view of existing village gateway entrance and parking area to the right.

The locations of the newly planted trees, shown on the photographic impression on page 11 of the report, are at either extent of the proposed upgraded parking area. These are different locations than shown on the proposed plan drawing of the new parking area show on page 10, where they are either side of the carriageway on the northern entrance to the village. It is felt that if the trees are planted at either extent of the parking area, then in the future when mature they may restrict the visibility of vehicles exiting the parking area, leading to side impact or head on collisions with vehicles travelling on the main carriageway. In addition, the southernmost tree also presents a risk of far greater injury to a driver, should they lose control and strike it on exiting the bend to the south.

The Audit Team feels that the safest and most appropriate location for any newly planted trees is at the current southbound entrance to the village, where the existing Great Gap nameplate is situated. They would be situated far enough away from the parking area to not cause any restrictions to the visibility of cars exiting, and also is on a straight approach, so the risk of loss of control collisions is lower.

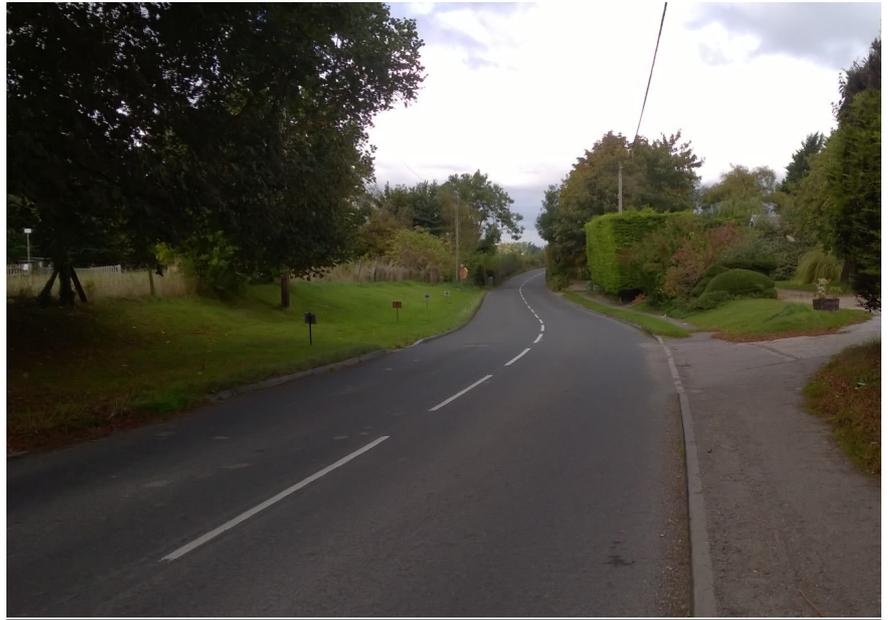
6a. Northwest approach to Ford End Bridge.

Removal of carriageway center lines.

The removal of the carriageway center lines increases the risk of head on collisions around bends.

Whilst the Audit Team does not have issue with the removal of the centerlines across the bridge, they should be retained around the bend southeast of the bridge. Additionally, appropriate 'Road Narrows' warning signage should be installed prior to the bridge on both approaches.

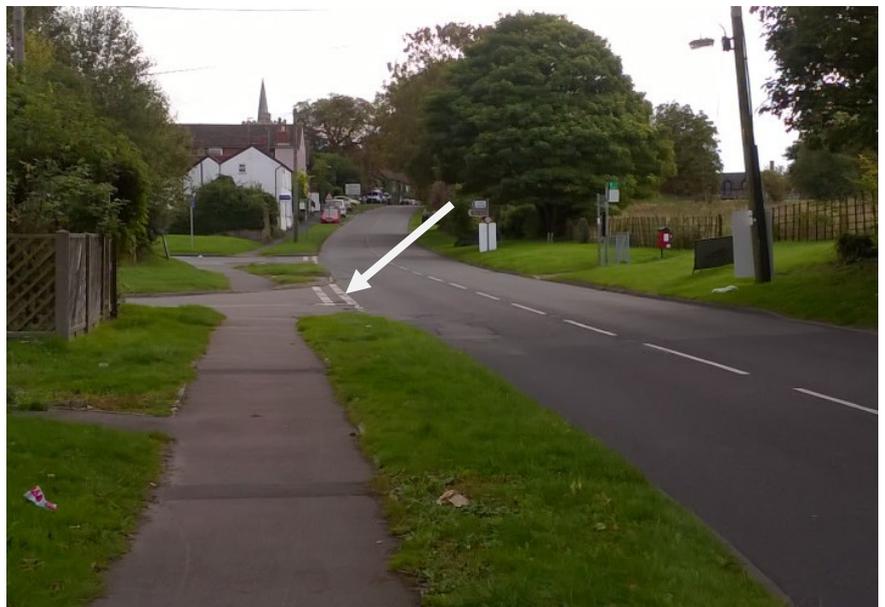
Lack of clarity over whether pedestrians have right of way at crossing points.

7. Southeast approach to Ivinghoe showing junction of Maud Jane's Close to the left.

The proposed informal courtesy crossings for pedestrians show no delineation between the footway and the carriageway; they are just one continuous extension of the footway material, across the road. This is likely to lead to confusion as to whose right of way it is, and may lead to pedestrians stepping out in front of vehicles and being injured.

Provide clear delineation between the footway and carriageway, and a visible reminder to pedestrians that they are leaving the footway.

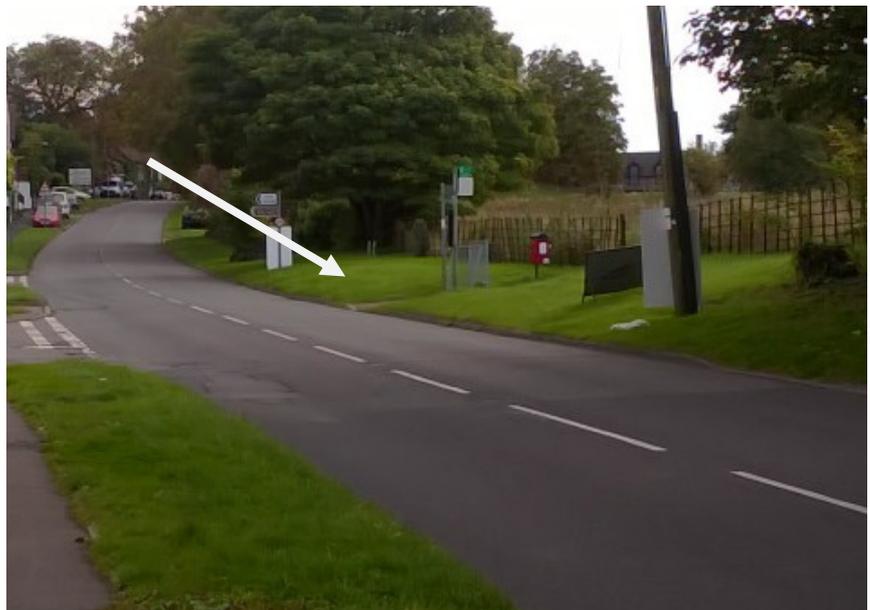
Conflict between vehicles on the carriageway and vehicles using the proposed drop-off area.

8. Proposed drop-off area opposite Maud Jane's Close

The proposed drop-off area is opposite the junction with Ladysmith Road and adjacent to an informal roundabout feature. The artist's impression shows that it is intended for vehicles to park at a right-angle to the carriageway. This means that vehicles using the drop-off area will have to reverse out onto the carriageway, at a point where multiple turning movements at the junction may already be taking place, and also vehicle speeds travelling on Station Road downhill are likely to be faster. This is likely to lead to vehicle vs. vehicle collisions, but also with a possibility of pedestrian collisions involving people who have been dropped off here.

Design the proposed drop-off area so that vehicles park alongside the carriageway and are able to enter and exit without reversing.

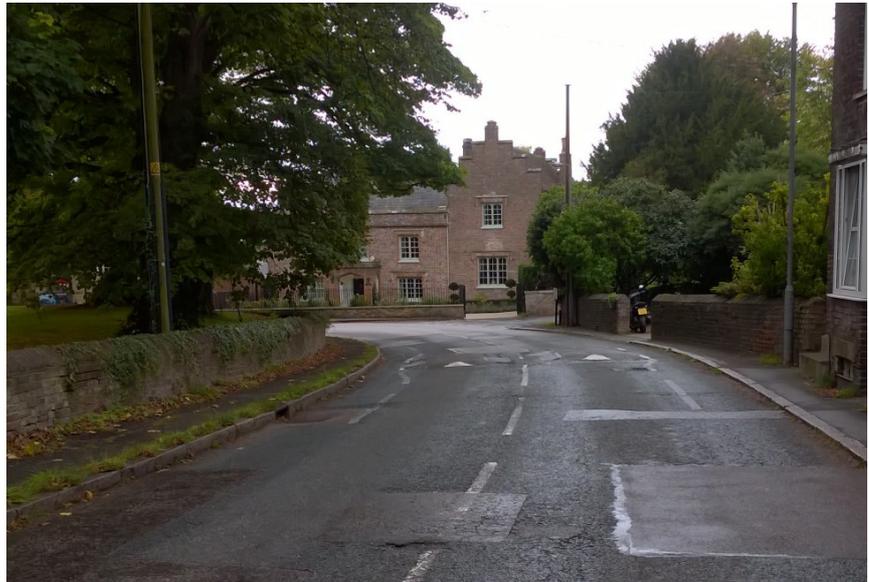
Removal of speed cushions is likely to result in increased vehicle speeds.

9. Northwest approach to Ivinghoe showing junction of Vicarage Lane to the right.

Whilst the existing speed cushions only provide a modest traffic calming effect, if they are removed and there are no physical measures in place, vehicles speeds are almost certainly going to increase. Although the proposed change in tone and colour of the surface may influence a reduction in vehicle speeds in the short term, this effect is likely to decrease as drivers become used to the environment and lack of physical traffic calming measures. This may increase the possibility of speed related collisions.

Retain the existing speed cushions, or install other appropriate physical measures to force drivers to reduce vehicle speeds.

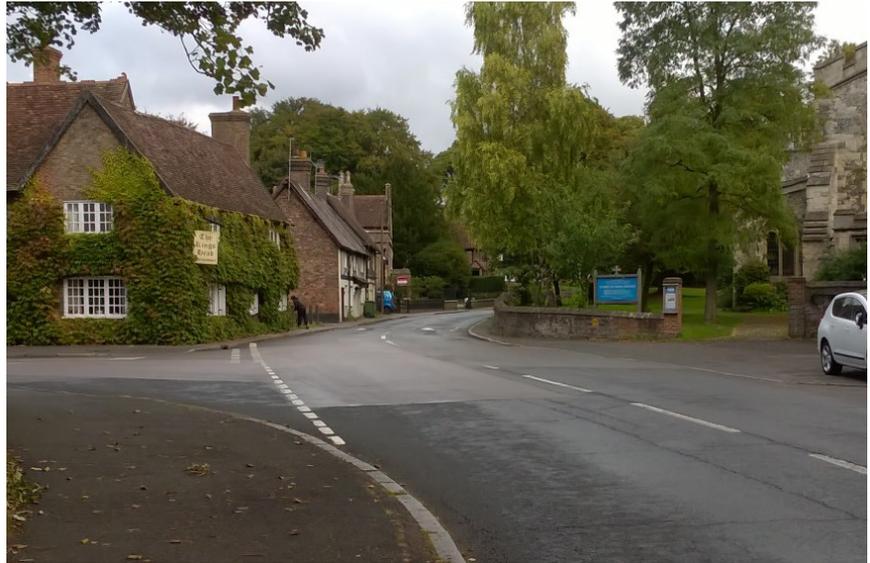
Removal of speed cushions is likely to result in increased vehicle speeds on approach to proposed new informal junction.

10. View of southwest approach to village centre and location of proposed new informal junction.

As highlighted in 4.0 - Whilst the existing speed cushions only provide a modest traffic calming effect, if they are removed and there are no physical measures in place, vehicles speeds are almost certainly going to increase. Although the proposed change in tone and colour of the surface may influence a reduction in vehicle speeds in the short term, this effect is likely to decrease as drivers become used to the environment and lack of physical traffic calming measures. This may increase the possibility of speed related collisions.

Retain existing speed cushions on the approach to the junction with Station Road.

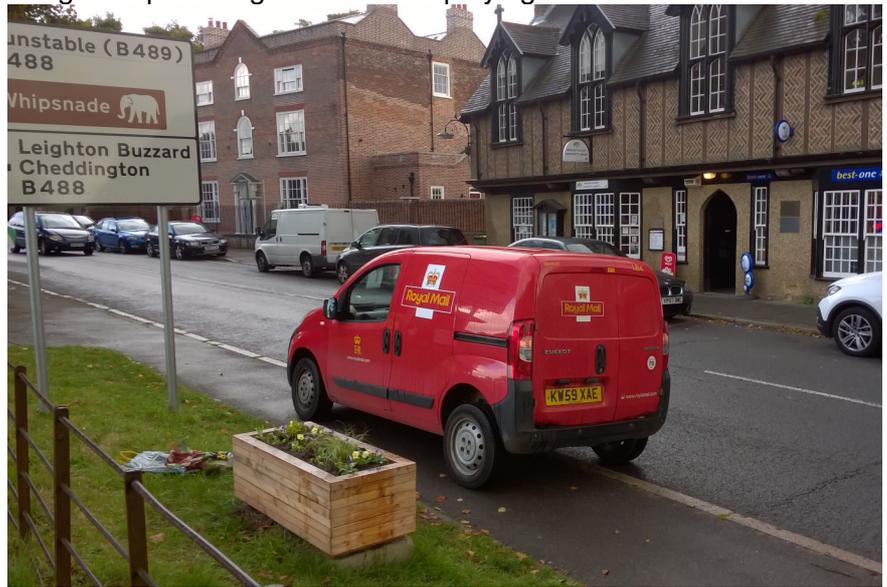
Visibility of pedestrians and parking in the vicinity of the proposed crossing point.

11. Location of proposed informal pedestrian crossing outside the village shop leading to The Lawn playing field.

Observations during the Safety Audit noted that parking is already at a premium, and Ivinghoe Parish Clerk spoke with us whilst we were on site regarding the existing problem they have with vehicles parking on the grass verge area adjacent to The Lawn; the parish council was installing wooden planters on the grass verge to prevent this at the time. The installation of the crossing point will remove a parking space from outside the village shop, however as the crossing is only a courtesy crossing, there is nothing to prevent a car parking across it and blocking it for pedestrians, or obstructing visibility by parking close to the crossing area. This may force pedestrians to attempt to cross between vehicles at points where approaching drivers are not expecting them to, increasing the risk of pedestrian collisions.

Provide a physical measure to prevent parking across the entrances to the crossing.

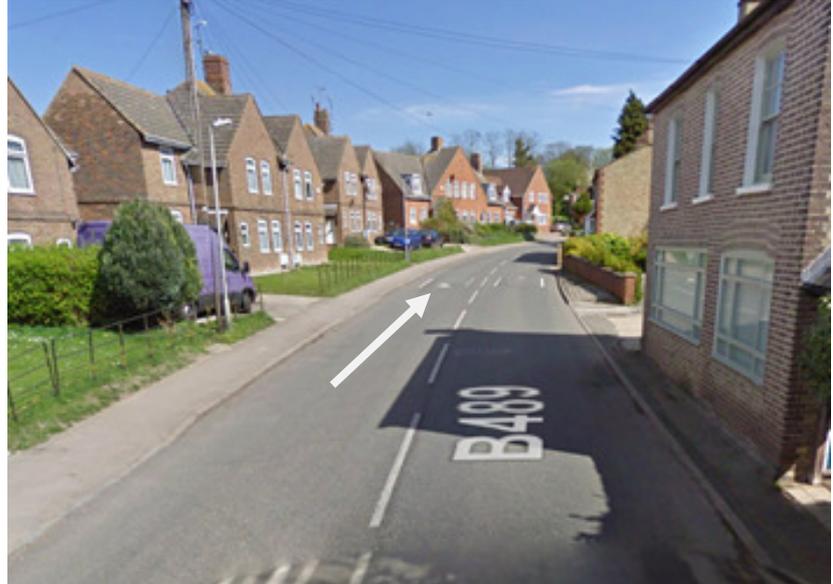
Removal of physical speed reduction measures on the approach to Brookmead School.

12. View of existing speed cushions on the downhill westbound approach to Brookmead School.

Currently there are speed cushions on the section of the B489 High Street to the east of Brookmead School, which whilst only provide a modest speed reduction effect, act as a physical reminder to drivers to slow down. The removal of these is likely to lead to an increase in vehicle speeds, particularly of vehicles travelling on the downhill westbound approach to the school, which may result in speed related collisions.

Retain the speed cushions on High Street.
