the play inspection company

Annual Inspection

Battle Town Council - WPS

Battle Recreation Ground

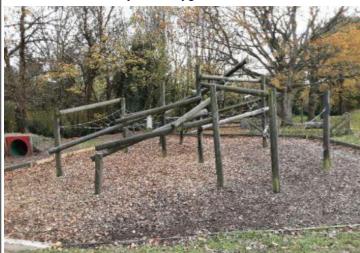
Item: Activity Equipment - Log Climber

Finding: There is some evidence of rot in the timber

Action: Monitor for any further deterioration and replace as required

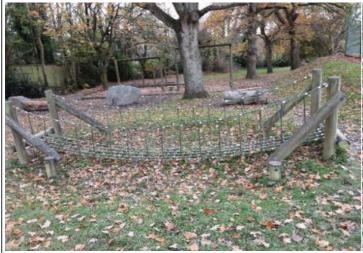
V - Very Low Risk Activity Equipment - Bridge Risk Level: Item:

Finding: There is/are bolt cap covers missing or damaged Action: Replace missing or damaged bolt cap covers on the item

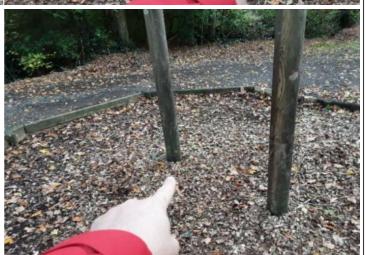
Finding: Three of the posts have rotted at or below ground level and the remaining post is showing signs of rot

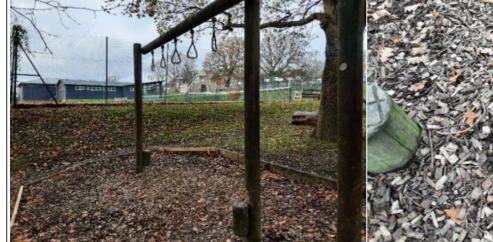
Item:Activity Equipment - Monkey BarsRisk Level:L - Low RiskManufacturer:Playdale Playgrounds LtdSurface:Woodchip

Finding: There is some evidence of rot in the timber

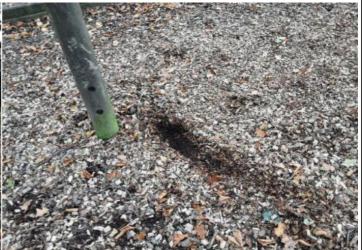
Finding: The depth of the loose fill surfacing is lower than the recommended depth specified in BS EN 1176; the free height of fall of the equipment is less than 2.0m and a minimum of 300mm depth should be provided (including an extra 100mm to allow for compaction and displacement as per BS EN 1176 Part 1 - Table 4)

Action: Top up loose fill surfacing to recommended levels

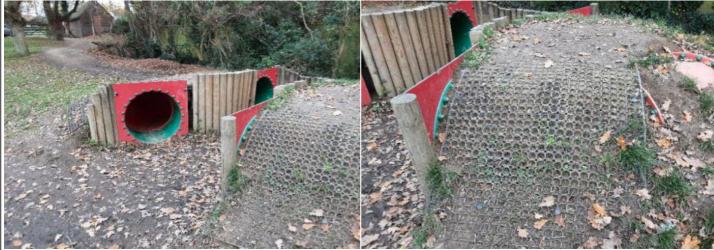
Item:Activity Equipment - Crawling TunnelRisk Level:L - Low RiskManufacturer:Playdale Playgrounds LtdSurface:Grass

Finding: The grass mats are silted up, the soil is compacted **Action:** Reinstate as required and the area will become very slippery when the soil is wet.

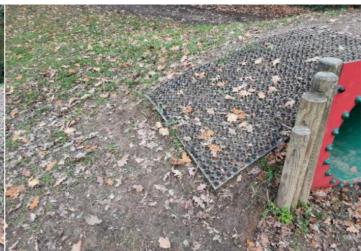
Item:Activity Equipment - Crawling TunnelRisk Level:L - Low RiskManufacturer:Playdale Playgrounds LtdSurface:Grass

Finding: The edges of the grass mat surface have not been **Action:** Tuck in edges of grass mat to remove trip hazards installed in accordance with the API Code of Practice

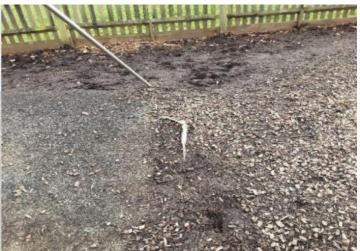
Finding: The safety surface is low and the membrane is exposed creating trip points

Action: Remove or resecure the exposed membrane and top up the surface to the correct level

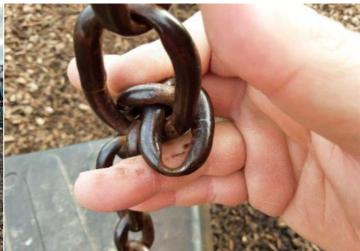
Finding: The chain links are worn in excess of 80% and require renewing

Risk Level: M - Moderate Risk Surface: Woodchip

Action: Replace worn chains

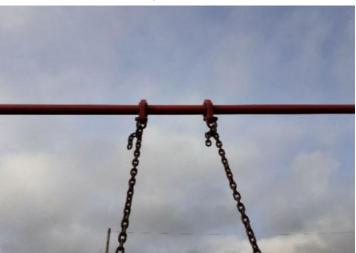
Finding: There is some wear to the shackles.

Risk Level: L - Low Risk Surface: Woodchip

Action: Monitor for any further deterioration and replace when 40% worn

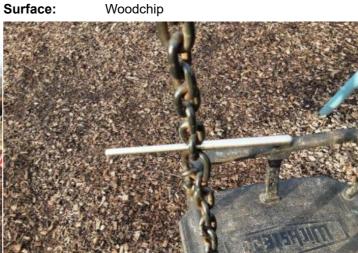
Finding: The chain openings are in excess of the 8.6mm as **Action:** Monitor - No remedial work recommended recommended by BS EN 1176

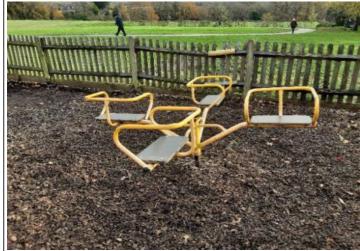
V - Very Low Risk Rotor Play - Rotating Chairs **Risk Level:** Item: Woodchip

Finding: Parts of the steel structure protrude beyond the protected elements of the seat and fail to meet the requirements of BS EN 1176 Part 5

Action: Monitor - no remedial action recommended

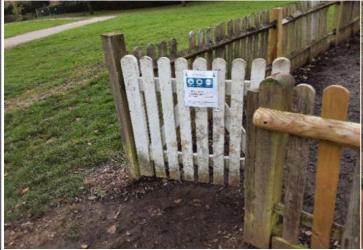
Item:Ancillary Items - GateRisk Level:L - Low RiskManufacturer:Not IdentifiedSurface:Woodchip

Finding: There are openings that are less than 12mm that could trap or crush fingers

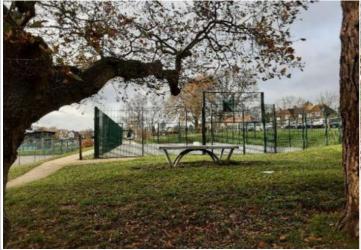
Multi Use Games Area - Multi Use Games Risk Level: Item: L - Low Risk Area (MUGA)

Finding: The grid at the entrance is full of weeds and/or

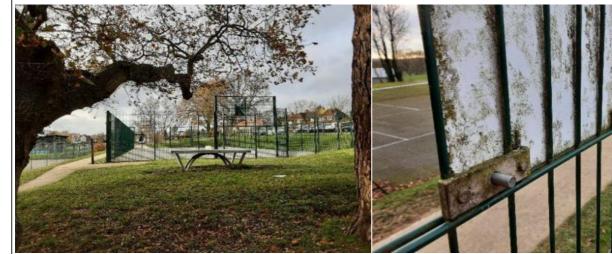
Finding: There are projecting bolt thread(s) present on the rear of the sign

Action: Remove excess thread length and deburr or provide cap

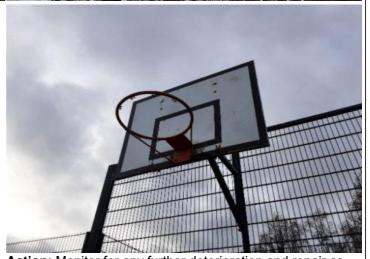
Finding: The backboards are damaged

Action: Monitor for any further deterioration and repair as required

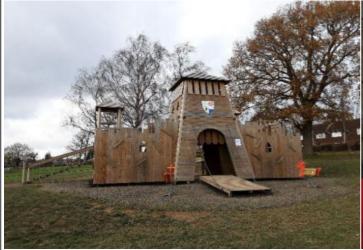
V - Very Low Risk Activity Equipment - Castle Risk Level: Item: Manufacturer: Eibe Play Ltd Surface: Tigermulch

Finding: The item fails to meet the requirements of BS EN 1176 Part 1 4.2.7.2 head and neck entrapment in the barriers and/or steps
