**Annual Inspection**

Fields in Trust - (NPFA)

Bockhampton

Bockhampton Lane, Lower Bockhampton, Dorset, DT2  
8PZ

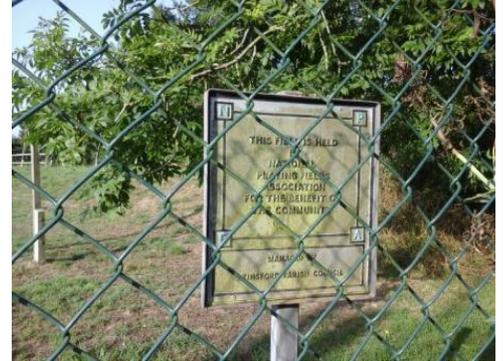
It is recommended that information signs with emergency contact details are installed at each entrance/exit point to the playground - Provide in accordance with the recommendations set out in BS EN 1176

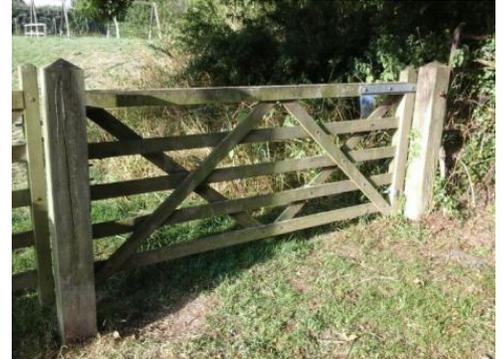
There is no padlock on the maintenance gate - Provide padlock to secure gate

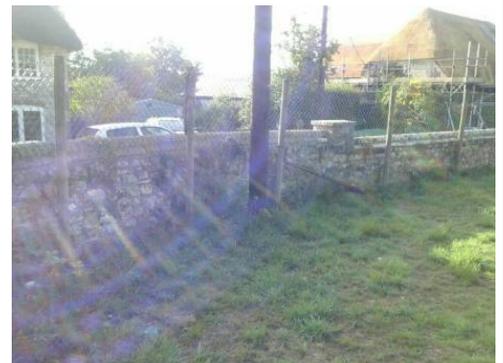
There are a number of loose posts around the fence - Monitor for any further deterioration and reset as required

There is some evidence of rot in the timber - Monitor for any further deterioration and replace as required

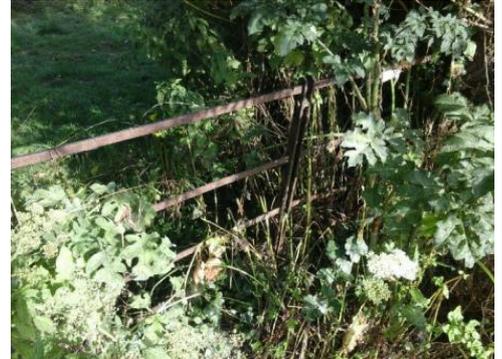
There is surface corrosion present on the item - Consider treating and repainting the item

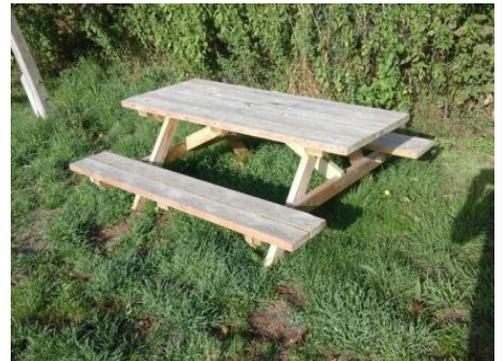
The table is not secured to the ground and there is some potential for the item to be moved within falling spaces of equipment - Secure the item to the ground

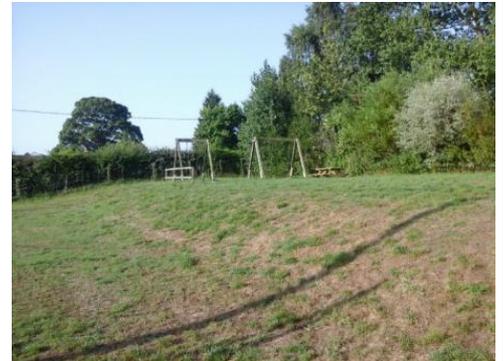
There are stinging nettles/vegetation growth protruding through the fencing surrounding the play area - Cut back and maintain area

Fixing Pins have been installed in the impact areas of the grass mats - Remove pins from impact areas

The grass is overgrown within the play area and may hide hazards - Reduce the length of grass to an acceptable height and maintain

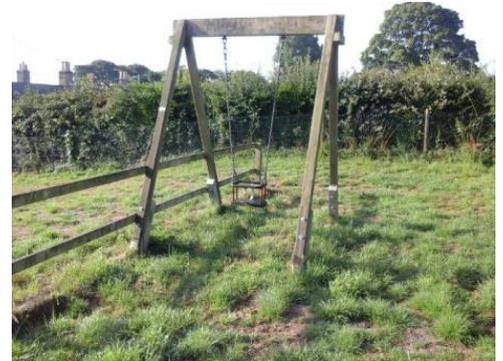
There are stinging nettles beneath the item - Remove

There is some strimmer / machinery damage apparent on the posts, this can penetrate the preservative applied to the timber and accelerate the rotting process - Monitor for any deterioration (rot) and replace as required

There is some evidence of rot in the timber - Monitor for any further deterioration and replace as required

There is algae or moss on the surface of the equipment - Clean and treat appropriately

The posts on the swing barrier are slightly loose in the ground - Monitor for any further deterioration and repair as required

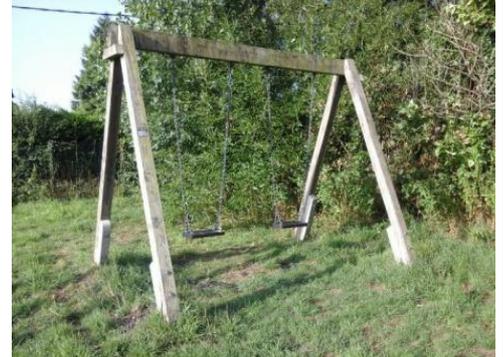
There is some strimmer / machinery damage apparent on the posts, this can penetrate the preservative applied to the timber and accelerate the rotting process - Monitor for any deterioration (rot) and replace as required

There are areas or parts of the timber on the structure that have rotted ( 2 of 4 posts ) - Replace all affected timbers

There is some evidence of rot in the timber - Monitor for any further deterioration and replace as required

The seats are too close to the frame as defined in BS EN 1176 Part 2; this is a low risk failure and no remedial action is required - Monitor use

There is excrement on the equipment - Clean and maintain

The picnic table forms a hard object within the falling space of the equipment in contravention of the requirements of BS EN 1176 Part 1 - Re - locate the picnic table

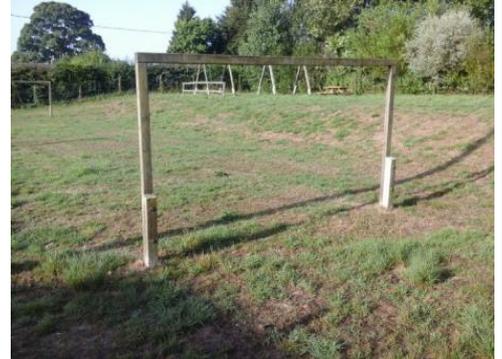
NB: We have undertaken a maintenance inspection only of the football goal(s); full load testing fall outside the scope of our inspection. - Implement load testing as required

There is some strimmer / machinery damage apparent on the posts, this can penetrate the preservative applied to the timber and accelerate the rotting process - Monitor for any deterioration (rot) and replace as required

There are areas or parts of the timber on the structure that have rotted - Replace all affected timbers

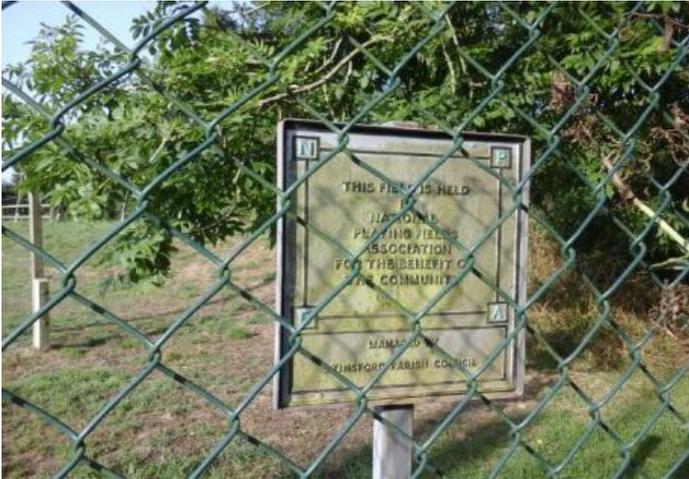
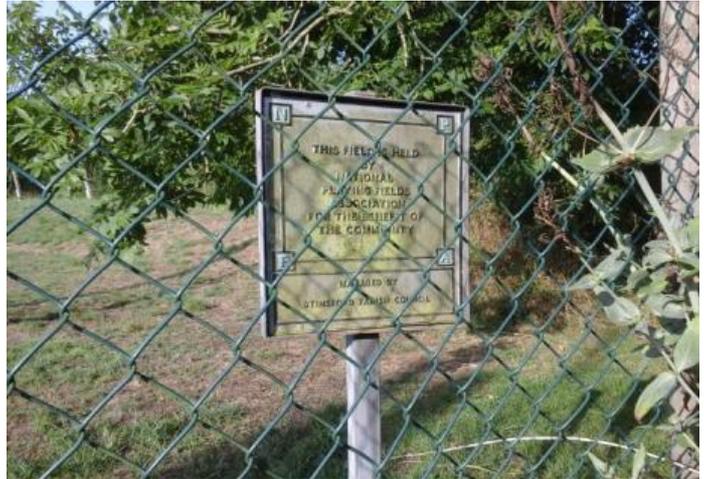
**Finding:** It is recommended that information signs with emergency contact details are installed at each entrance/exit point to the playground

**Action:** Provide in accordance with the recommendations set out in BS EN 1176

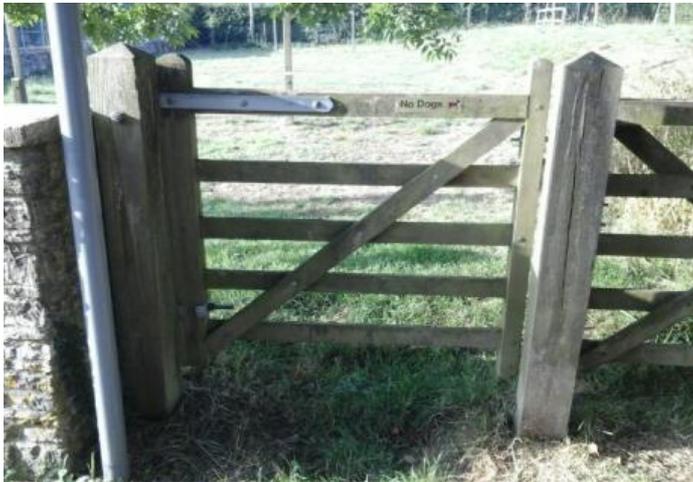
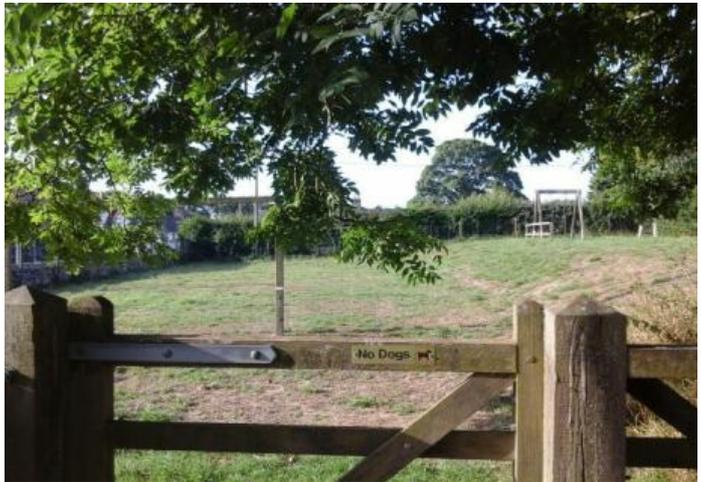
**Finding:** Tree canopies overhang the access route to the equipment and are less than 2.0m high

**Action:** Lift tree canopy to ensure a minimum clearance of 2.0m from ground level

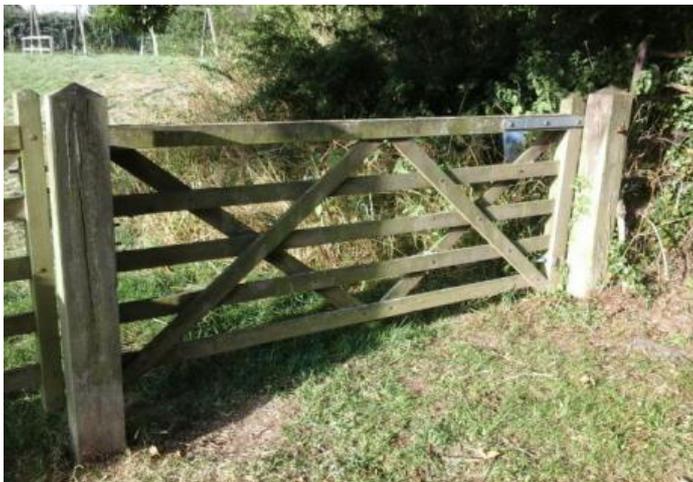
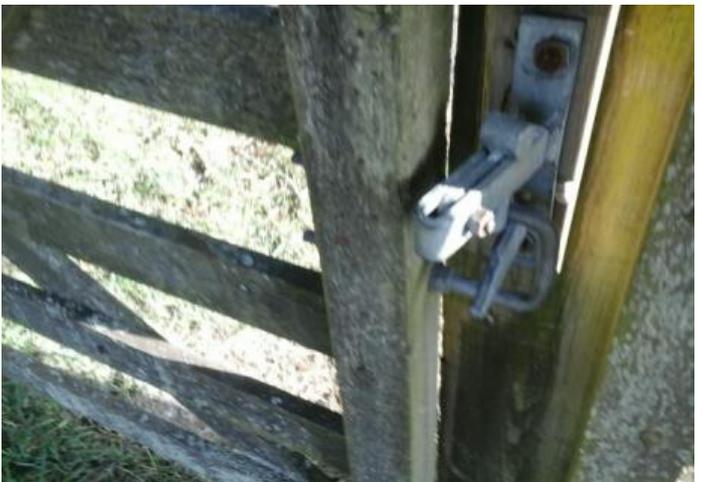
**Finding:** There is no padlock on the maintenance gate

**Action:** Provide padlock to secure gate

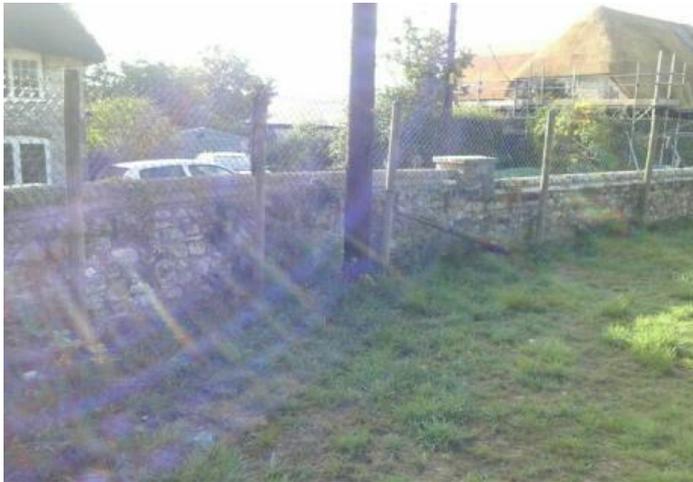
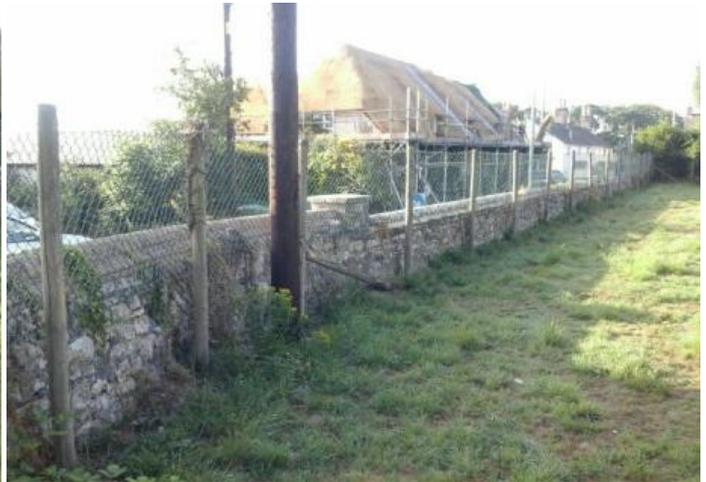
**Finding:** There are a number of loose posts around the fence

**Action:** Monitor for any further deterioration and reset as required

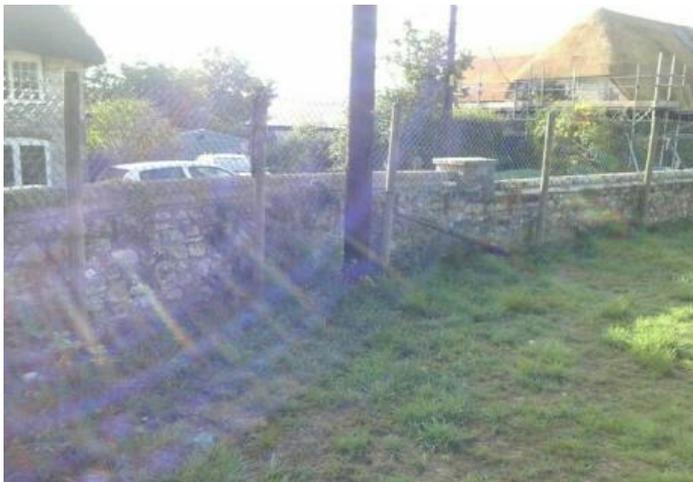
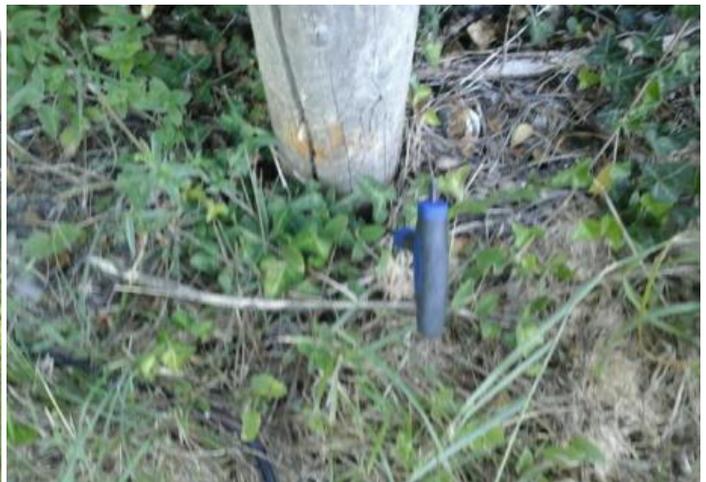
**Finding:** There is some evidence of rot in the timber

**Action:** Monitor for any further deterioration and replace as required

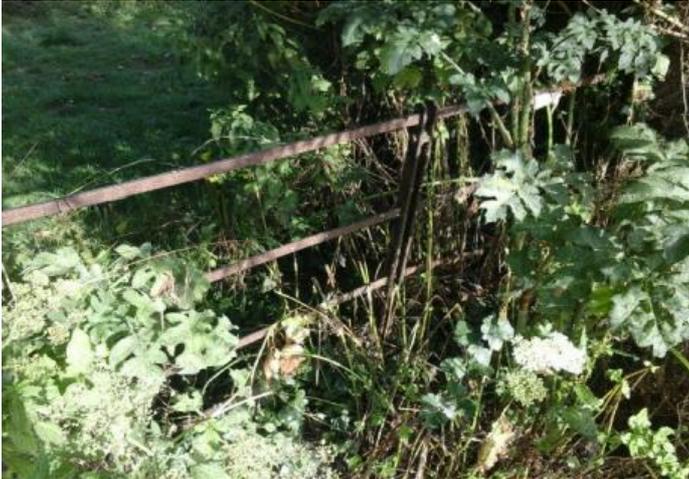
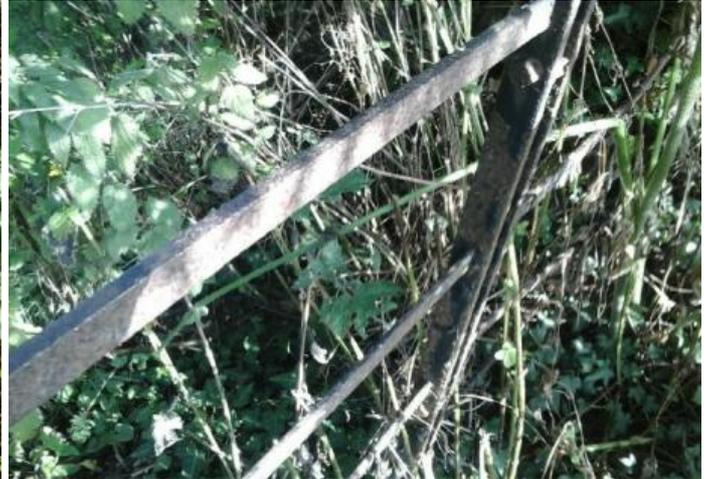
**Finding:** There is surface corrosion present on the item      **Action:** Consider treating and repainting the item

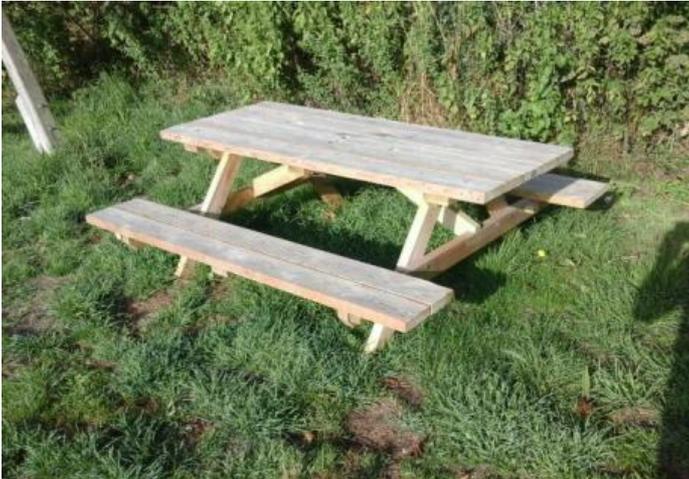
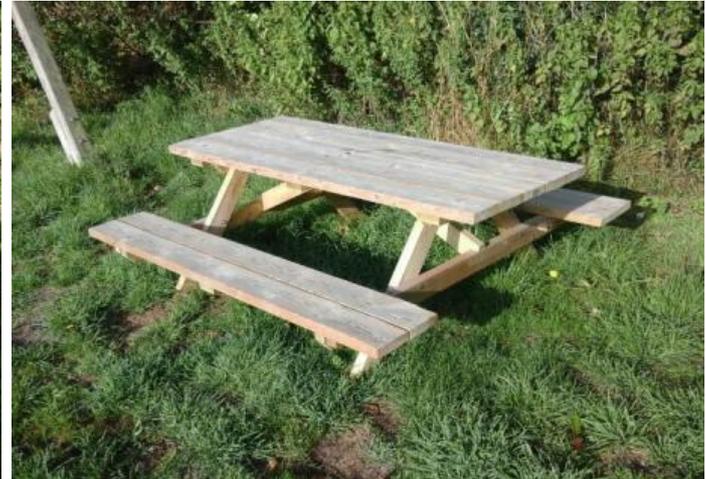
**Finding:** The table is not secured to the ground and there is some potential for the item to be moved within falling spaces of equipment      **Action:** Secure the item to the ground

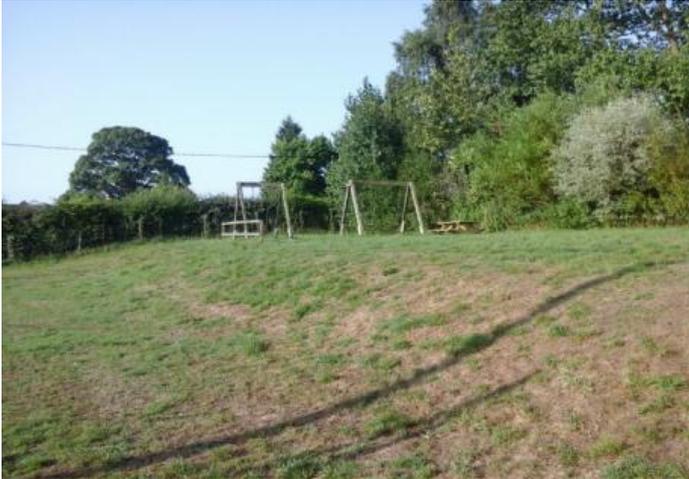
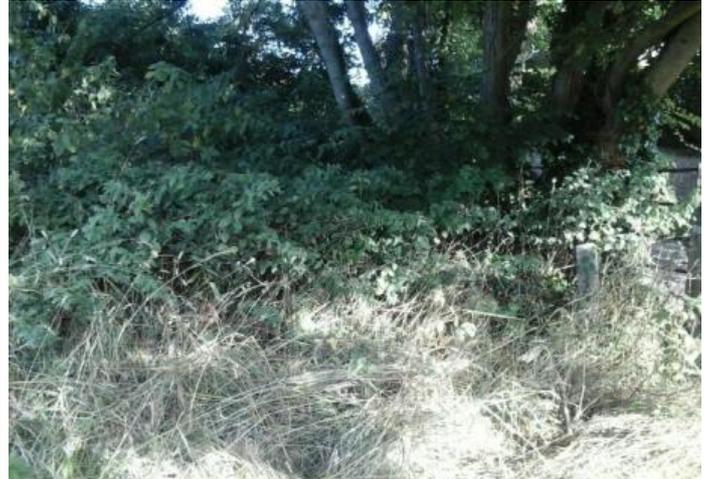
**Finding:** There are stinging nettles/vegetation growth protruding through the fencing surrounding the play area

**Action:** Cut back and maintain area

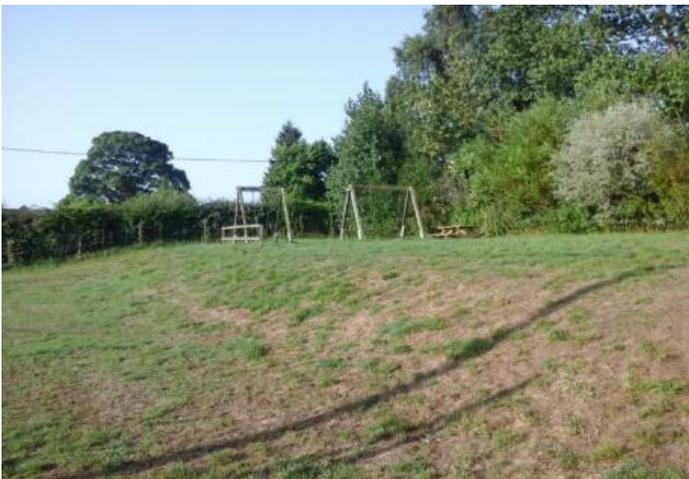
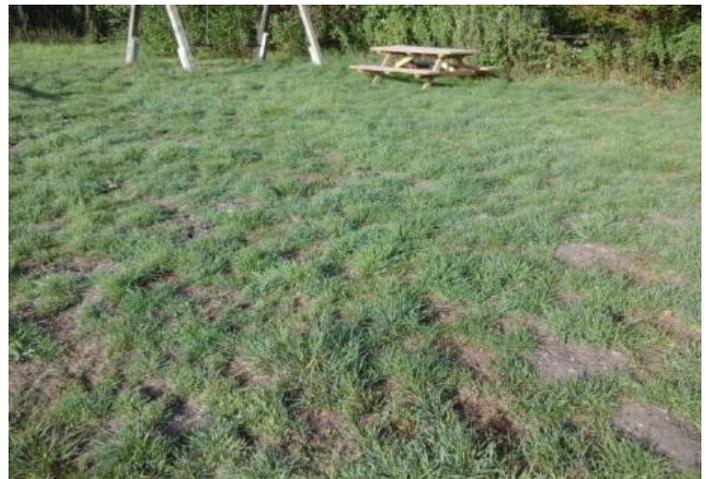
**Finding:** The grass is overgrown within the play area and may hide hazards

**Action:** Reduce the length of grass to an acceptable height and maintain

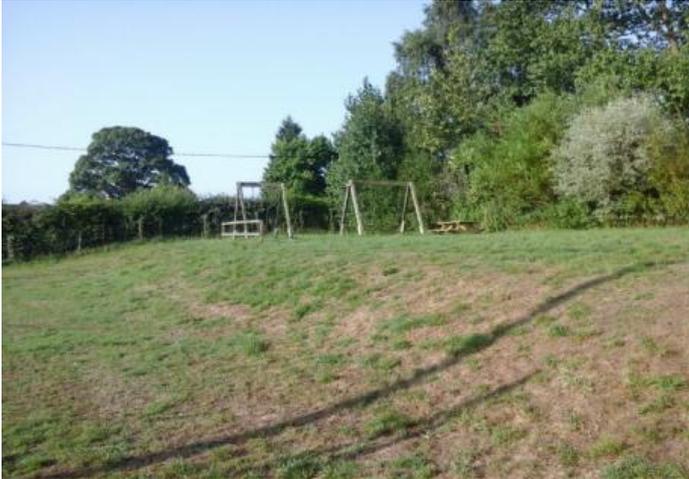
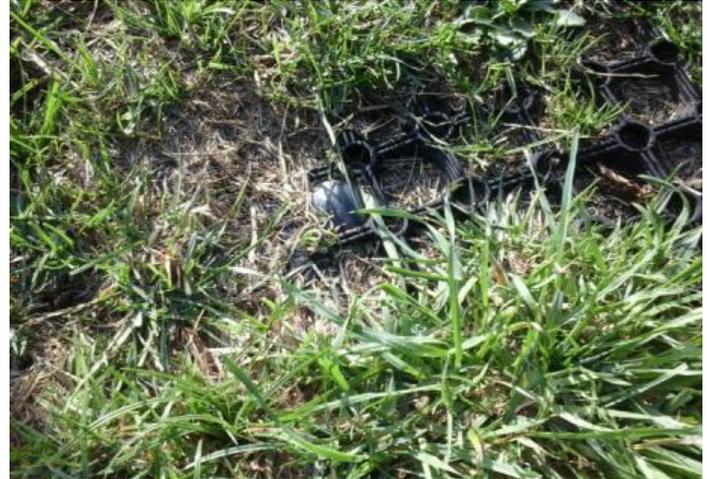
**Finding:** Fixing Pins have been installed in the impact areas of the grass mats

**Action:** Remove pins from impact areas

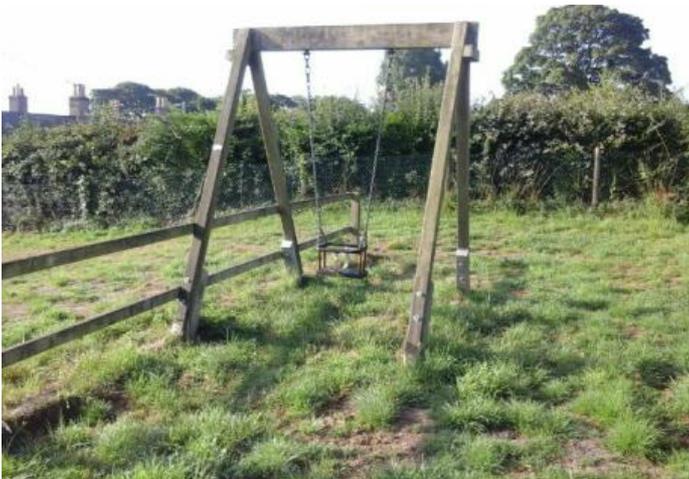
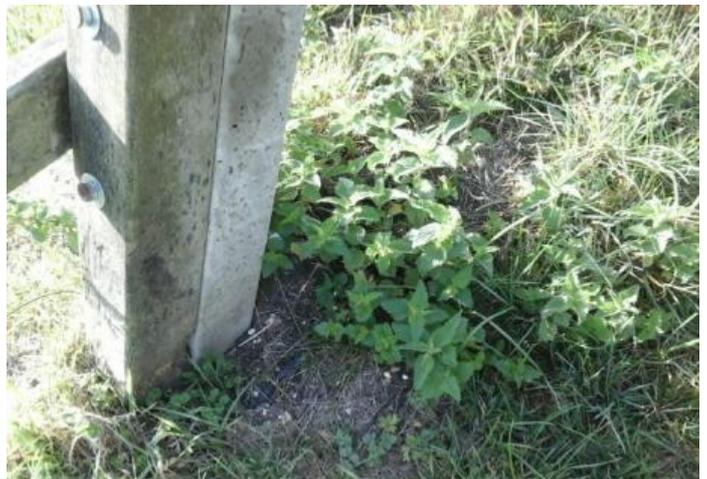
**Finding:** There are stinging nettles beneath the item

**Action:** Remove

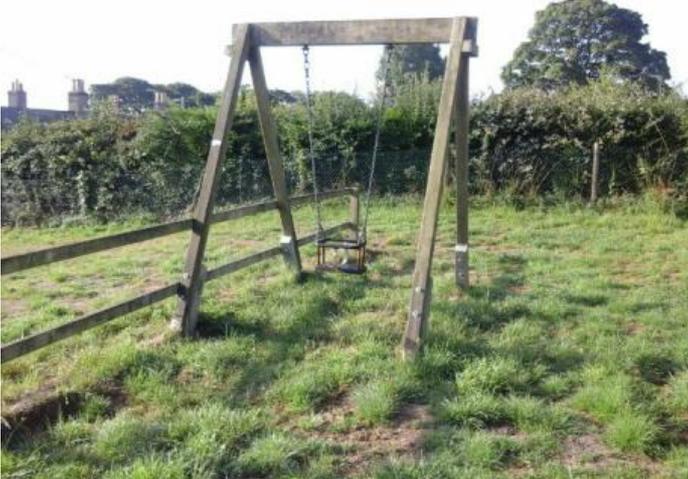
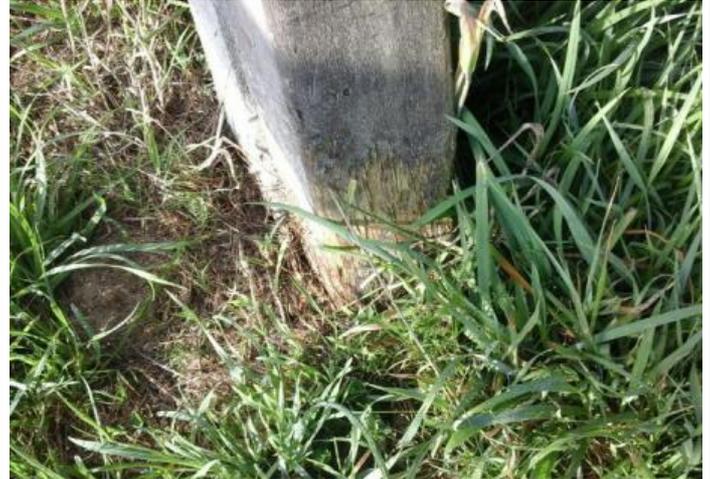
**Finding:** There is some strimmer / machinery damage apparent on the posts, this can penetrate the preservative applied to the timber and accelerate the rotting process

**Action:** Monitor for any deterioration (rot) and replace as required

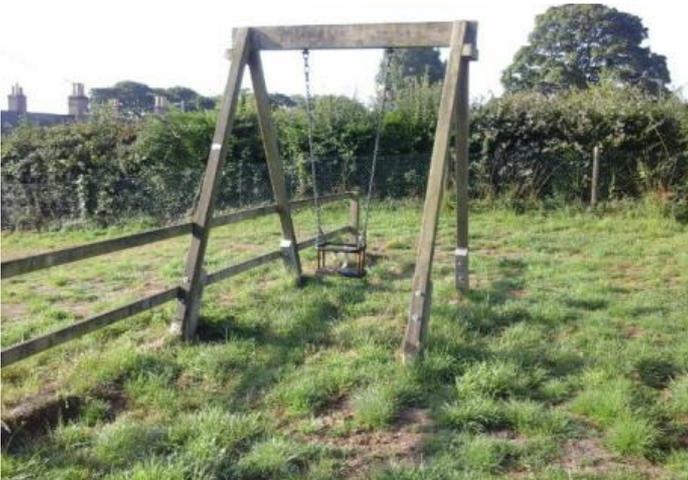
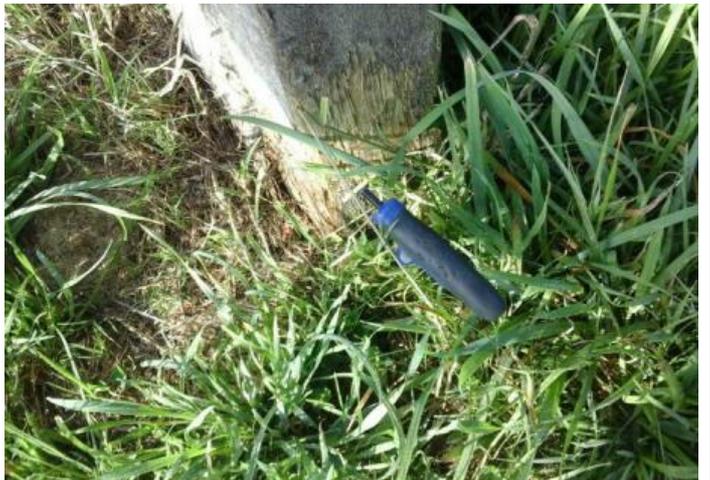
**Finding:** There is some evidence of rot in the timber

**Action:** Monitor for any further deterioration and replace as required

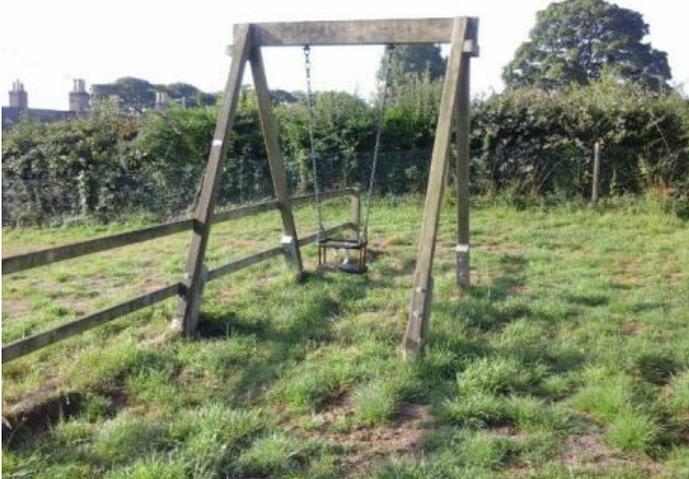
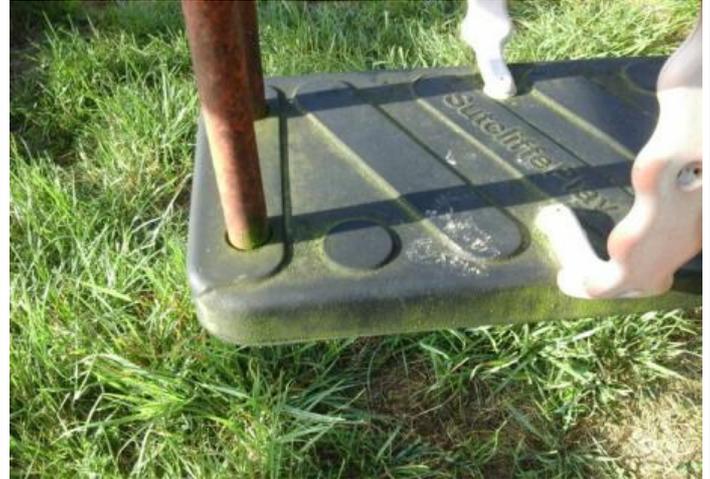
**Finding:** There is algae or moss on the surface of the equipment

**Action:** Clean and treat appropriately

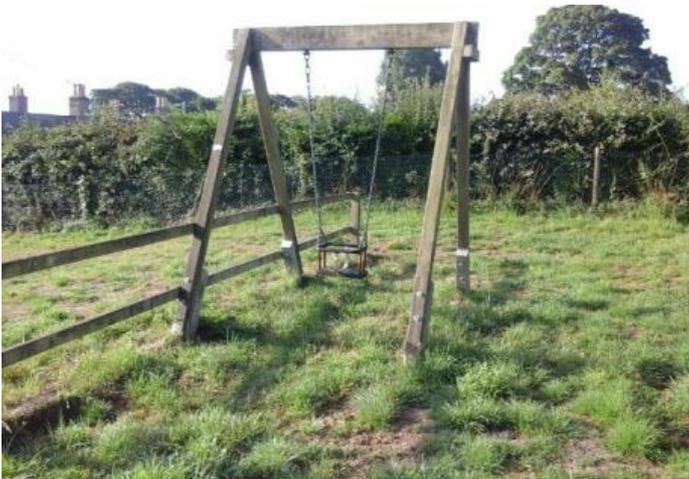
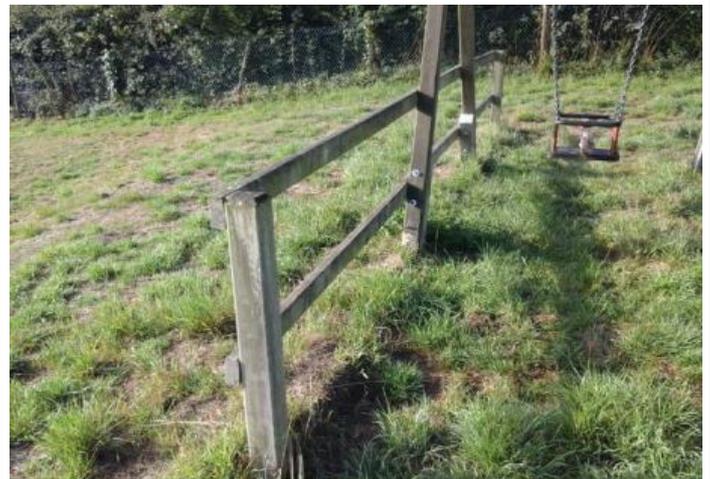
**Finding:** The posts on the swing barrier are slightly loose in the ground

**Action:** Monitor for any further deterioration and repair as required

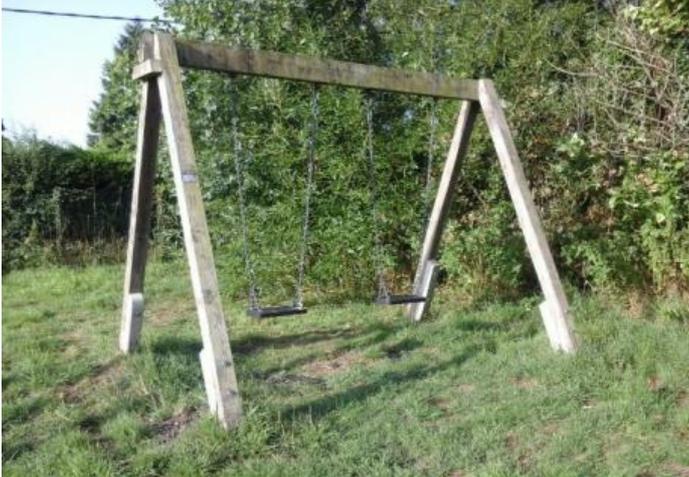
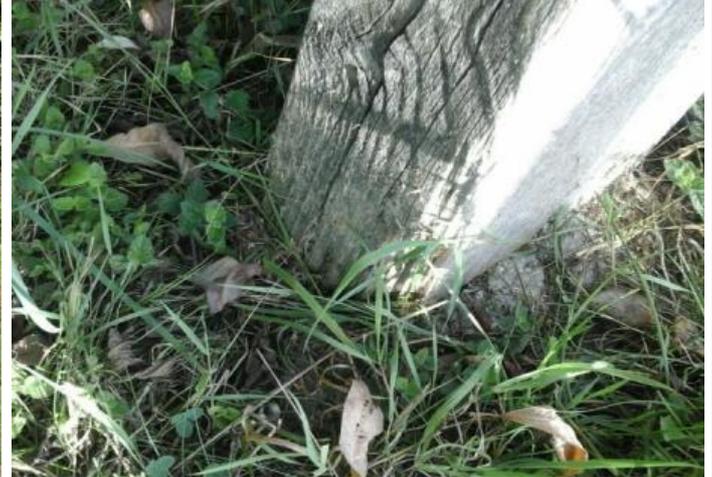
**Finding:** There is some strimmer / machinery damage apparent on the posts, this can penetrate the preservative applied to the timber and accelerate the rotting process

**Action:** Monitor for any deterioration (rot) and replace as required

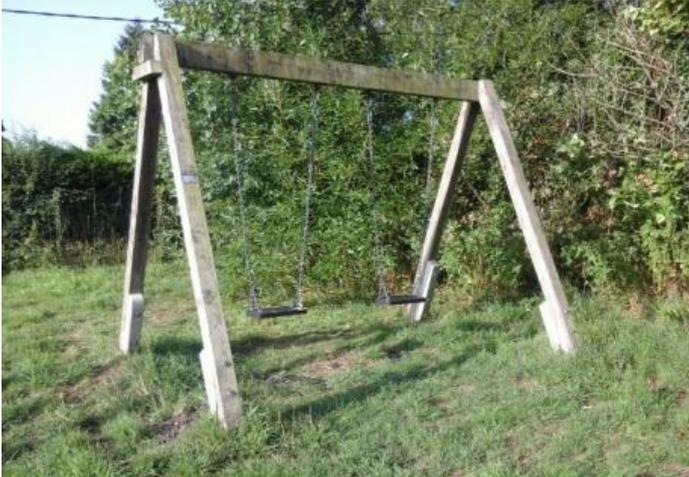
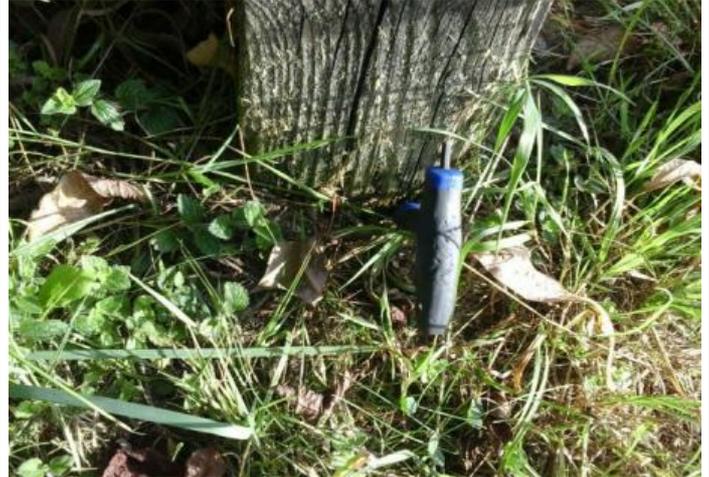
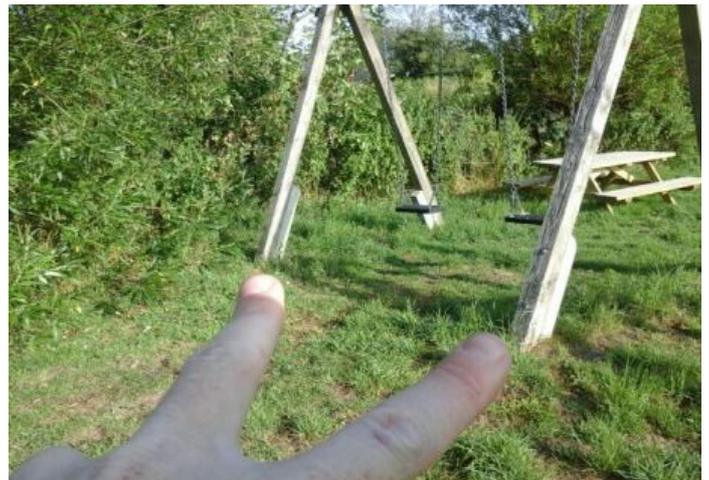
**Finding:** There are areas or parts of the timber on the structure that have rotted ( 2 of 4 posts )

**Action:** Replace all affected timbers

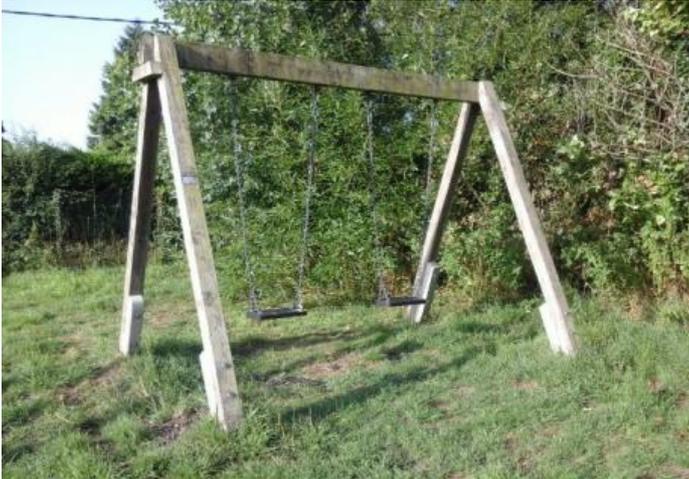
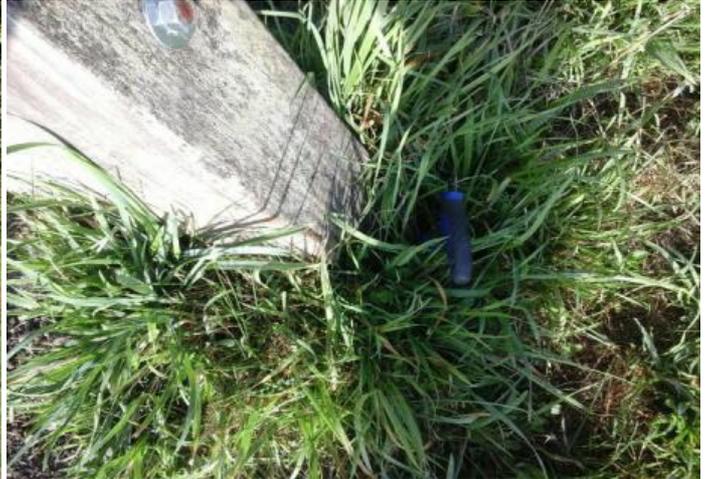
**Finding:** There is some evidence of rot in the timber

**Action:** Monitor for any further deterioration and replace as required

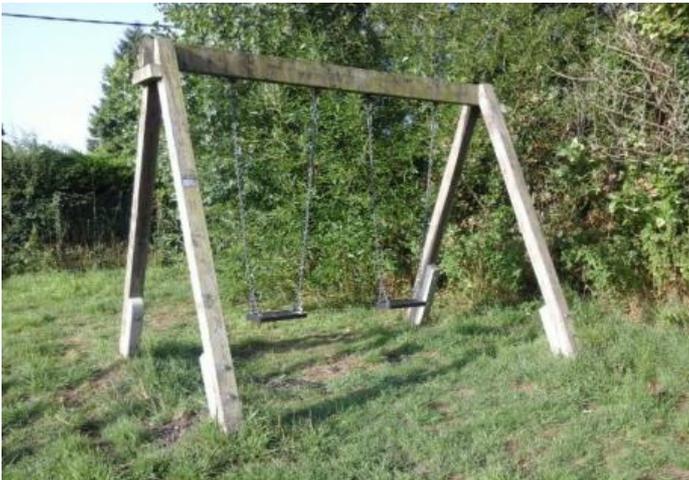
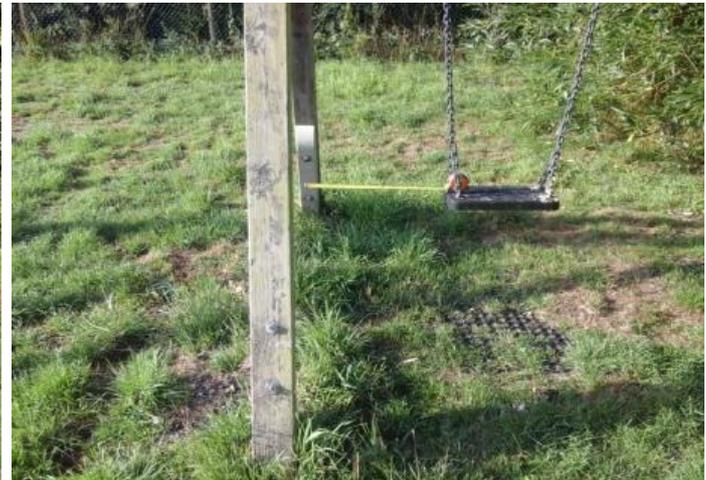
**Finding:** The seats are too close to the frame as defined in BS EN 1176 Part 2; this is a low risk failure and no remedial action is required

**Action:** Monitor use

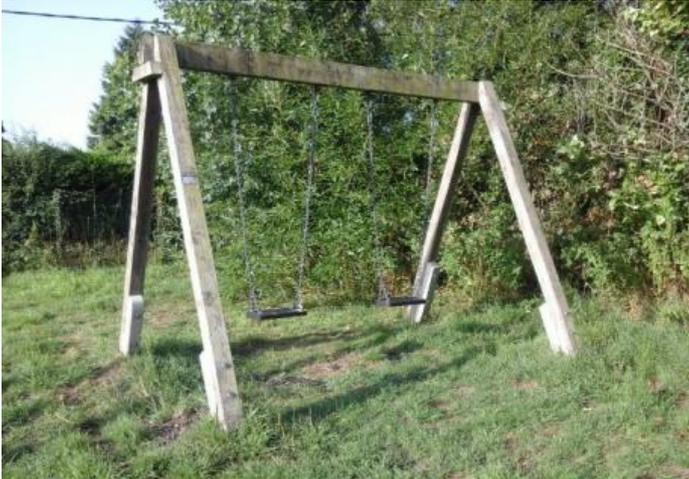
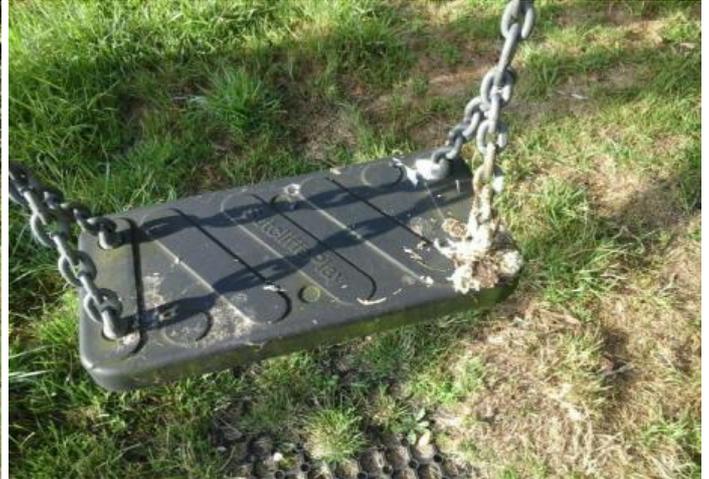
**Finding:** There is excrement on the equipment

**Action:** Clean and maintain

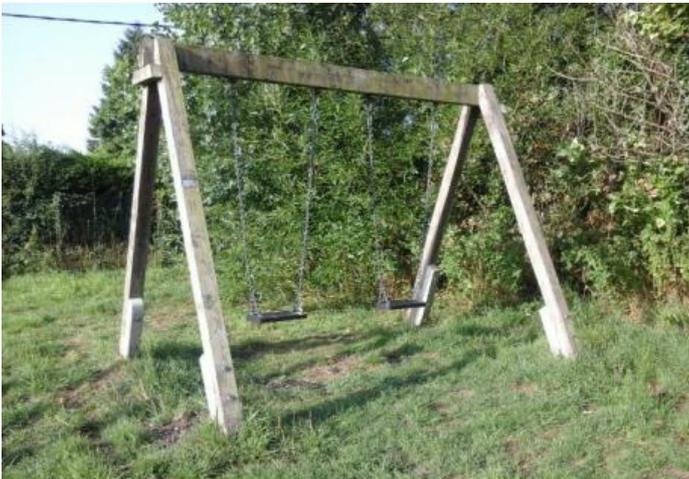
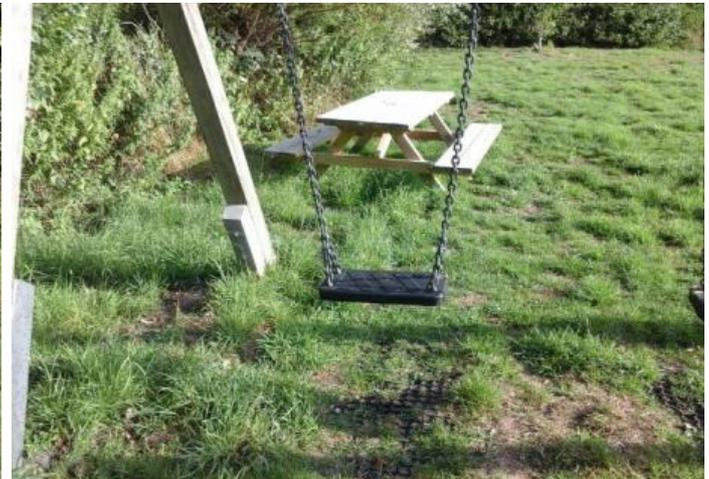
**Finding:** The picnic table forms a hard object within the falling space of the equipment in contravention of the requirements of BS EN 1176 Part 1

**Action:** Re - locate the picnic table

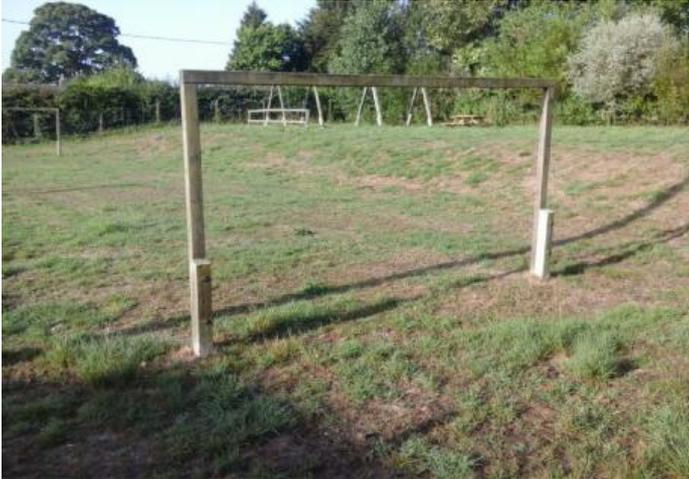
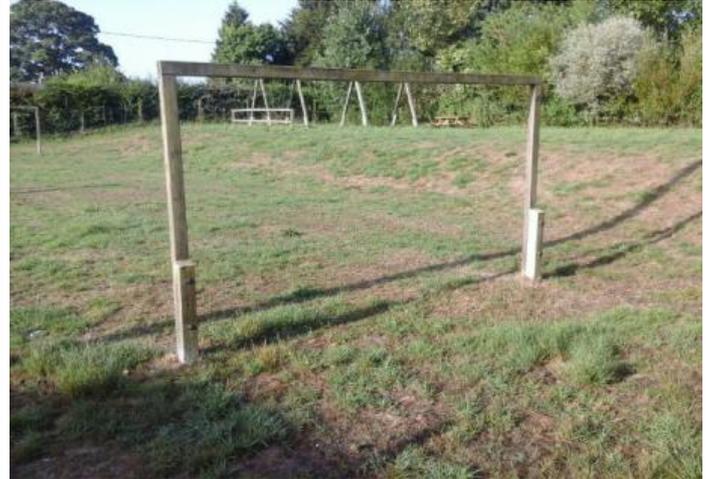
**Finding:** NB: We have undertaken a maintenance inspection only of the football goal(s); full load testing fall outside the scope of our inspection.

**Action:** Implement load testing as required

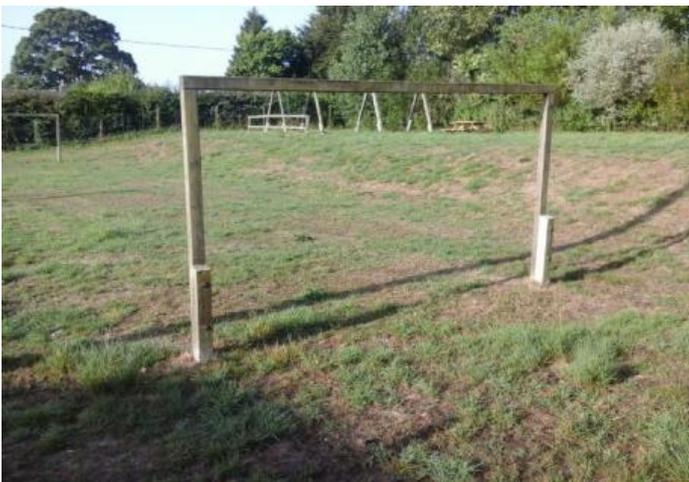
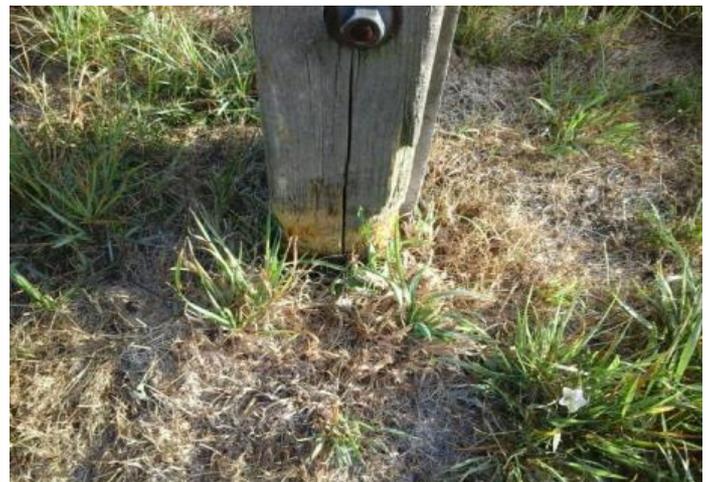
**Finding:** There is some strimmer / machinery damage apparent on the posts, this can penetrate the preservative applied to the timber and accelerate the rotting process

**Action:** Monitor for any deterioration (rot) and replace as required

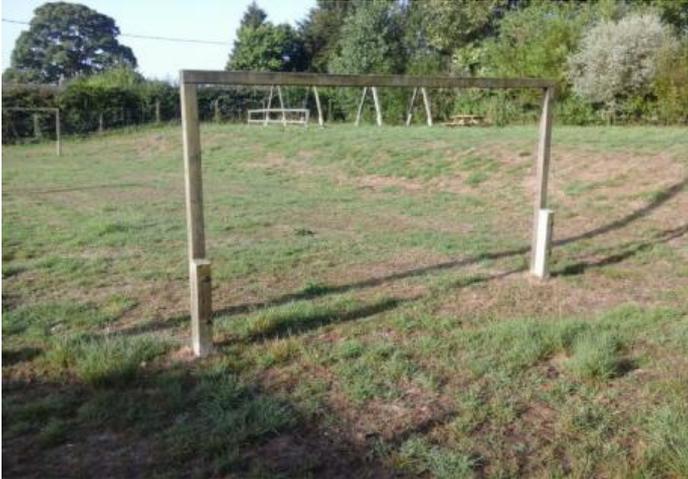
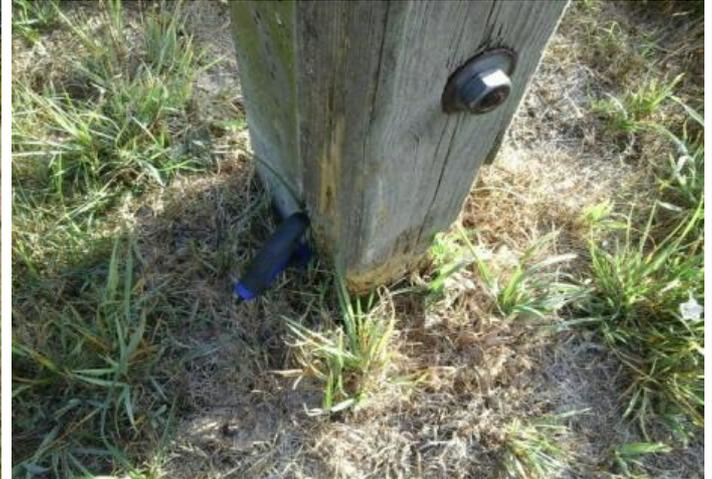
**Finding:** There are areas or parts of the timber on the structure that have rotted

**Action:** Replace all affected timbers
