Operational Inspection

Thornhackett Parish Council

Thornford Play Area

adj The Village Hall, Blacksmiths Lane, Thornford,
Dorset, DT9 6PH

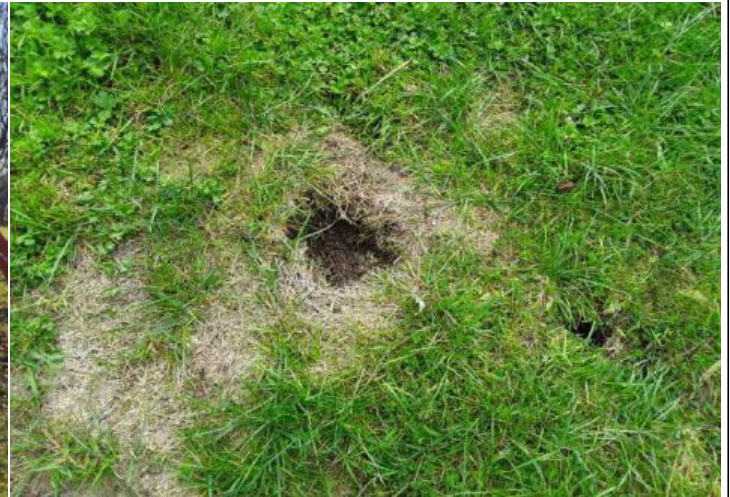
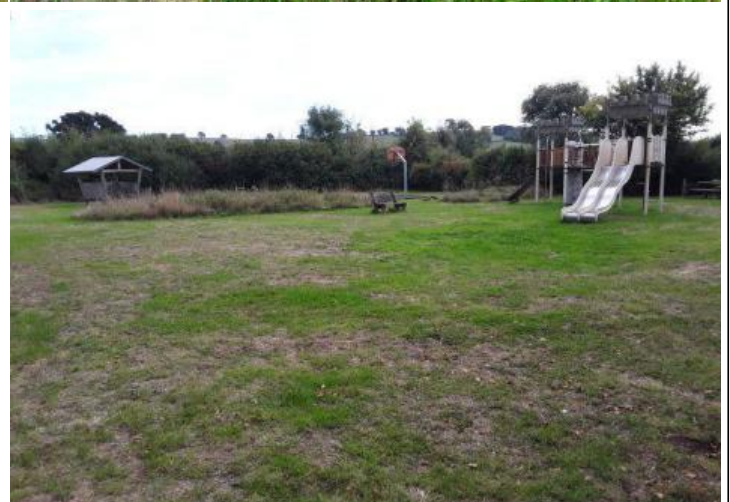
Finding: There are trip hazards present due to ground erosion

Action: Reinststate surrounding surfaces to level to remove the trip points

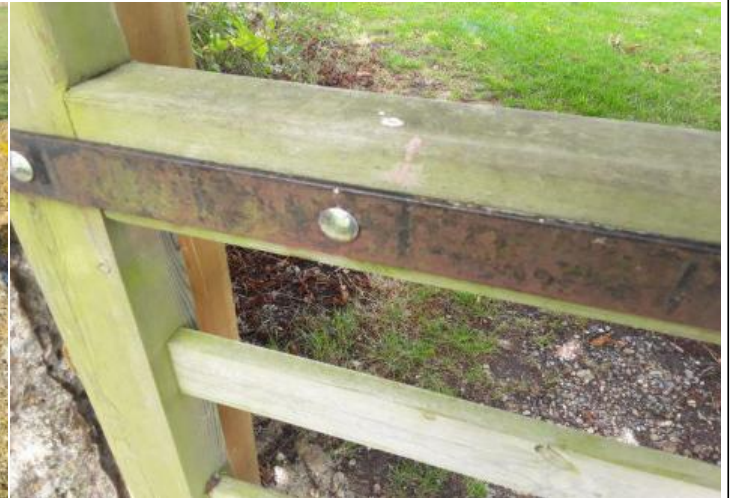
Finding: There is surface corrosion present on the item

Action: Consider treating the item

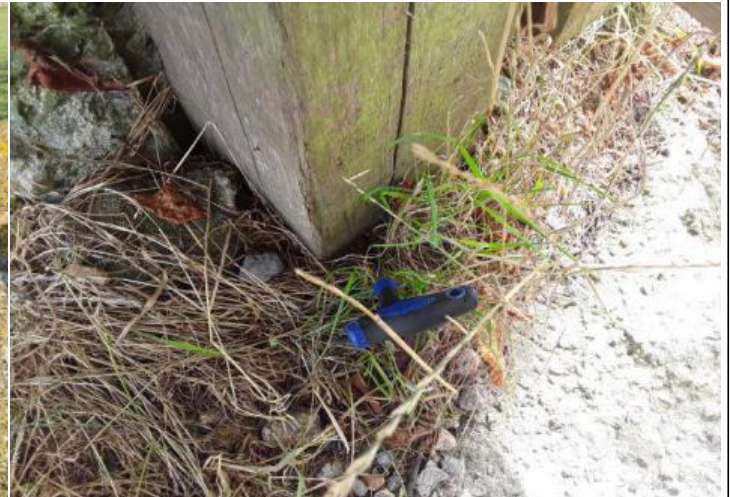
Finding: There is some evidence of rot in the timber

Action: Monitor for any further deterioration and replace as required

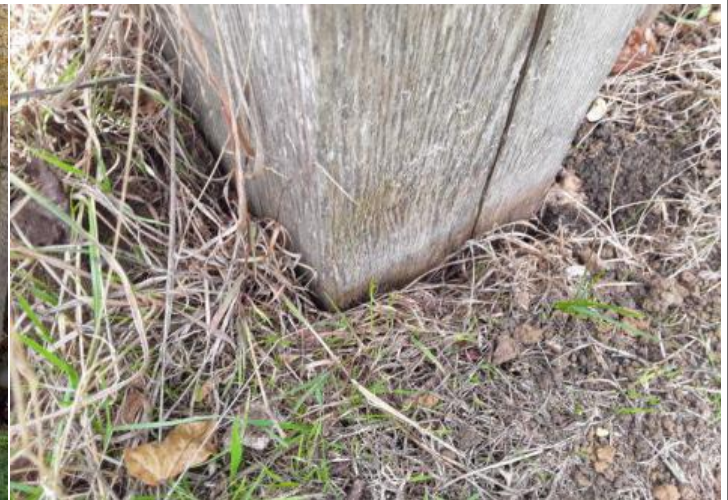
Finding: There is some strimmer / machinery damage apparent on the posts, this can penetrate the preservative applied to the timber and accelerate the rotting process
Action: Monitor for any deterioration (rot) and replace as required

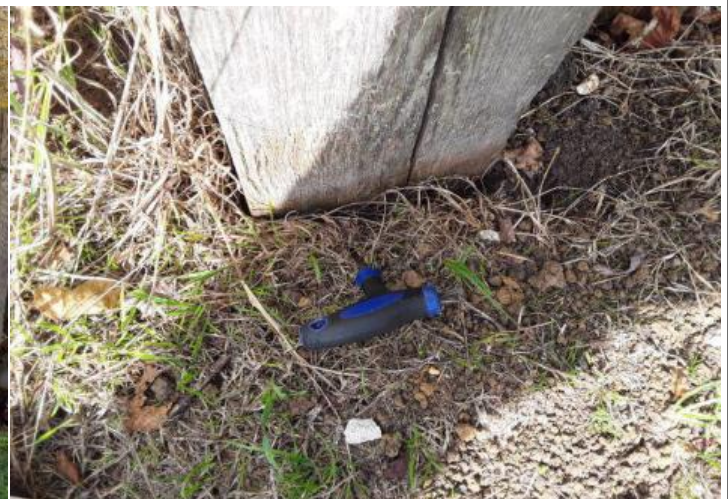
Finding: There is some evidence of rot in the timber
Action: Monitor for any further deterioration and replace as required

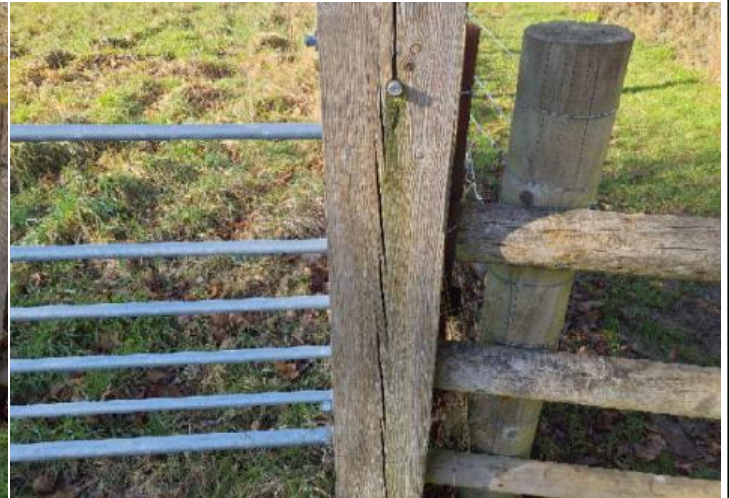
Finding: The timber has a number of splits/shakes or air cracks and this may affect the stability or allow water ingress which will accelerate the rotting process
Action: Monitor to ensure the splits do not cross through fixing points of the structure and/or cause any instability

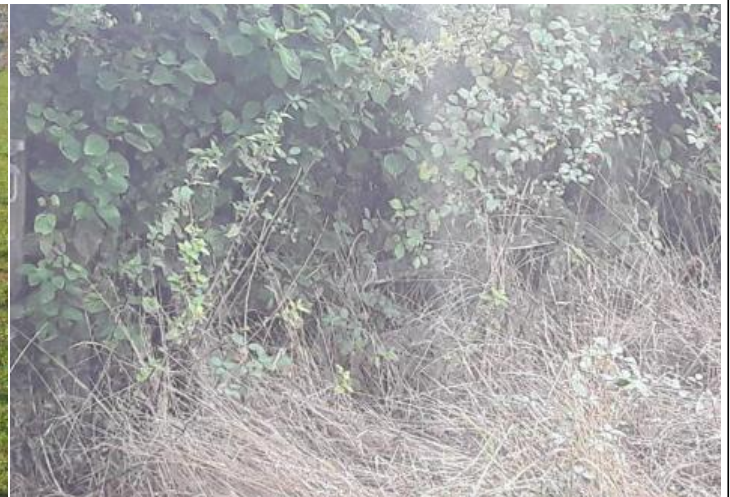
Finding: There are areas or parts of the timber on the structure that have rotted
Action: Replace all affected timbers

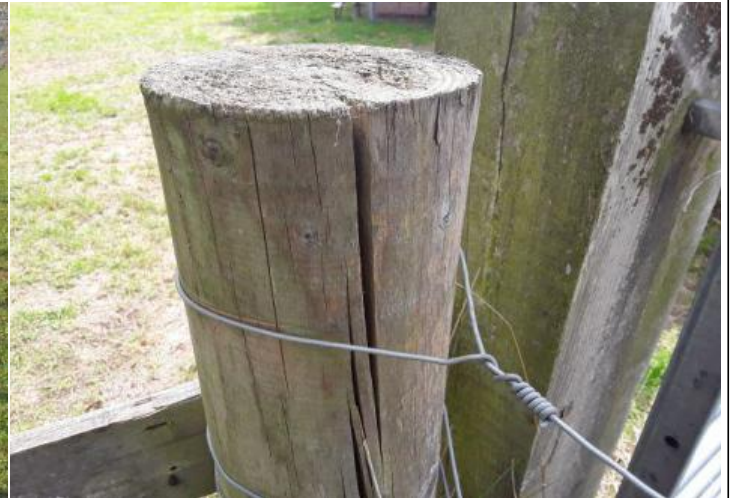
Finding: The timber has a number of splits/shakes or air cracks and this may affect the stability or allow water ingress which will accelerate the rotting process
Action: Monitor to ensure the splits do not cross through fixing points of the structure and/or cause any instability

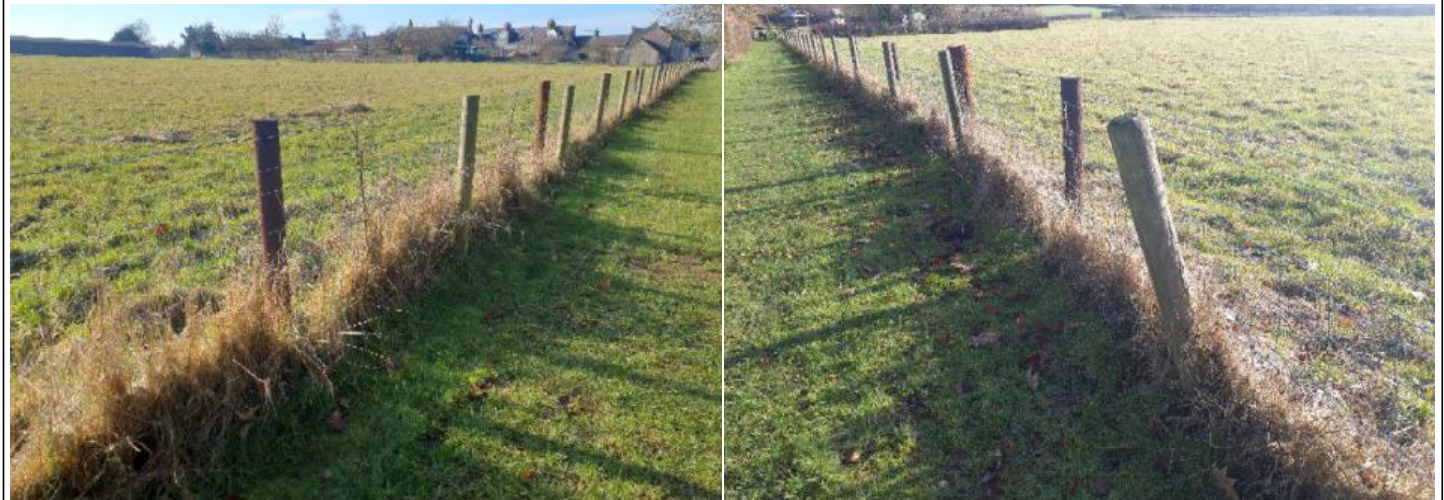
Finding: There are a number of loose posts around the fence	Action: Monitor for any further deterioration and reset as required
--	--

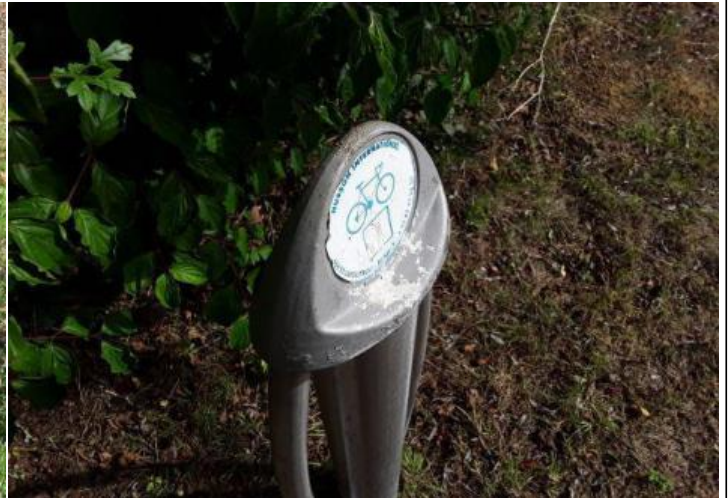
Finding: There is some minor damage to the item

Action: Monitor for any further deterioration and remove any rough or sharp edges

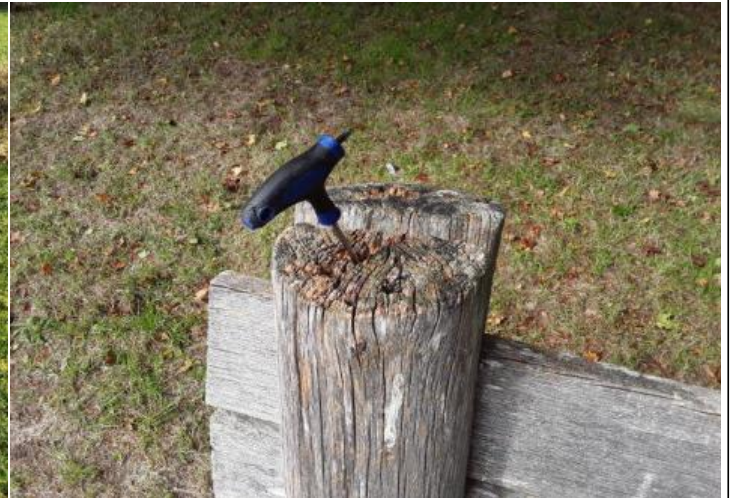
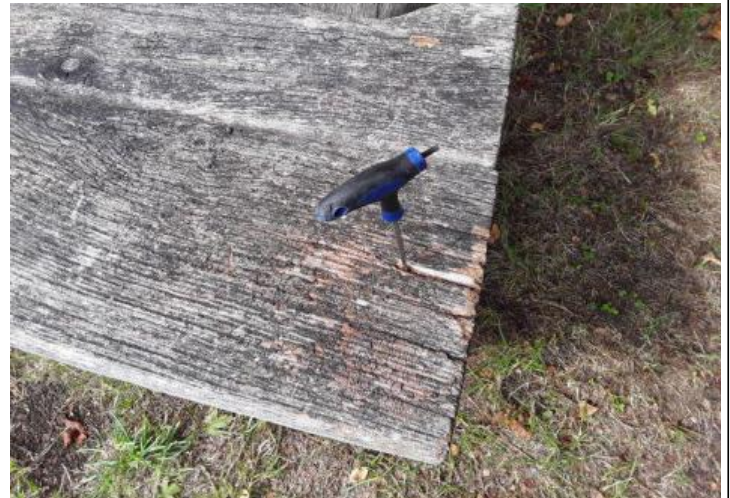
Finding: There is some evidence of rot in the timber

Action: Monitor for any further deterioration and replace as required

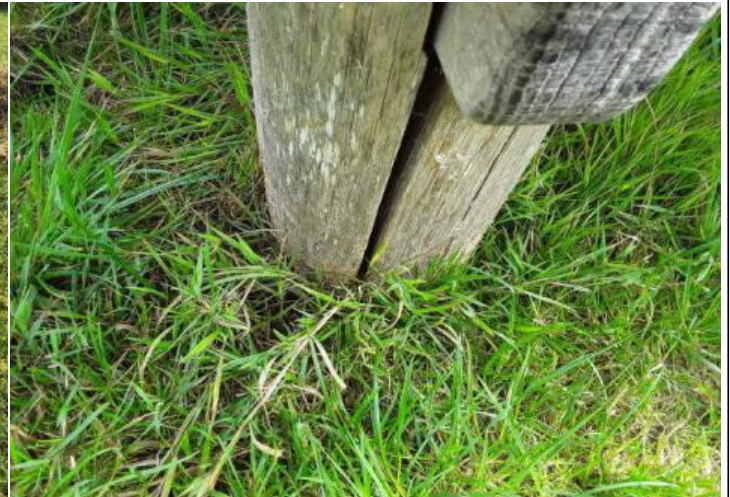
Finding: The timber has a number of splits/shakes or air cracks and this may affect the stability or allow water ingress which will accelerate the rotting process

Action: Monitor to ensure the splits do not cross through fixing points of the structure and/or cause any instability

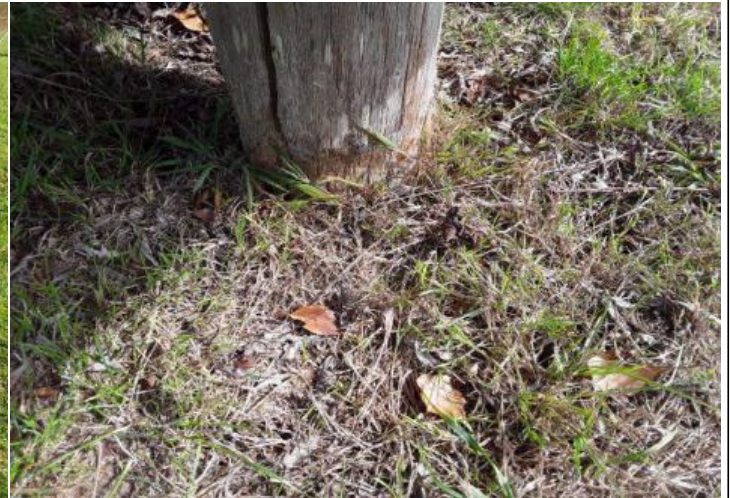
Finding: There is some strimmer / machinery damage apparent on the posts, this can penetrate the preservative applied to the timber and accelerate the rotting process

Action: Monitor for any deterioration (rot) and replace as required

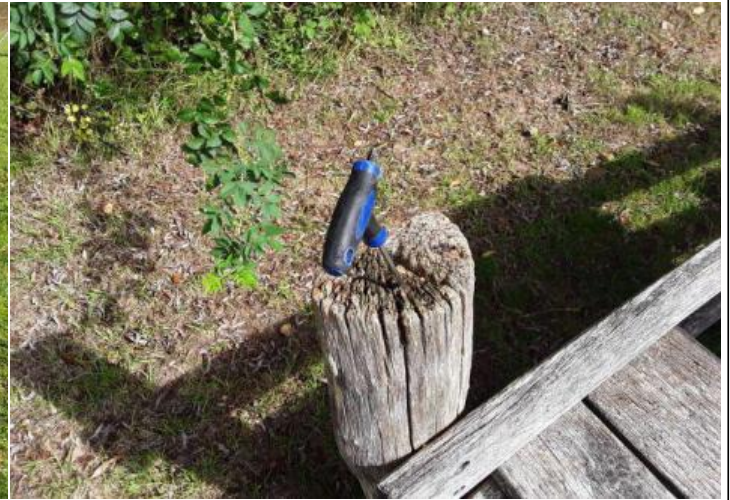
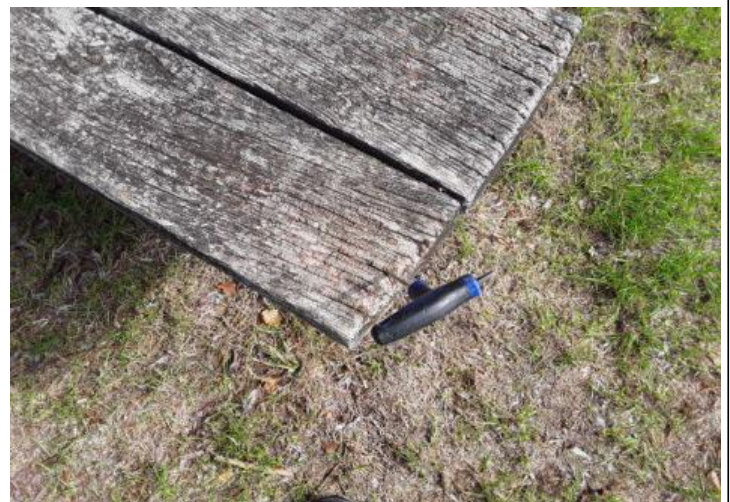
Finding: There is some evidence of rot in the timber

Action: Monitor for any further deterioration and replace as required

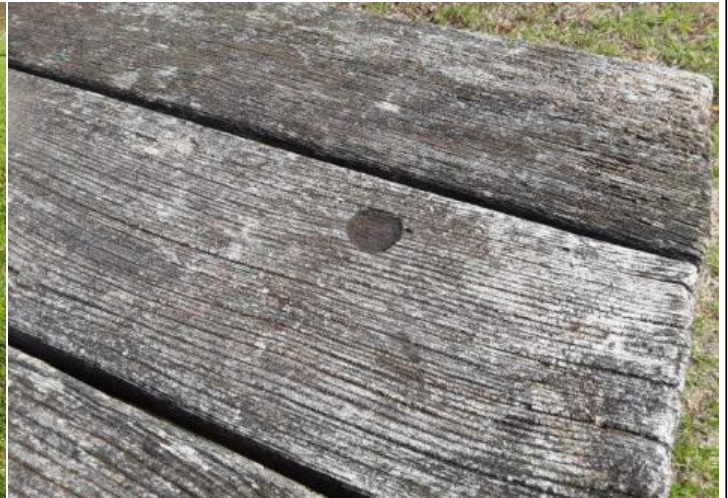
Finding: There is some evidence of fire damage to the item **Action:** Monitor for any further deterioration and repair as required

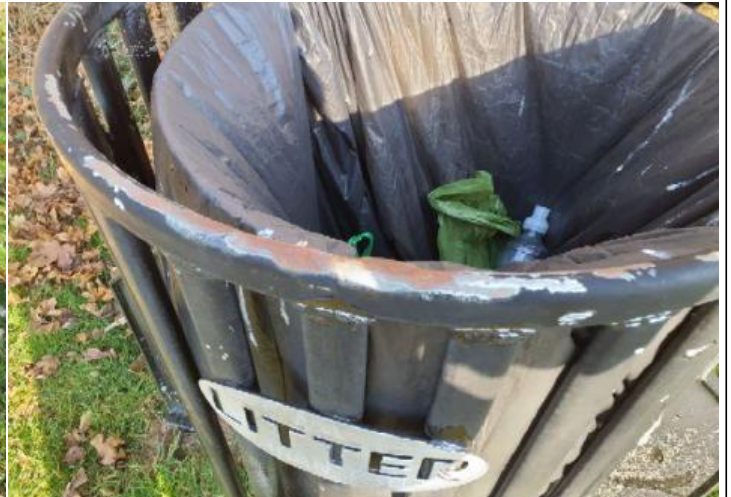
Finding: The paintwork on this item has been damaged or worn exposing the metal underneath which is rusting

Action: Treat any rusting components and repaint

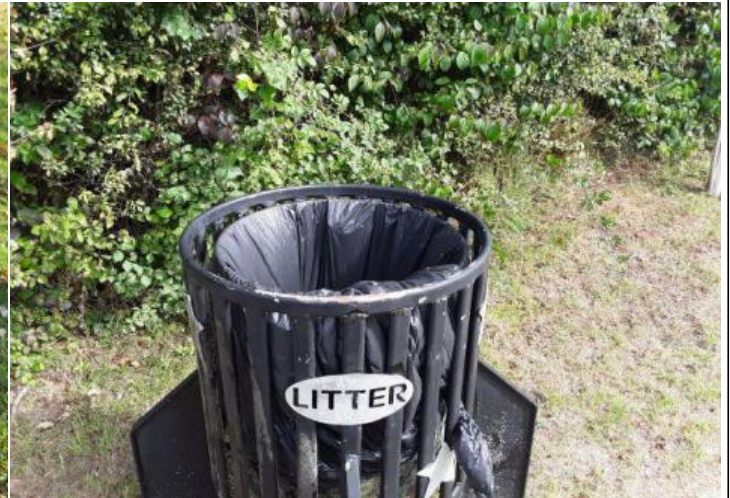
Finding: The bin lid is missing

Action: Replace

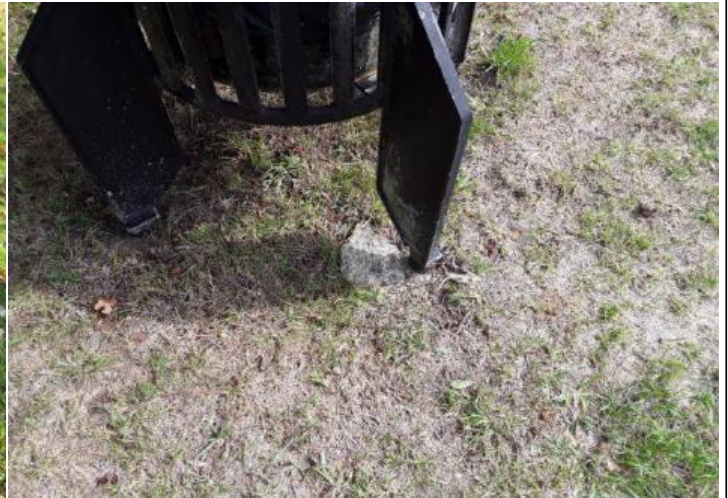
Finding: The surface has eroded and the foundations are exposed

Action: Reinstate surrounding surfaces to cover the foundations

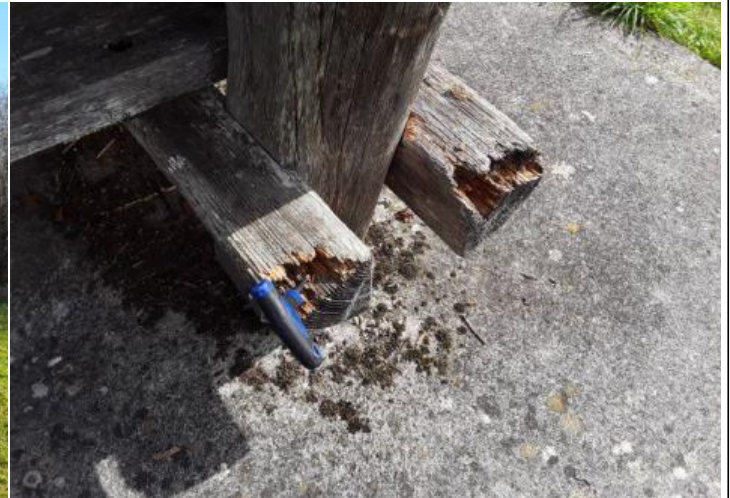
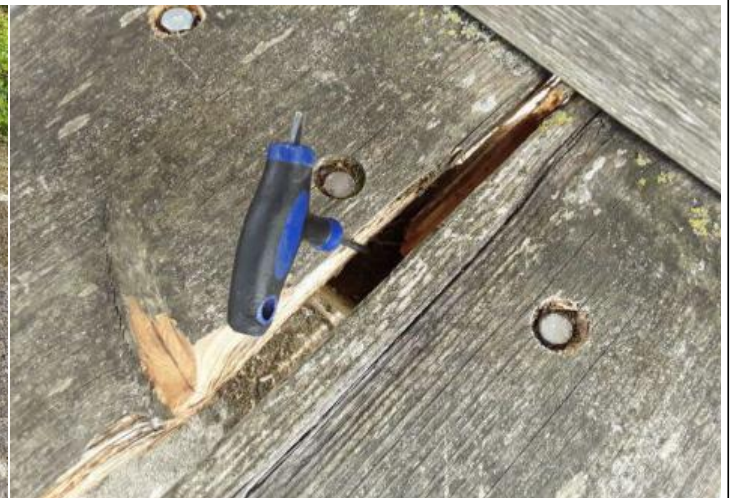
Finding: There are areas or parts of the timber on the structure that have rotted

Action: Replace all affected timbers

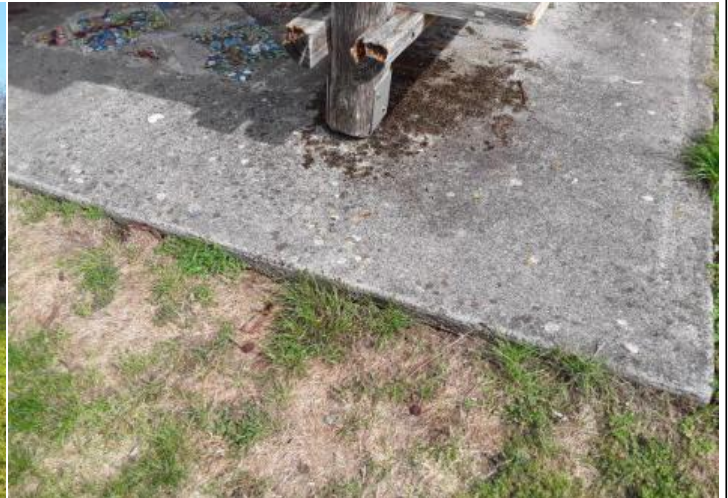
Finding: There are trip hazards at the edges of the concrete pad
Action: Reinstate surrounding surface levels to remove the trip points

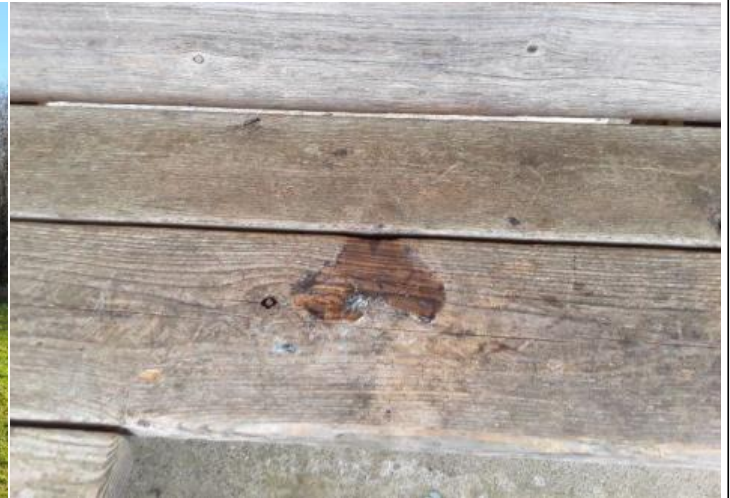
Finding: There is fire damage to the item

Action: Monitor for any further deterioration and repair as required

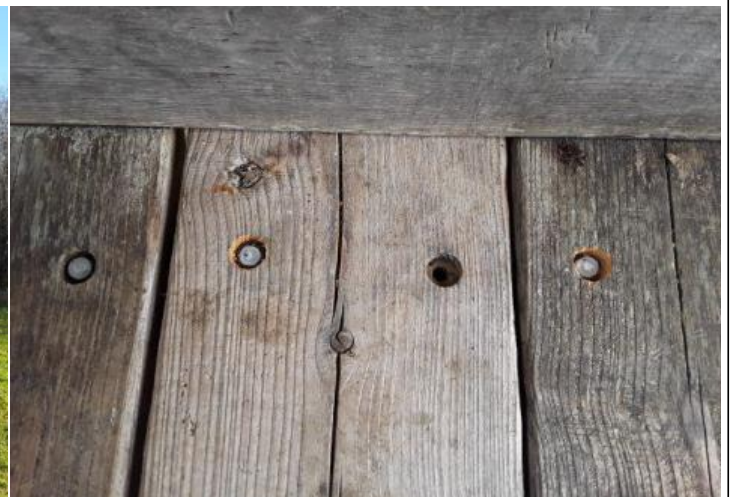
Finding: There is or are fixings missing on the item

Action: Replace all missing fixings

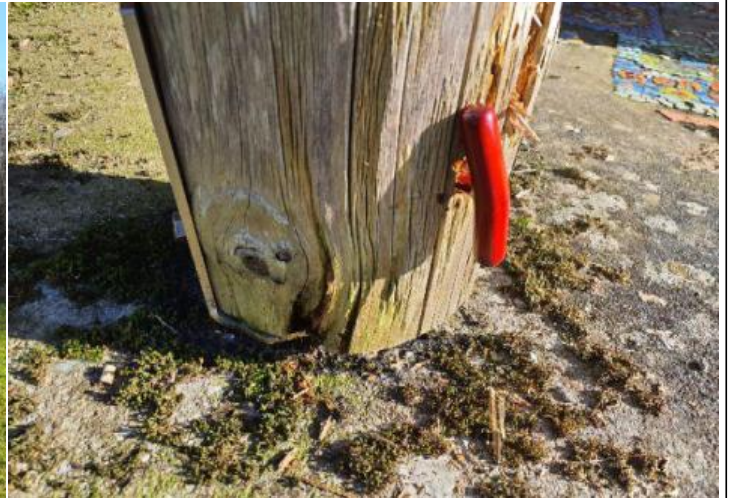
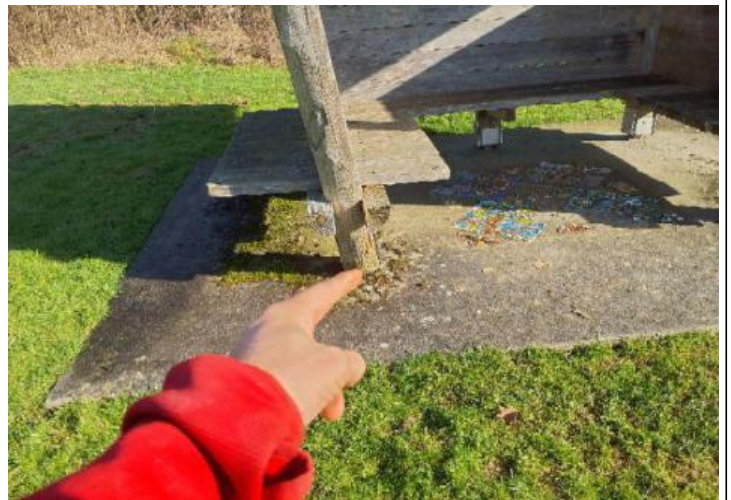
Finding: There are areas or parts of the timber on the structure that have rotted

Action: Replace all affected timbers

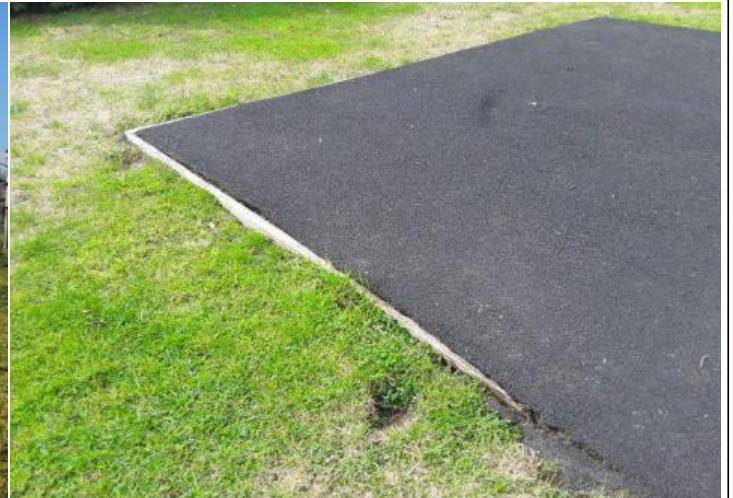
Finding: There are trip hazards at the edges of the wet pour surfacing
Action: Reinstate surrounding surface levels to remove the trip points

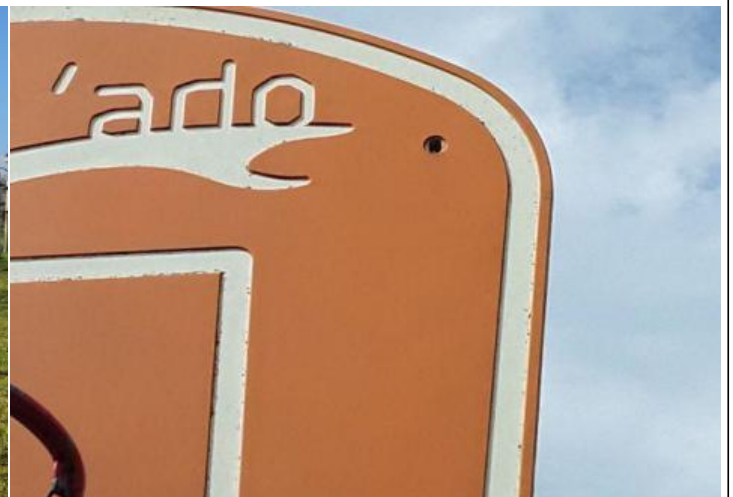
Finding: There is or are fixings missing on the backboard
Action: Replace all missing fixings

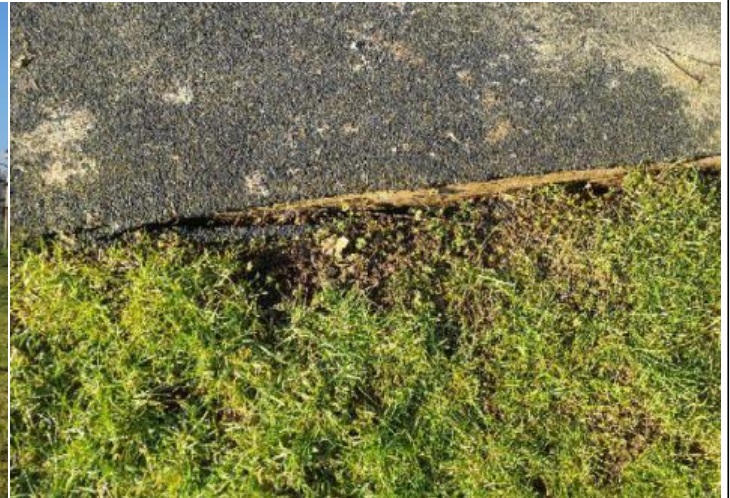
Finding: There are significant gaps (over 30mm) between the surface and the edging or between the joints in the surface; these are large enough for a small foot to enter

Action: Repair surfacing

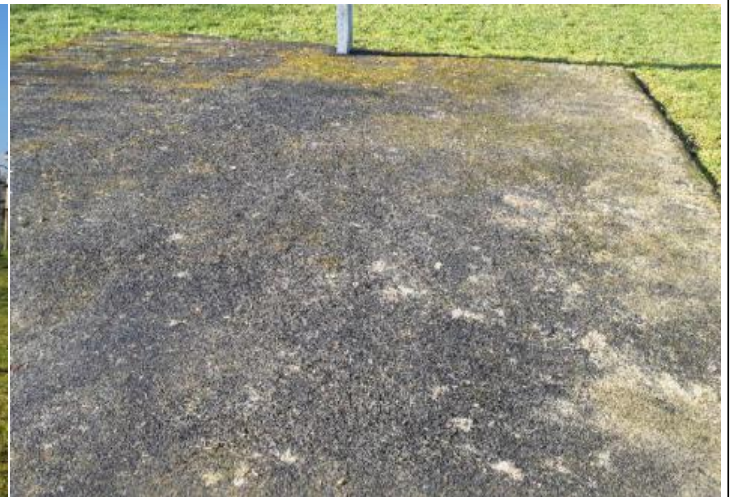
Finding: There is algae or moss growth on the surface resulting in slippery conditions

Action: Clean and treat appropriately

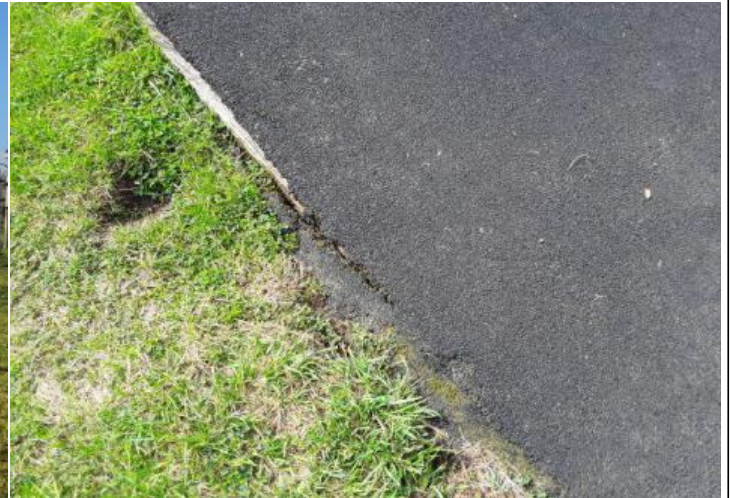
Finding: The safety surface under or around this unit has been damaged

Action: Monitor for any further deterioration and repair as required

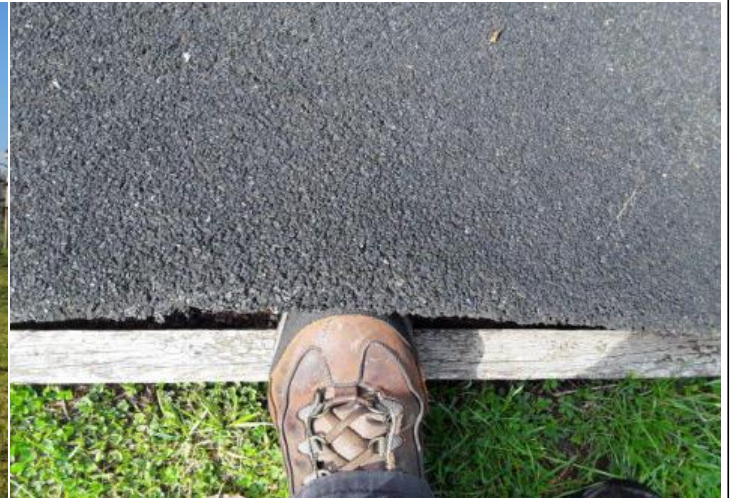
Finding: The surface is lifting at the edges and creating trip points

Action: Repair perimeter of surfacing to remove trip points

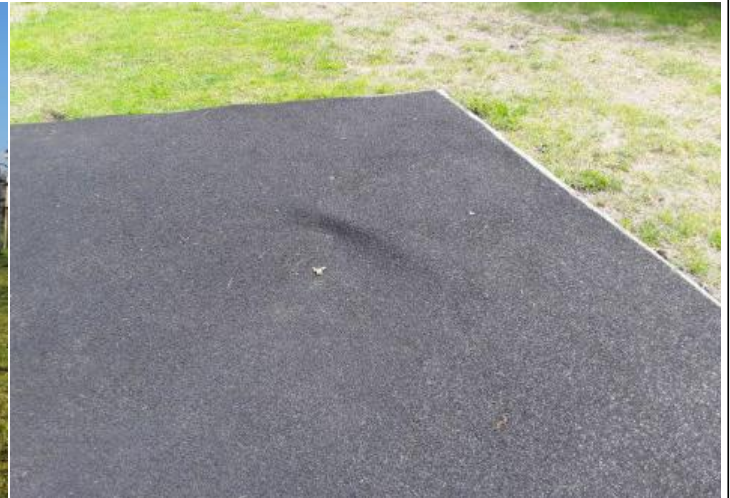
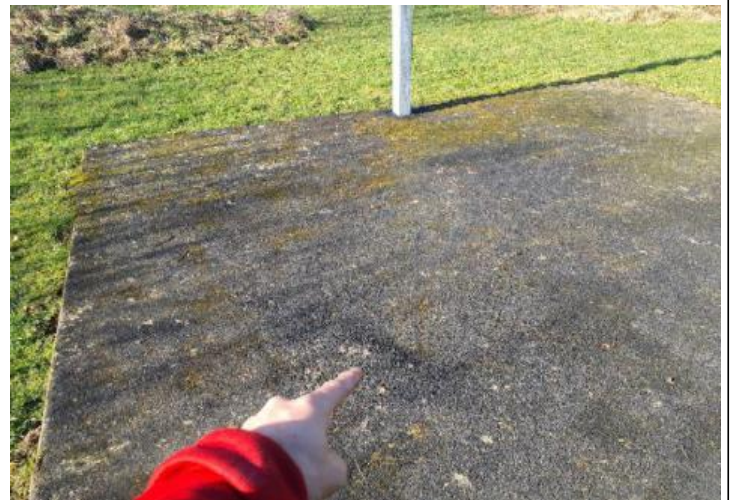
Finding: The surface is rippling

Action: Repair surfacing

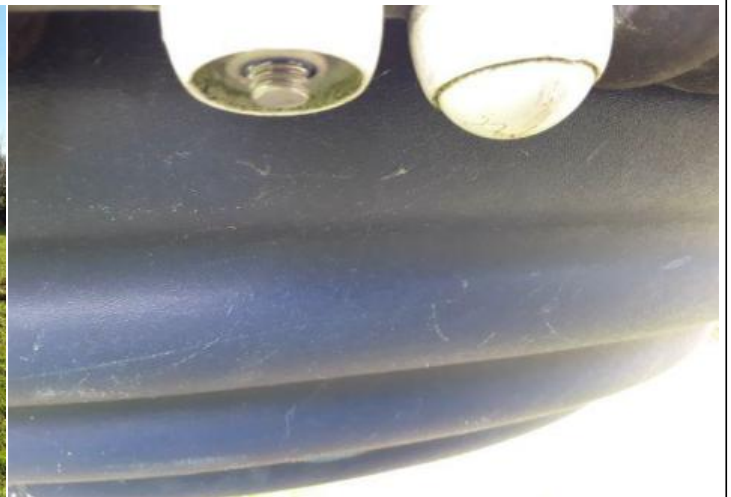
Finding: There is/are bolt cap covers missing or damaged on the item

Action: Replace missing or damaged bolt cap covers

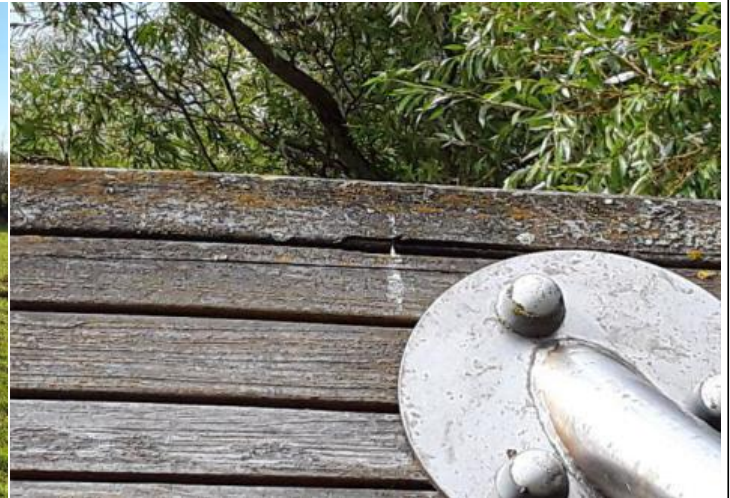
Finding: There is some evidence of rot in the crossbeam
Action: Monitor for any further deterioration and replace as required

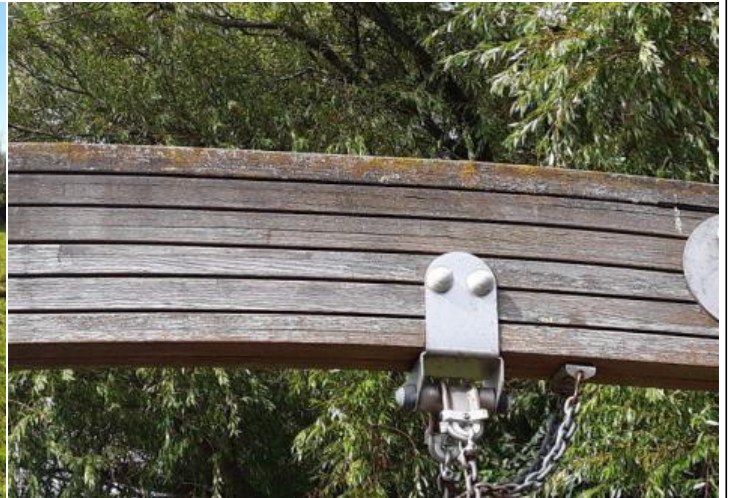
Finding: There is algae or moss on the surface of the equipment that can lead to the onset of rot

Action: Monitor condition of the timbers (rot), clean and treat appropriately

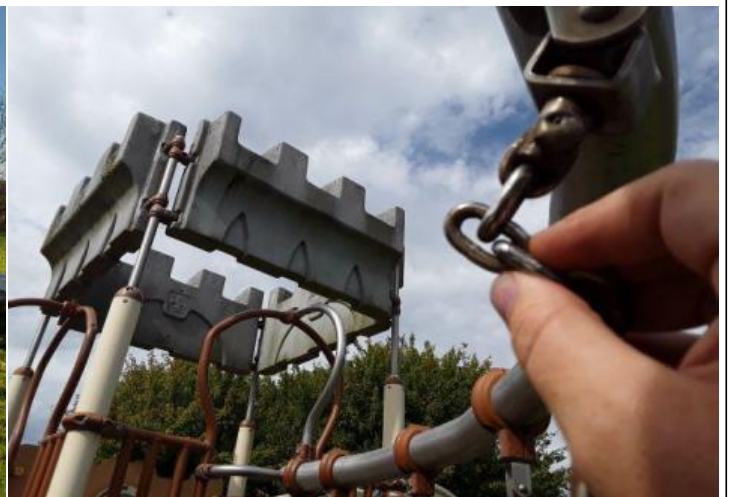
Finding: There is some notable evidence of chain wear

Action: Monitor for any further deterioration and replace when 40% worn

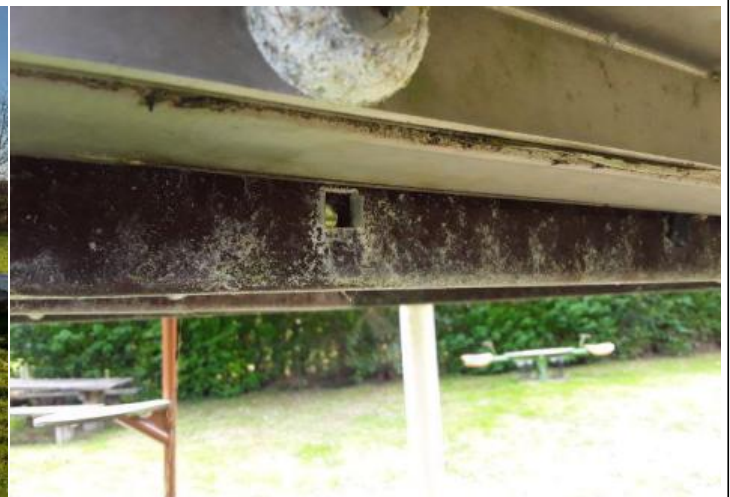
Finding: There is/are several inserts missing

Action: Replace missing inserts

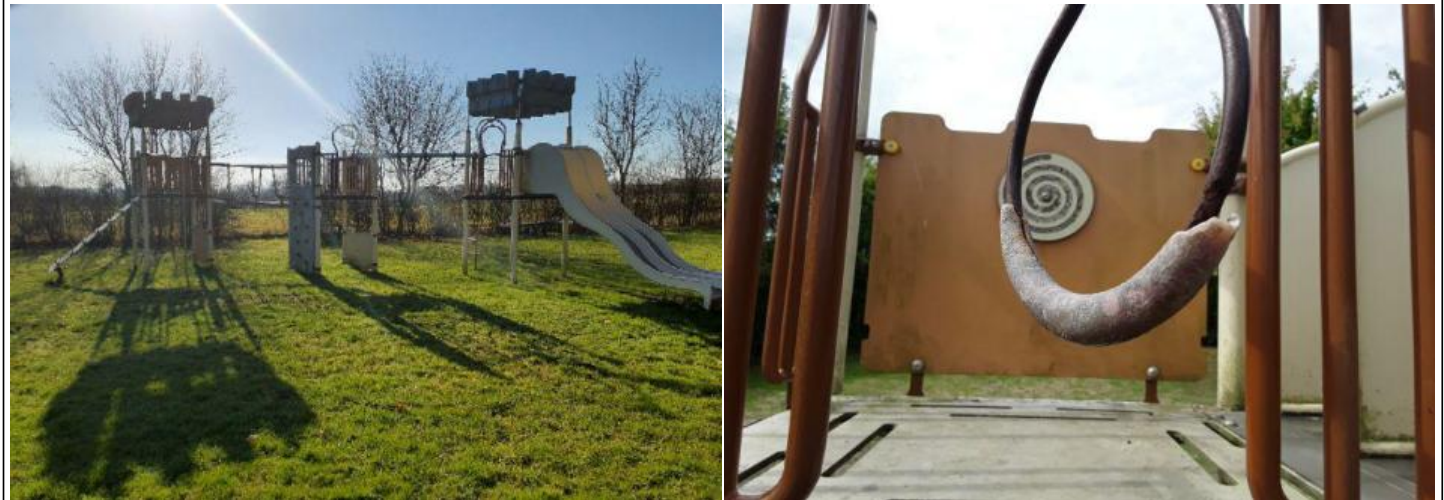
Finding: There is some minor damage to the handgrips
Action: Monitor for any further deterioration and repair as required

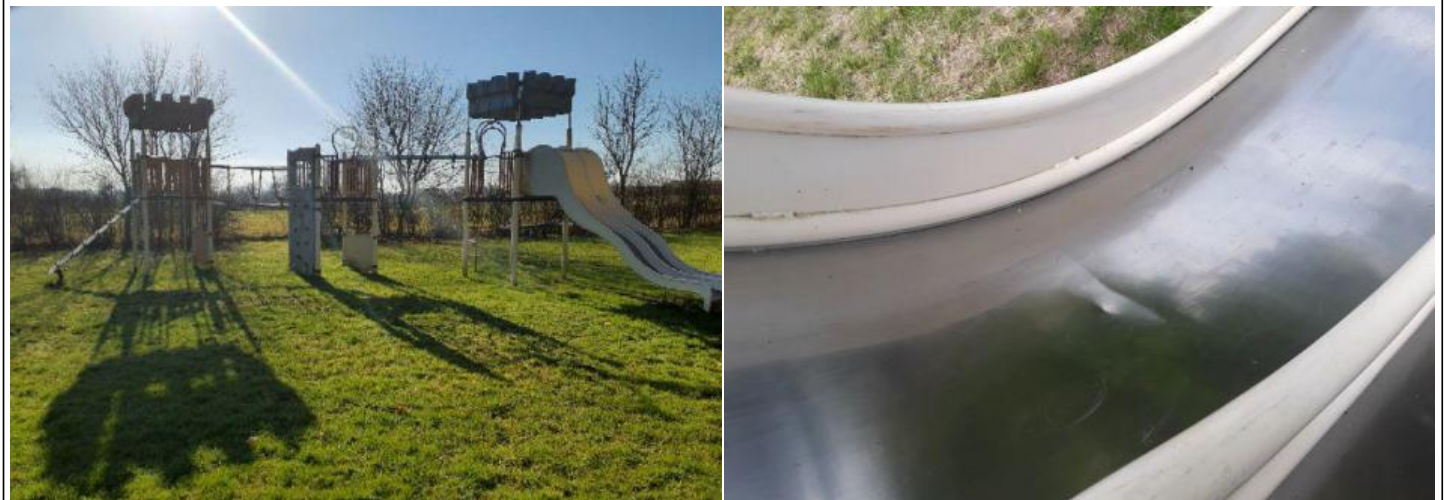
Finding: There are a number of dents in the slide surface
Action: Monitor for any further deterioration and repair as required

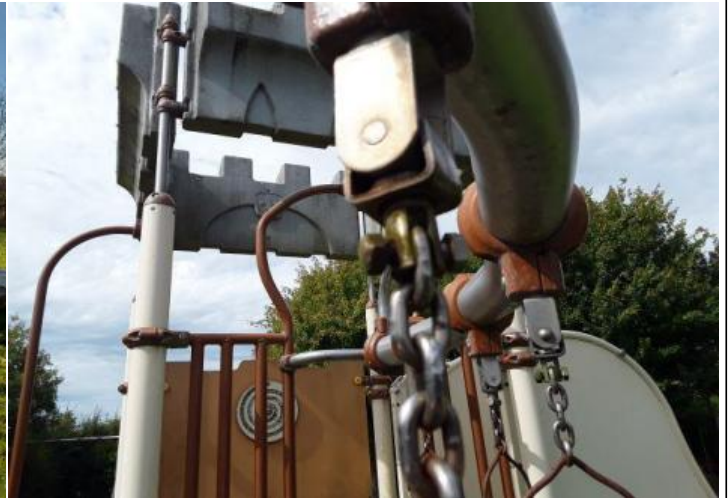
Finding: A number of handgrip fixing(s) appear to have worked loose - but have been welded

Action: No further action required

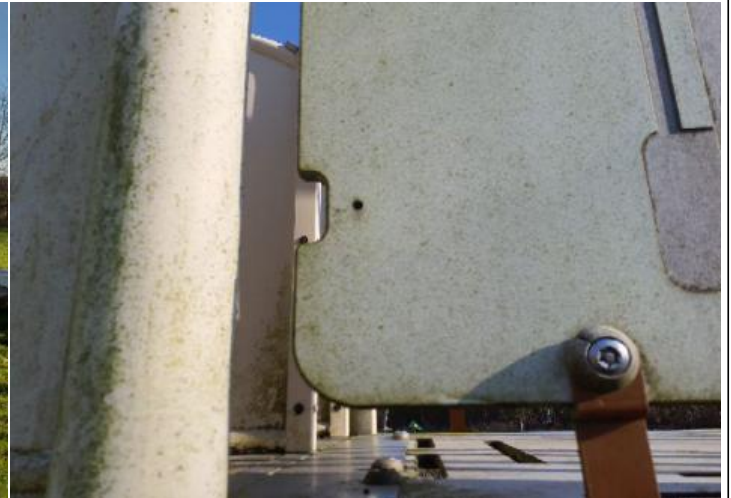
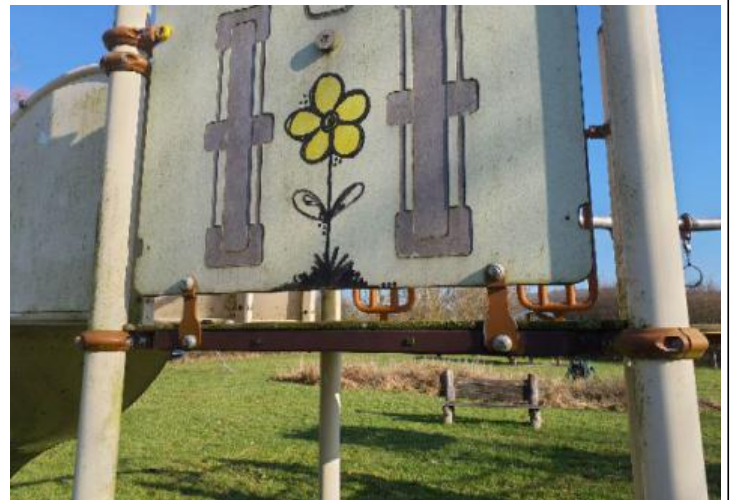
Finding: There is or are unused fixing points on the item

Action: Refer to manufacturer and replace all missing fixings

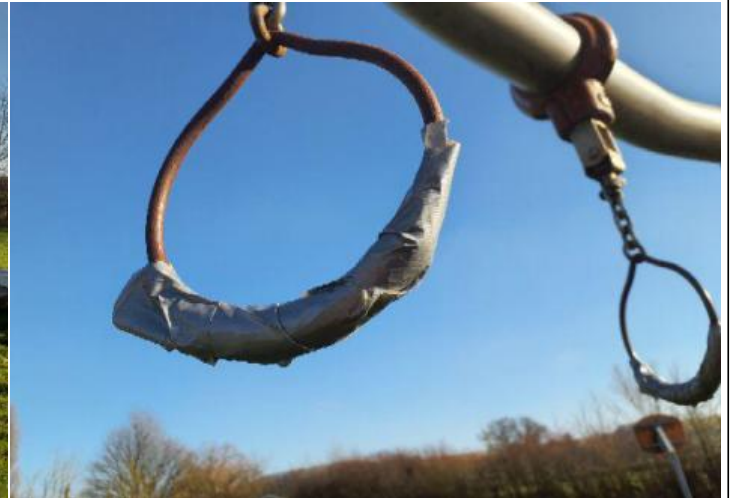
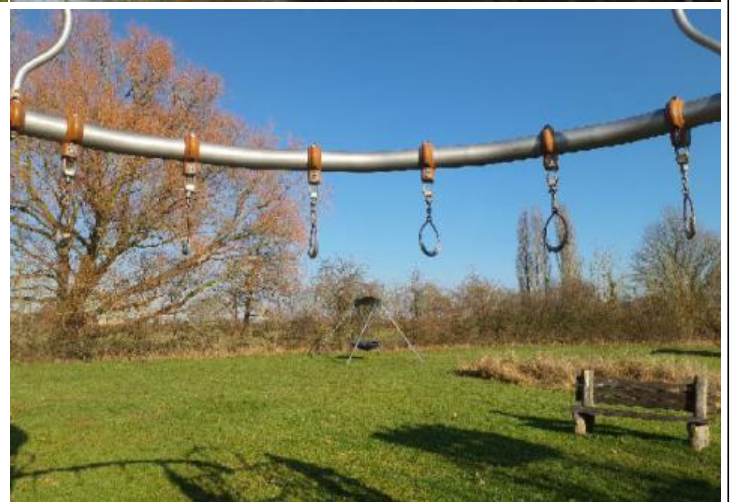
Finding: The handgrips on this item have been taped and we are unable to fully assess their condition. However we do not think tape is suitable as a grip surface

Action: Repair or replace handgrips

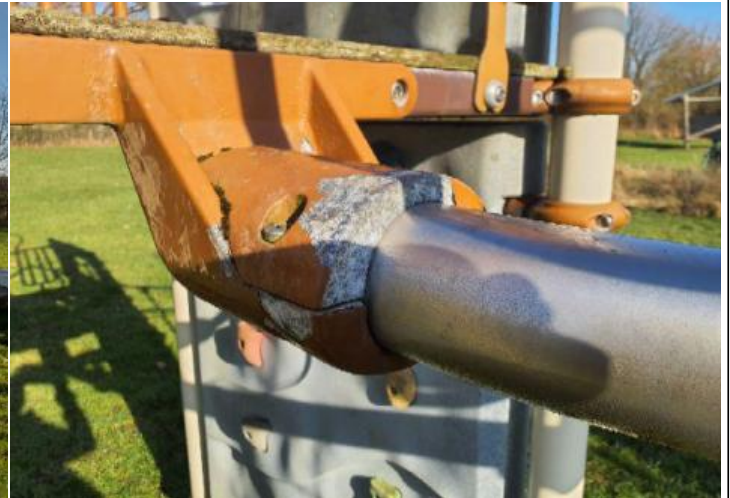
Finding: There is surface corrosion present on the item

Action: Consider treating the item

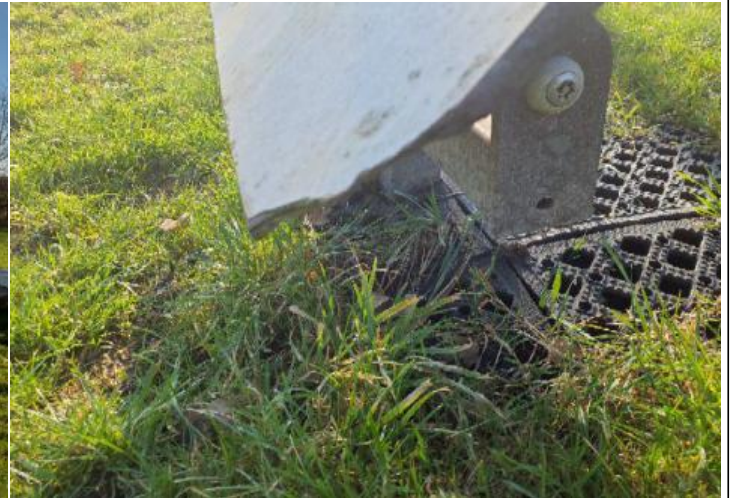
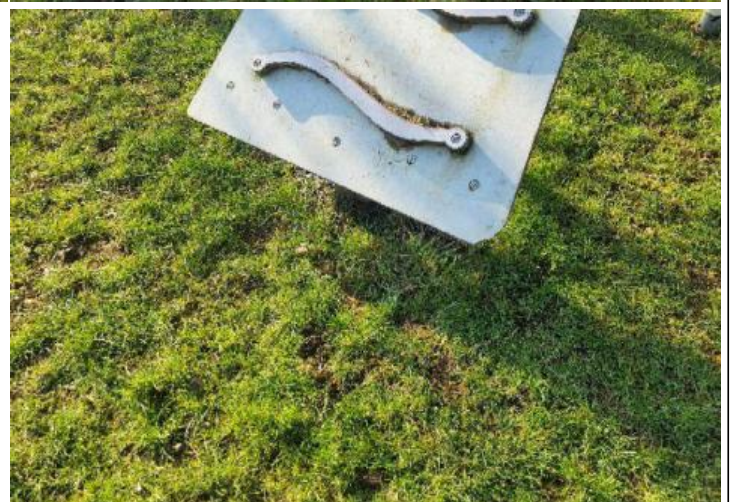
Finding: There is some damage to the corners of the access ramp

Action: Monitor for any further deterioration and repair as required

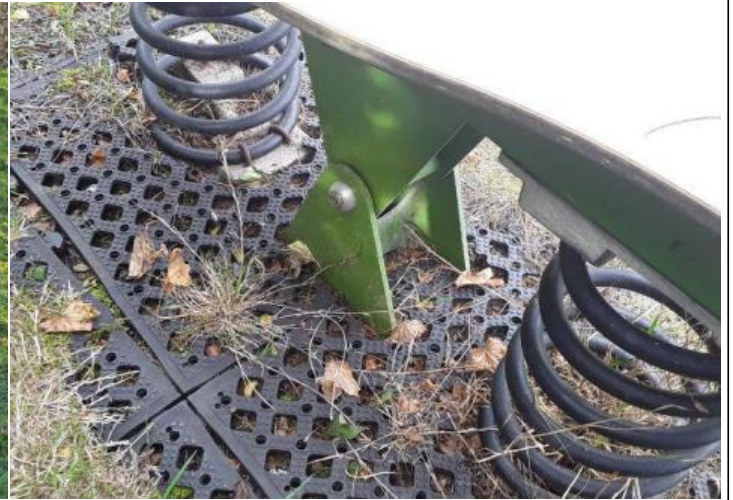
Finding: The pivot mechanism is showing signs of wear

Action: Monitor for any further deterioration and repair as required

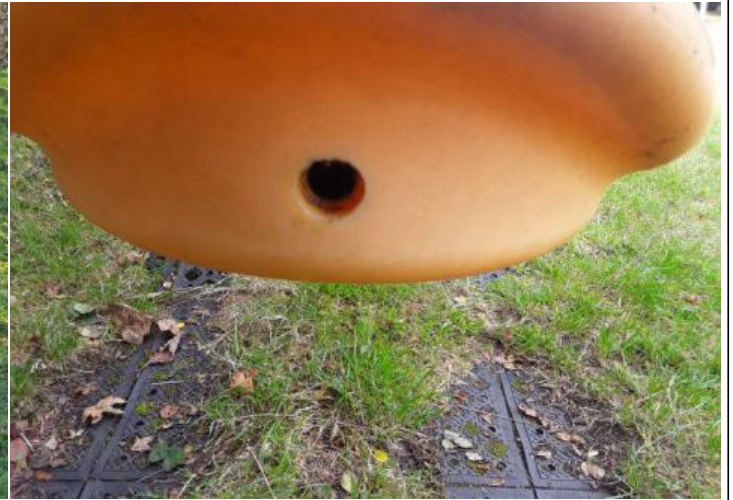
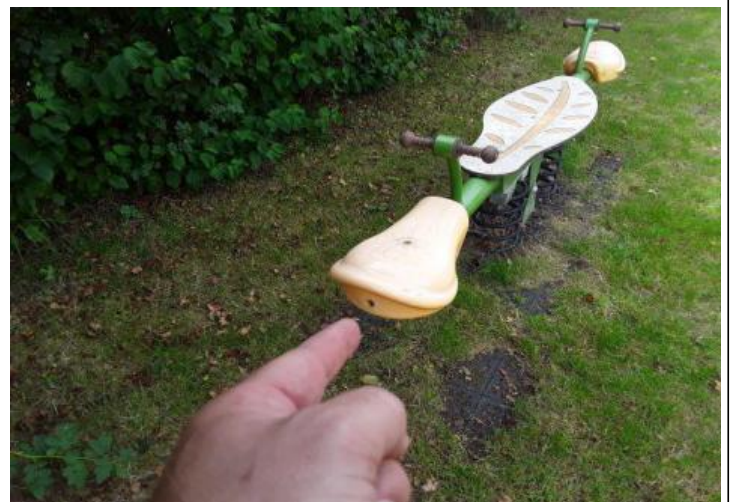
Finding: There is or are fixings missing on the item

Action: Replace all missing fixings

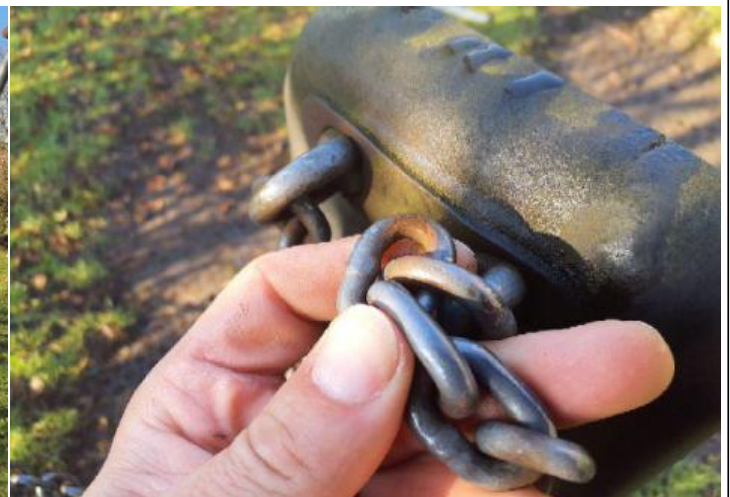
Finding: There is some notable evidence of chain wear

Action: Monitor for any further deterioration and replace when 40% worn

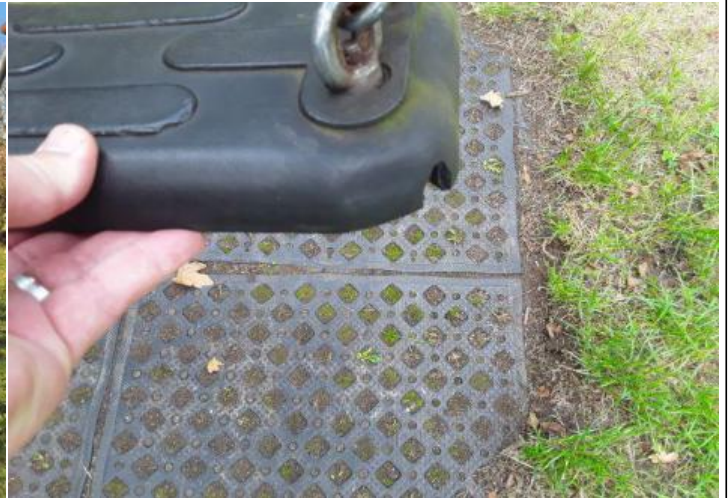
Finding: The seat has minor damage or wear

Action: Monitor for any further deterioration and replace as required
