Operational Inspection

Thornhackett Parish Council

Thornford Play Area

adj The Village Hall, Blacksmiths Lane, Thornford,
Dorset, DT9 6PH

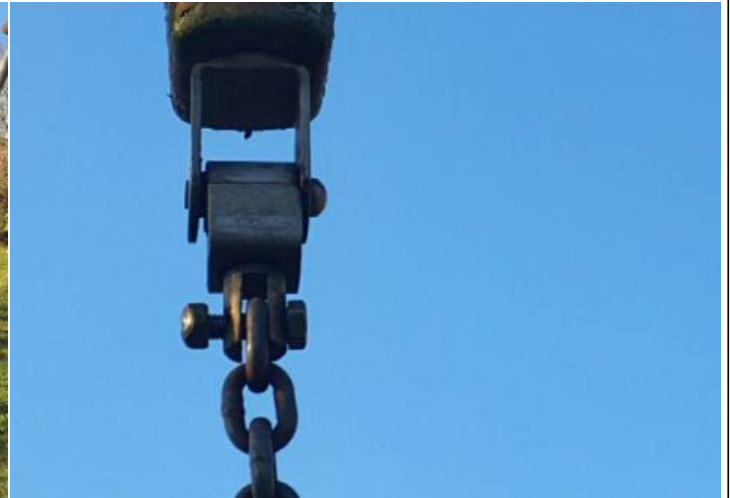
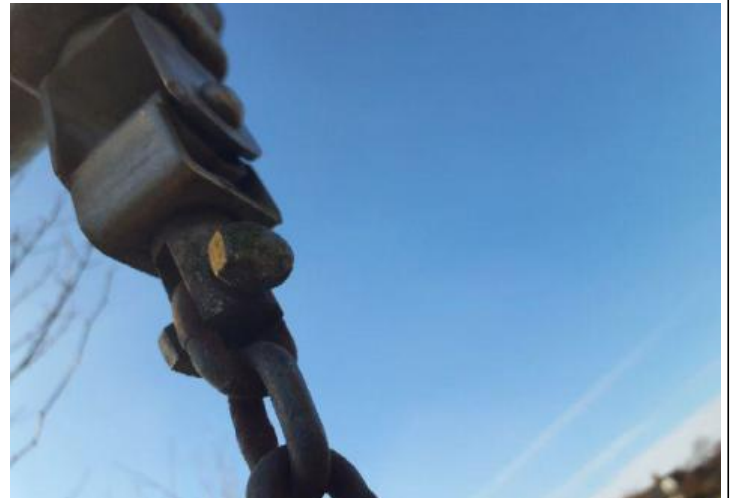
Finding: A number of fixing(s) appear to have worked loose - but they have been welded
Action: No further action required

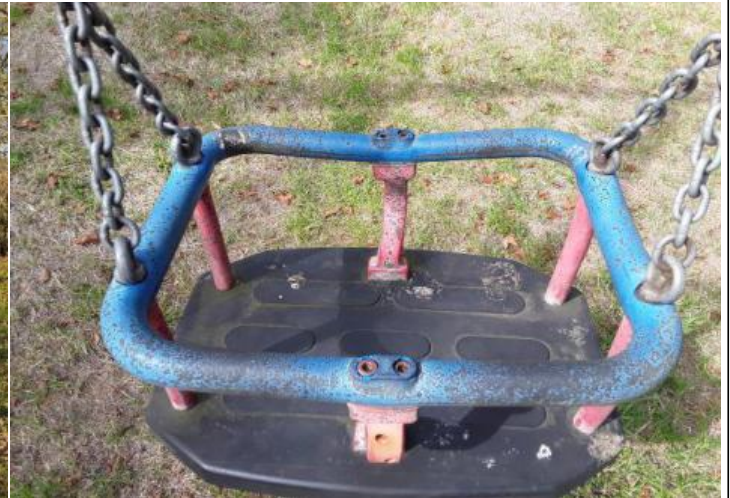
Finding: The seat has minor damage or wear

Action: Monitor for any further deterioration and replace as required

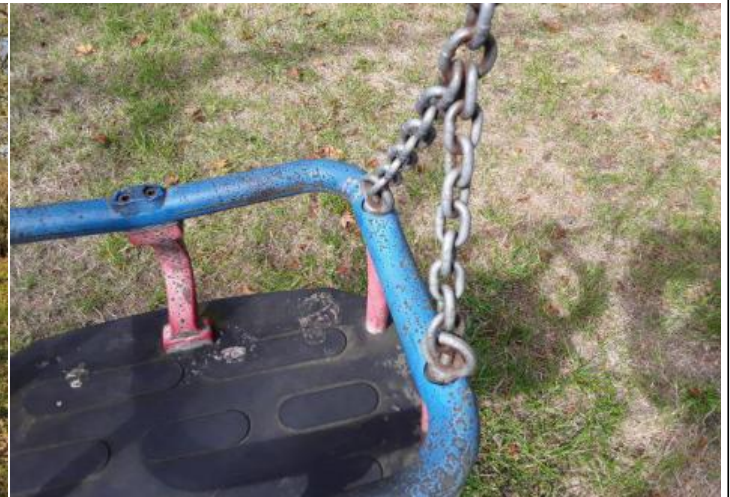
Finding: The swing seat connectors are loose

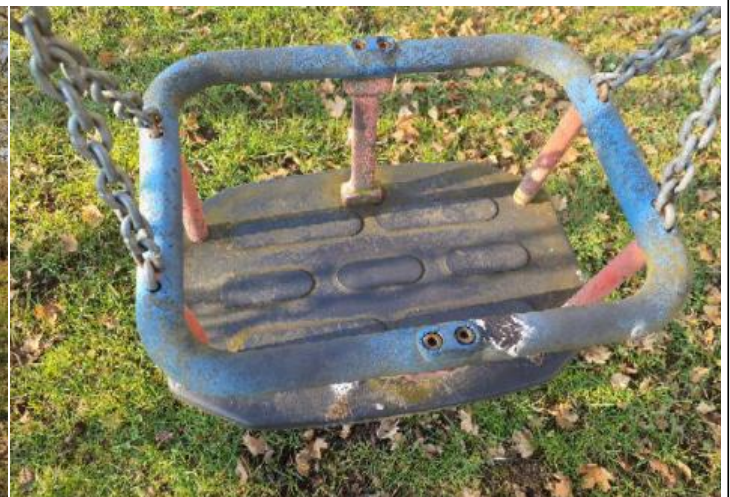
Finding: Fungus or algae was found on the equipment

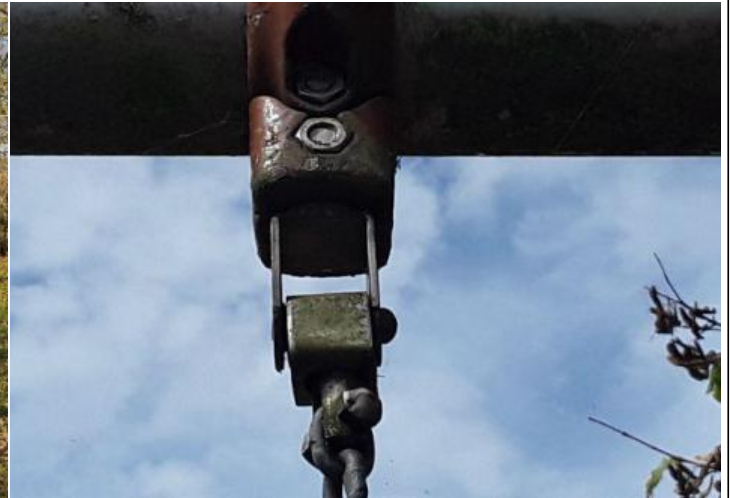
Finding: The bushes are showing signs of wear

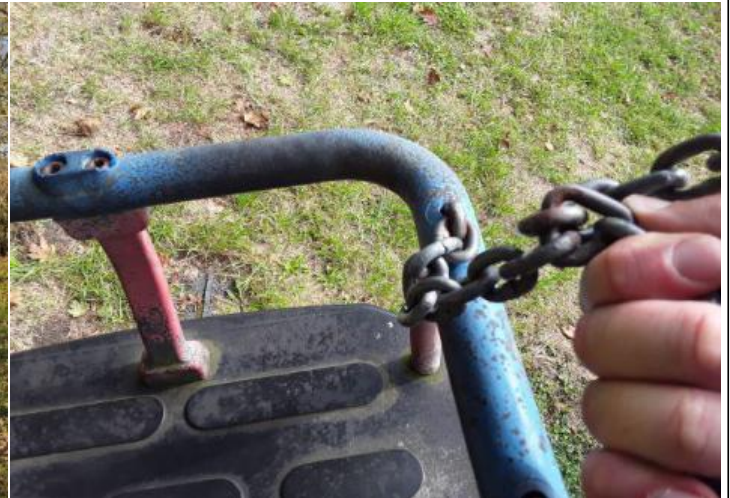
Finding: There is some wear to the connecting links

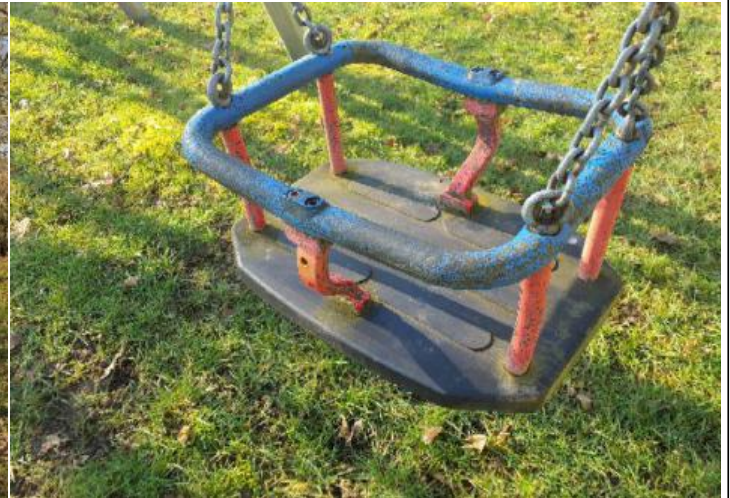
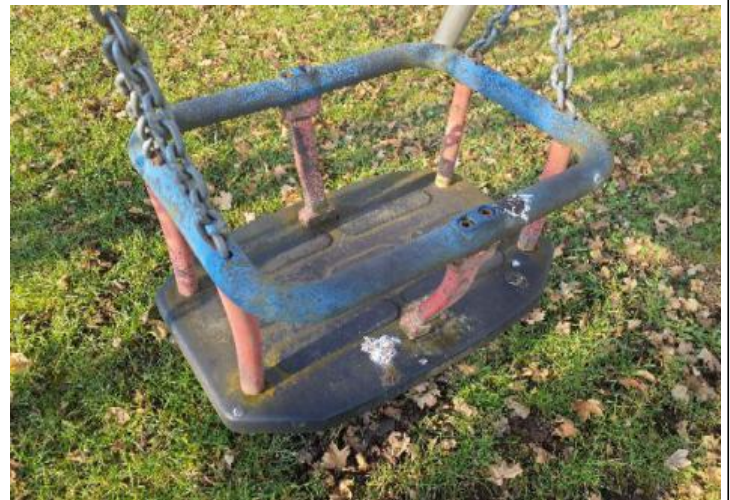
Finding: The seats are deteriorating and could do with being replaced

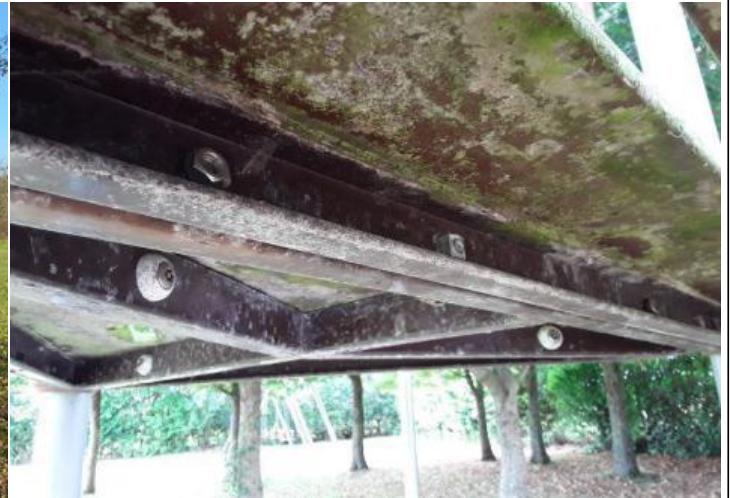
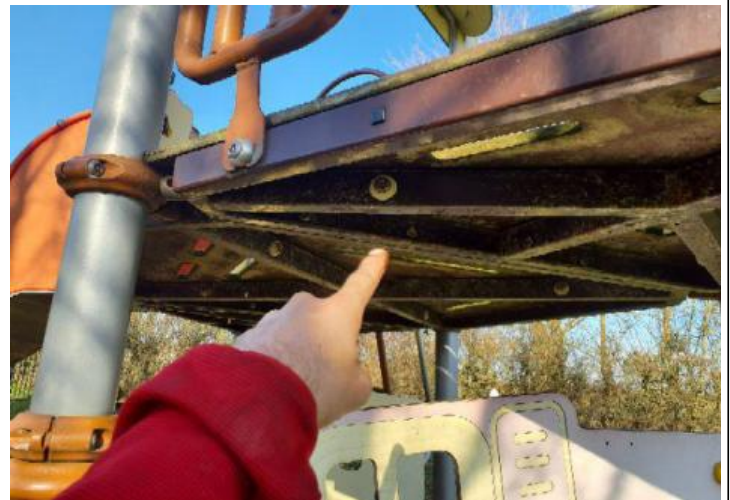
Finding: A number of fixing(s) have worked loose beneath the platforms

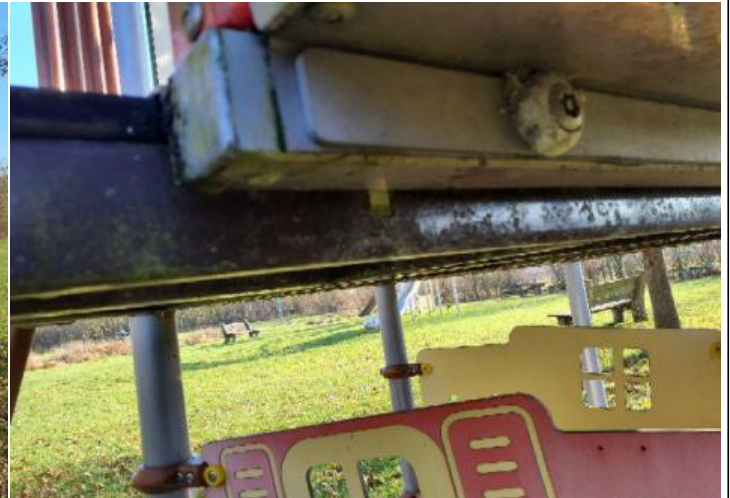
Finding: There is/are several inserts missing

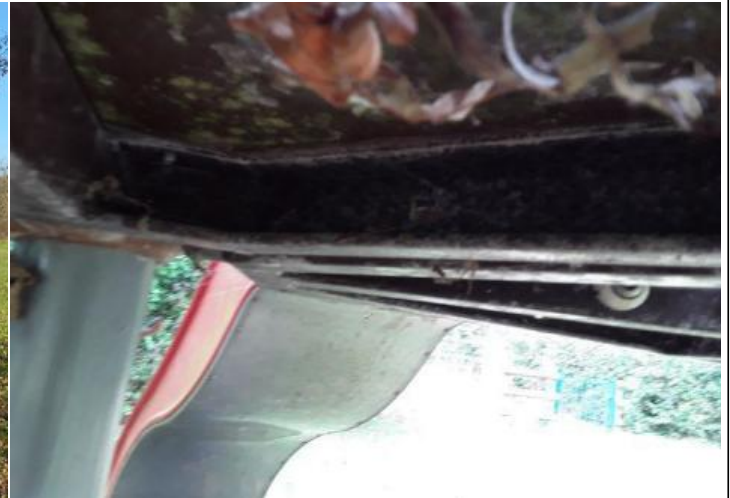
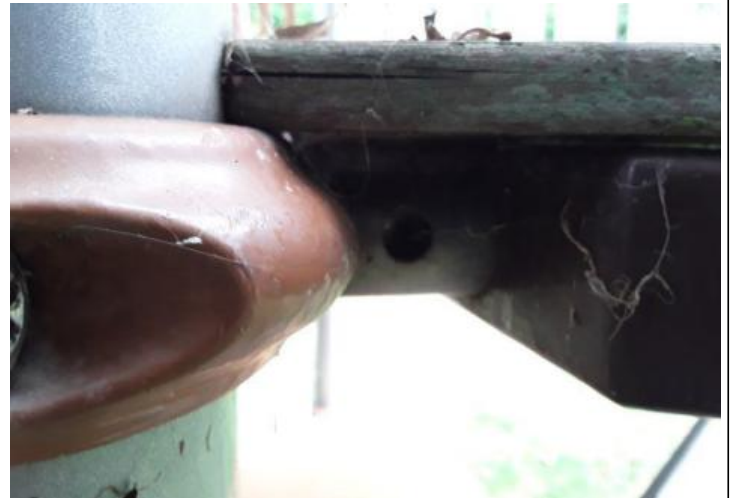
Finding: There is or are fixings missing on the item
