the **play inspection** company

Annual Inspection

Shoreham Parish Council

Shoreham Playground

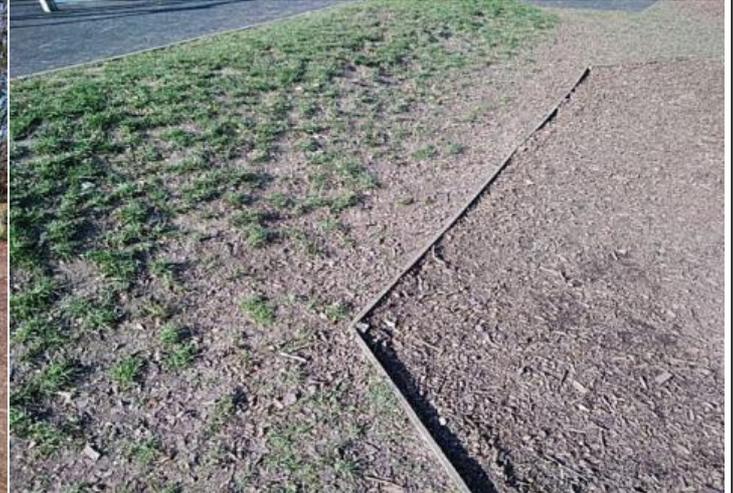
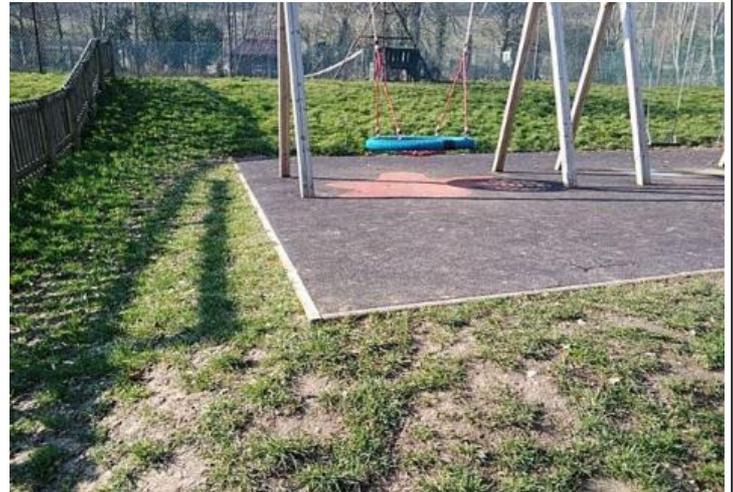
There are trip hazards at the edges of the surface - Reinstate surrounding surface levels to remove the trip points

Finding: There are trip hazards at the edges of the surface

Action: Reinstate surrounding surface levels to remove the trip points

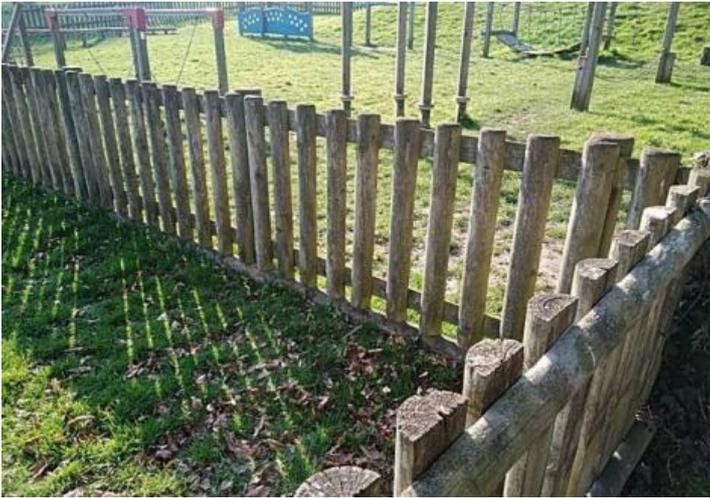
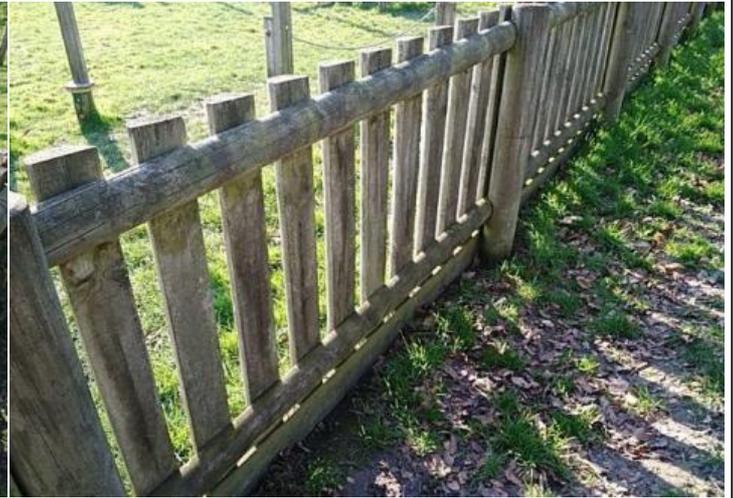
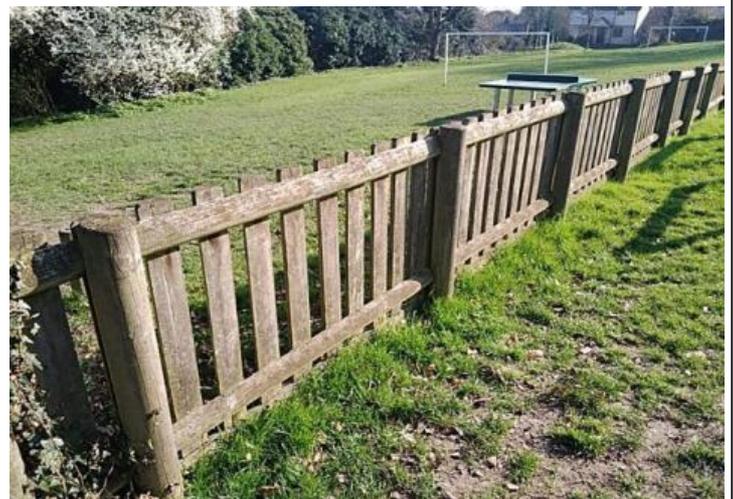
A number of posts have rotted - Replace all affected timber

Finding: A number of posts have rotted

Action: Replace all affected timber

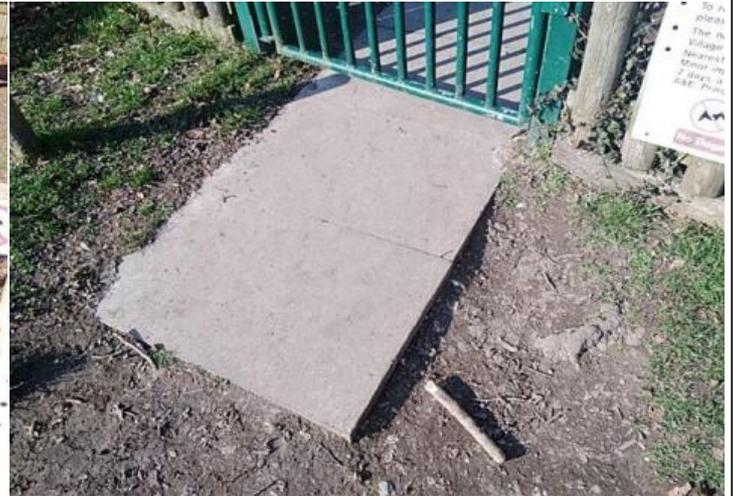
The area under the gate has eroded leaving uneven areas, or the concrete foundations exposed, resulting in trip hazards at the entrance/exit to the playground - Reinstate to level with surrounding surfaces

Finding: The area under the gate has eroded leaving uneven areas, or the concrete foundations exposed, resulting in trip hazards at the entrance/exit to the playground

Action: Reinststate to level with surrounding surfaces

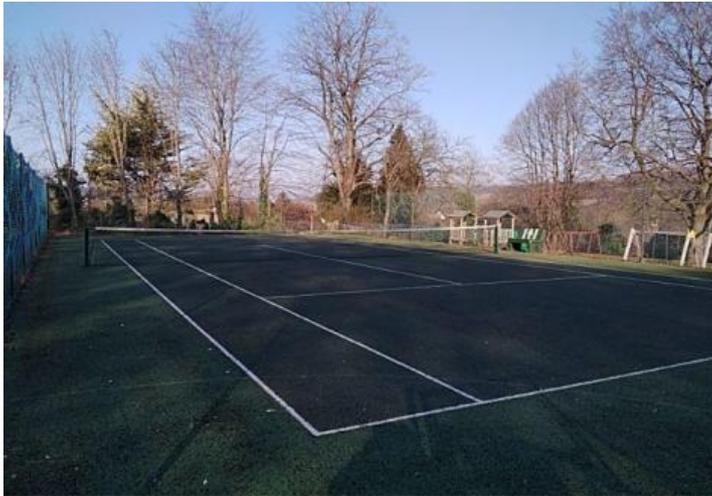
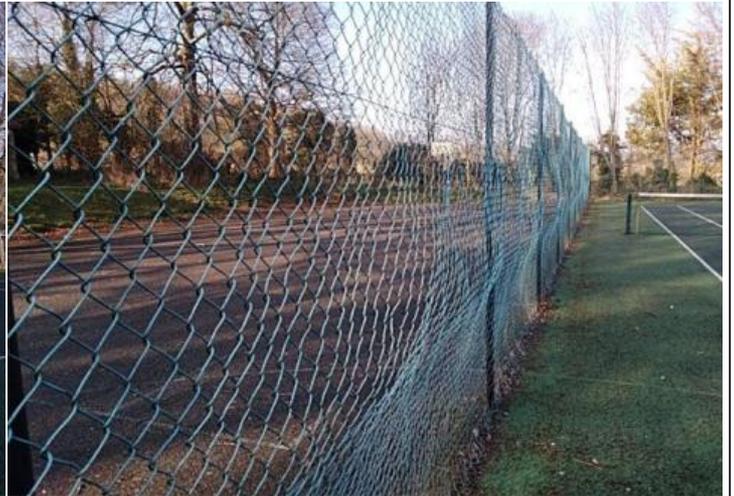
There is some damage to the fence sections - Monitor for any further deterioration and repair as required

Finding: There is some damage to the fence sections

Action: Monitor for any further deterioration and repair as required

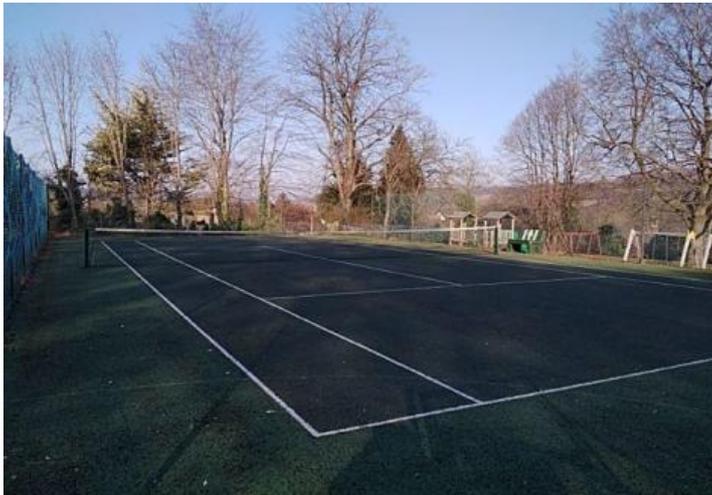
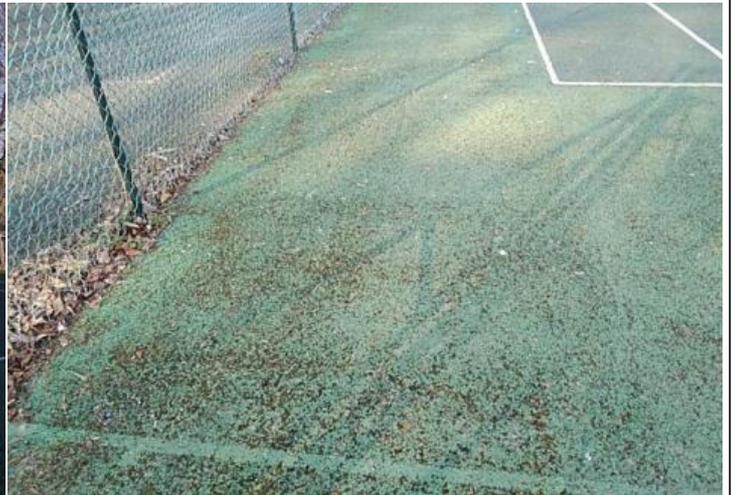
There is algae or moss growth on the surface resulting in slippery conditions - Clean and treat appropriately

Finding: There is algae or moss growth on the surface resulting in slippery conditions

Action: Clean and treat appropriately

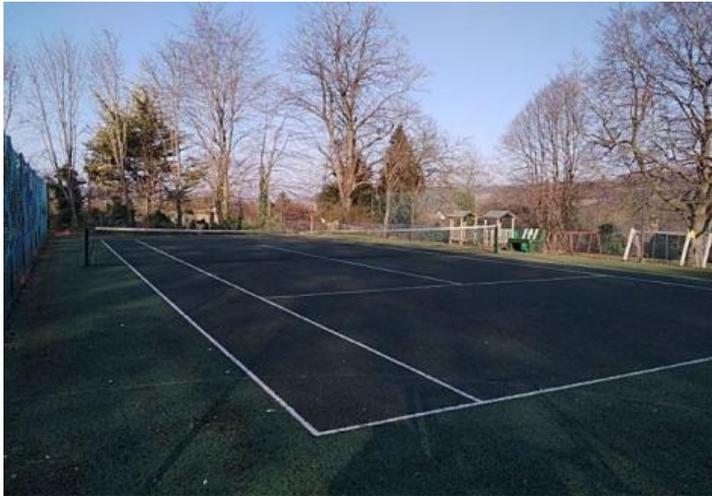
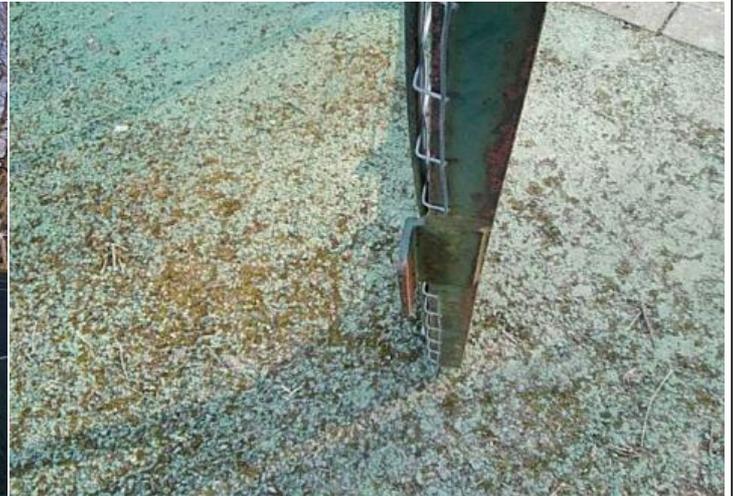
The rubber buffer is missing from the latch plate - Replace rubber buffer

Finding: The rubber buffer is missing from the latch plate
Action: Replace rubber buffer

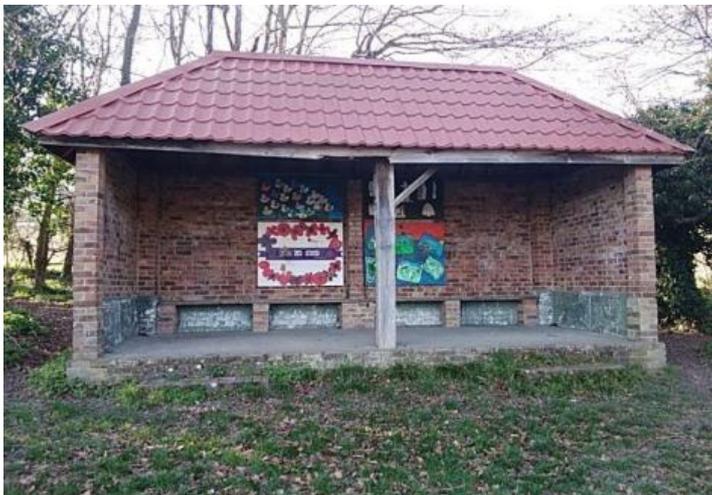
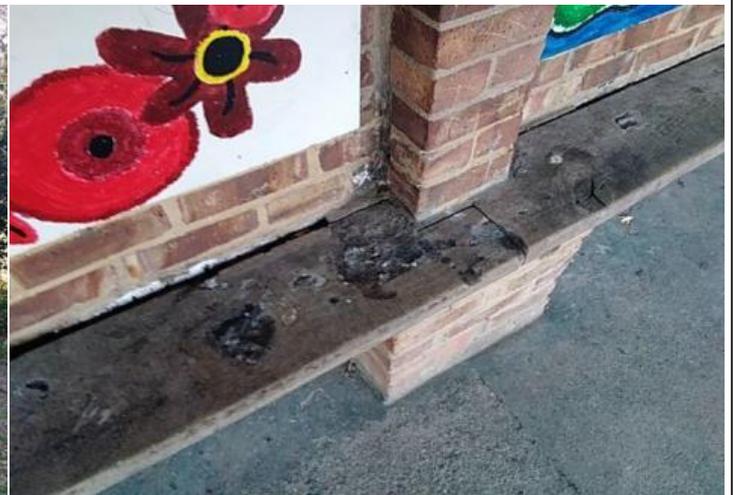
There is some evidence of fire damage to the item - Monitor for any further deterioration and repair as required

Finding: There is some evidence of fire damage to the item
Action: Monitor for any further deterioration and repair as required

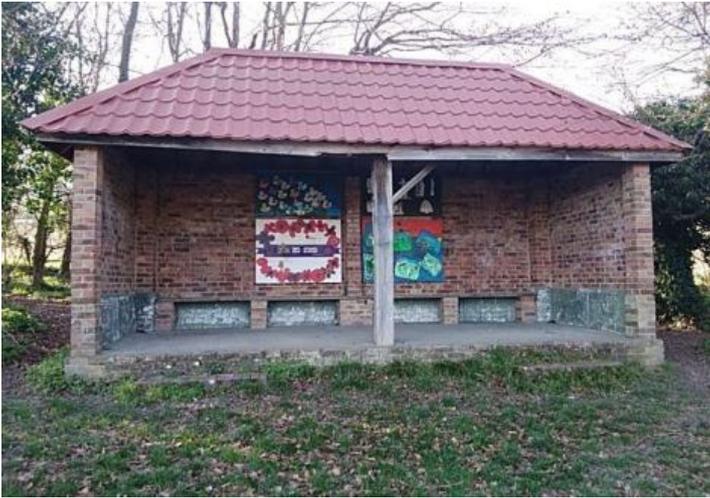
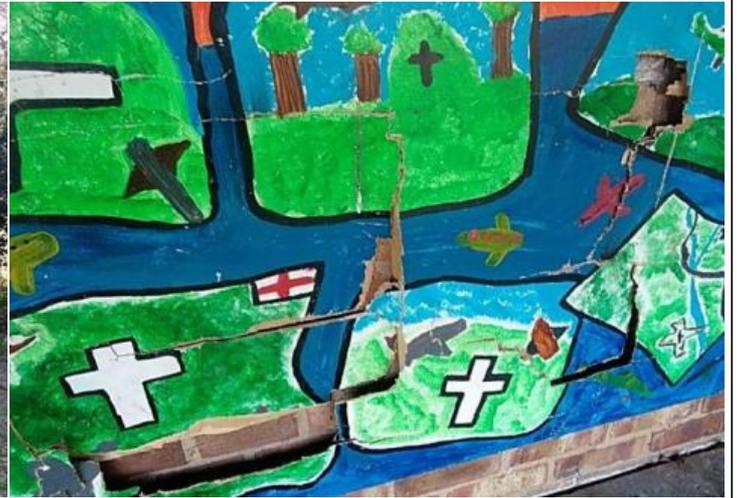
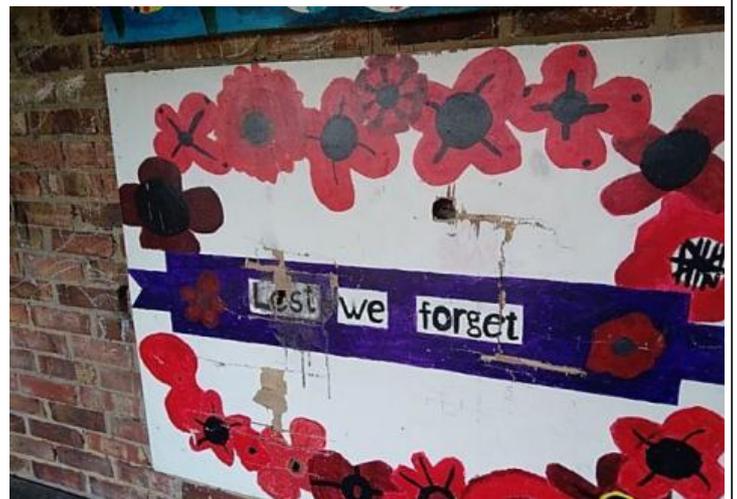
The art panels has been severely damaged - Repair or replace the item

Finding: The art panels has been severely damaged

Action: Repair or replace the item

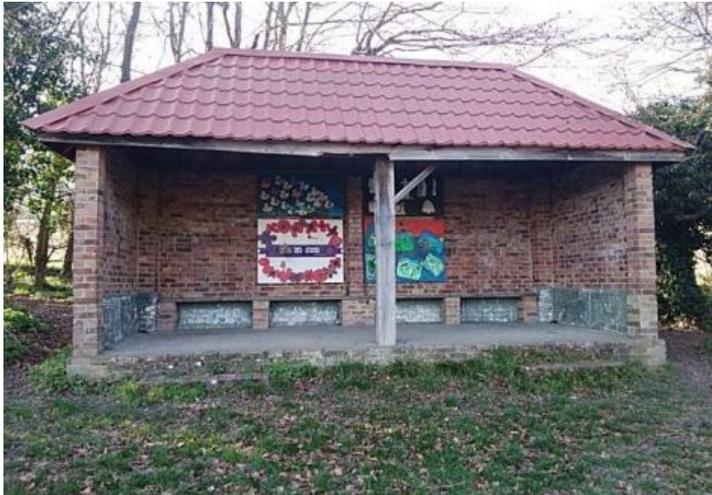
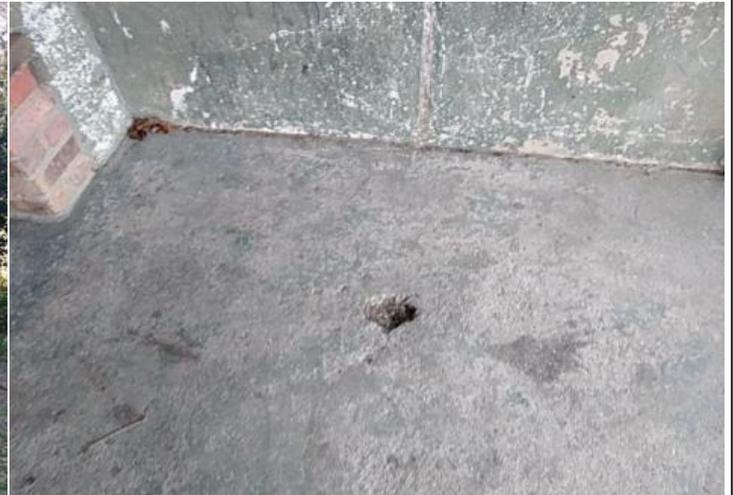
There is some minor damage to the surface - Monitor for any further deterioration and repair as required

Finding: There is some minor damage to the surface

Action: Monitor for any further deterioration and repair as required

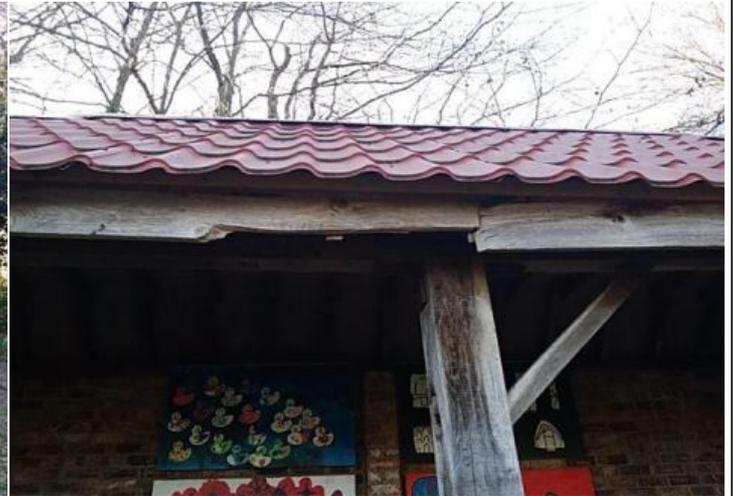
The roof timber has been damaged - Monitor for any further deterioration and replace as required

Finding: The roof timber has been damaged

Action: Monitor for any further deterioration and replace as required

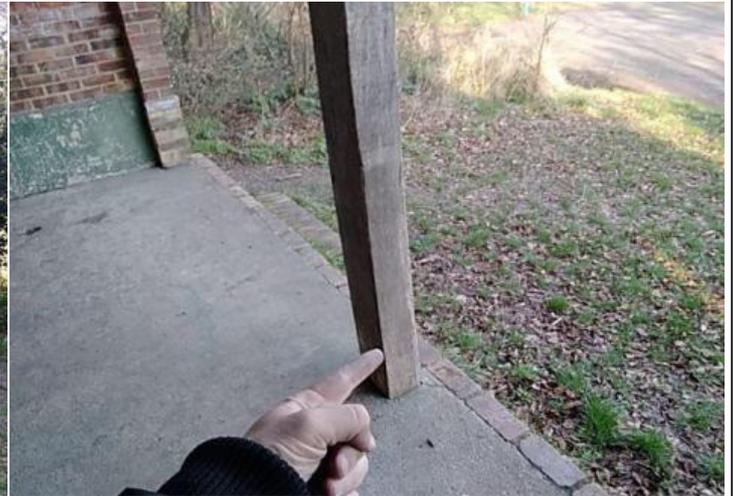
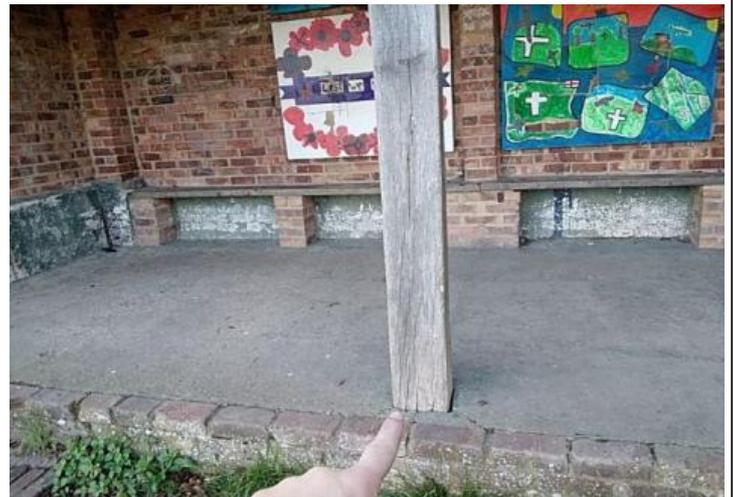
There are areas or parts of the timber on the structure that have rotted - Replace all affected timbers

Finding: There are areas or parts of the timber on the structure that have rotted

Action: Replace all affected timbers

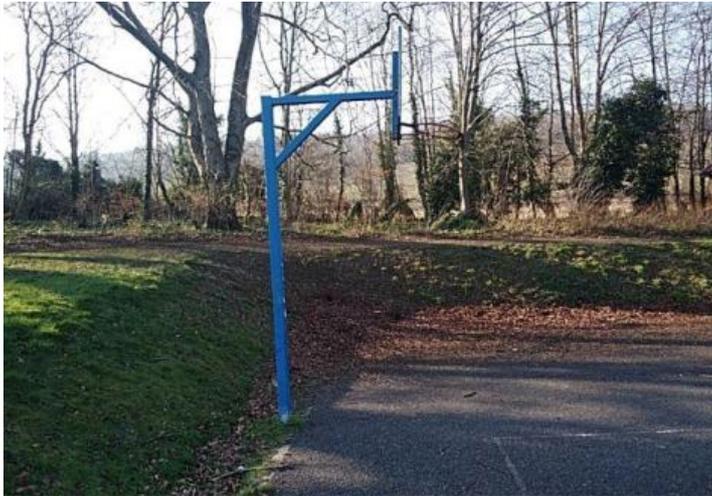
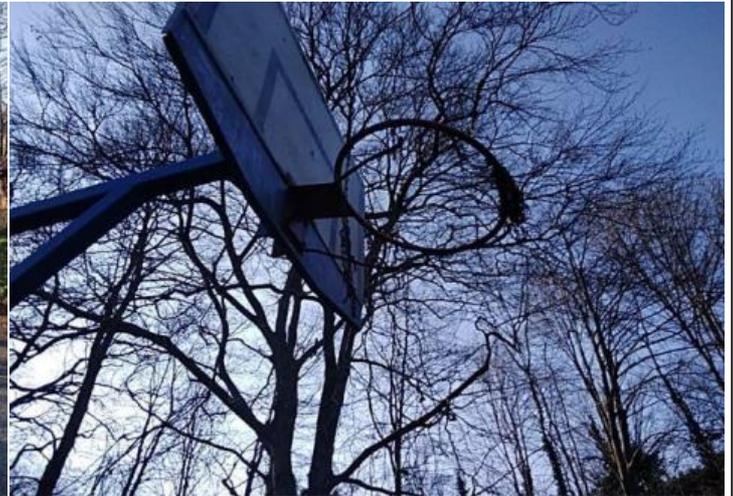
The net has been damaged - Replace the item

Finding: The net has been damaged

Action: Replace the item

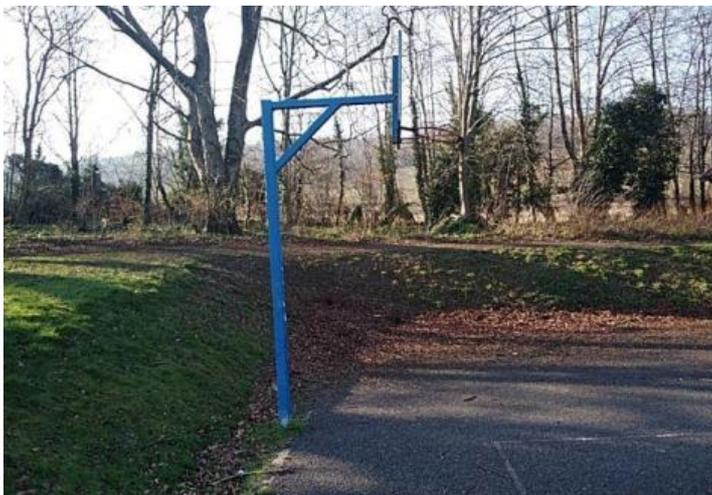
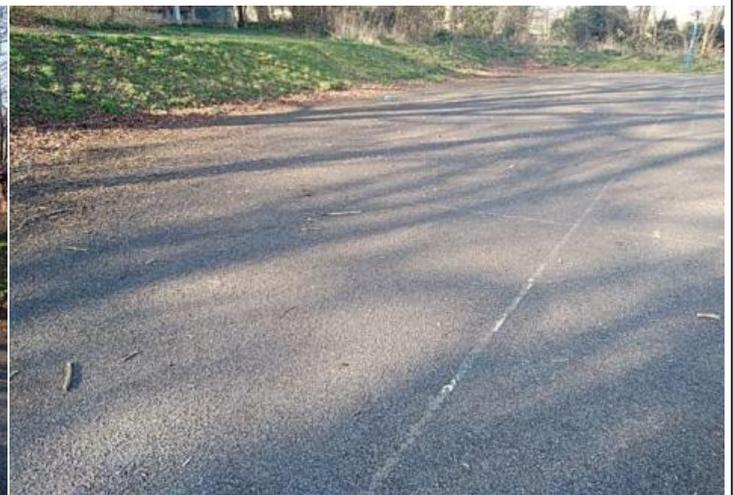
The surface is crumbling in areas creating slippery conditions - Sweep and clear all loose debris and monitor

Finding: The surface is crumbling in areas creating slippery conditions

Action: Sweep and clear all loose debris and monitor

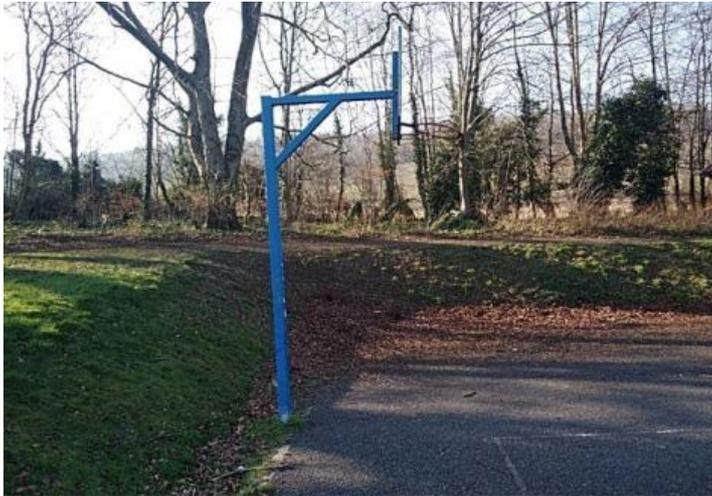
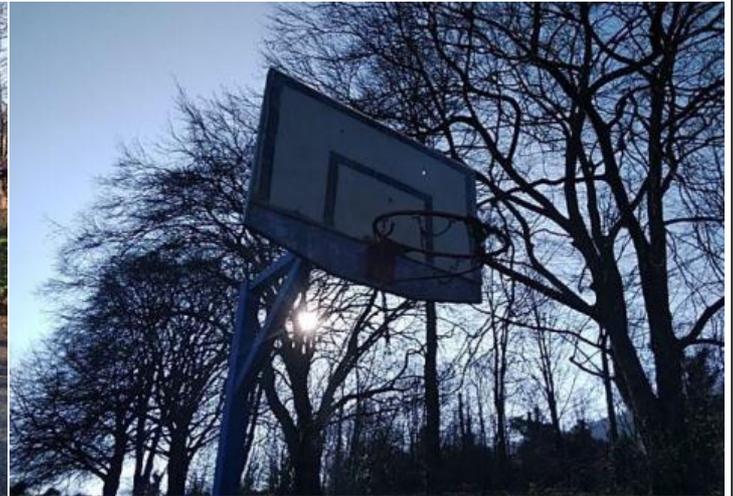
The basketball hoops are damaged - Replace all affected components

Finding: The basketball hoops are damaged

Action: Replace all affected components

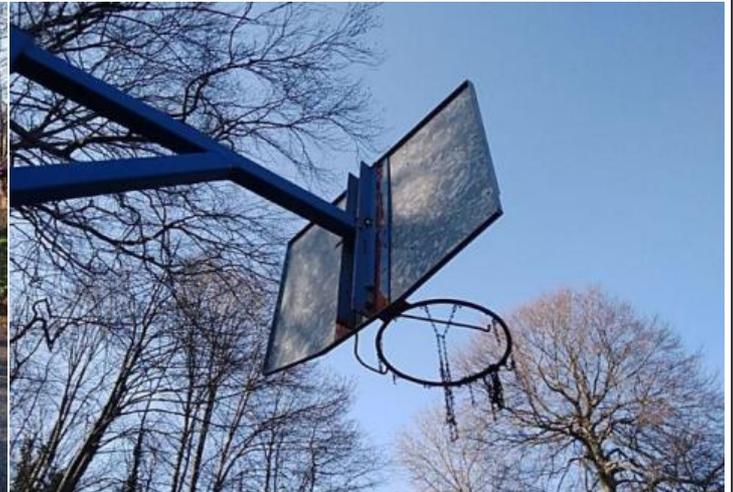
The paintwork on this item has been damaged or worn exposing the metal underneath which is rusting - Treat any rusting components and repaint

Finding: The paintwork on this item has been damaged or worn exposing the metal underneath which is rusting

Action: Treat any rusting components and repaint

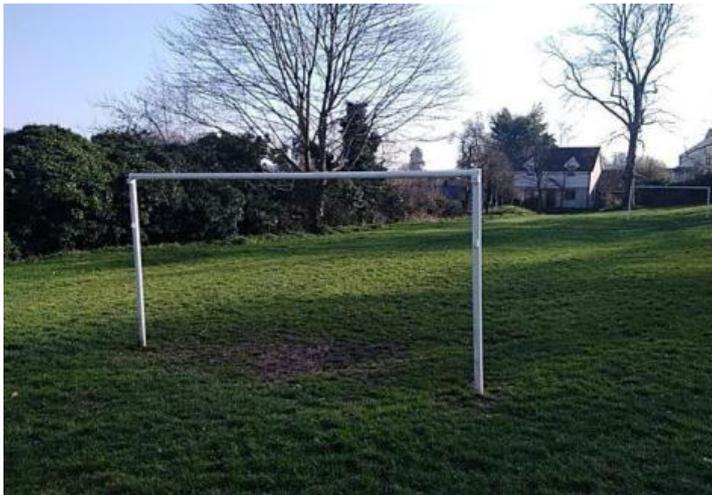
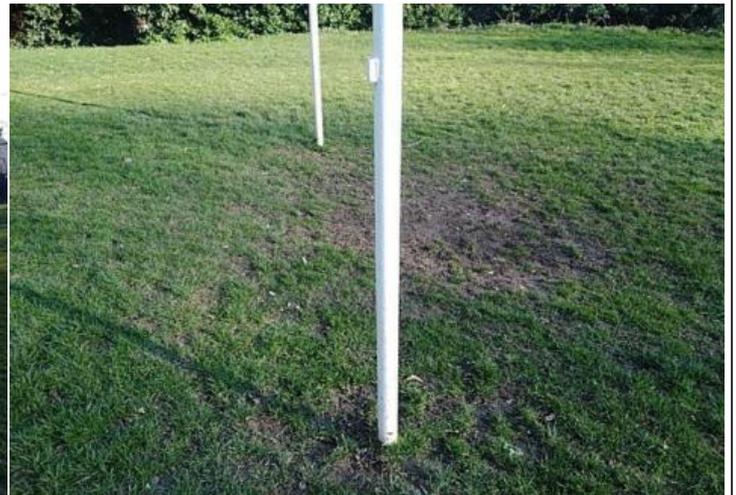
The item is slightly loose in its foundations - Monitor for any further deterioration and repair as required

Finding: The item is slightly loose in its foundations

Action: Monitor for any further deterioration and repair as required

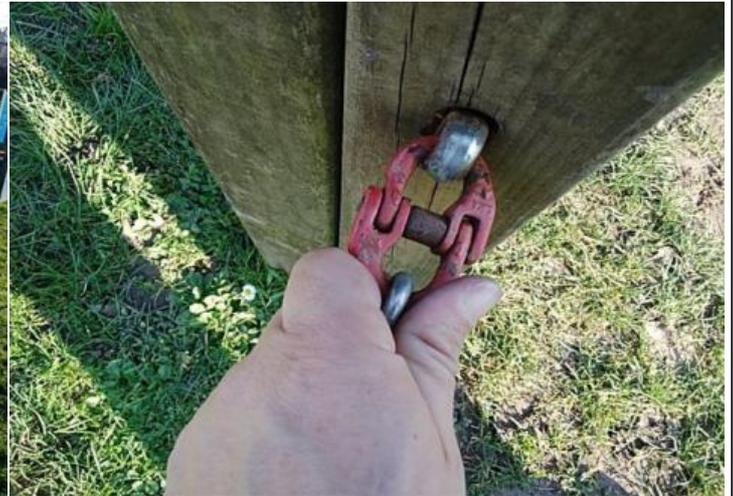
There is some wear to the shackles - Monitor for any further deterioration and replace when 40% worn

Finding: There is some wear to the shackles

Action: Monitor for any further deterioration and replace when 40% worn

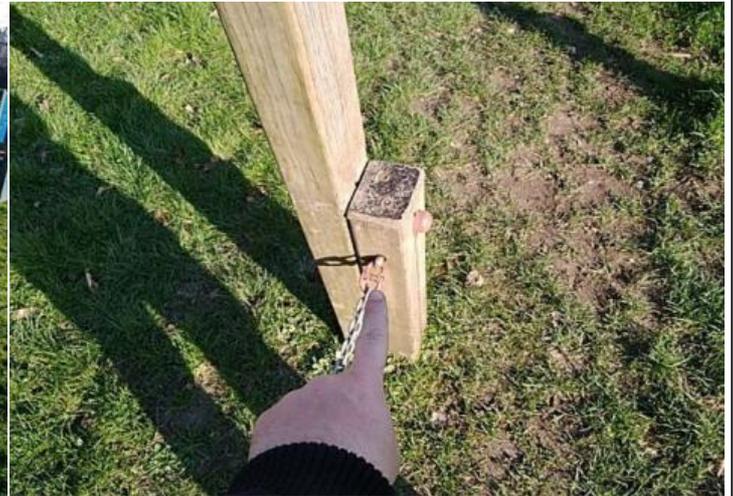
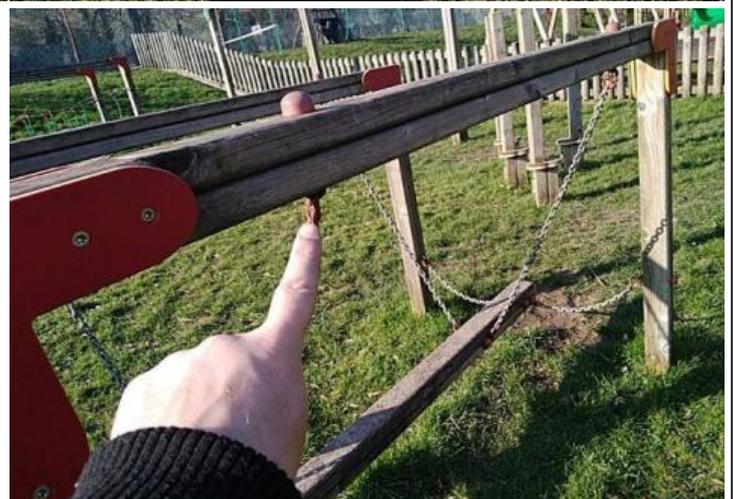
A number of eyebolt fixing(s) have worked loose - Secure all loose fixings

Finding: A number of eyebolt fixing(s) have worked loose

Action: Secure all loose fixings

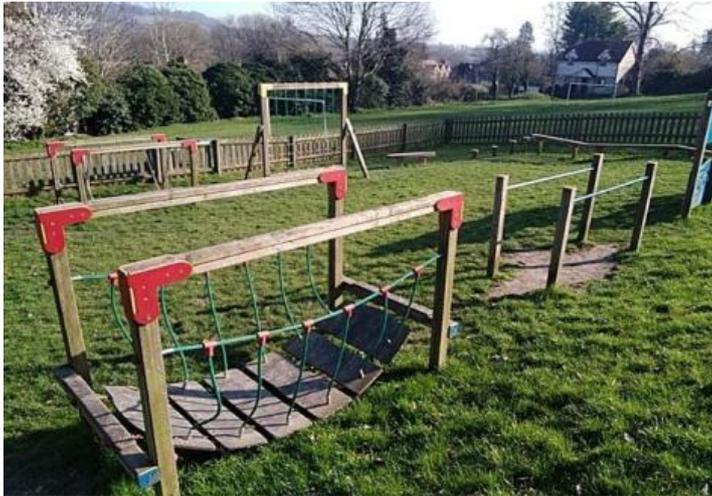
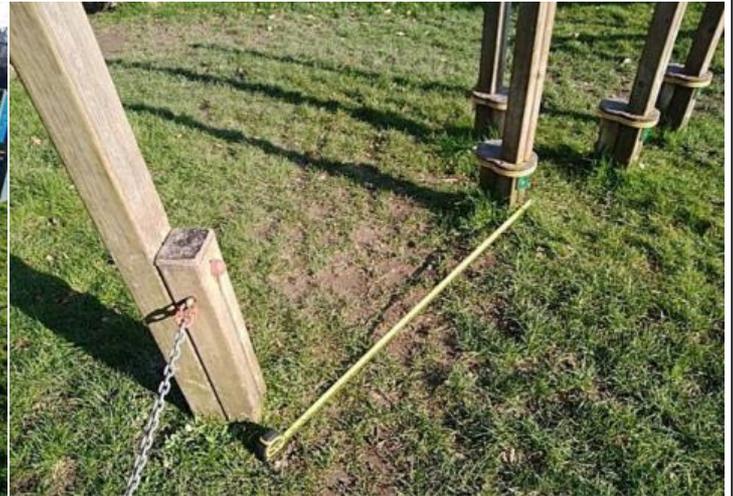
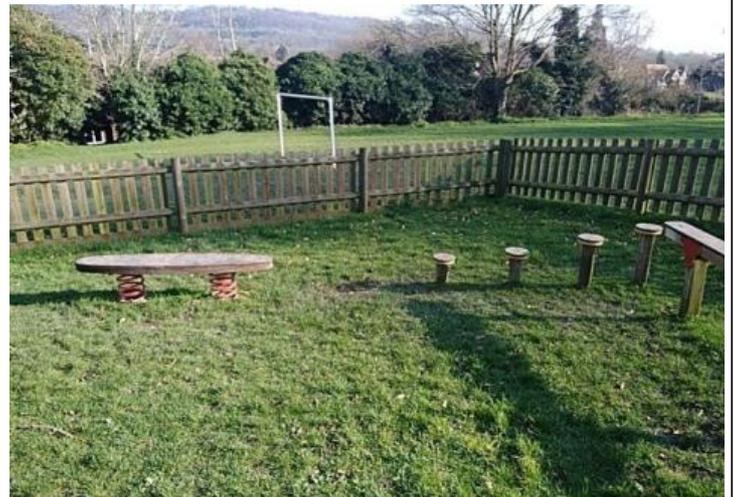
The step between the items is quite large and users may not be able to complete the step without touching ground, the items could therefore be considered to be within the falling space of each other, however the intention of the play activity continuity is easily apparent and foreseeable to the user - Monitor - No remedial work recommended

Finding: The step between the items is quite large and users may not be able to complete the step without touching ground, the items could therefore be considered to be within the falling space of each other, however the intention of the play activity continuity is easily apparent and foreseeable to the user

Action: Monitor - No remedial work recommended

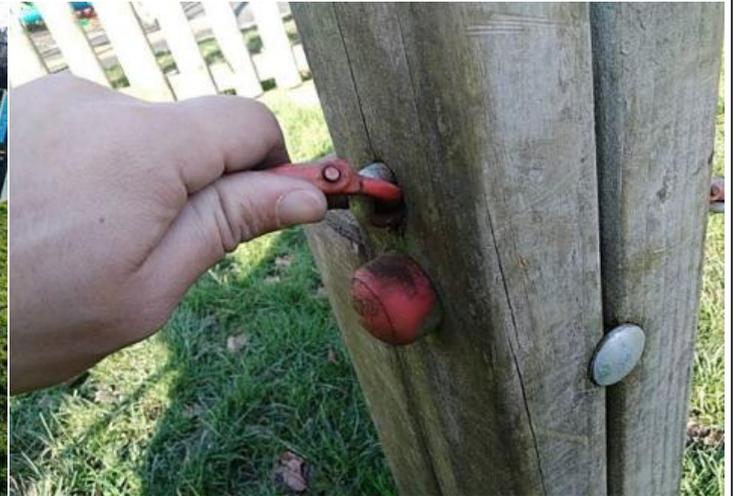
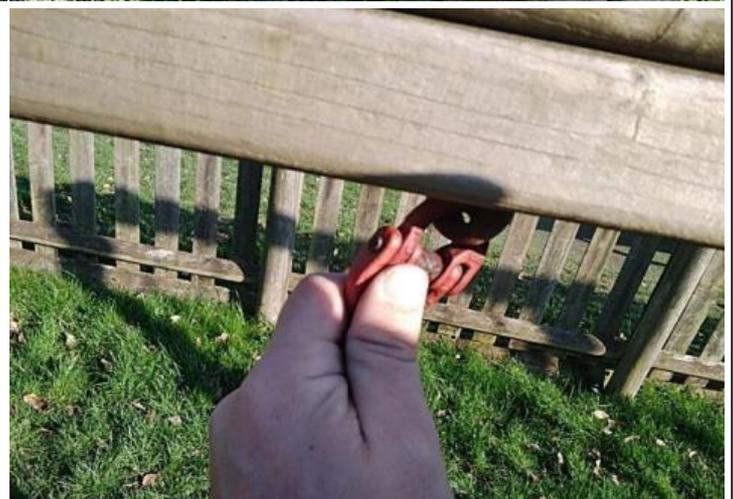
The connecting lugs are showing signs of wear - Monitor for any further deterioration and repair as required

Finding: The connecting lugs are showing signs of wear

Action: Monitor for any further deterioration and repair as required

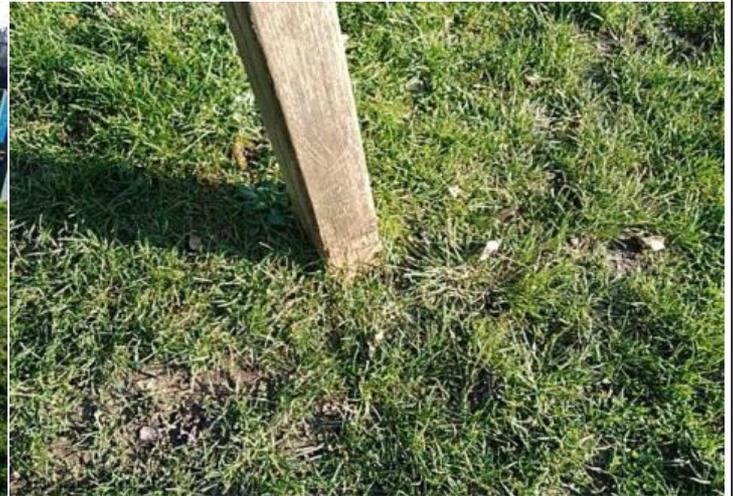
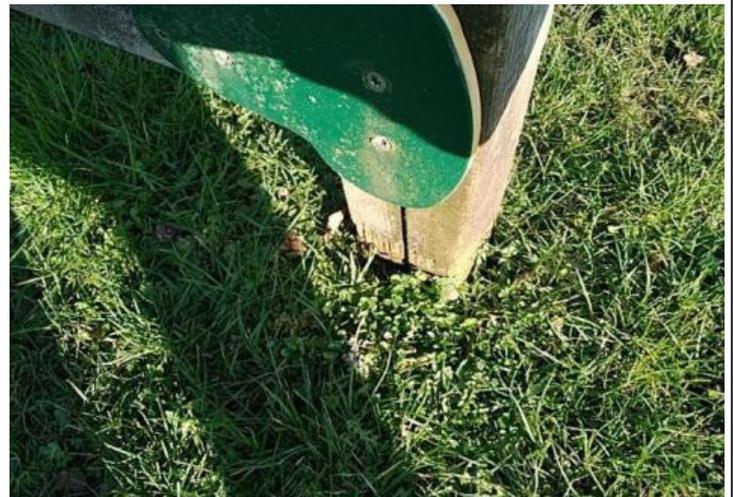
There is some strimmer / machinery damage apparent on the posts, this can penetrate the preservative applied to the timber and accelerate the rotting process - Monitor for any deterioration (rot) and replace as required

Finding: There is some strimmer / machinery damage apparent on the posts, this can penetrate the preservative applied to the timber and accelerate the rotting process

Action: Monitor for any deterioration (rot) and replace as required

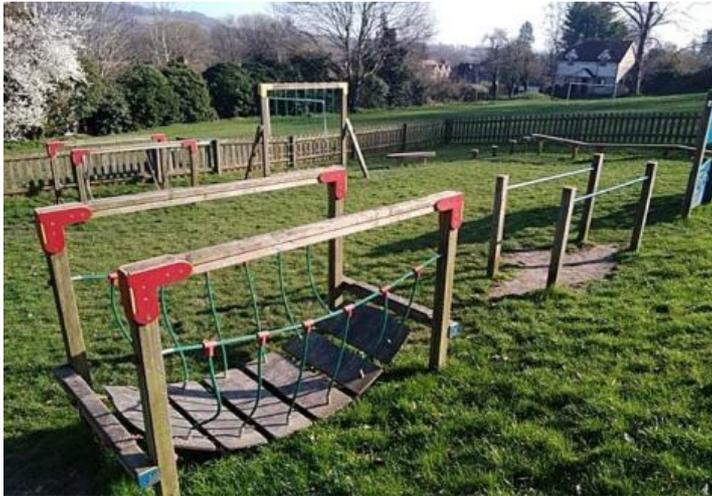
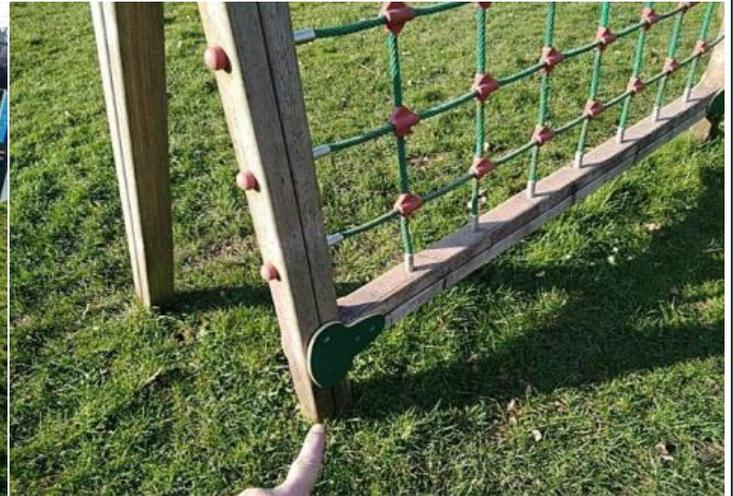
There is some evidence of rot in the timber - Monitor for any further deterioration and replace as required

Finding: There is some evidence of rot in the timber

Action: Monitor for any further deterioration and replace as required

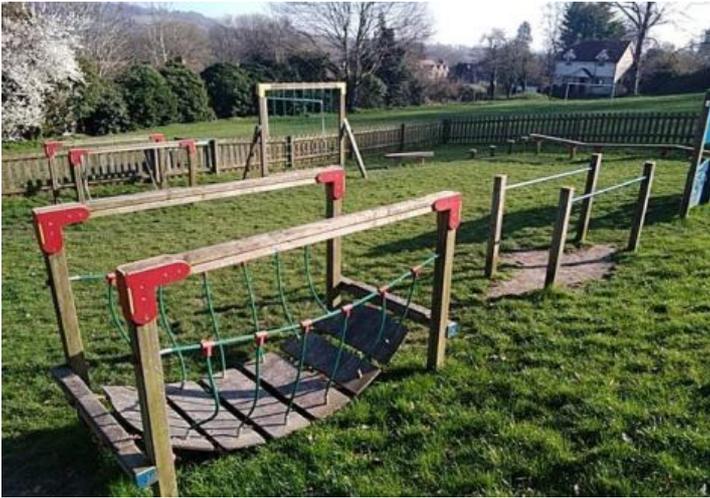
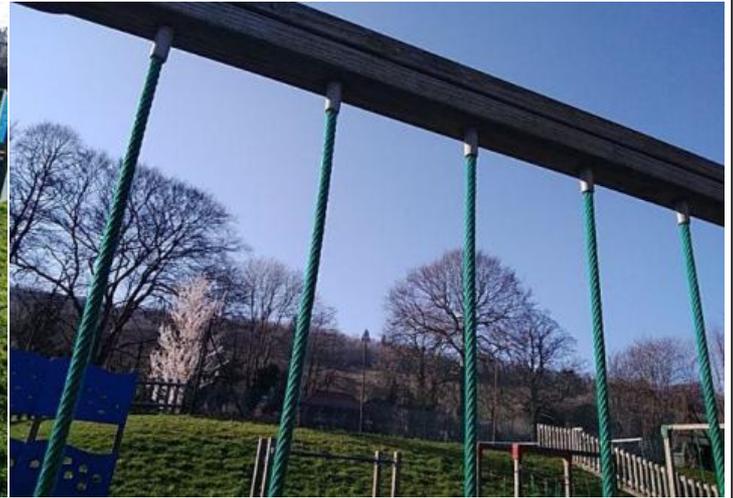
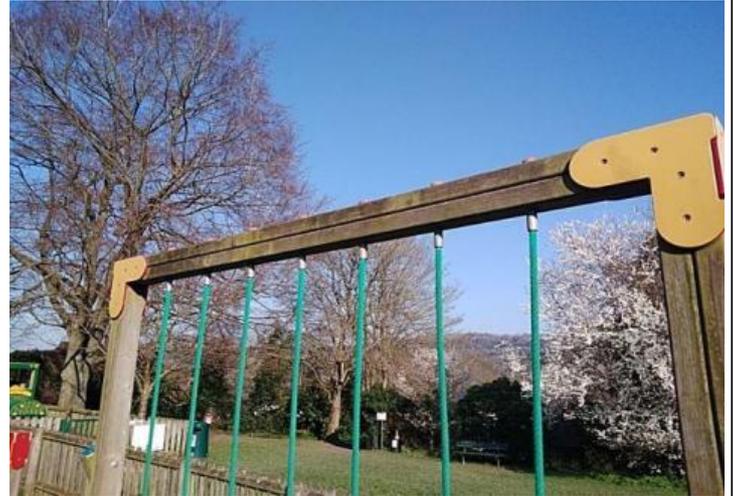
A number of fixing(s) have worked loose - Secure all loose fixings

Finding: A number of fixing(s) have worked loose

Action: Secure all loose fixings

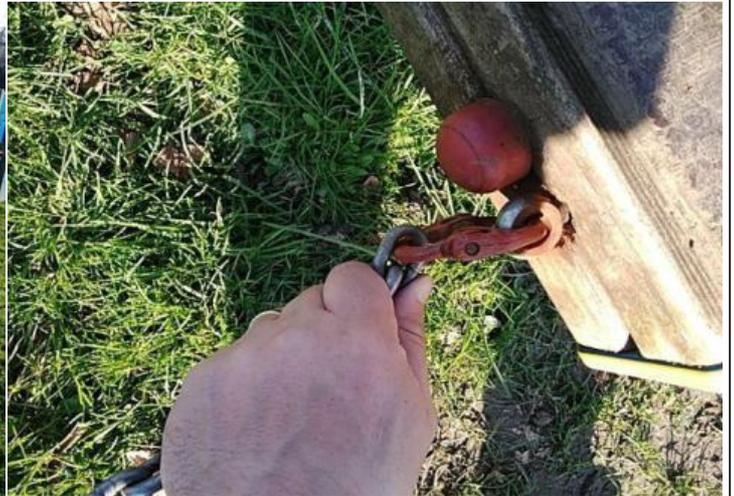
There is some notable evidence of chain wear - Monitor for any further deterioration and replace when 40% worn

Finding: There is some notable evidence of chain wear

Action: Monitor for any further deterioration and replace when 40% worn

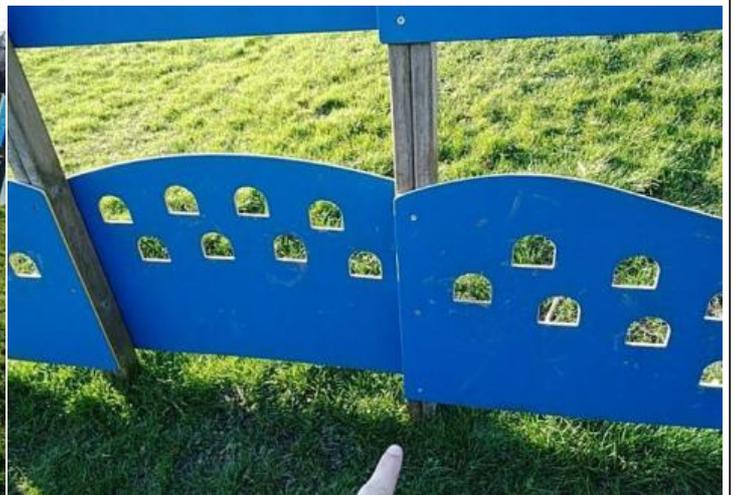
The item is slightly loose in its foundations - Monitor for any further deterioration and repair as required

Finding: The item is slightly loose in its foundations

Action: Monitor for any further deterioration and repair as required

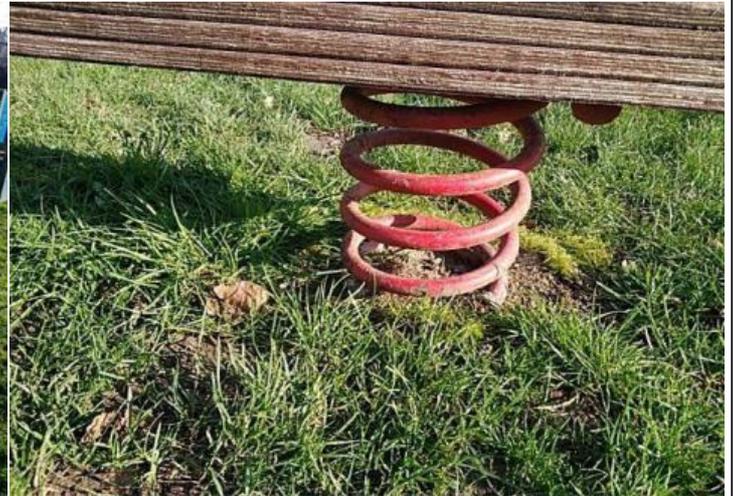
The paintwork on the spring has been damaged or worn exposing the metal underneath which is rusting - Treat any rusting components and repaint

Finding: The paintwork on the spring has been damaged or worn exposing the metal underneath which is rusting
Action: Treat any rusting components and repaint

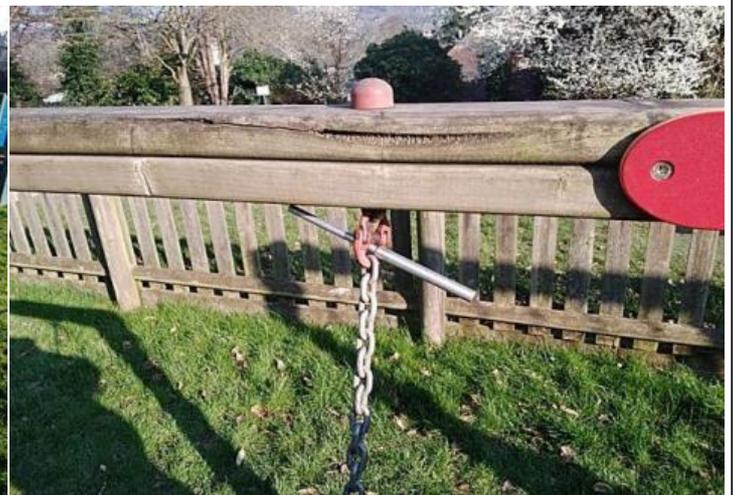
The connecting links are in excess of 8.6mm and less than 12mm and fail the requirements of BS EN 1176 Part 1; clause 4.2.13, Chains - Monitor use and replace with compliant links at the next maintenance cycle

Finding: The connecting links are in excess of 8.6mm and less than 12mm and fail the requirements of BS EN 1176 Part 1; clause 4.2.13, Chains
Action: Monitor use and replace with compliant links at the next maintenance cycle

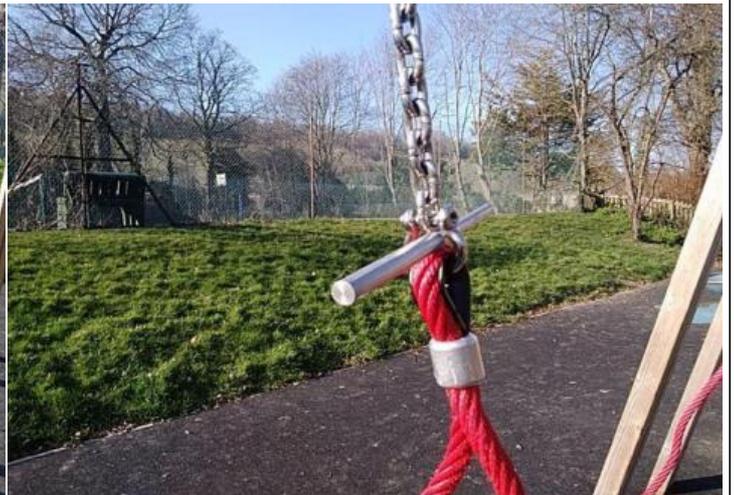
The connecting links are in excess of 8.6mm and less than 12mm and fail the requirements of BS EN 1176 Part 1; clause 4.2.13, Chains - Monitor use and replace with compliant links at the next maintenance cycle

Finding: The connecting links are in excess of 8.6mm and less than 12mm and fail the requirements of BS EN 1176 Part 1; clause 4.2.13, Chains

Action: Monitor use and replace with compliant links at the next maintenance cycle

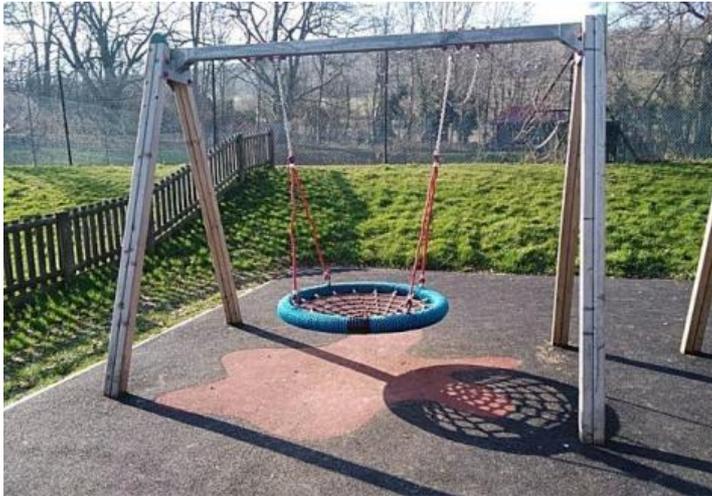
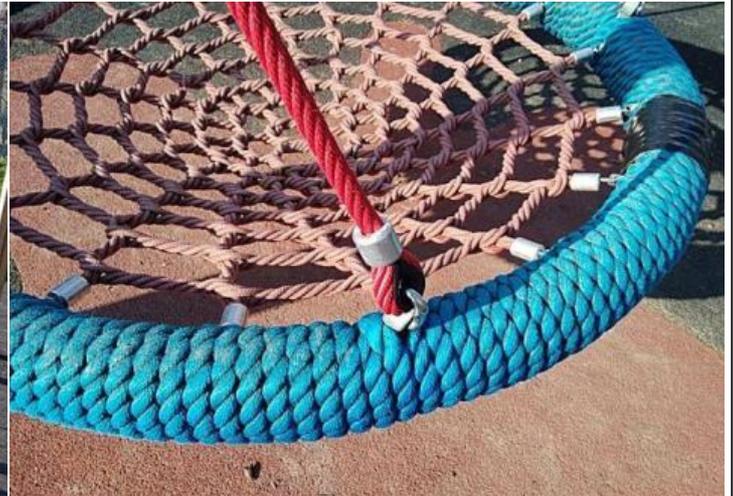
The bushes are showing signs of wear - Monitor for any further deterioration and replace as required

Finding: The bushes are showing signs of wear

Action: Monitor for any further deterioration and replace as required

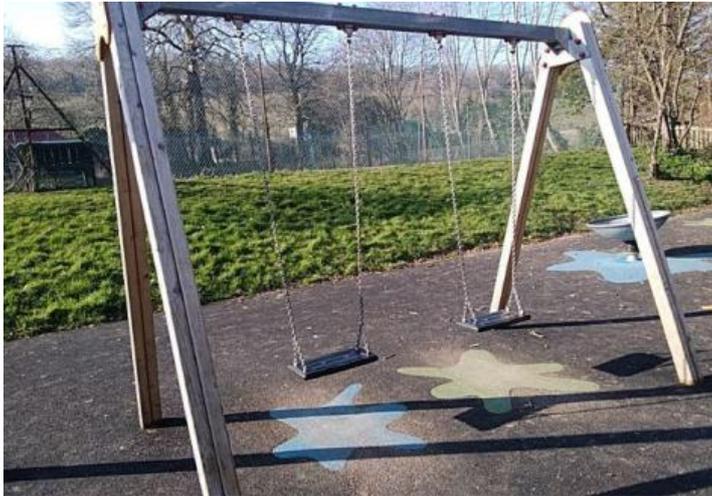
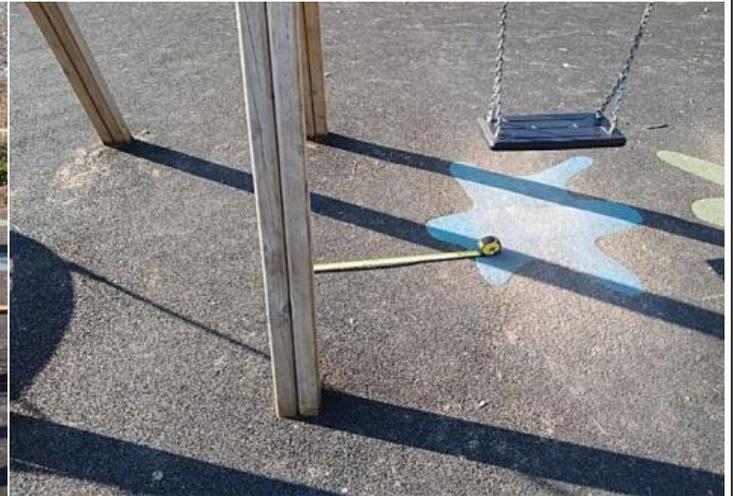
The seats are too close to the frame as defined in BS EN 1176 Part 2; this is a low risk failure and no remedial action is required - Monitor - No remedial work recommended

Finding: The seats are too close to the frame as defined in BS EN 1176 Part 2; this is a low risk failure and no remedial action is required

Action: Monitor - No remedial work recommended

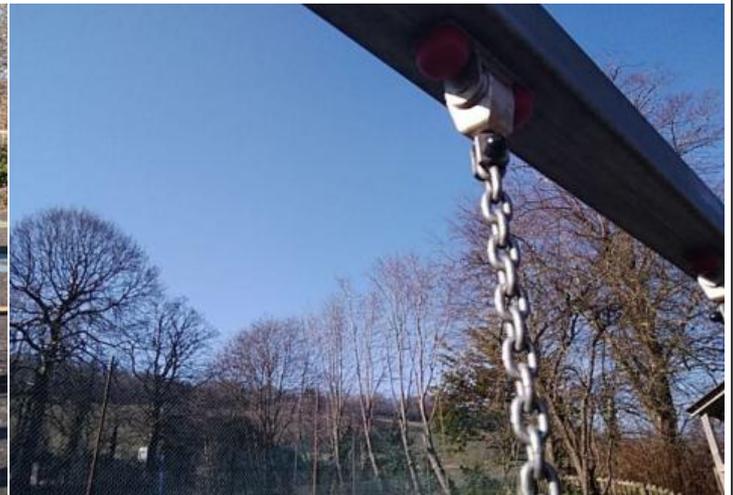
There is some notable evidence of chain wear - Monitor for any further deterioration and replace when 40% worn

Finding: There is some notable evidence of chain wear

Action: Monitor for any further deterioration and replace when 40% worn

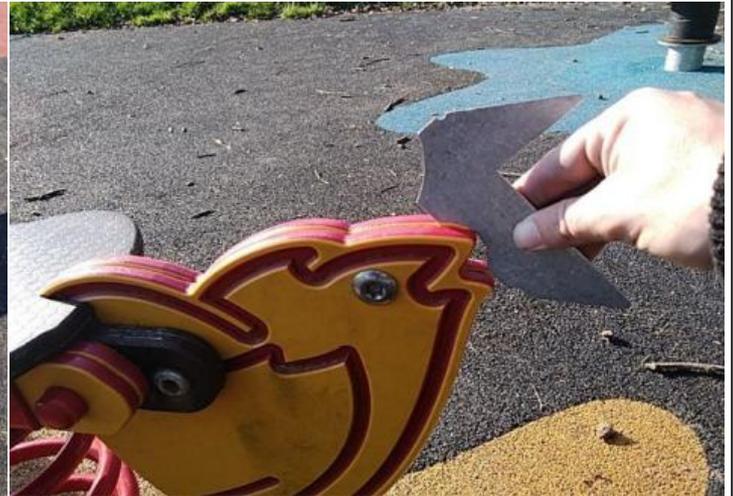
The main body profile has a radius of less than 20mm in places - Monitor - No remedial work recommended

Finding: The main body profile has a radius of less than 20mm in places

Action: Monitor - No remedial work recommended
