the **play inspection** company

Annual Inspection

Shoreham Parish Council

Shoreham Playground

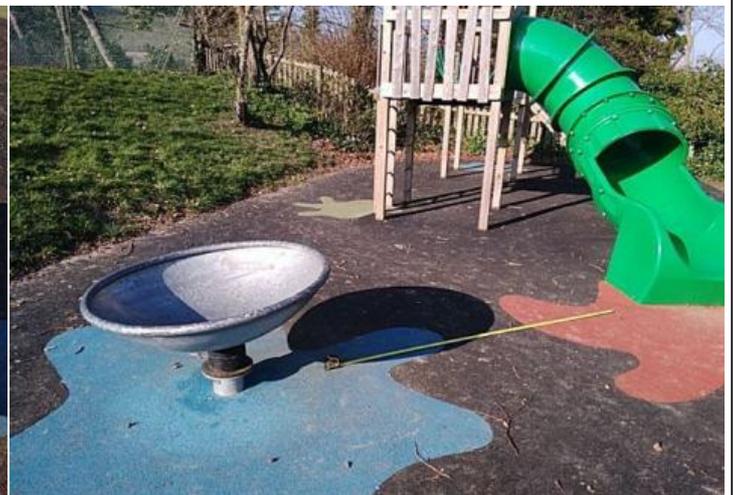
The falling space overlaps the free space between the dish roundabout and the slide in contravention of the requirements of BS EN 1176:2017 Part 1 - Monitor - No remedial work recommended

Finding: The falling space overlaps the free space between the dish roundabout and the slide in contravention of the requirements of BS EN 1176:2017 Part 1

Action: Monitor - No remedial work recommended

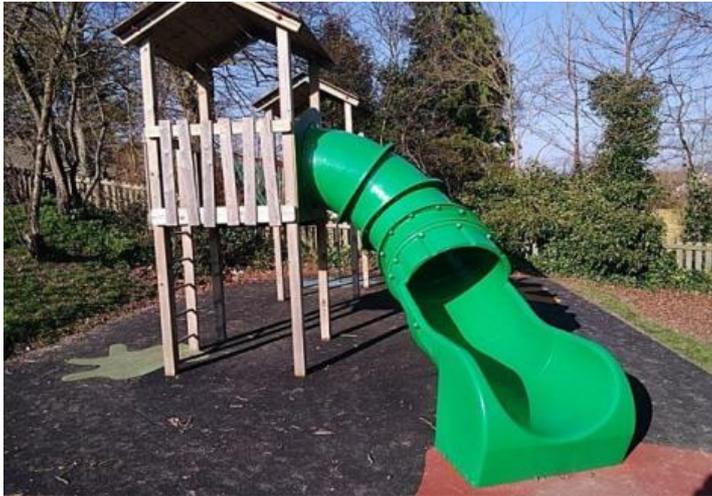
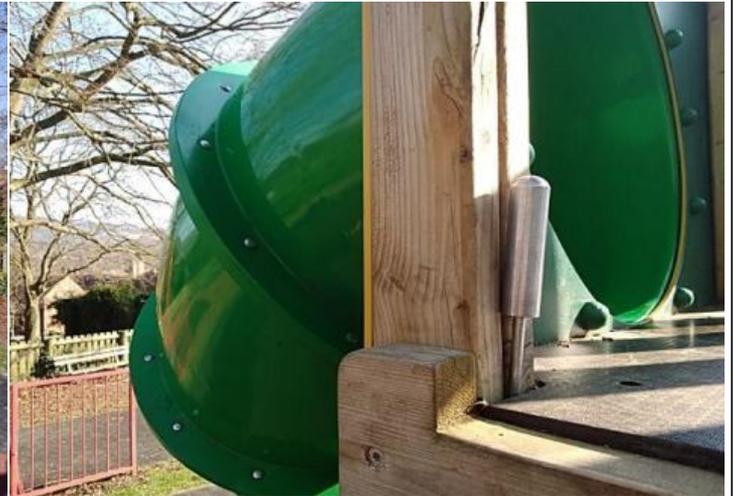
There is/are finger entrapment/s in the framework the item fails to meet the requirements of BS EN 1176 Part 1 4.2.7.6
 Entrapment of fingers - Monitor - No remedial work recommended

Finding: There is/are finger entrapment/s in the framework the item fails to meet the requirements of BS EN 1176 Part 1 4.2.7.6 Entrapment of fingers
Action: Monitor - No remedial work recommended

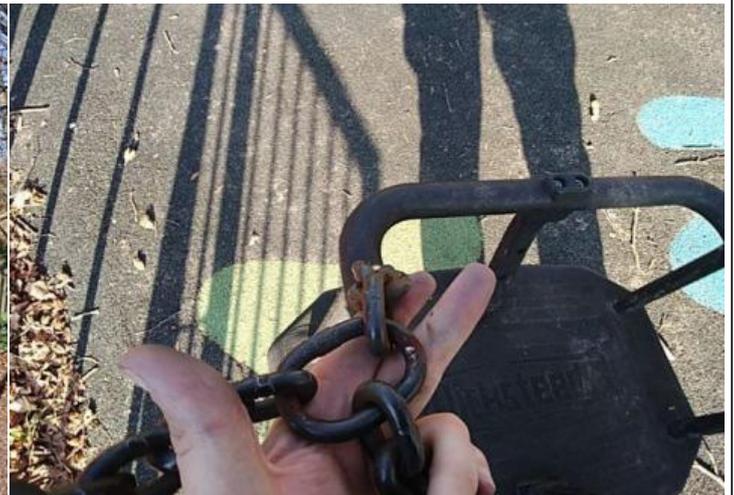
There is some notable evidence of chain wear - Monitor for any further deterioration and replace when 40% worn

Finding: There is some notable evidence of chain wear
Action: Monitor for any further deterioration and replace when 40% worn

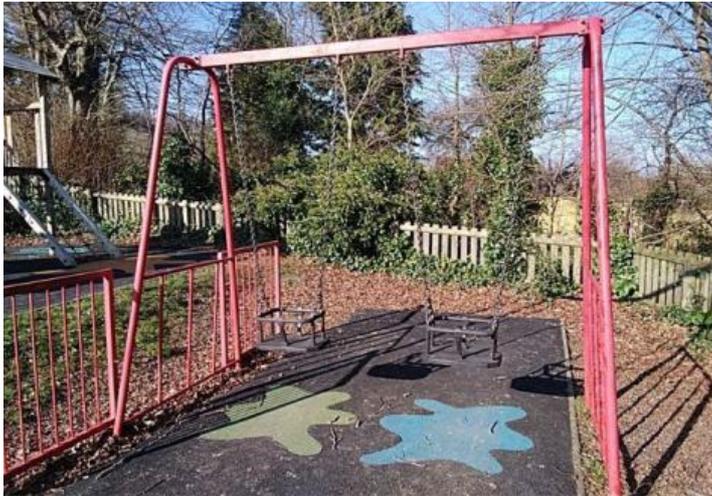
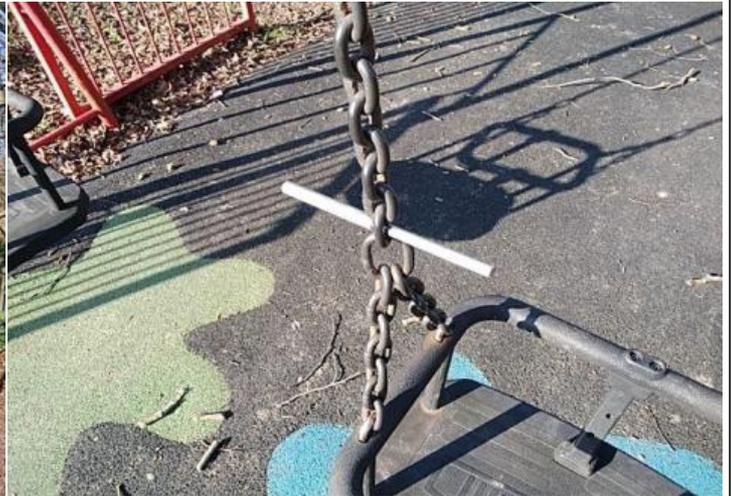
The chain openings are in excess of 8.6mm and do not meet the recommendations of BS EN 1176 Part 1 - Monitor - No remedial work recommended

Finding: The chain openings are in excess of 8.6mm and do not meet the recommendations of BS EN 1176 Part 1

Action: Monitor - No remedial work recommended

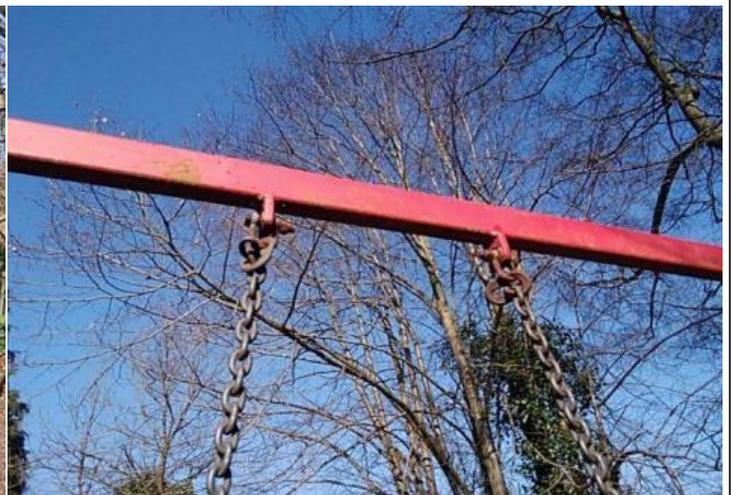
There is some wear to the shackles - Monitor for any further deterioration and replace when 40% worn

Finding: There is some wear to the shackles

Action: Monitor for any further deterioration and replace when 40% worn

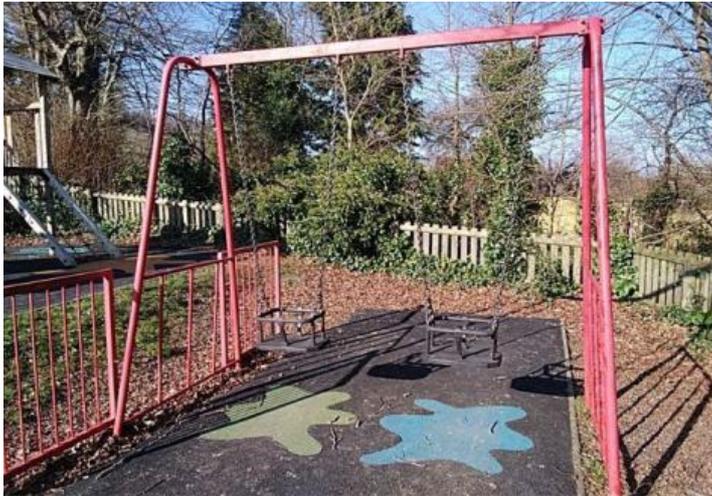
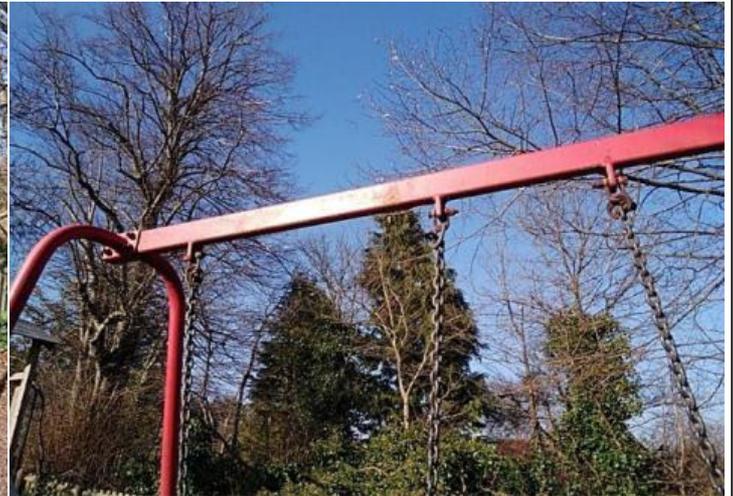
The bushes are showing signs of wear - Monitor for any further deterioration and replace as required

Finding: The bushes are showing signs of wear

Action: Monitor for any further deterioration and replace as required

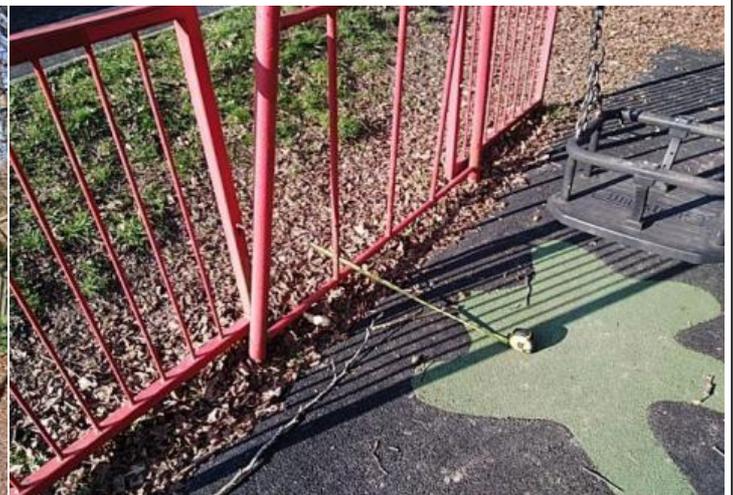
The seats are too close to the frame as defined in BS EN 1176 Part 2; this is a low risk failure and no remedial action is required - Monitor - No remedial work recommended

Finding: The seats are too close to the frame as defined in BS EN 1176 Part 2; this is a low risk failure and no remedial action is required

Action: Monitor - No remedial work recommended

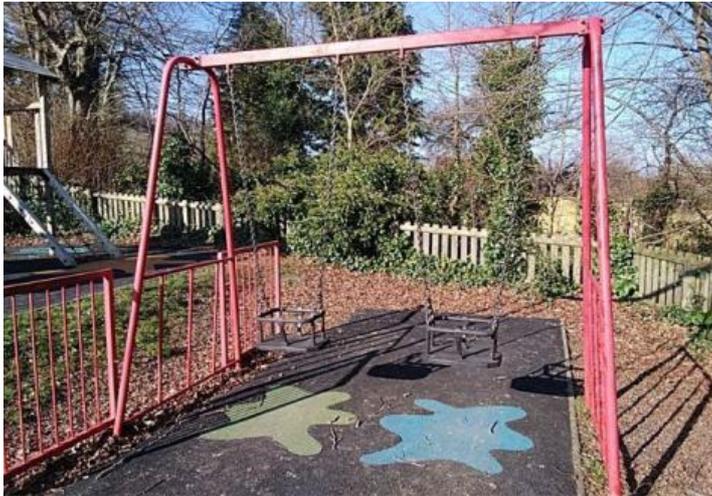
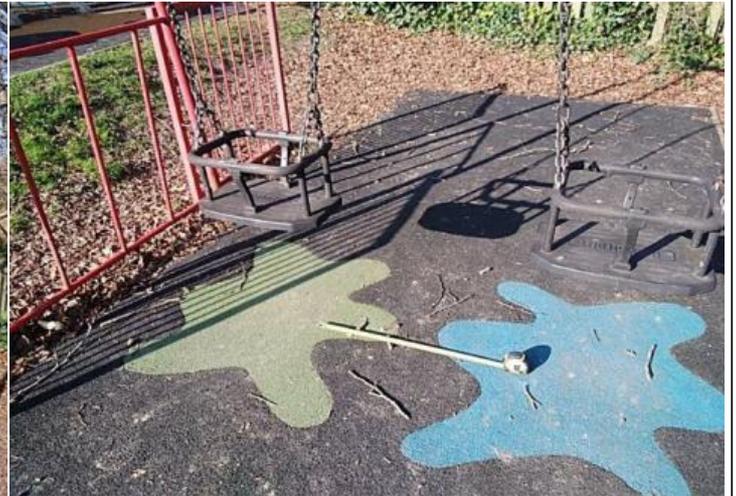
The seats are too close to each other as defined in BS EN 1176 Part 2; this is a low risk failure and no remedial action is required - Monitor - No remedial work recommended

Finding: The seats are too close to each other as defined in BS EN 1176 Part 2; this is a low risk failure and no remedial action is required
Action: Monitor - No remedial work recommended

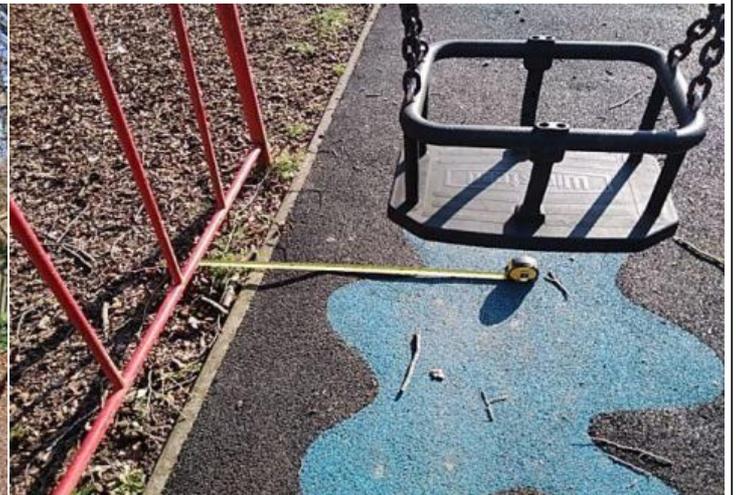
Finding: The surfacing width under each seat is less than 1.75 metres and fails the requirements of BS EN 1176 Part 2
Action: Monitor - No remedial work recommended
