# Safety Inspection Report

## St Mary Bourne Play Area

St Mary Bourne Parish Council

14 May 2026

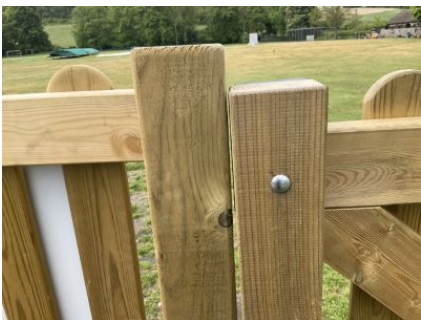
There is a crushing or shearing point on the side of the gate. Where the gaps reduce to less than 12 mm these have been known to cause serious, permanent injury to children, especially on the hinge side where the leverage forces are significant.

Adjust gate / posts / fit new rubber buffer to ensure a spacing of at least 12 mm throughout the range of the gate to remove the entrapment. The 12 mm gap also should apply on the hinge side of the gate.

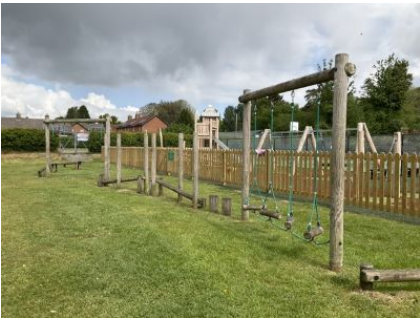
This equipment relies on one post for its stability. Special attention should be paid to maintenance (e.g. by monitoring degradation) and if necessary decommissioning the item before the end of its operating life. This is a requirement of the British Standard.

Consult with the manufacturer's guidance to determine suitable maintenance.

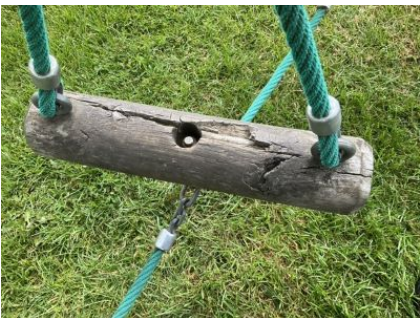
Timber is not in good condition.

Replace.

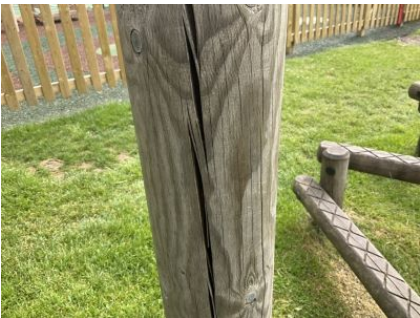
There are natural splits / shakes in the timbers.

Monitor and sand back any splintered edges as required.

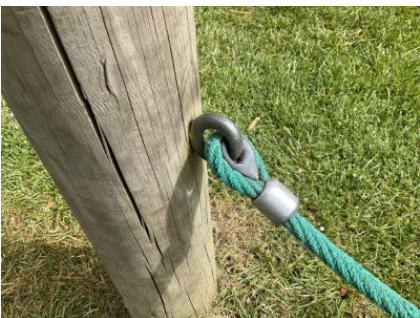
Bolt(s) loose.

Tighten.

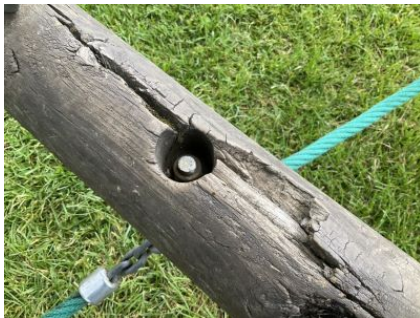
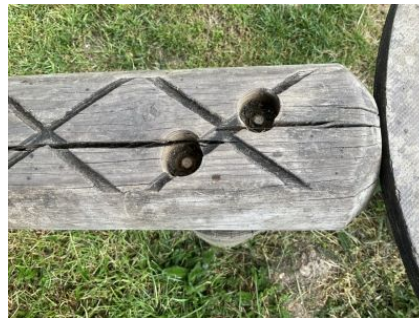
Cap missing.

Replace.

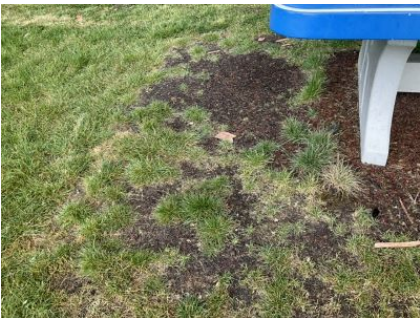
Surface has unintended weeds.

Remove.

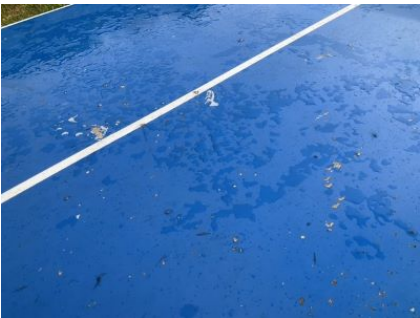
The paint is chipped.

Touch up the paint.

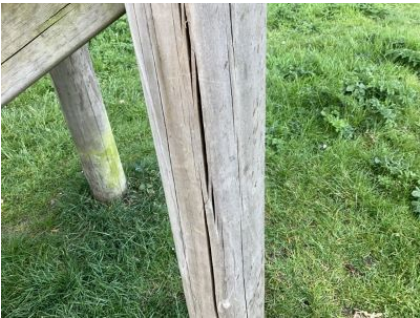
There are natural splits / shakes in the timbers.

Read the notes for further action.

Monitor.

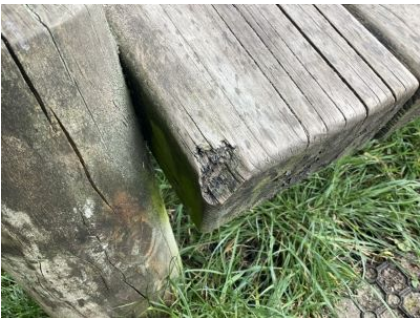
There are splinters or the potential for splinters.

Sand the timber down to remove the splinters and/or the places liable to give splinters.

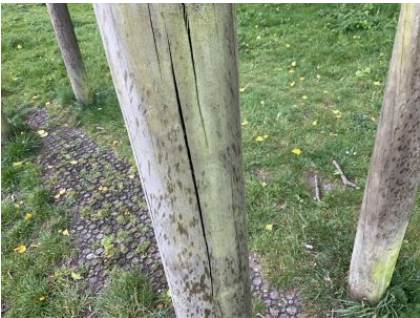
There are natural splits / shakes in the timbers.

Read the notes for further action.

Monitor.

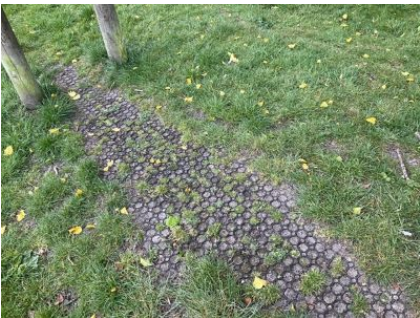
Surface is wearing.

Monitor for significant deterioration and rectify when necessary.

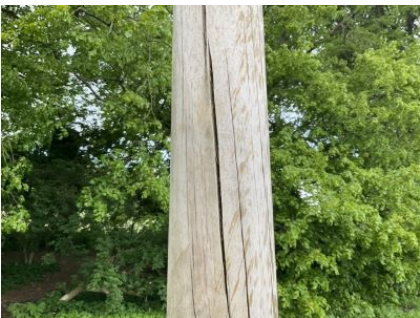
| Description | Tasks | Risk score |
|---|---|---|
| There are natural splits / shakes in the timbers. | Monitor and sand back any splintered edges as required. | 4 |

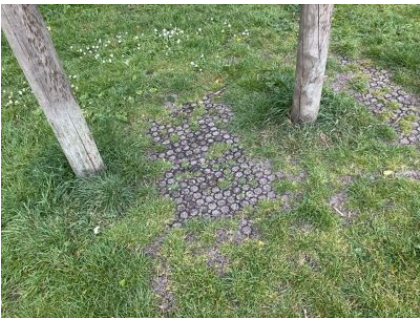
Surface is wearing.

Monitor for significant deterioration and rectify when necessary.

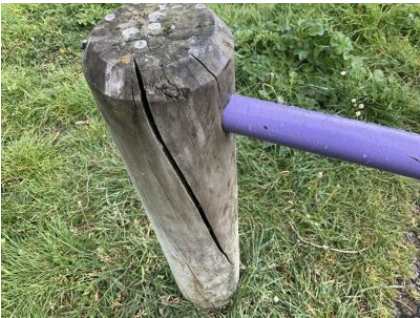
| Description | Tasks | Risk score |
|---|---|---|
| There are natural splits / shakes in the timbers. | Read the notes for further action. | 3 |

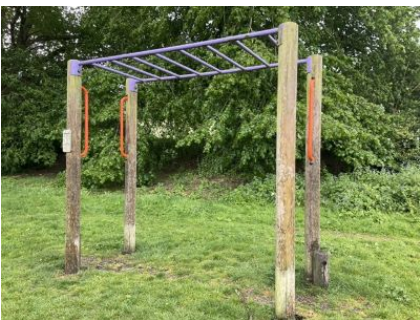
Overhead ladders and rings provide significant play value and benefits to children, and with it the risk of falling. Ensuring the surface remains in good condition will help to keep the correct balance between benefits and risk.

The protective surface under all bars and rings must be kept in good condition.

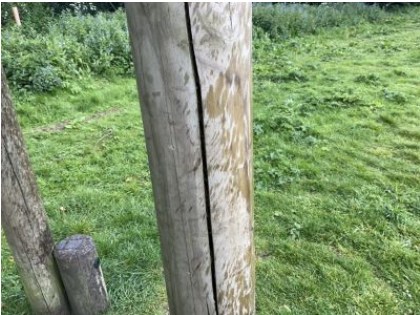
| Description | Tasks | Risk score |
|---|---|---|
| There are natural splits / shakes in the timbers. | Read the notes for further action. | 4 |

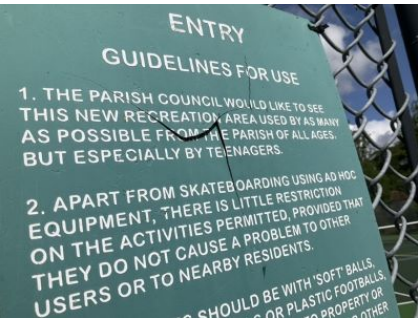
Item is cracked.

Replace.

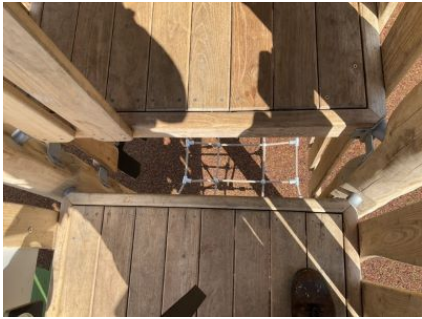
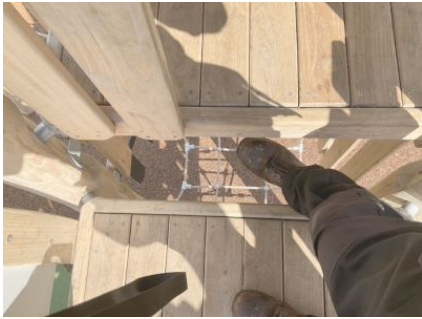
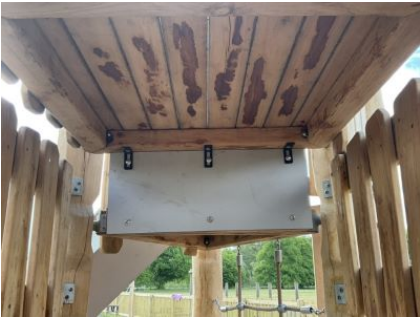
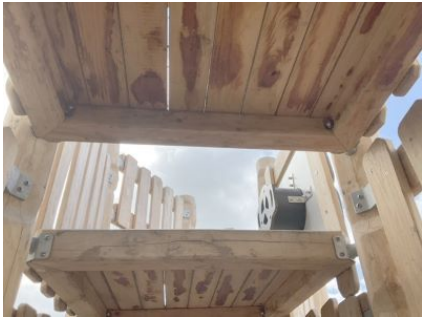
Item has some parts missing.

Query with the manufacturer a part is possibly missing. There is an infill panel present between one set of stepped decks but not the other. The gap is of sufficient size that users of the equipment are likely to try and pass through it, both intentionally and unintentionally.

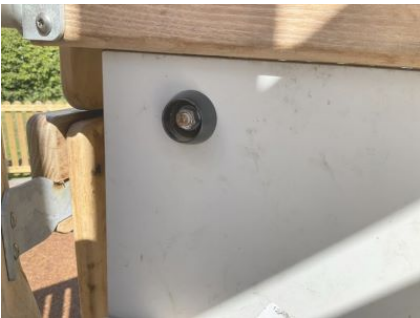
Cap missing.

Replace.
