PLAY AREA SAFETY INSPECTION REPORT

Chideock Parish Council

Inspection undertaken September 2022
This report issued October 16th 2022

Park Name: Mill Lane
Location: Mill Lane, Chideock. DT6 6JS

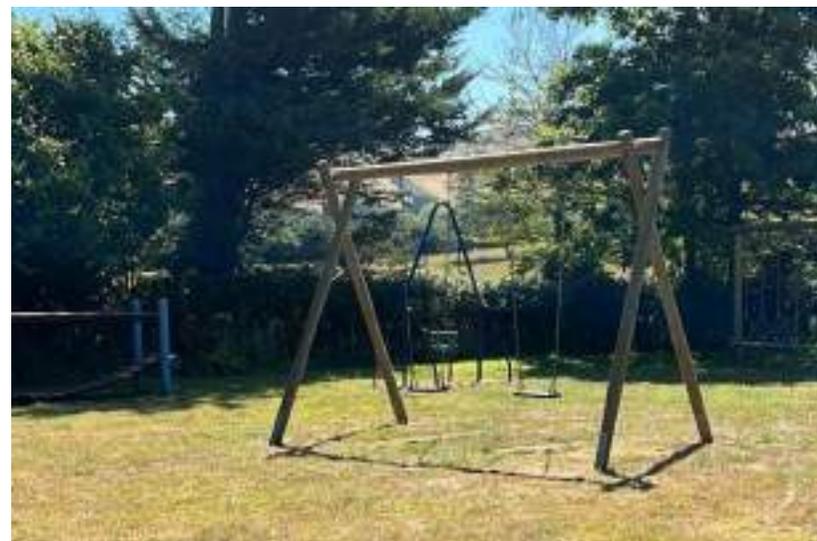
4.1 *Twin Junior Swing Set*

New crossbar fitted and previous movement in the post shoes has reduced.

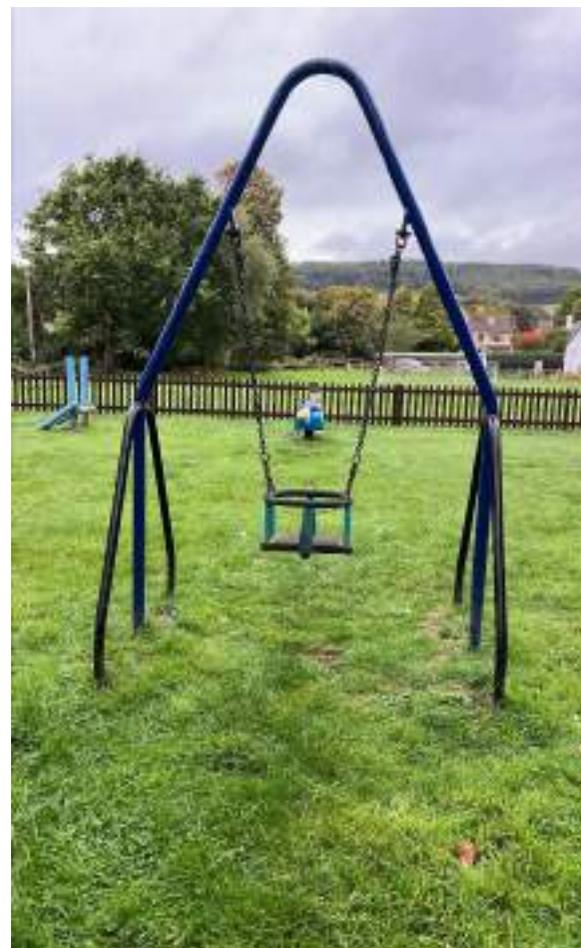
4.2 Toddler Swing

This traditional frame from Wicksteeds' heritage range is old but in good condition. The gate latch links are in reasonable condition with sufficient links on the outside.

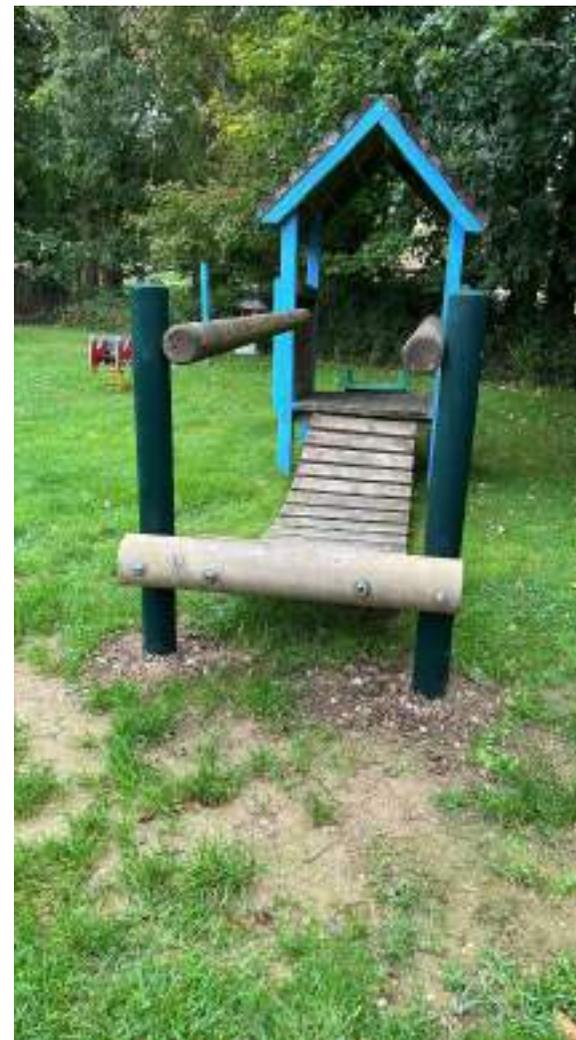
4.3 *Playhouse with bridge & Slide*

This item is in reasonable condition for its age and the bridge end posts have now been replaced.

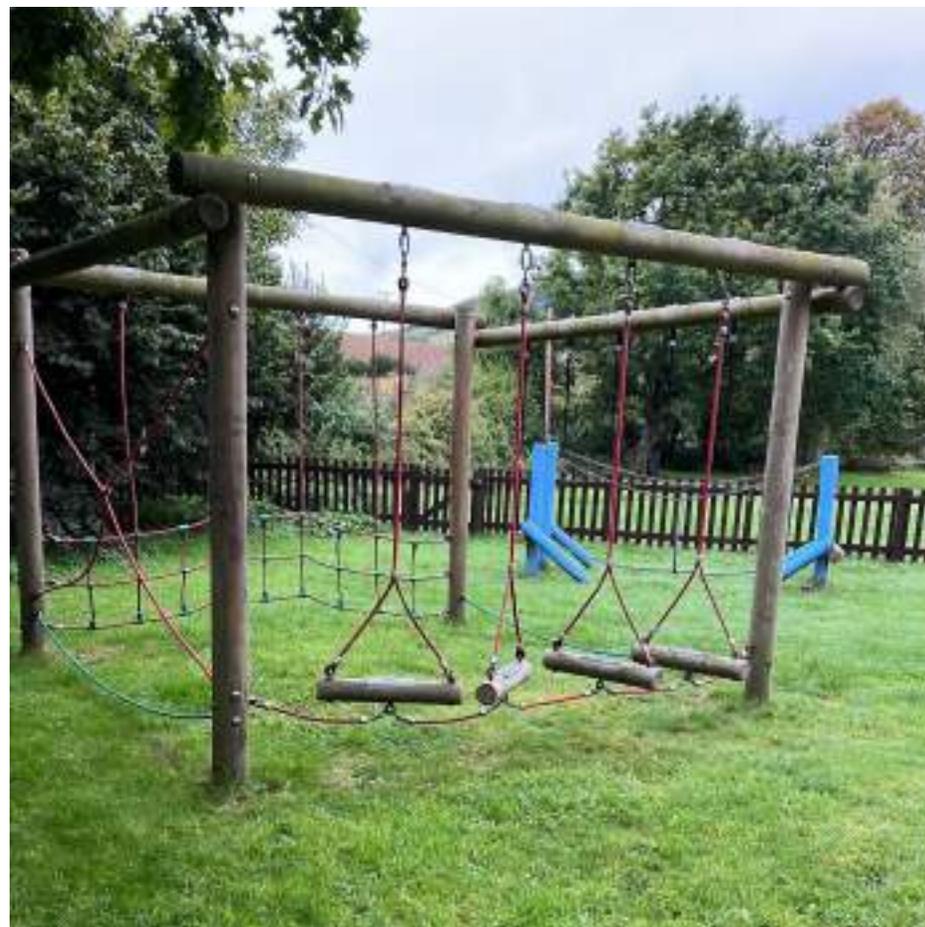
4.4 *Sovereign Agility Cube*

There are no issues with this unit currently.

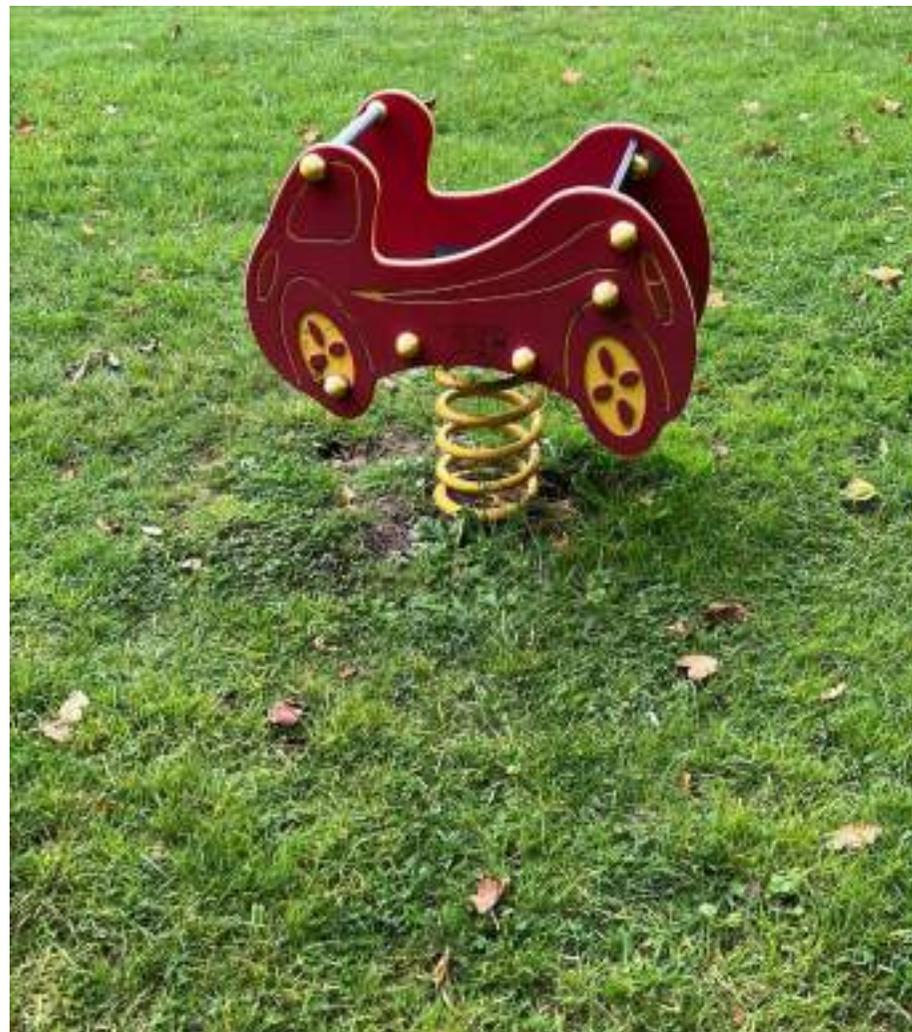
4.5 *Sit in Car Springer*

There is a great of corrosion on the base plates for this unit. Replacement of these components is possible and costs are shown at 5.

Item	Issues	Recommendation (s)
4.5	The decay in the springer base plate will lead to product failure	Plan for removal and replacement within 2.5 years / possibility of replacement of parts only.
4.8	Timbers are decaying	Replace older timber elements within 2 years. Treat all existing timbers
4.11	Picnic table inside play area	Must be fixed or relocated outside of fenced area.

Costs have been obtained for the springer and are shown at 5. This cost is contingent on re-installing the unit in a different location.

Item	Issues	Recommendation (s)	Supply Only	Supply & fit
4.5	Springer corroding	Replace parts		£450.00
4.8	Original timbers decaying	Supply and fit new timbers to Burmese bridge		POA

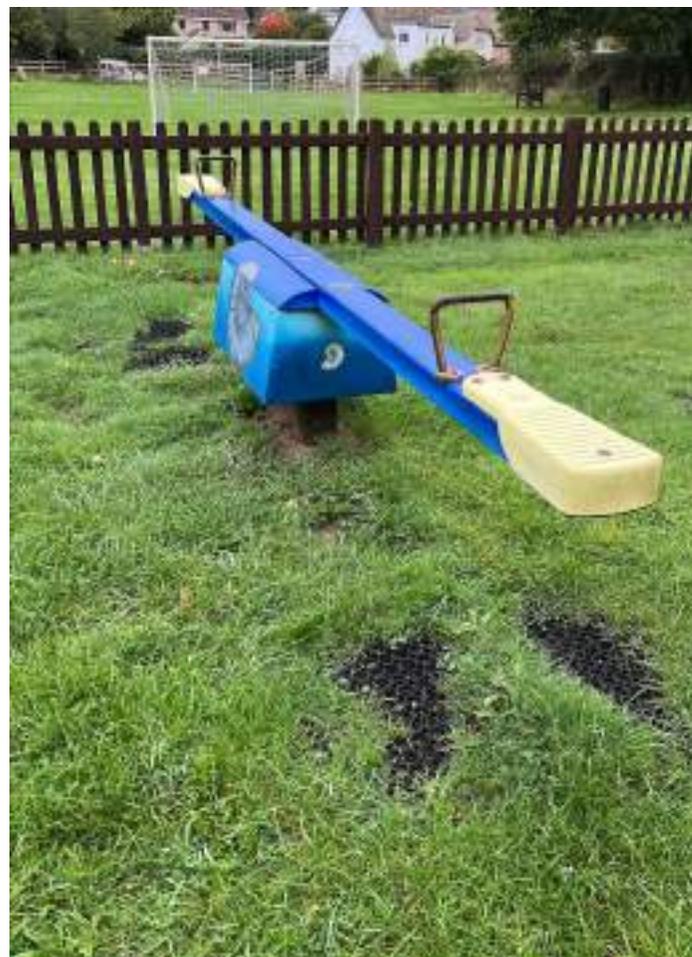
4.6 **Wicksteed See saw**

This Wicksteed see-saw is still in good working order.

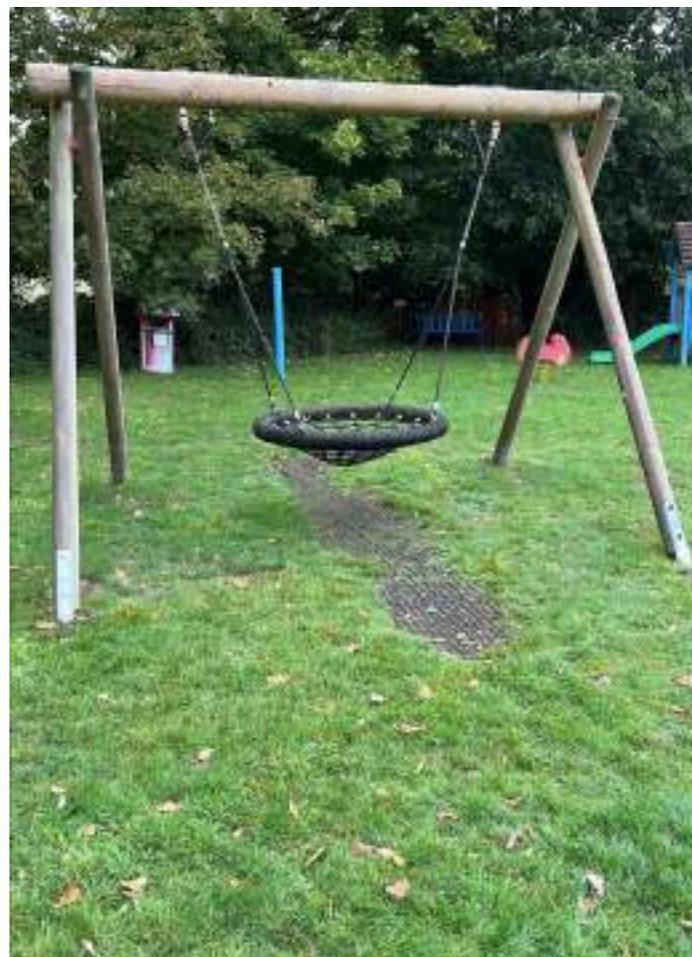
4.7 *Caledonian Play Basket Swing*

This item is in good condition

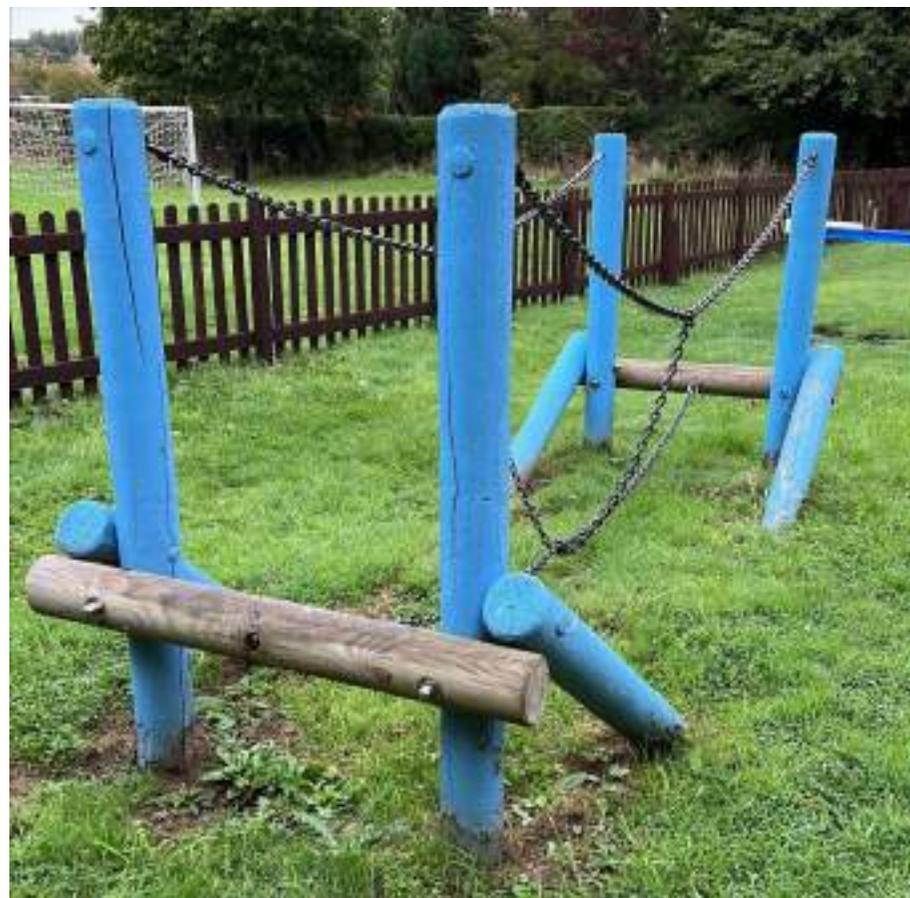
4.8 *Playquest Burmese Bridge*

This item is in reasonable condition for its age, but the remaining timbers will need replacing soon.

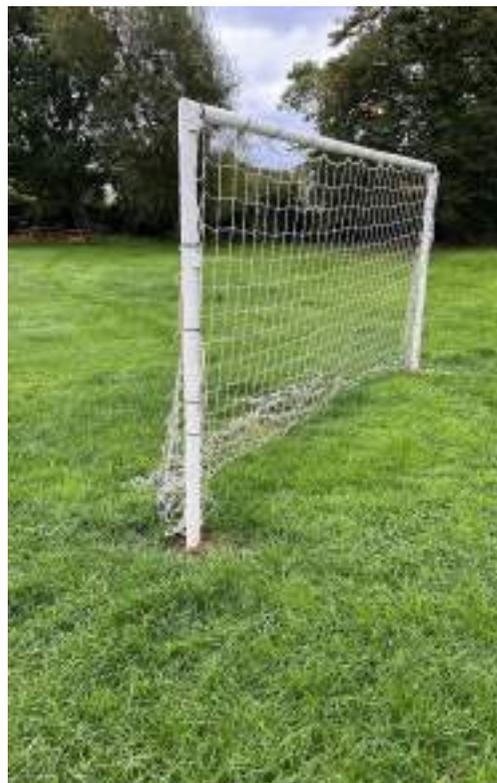
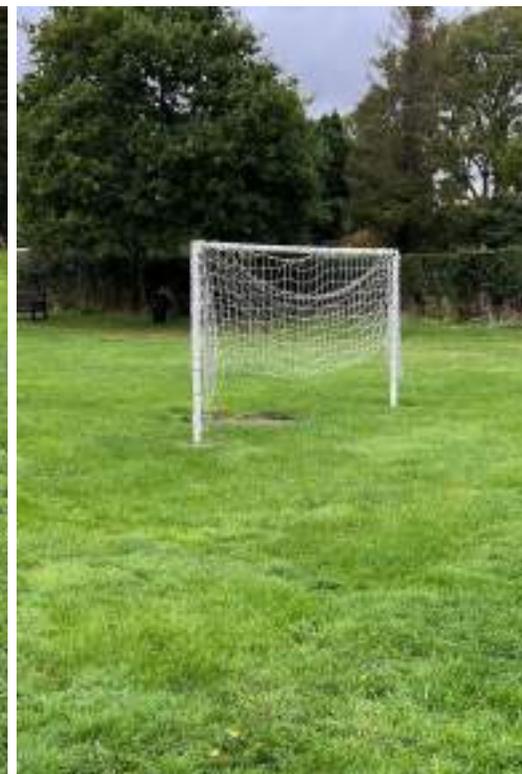
4.9 Goalposts

It should be noted that the nets were out of place and not securely pegged again. As previously indicated it is possible to get goal sets with fitted run backs or with run backs that can be raised for mowing.

These goal posts are ageing and thought should be given to their replacement over the next 15 months.

Depending on who uses them it may be worth considering goals with fully fitted nets that can be moved for mowing. Depending on size and strength these vary from £480 to around £1,200. It really depends if the goals are ever used for league fixtures of any kind. If not then it is worth considering smaller 5 or 7 a side style goals with fixed nets.

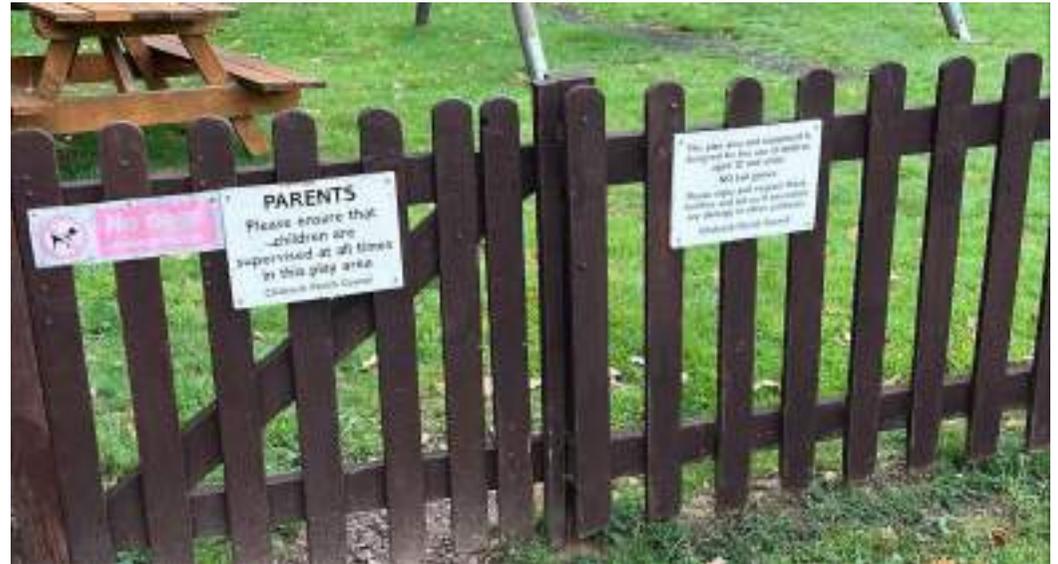
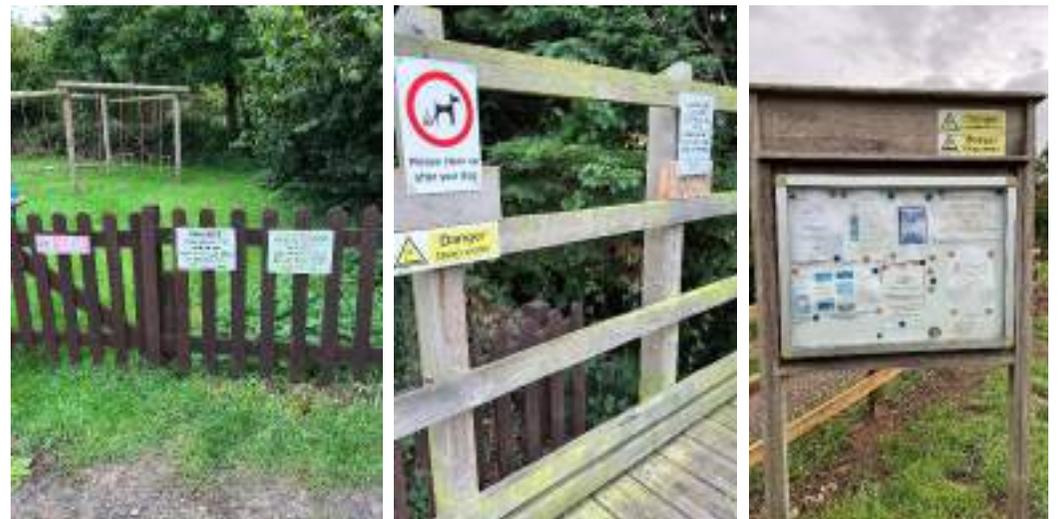
4.10 Signs

Effective location signs are now in place.

Warnings against deep water and overhead power cables are also present.

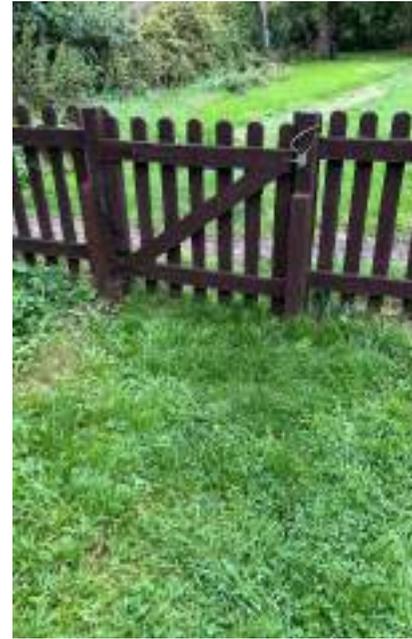
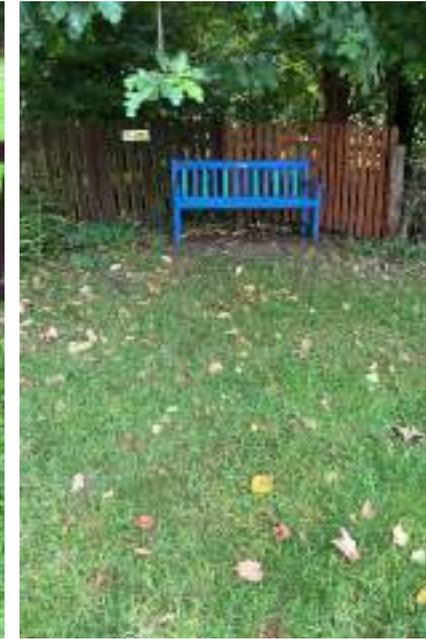
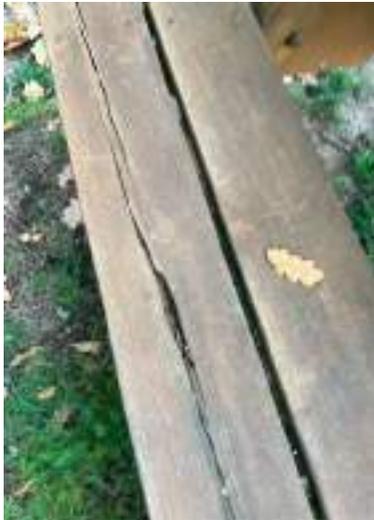
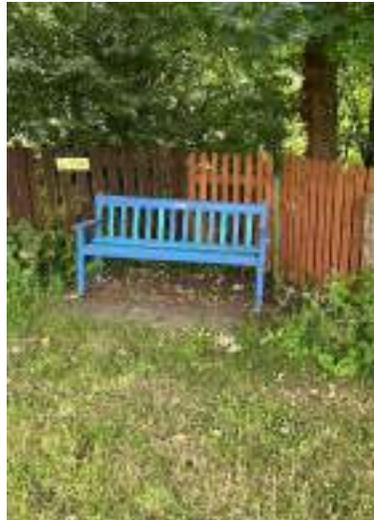
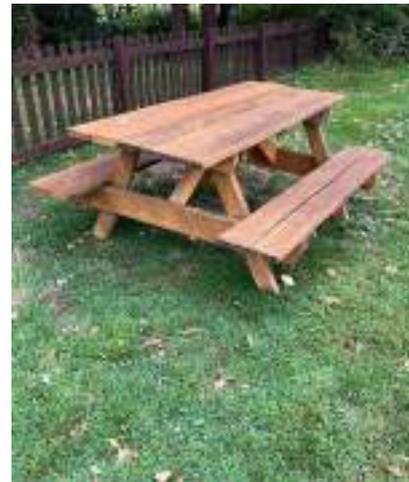
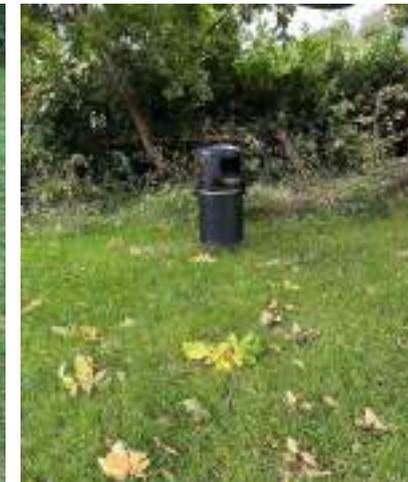
4.11 Barriers, Boundaries, Benches & Bins

The site is bordered on several sides by water. In most cases these are shallow drains but just below the main play area is a deep gully with the River Winniford flowing through it. The gates are self-closing and the mechanism is working effectively.

Fencing and gates are in reasonable condition and are being well maintained.

There are several nearby bins and a variety of benches around the site in reasonable condition. There is some decay in the seat of one of the picnic tables. It should also be noted that if picnic tables are going to be positioned inside the play area they must be fixed to prevent them being placed in the fall area of swings or climbing equipment where they could cause injury.

A picnic table has been placed inside the play area. This must be either fixed to prevent movement (screw in ground anchor and chain are sufficient – approx. £25) or moved outside the play area. Otherwise they can be placed in the fall area of climbing and swinging equipment and can then cause injury.
