PLAY AREA SAFETY INSPECTION REPORT

Chideock Parish Council

Inspection undertaken April 26th 2021

Park Name: Mill Lane

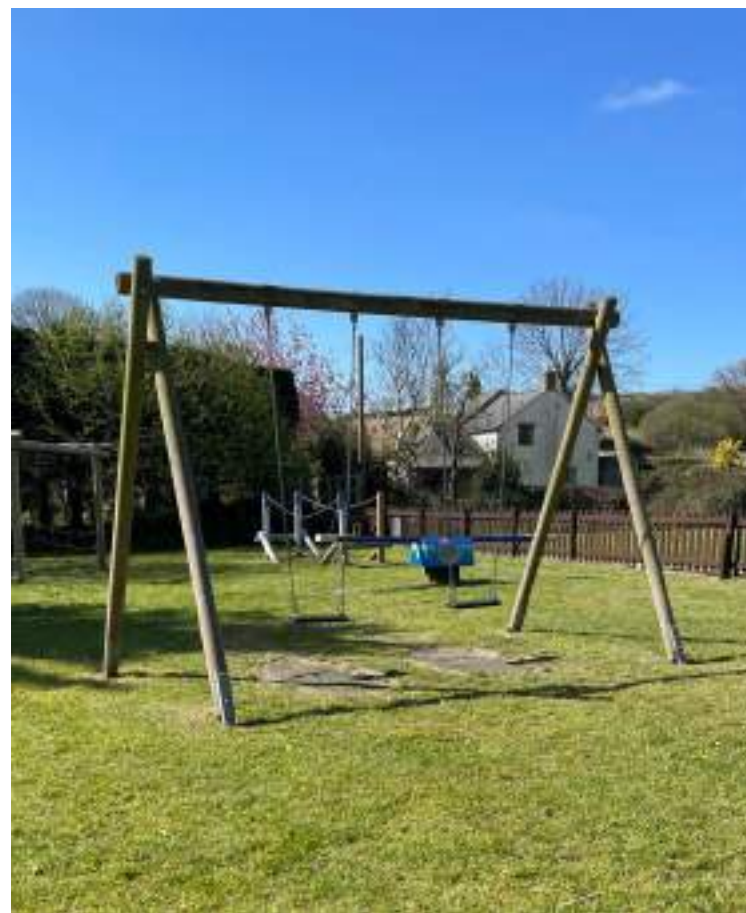
4.1 *Twin Junior Swing Set*

There is a need for the application of a penetrative preservative to reduce the likelihood of decay. There is some movement in the top joints, but this has not increased since the last inspection.

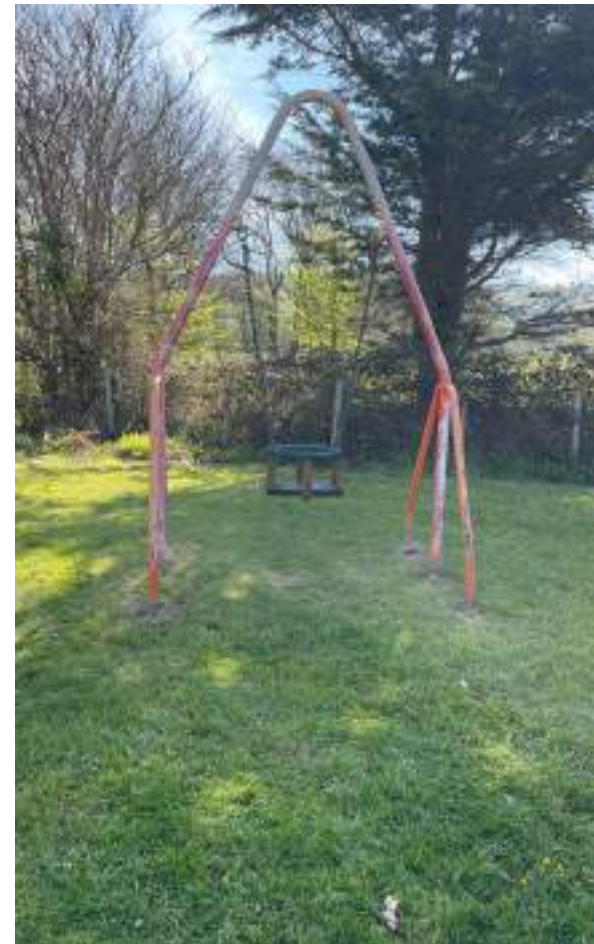
4.2 Toddler Swing

This traditional frame from Wicksteeds' heritage range is old but in good condition. The gate latch links are in reasonable condition with sufficient links on the outside.

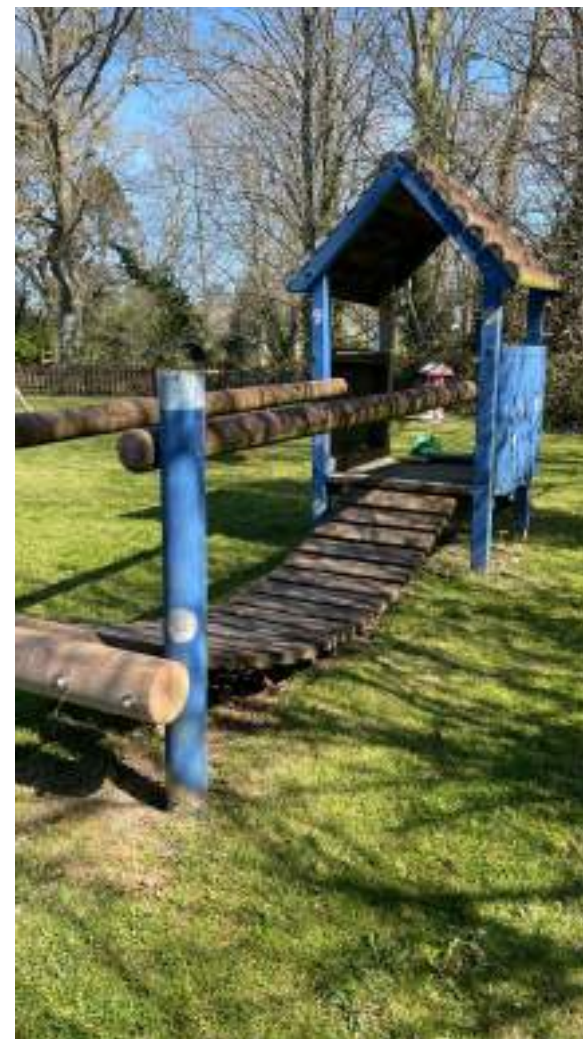
4.3 *Playhouse with bridge & Slide*

The bridge supports have been replaced and this has improved the ground clearance. There is a need for the application of a penetrative preservative to reduce the likelihood of decay.

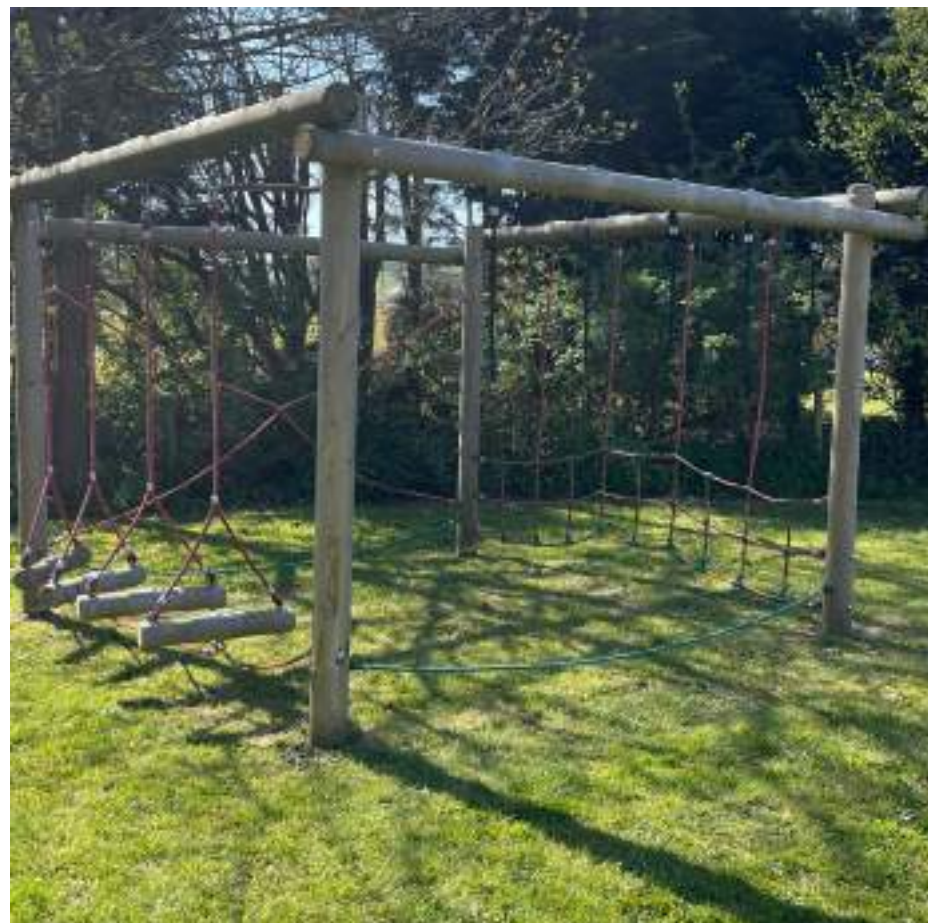
4.4 Sovereign Agility Cube

There is a need for the application of a penetrative preservative to reduce the likelihood of decay.

There are no other issues with this unit currently.

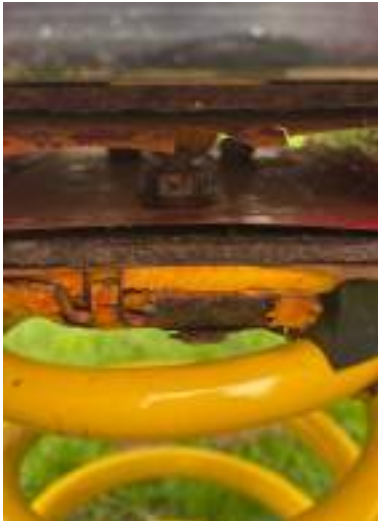
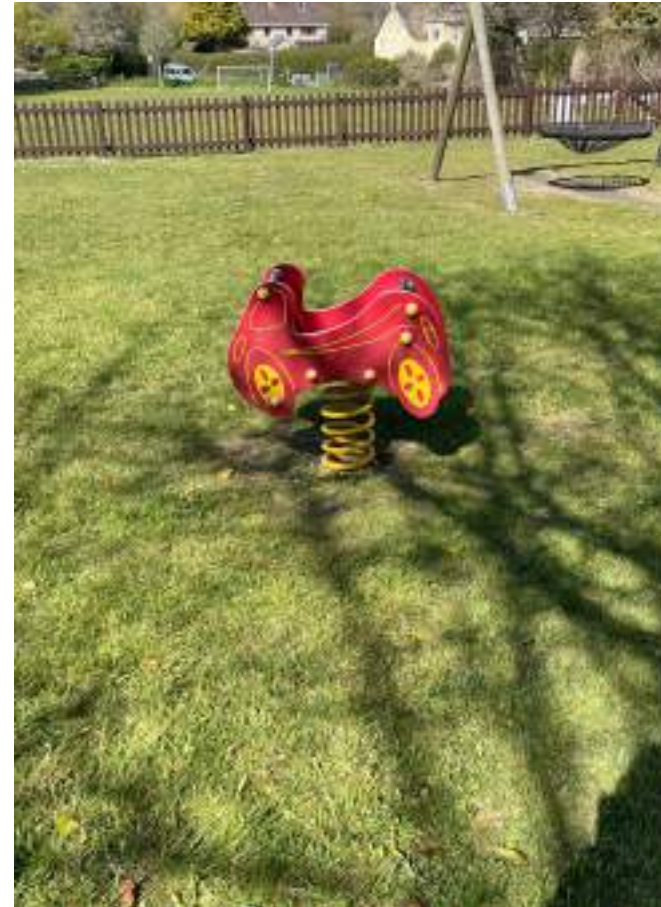
4.5 *Sit in Car Springer*

This springer is supplied by PlayQuest and Venture Play amongst others. The mounting base plate is showing its age and a significant degree of corrosion can be seen. This is the point at which the unit connects to its spring and the stress here means that unit is likely to fail in 2-4yrs. There is no adequate remedial action that can be taken.

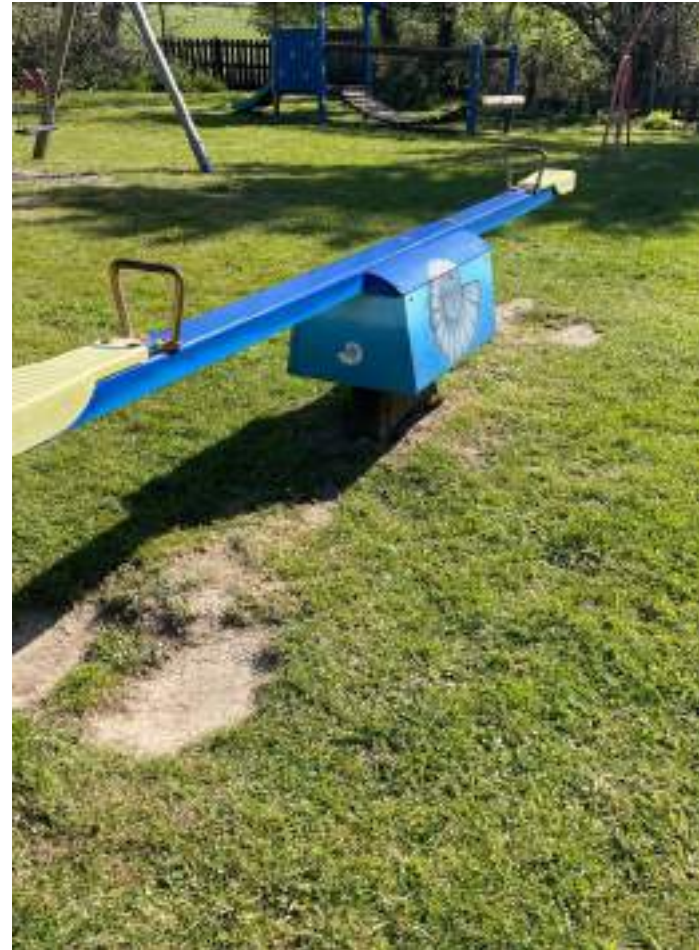
4.6 **Wicksteed See saw**

This Wicksteed see-saw is still in good working order. These units are fitted with an internal “anti-bump” mechanism that damps the unit and prevents children lifting clear of the seat and prevents entrapment issues.

The unit predates the BSEN 1176 standards and the clearance is lower than the current standard recommends. However the damping mechanism means that any element of risk is extremely low.

The fall height of 1.65m means that where grass is the safety surface then it should be maintained in good condition. It may be worth considering rubber grass mats around this unit to prevent further wear and compaction of the surface which is becoming quite apparent.

Item	Issues	Recommendation (s)	Supply Only	Supply & fit
4.6	Possible compaction issues	Grass mats recommended (min 6)	£180	£255.00
4.8	Original timbers decaying	Supply and fit new timbers to Burmese bridge		415.00

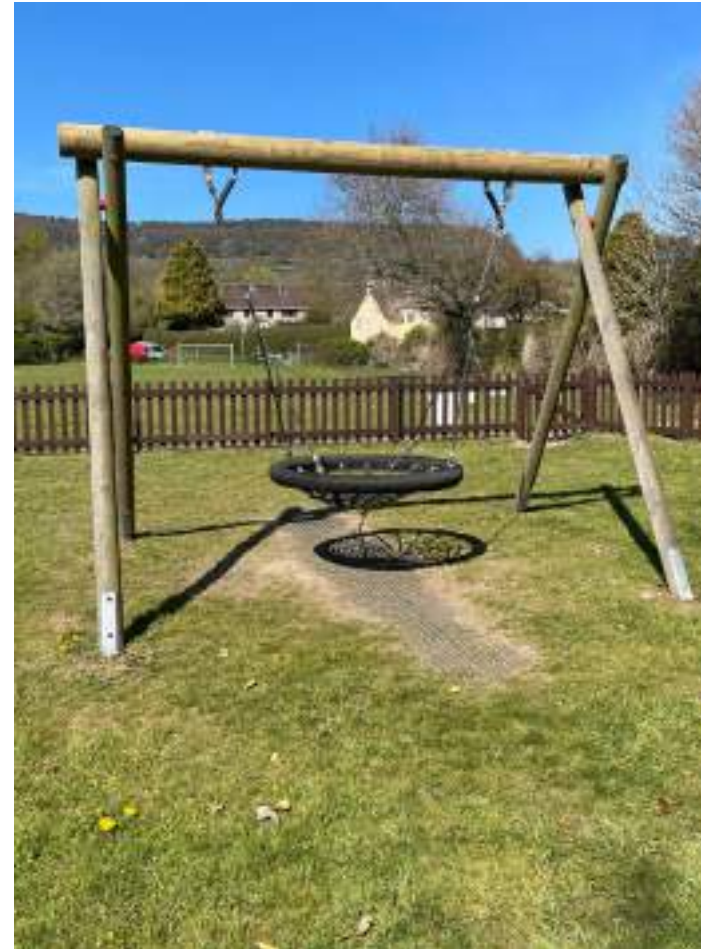
4.7 Caledonian Play Basket Swing

The crossbar on this unit had rotted out and a new crossbar was supplied on the 5/10/2020 and fitted on the 19th October 2020

There is a need for the application of a penetrative preservative to reduce the likelihood of decay.

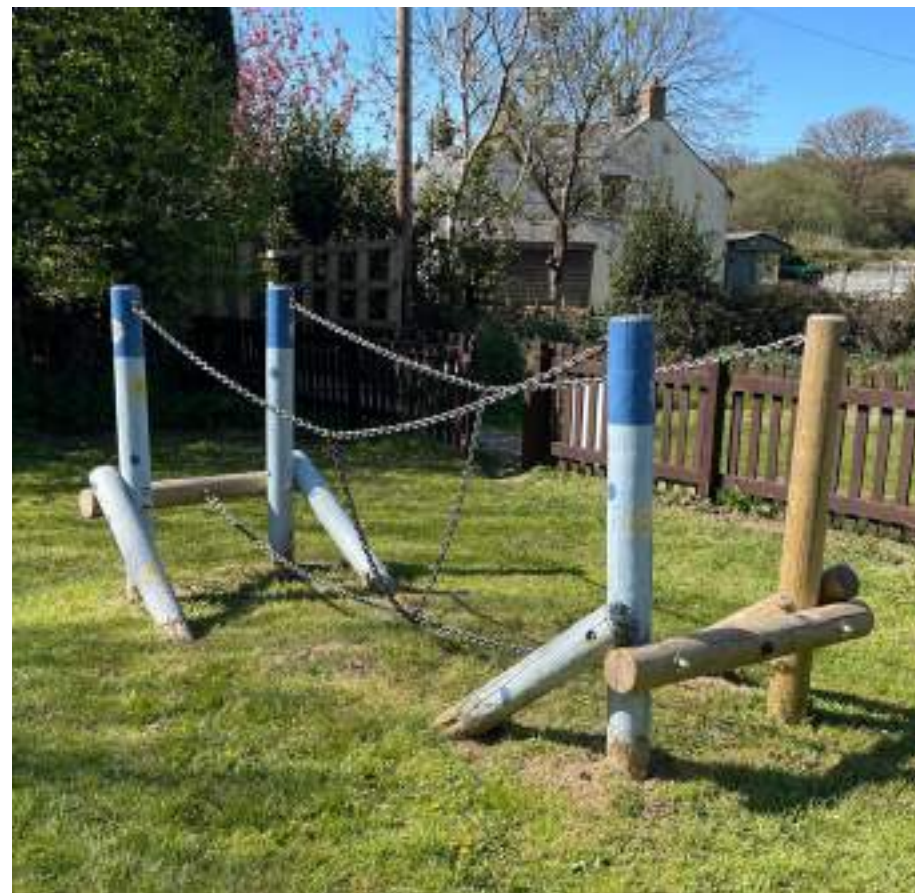
4.8 *Playquest Burmese Bridge*

Elements of this unit had rotted out and were replaced on 29th July 2020
The remaining elements (still painted blue) are likely to require replacement over the next 18 months – two years

There is a need for the application of a penetrative preservative to reduce the likelihood of decay.

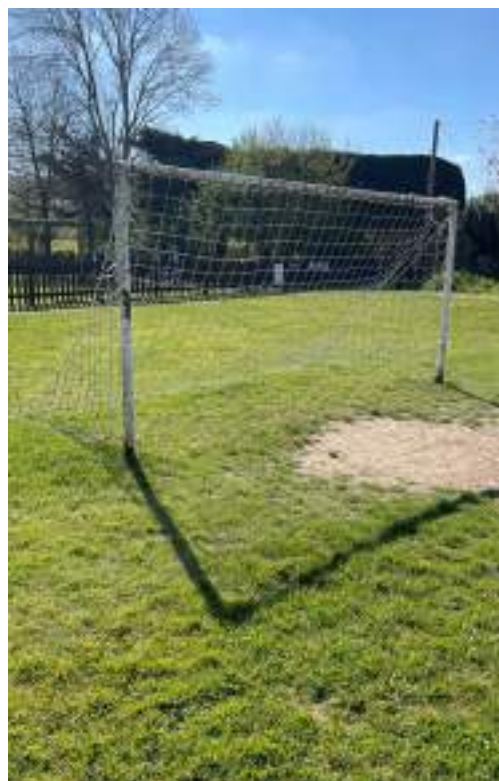
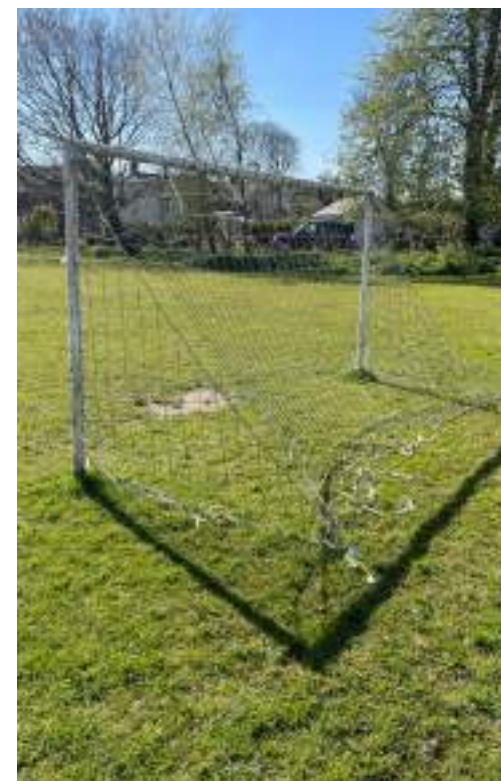
4.9 Goalposts

The crossbar deflection on both goals is within tolerance.

These 16 x 6 Goalposts are in average condition. There is some rust, and the stanchions are missing. These are replaceable and should be in place if nets are fitted. (Available from Huck /Edwards in Bridport).

The need to keep the nets securely pegged has been raised with the groundsman. There is an ongoing issue with the removal of pegs and this should be monitored as unpegged nets may cause a hazard.

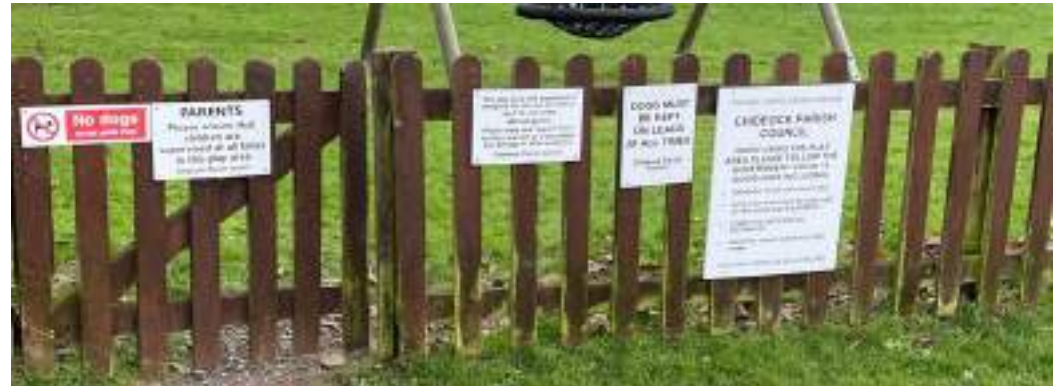
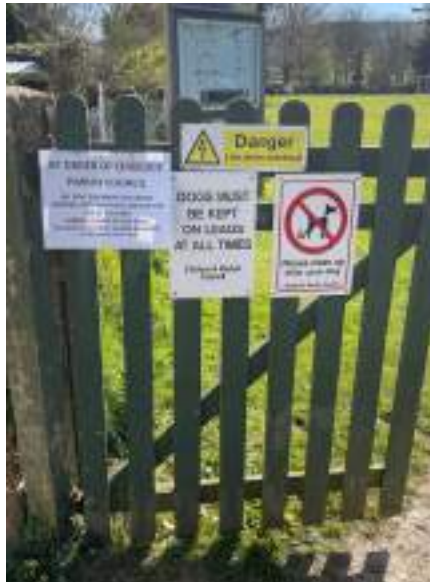
4.10 Signs

There is no location sign with UK emergency contact number displayed. This should be understood in the context of a visitor being unsure of their location, a strong possibility here with visiting campers, and being in need of urgent assistance. The sign should display the location including the post code and 999 as the emergency number

There is an operators' sign asking users to report damage etc. but this has no contact details. This can be an email address or phone number, but it is a requirement.

Effective signs are present indicating the need for social distancing and the need for hand sanitation. These are can now be safely assumed to be a requirement under UK Health & safety legislation.

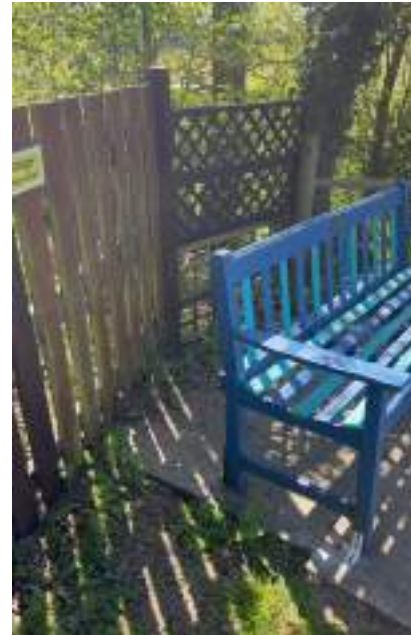
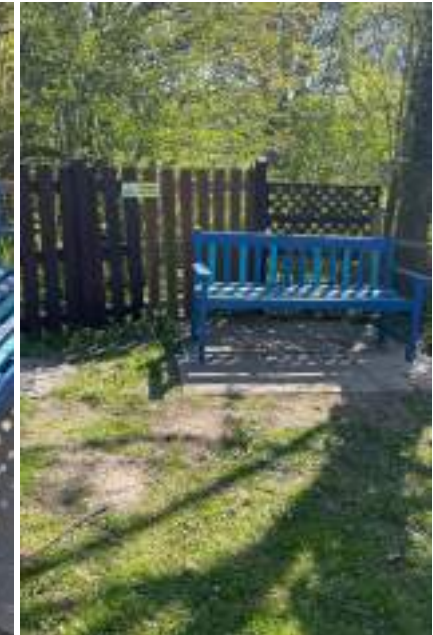
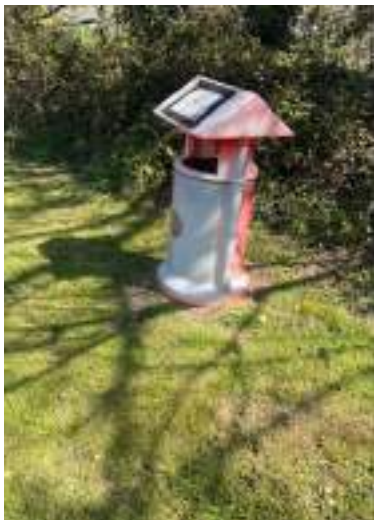
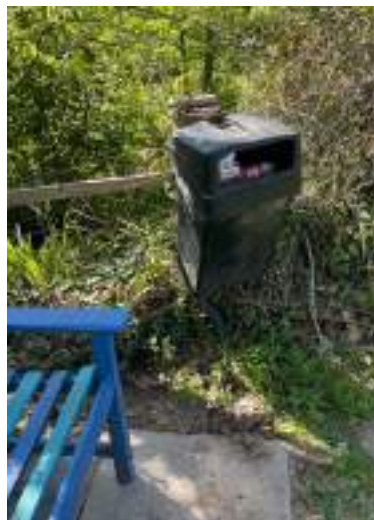
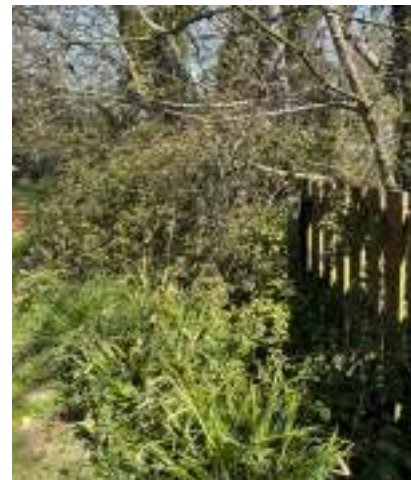
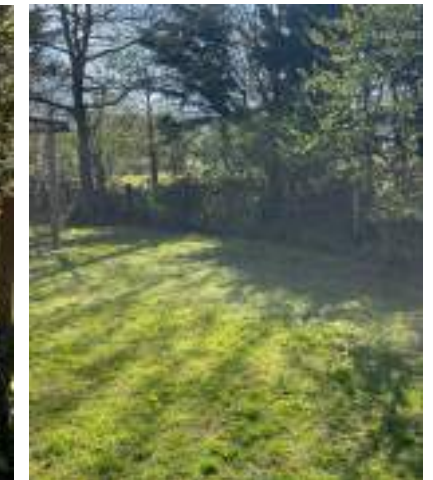
4.11 Barriers, Boundaries, Benches & Bins

The site is bordered on several sides by water. In most cases these are shallow drains but just below the main play area is a deep gully with the River Winniford flowing through it. The bench shown right has been moved away from the fence but there are still elements of the fencing configuration which mean it can be easily surmounted. Discussions on site took place and recommendations were made to replace the section shown right with chestnut palings fixed to stakes. This could be moved further out from the bench and cannot be climbed giving an affordable and aesthetically more pleasing finish to the area.

There are several nearby bins and a variety of benches around the site in reasonable condition. During Covid additional care should be taken when emptying bins. The bin shown bottom right should be relocated away from the bench – during the summer this could cause a problem with wasps.

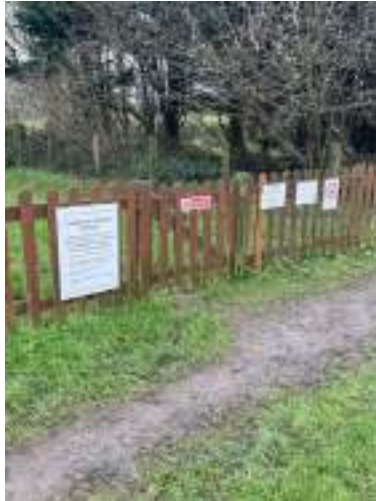
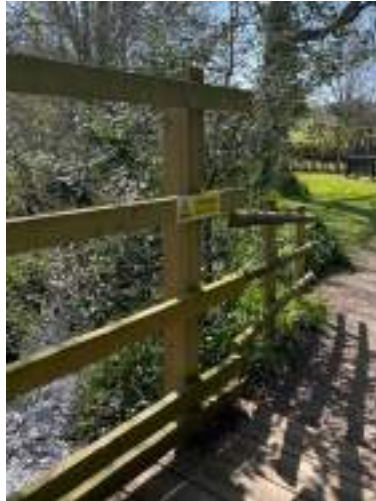
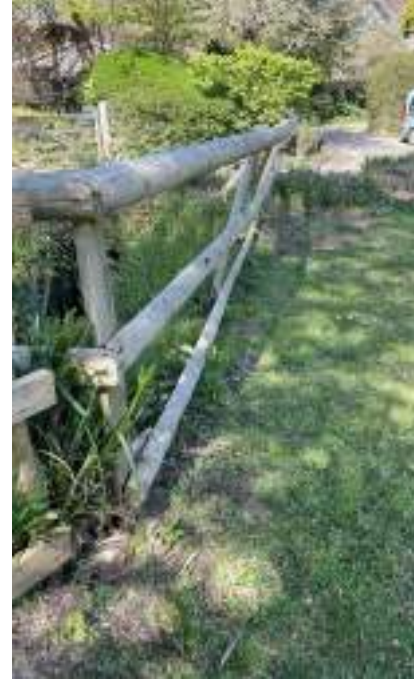
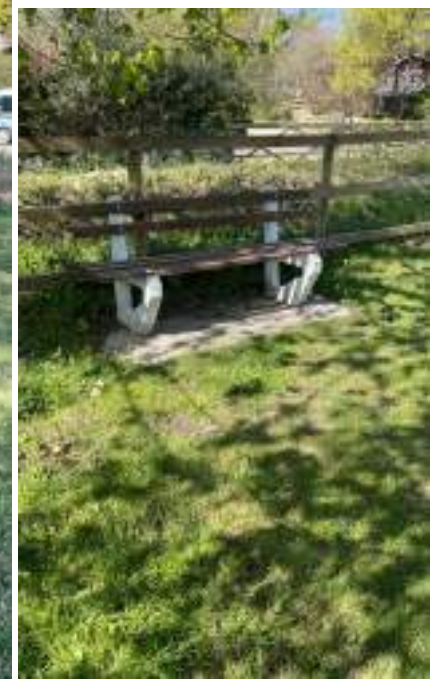
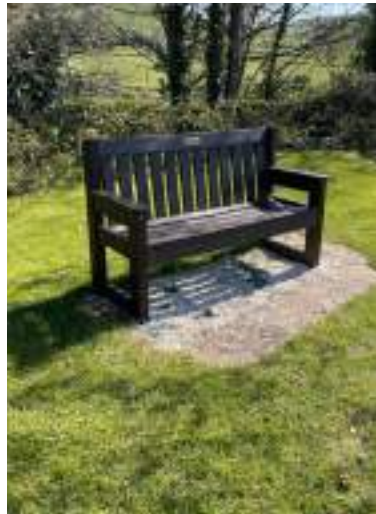
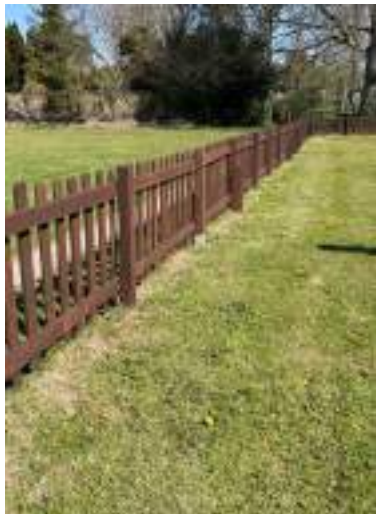
The fencing in the corner with the bench closest to the road is in need of repair. The bench is too close to the fence, but the risk is lower here outside the main play area.
