## Annual Inspection

Winchester City Council

West Meon Village Hall RG (West Meon PC)

Headon View, West Meon, Hampshire, GU32 1LH

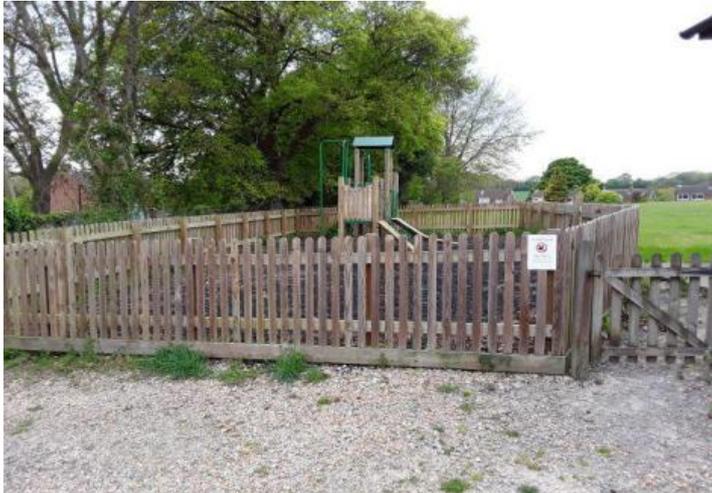
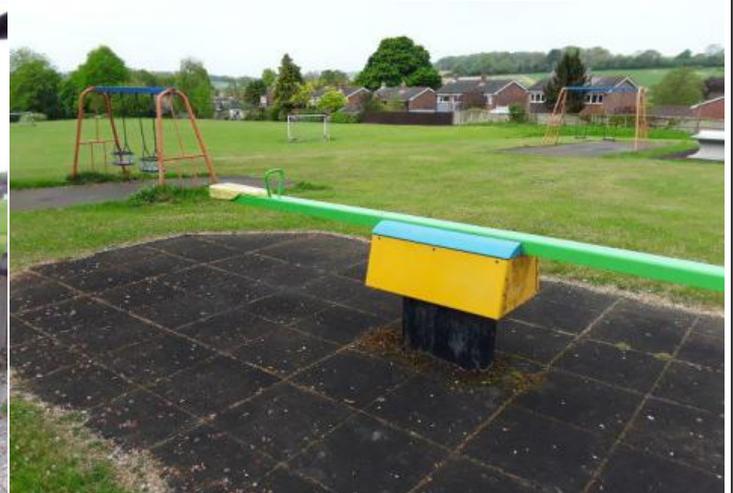
**Finding:** There is algae or moss growth on the safety surfacing resulting in slippery conditions

**Action:** Clean and treat appropriately

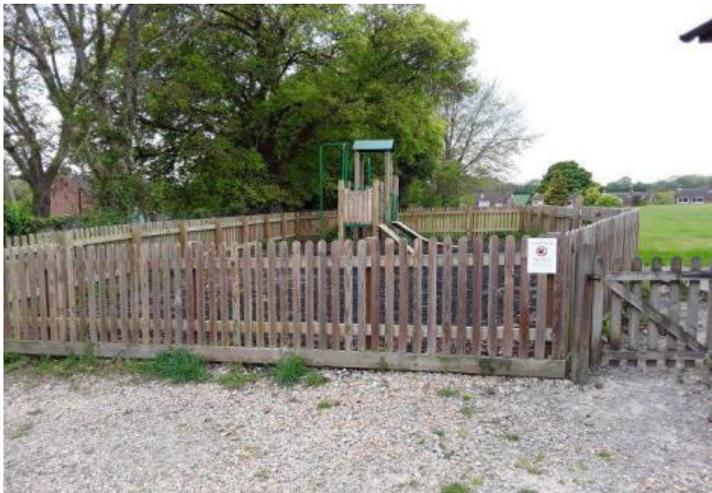
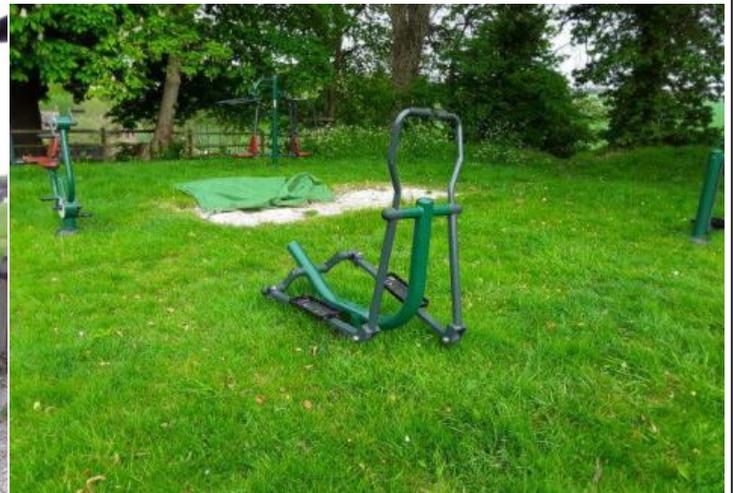
**Finding:** The grass is overgrown within the play area and may hide hazards

**Action:** Reduce the length of grass to an acceptable height and maintain

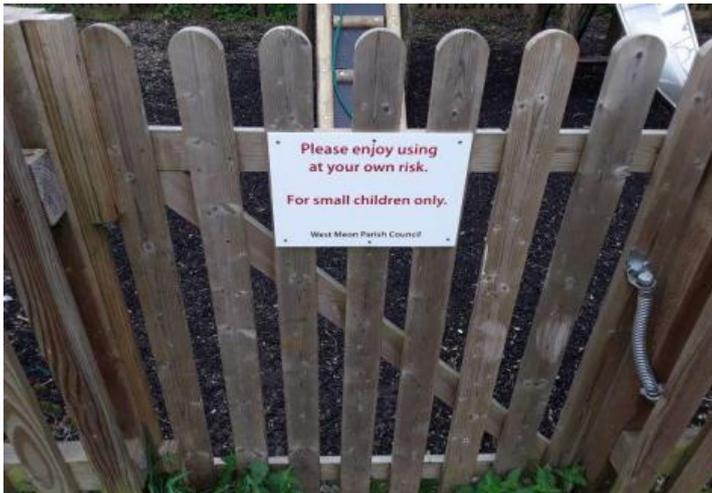
**Finding:** BS EN 1176 recommends that signage, with information including the site address, contact information for maintenance issues and emergency contact details are provided on the playground  
**Action:** Provide in accordance with the recommendations set out in BS EN 1176 Part 7

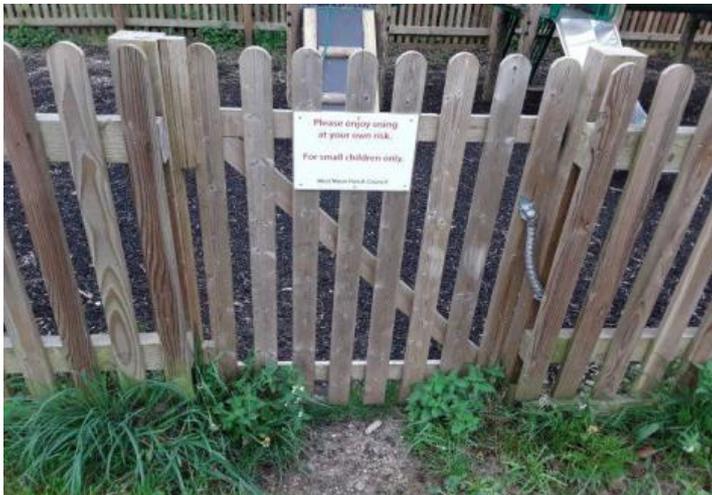
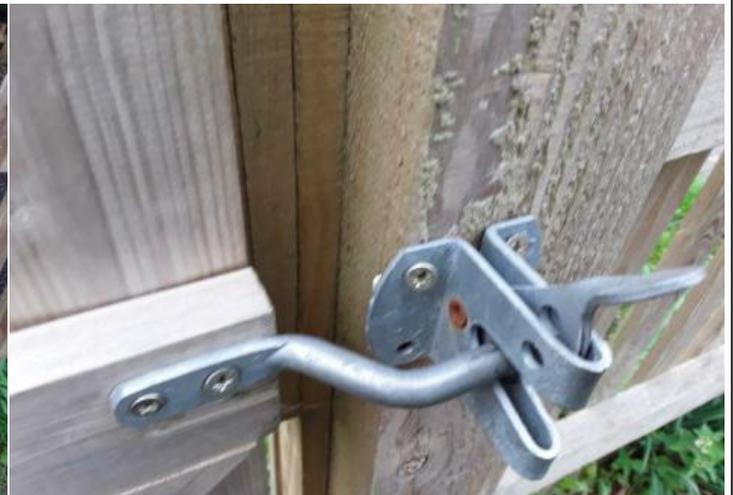
**Finding:** There is or are fixings missing on the item

**Action:** Replace all missing fixings

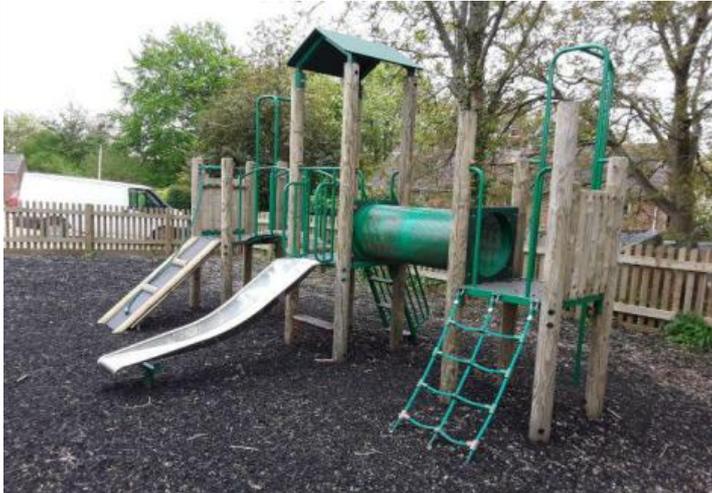
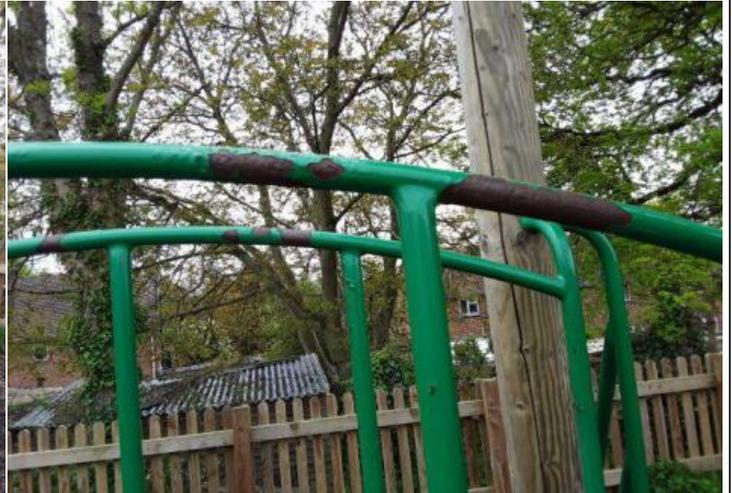
**Finding:** The paintwork on this item has been damaged or worn exposing the metal underneath which is rusting

**Action:** Treat any rusting components and repaint

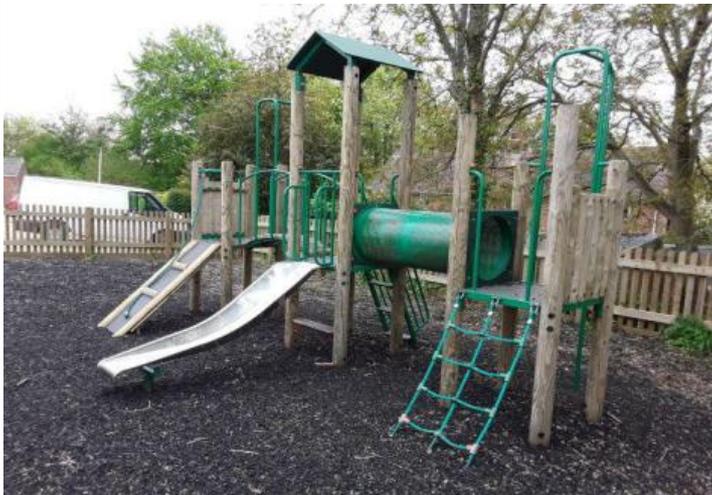
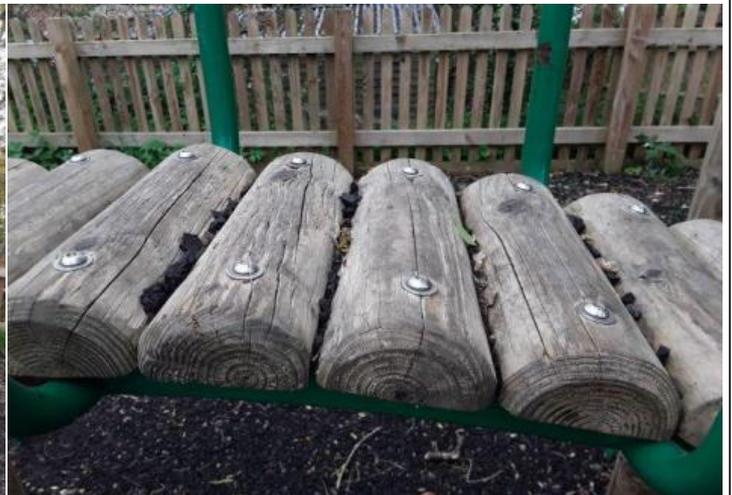
**Finding:** A number of tread fixing(s) have worked loose

**Action:** Secure all loose fixings

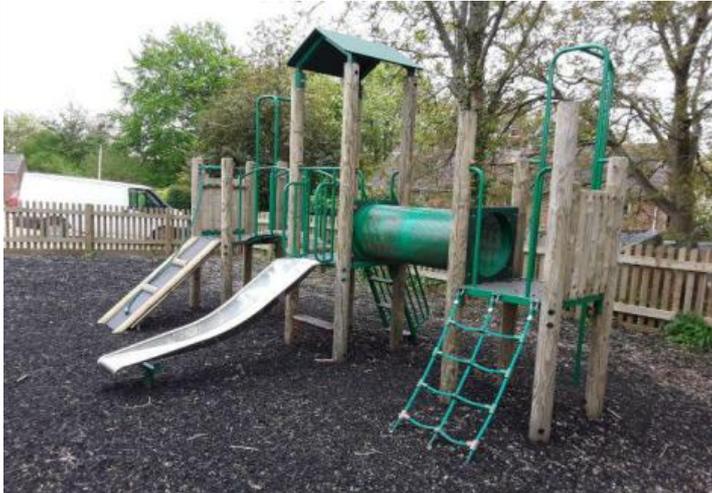
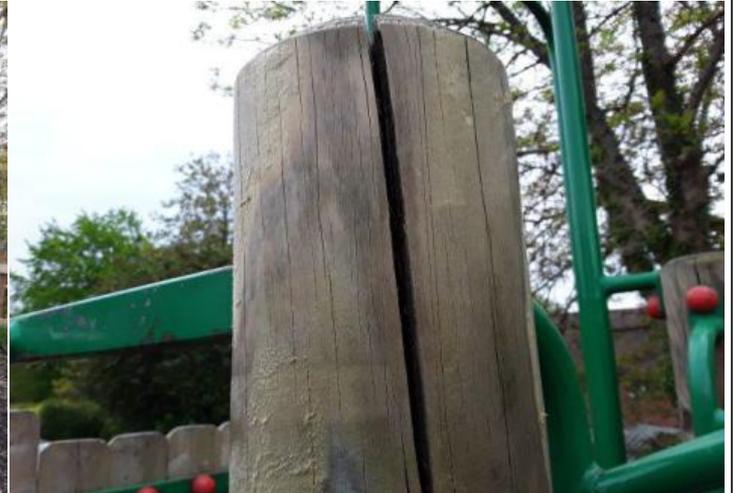
**Finding:** The timber has a number of splits/shakes or air cracks and this may affect the stability or allow water ingress which will accelerate the rotting process  
**Action:** Monitor to ensure the splits do not cross through fixing points of the structure and/or cause any instability

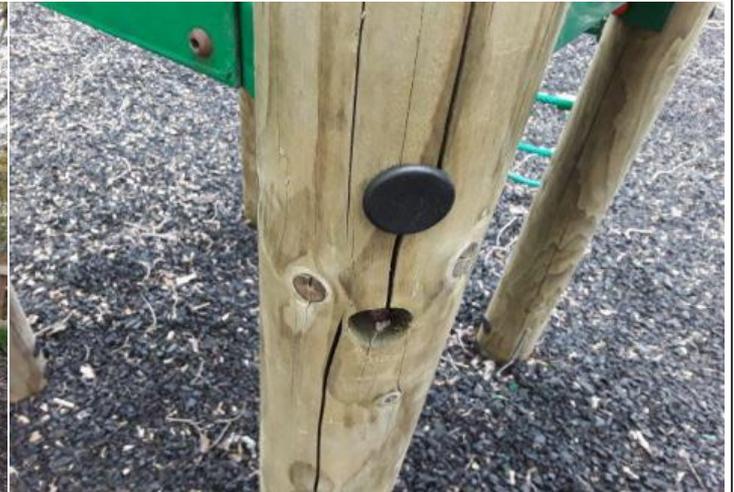
**Finding:** There is/are bolt cap covers missing or damaged on the item  
**Action:** Replace missing or damaged bolt cap covers

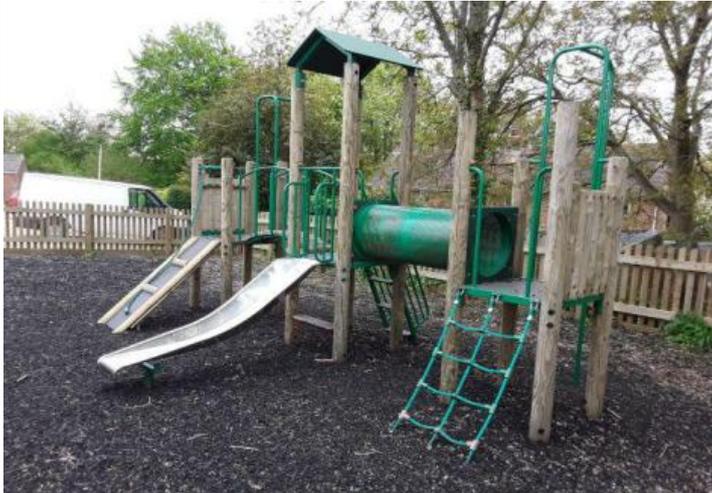
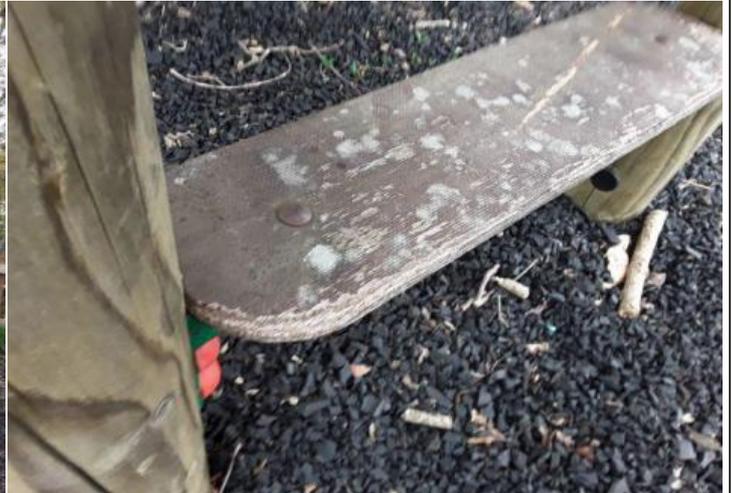
**Finding:** Parts of the timber are rough or splintered

**Action:** Remove all rough or sharp edges

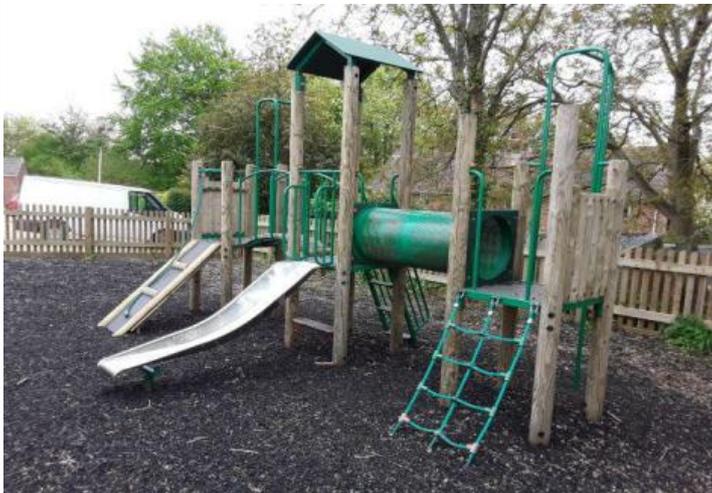
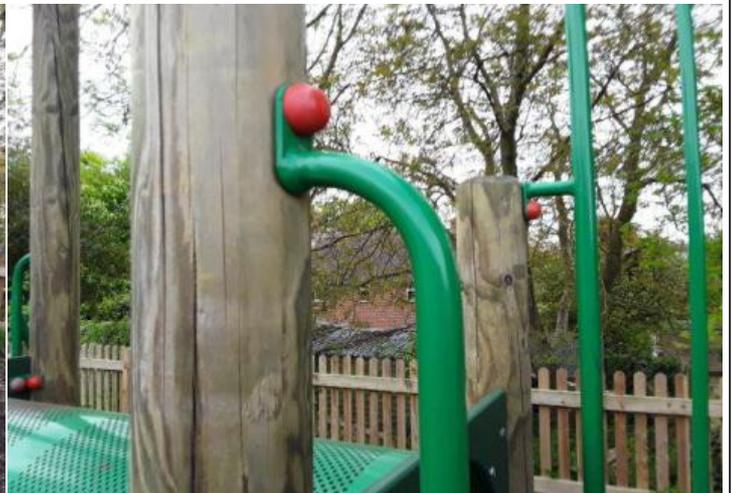
**Finding:** A number of barrier fixing(s) have worked loose

**Action:** Secure all loose fixings

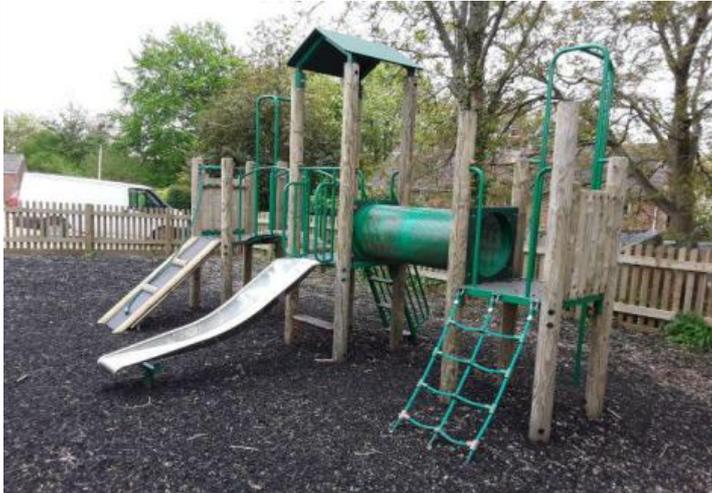
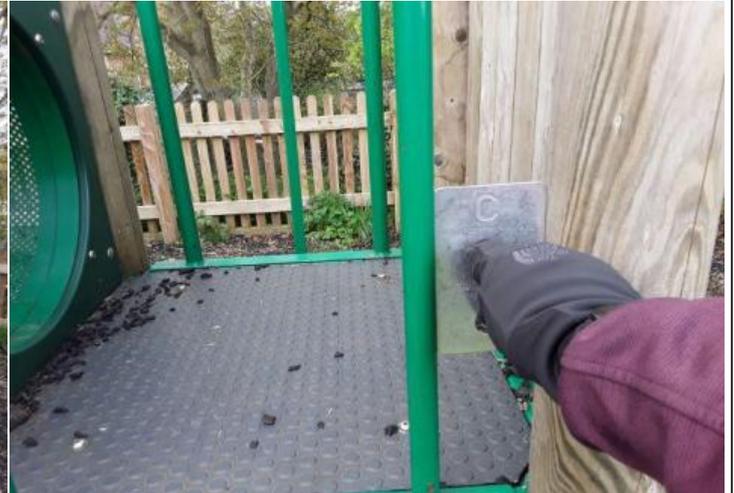
**Finding:** The item fails to meet the requirements of BS EN 1176 Part 1 4.2.7.2 head and neck entrapment in the barriers and/or steps

**Action:** Monitor - No remedial work recommended

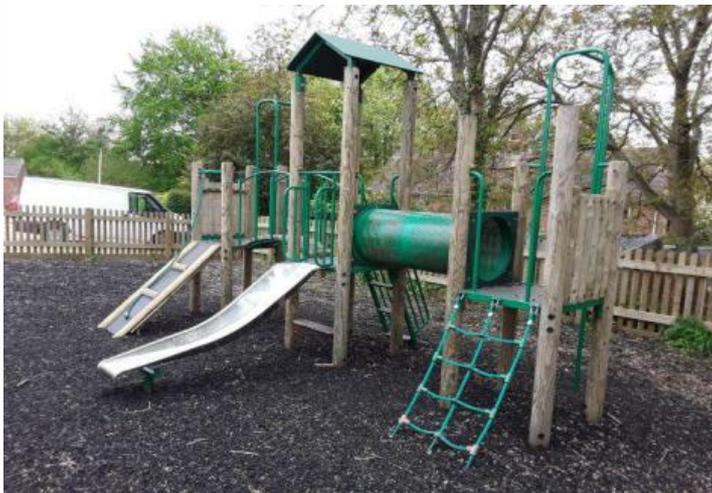
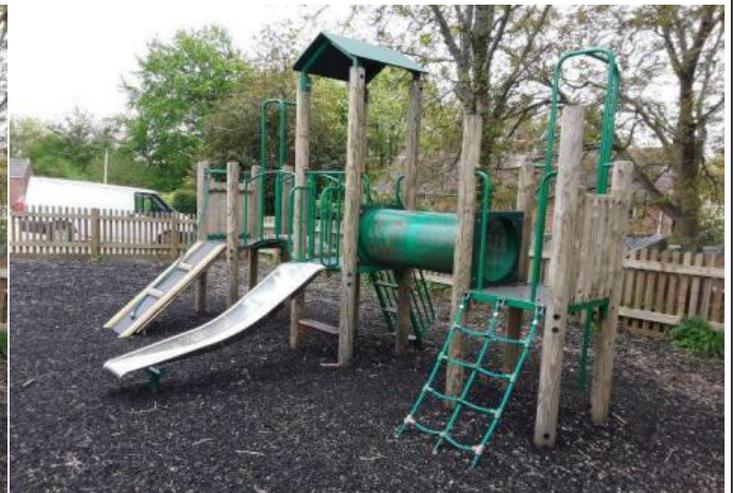
**Finding:** The unit is easily accessible and should have the appropriate barriers installed to meet the requirements of BS EN 1176 Part 1 as the height of the unit exceeds 600mm

**Action:** Monitor - No remedial work recommended

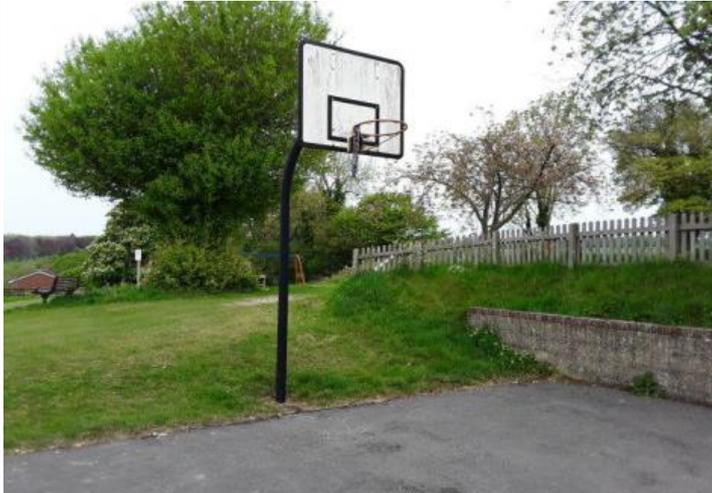
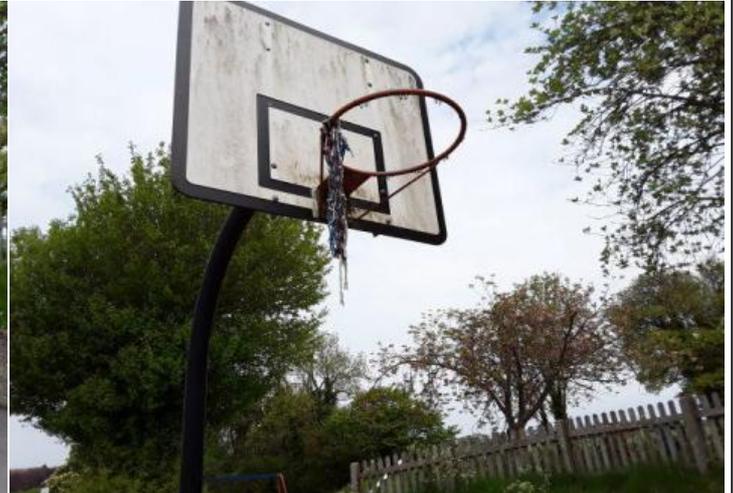
**Finding:** The net is damaged

**Action:** Replace / remove net

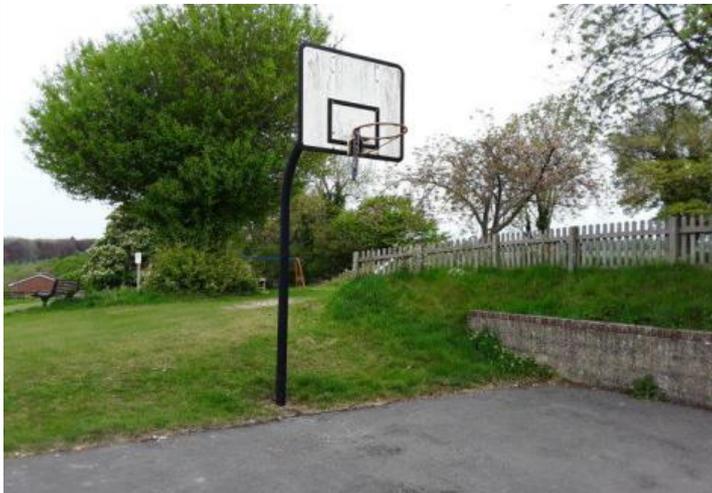
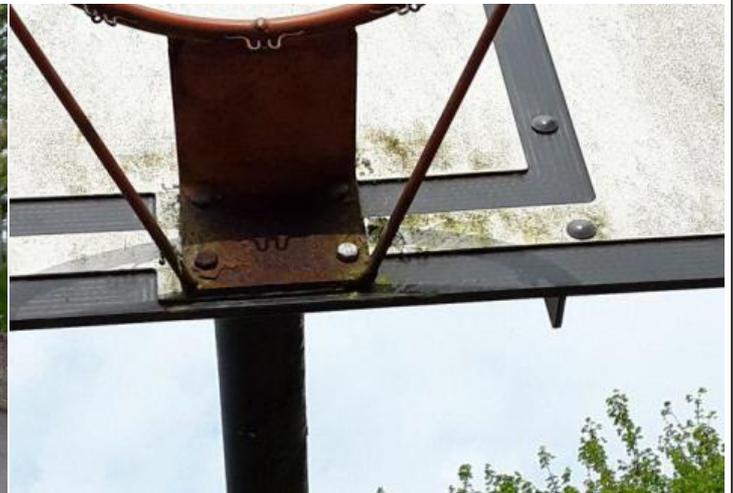
**Finding:** The paintwork on this item has been damaged or worn exposing the metal underneath which is rusting

**Action:** Treat any rusting components and repaint

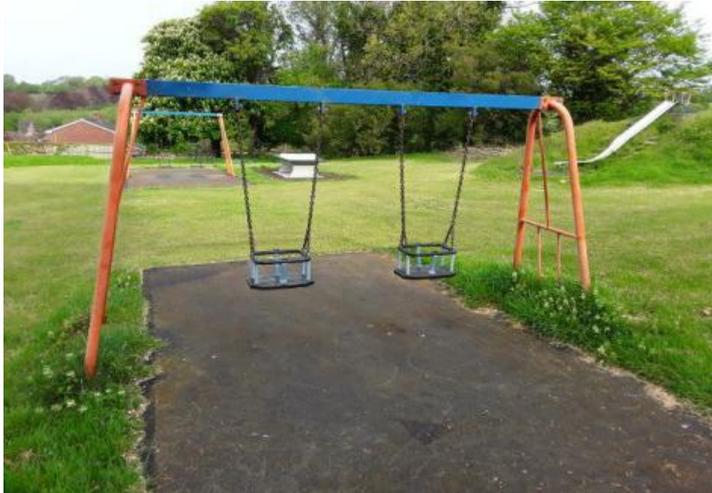
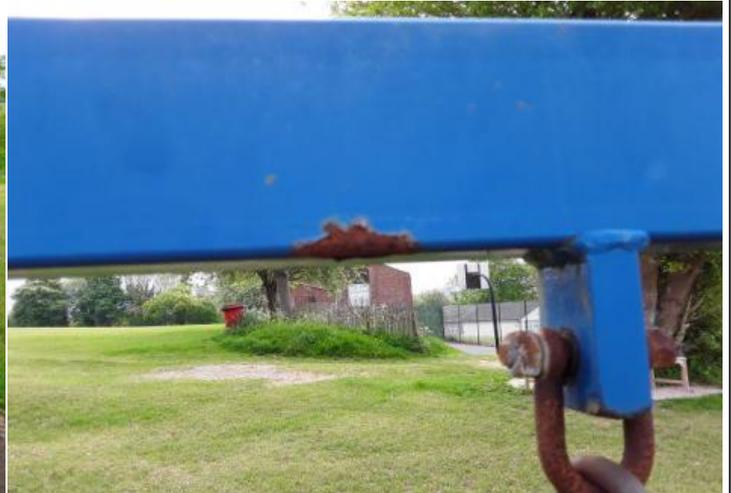
**Finding:** The paintwork on this item has been damaged or worn exposing the metal underneath which is rusting

**Action:** Treat any rusting components and repaint

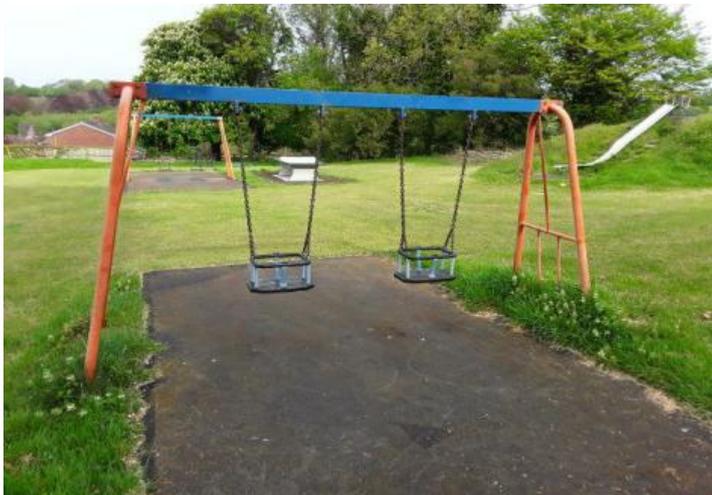
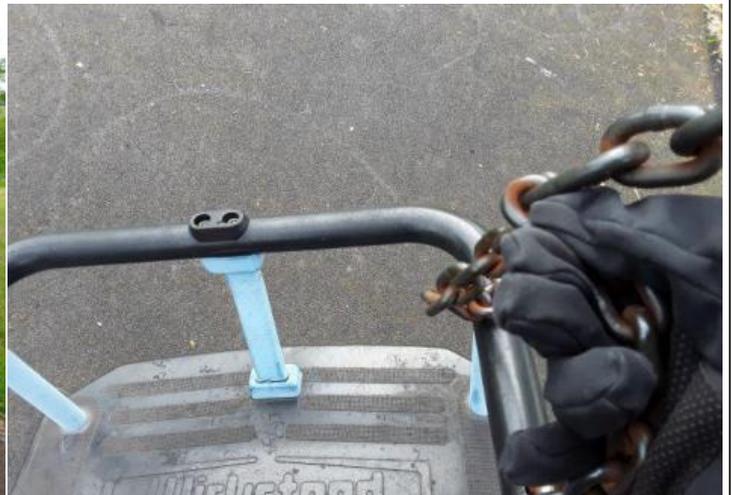
**Finding:** There is some notable evidence of chain wear

**Action:** Monitor for any further deterioration and replace when 40% worn

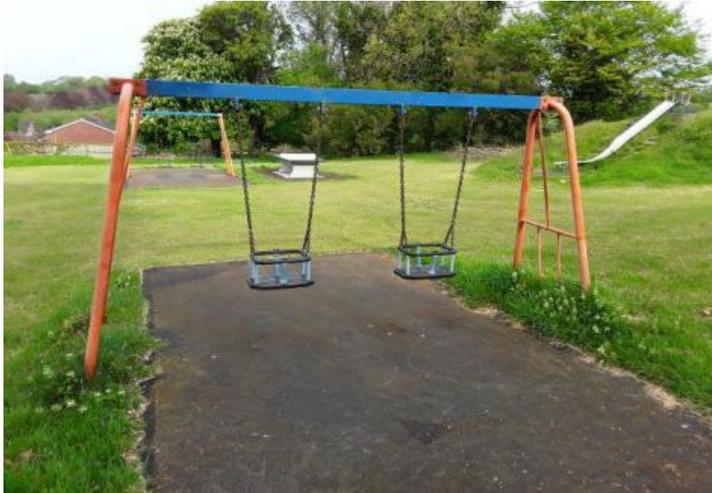
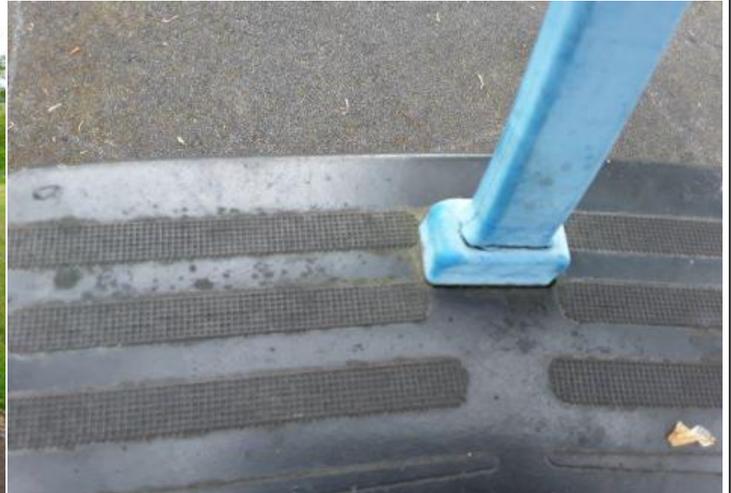
**Finding:** The seat has minor damage or wear

**Action:** Monitor for any further deterioration and replace as required

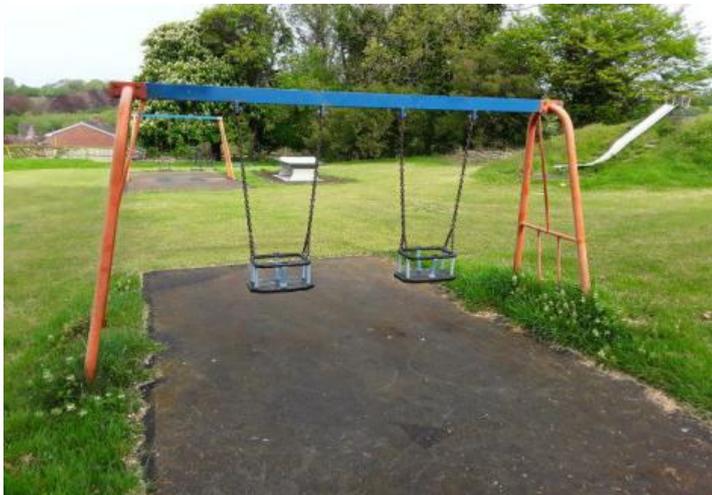
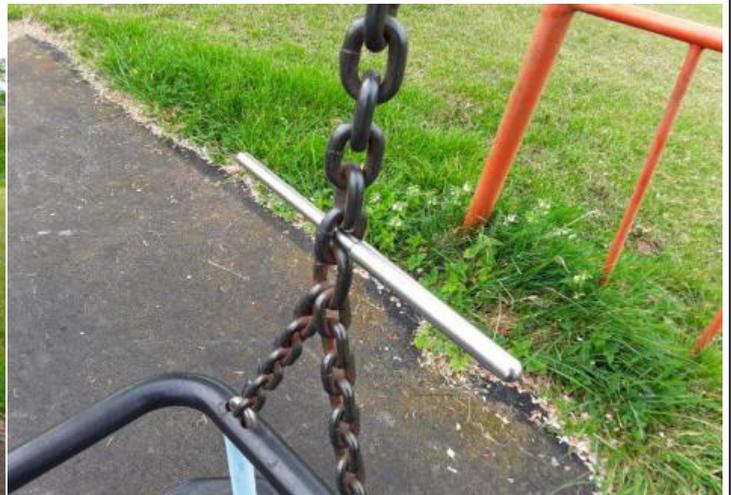
**Finding:** The chain openings are in excess of the 8.6mm as recommended by BS EN 1176

**Action:** Monitor - No remedial work recommended

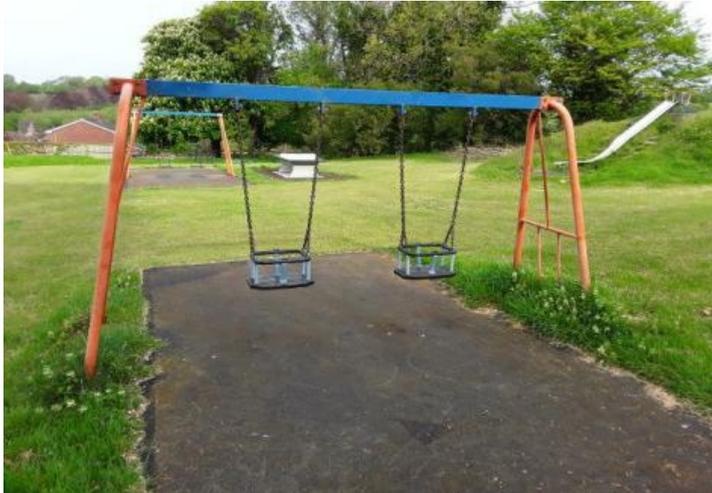
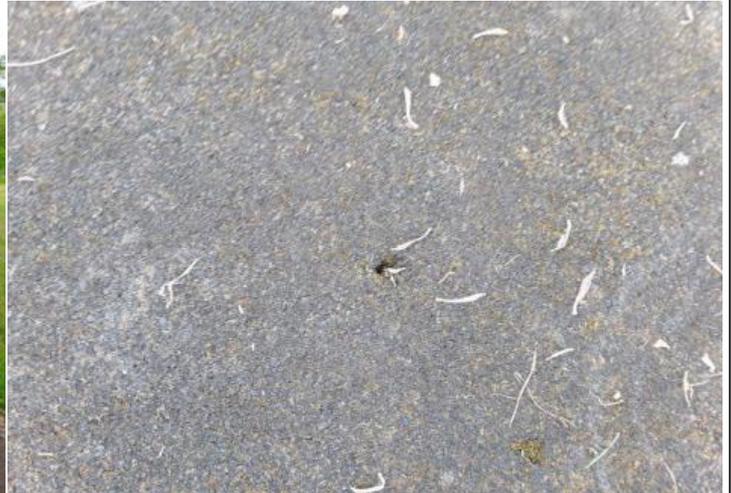
**Finding:** The safety surface under or around this unit has been damaged

**Action:** Monitor for any further deterioration and repair as required

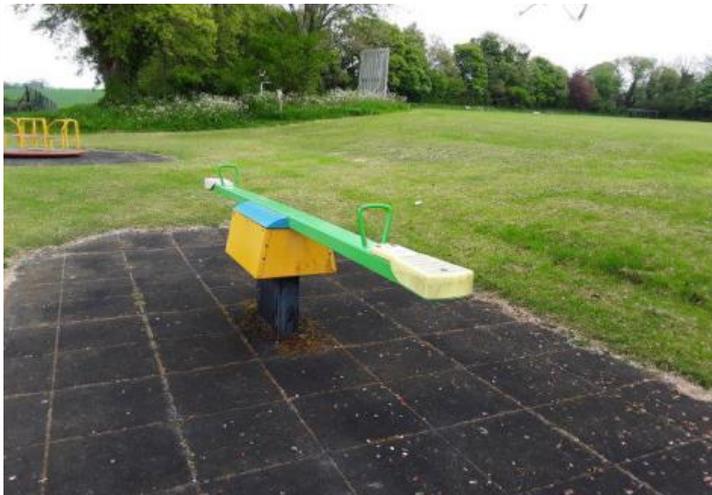
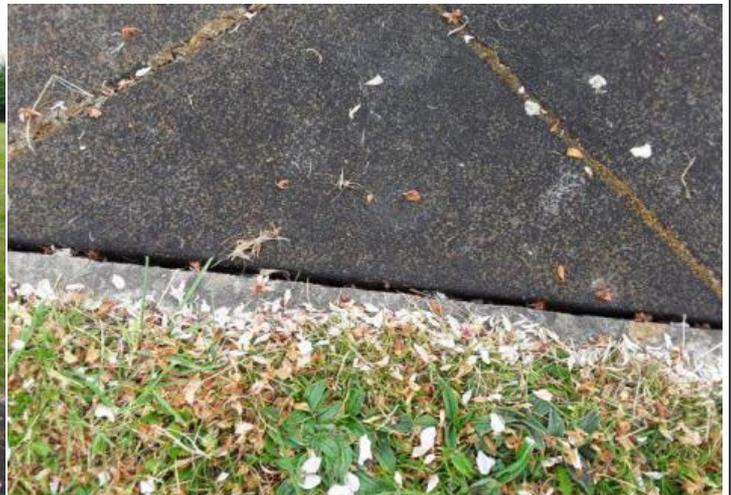
**Finding:** There are gaps opening in between the tiles

**Action:** Monitor for any further deterioration and repair as required

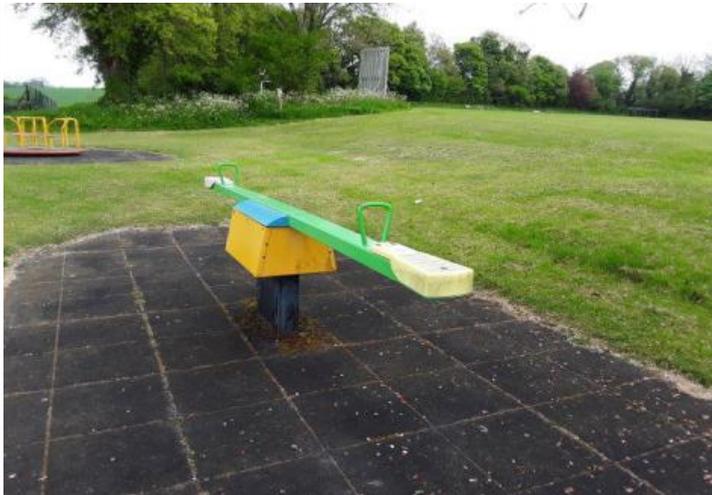
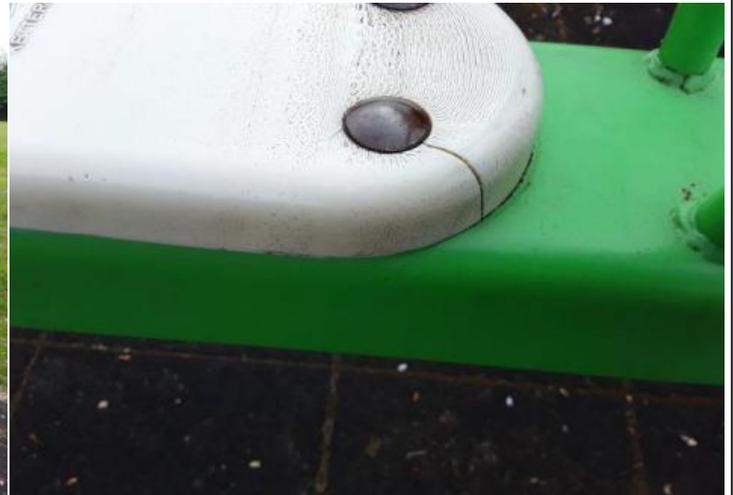
**Finding:** The seat has minor damage or wear

**Action:** Monitor for any further deterioration and replace as required

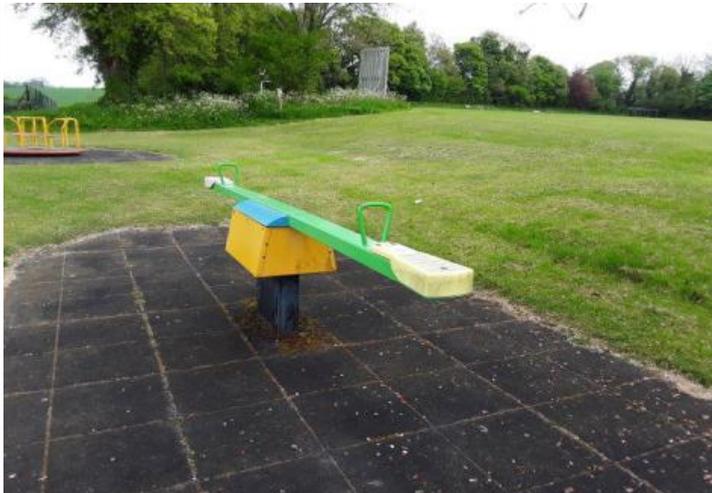
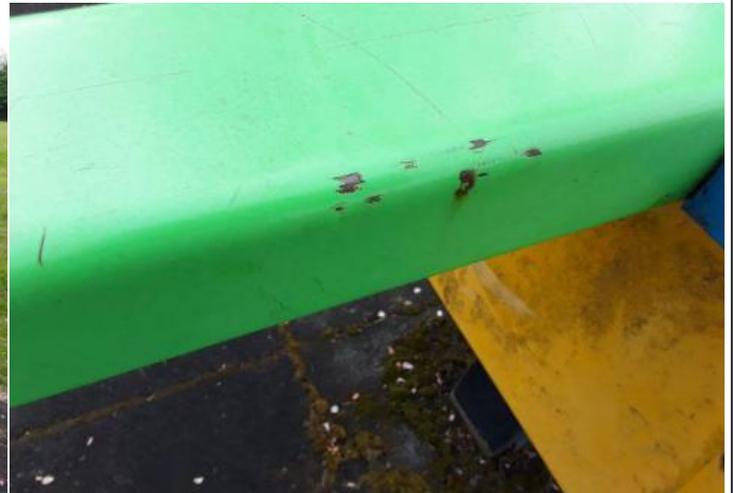
**Finding:** The paintwork on this item has been damaged or worn exposing the metal underneath which is rusting

**Action:** Treat any rusting components and repaint

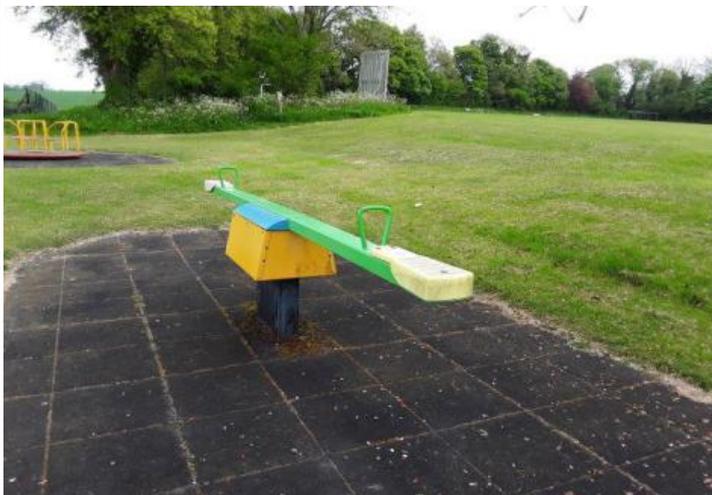
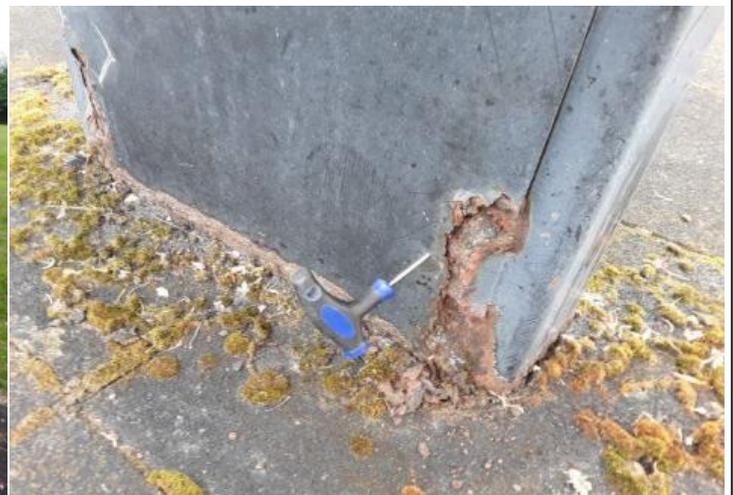
**Finding:** Parts of the steel on this item have corroded excessively and the metal has perforated in places

**Action:** Ensure all affected areas are treated and repaired

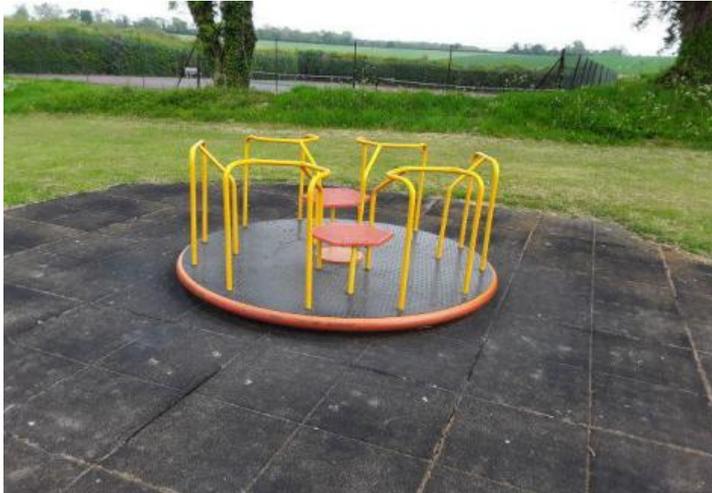
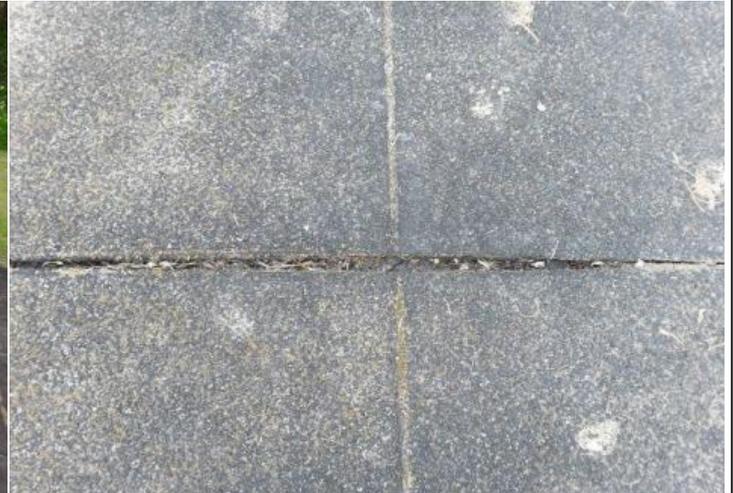
**Finding:** There are gaps opening in between the tiles

**Action:** Monitor for any further deterioration and repair as required

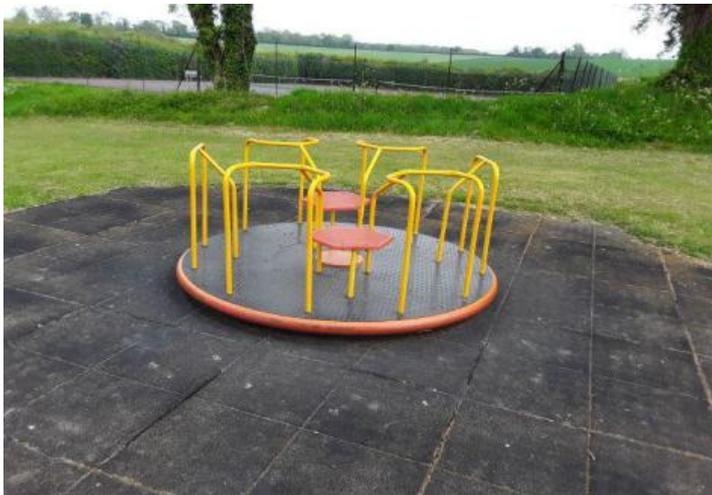
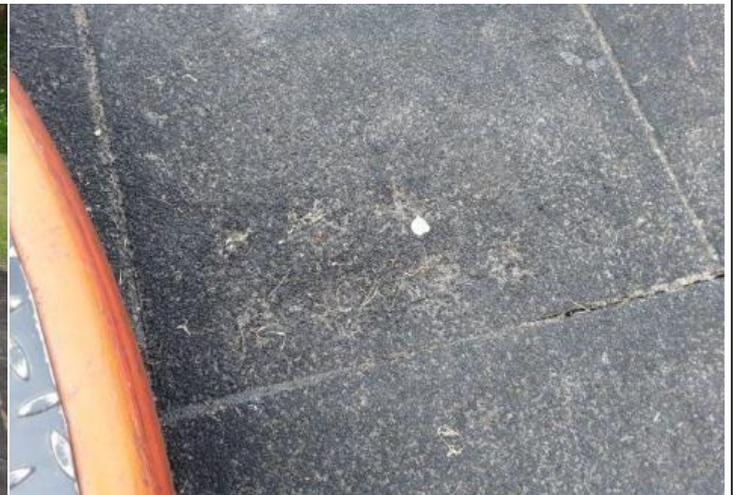
**Finding:** The safety surface under or around this unit has been damaged

**Action:** Monitor for any further deterioration and repair as required

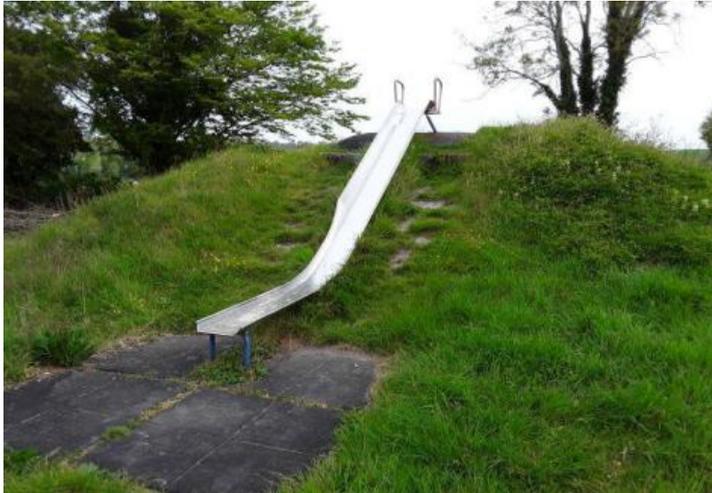
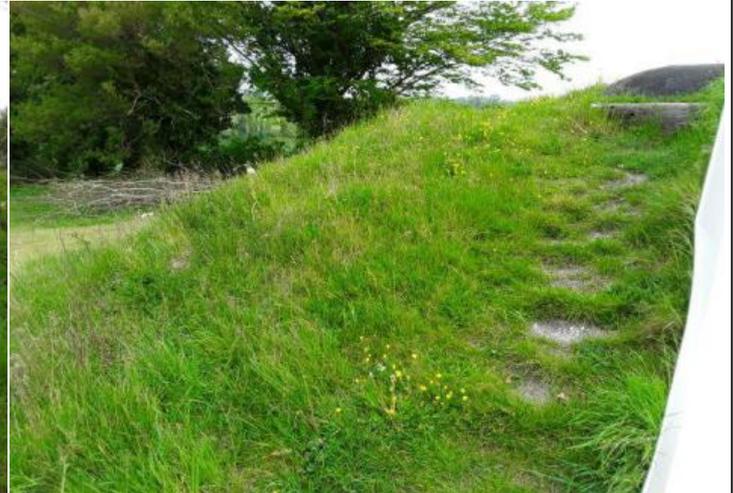
**Finding:** The grass is overgrown within the play area and may hide hazards

**Action:** Reduce the length of grass to an acceptable height and maintain

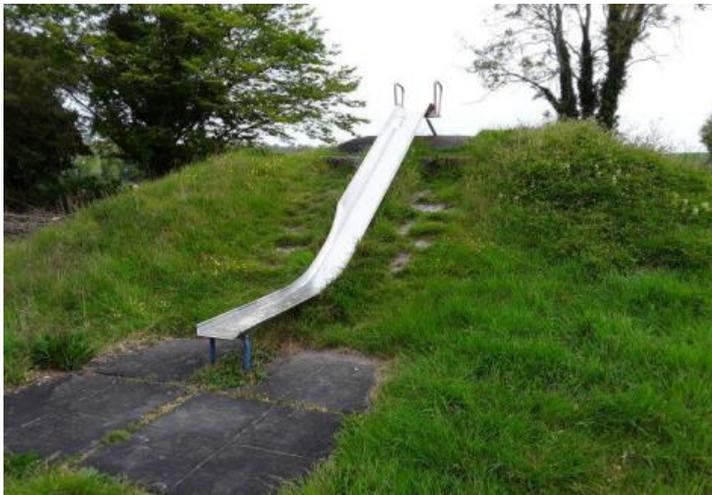
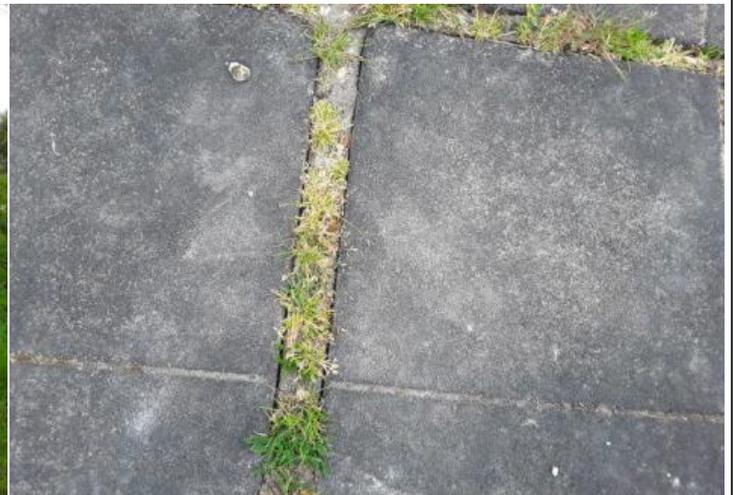
**Finding:** There are gaps opening in between the tiles

**Action:** Monitor for any further deterioration and repair as required

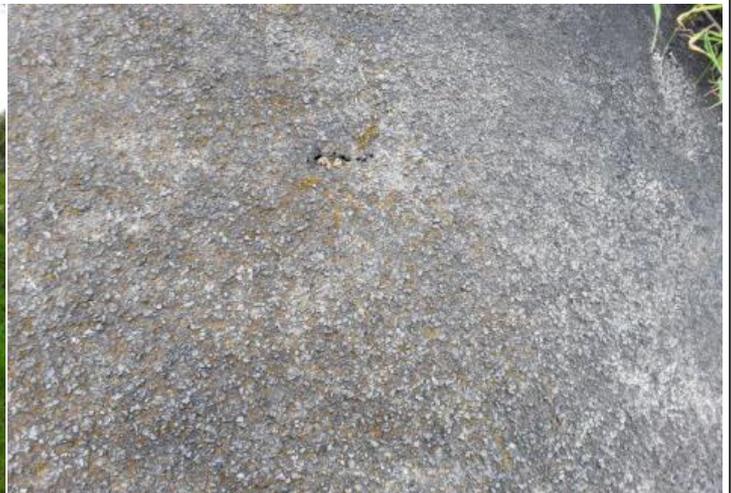
**Finding:** The safety surface under or around this unit has been damaged  
**Action:** Monitor for any further deterioration and repair as required

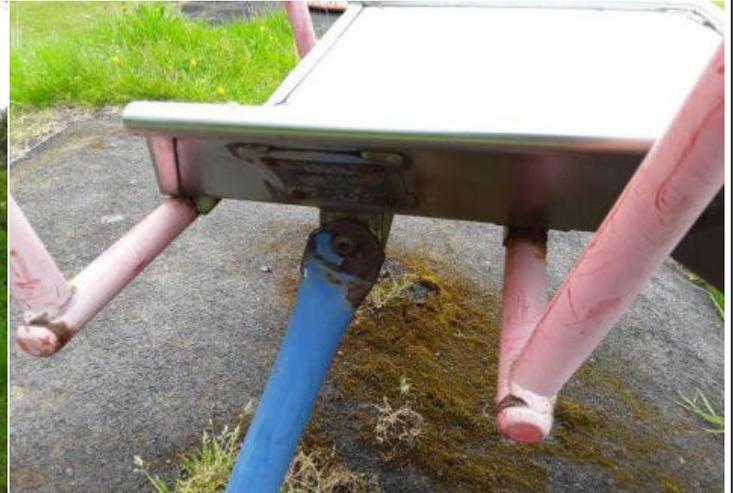
**Finding:** The paintwork on this item has been damaged or worn exposing the metal underneath which is rusting

**Action:** Treat any rusting components and repaint

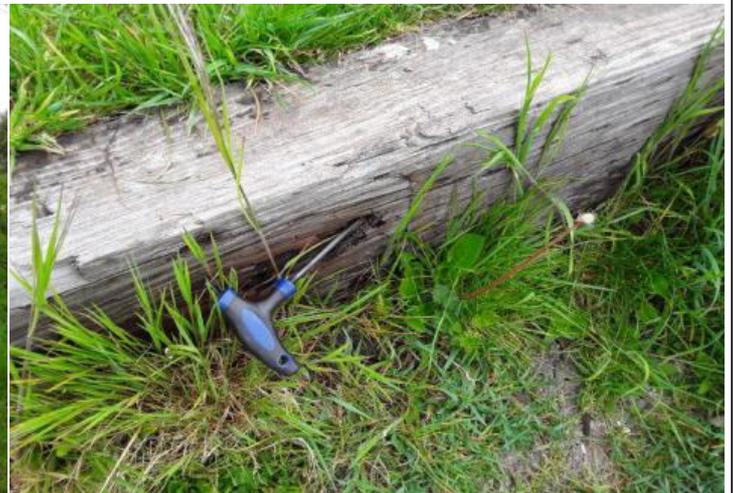
**Finding:** There is some evidence of rot in the timber sleeper

**Action:** Monitor for any further deterioration and replace as required

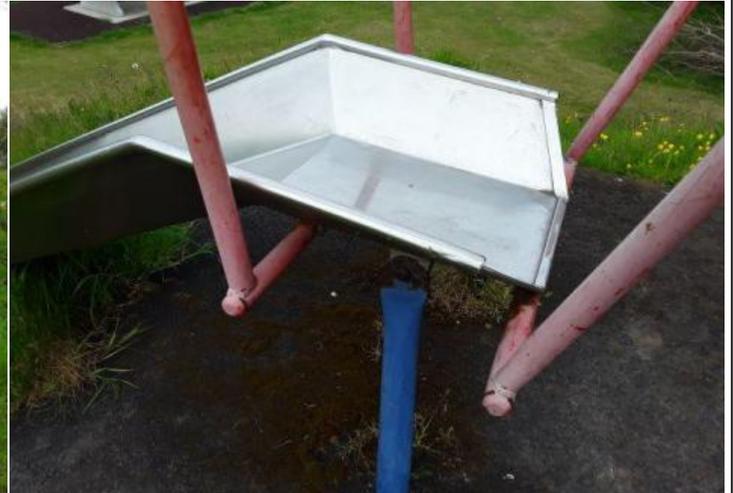
**Finding:** The slide start section incline is not in the direction of travel; it should slope towards the direction of the sliding surface to meet the requirements of BS EN 1176 Part 3  
**Action:** Monitor - No remedial work recommended

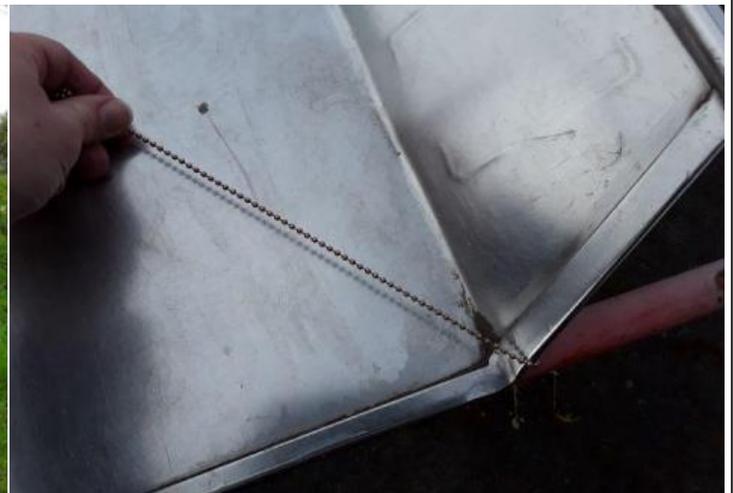
**Finding:** There is / are toggle entrapment/s present in contravention of the recommendations set out in BS EN 1176 Part 3  
**Action:** Monitor - no remedial work recommended

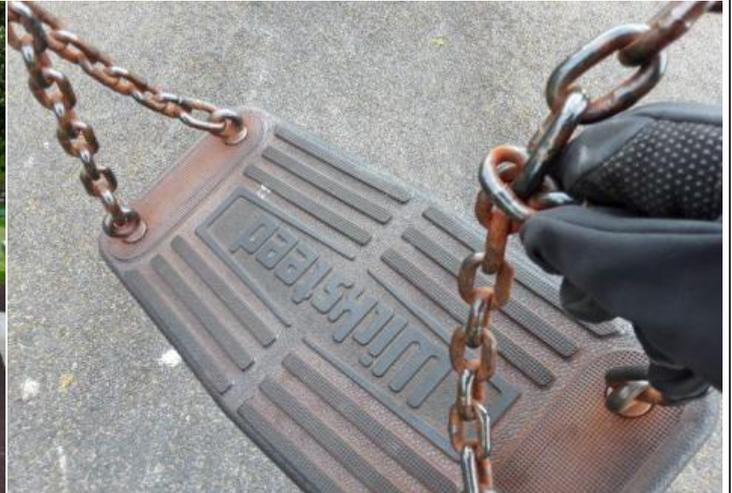
**Finding:** There is some notable evidence of chain wear

**Action:** Monitor for any further deterioration and replace when 40% worn

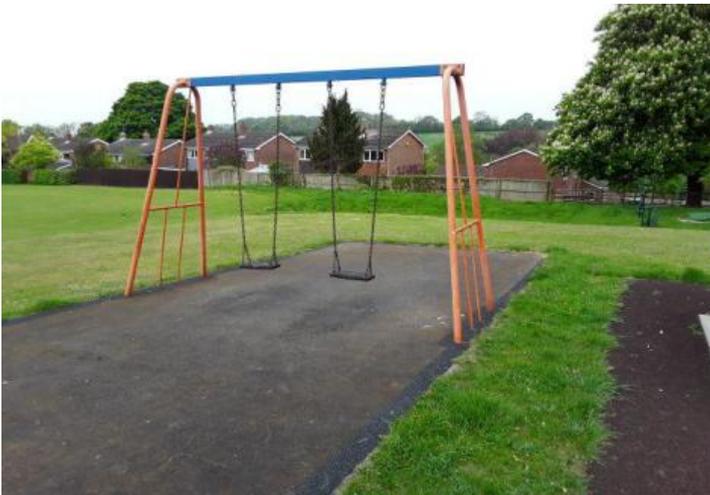
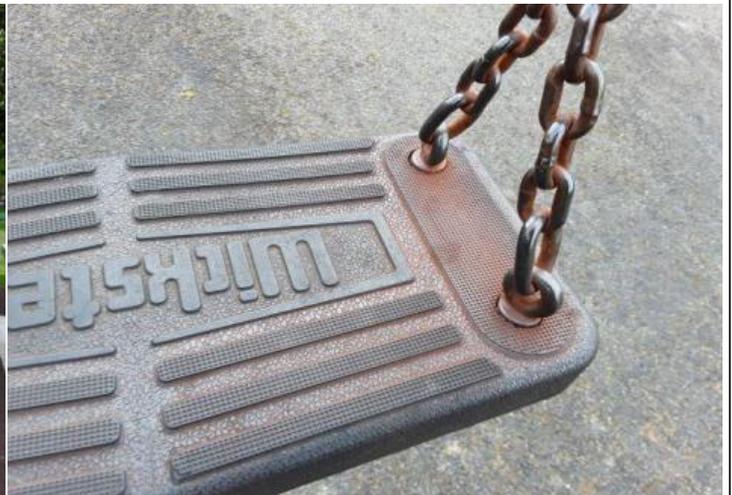
**Finding:** The swing seat connectors are loose

**Action:** Tighten to secure

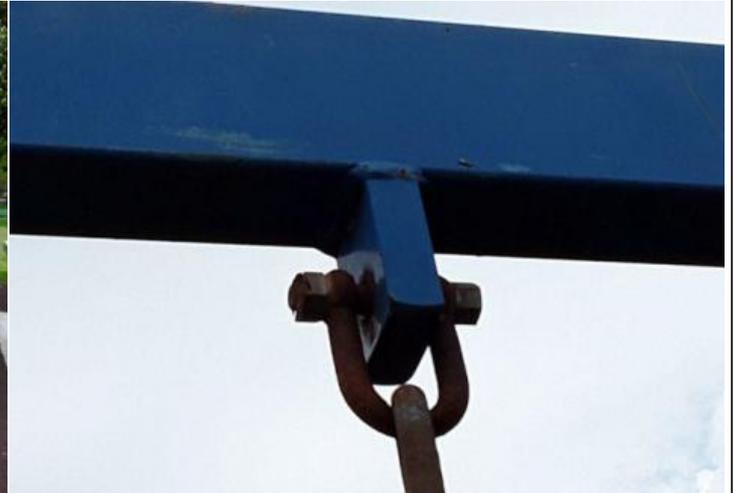
**Finding:** The bushes are showing signs of wear

**Action:** Monitor for any further deterioration and replace as required
