## Annual Inspection

Winchester City Council

West Meon Village Hall RG (West Meon PC)

Headon View, West Meon, Hampshire, GU32 1LH

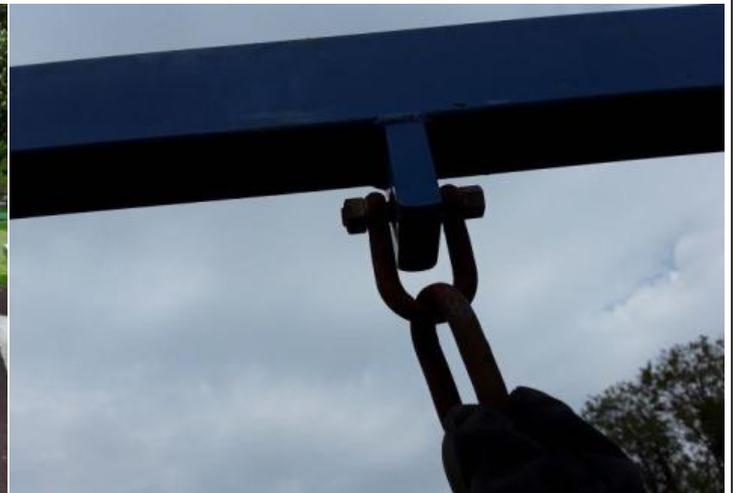
**Finding:** There is some wear to the shackles.

**Action:** Monitor for any further deterioration and replace when 40% worn

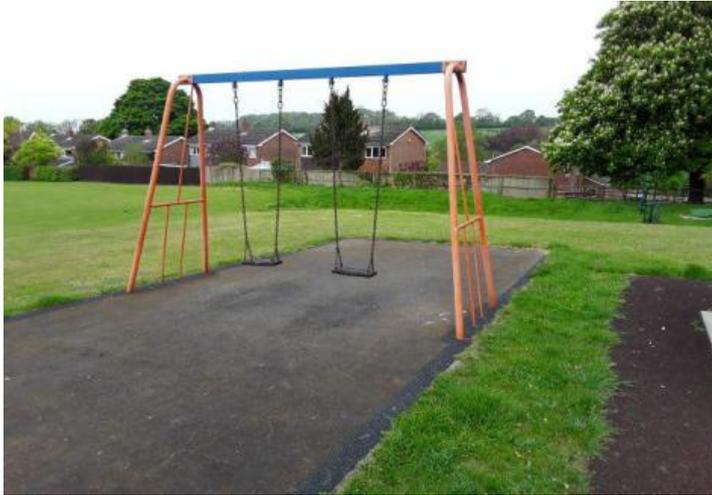
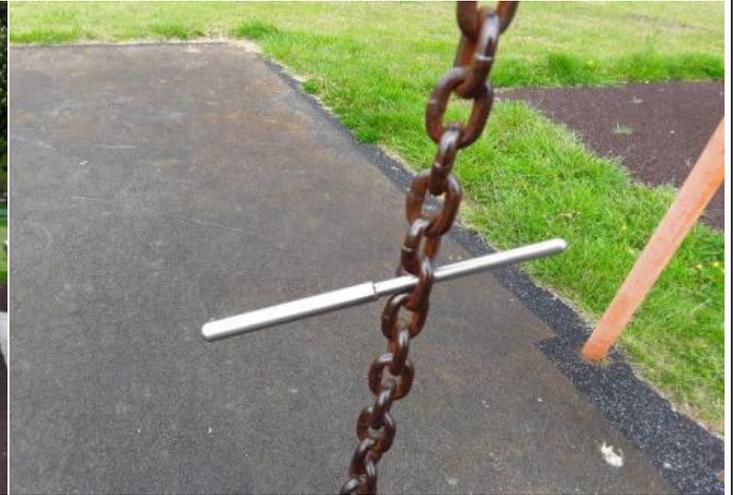
**Finding:** The chain openings are in excess of the 8.6mm as recommended by BS EN 1176 **Action:** Monitor - No remedial work recommended

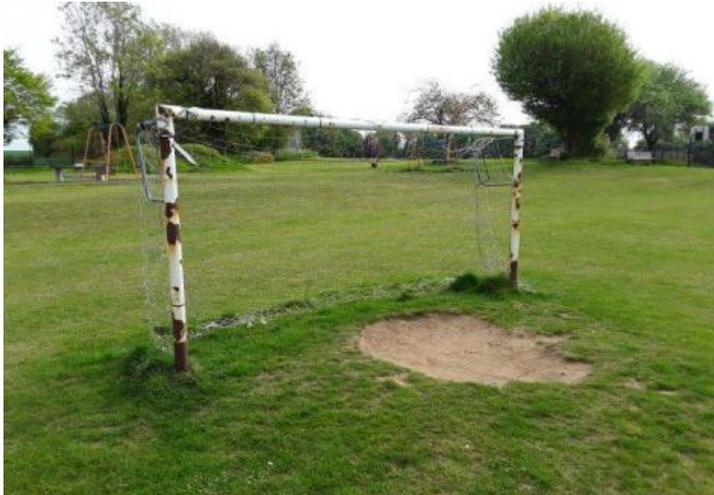
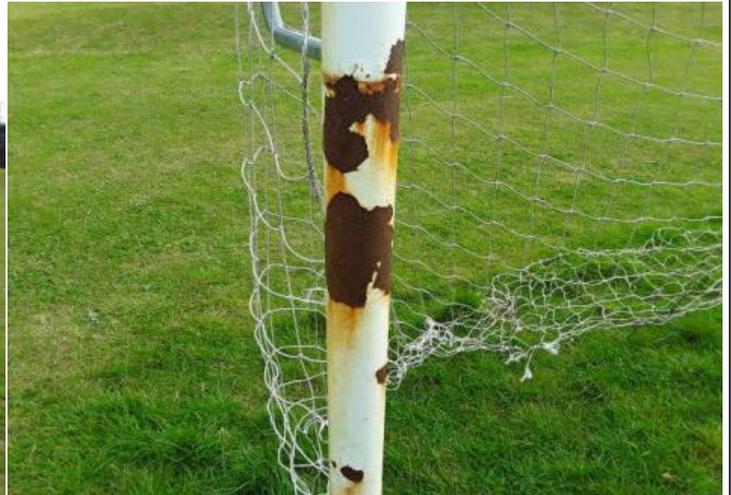
**Finding:** The paintwork on this item has been damaged or worn exposing the metal underneath which is rusting

**Action:** Treat any rusting components and repaint

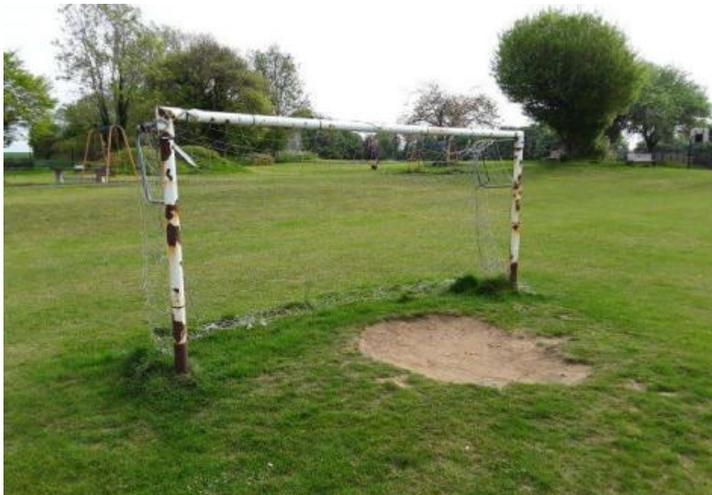
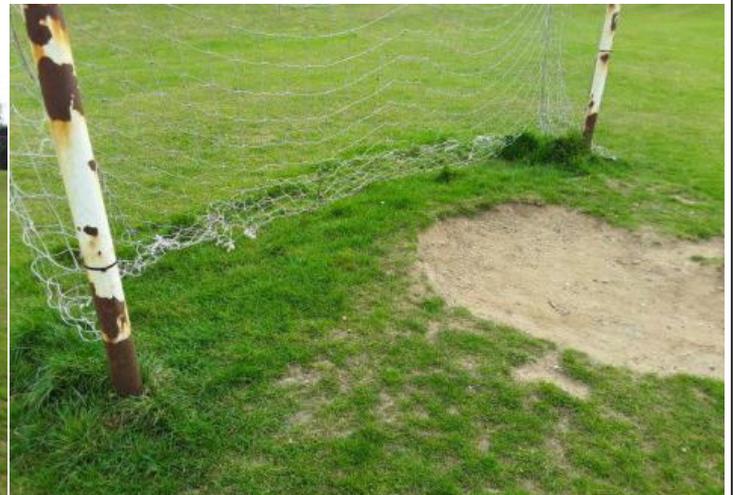
**Finding:** The posts are loose in the ground

**Action:** Reset posts

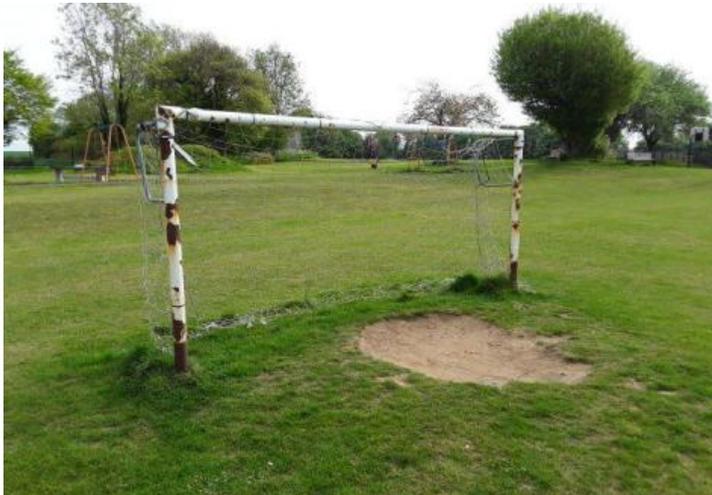
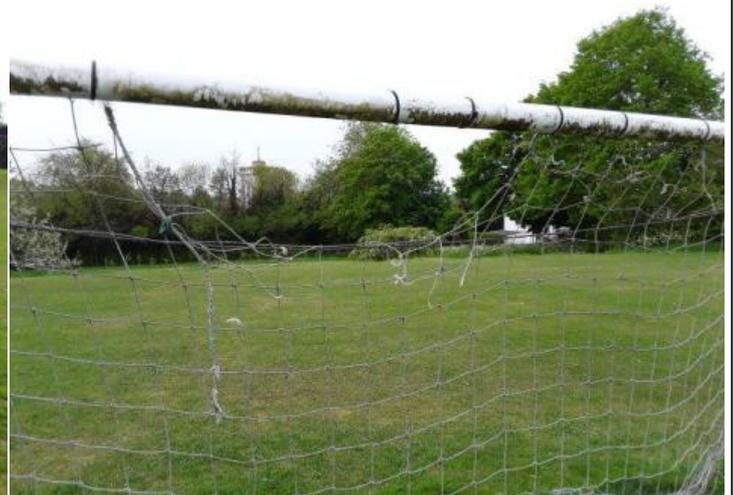
**Finding:** The nets are damaged

**Action:** Repair / replace as required
