## **BISHOPS FARM BARN, HOLT LANE, BISHOPS CAUNDLE**

### **FEASIBILITY SURVEY FOR POTENTIAL CONVERSION (TO DOMESTIC ACCOMMODATION)**

**Project Ref**                      026/196

**Date**                                August 2022

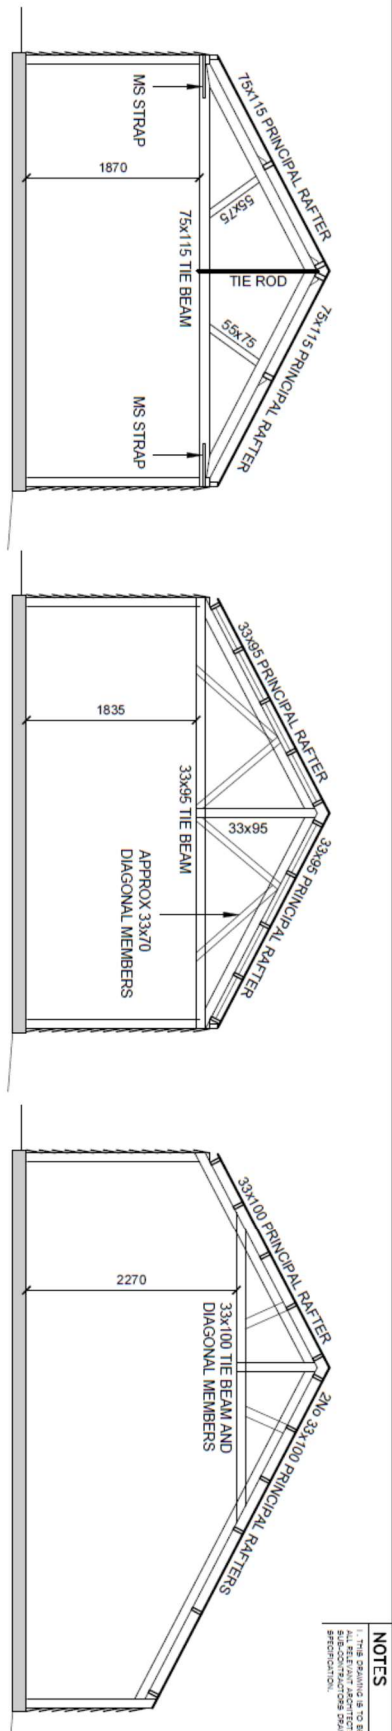
SECTION ON TRUSS TYPE 1  
~1:50

SECTION ON TRUSS TYPE 3  
~1:50

SECTION ON TRUSS TYPE 4  
~1:50

SECTION ON TRUSS TYPE 2 SIMILAR,  
BUT WITH ~50x155 TIE BEAM AND  
PRINCIPAL RAFTERS AND NO MS STRAPS

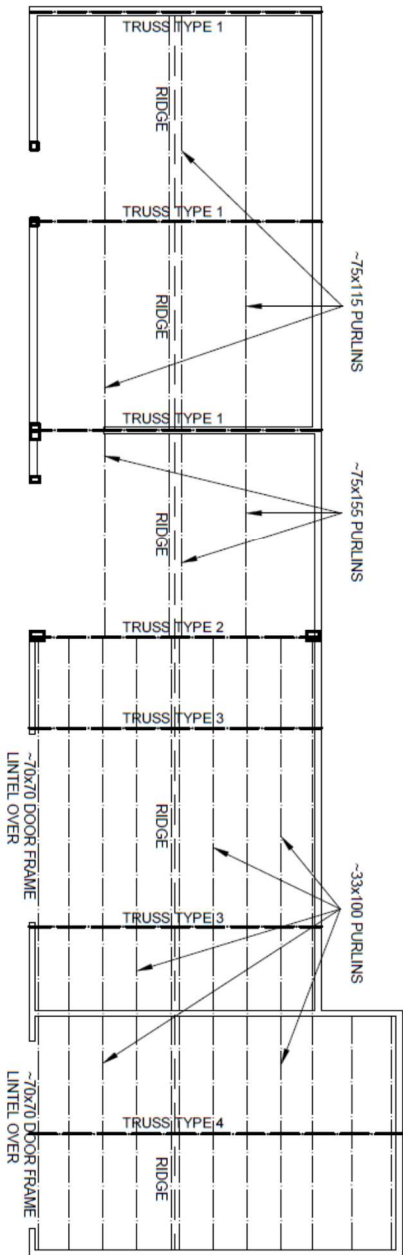
GENERAL ARRANGEMENT SURVEY PLAN  
APPROX 1:75

Studwork to the west end of the barn generally comprises 50x100 studs @ approximately 725mm centres. In one area, between the internal partition and truss type 2 (see drawing 01, Appendix A) on the west end of the barn where the rear wall appears to be constructed from vertical boards, rather than studwork.
