# Safety Inspection Report

Annual Inspection

## Jubilee Field

Matching Parish Council

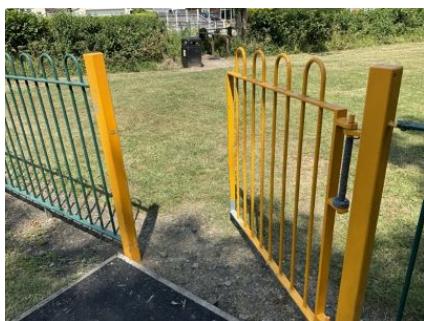
The gate's closing mechanism does not work correctly.

Adjust to allow gate to self close. Ideally gate from open should not close in less than 5 seconds.

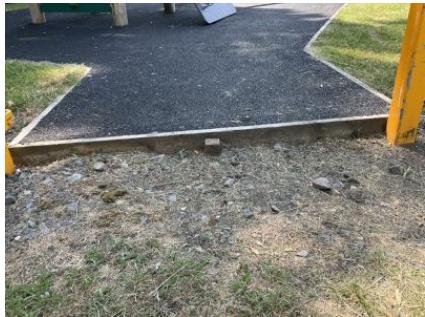
Trip points on the surface.

Remove trip points.

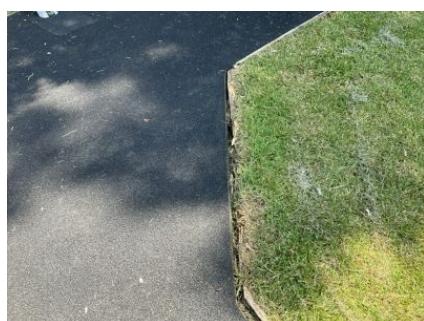
Surface needs repair.

Timber edging is rotting in areas, causing wet pour to lift/have separation. Repair.

Repair.

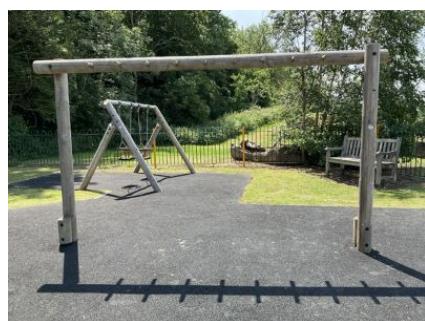
Overhead ladders and rings provide significant play value and benefits to children, and with it the risk of falling. Ensuring the surface remains in good condition will help to keep the correct balance between benefits and risk.

The protective surface under all bars and rings must be kept in good condition.

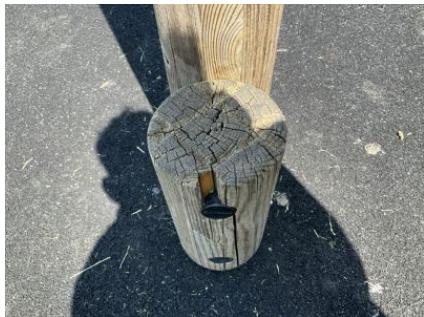
Timber is rotting.

Tops of steppers. Monitor.

Read the notes for further action.

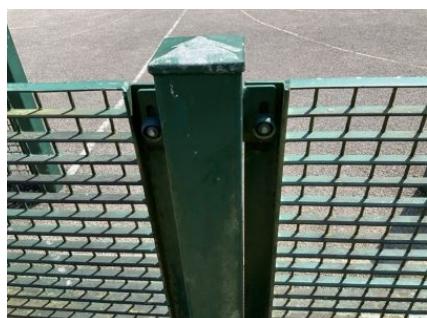
Cap missing.

Various caps missing.

Replace.

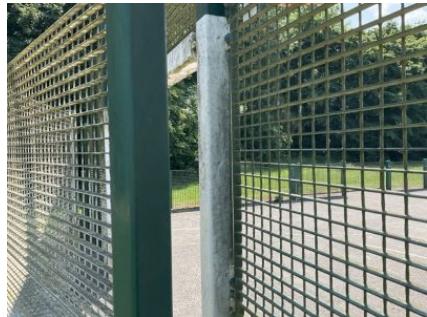
The equipment is dirty or algae covered.

Clean off.

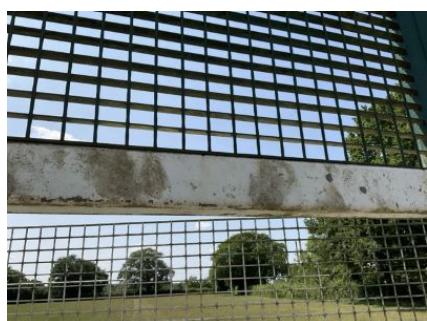
The paint is chipped.

De-scale back to good base material and coat with lead free paint, using appropriate precautions. Repairs may be necessary where corrosion is severe., Touch up the paint.

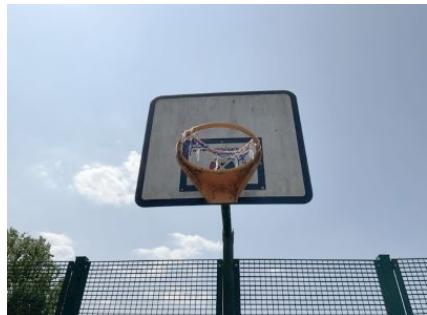
Minor repairs are needed.

Netting.

Repair.

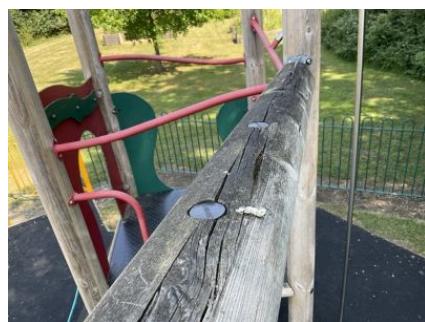
Timber is rotting.

Monitor rot and structural stability on cross beam of netting. Replace when necessary.

Read the notes for further action.

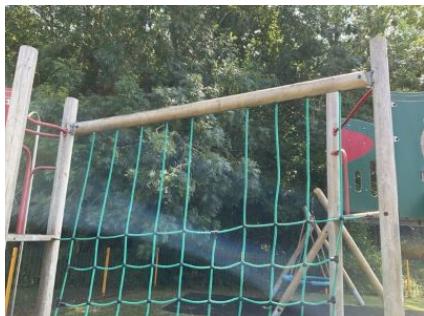
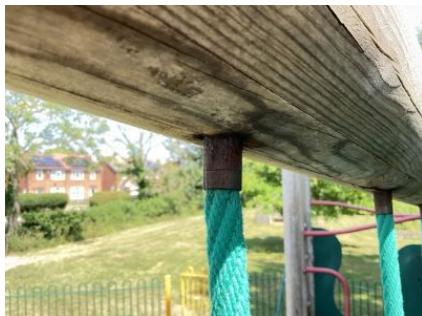
Item was not inspected on this occasion.

Rope connections are enclosed with no access for inspection. Ensure these are dismantled and inspected for internal rust/corrosion as the external parts are rusting/corroding.

Ensure a proper inspection is conducted at the appropriate time.

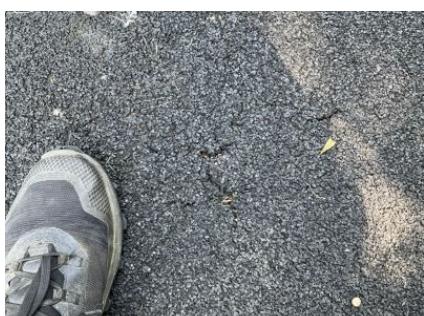
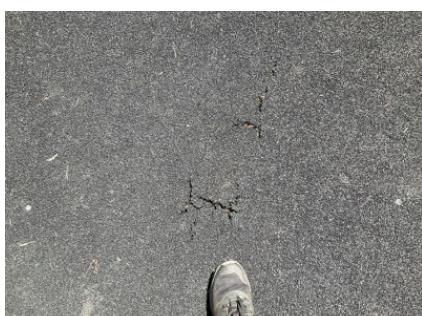
The surface is cracking.

Repair.

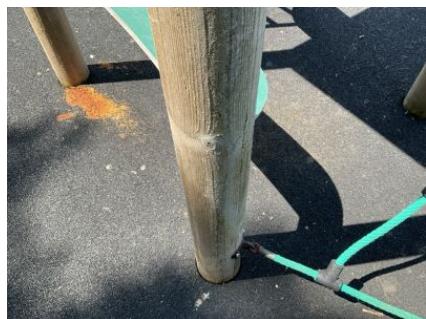
There are splinters or the potential for splinters.

Splinters on supports, possibly due to power washing.

Sand the timber down to remove the splinters and/or the places liable to give splinters.

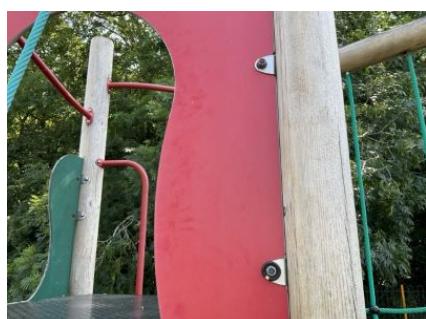
Cap missing.

Various caps are missing. Replace.

Replace.

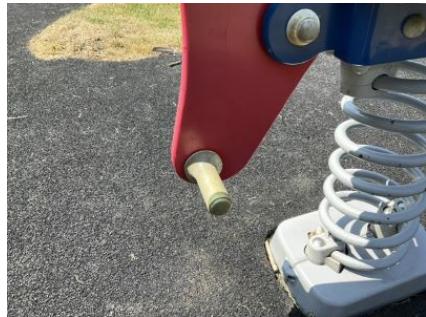
Protruding handles / foot rests.

No reasonably practicable action is identified.

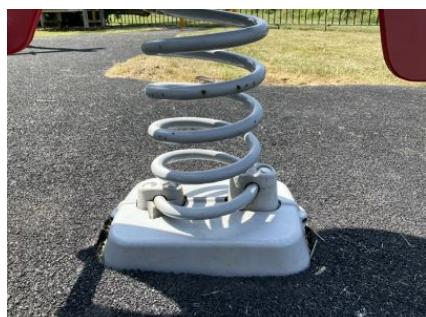
Bolt(s) loose.

The spring is loose.

Tighten.

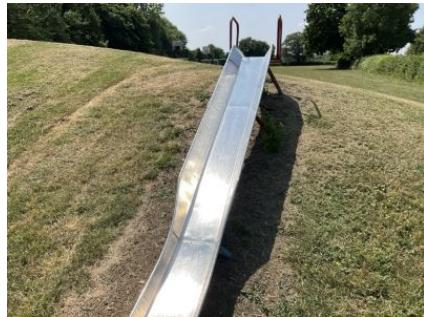
1. The supports are within the falling or free space area.

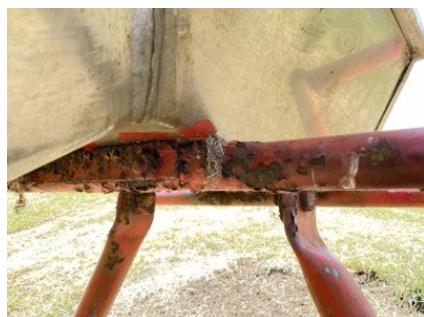
There is significant corrosion on this item.

Bar under slide.

De-scale back to good metal and coat with lead free paint, using appropriate precautions. Repairs may be necessary where corrosion is severe.

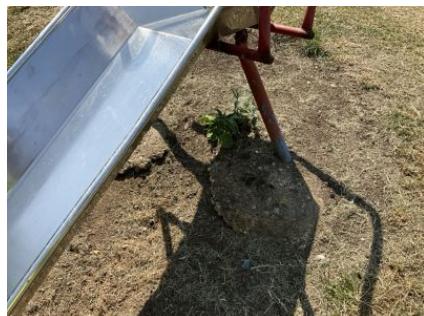
The foundations should be designed such that they do not present a hazard (tripping, impact). Care should be taken to ensure that foundations are not exposed as a result of erosion.

Eliminate the hazard.

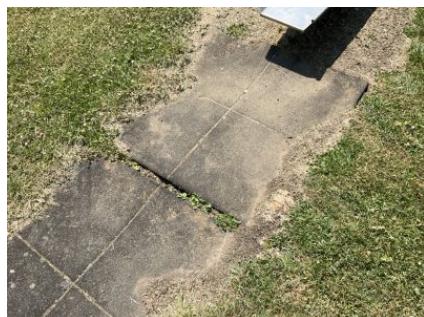
Gaps have opened up between tiles causing trip hazard.

Re-glue and fill gaps and joints as necessary.

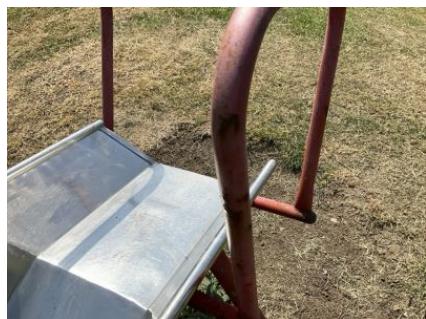
Paintwork is in poor condition.

Frame under slide start.

De-scale back to good base material and coat with lead free paint, using appropriate precautions. Repairs may be necessary where corrosion is severe.

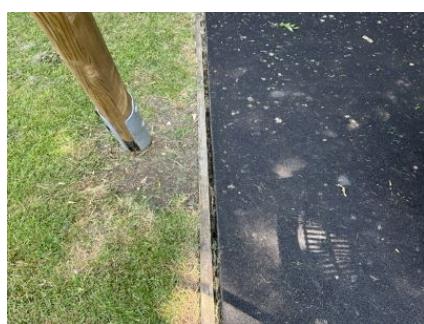
Shrinkage / separation of the surface. This may give a trip hazard.

Repair.

Also repair damaged wooden edging.

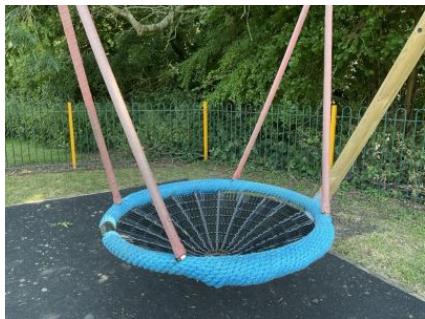
8
Chain covers prevent a thorough inspection of all chain links.	Remove chain covers to inspect according to manufacturer's instructions.

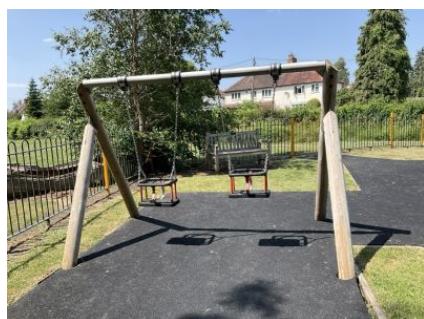
Timber is decayed.

Older timbers are soft below wet pour level and can be probed easily in areas, Resistance testing is advised. Monitor and replace accordingly.

Check on a routine basis., We recommend resistance penetration testing to determine the internal condition of the timber. We can undertake this testing at additional cost. Please contact us for details., Replace affected parts.

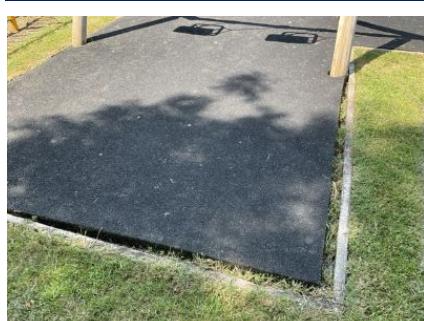
Shrinkage / separation of the surface. This may give a trip hazard.

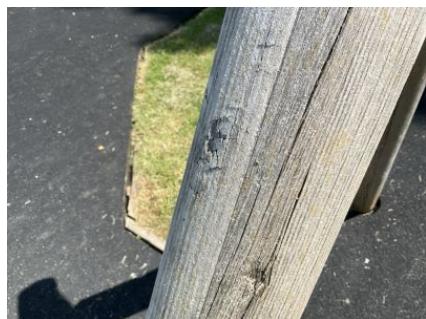
Splinters on supports. Possibly due to power washing.

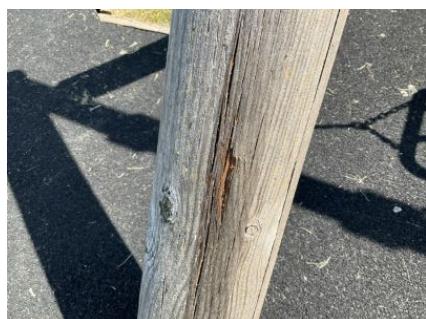
Minor rot to support leg x 1, 500 mm up from surface.

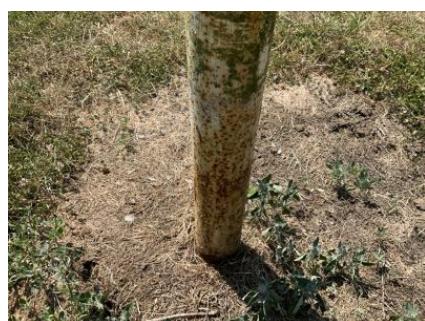
Paintwork is in poor condition.

De-scale back to good base material and coat with lead free paint, using appropriate precautions. Repairs may be necessary where corrosion is severe.
