Asbestos Re-Inspection for West Moors Memorial Hall

West Moors Memorial Hall
231 Station Road
West Moors
Dorset
BH22 0HZ

Project Number: AS10008 & AS10120

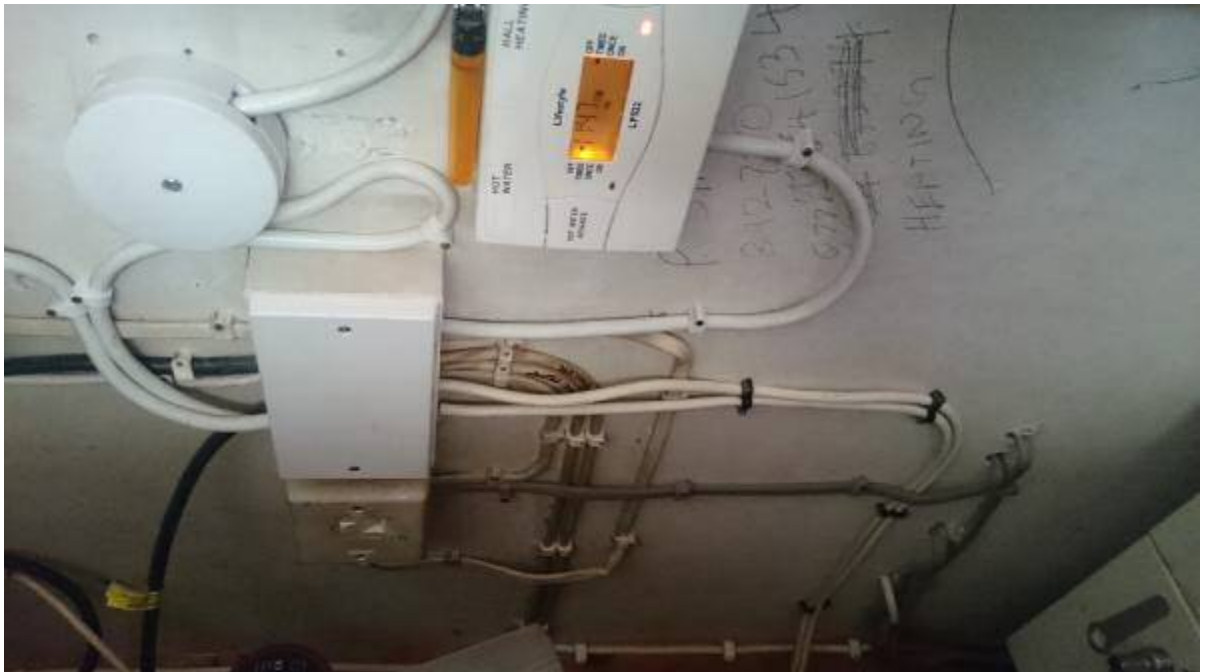
| Product: | Insulation Board | Damage: | NADIS |

Insulation board panel forming wall to boiler cupboard.

No Action Required

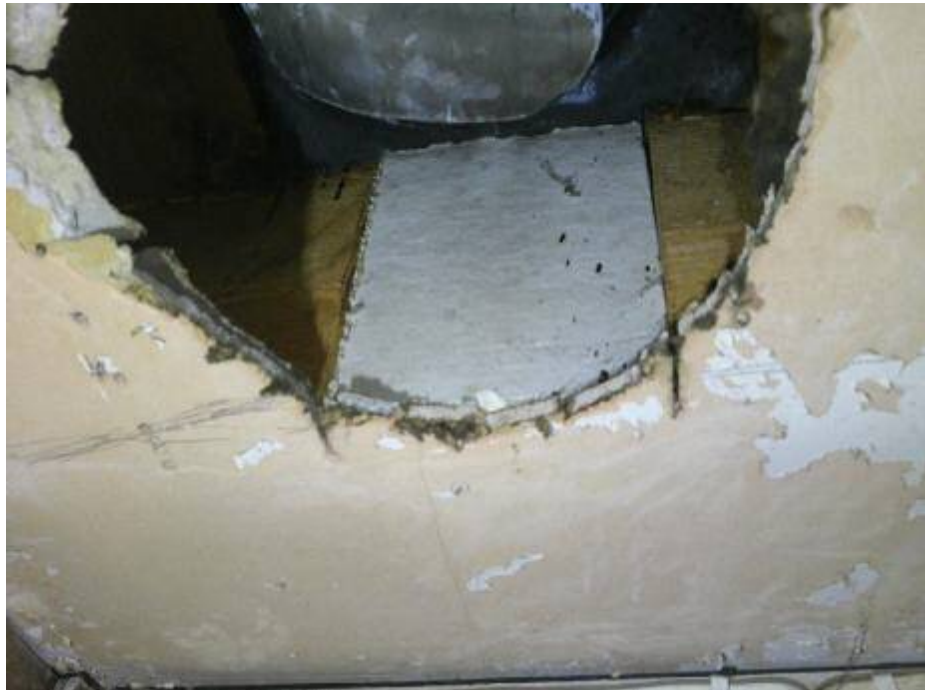
| Product: | Insulation Board | Damage: | NADIS |

Panel above ceiling next to flue in boiler cupboard. Identified as supalux (same as wall panel below) on 2023 re-inspection.

No Action Required

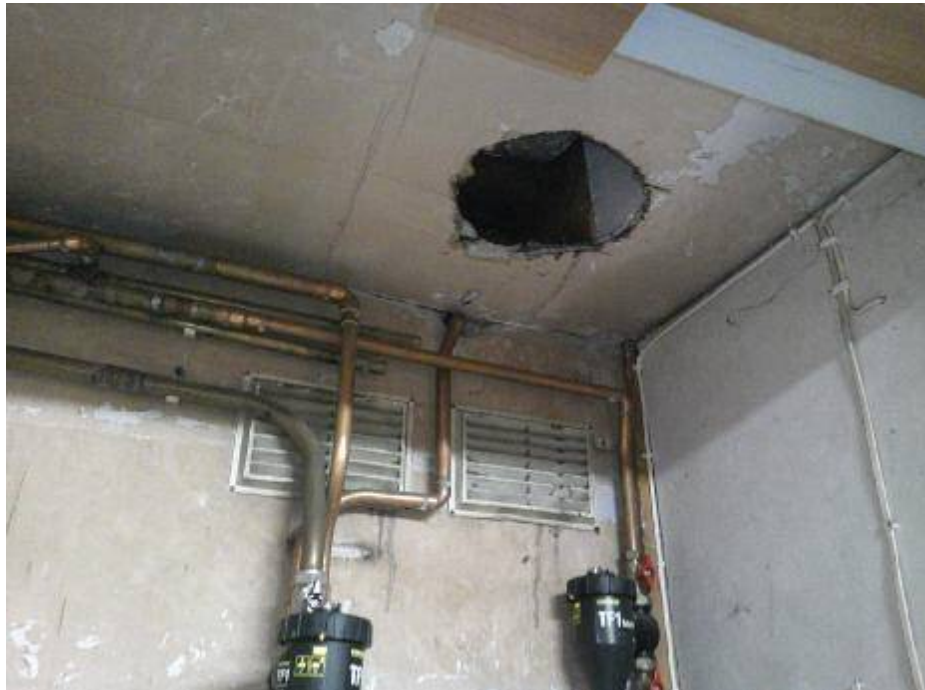
| Product: | Cement flue pipe | Damage: | NADIS |

Asbestos cement flue pipe in boiler cupboard. Found to have been removed on 2023 re-inspection.

No Action Required

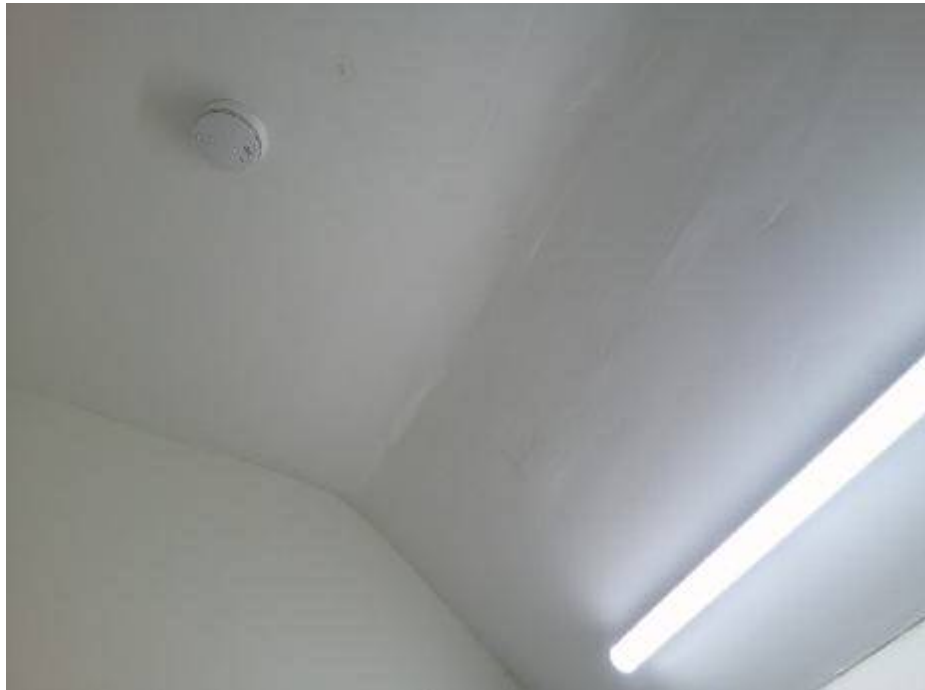
| Product: | Cement board | Damage: | Good condition |

Ceiling panels. Plasterboard ceiling in place on 2023 re-inspection, based on evidence in the loft space strongly presumed still present above.

Apply Warning Labels & Annually Re-Inspect

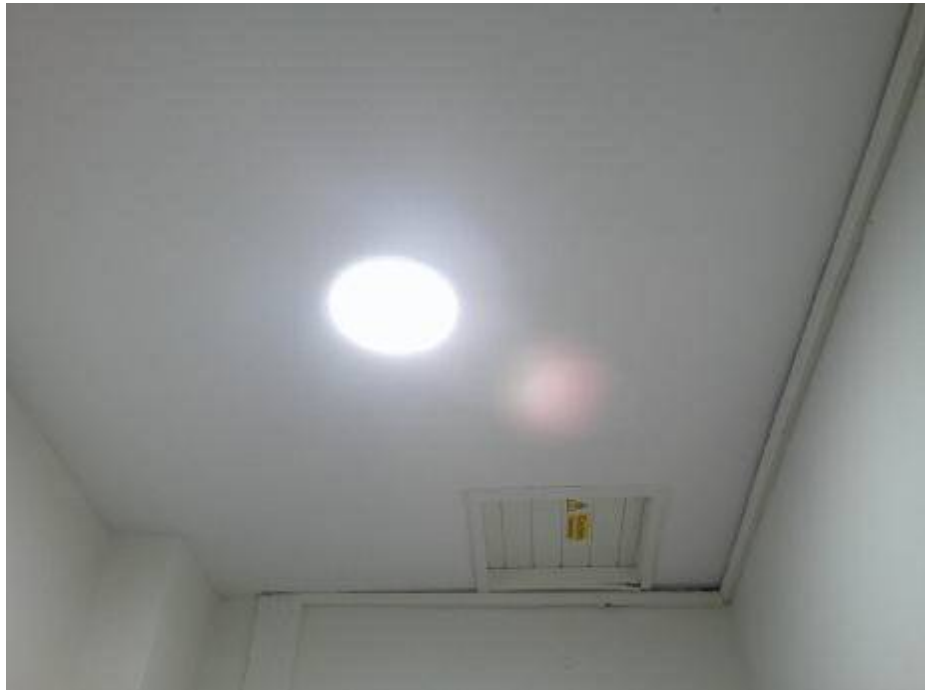
| Product: | Cement board | Damage: | Good condition |

Ceiling panels. Plasterboard ceiling in place on 2023 re-inspection, based on evidence in the loft space strongly presumed still present above.

Apply Warning Labels & Annually Re-Inspect

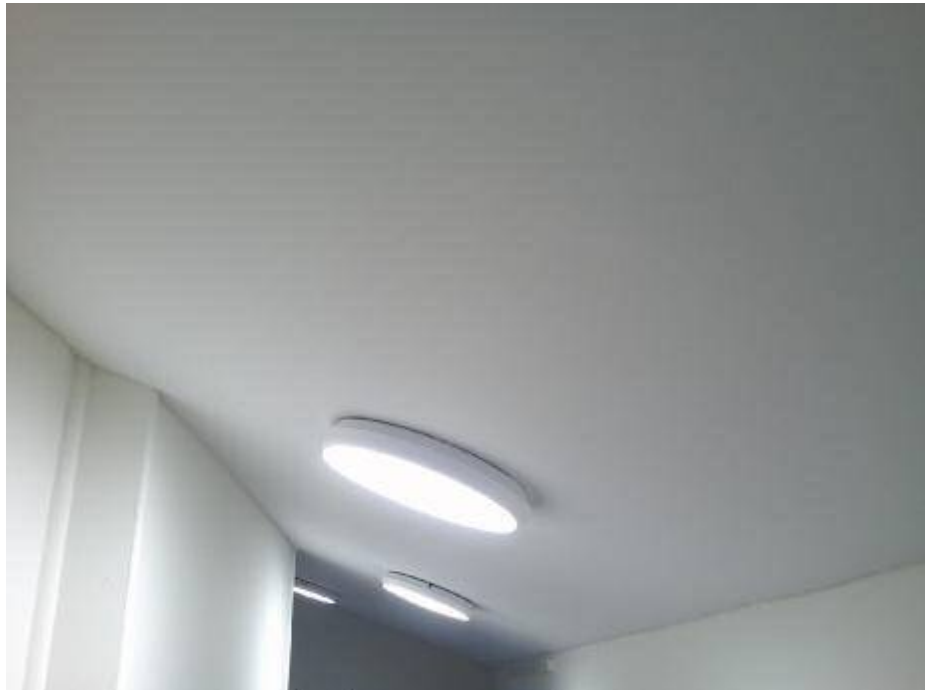
| Product: | Cement board | Damage: | Good condition |

Ceiling panels. Plasterboard ceiling in place on 2023 re-inspection, based on evidence in the loft space strongly presumed still present above.

Apply Warning Labels & Annually Re-Inspect

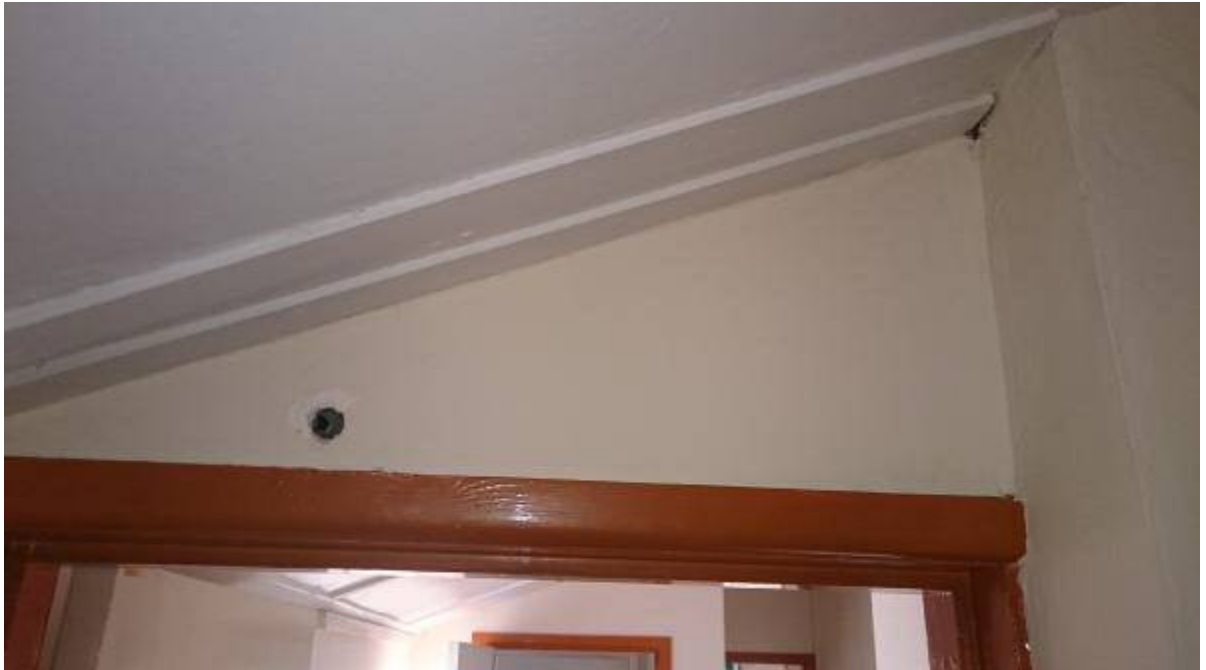
| Product: | Insulation Board | Damage: | NADIS |

Insulation board panel above door.

No Action Required

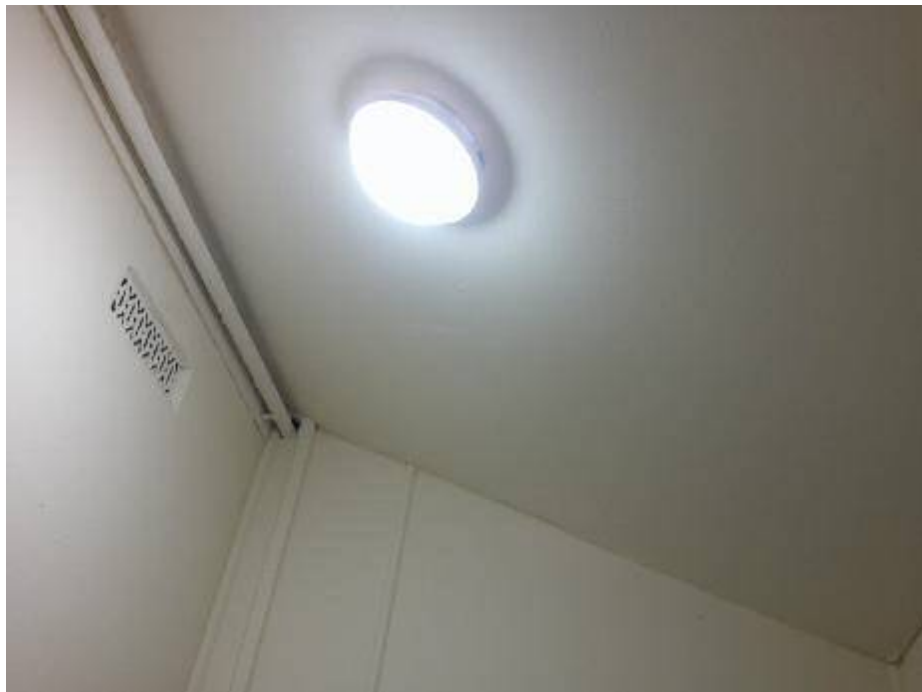
| Product: | Cement board | Damage: | Good condition |

Ceiling panels. Plasterboard ceiling in place on 2023 re-inspection, based on evidence in the loft space strongly presumed still present above.

Apply Warning Labels & Annually Re-Inspect

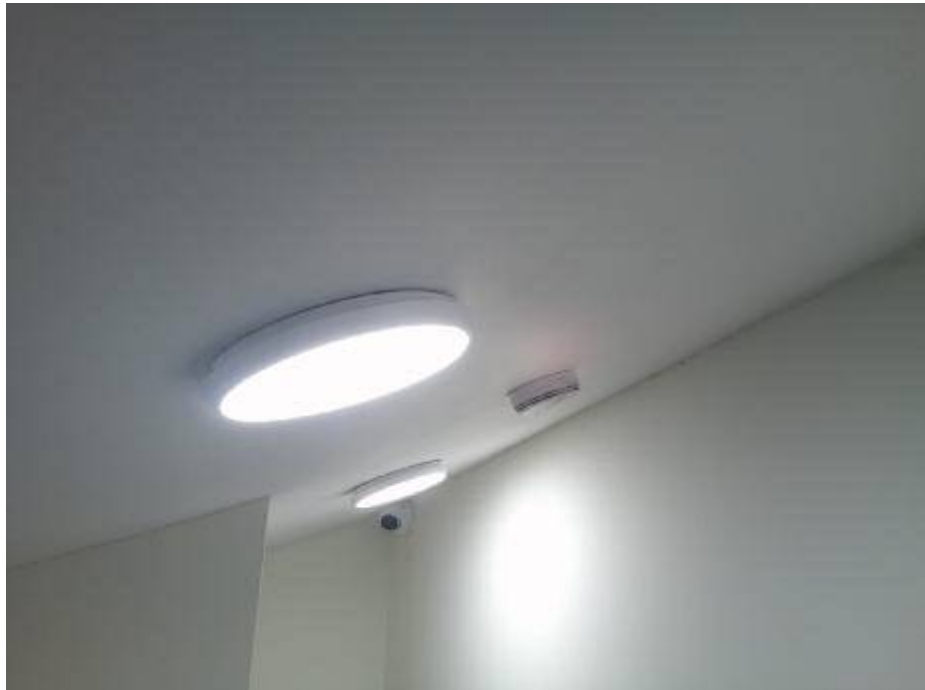
| Product: | Cement board | Damage: | Good condition |

Ceiling panels. Plasterboard ceiling in place on 2023 re-inspection, based on evidence in the loft space strongly presumed still present above.

Apply Warning Labels & Annually Re-Inspect

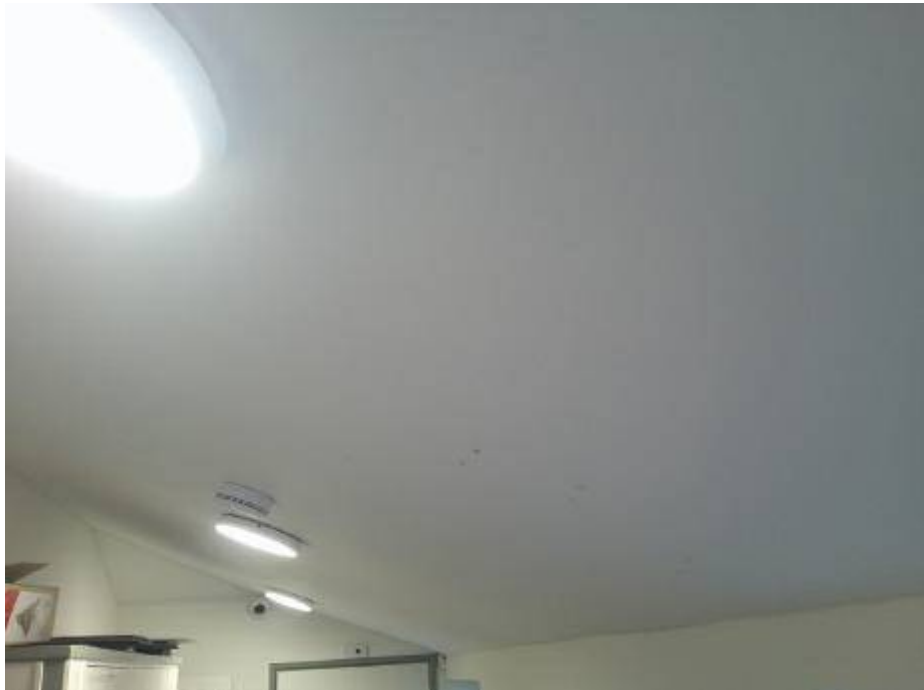
| Product: | Cement board | Damage: | Good condition |

Ceiling panels. Plasterboard ceiling in place on 2023 re-inspection, based on evidence in the loft space strongly presumed still present above.

Apply Warning Labels & Annually Re-Inspect

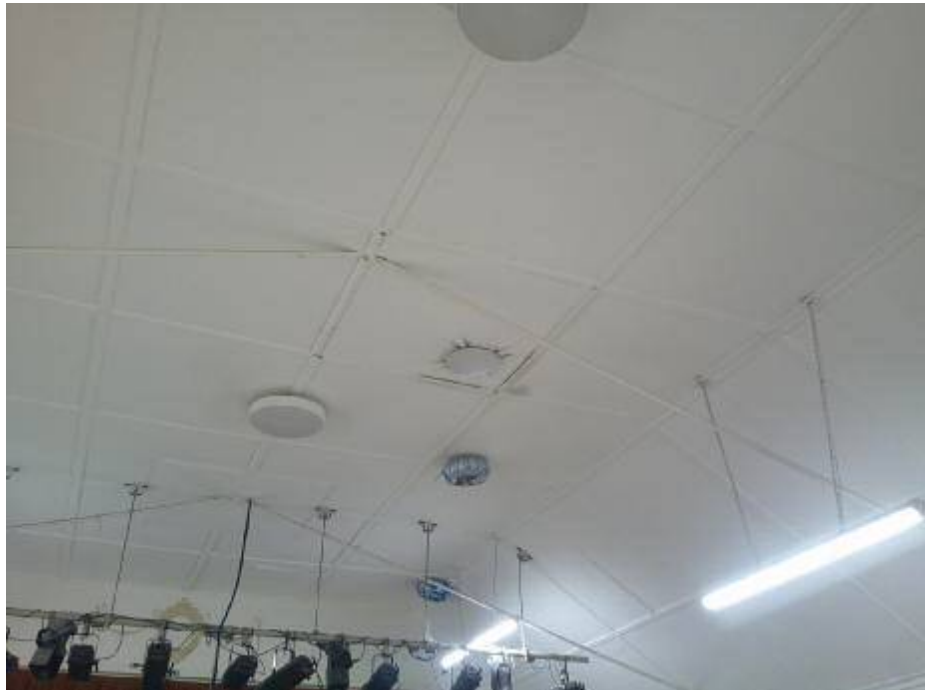
| Product: | Cement board | Damage: | Good condition |

Ceiling panels.

Apply Warning Labels & Annually Re-Inspect

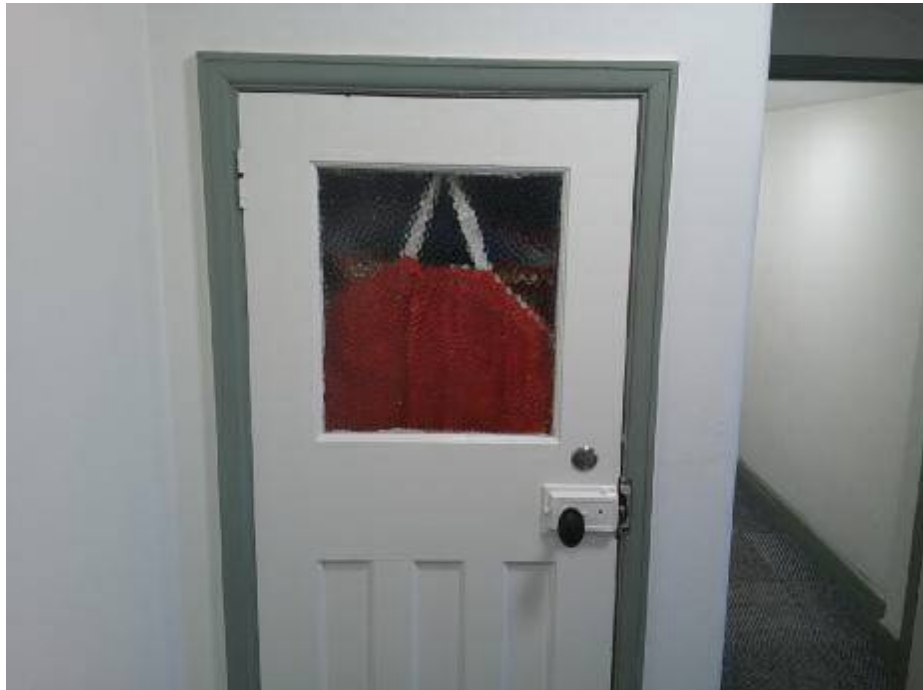
| Product: | Cement board | Damage: | Good condition |

Ceiling panels. Locked at time of inspection so presumed plasterboard ceiling in place on 2023 re-inspection, based on evidence in the loft space strongly assumed still present above.

Apply Warning Labels & Annually Re-Inspect

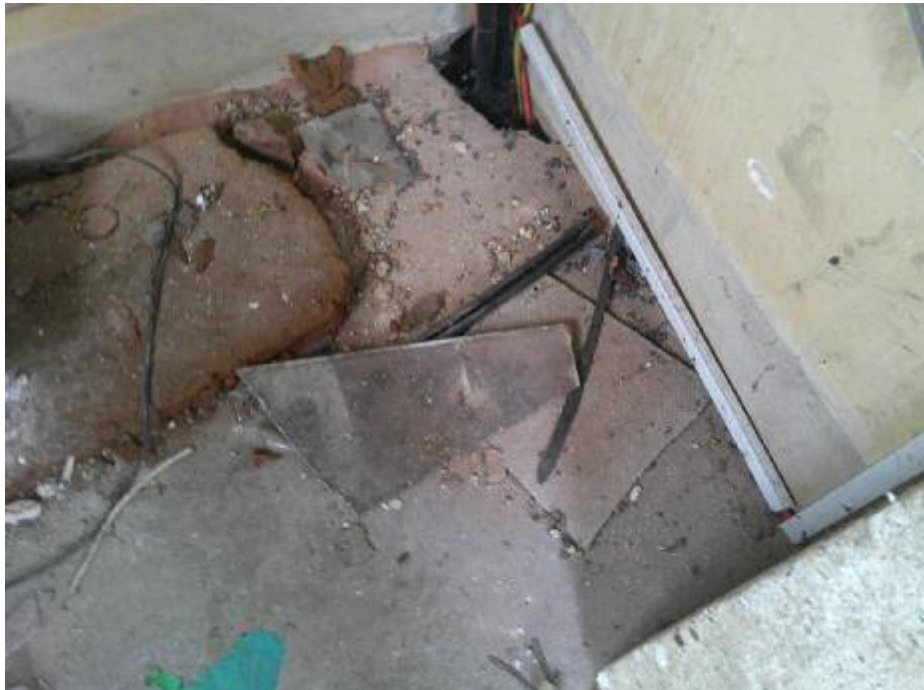
| Location | Product type and name | | Extent | Accessibility | Condition | Surface treatment | Asbestos Type | Sample | Sample no | Material Risk Score | Priority Risk Score | Total Score |
|---|---|---|---|---|---|---|---|---|---|---|---|---|
| 18, Roof, Projector room | Asbestos cement | Cement board debris | Small items strings gaskets | Easy Accessibility | High damage | Debris | Chrysotile | Strongly Presumed | Visual ID | 8 | 1 | 9 |

| Product: | Cement board debris | Damage: | High damage |

Asbestos cement debris to floor of projector room.

| Sample Date | Location Ref | Location ID | Drawing Reference | Area | Floor | Room | Product Name | Material Risk Score | Material Risk Band | Priority Risk Score | Comments | Action | Survey Type |
|---|---|---|---|---|---|---|---|---|---|---|---|---|---|
| 05/01/23 | Visual ID | 18414 | 18 | 18 | Roof | Projector room | Cement board debris | 8 | Medium Risk | 1 | Asbestos cement debris to floor of projector room. | Remove & Dispose Of As Hazardous Waste | RI |

Remove & Dispose Of As Hazardous Waste

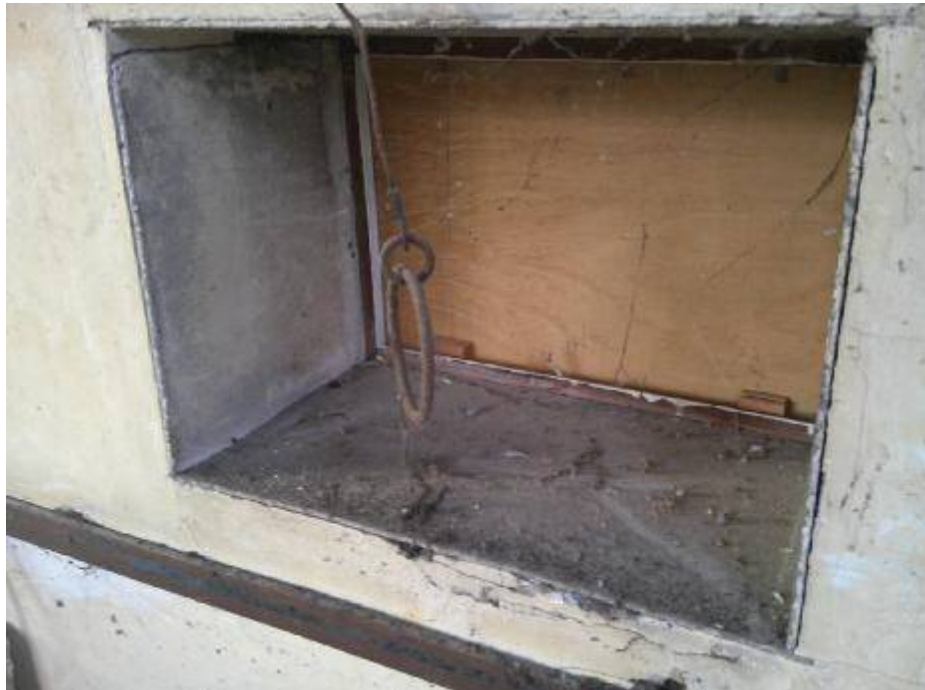
| Location | Product type and name | | Extent | Accessibility | Condition | Surface treatment | Asbestos Type | Sample | Sample no | Material Risk Score | Priority Risk Score | Total Score |
|---|---|---|---|---|---|---|---|---|---|---|---|---|
| 18, Roof, Projector room | Asbestos cement | Cement board | <=10 m² or <=10 m pipe run | Easy Accessibility | Low damage: Scratches or marks | Asbestos cement sheets etc | Chrysotile | Strongly Presumed | Visual ID | 4 | 1 | 5 |

| Product: | Cement board | Damage: | Low damage: Scratches or marks |

Lining panels to voids in wall.

Apply Warning Labels & Annually Re-Inspect

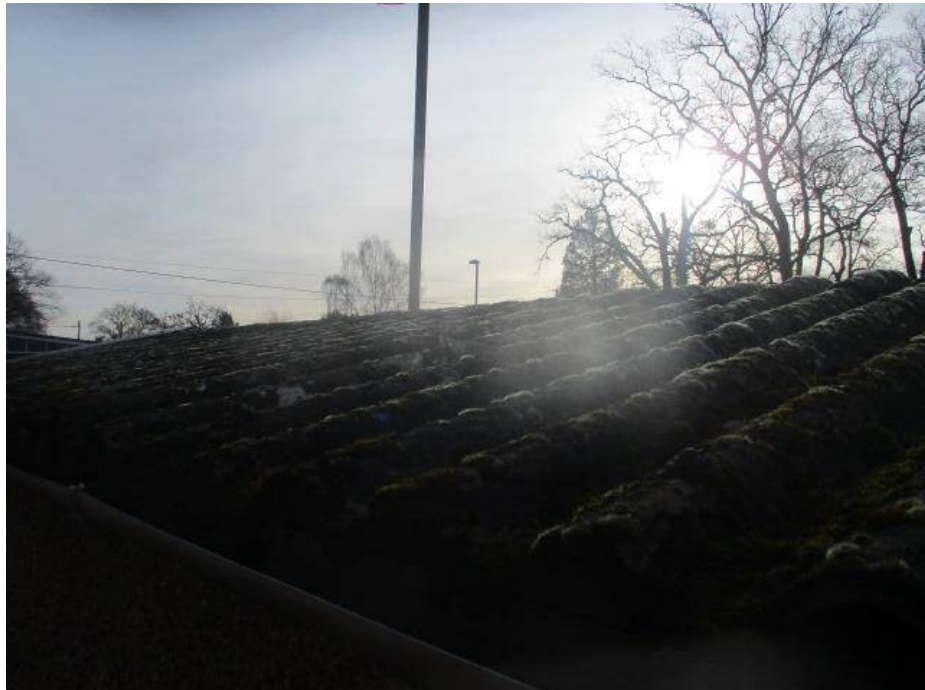
| Location | Product type and name | | Extent | Accessibility | Condition | Surface treatment | Asbestos Type | Sample | Sample no | Material Risk Score | Priority Risk Score | Total Score |
|---|---|---|---|---|---|---|---|---|---|---|---|---|
| 19, External, External | Asbestos cement | Cement Roof Sheets | >10 to <=50 (m² or pipe run) | Medium Accessibility | Good condition | Asbestos cement sheets etc | Chrysotile | Identified | Sample 5 (AS10120) | 3 | 4 | 7 |

| Product: | Cement Roof Sheets | Damage: | Good condition |

Cement roof sheets to shed directly outside exit of area 20.

Annually Re-Inspect

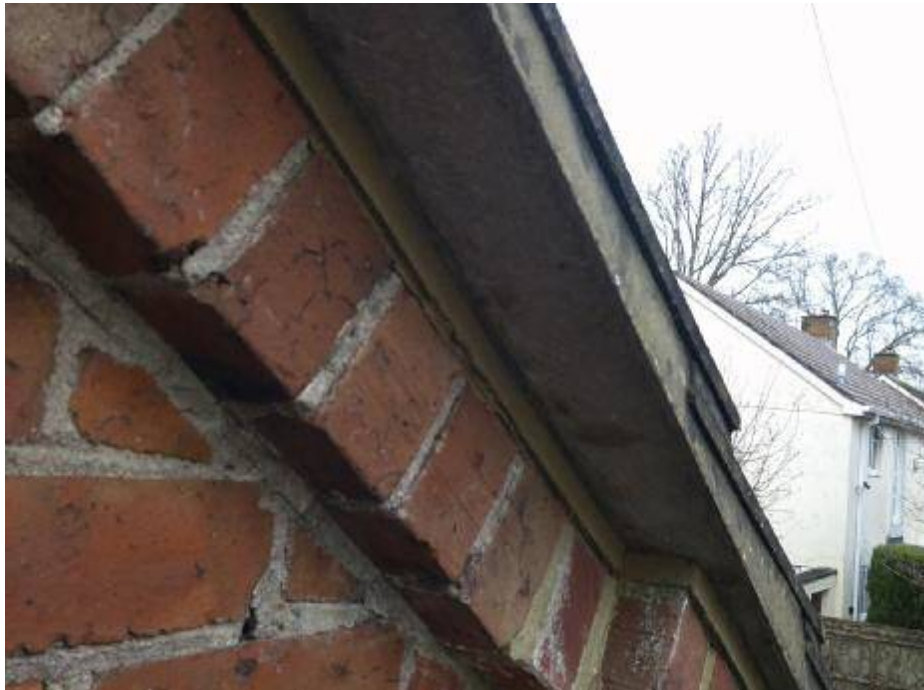
| Location | Product type and name | | Extent | Accessibility | Condition | Surface treatment | Asbestos Type | Sample | Sample no | Material Risk Score | Priority Risk Score | Total Score |
|---|---|---|---|---|---|---|---|---|---|---|---|---|
| 19, External, General externals | Asbestos cement | Undercloaking | >10 to <=50 (m² or pipe run) | Difficult Accessibility | Good condition | Asbestos cement sheets etc | Chrysotile | Strongly Presumed | Visual ID | 3 | 3 | 6 |

| Product: | Undercloaking | Damage: | Good condition |

Asbestos cement board undercloaking to both gable ends.

Annually Re-Inspect

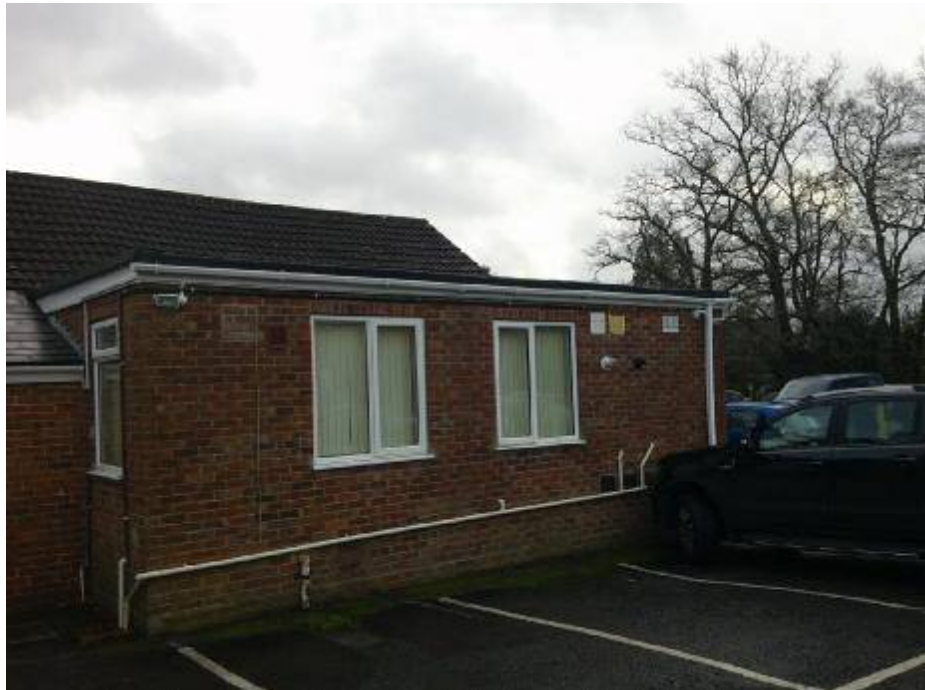
| Product: | Cement flue pipe | Damage: | NADIS |

Asbestos cement flue pipe and chimney cowl. Found to have been removed on 2023 re-inspection.

| Sample Date | Location Ref | Location ID | Drawing Reference | Area | Floor | Room | Product Name | Material Risk Score | Material Risk Band | Priority Risk Score | Comments | Action | Survey Type |
|---|---|---|---|---|---|---|---|---|---|---|--|---|---|
| 05/01/23 | Visual ID | 18417 | 19 | 19 | External | General externals | Cement flue pipe | 0 | NADIS | N/A | Asbestos cement flue pipe and chimney cowl. Found to have been removed on 2023 re-inspection. | No Action Required | RI |

No Action Required

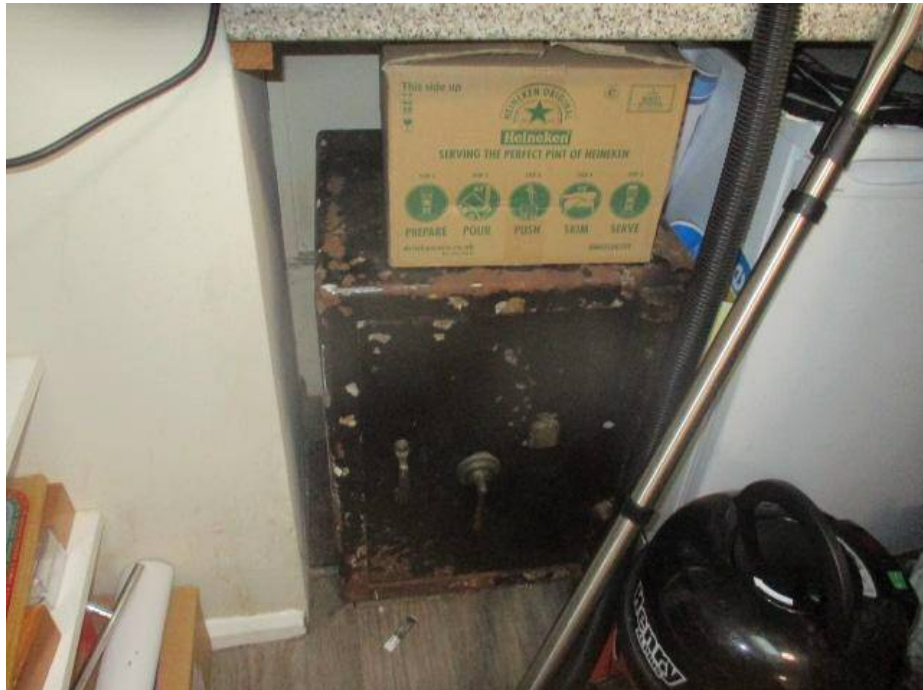
| Product: | Safe | Damage: | Not Applicable |

Safe not accessed. Presumed to have asbestos containing materials within inner workings/lining the door.

Annually Re-Inspect

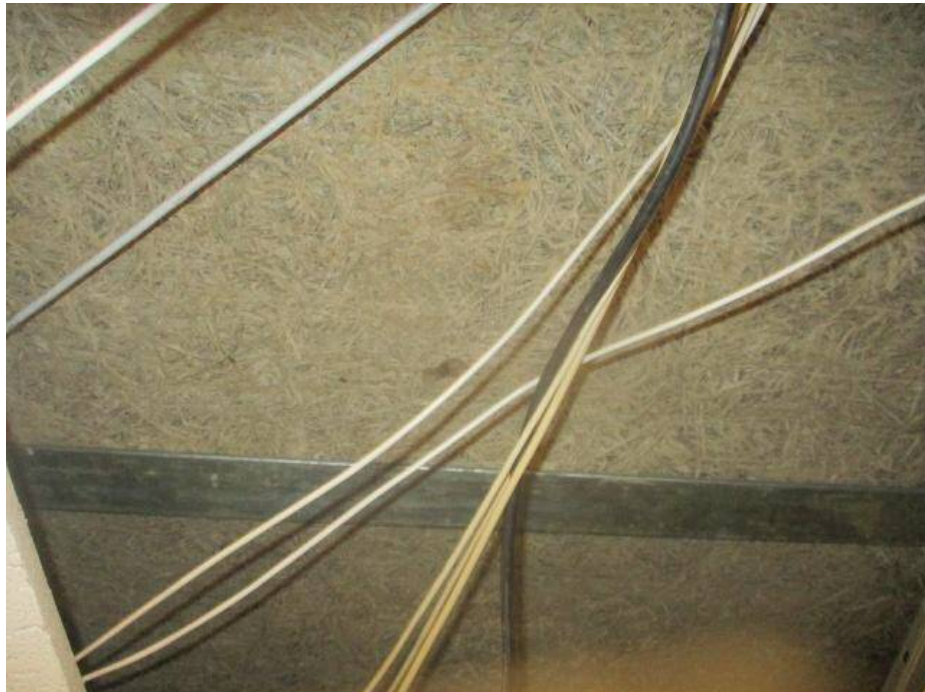
| Product: | Stramit Board | Damage: | NADIS |

Stramit board present above suspended ceiling and overlapping into adjoining areas in ceiling void.

No Action Required

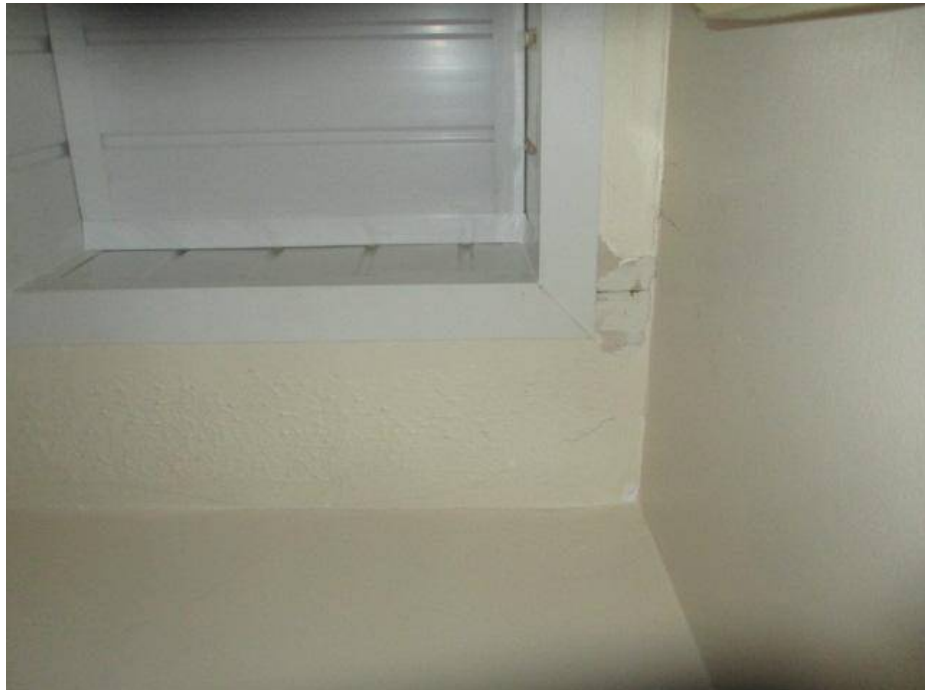
| Location | Product type and name | | Extent | Accessibility | Condition | Surface treatment | Asbestos Type | Sample | Sample no | Material Risk Score | Priority Risk Score | Total Score |
|---|---|---|---|---|---|---|---|---|---|---|---|---|
| 24, Ground floor, Mens Toilet | Textured coatings | Textured coating | <=10 m² or <=10 m pipe run | Medium Accessibility | Low damage | Decorative Paints | Chrysotile | Identified | Sample 2 (AS10120) | 4 | 4 | 8 |

| Product: | Textured coating | Damage: | Low damage |

Textured coating to plasterboard ceiling.

| Sample Date | Location Ref | Location ID | Drawing Reference | Area | Floor | Room | Product Name | Material Risk Score | Material Risk Band | Priority Risk Score | Comments | Action | Survey Type |
|---|---|---|---|---|---|---|---|---|---|---|---|---|---|
| 03/02/23 | Sample 2 (AS10120) | 71875 | 24 | 24 | Ground floor | Mens Toilet | Textured coating | 4 | Very Low Risk | 4 | Textured coating to plasterboard ceiling. | Encapsulate Damaged Areas & Annually Re-Inspect | RI |

Encapsulate Damaged Areas & Annually Re-Inspect

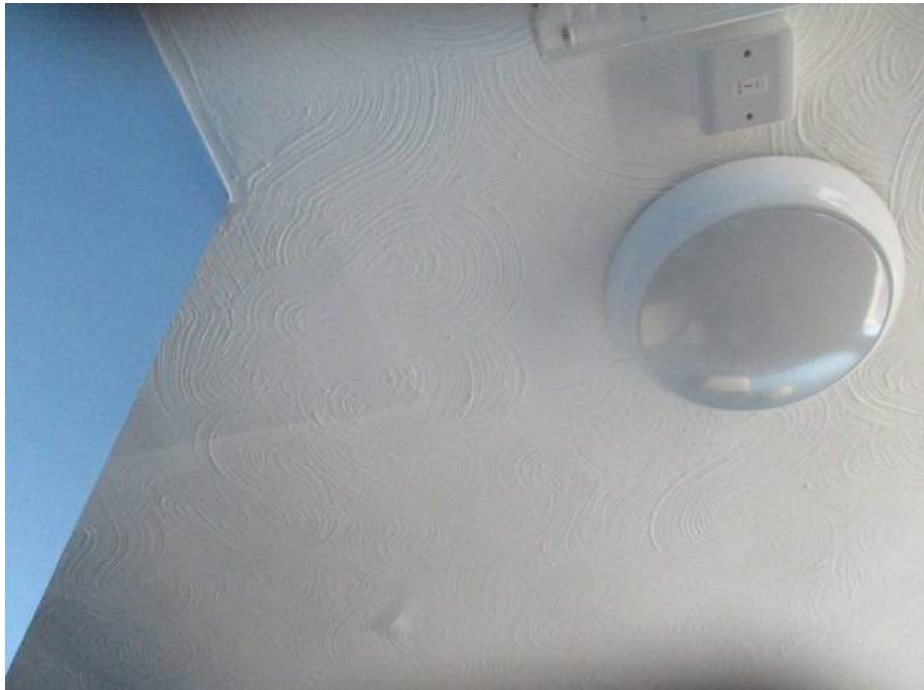
| Product: | Textured coating | Damage: | NADIS |

Material Comments: Textured coating to plasterboard ceiling.

Action: No Action Required

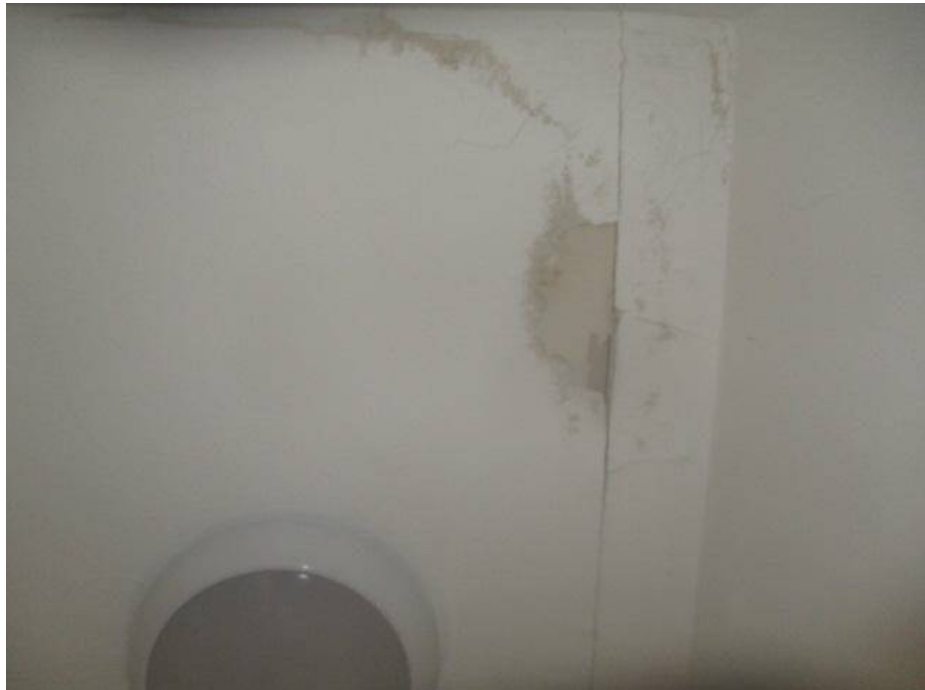
| Product: | Textured coating | Damage: | NADIS |

Textured coating to plasterboard ceiling.

No Action Required

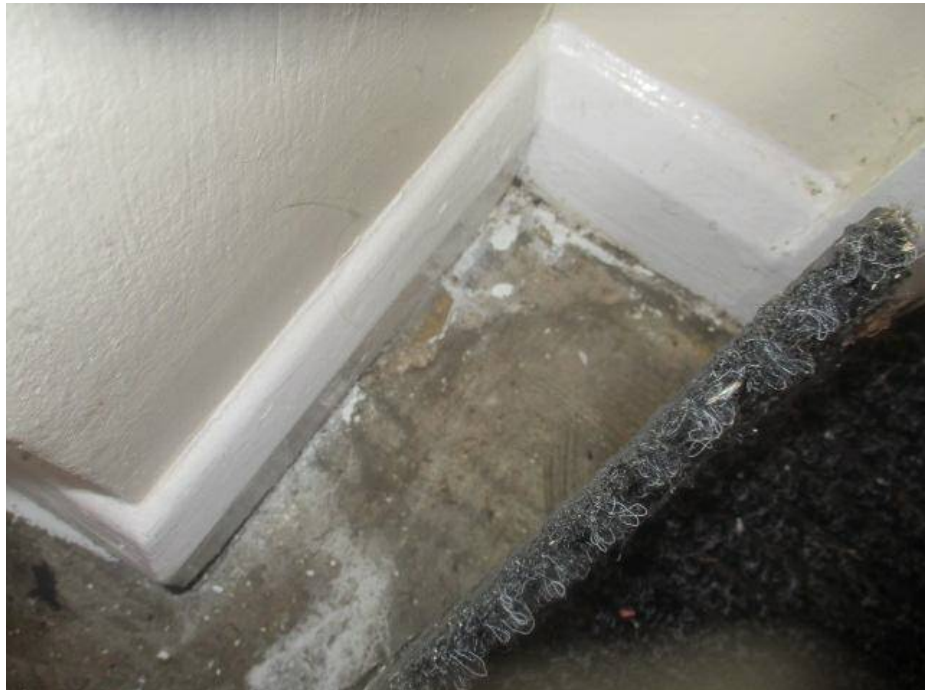
| Product: | Floor tiles | Damage: | NADIS |

Floor tiles under fitted carpet.

No Action Required

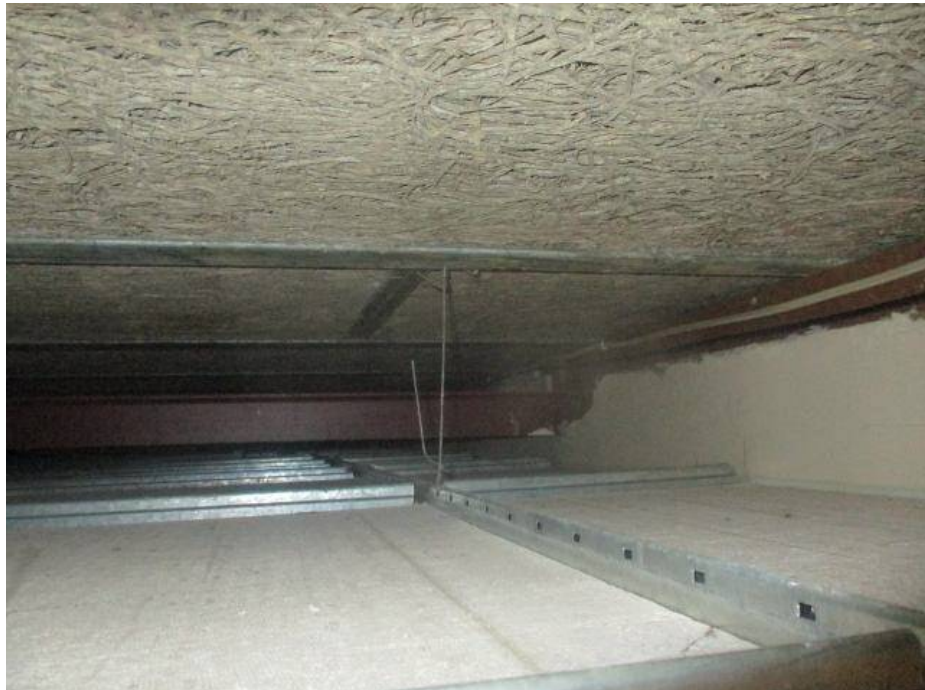
| Product: | No Asbestos Found | Damage: | Not Applicable |

Void above suspended ceiling accessed in multiple areas. No ACM's present where inspected.

| Sample Date | Location Ref | Location ID | Drawing Reference | Area | Floor | Room | Product Name | Material Risk Score | Material Risk Band | Priority Risk Score | Comments | Action | Survey Type |
|---|---|---|---|---|---|---|---|---|---|---|--|---|---|
| 03/02/23 | Visual ID | 71872 | | Throughout | Ground floor | Throughout | No Asbestos Found | 0 | Not Applicable | N/A | Void above suspended ceiling accessed in multiple areas. No ACM's present where inspected. | No Action Required | RI |

No Action Required
