FELBRIDGE PARISH COUNCIL

16th October 2023

EA Ref: HA/2022/124189/04-L01

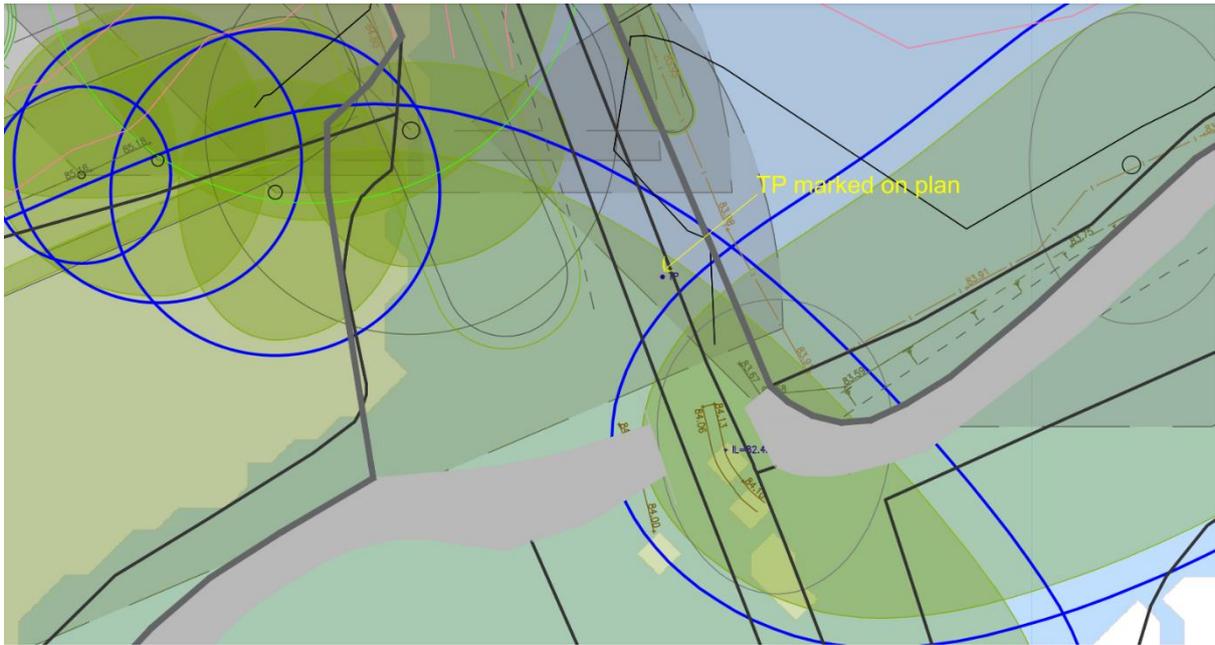
Figure 1: Site Plan showing position of Telegraph Pole

Please find below our evidence that the flood events observed frequently within the last decade exceed the 20 year event modelling. See figures 1, 2 and 3 which identify the position of the telegraph pole on the north side of Bridge 1 using the applicant's site plans. Figure 3 has used GIS mapping to identify the position of this pole in relation to the extract of the flood modelling.

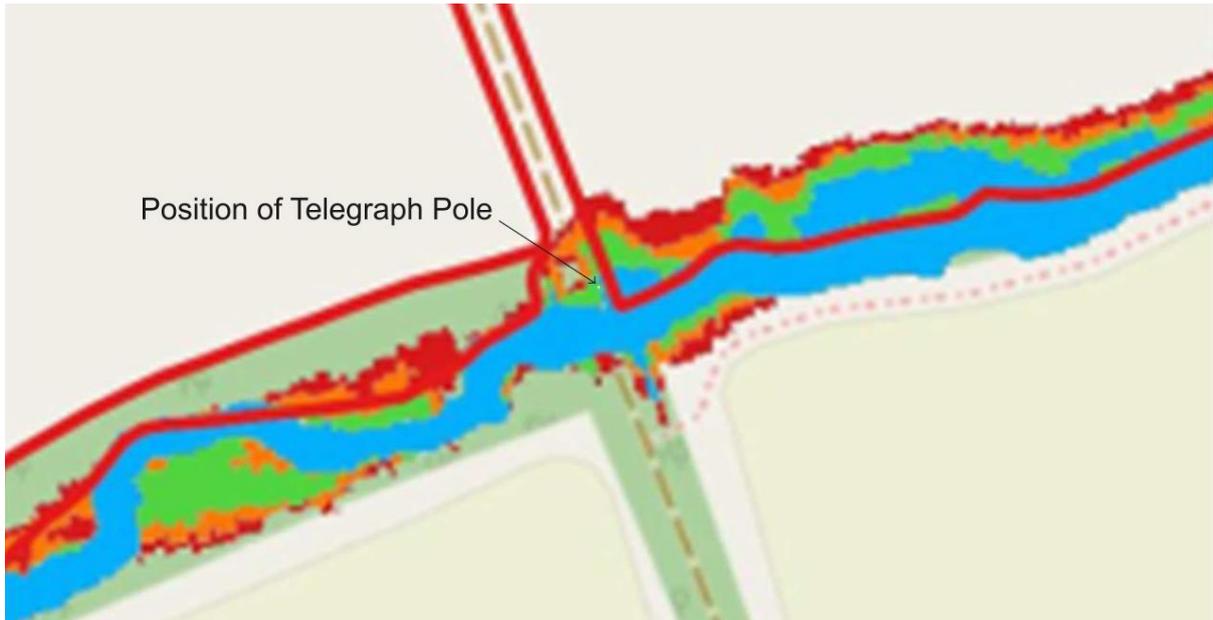
Figure 3: Position of Telegraph Pole superimposed upon the detailed extract of the flood modelling provided as Figure 2 in A359 - TN004 dated 19/9/23. Blue is the 20yr event, Green is the 100yr event.

Thus, the hydraulic modelling of the 20 year event (Figure 3) shows that the northern extent of flooding of the bridleway does not reach the telegraph pole. This is contrary to the flood event photographs in Appendix A which clearly show five photographed flood events in the last 17 years that extend to the telegraph pole and more often much beyond it. In fact, the flood extent photographed on 6th November is close to the 100 year event modelling shown in figure 3.

We therefore continue to recommend that RPS are asked whether their hydraulic model is adequately predicting the frequency and extent of the flooding when compared to the photographic evidence. As they are the hydraulic modelling experts, we believe it is reasonable that RPS provide a response regarding this matter, rather than a third party interpreting the output of their model.

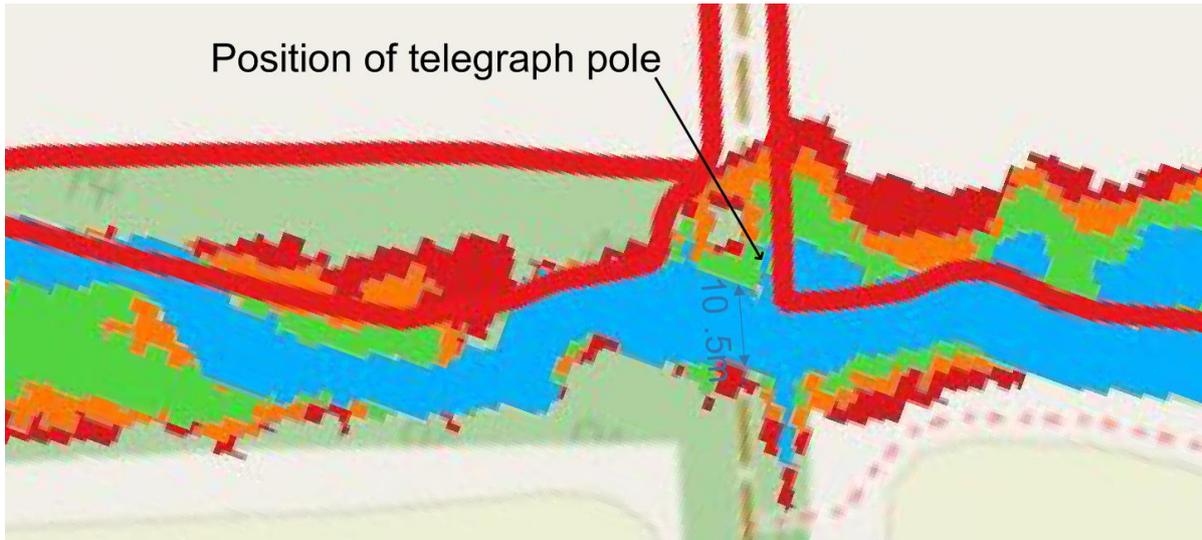
Figure 4 measures the approximate flooded extent of the bridleway from the modelling, the pixilation of the model means that this is an approximate flood width +/-1m. However, the photograph in Appendix B looking south and the February 2014 photograph in Appendix A shows the southern extent of the flood events reaching very close to the old gate post which is 14m from the telegraph pole.

Therefore, we have at least two events within the past 19 years where the flooded extent has reached at least 14m which is far greater than the approximate 10m extent suggested by the hydraulic model for 1 in 20 year event.

Figure 4: Showing the approximate measurement of the extent of the 20yr event flooding

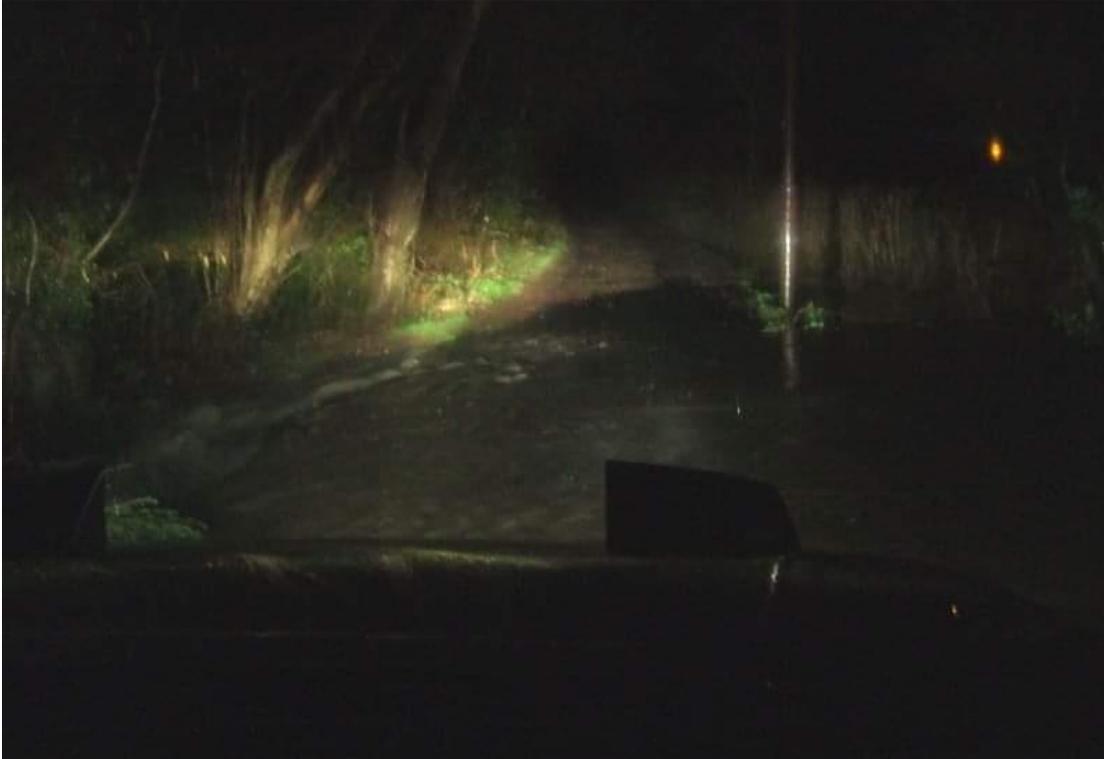
March 2006

Public Photographs of flood events all of which were taken looking north with the telegraph pole clearly visible on the right of the photograph.

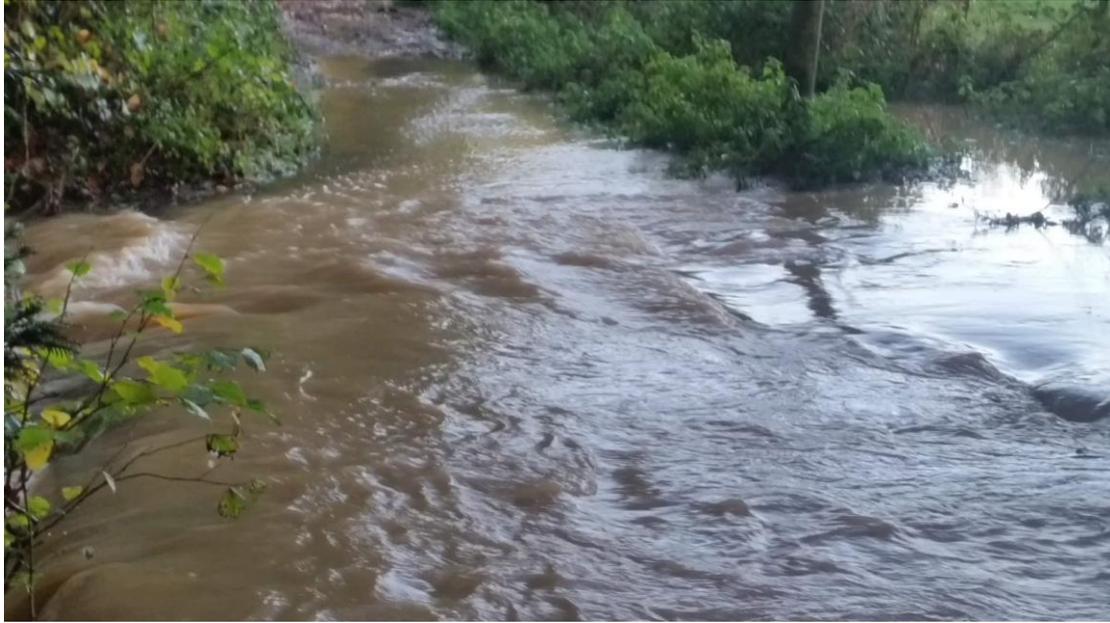
Considering that the photograph in Appendix 2 shows the water level reaching near to the old gate post on the south and also close to the telegraph pole on the north, it has to be assumed that the southern flooded extent was further for the event photographed on 6th November 2022 in Appendix 1 as the northern extent was considerably beyond the telegraph pole.

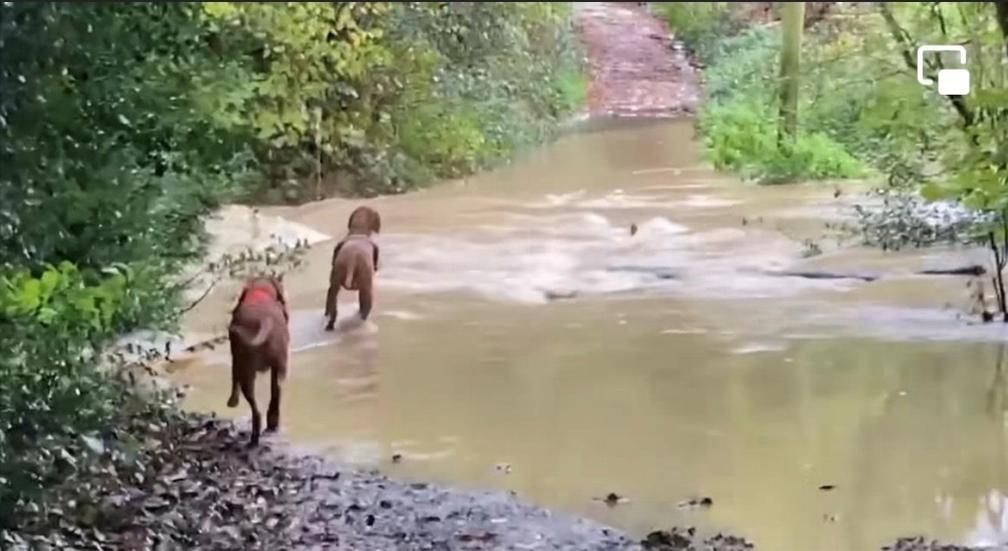
Be very careful if you're walking from the playfields in Felbridge down the lane towards Gulliage house as this flow of water is deeper than it looks. Shortly after this my dog was washed into the pond. He's fine but would be dangerous for small children and dogs

A photograph showing two dogs wading through a shallow stream. The water is brown and turbulent. The dogs are seen from behind, moving away from the camera. The stream is surrounded by green foliage and trees. A small white icon of a document is visible in the top right corner of the photo.

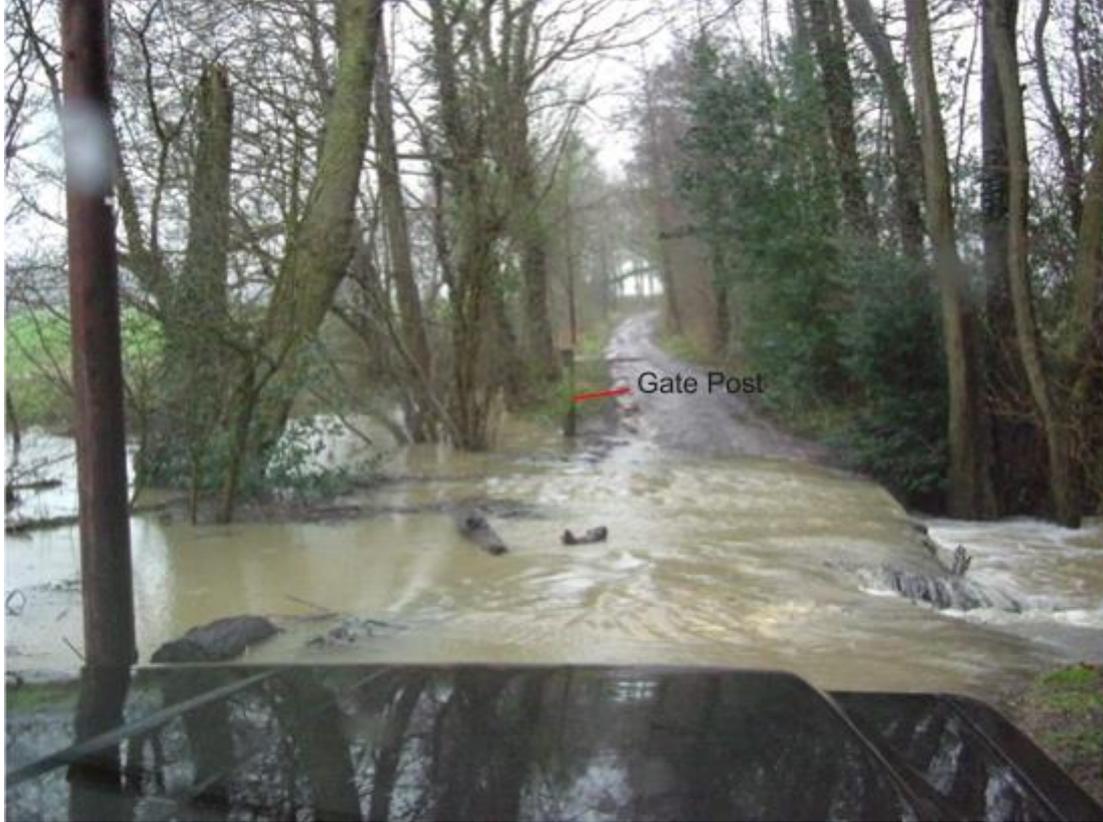
February 2004

Public Photograph of flood event looking south
