PRELIMINARY REPORT REGARDING ONGOING AND FUTURE FLOOD PREVENTION IN CHIDEOCK.

The floods of Dec.19th and later in Feb. served to highlight a longstanding issue in Chideock as well as drawing attention to some others.

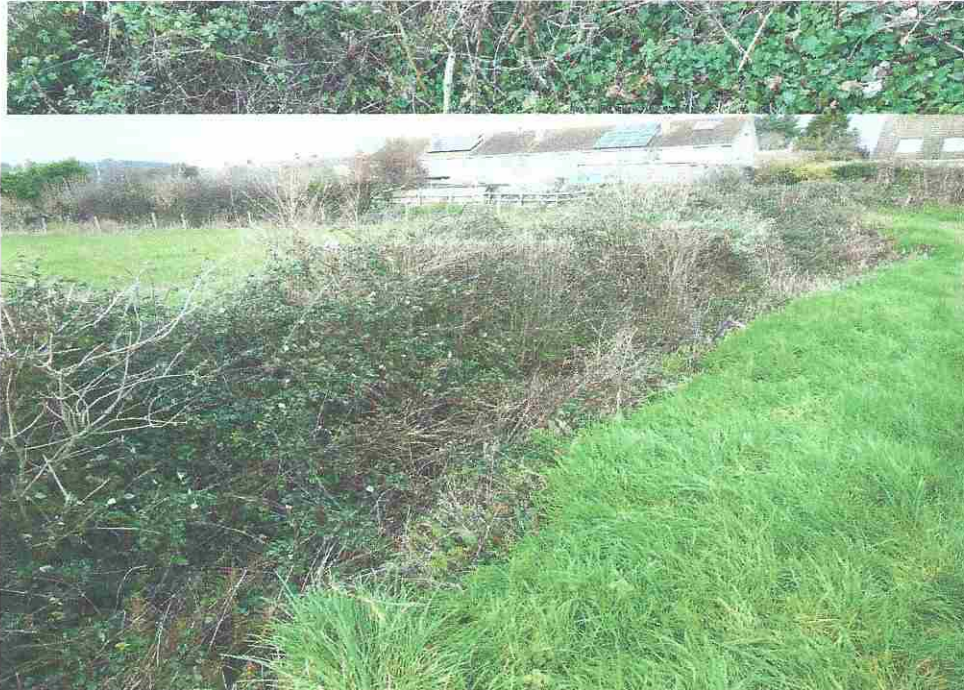
The walk commenced with FP17.

As can be seen the watercourse is in need of attention,bearing in mind it is the route of surface water drainage from Park Farm and above as well as Quarr Hill. Riparian ownership is being investigated hopefully those responsible for its upkeep will commence upkeep.

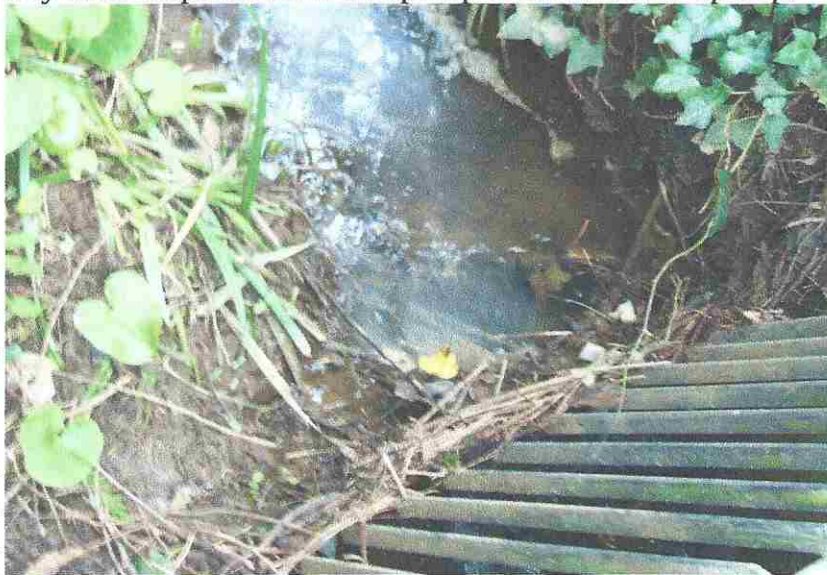
Crossing A35 the private road to the Firs checked the culvert which blocks leading to flooding rear of Park Farm Cottage.

Agreed the watercourse itself is in need of restoration.The grid is a necessity to prevent debris washing further into and blocking

culverts downstream. Requiring frequent clearance,again the ownership is being sought as it appears it may be on private land.

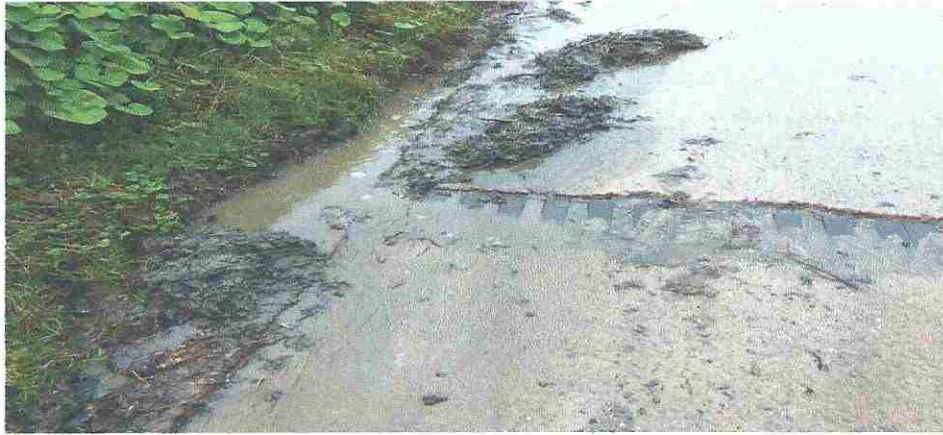
To Park Farm Rd has a grid to deflect run off from beyond, completely full of silt,requires simply lifting and 10 minutes with a shovel.

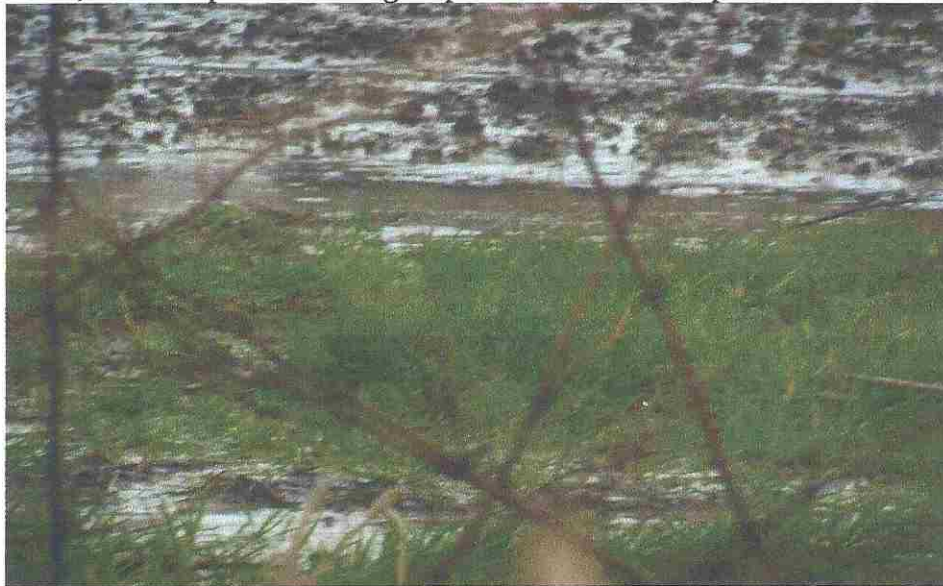
Housekeeping at the farm, slurry by lower barn containing oily deposit which in wet periods washes directly into stream, sheets of plastic waiting disposal which ended up blown into the watercourse.

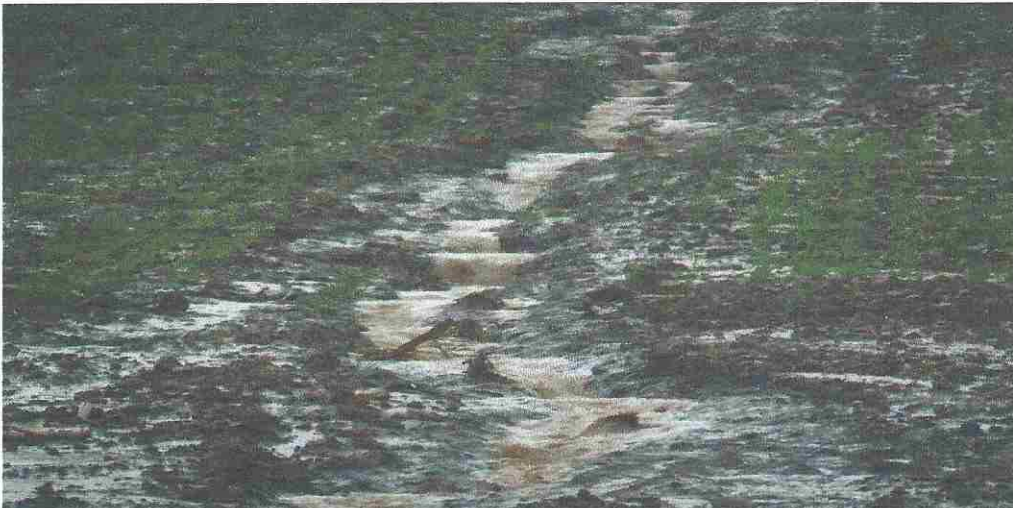
MEADOW.

Run off in progress, the above pictures refer to the earlier paragraphs regarding soil and its management. Taken recently they serve to highlight seriously bad land management going against all advice. Visible capping of almost the entire field.

Maize should never be grown on poor draining soils, it is impossible to harvest without damaging soils.

Level fields should be used to avoid channelling water downslope. Timely management, harvesting

early autumn followed by deep ploughing to loosen compacted soil then early drilling to ensure good crop cover before onset of wet winter months.

Just following simple recommendations would I feel sure go massively to removing future risk of run off from the meadow. Perhaps the benefits of growing winter wheat could be looked at.

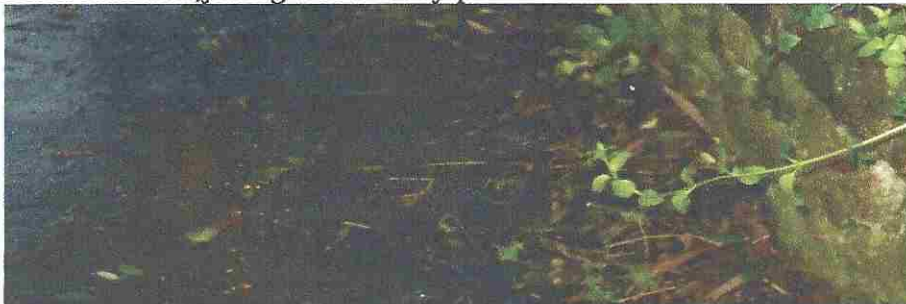
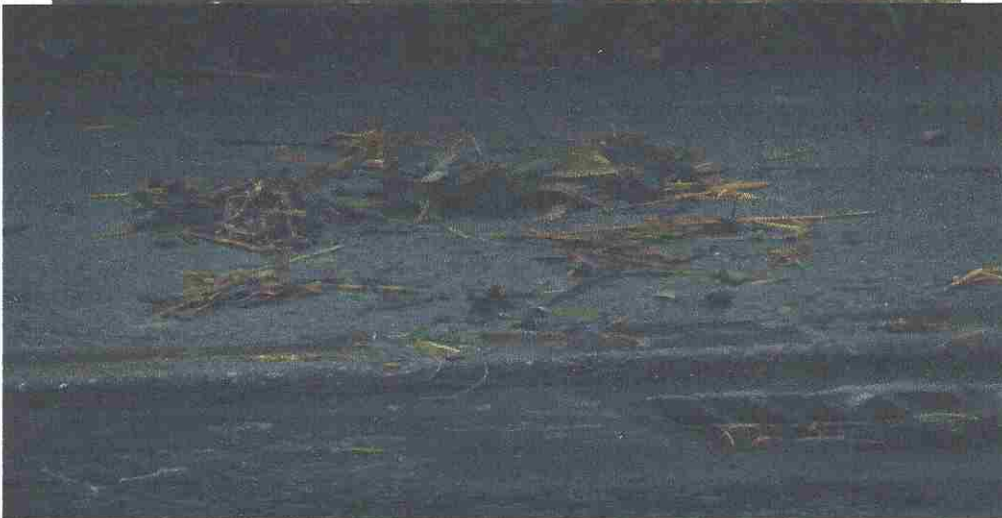
I requested
footpath
clearance. The
picture an
example of
what will end
up blocking a
drain cover.

They are
aware of
the failing

embankment Quarr Hill and Spring surface planeing should rectify many pothole problems.
