Oakley Traffic Information Survey

Report number 2
Survey location - St John's Road
February 2019
Revision number 3

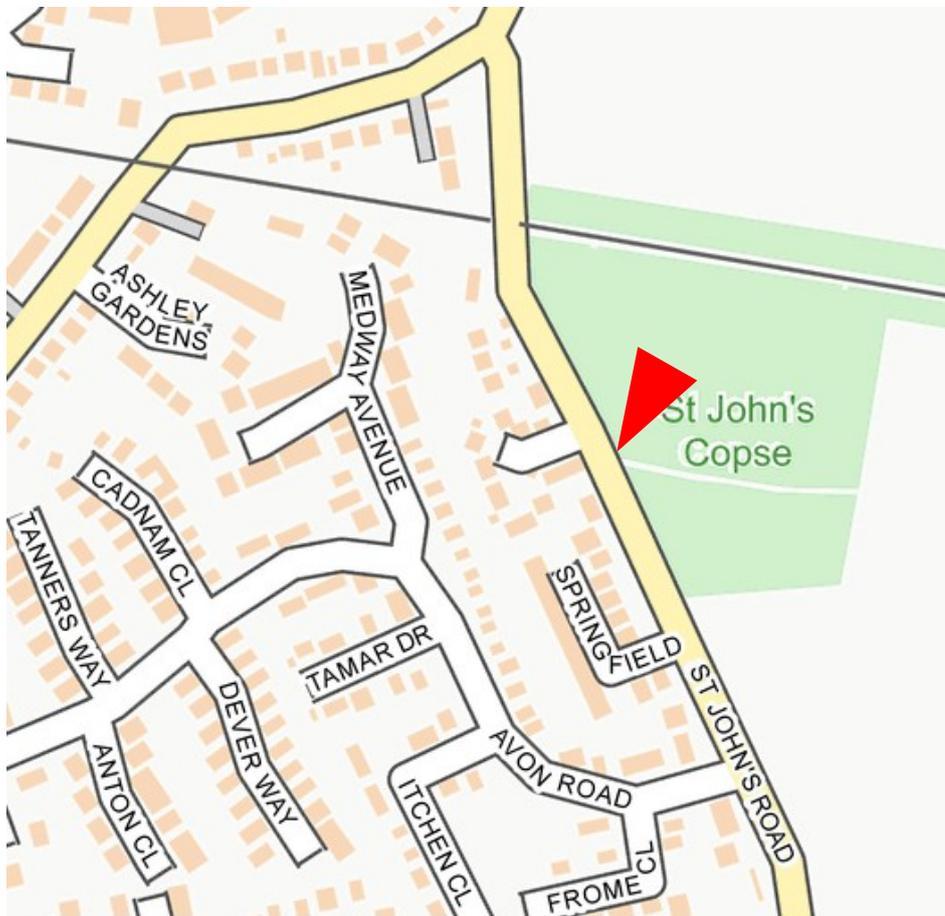
Figure 1: showing OTIS's location

This survey was made using a Viacount II device, known as OTIS (Oakley Traffic Information Surveyor), mounted on lamp post no 10 (GPS° 15.109' N, 001° 10.175' W) in St John's Road Road, Oakley.

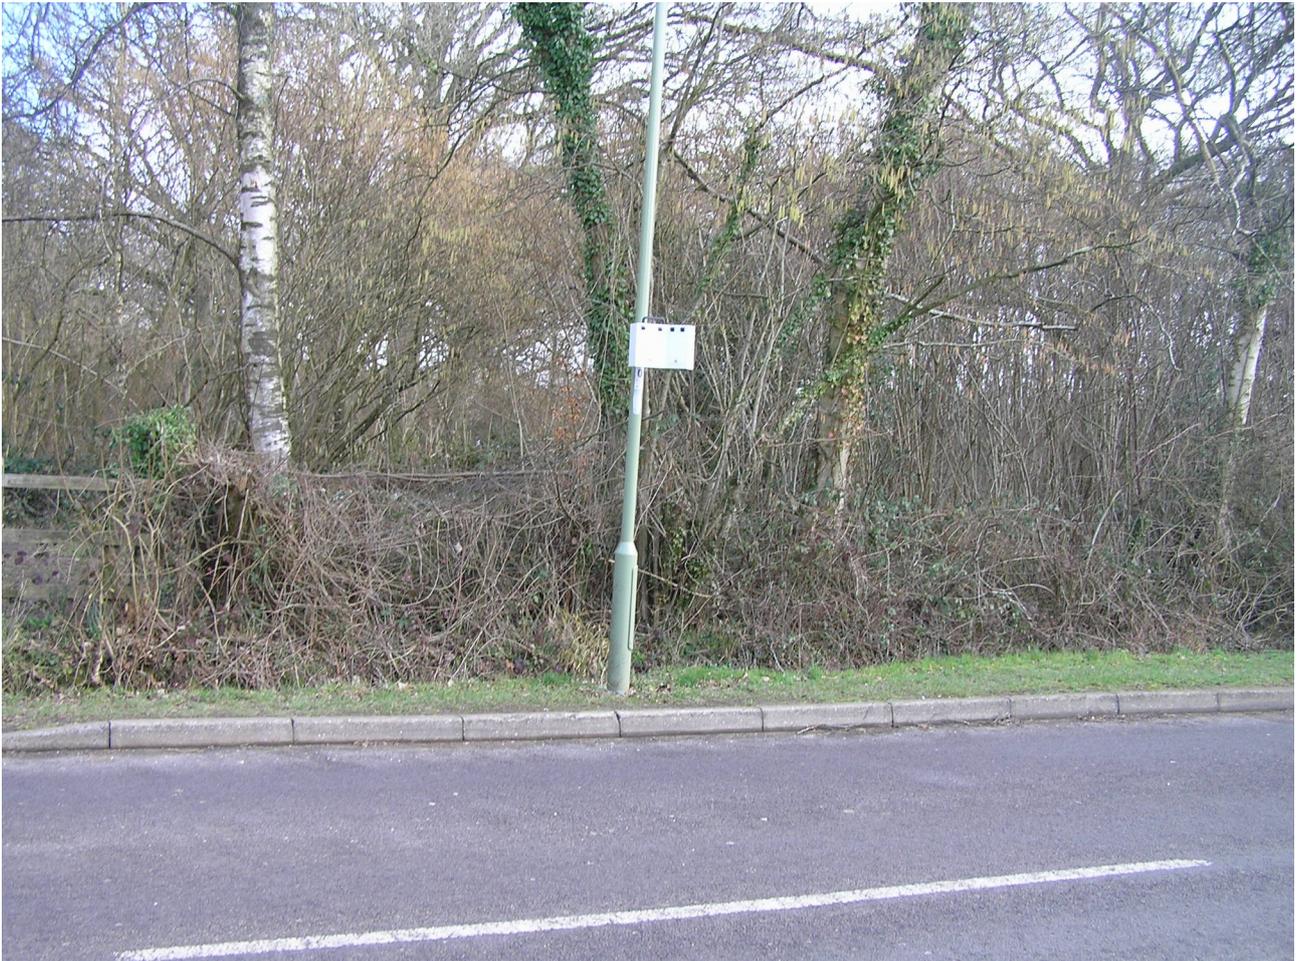
Figure 2: OTIS on lamp post 10 in St John's Road

Mounting height – lower edge of Viacount II device approximately 2.25m from ground level.

Distance from near kerb – approximately 1m

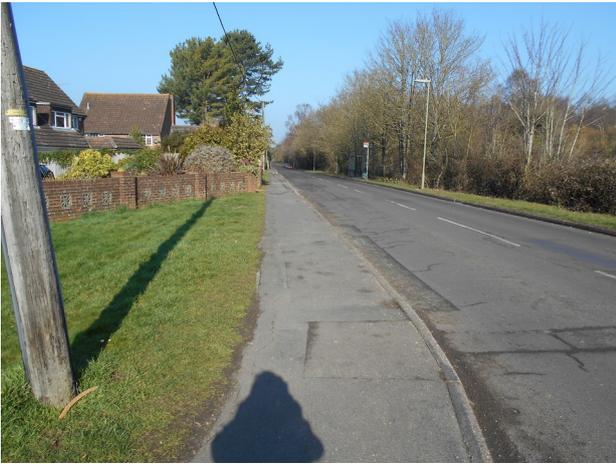
Figure 11: St Johns Road looking north

Speeding is clearly a significant problem with speeds in the mid 40s being common and with many speeds in the low 50s recorded. The maximum recorded speed was 70mph: over twice the speed limit! This is a stretch of straight road with good visibility as shown in figures 11 and 12. Being open to the countryside on one side, it gives the impression of not being a speed restricted road. Modern cars are easy to drive, have excellent braking and acceleration characteristics which can easily lull drivers into a false sense of security.

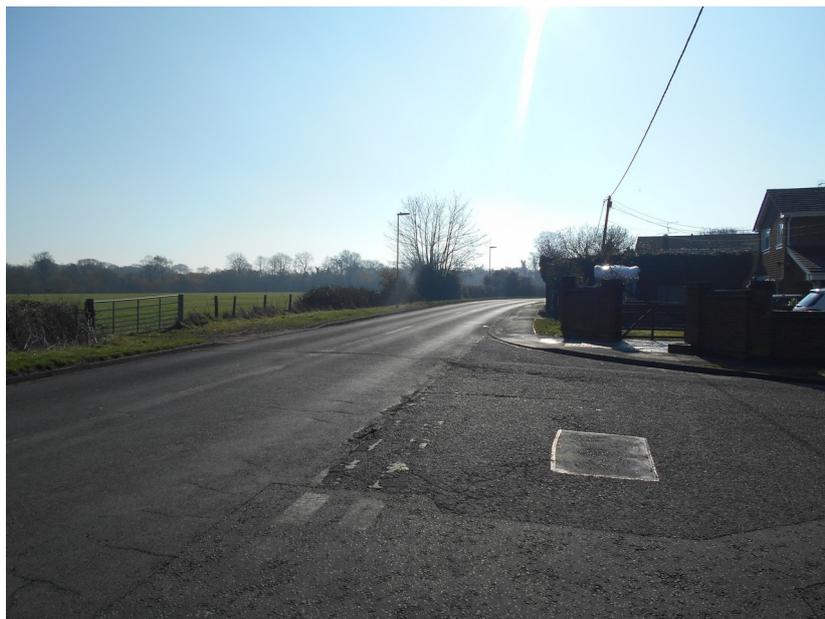
Figure 13: looking south from the Avon Road junction

For drivers attempting to join St John’s Road from Avon Road and Matthews Way, approaching traffic speed poses a problem. The sight line looking south from the junctions is very restricted as the road curves to the right as shown in figure 13. Consequently, traffic travelling north at speed can easily conflict with vehicles emerging from Avon Road or Matthews Way. Similar conditions exist at The Greenaways and Springfield but to a lesser extent because the sight lines are better.

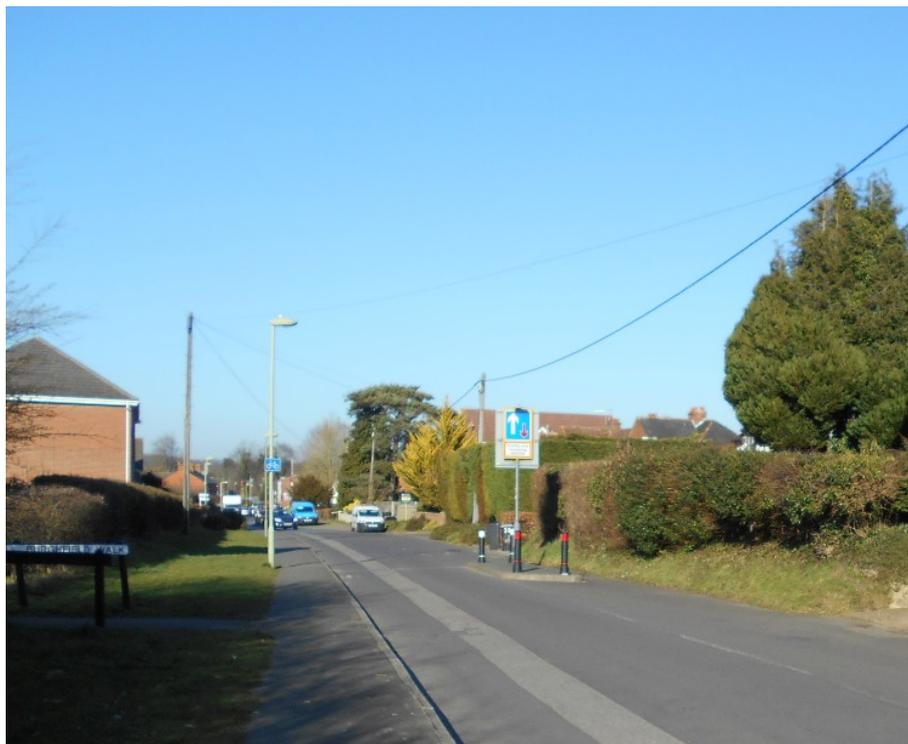
Figure 14: general view of a typical pinch point

- Sleeping policemen and road humps (such as are used in Pack Lane east of Fiveways Junction). These encourage drivers to slow down but have the disadvantages that vehicle suspension can be damaged and pollution is increased as drivers slow down to cross them and then accelerate away. They also require regular maintenance as traffic gradually breaks the surface down. Another disadvantage seen in some areas where humps have been deployed is that young drivers in particular, see them as an opportunity to have a "white knuckle ride" by driving over them at excessive speed.
- Pinch points are much more effective by restricting traffic flow in one direction. By using alternate pinch points with controlled traffic priority, traffic flowing in each direction is restricted. Figure 14 shows a typical example.

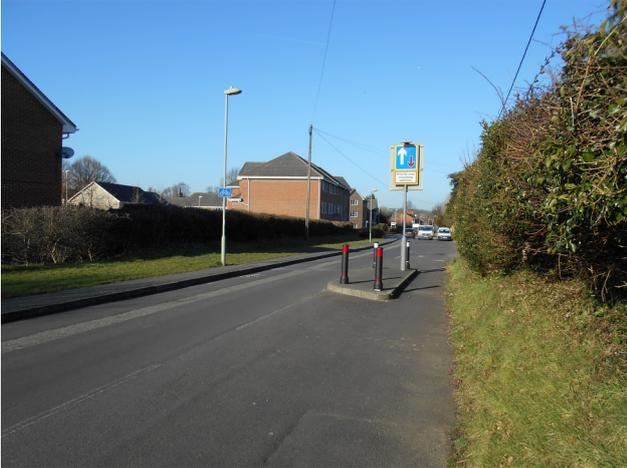
Figure 15: traffic from this side has priority

These are cheaper to construct and require minimal maintenance. They can cause frustration during peak flow times with drivers having to wait for oncoming traffic. Figures 15 and 16 below show how traffic priorities are controlled.

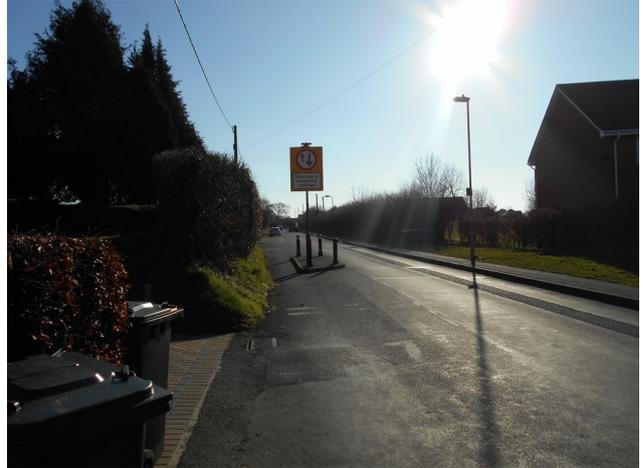
Figure 16: traffic from this side must give way to oncoming vehicles

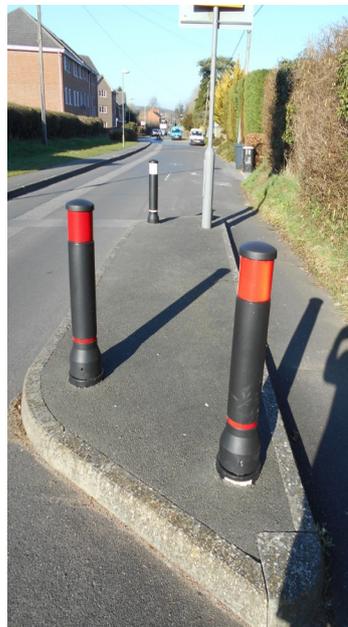
Figure 17: showing pinch point construction and the two wheeler/pedestrian lane

Construction of a pinch point is very simple. Kerb stones are laid to form a base which is filled with tarmac. Bollards are placed at each "corner" to emphasise the pinch and a pole mounted sign shows the traffic priorities. A through lane can be left clear for 2 wheelers and pedestrians.
