**Environment Agency – Southern Region  
Hampshire and Isle of Wight Area**

**Winter 2002-2003 Flooding in Hampshire  
Thruxton**

**June 2005**

*Groundwater Flooding in Hampshire*

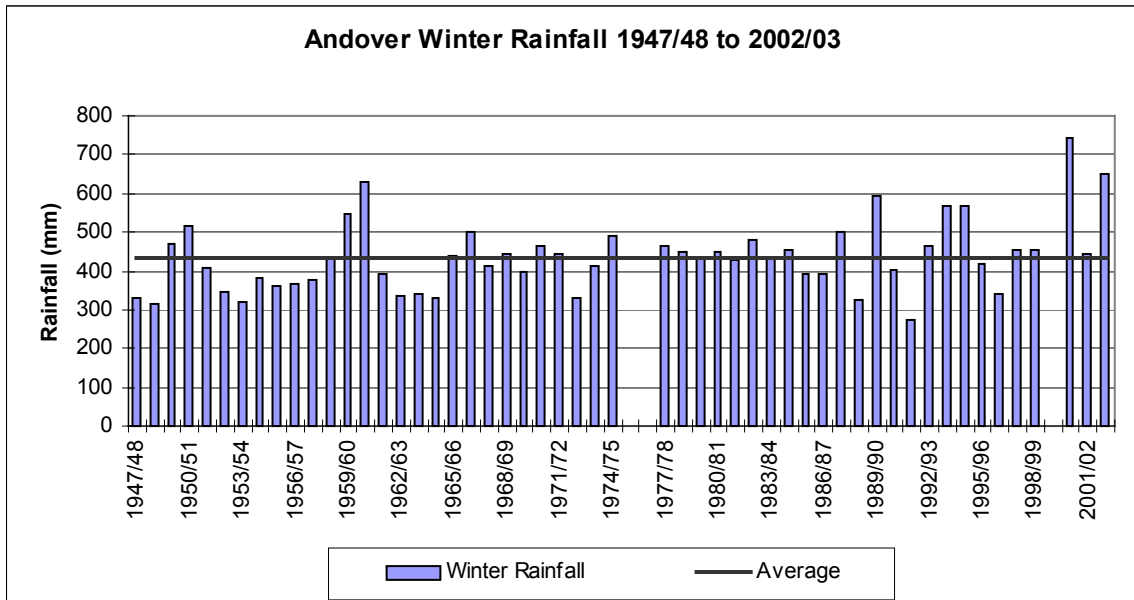
**Figure 3: Andover Water Works Rainfall Data, 1947 - 2003**

Rainfall for the area is recorded at Andover (NGR SU 3680 4670). Figures 3 and 4 show that rainfall was above average throughout the winters of 2000/01 and 2002/03. In 2000/01 the rainfall was consistently above average between September and April. In 2002 rainfall was only above average in October, November and December with particularly heavy rainfall in November.

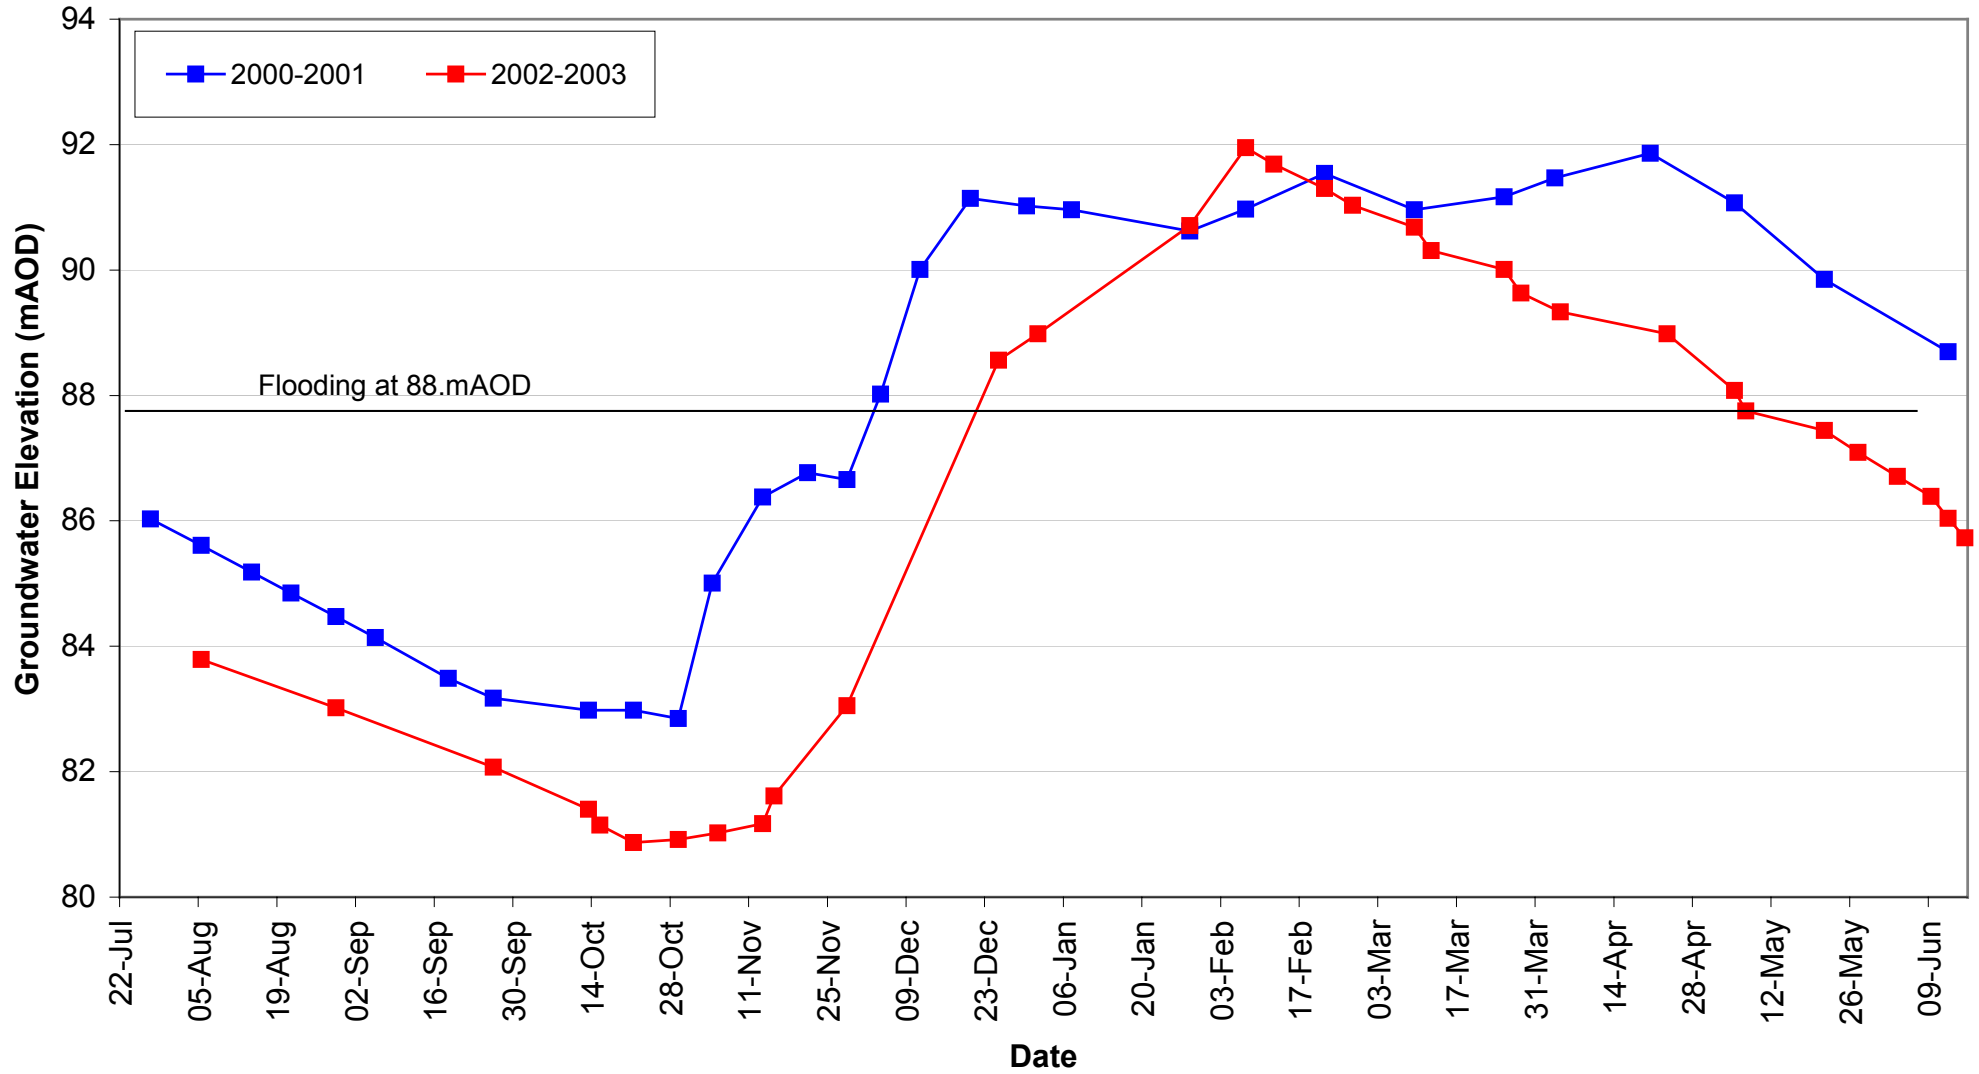
Figure 10: Well hydrograph for Clanville Gate Lodge, comparison between 2000/01 & 2002/03

When groundwater levels are above 87.2 mAOD at Clanville Lodge Gate flooding is expected at Appleshaw with cellar flooding at Hatherden. Above 88.2 mAOD flooding is also expected at Penton Mewsey and Kimpton. Figure 10 shows a comparison between groundwater levels in 2000/01 and 2002/03. It appears that flooding was more prolonged in 2000/01.
