Alton Station Footbridge Restoration Prospectus 2017

Report: v4 23 October 2017

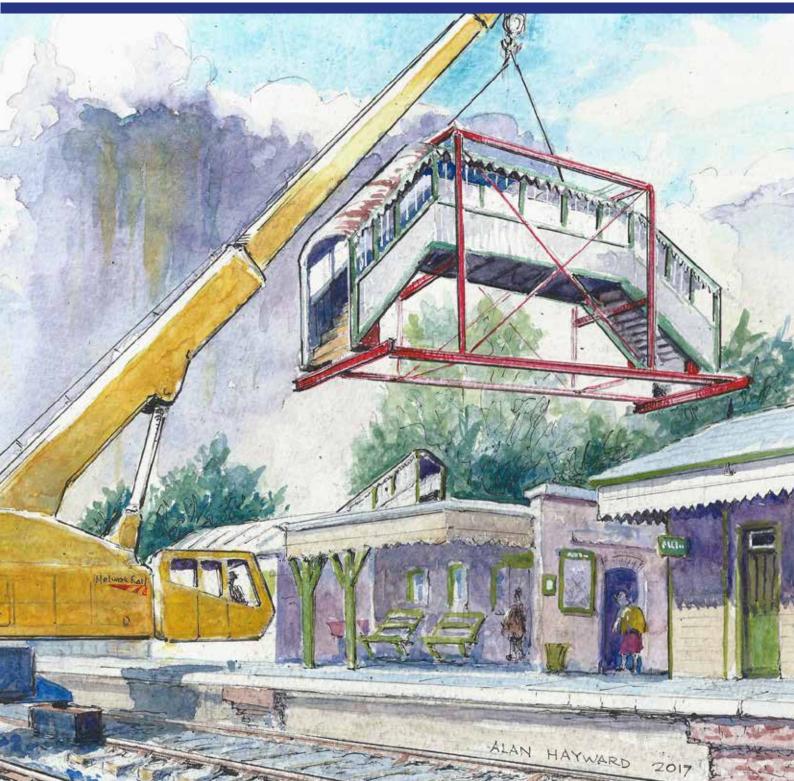
Artist's impression of the footbridge section being lifted, by Alan Hayward

We have Alan Hayward's watercolour painting shown on the cover to illustrate the lifting process. He insists that it depicts the replacement of the bridge section, as this is the desired positive outcome.

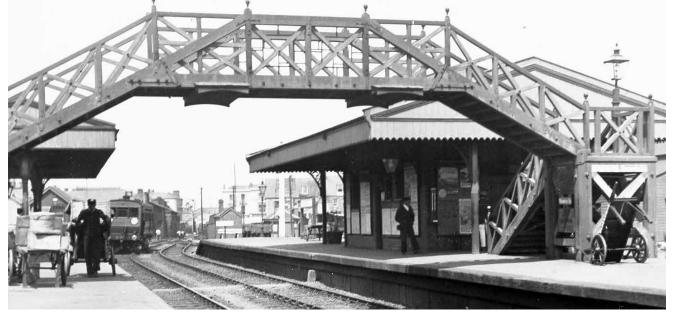
The London & South Western Railway wooden footbridges were an open structure with lattice sides, as shown above. Alton's footbridge differs from the rest because it was enclosed following a petition organised by the Suffragette wife of the local MP on behalf of the "ladies of Alton". The roof was added in 1894 and the windows in 1896.

In its time, this design was reasonably common across southern England. The best photograph of the type installed at Alton station is of the former footbridge at Wadebridge station (above). There are also photos of similar footbridges at Andover Town, three of the Meon Valley stations and Woolston station. We also have a very distrant image of West Clandon station in Surrey, which was built to an earlier design. All have gone, and we don't have photos of the unmodified footbridge at Alton Station, so our best references are the plans and the bridge as it stands today at Alton. Our research has established that it is the only Victorian timber footbridge still in existence over a mainline railway.

Timber footbridges were fairly common in the early railway period because they were comparatively cheap and quick to construct. Cast iron was generally the alternative material at the time, but this was brittle and more expensive. It was not until the production methods for wrought iron and later steel were improved that wooden structures were outmoded. However, by 1892 when the bridge at Alton was built, metal bridges were the standard. It is therefore a curious anomaly that timber footbridges were installed at Alton and at four stations along the Meon Valley Railway. The former footbridge at Wadebridge shows the same timber framework as at Alton, later concealed by the added roof and glazing.

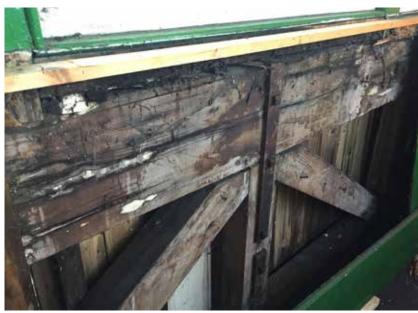
The bridge frame exposed during the inspection

The Ebbutt Report concluded that the bridge span is basically sound, but that it needed stiffening to resist lateral wind pressure. It was also clear that timbers on the half-way landing and one of the corners would need replacing. Later in the year renowned bridge engineer (retired) Alan Hayward FREng CEng FICE FIStructE joined our group. He studied the various reports and concluded that the best option would be to lift out the centre section for repair off-site. This would minimise the costs of closing the working railway and give FAS time to raise further funds once the section was safely stored.

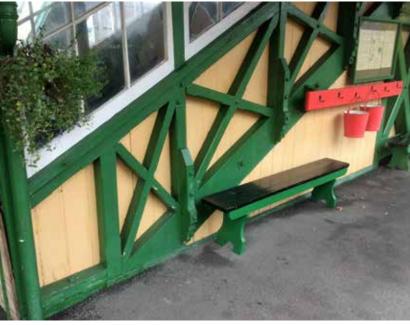
The original design of the bridge exterior, visible on platform 3

The remaining issue is the external appearance which currently looks rather bland. This is because the outside was boarded over, probably between the wars, to stop rot in the cross-bracing. Prior to that, the exterior looked like the section facing platform 3, pictured above and on page 5. Although our inspection revealed that it was probably unpainted originally, we have the option to remove the boards to reveal the cross-bracing and paint it in green and cream, making the bridge look far more picturesque.

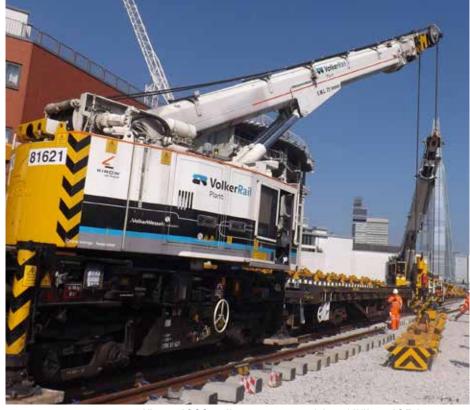
Kirow 1200 rail crane, capable of lifting 125 tonnes. Operated by Volker Rail

a suitable crane. Our hope is to use a very large Kirow rail-borne crane (pictured right) for the lift-out. This could be done with an over-night possession, considerably reducing the costs incurred closing the mainline railway.

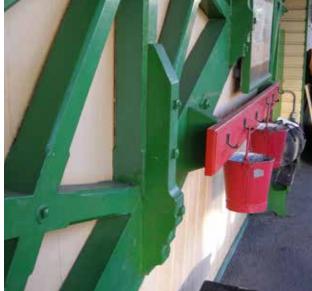
The shaped wooden brackets, platform 3
