# **PRELIMINARY ECOLOGICAL APPRAISAL**

**The Cow Shed, Holt Lane, Bishops Caundle, Dorset DT9 5LY**

Prepared on: 8th June 2023

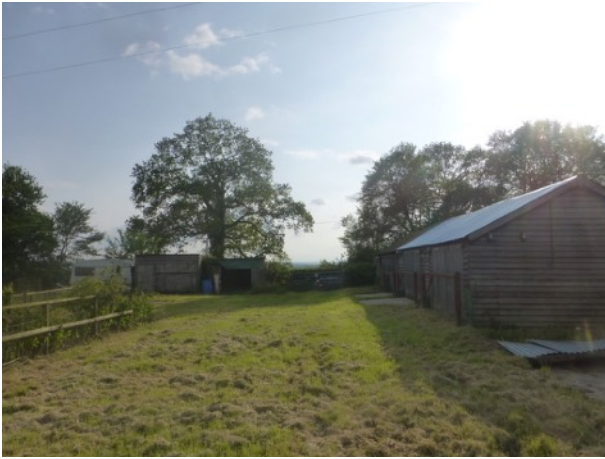
Figure 2. View of across the site from the E

Barn - The existing barn is located in the NW corner of the site. It is a single-storey timber frame barn with a concrete floor and horizontal timber clad walls to the sides under a pitched sheet roof (Figs. 2 - 4, 8 & 9).

Sheds - There are three small sheds on the site, all of which are timber-framed, with horizontal timber clad walls and flat corrugated metal roofs. Two of them are open on one side (Figs. 2, 5 & 6).

Caravan - There is a disused caravan on the site (Figs. 2 & 5).

No bats, bat droppings or other evidence of bats was found in any of the buildings. They have negligible bat roost potential. No evidence of birds or bird nests were found in any of the buildings.
