**FLOODING**  
**around**  
**Zebon Copse Estate**  
**Church Crookham**  
**Hants GU52**  
**Friday 20 July 2007**

**by**  
**David Jackson**  
**Chairman**  
**Zebon Copse Residents' Association**

This report has been prepared by ZCRA to inform those responsible for flood management of the effect of the storm of 20 July 2007 on Zebon Copse Estate and to make associated recommendations.

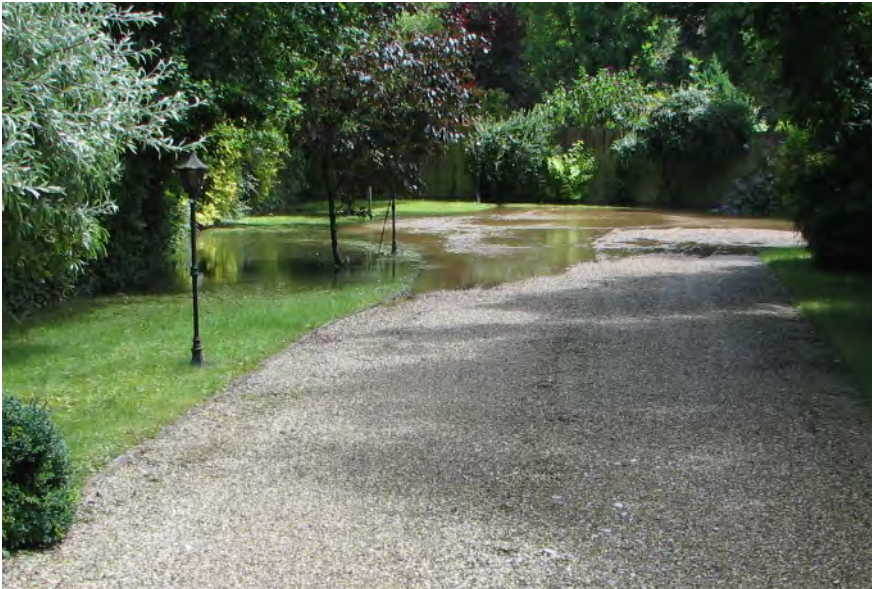
**Picture 2**

Looking south towards the southern end of Rebecca Close after most of the flood had subsided. The flow of water from the balancing pond can be seen coming from the left.

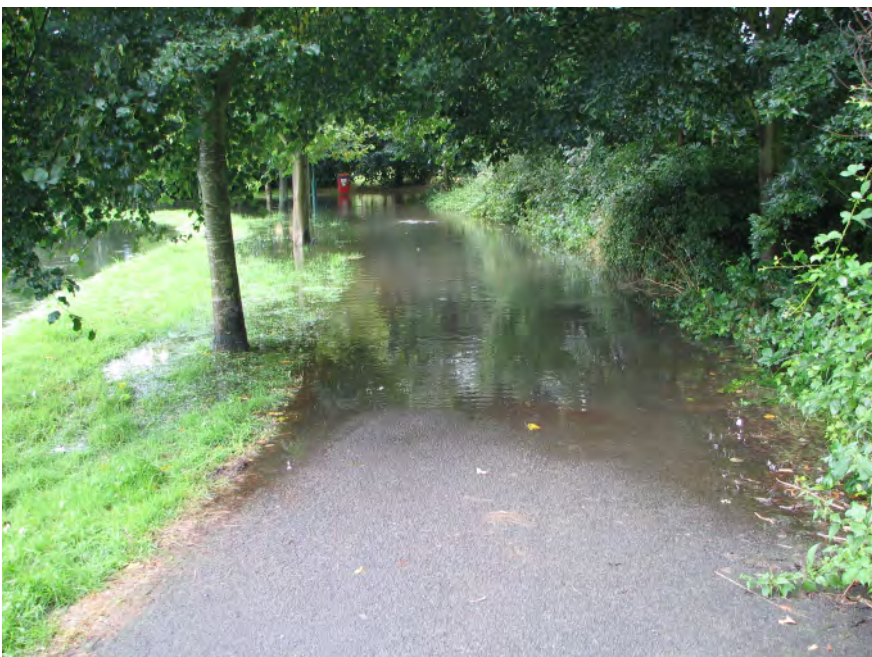
**Picture 3**

Water escaping through the bund also covered the path along the northern side of the pond.

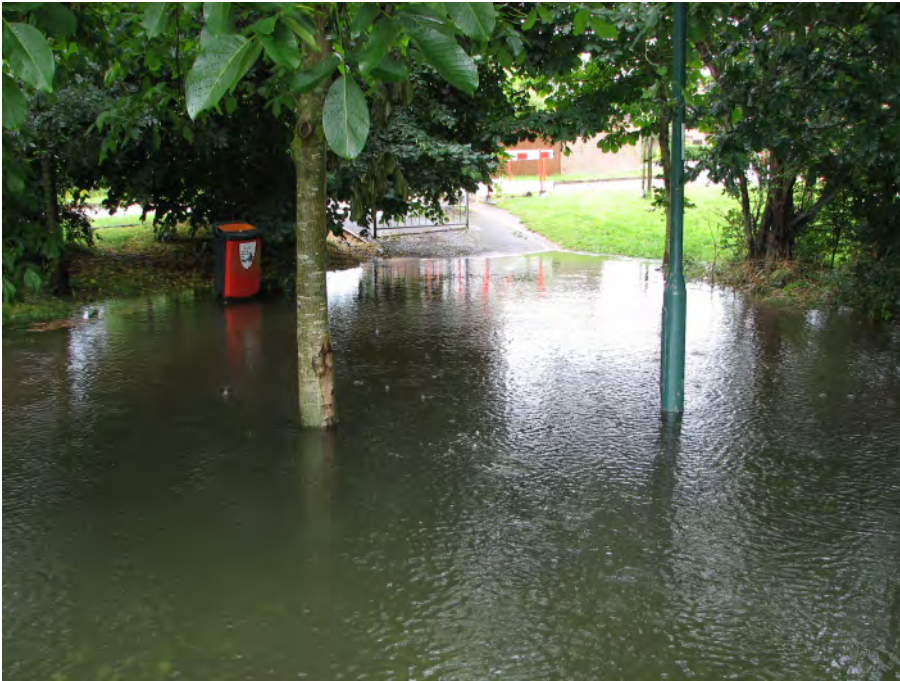
**Picture 4**

Natural contours retained the water at the northern western edge of the pond area.

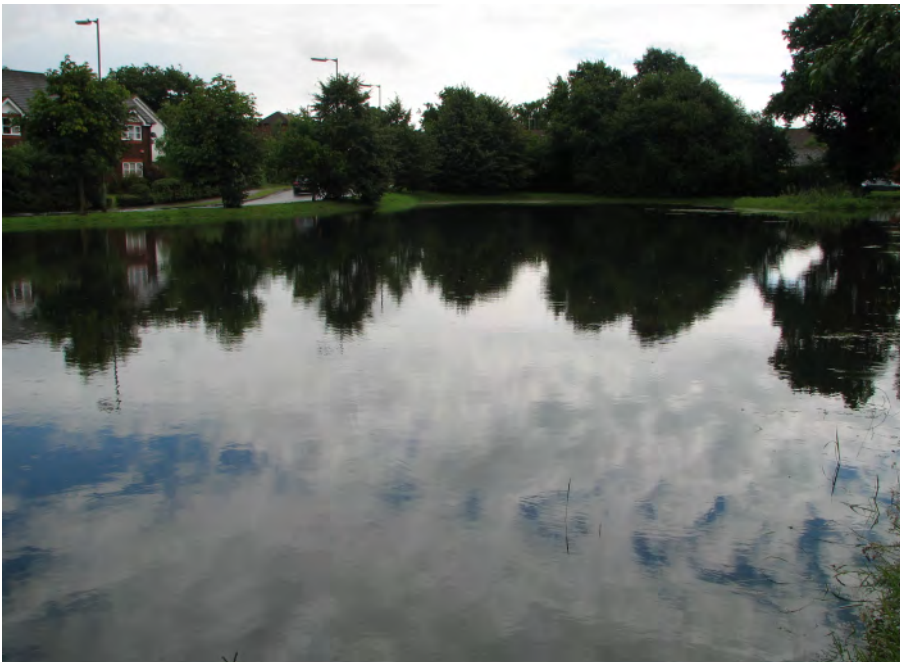
**Picture 5**

Although the balancing pond was almost full, the southeastern corner was not breached.

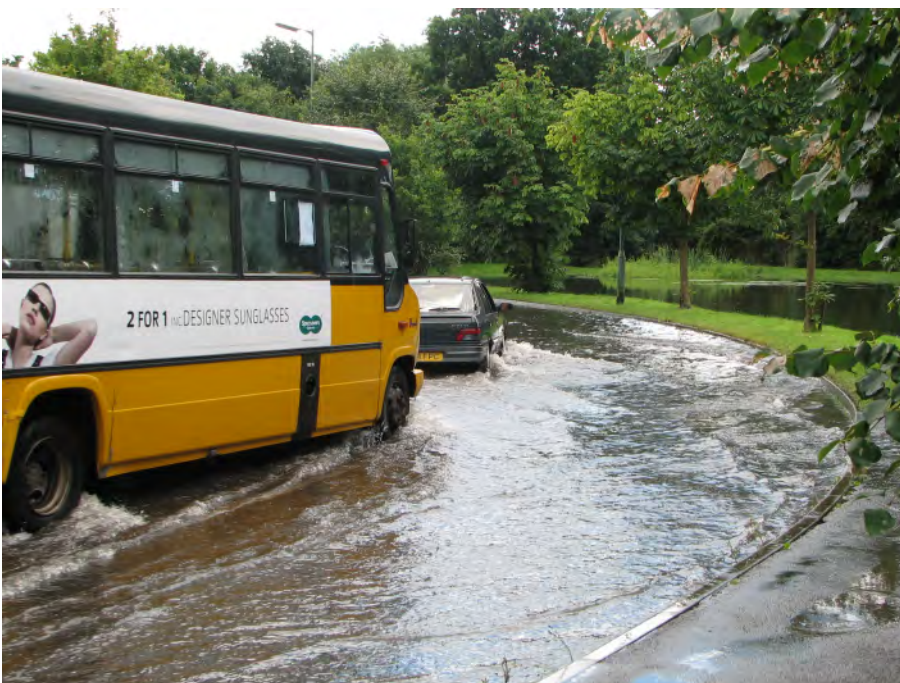
**Picture 6**

The balancing pond overflowed onto Brandon Road from a point close to its northeastern corner.

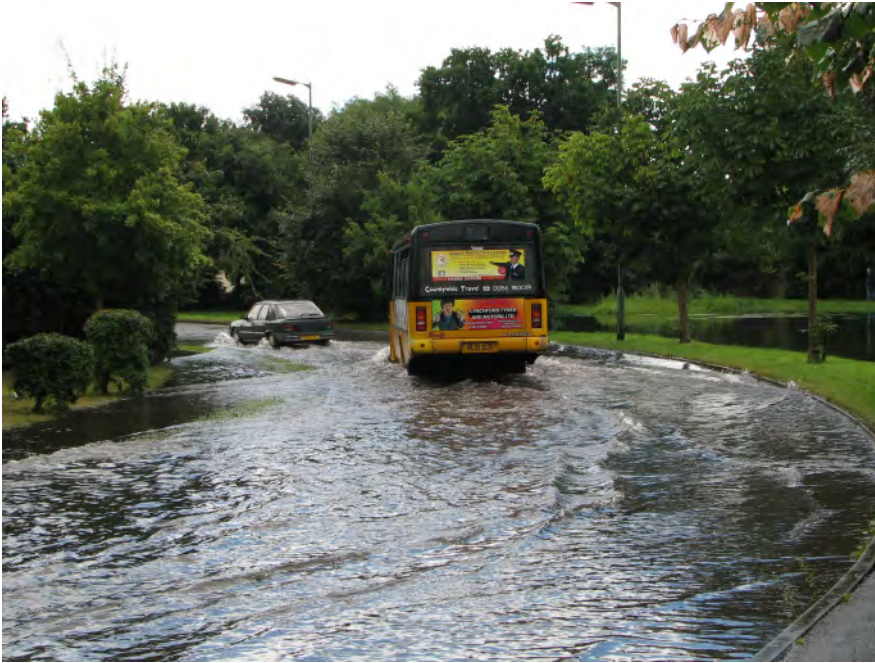
**Picture 7**

Southern extent of the flood on Brandon Road was short of Blue Prior Court.

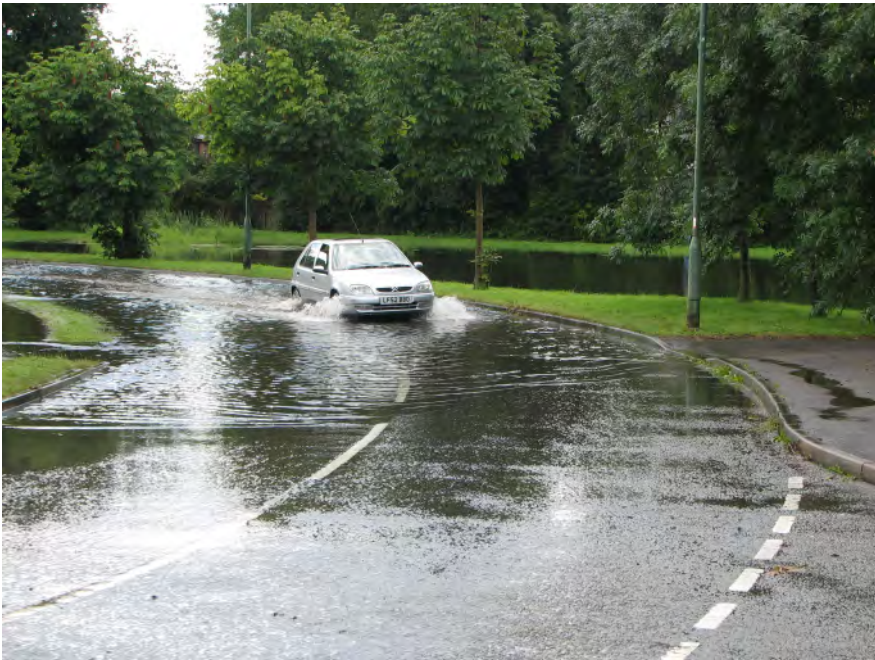
**Picture 8**

Northern extent of the flood on Brandon Road was almost to Daphne Drive.

The breach was just behind the car shown in this picture.

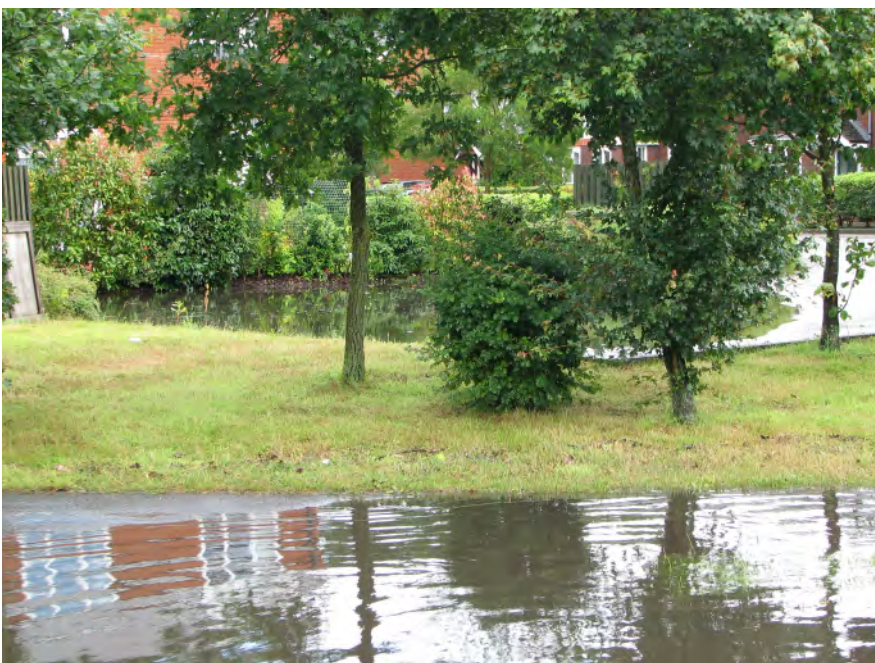
**Picture 9**

Water also flowed into the southern end of Water Rede, seen here looking from Brandon Road in the foreground.

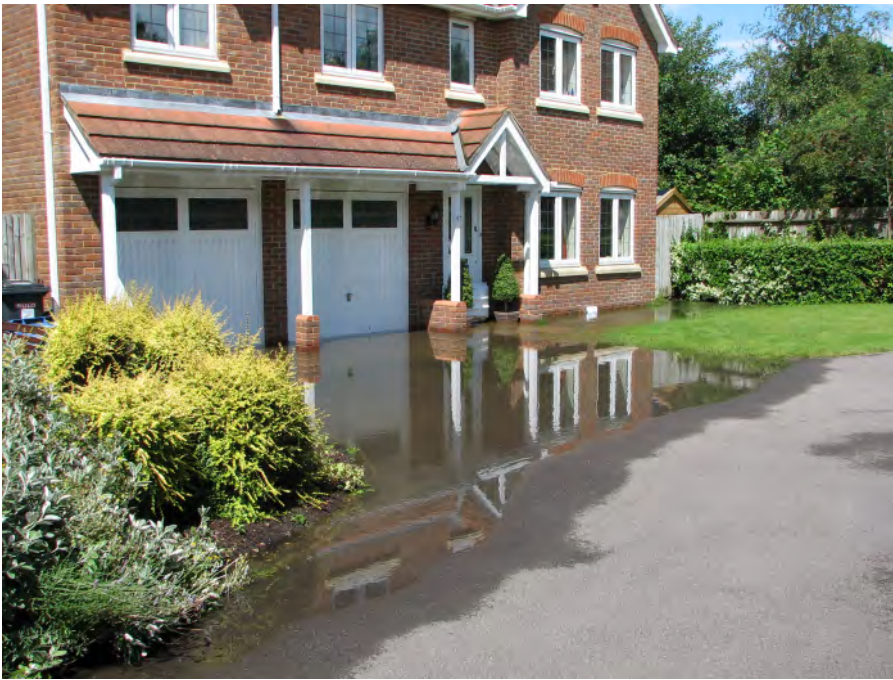
**Picture 10**

The garden of No 6 Rasset Mead was flooded from the flow out of the balancing pond across Rebecca Close.

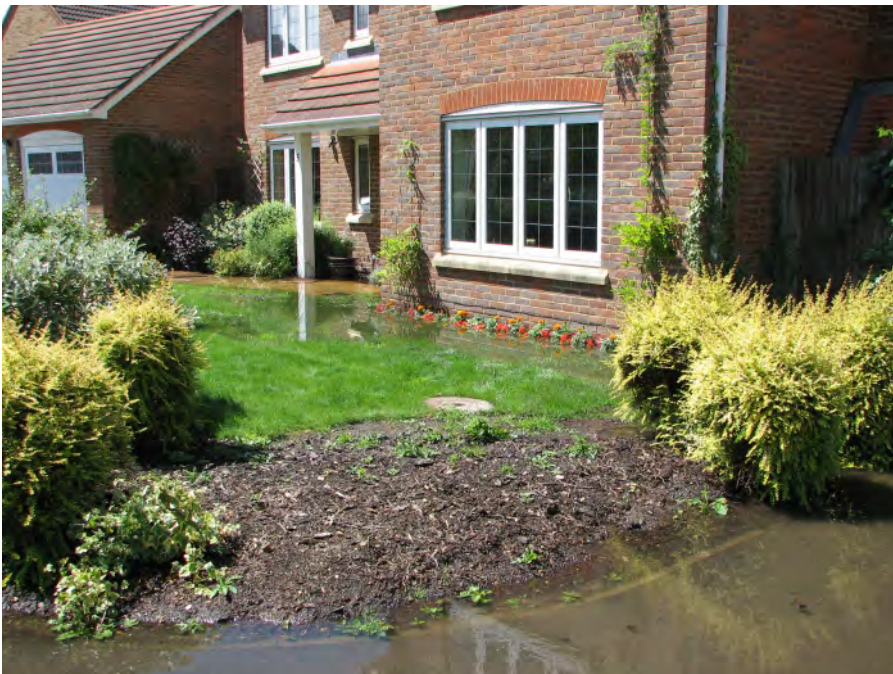
**Picture 11**

The garden adjacent of No 5 Rasset Mead was also flooded.

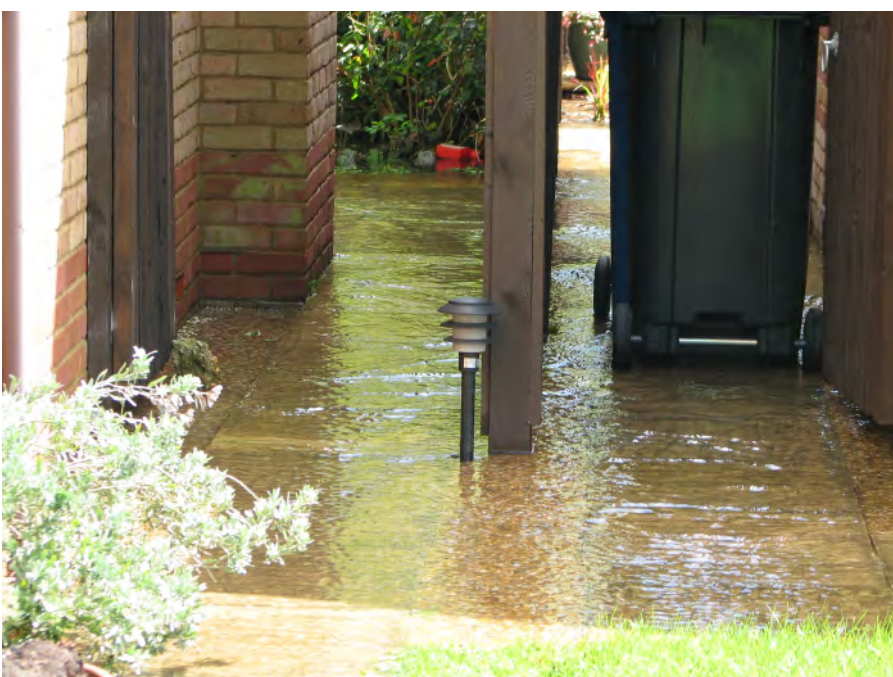
**Picture 12**

Overflowing roadway drains on Browning Road affected Nos 25 and 27.

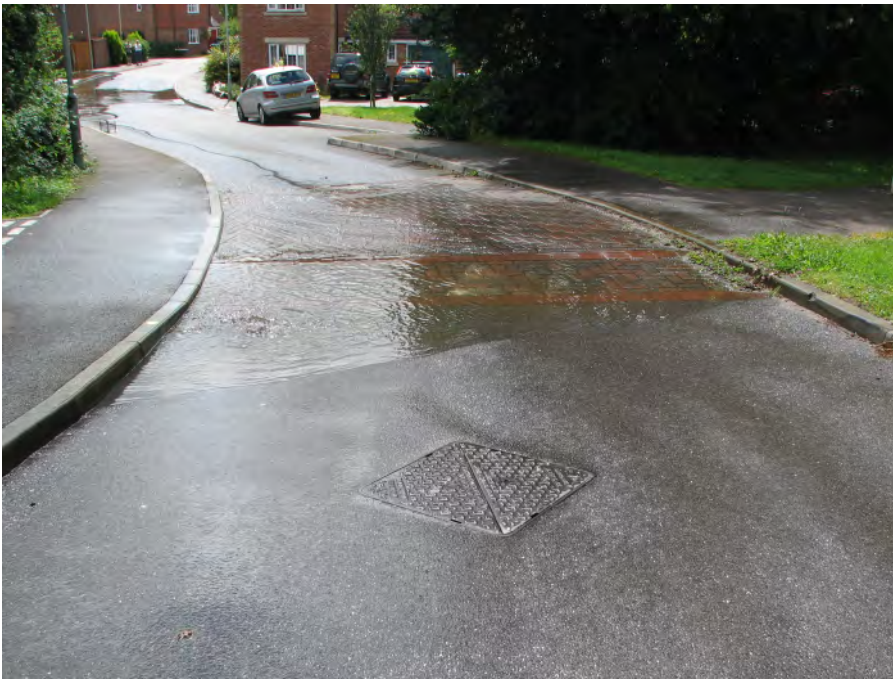
**Picture 13**

Further water in Browning Road came from an overflowing storm drain near the junction with Rebecca Close.

4. The storm drains in Browning Road (*picture 13*) and Nether Vell Mead (*picture 27*) are checked and the adequacy of their capacity re-assessed.

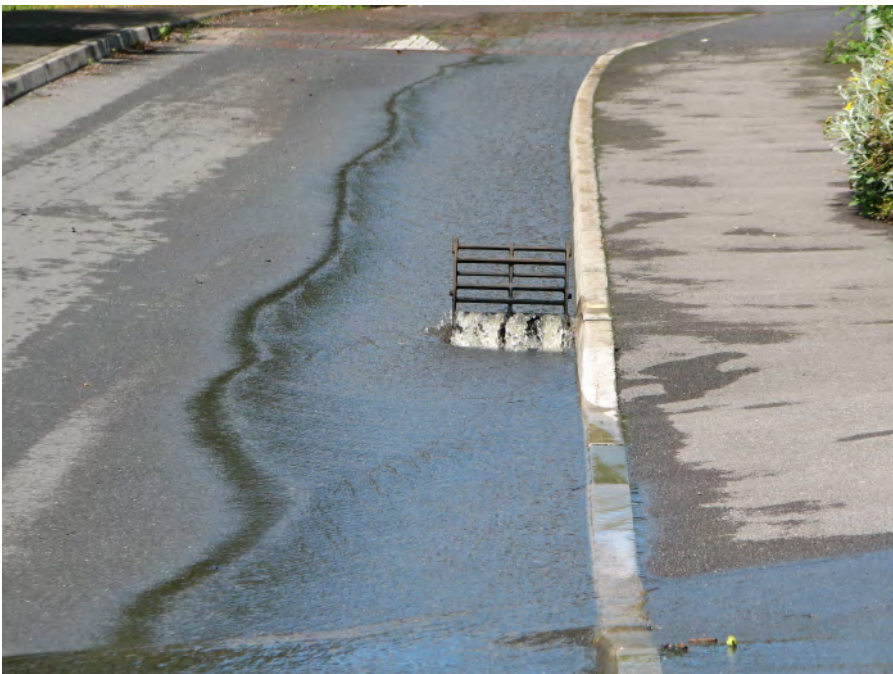
**Picture 14**

Blocked drain covers were another problem - cured in this case by raising the cover.

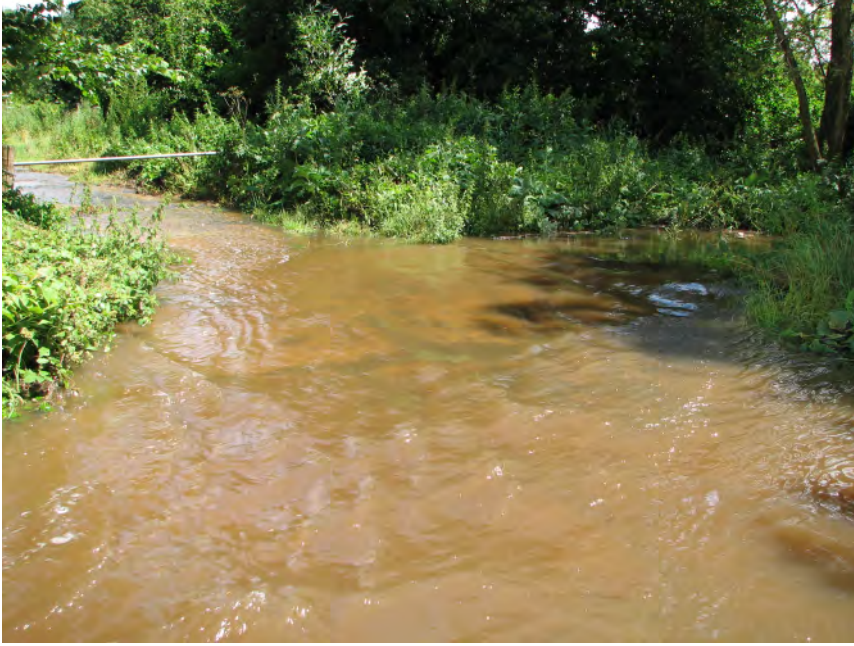
**Picture 15**

Runoff from the QEB site generated a torrent running down Ewshot Lane towards Redfields Lane.

This picture was taken from Ewshot Lane at SU 8082 5120 looking northeast. The water at this point was over a foot deep and moving very quickly. There were two feeds: One from the right of the picture and the other from straight ahead.

2. Measures are taken now to alleviate the escape of flood water down Ewshot Lane into properties at the high-number end of Nether Vell Mead (*see Sections 2 and 3*).

3. The QEB Inquiry Inspector is provided with this further evidence of flooding generated from the QEB site and that any approval for development of the QEB site addresses fully the prevention of flood water running off the site towards Zebon Copse Estate (*see section 2*).

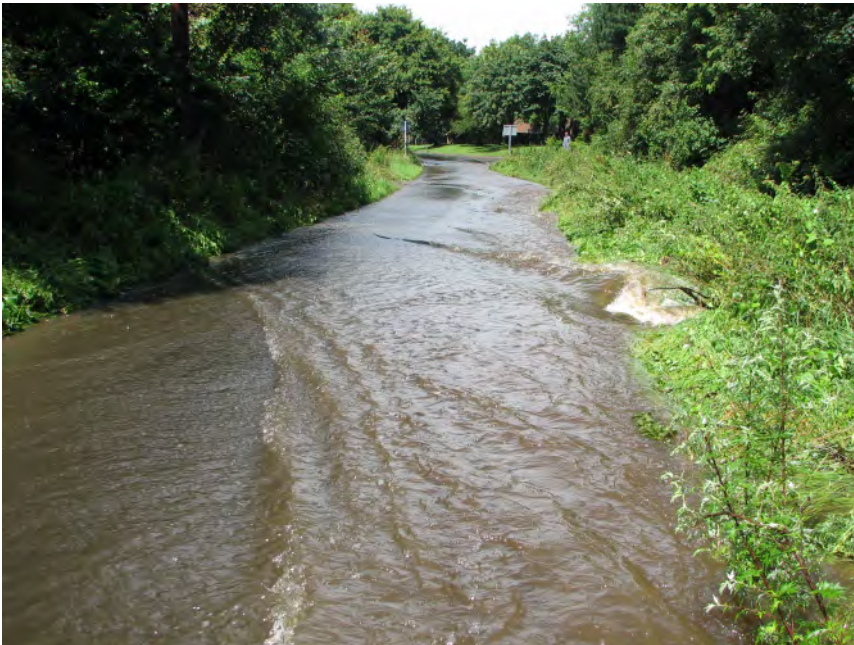
**Picture 16**

Looking towards Redfields Lane from the same point.

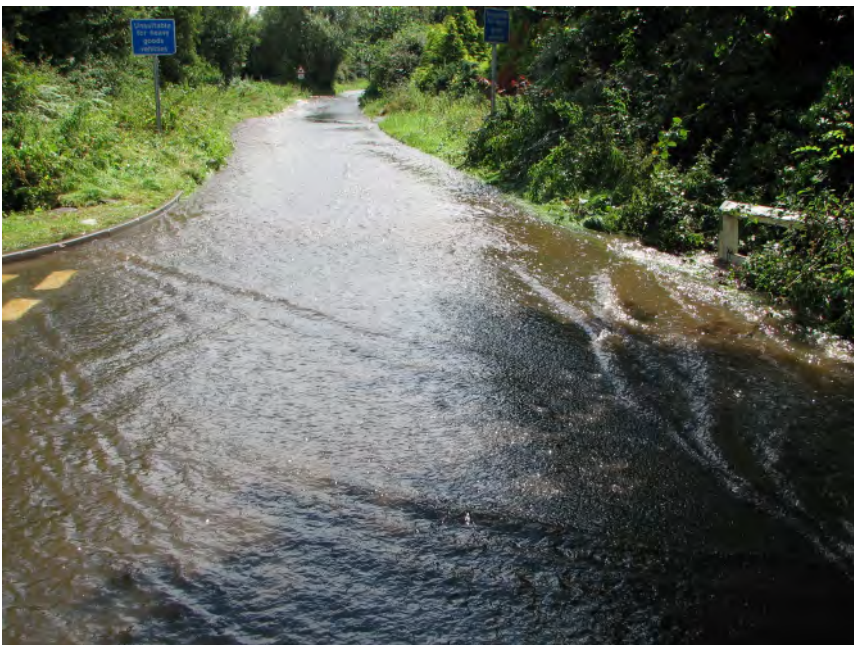
**Picture 17**

Looking up Ewshot Lane away from Redfields Lane from the exit from Humphrey Park at SU 8078 5128.

The ditch to the right of this picture was unable to cope.

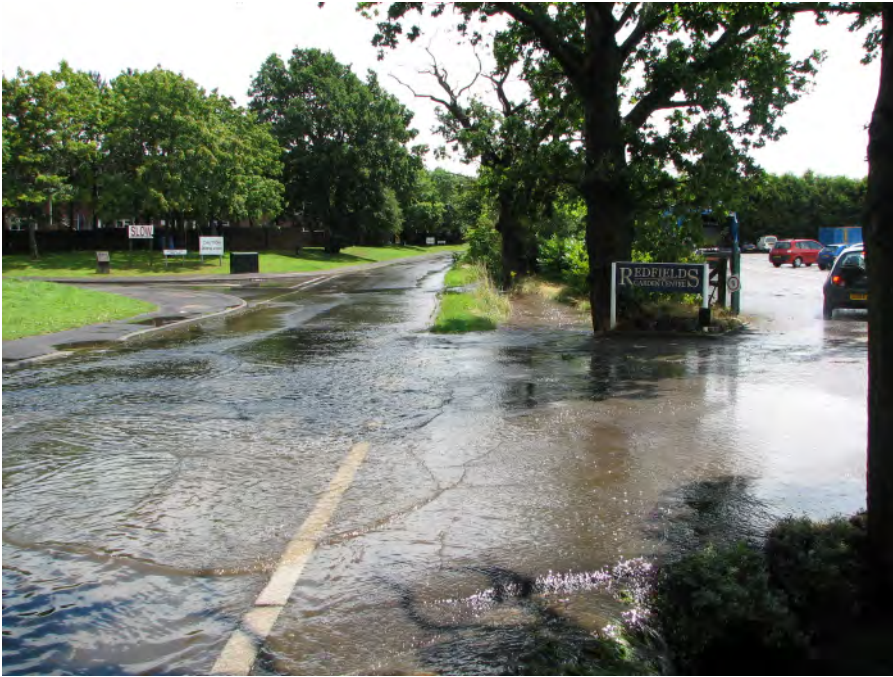
**Picture 18**

The ditch across the entrance to Redfields Garden centre was over full and spilling further water onto the road.

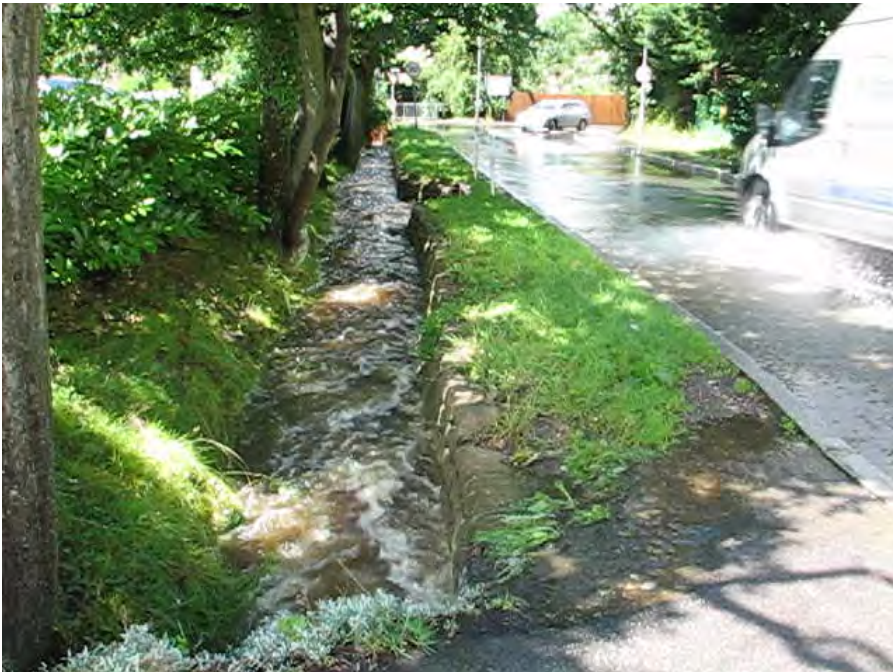
**Picture 19**

The ditch beside Ewshot Lane between Redfields Garden Centre entrance and Redfields Lane after the rain had stopped.

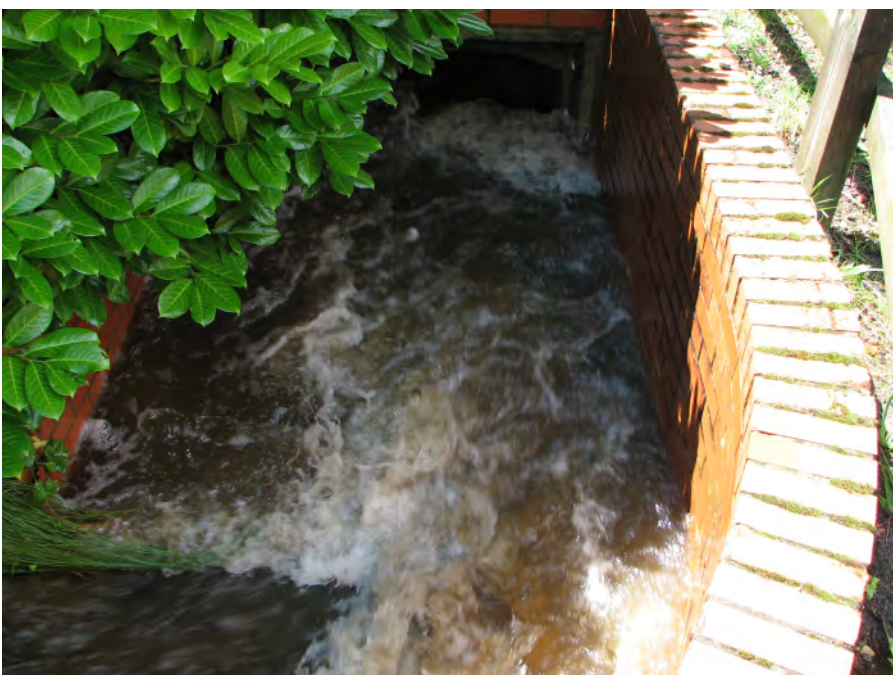
**Picture 20**

By the time this picture was taken at 1300A, the flow into the culvert under Redfields Lane from the corner of Ewshot Lane was below its maximum.

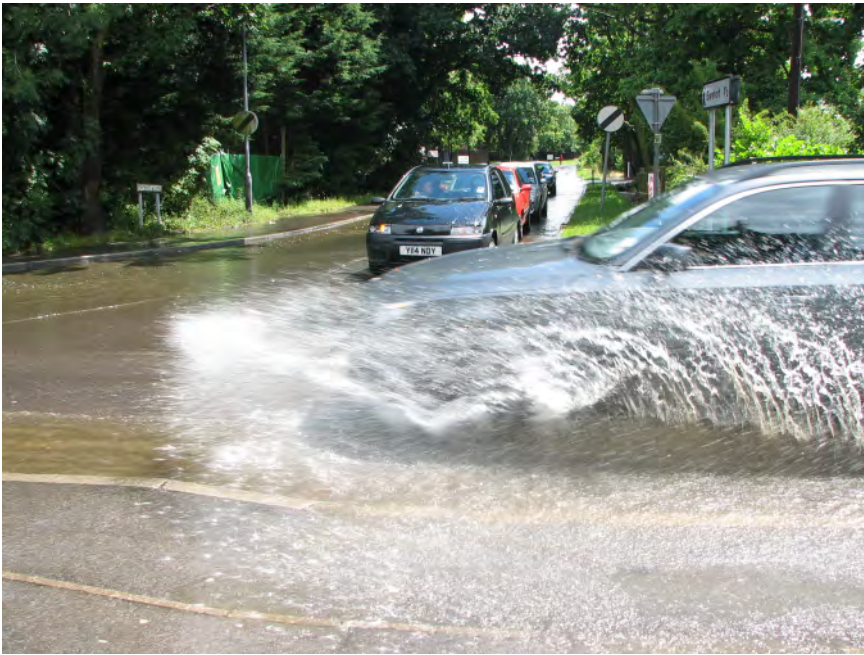
**Picture 21**

The flow down Ewshot Lane and across Redfields Lane affected Nether Vell Mead.

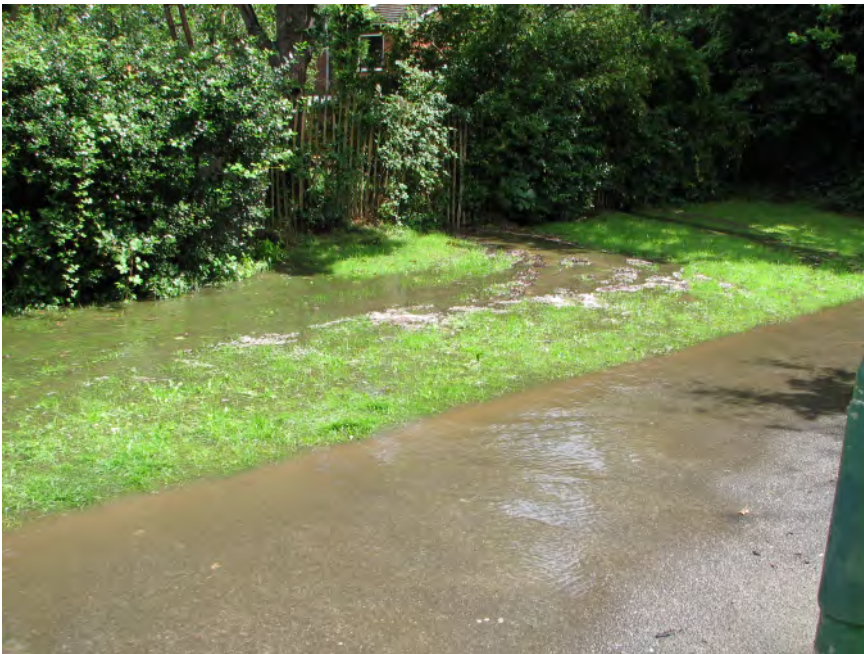
**Picture 22**

Water from the gardens of 120 and 122 Nether Vell Mead flowing onto the path between Redfields Lane and Nether Vell Mead at SU 8062 5141.

Gardens of properties at this end of Nether vell Mead were flooded to a depth of about 4 inches, but most of the the water had subsided before pictures could be taken.

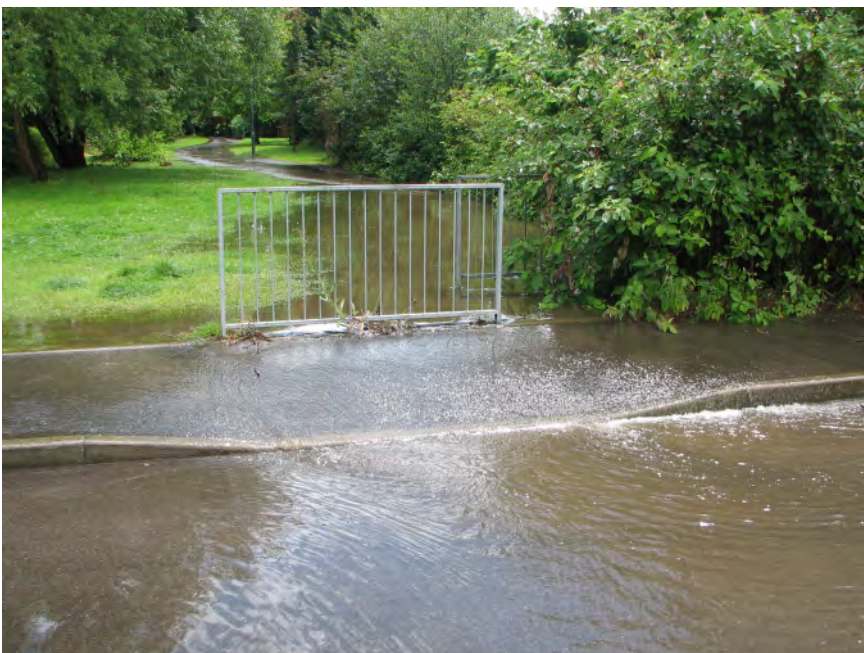
**Picture 23**

After flowing down the metalled path, the flood reached Nether Vell Mead at SU 8057 5146.

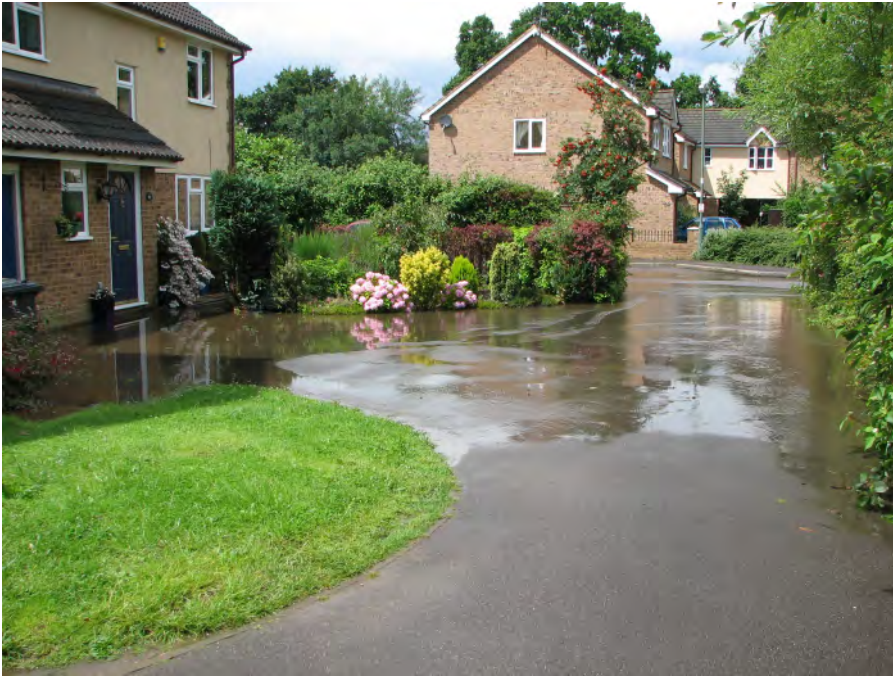
**Picture 24**

Water flowed from the path between Redfields Lane and Nether Vell Mead towards the front of No 100 Nether Vell Mead.

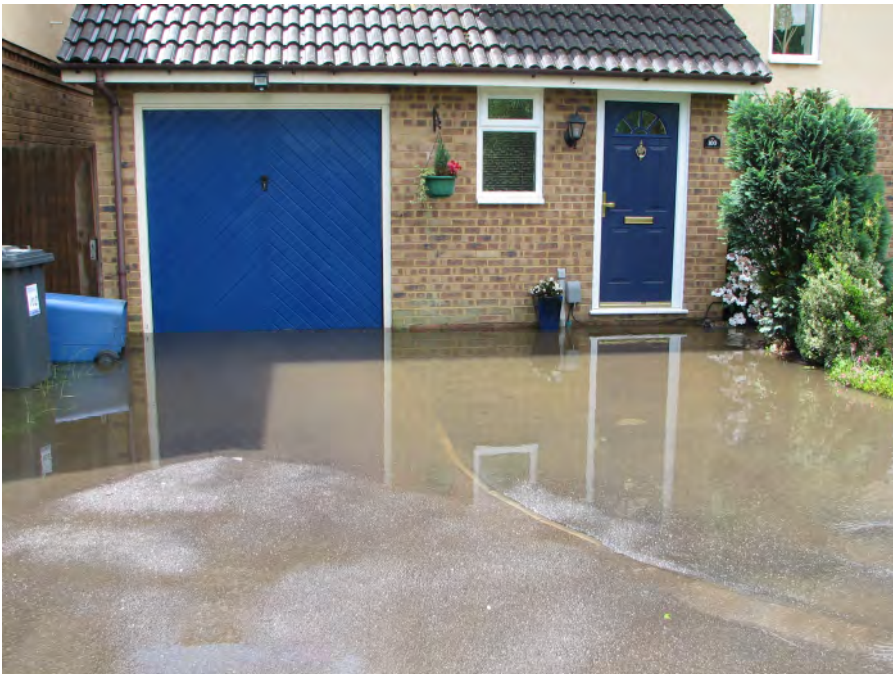
**Picture 25**

Water lapping at the garage of No100 Nether Vell Mead.

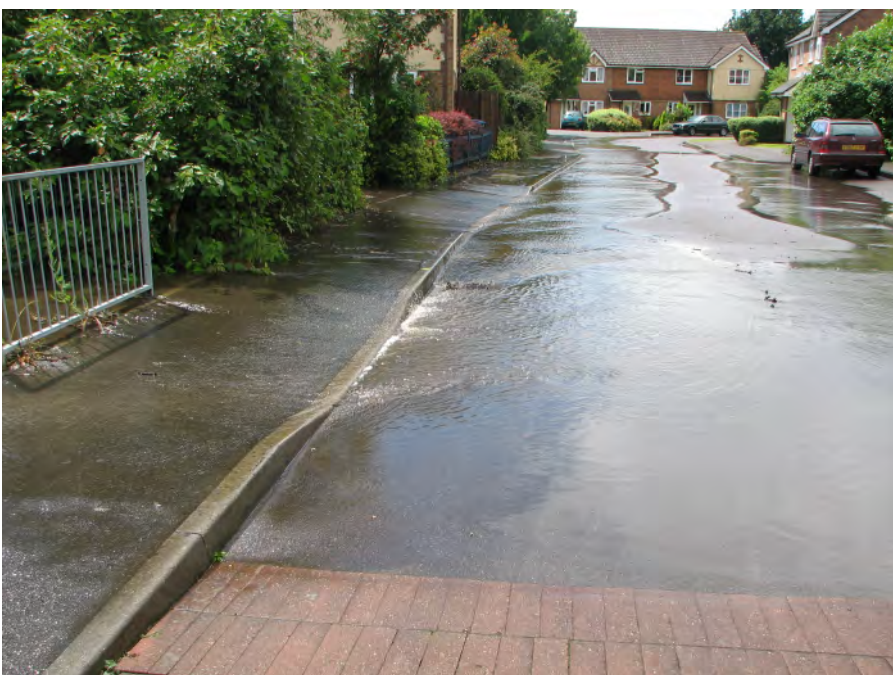
**Picture 26**

From the end of the path to Redfields Lane, water flowed along Nether Vell Mead towards Brandon Road.

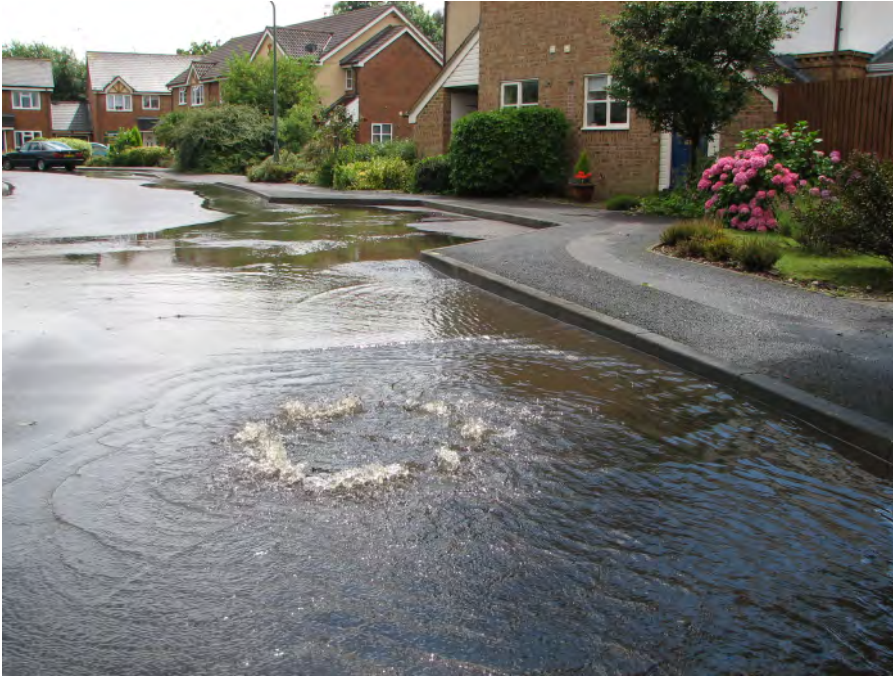
**Picture 27**

Water from the storm drain overflowed from the manhole near No 70 Nether Vell Mead and contributed to the flow towards Brandon Road, where it flowed south towards the general flood from the balancing pond, but when seen at about 1300A it did reach that far before going into the roadside drains.

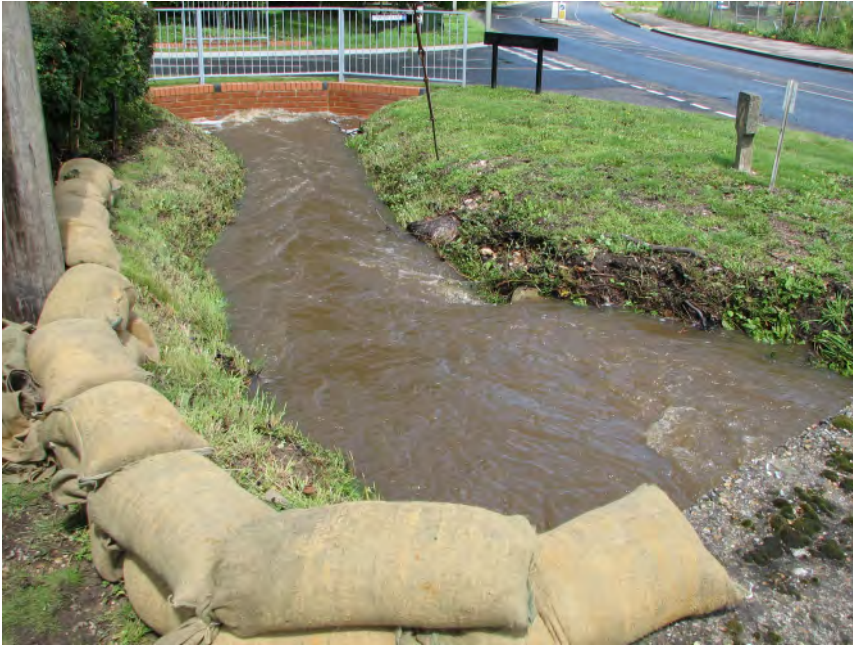
**Picture 28**

The ditch between Watery Land and Brandon Road was filled to capacity.

3. The capacity of the ditch along Redfields Lane opposite the Blue Prior site (SU 804 512) is increased and, if necessary, additional measures are taken to prevent overflow onto the roadway and into properties on Watery Lane and Du Maurier Close as happened in November 2006 (*see Section 4*). This assessment should take into account the projected development of the Blue Prior industrial site opposite.

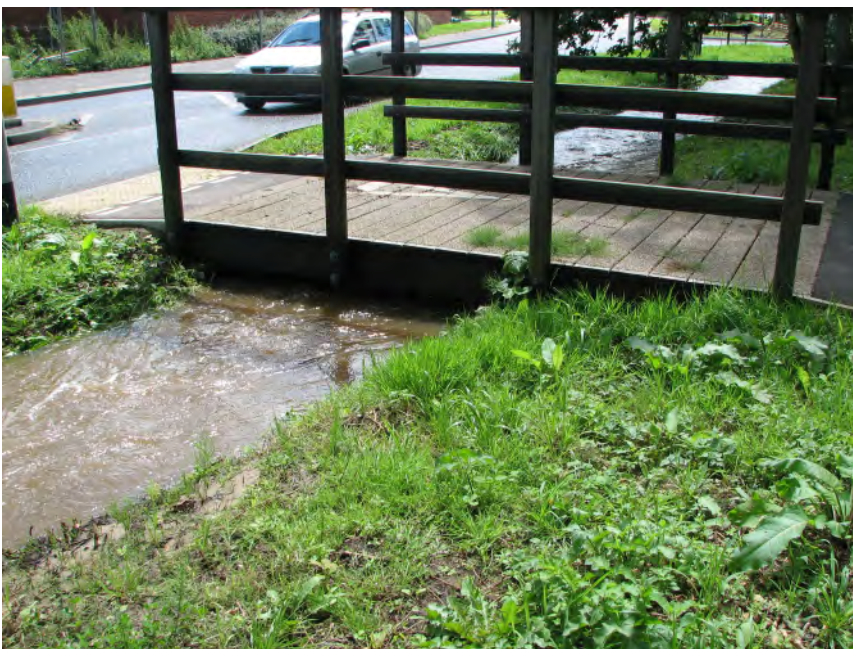
**Picture 29**

Insufficient capacity under the footbridge between Watery Lane and Brandon Road at SU 804 512.

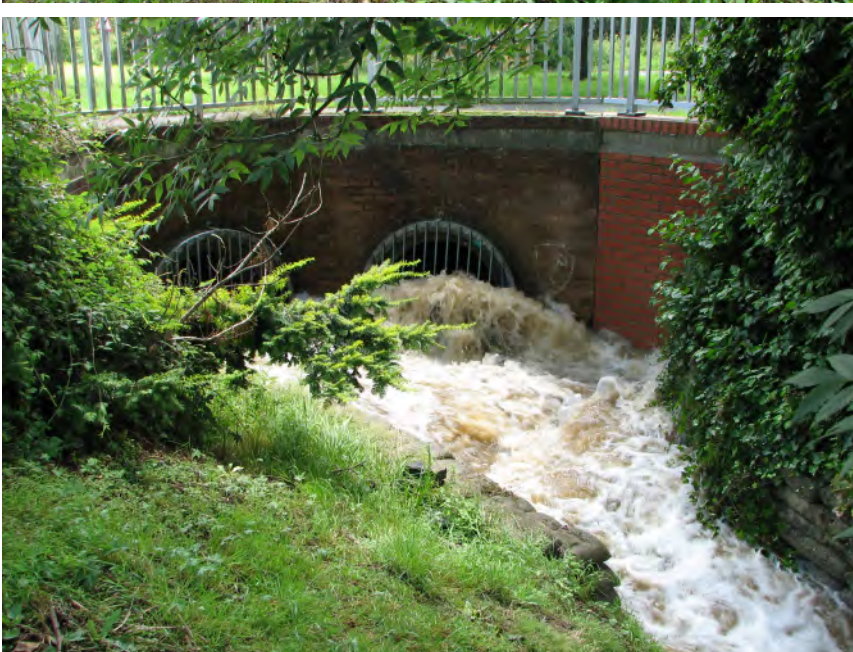
**Picture 30**

Culvert exit beside Brandon Road at SU 805 512 after the rain had stopped.

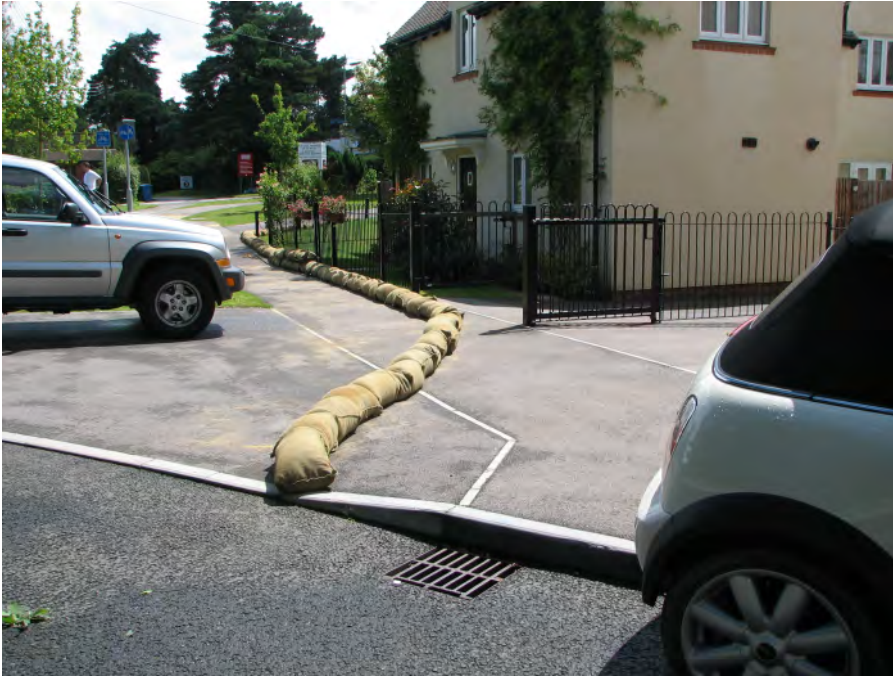
**Picture 31**

Sandbags were deployed in front of properties at the Redfields Lane end of Watery Lane, but the ditch just coped on this occasion.
