DRAFT CONSERVATION AREA APPRAISAL AND MANAGEMENT PLAN

Bucklebury Village

Vn. 0.5 11 May 2023

Report Title: Bucklebury Village Conservation Area Appraisal Management Plan

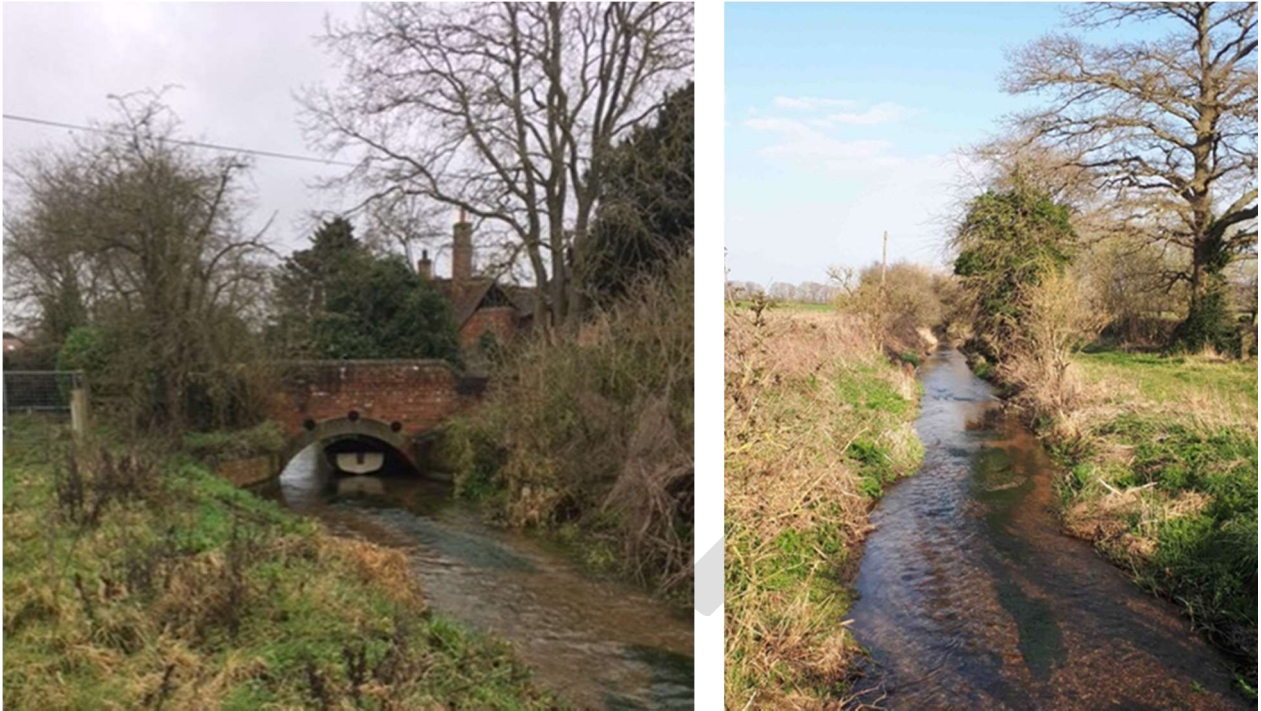
Figure 6: The River Pang

- 4.16 The River Pang, a fine example of a chalk stream [figure 6], flows through the gardens of the domestic properties to the north of the CA and on the far side of the Glebe Field. The river runs under the road bridge which was constructed at the end of the 19th century and which provides an intermediate crossing point between the bridges at Marlston and at Stanford Dingley.

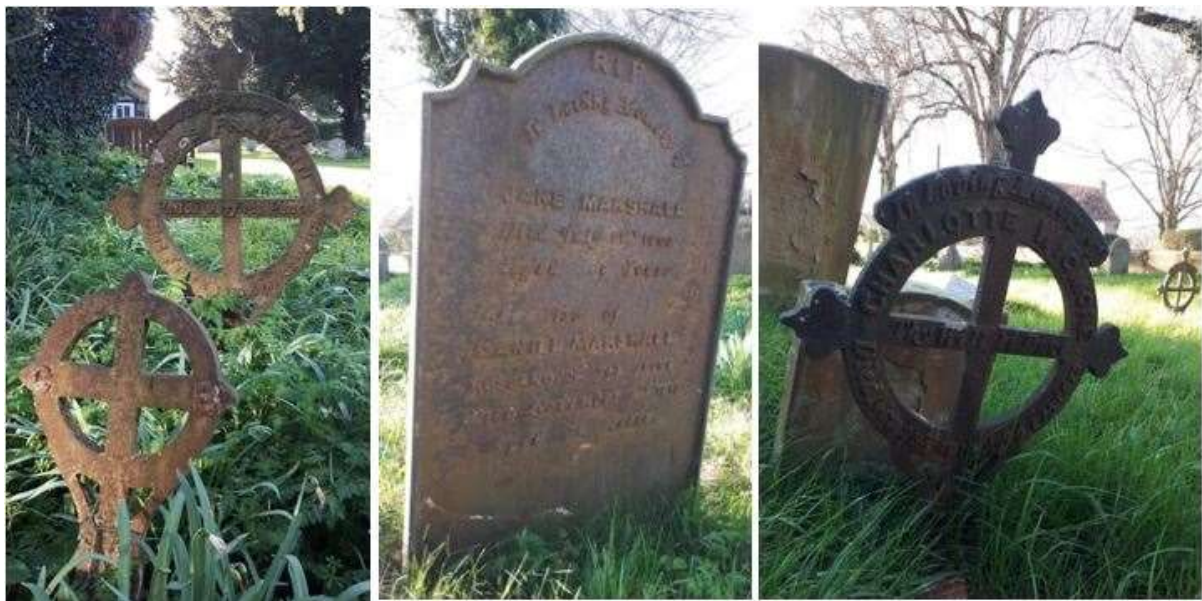
Figure 8: Cast Iron Memorials in Churchyard

4.22 The churchyard is almost “fully populated” although, from casual observation, this may not be obvious as some former memorials have disintegrated with time and as the result of weathering. In the churchyard, there are 4 listed tombs and a still significant population of standing memorials in both stone and cast iron. There are forty cast-iron memorials [figure 8]. They are historically significant, having been manufactured a short distance away in the former Bucklebury Foundry, and were designed by John Hedges the foundry owner.

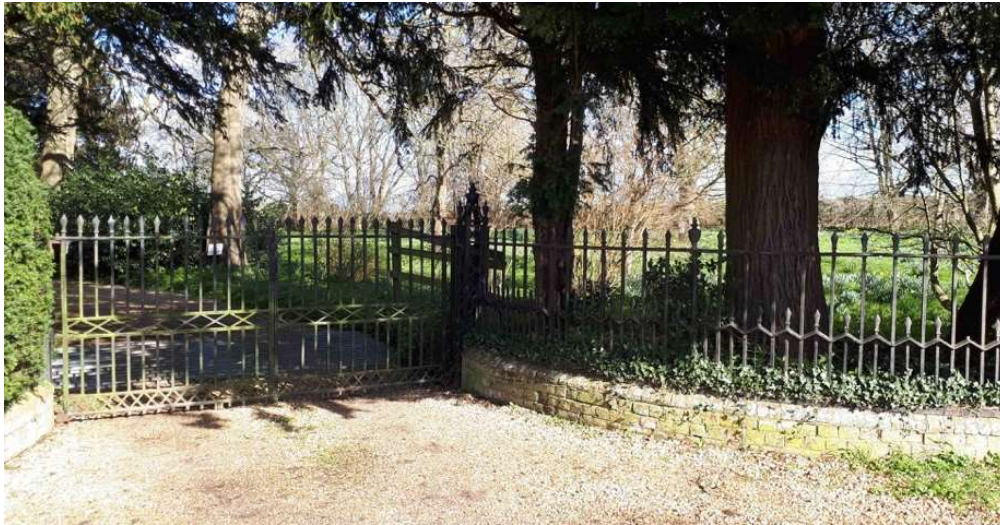
Figure 9: Listed cast iron railings at the entrance to The Old Vicarage.

The railings extend from the entrance to The Old Vicarage to The Old Post Office and were manufactured in the Bucklebury Foundry.

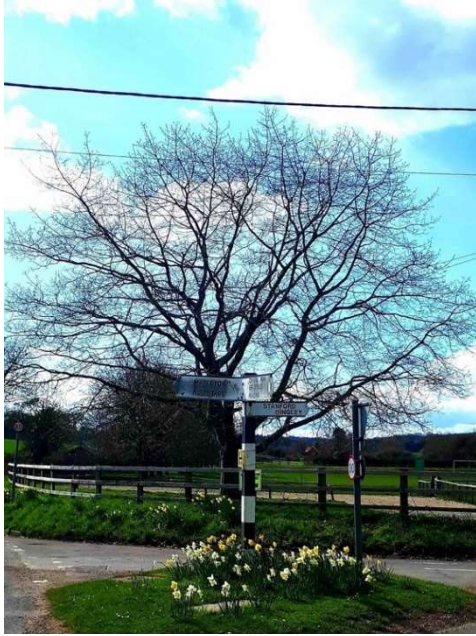
Figure 10: The traffic island in Bucklebury Village

- 4.25 The road through the CA is bounded by the frontages and picket-fenced front gardens of the CA cottages, by the low southern wall of the churchyard and also by some sections of taller hedging. The road, the spaces either side, and the low boundaries combine to give the impression of a larger space with considerable aesthetic appeal.
- 4.26 For part of its length within the CA the through-road has grass verges, and at its junction with the road that runs through the village to the west and north of the CA, there is a grassed island with a “traditional” black and white signpost. The island and the verges are planted with spring bulbs and maintained by residents although both have been damaged by traffic and have reduced in both size and appeal in recent years.

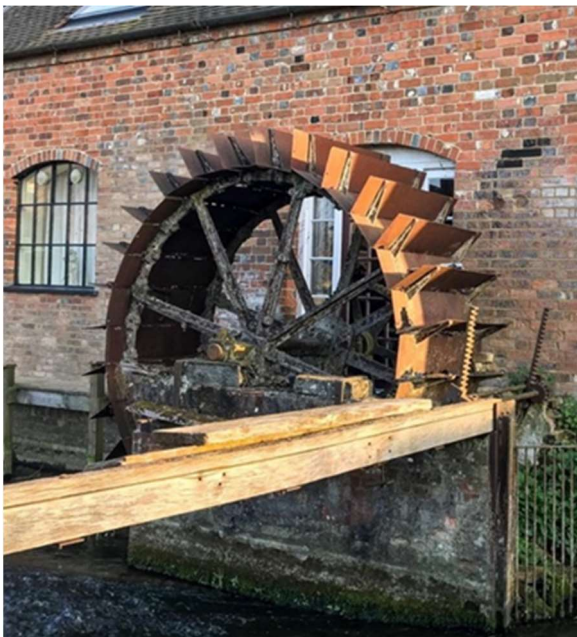
Figure 12: The water wheel that served the needs of the foundry

- 5.7 River Barn Mill is a late 19th century mill located on the Pang to the west of Bucklebury Village. The mill is listed in the West Berkshire Historic Environment Record which indicates that the mill equipment was manufactured in the Bucklebury foundry and supported a variety of farm operations. The mill had fallen into a state of disrepair but has been restored and returned to working order by the owners of River Barn Farm.
- 5.8 The iron water wheel that was used to provide mechanical assistance for foundry operations [figure 12] remains in place; overhanging the Pang and attached to the wall of the former foundry building.

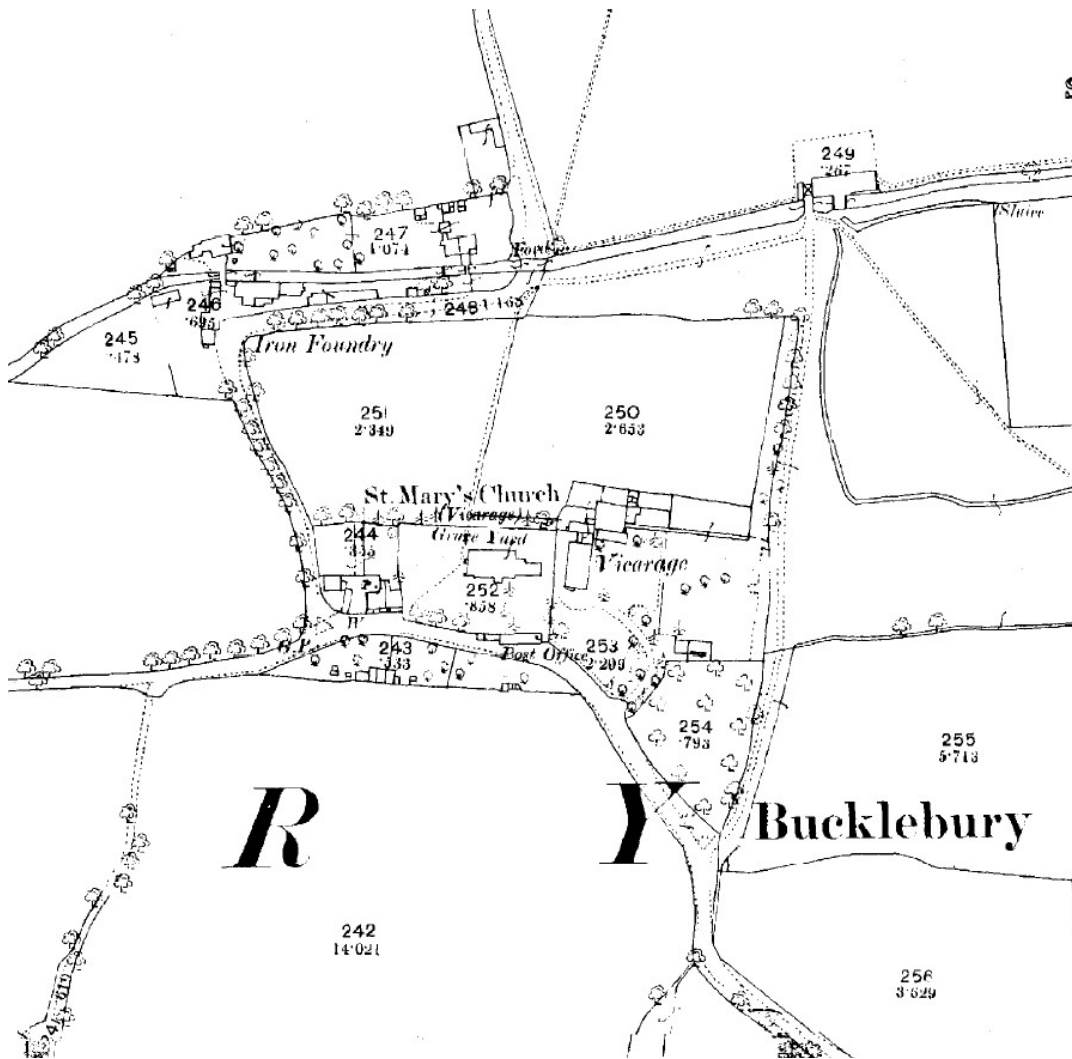
Figure 13: Bucklebury - OS Historic Epoch 1 (1877-78)

- 5.9 The Bucklebury foundry was located next to the Pang and close to what is now the CA [figure 13]. It was developed in the early part of the 19th century by the Hedges family adjacent to the site where they had operated as blacksmiths from 1736. The foundry was clearly successful, servicing the needs of the agricultural

An historic Ordnance Survey map indicating the site of the former Bucklebury Foundry

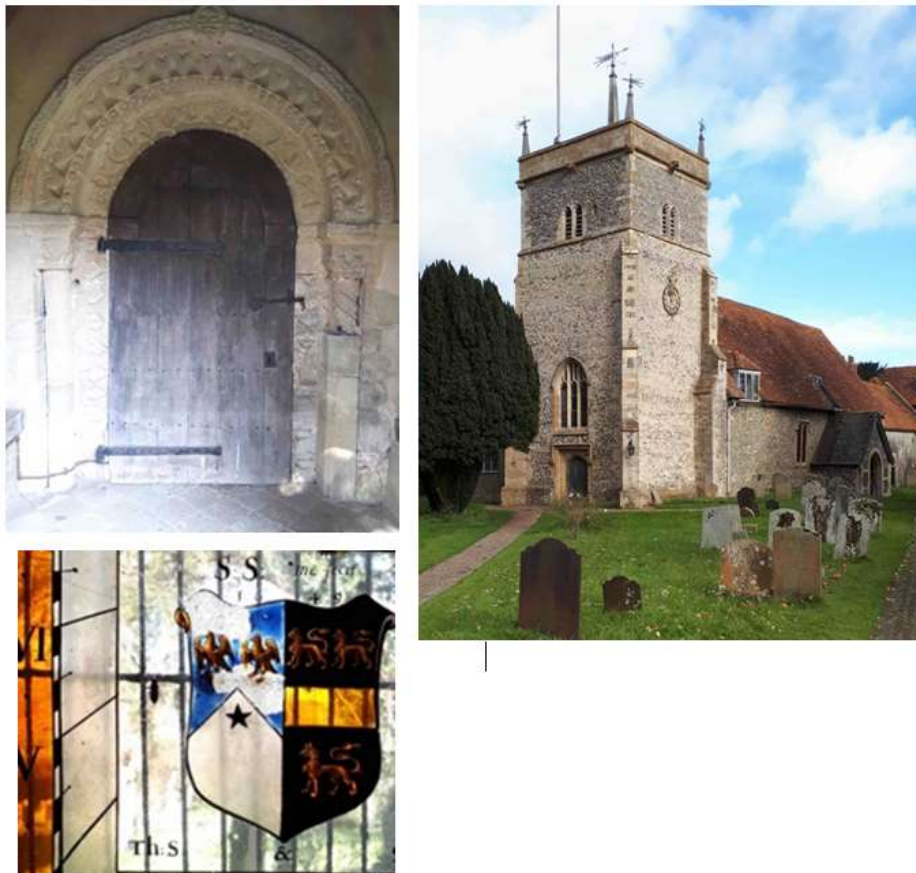
Figure 22: The Church of St Mary the Virgin

Right: View of from pathway leading up to C15th west tower.
 Above left: The South Door
 Below left: A detail of the 'Fly Window'

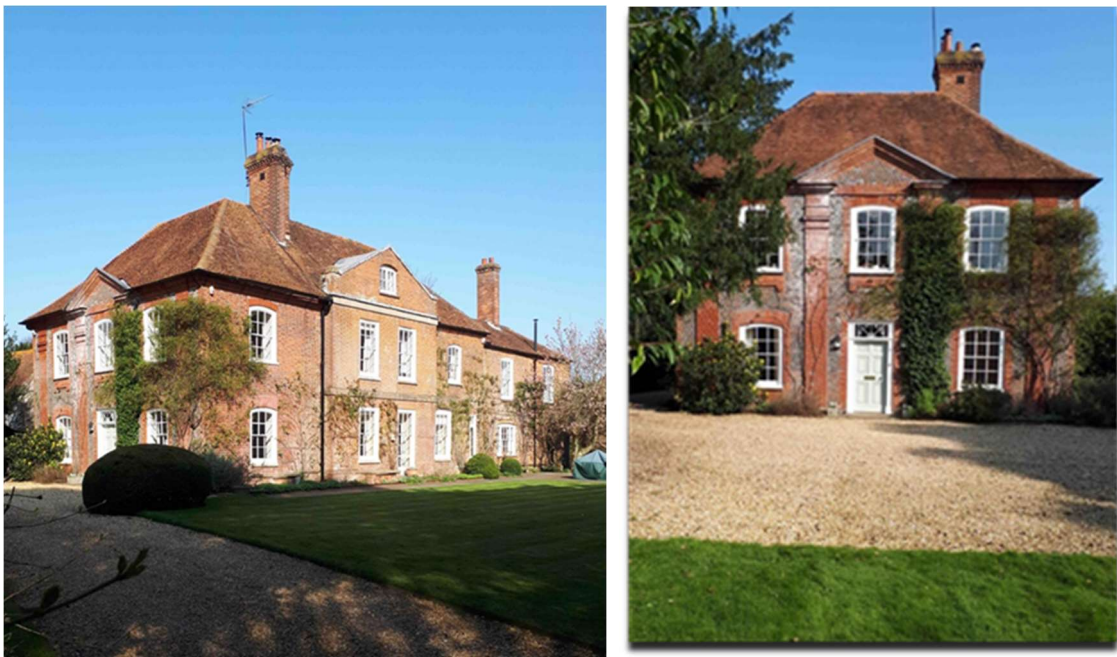
Figure 23: The Old Vicarage

- 8.7 The Old Vicarage [figure 23] is an impressive early Georgian house with Palladian features and set in extensive gardens. It dates from the early 18th century and is Grade II* listed.

Left: South and east elevations
Right: South elevation

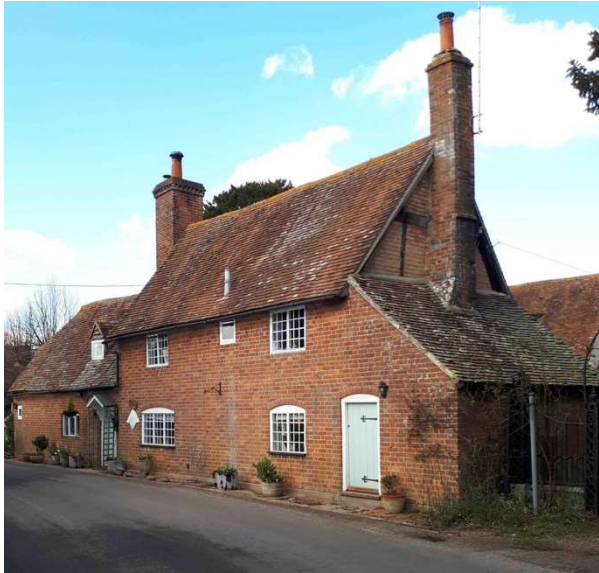
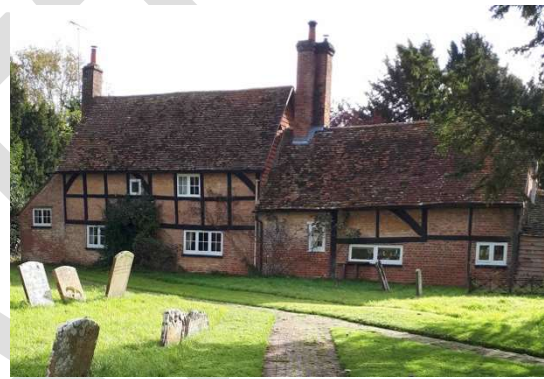
Figure 24: The Old Post Office

date from the 19th century but the building's timber-framed origins are clearly displayed in its rear and eastern elevations. The roof is tiled although the relative height of the chimney stacks at both ends of the two-story section, and the steep pitch of the roof, suggests that the roof may once have been thatched [figure 24].

Above: South elevation
Right: North (rear) elevation

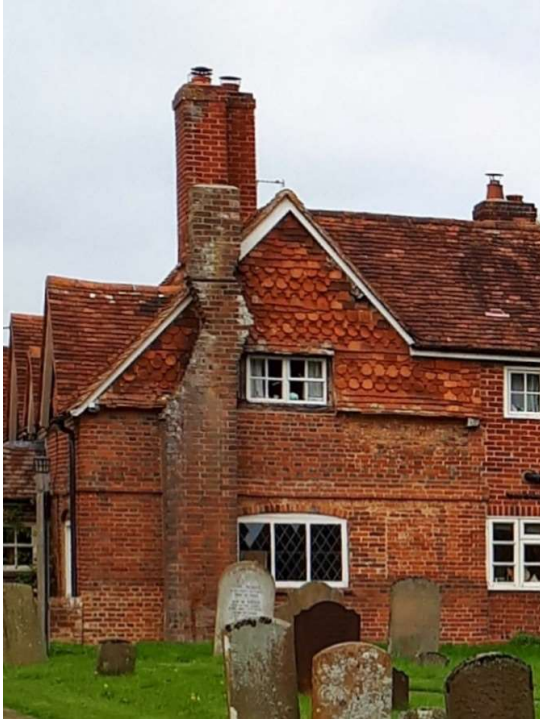
Figure 25: Glebe Cottage

- 8.9 Glebe Cottage, formerly the vicarage and at one time two joined cottages, is a Grade II listed structure that dates from the 18th century. The cottage is constructed of brick with clay hung tiled gables under a tiled roof. A rear extension, that can be seen from the churchyard and was added after listing in 1951 [figure 25].

Above: East elevation

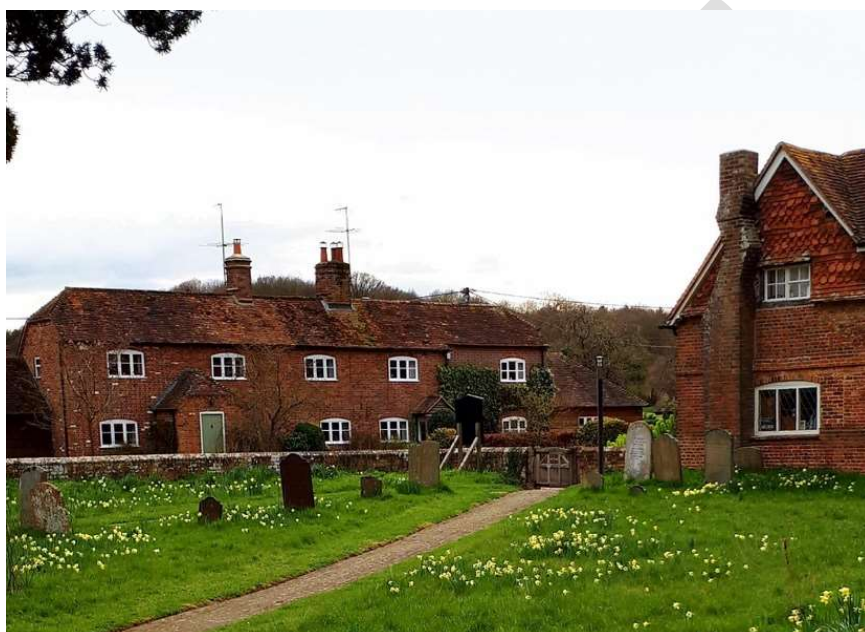
Figure 26:
Froude's
Cottage and
Christmas
Cottage from the
chuchyard

8.11 This pair of joined vernacular cottages has elements that date from the 18th century although the brick elevations may be more recent. The symmetry of the central section of these dwellings indicates that it originally took the form of three simple agricultural cottages. Both of the current dwellings have been extended sympathetically in brick to match the original and with lapped board on timber frames.

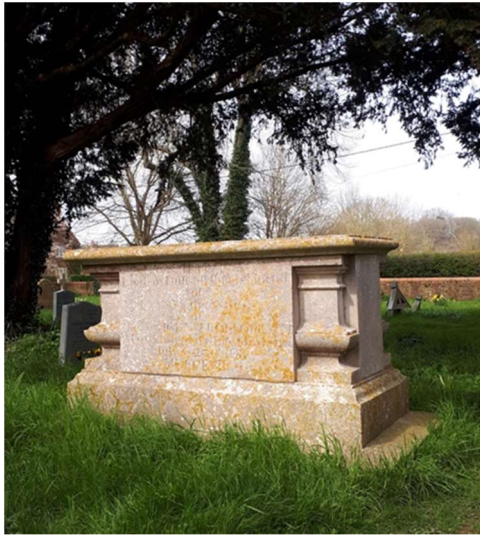
Figure 27: The Trollope Memorial

- The Trollope tomb 3 metres to the west of the west door of the church.
Grade II listed [figure 27]

The Trollope Memorial is one of four listed tombs within the churchyard.

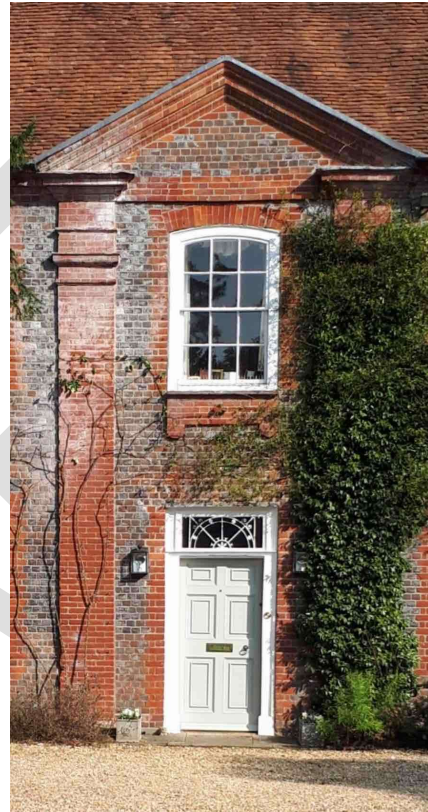
Figure 29: The Old Vicarage, features of the south elevation

9.2 The southern elevation of The Old Vicarage [figure 28] is built in grey brick with red brick dressings. It has Doric pilasters and decorative eaves that are formed from rubbed red brick that frame a central 6-panelled door which has a rectangular radiating fanlight. The southern and eastern facades of this two-story building, both have triangular pediments set into the hipped, tiled roof. The sash windows are typical of the era in both style and proportion, with exposed wooden boxes and segmental headers in brick.

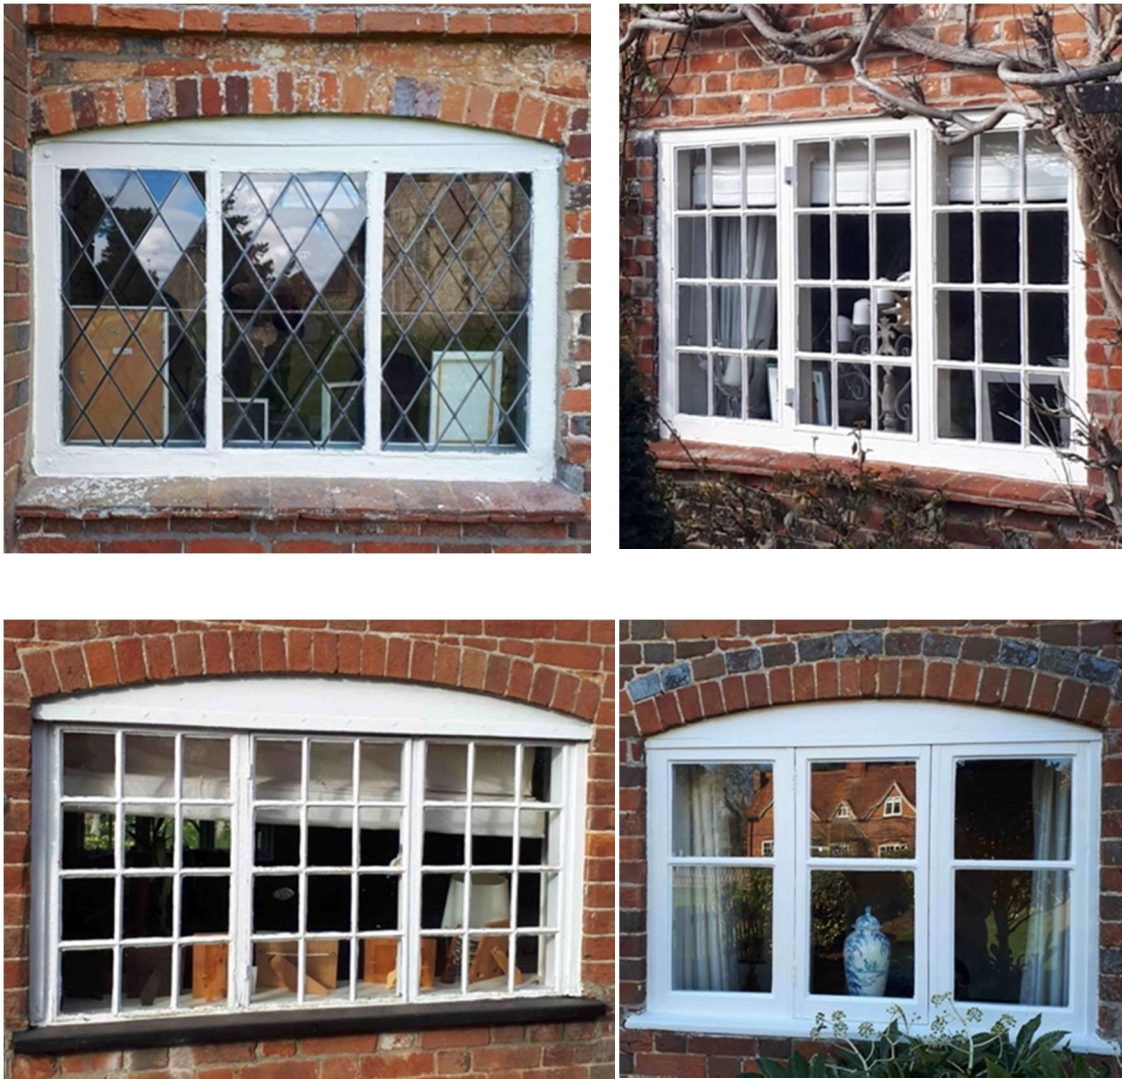
Figure 30: Typical windows within the conservation area

9.6 The casement windows [figure 29] in the cottages are Georgian in style. Most are constructed in timber although metal frames can be seen in both Glebe Cottage and the Old Post Office. Most street level windows have segmental headers with either brick or painted wood infills. In several cases this feature is repeated above the external doors. The cottage windows vary in age but some are thought to be of historic interest. There is no evidence of either UPVC or aluminium replacement windows.

Flush fitting timber windows, as well as those formed of metal and almost certainly, in the local foundry.

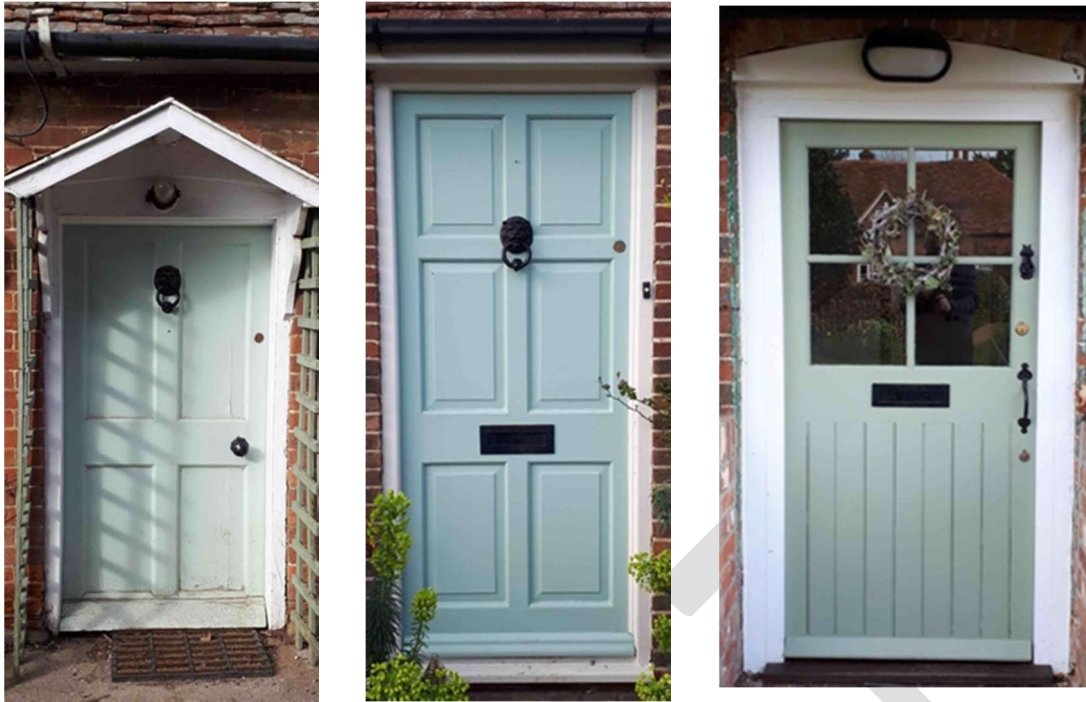
Figure 31: Examples of doors within the conservation area

9.7 The cottage doors [figure 30] that can be seen from the road are in good condition. At the time of publication, and by agreement between the residents, these doors are consistent though not identical, in colour.

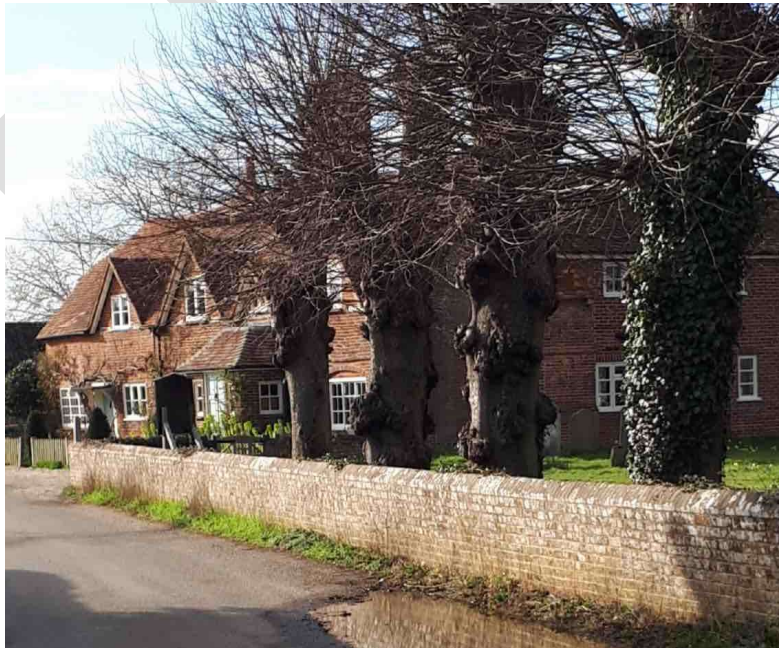
Figure 32: The capped church wall

- 9.8 The capped walls that bound the north and the south of the churchyard [figure 31] are formed of brick with lime mortar.

Picture shows the wall on the south side of the churchyard, with Glebe Cottage and pollarded lime trees behind.
