EA Ref: HA/2022/124189/04-L01

Further to our letter dated 16th October 2023. A local resident has sent us an additional set of flood images showing an even higher flood level than previously photographed. Again, it is unlikely that the photographs were taken at the peak extents of the flooding.

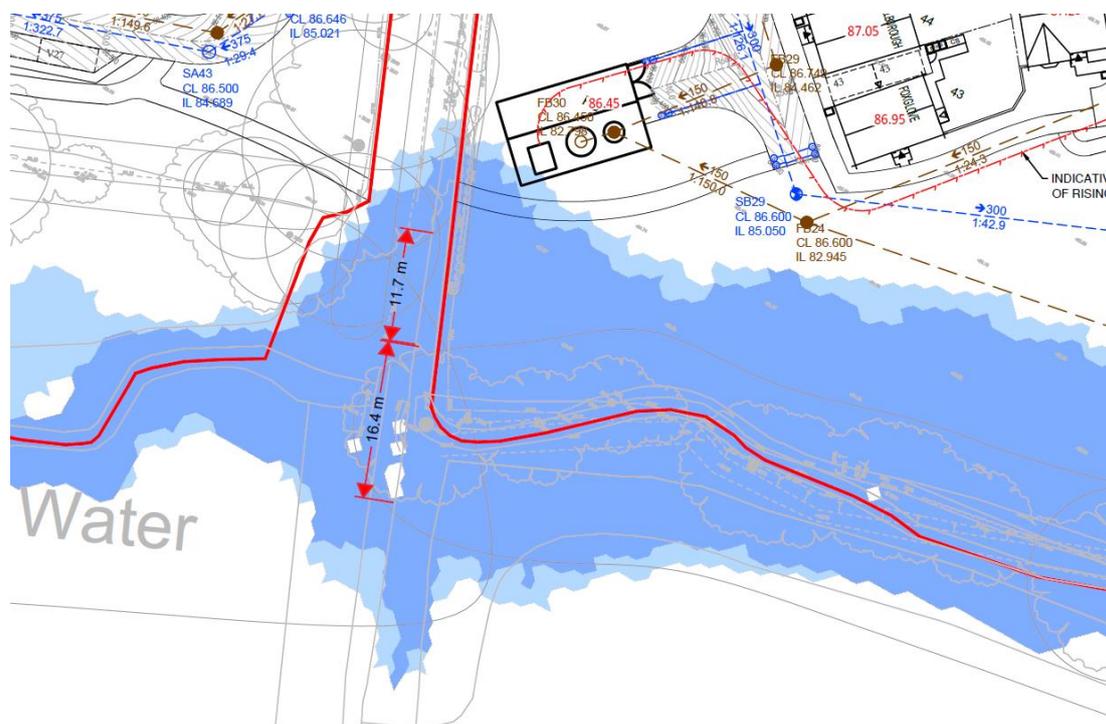
The later photographs were used to identify the actual level the water extended to and measure this back to the telegraph pole on the north side of the bridge as a geo-fixed location. This showed that the photographed flood extent on the brideway was 11.7m north of the telegraph pole and 16.4m to the south. These positions marked onto the applicant's drainage plan is shown below as figure 1.

Figure 1: Drainage Plan A359-RM-51 showing position of Telegraph Pole. The darker blue area is the modelled 1 in 100-year flood zone extent.

The 1 in 100-year flood zone extent shown on the above plan is 38m along the brideway (ignoring the drainage gullies along its eastern side). As previously stated, the 20-year modelled flood extent is about 10m. Thus, the flooding extent photographed on 2nd November 2023 at 28m is far closer to the 100-year event than it is a 20-year event.

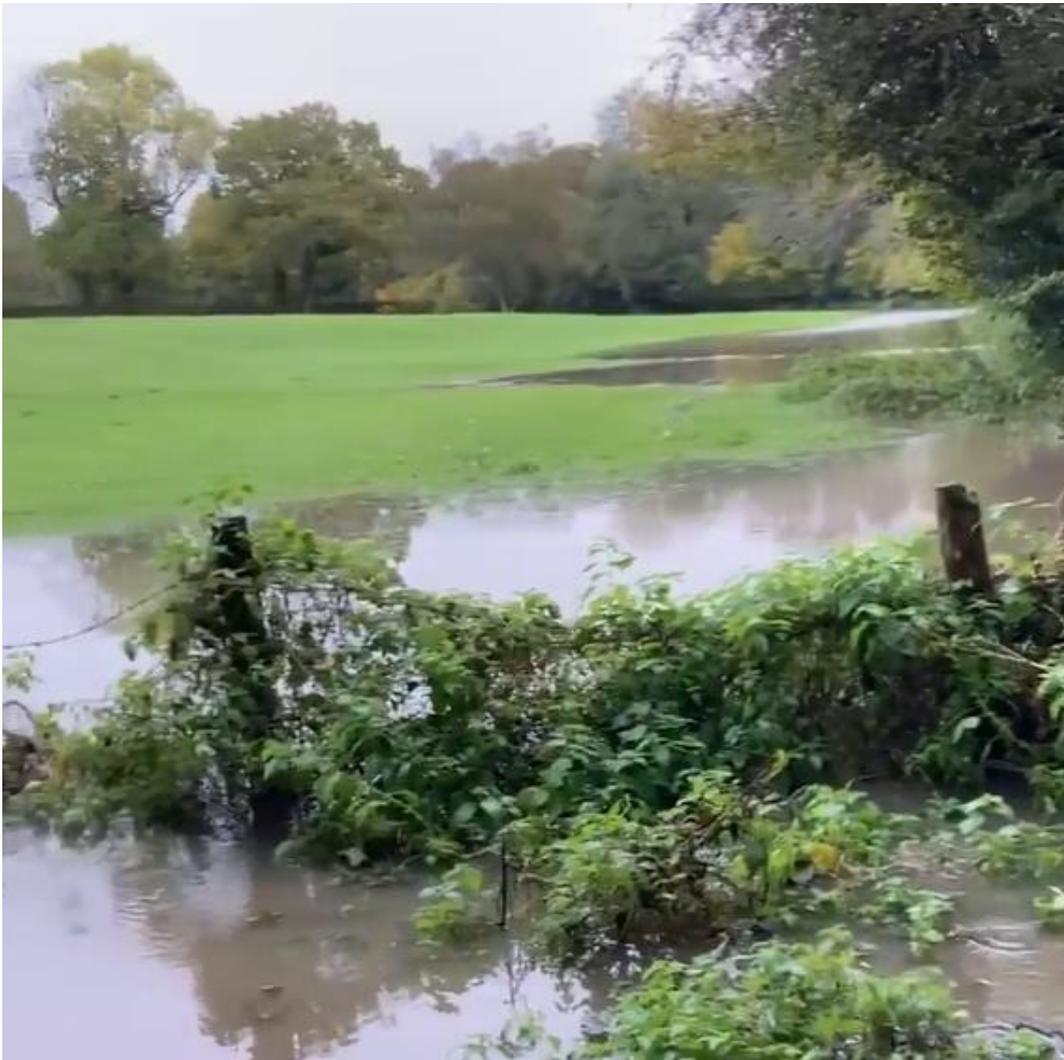
We also draw your attention to the photograph below taken at the same time on 2nd November 2023 showing the flood water extending far beyond the treeline into the proposed development site.

Image taken 2/11/23 from the telegraph pole looking east across the development site.

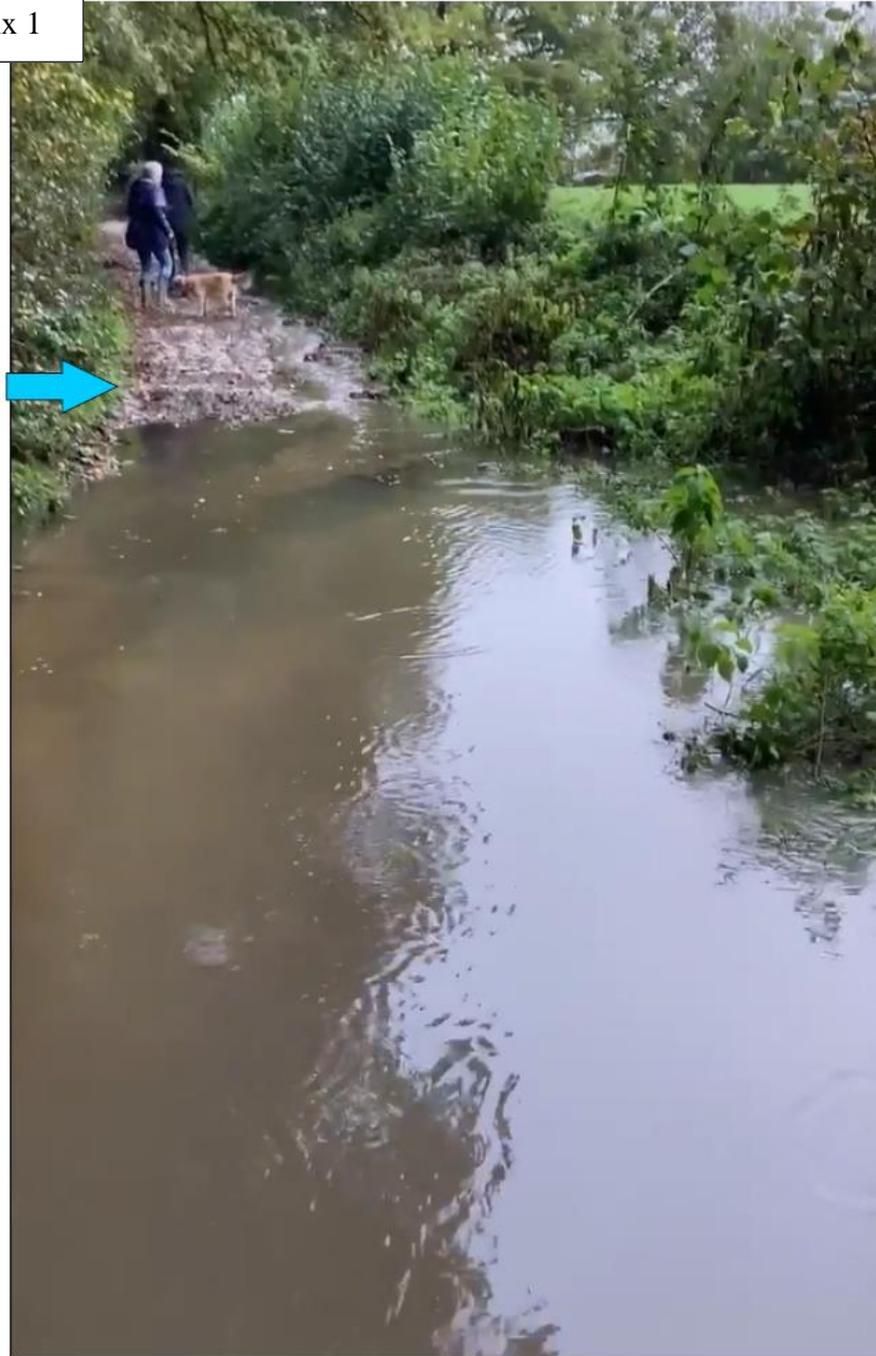
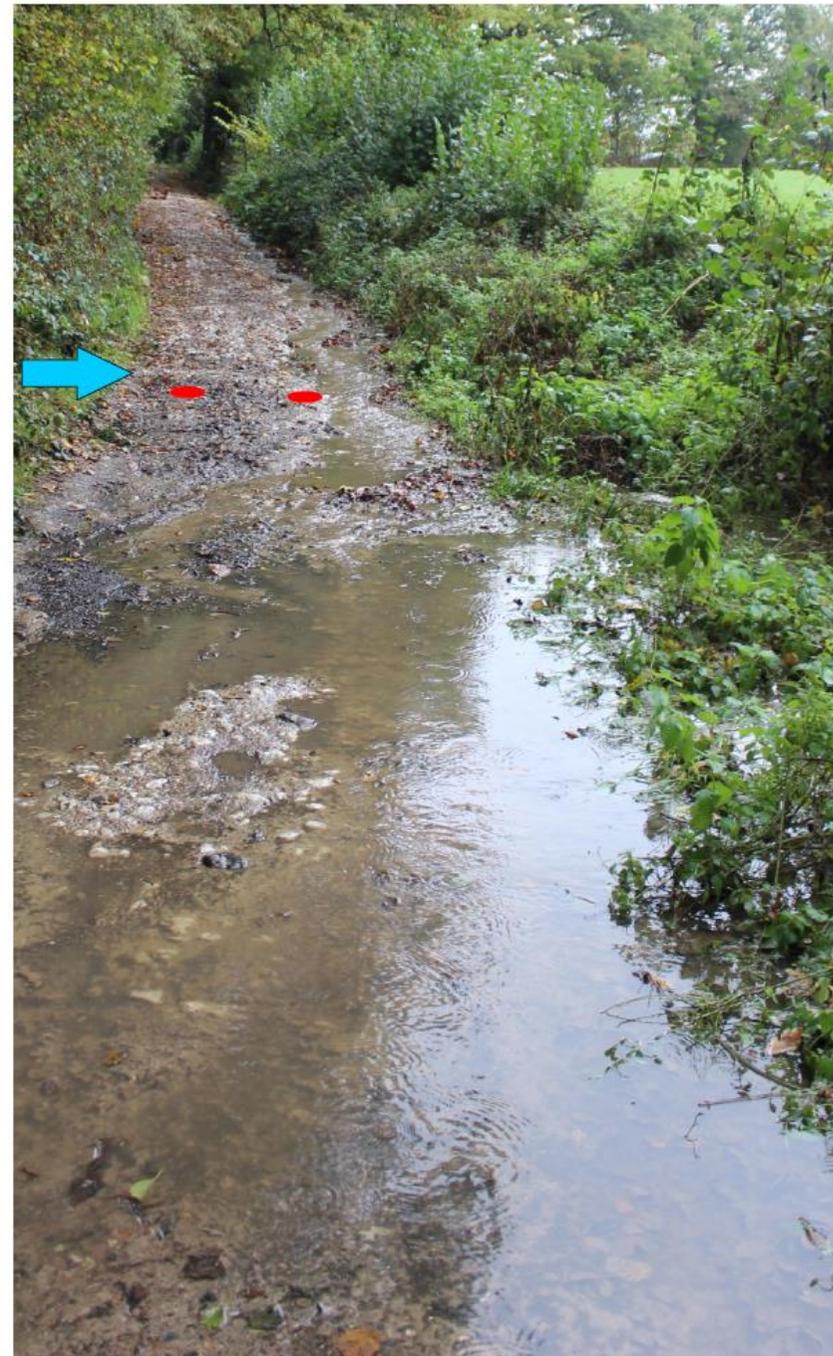
Photographs taken on 2/11/23 at 8:20am (left) and 2pm (right) looking north.
The nearest red spot on the later image representing the water level at 10am was measured at 11.7m from the telegraph pole

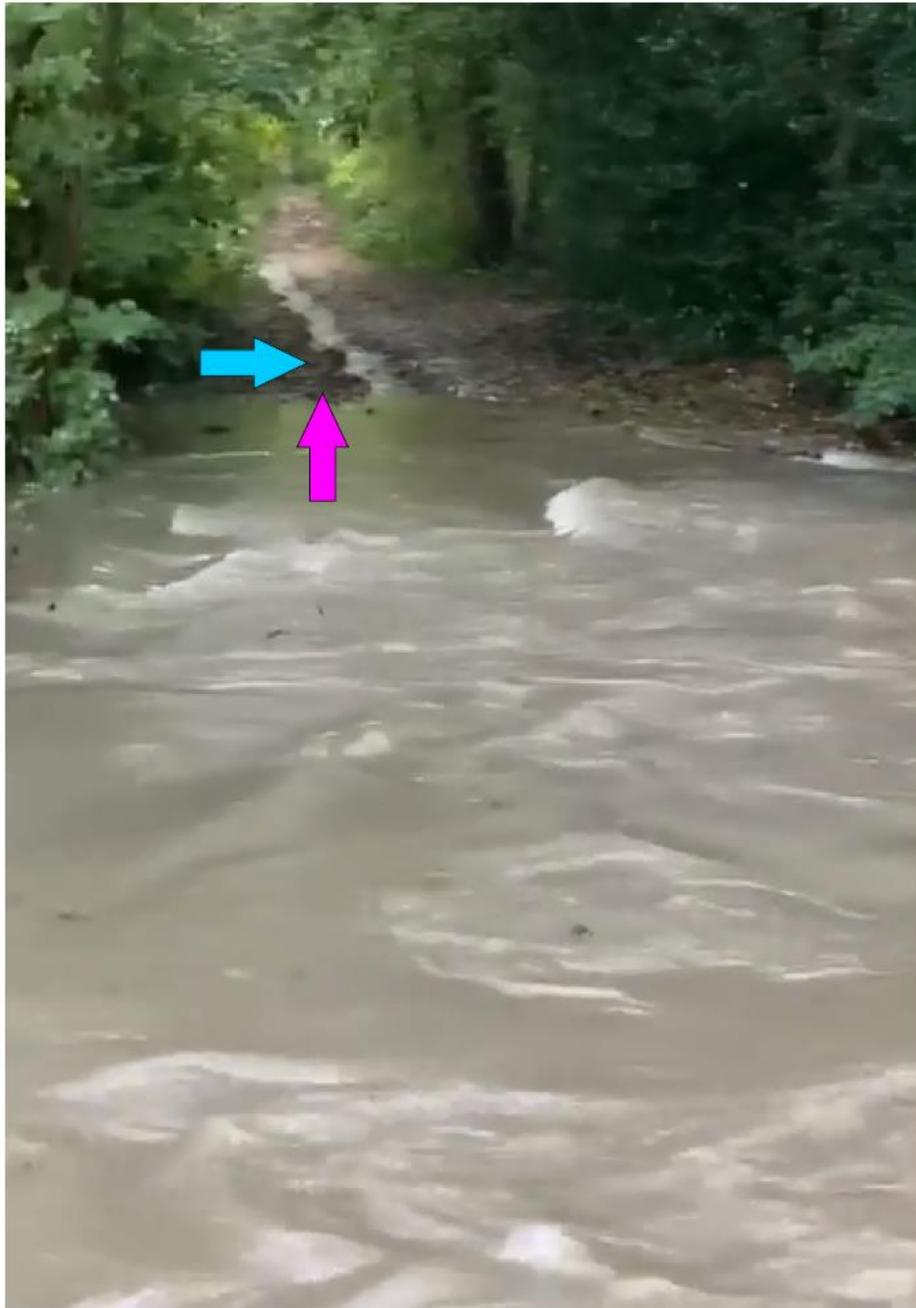
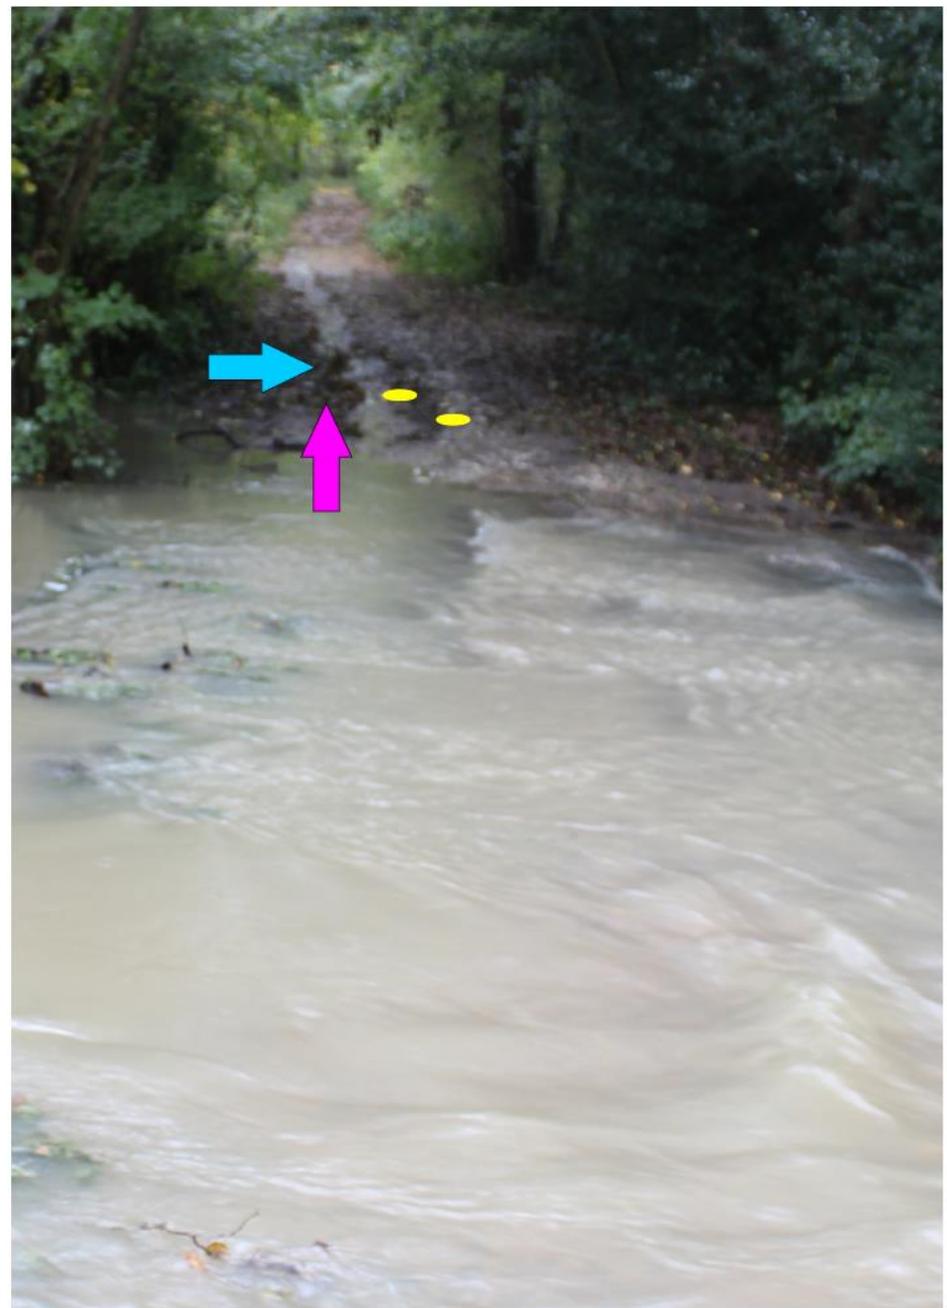
Photographs taken on 2/11/23 at 8:20am (left) and 2pm (right) looking south
The nearest yellow spot on the later image representing the water level at 10am was measured at 16.4m from the telegraph pole
