# The Acklington Parish Footpath Survey

Published on 8<sup>th</sup> January, 2019

## 1. Executive summary

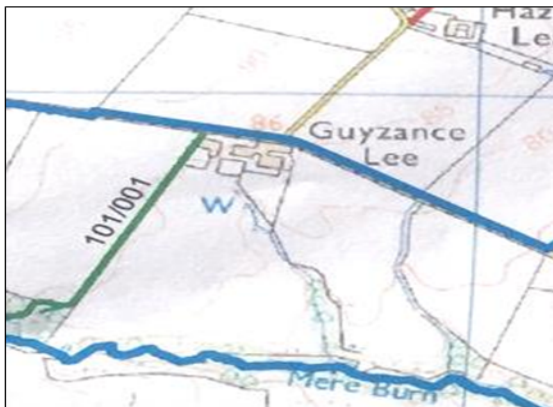
## Footpath No 1

Well-maintained field edge path. Broken gate at the mid point. Lack of waymarks in wood.

At the midway point a footpath gate has broken from its hinges and is lying on the ground.

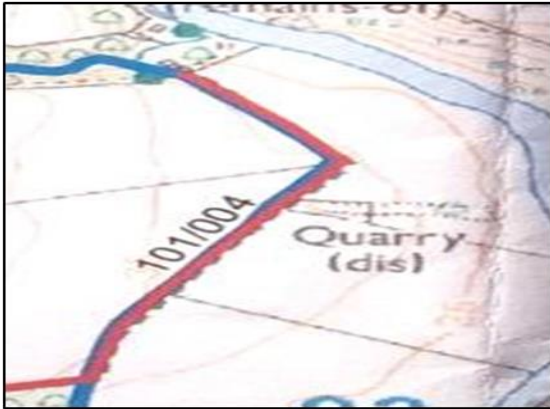
101/004

Footpath in excellent condition, but has a waymark issue.

A gate has collapsed at the mid-way point (with attached waymarks). The fence needs to be repaired and reinstated.

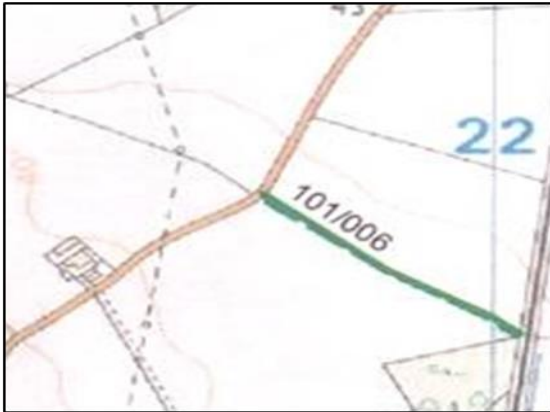
**Footpath No 6**

This footpath has disappeared completely from the landscape. No physical trace of this footpath could be found.

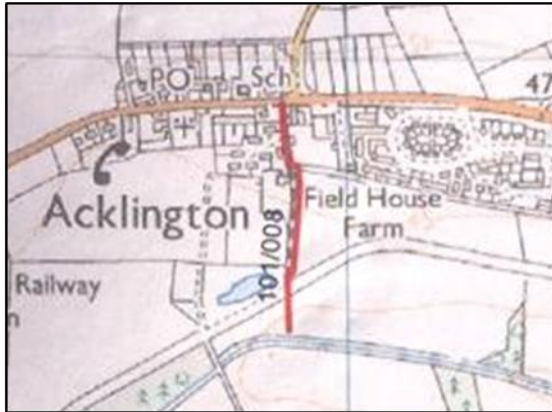
## Footpath No 8

A broken gate secured by plastic cable is very difficult to open

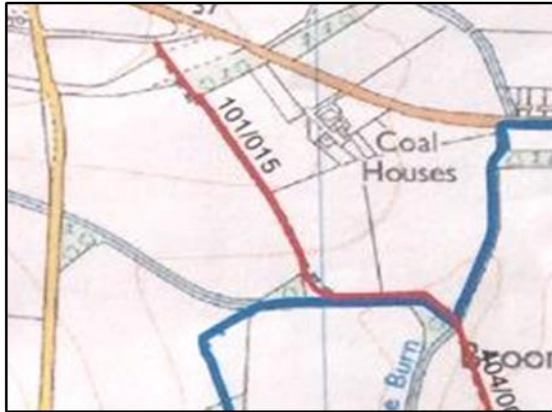
101/015

Footpaths Nos 3, 15 & 20 have rotted stile steps. Footpath 15 has two stiles, so badly rotten and decayed as to make them unusable.

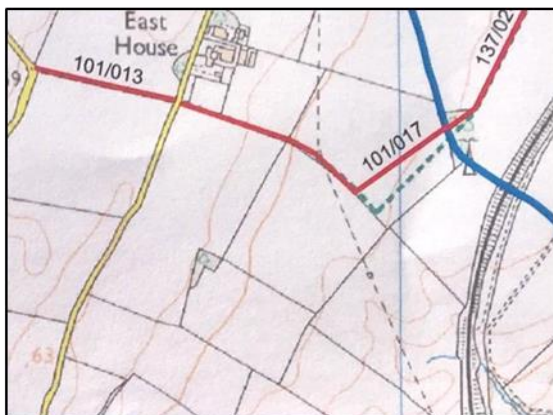
**Footpath No 17** 101/017

A missing footpath sign, and busy caravan site makes finding this path difficult. Deviates from the Definitive pathway
