the play inspection company

Annual Inspection

Bockhampton

Inspection Ref: 1211202 Site Ref: 3582 Customer Order: N/A

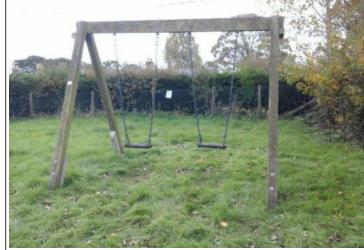
8 - Low Risk (Finding 4)

Item:Swings - 1 Bay 2 Seat (Flat)Risk Level:L - Low RiskManufacturer:Playline DesignSurface:Grass

Finding: There is algae or moss on the surface of the equipment

Action: Clean and treat appropriately

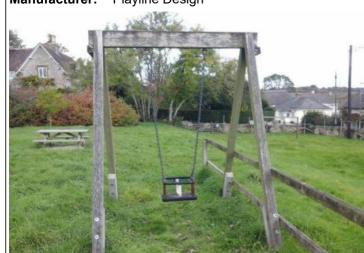
6 - Low Risk (Finding 3)

There is some evidence of rot in the timber - Monitor for any further deterioration and replace as required

Item: Swings - 1 Bay 1 Seat (Cradle) - Type 1 Risk Level: L - Low Risk Manufacturer: Playline Design Surface: Grass

Action: Monitor for any further deterioration and replace as required

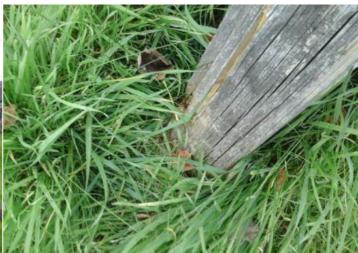
Swings - 1 Bay 1 Seat (Cradle) - Type 1 Item: Playline Design Manufacturer:

Finding: There is some strimmer / machinery damage apparent on the posts, this can penetrate the preservative applied to the timber and accelerate the rotting process

Action: Monitor for any deterioration (rot) and replace as required
