Bodle Street Green War Memorial Maintenance - 2021

Thank you for inviting us to provide an estimate to clean and undertake repairs to the Bodle Street Green War Memorial. We have attended at the War Memorial and assessed the general condition. Please find set out below associated cleaning and repair costs together with attendance and recommendation options.

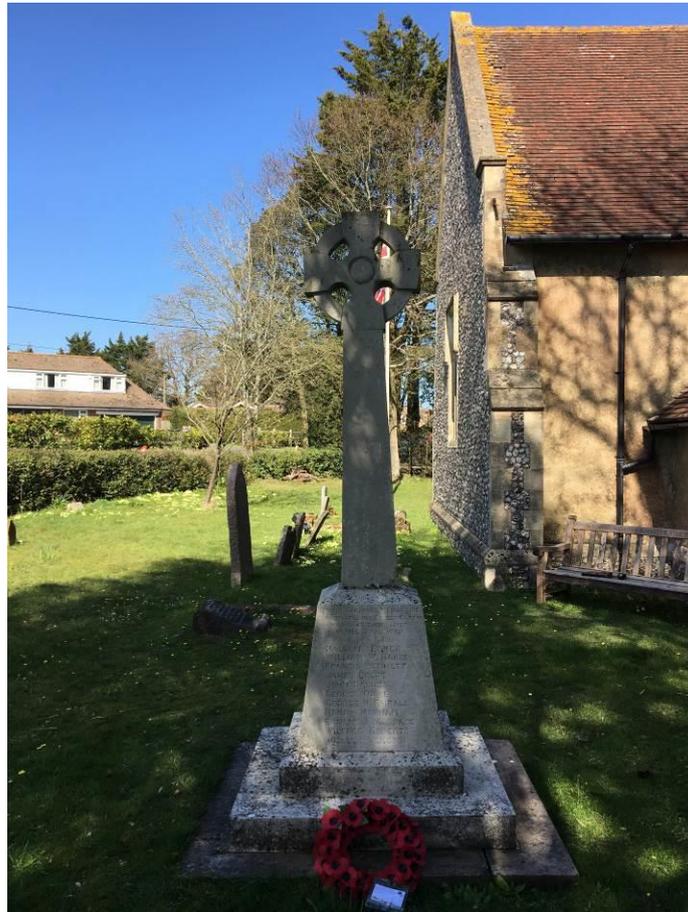
Fig.1 Bodle Street Green War Memorial, front elevation, April 2021.

The memorial consists of a Celtic cross on plinth and two-stepped base with paved surround. The plinth bears unpainted hand cut inscriptions. The memorial is constructed from Portland stone with York stone pavers beneath the base.

Using the Historic England condition survey guidelines our assessment is that the main structure of the War Memorial is, on visual inspection from ground level, in overall good condition. It is leaning slightly to the left as facing. We recommend that this should be monitored but would suggest that is not a cause for concern at this time.

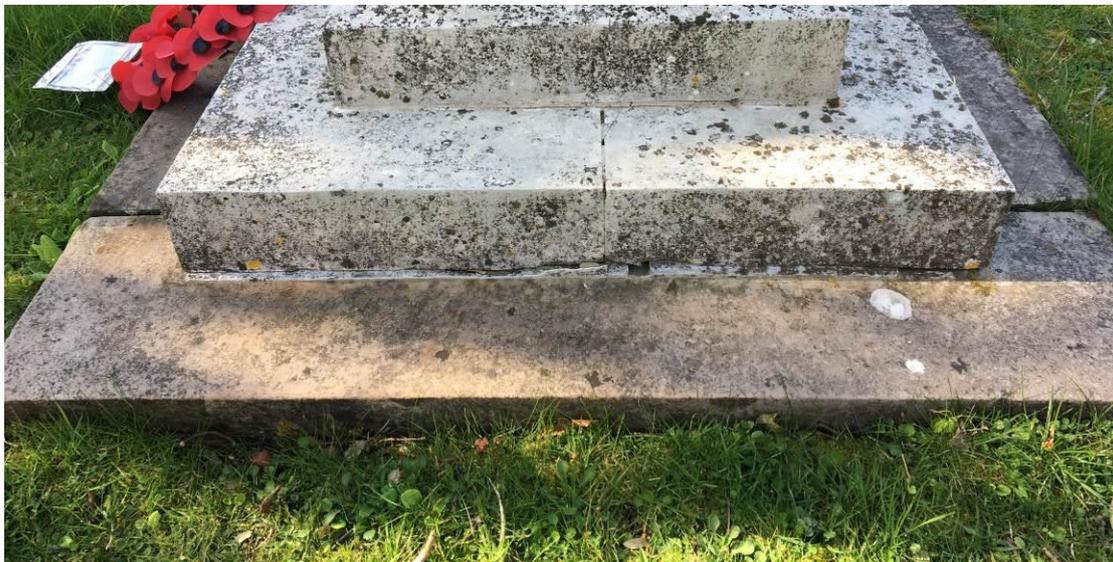
The paving to the right-hand side (as facing) of the memorial has become detached from the memorial, probably due to natural ground settlement. We would recommend that the joints are repointed and monitored for future movement.

Fig.2 Detail of paving showing movement from tiered base.

The approach for repointing would be to test the viability of all areas of pointing and rake out and repoint all defective areas using a natural hydraulic lime, coloured with stone dust to match the existing stone work as closely as possible.

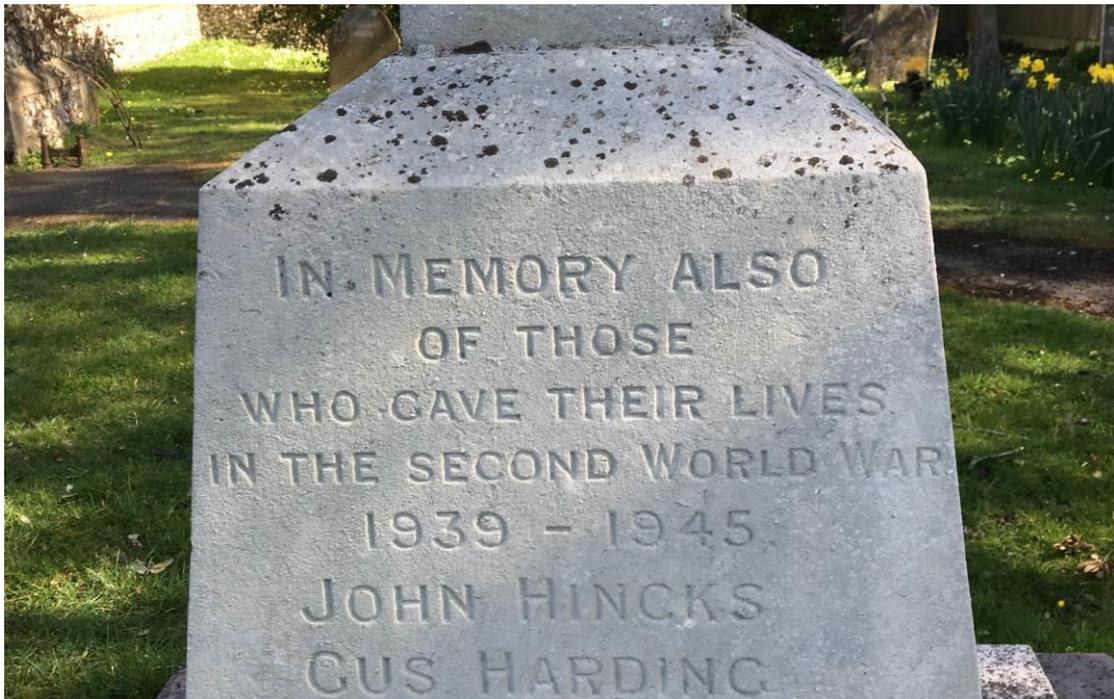
The overall appearance of the memorial is uneven at present. The panels bearing inscriptions have evidently been cleaned regularly whereas other areas less so. Black spot is a lichen which likes to feed off Portland limestone and is visibly present on many parts of the memorial. An alkali chemical treatment might help to reduce the presence of blackspot. We would recommend that such a treatment is only considered following a professional conventional clean. We would be happy to provide a quotation for this following a conventional clean. As blackspot spores are airborne blackspot is highly likely to return to the stone in future.

Fig.3 Detail showing the contrast between inscribed panel and sloping face above.

As the memorial is made from a limestone we would carefully and thoroughly water wash the memorial by hand using a bristle brush, and use a steam cleaner with an atomizing nozzle to ensure low surface water pressure. We would not seek to achieve a 'like new' finish, or remove all surface lichens. No chemicals would be used in the cleaning of the memorial.
