# Safety Inspection Report

Annual Inspection

## Widdrington Station Outdoor Fitness

Widdrington Station and Stobswood Parish Council

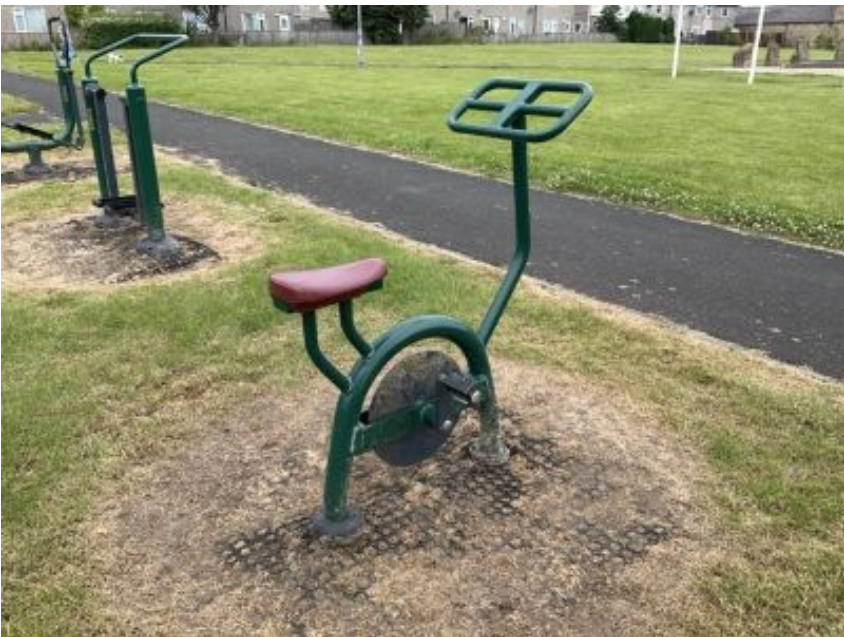
# Adult Fitness - Exercise Bike

EN 16630:2015  
The item and its surfacing (where applicable) meet with the requirements of the relevant standards.

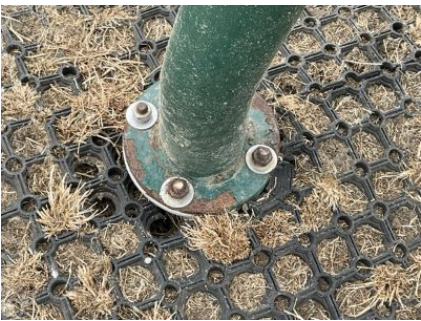
Finding Photos

Item is rusting in places.

Repair.

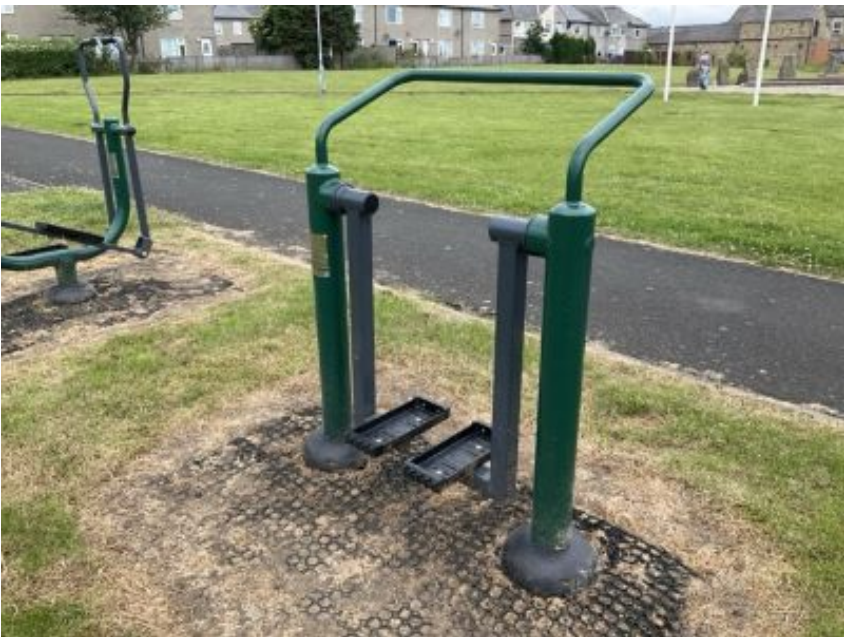
# Adult Fitness - Air Walk

The item and its surfacing (where applicable) meet with the requirements of the relevant standards.

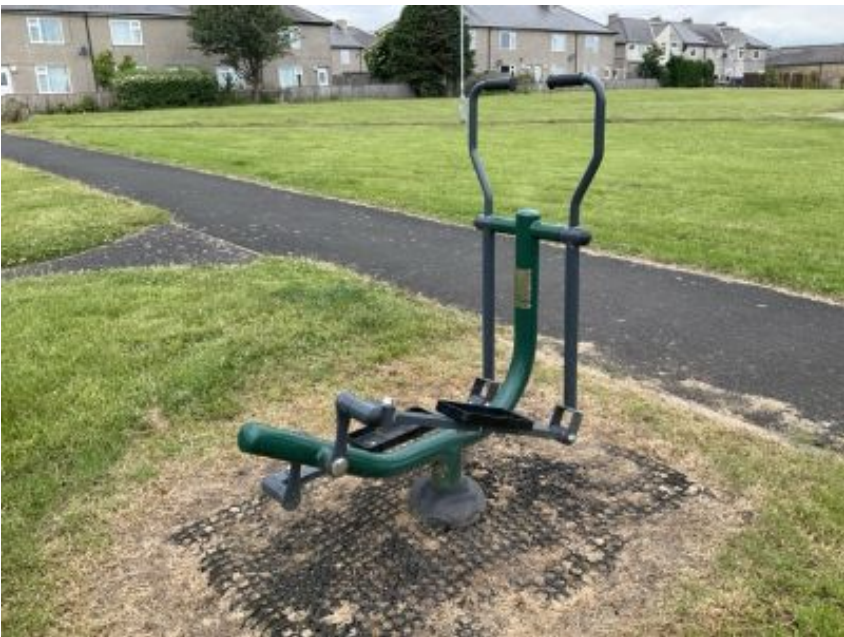
# Adult Fitness - Cross Trainer

The item and its surfacing (where applicable) meet with the requirements of the relevant standards.

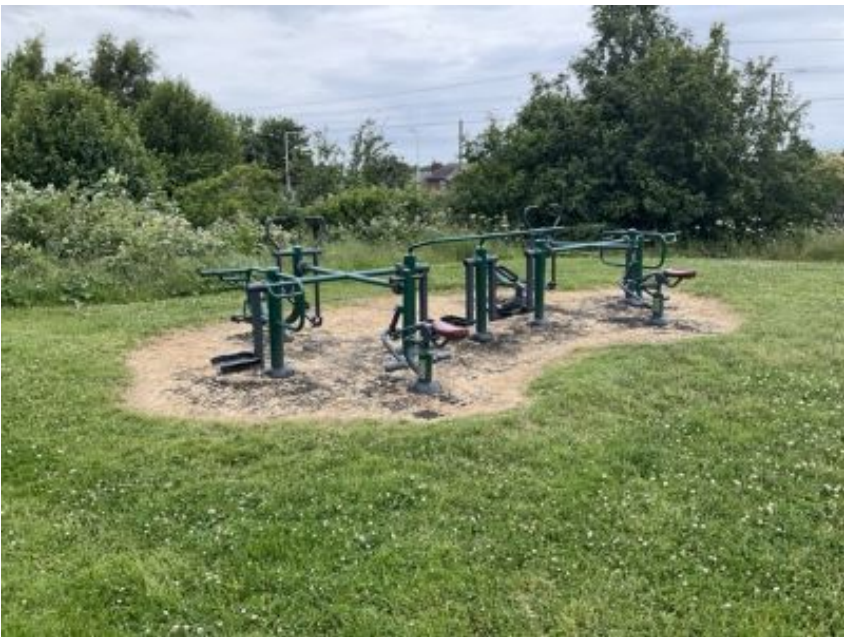
# Adult Fitness - Combination Unit

EN 16630:2015  
The item and its surfacing (where applicable) meet with the requirements of the relevant standards.

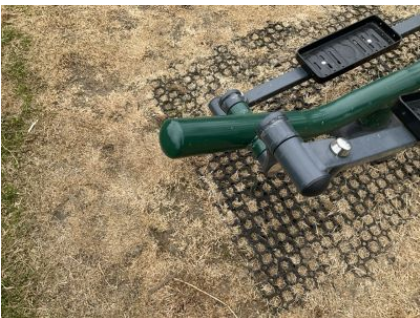
## Finding Photos

Moving parts require greasing.

Apply lubricant according to the manufacturer's instructions.
