# **Flooding around Zebon Copse Estate**

**Church Crookham**

**January 2014**

**prepared by  
David Jackson  
Chairman Zebon Copse Residents' Association**

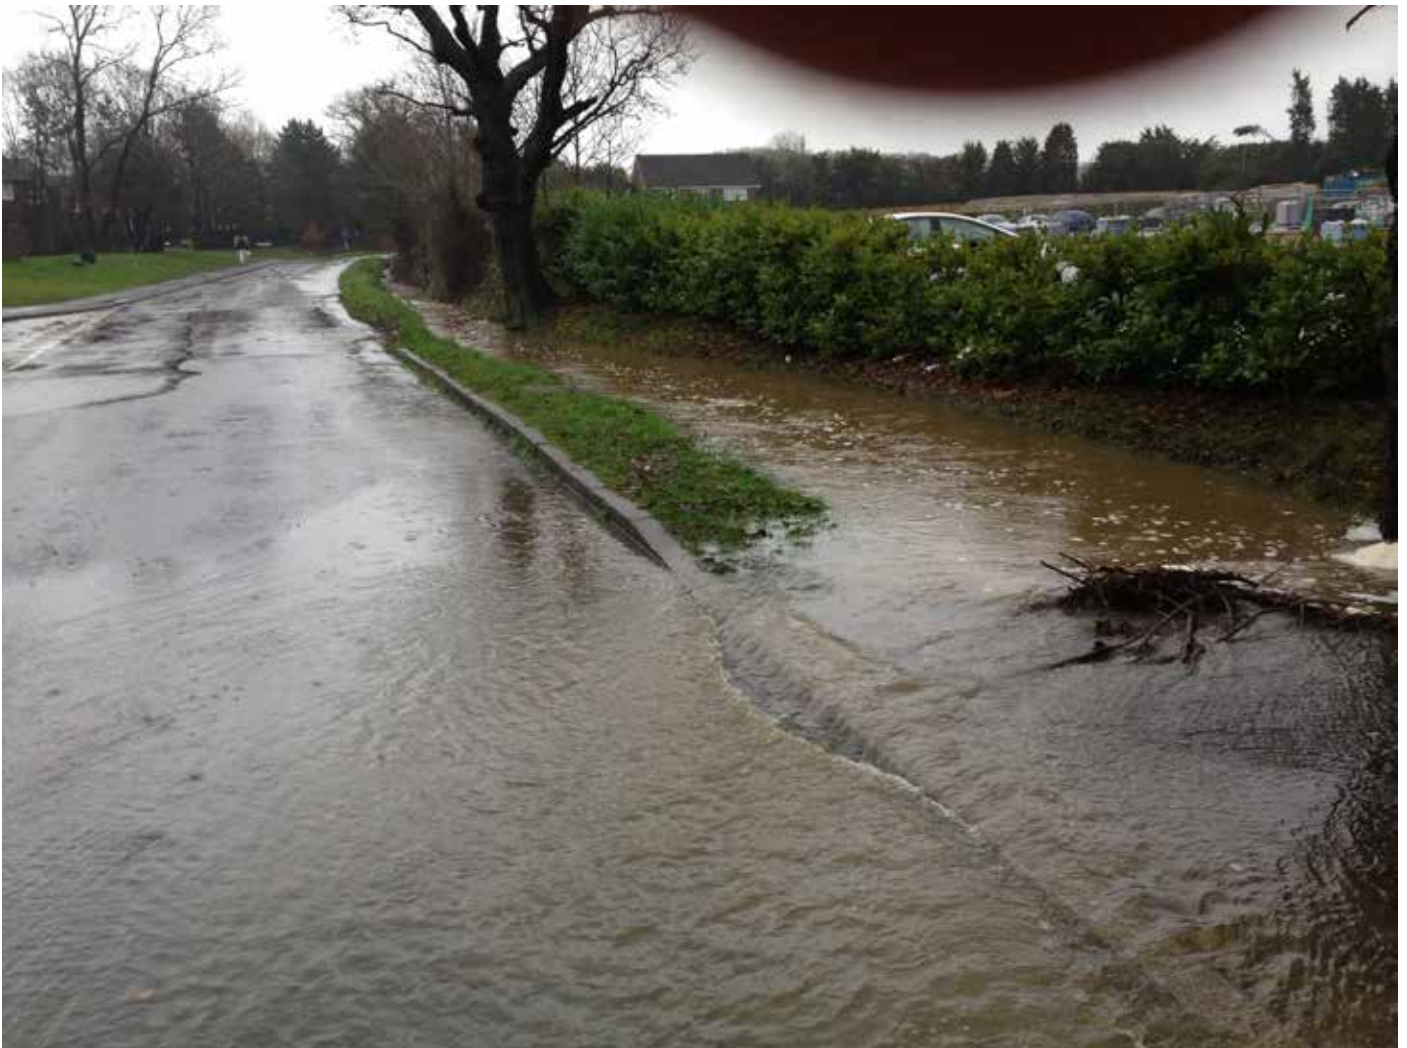
The ditch running along the South side of Ewshot Lane overflowed because the culvert under the entrance to Redfields Garden Centre was blocked by debris. Even when this was cleared by concerned locals, the roadway continued to flood with water running into both Nether Vell Mead and Elmfield.

Blocked Culvert under Ewshot Lane entrance to Redfields Garden Centre 10:30am 4 Jan 2014

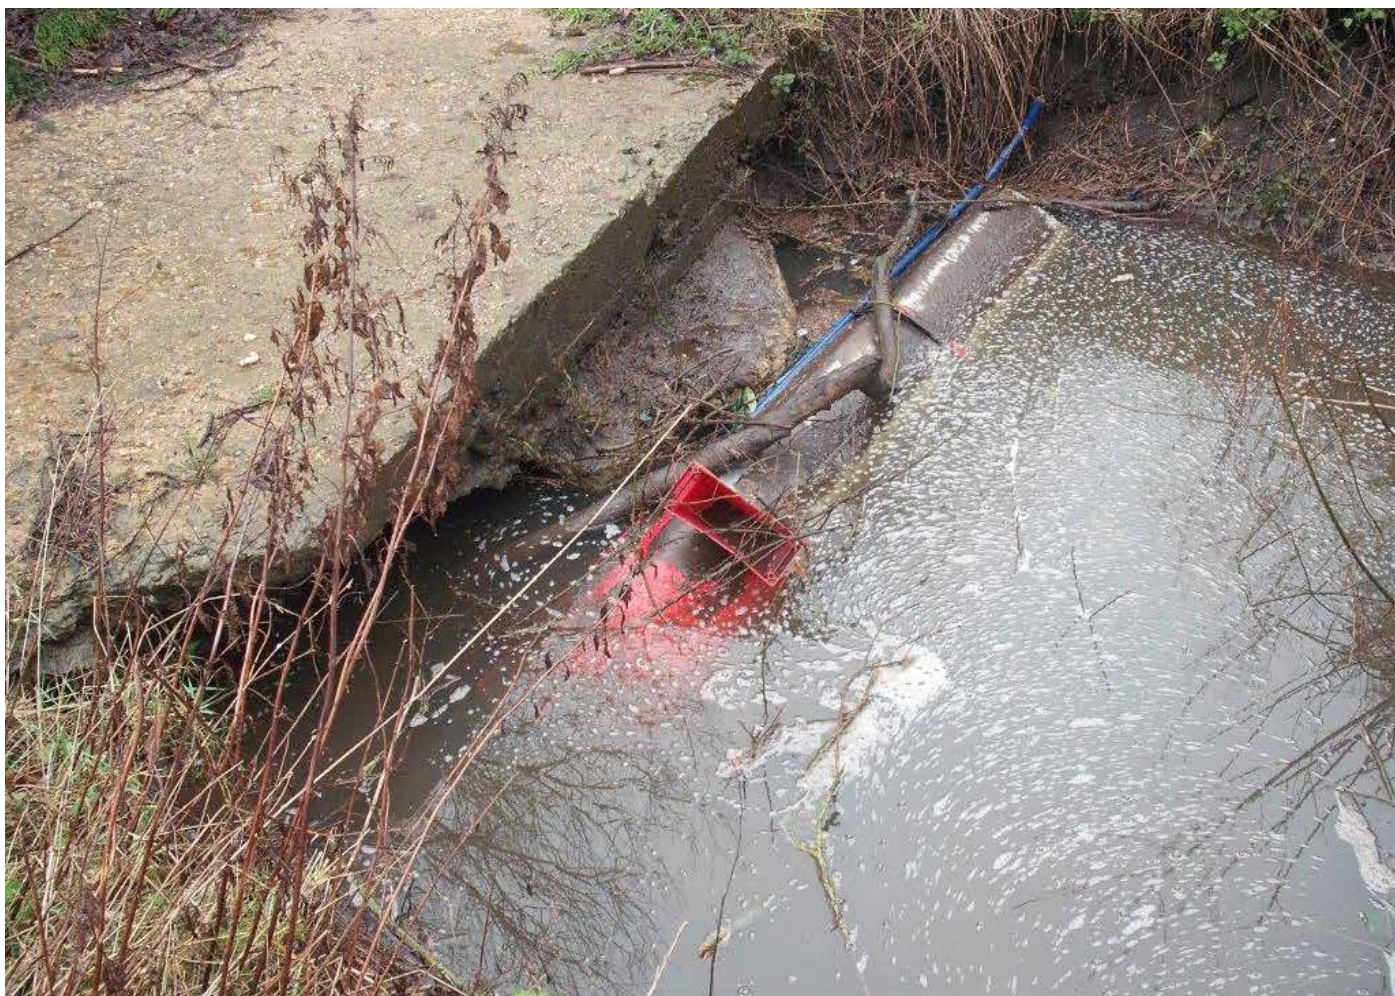
Detritus in culverts and streams played some part in the overflows that caused flooding.

Detritus adjacent to the old QEB entrance on the Ewshot side

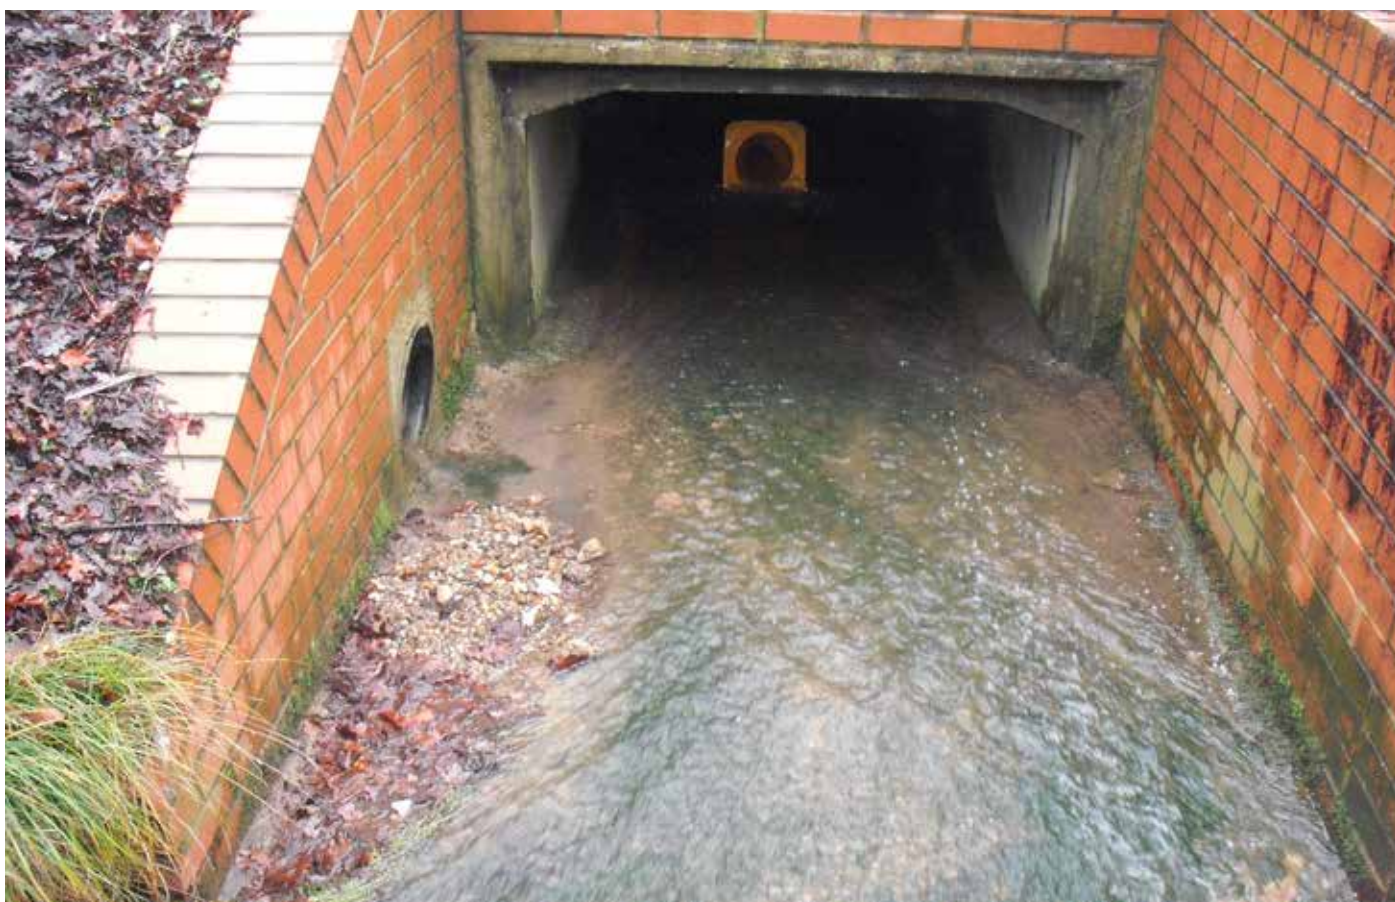
Detritus in the culvert leading from Ewshot Lane under Redfields Lane at 11am 4 Jan 2014

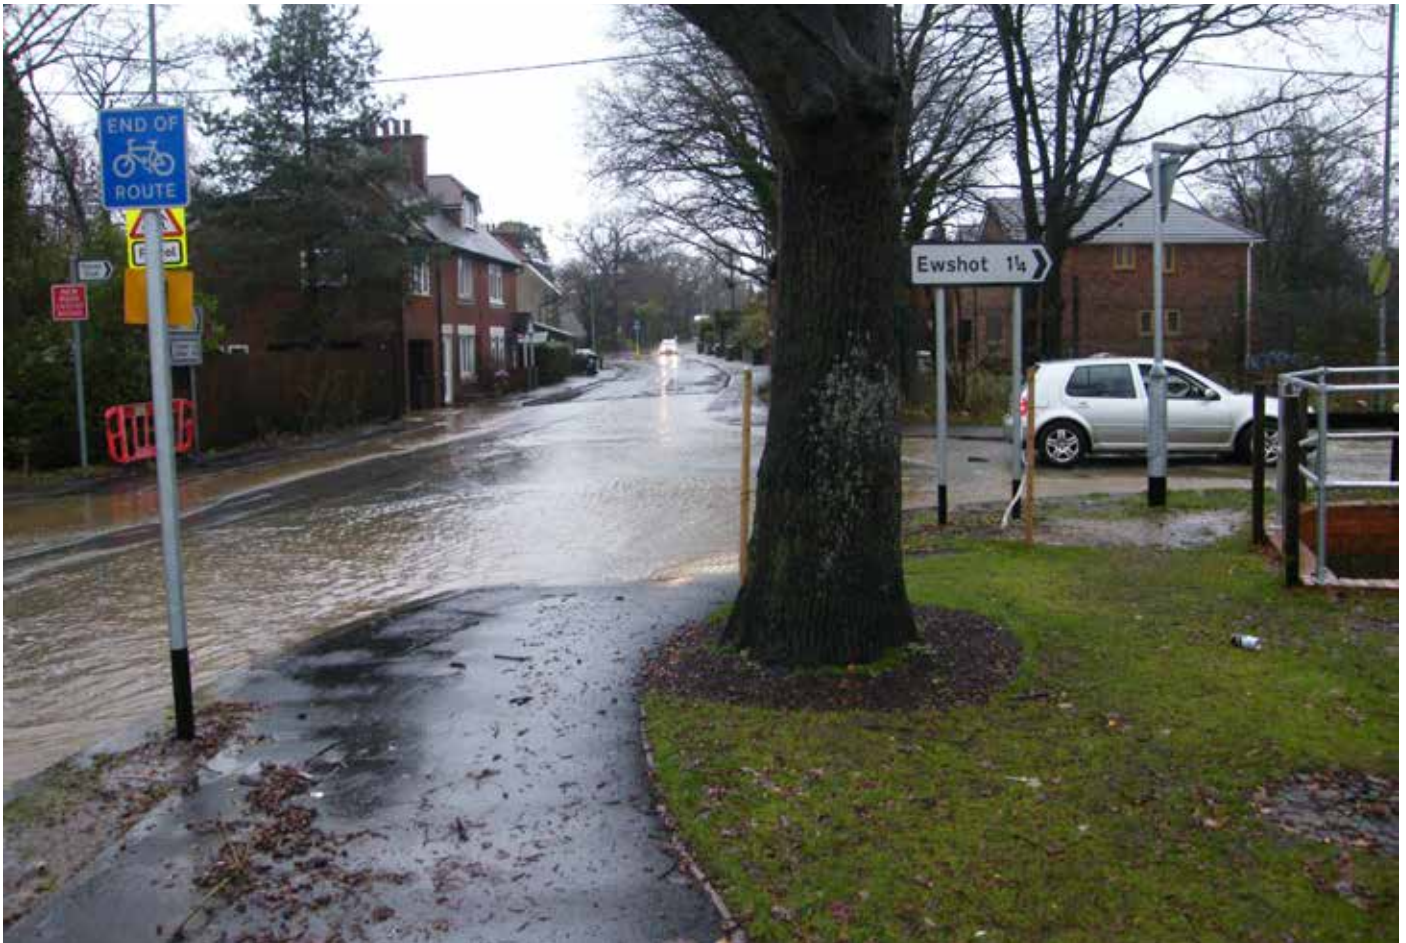
Significant flooding occurred along Aldershot Road/Redfields Lane near the junction with Ewshot Lane.

Flooded junction of Aldershot Road and Ewshot Lane at 11am 4 Jan 2014

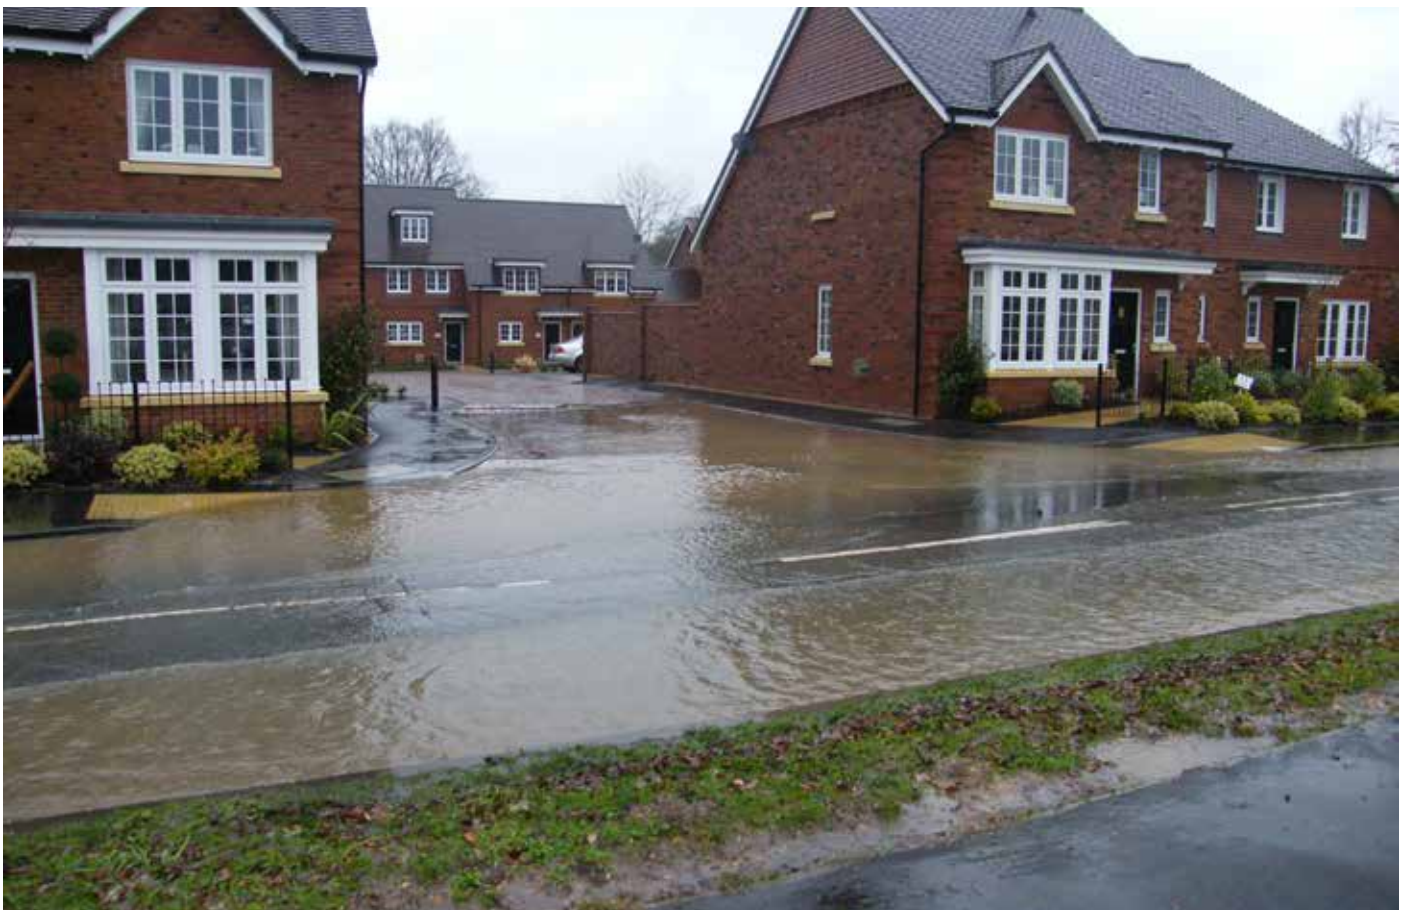
Flooded frontage of Elmfield 11am 4 Jan 2014

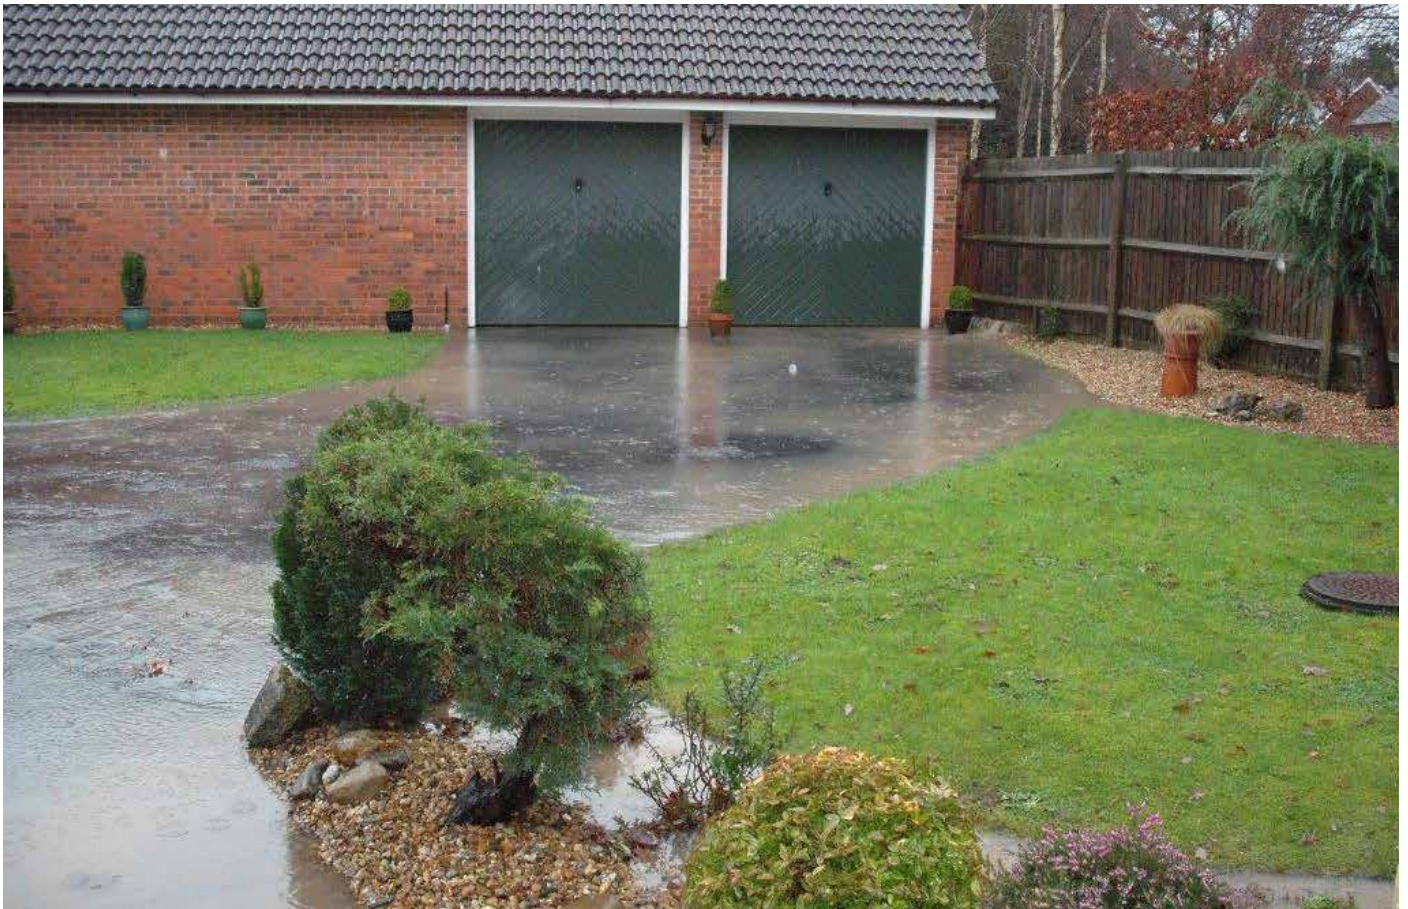
Once again 89 to 123 Nether Vell Mead suffered flooding from runoff originating at the Ewshot Lane junction with Aldershot Road.

Water in garage in Nether Vell Mead 09:30pm 4 Jan 2014. Note large inflow beside doors.

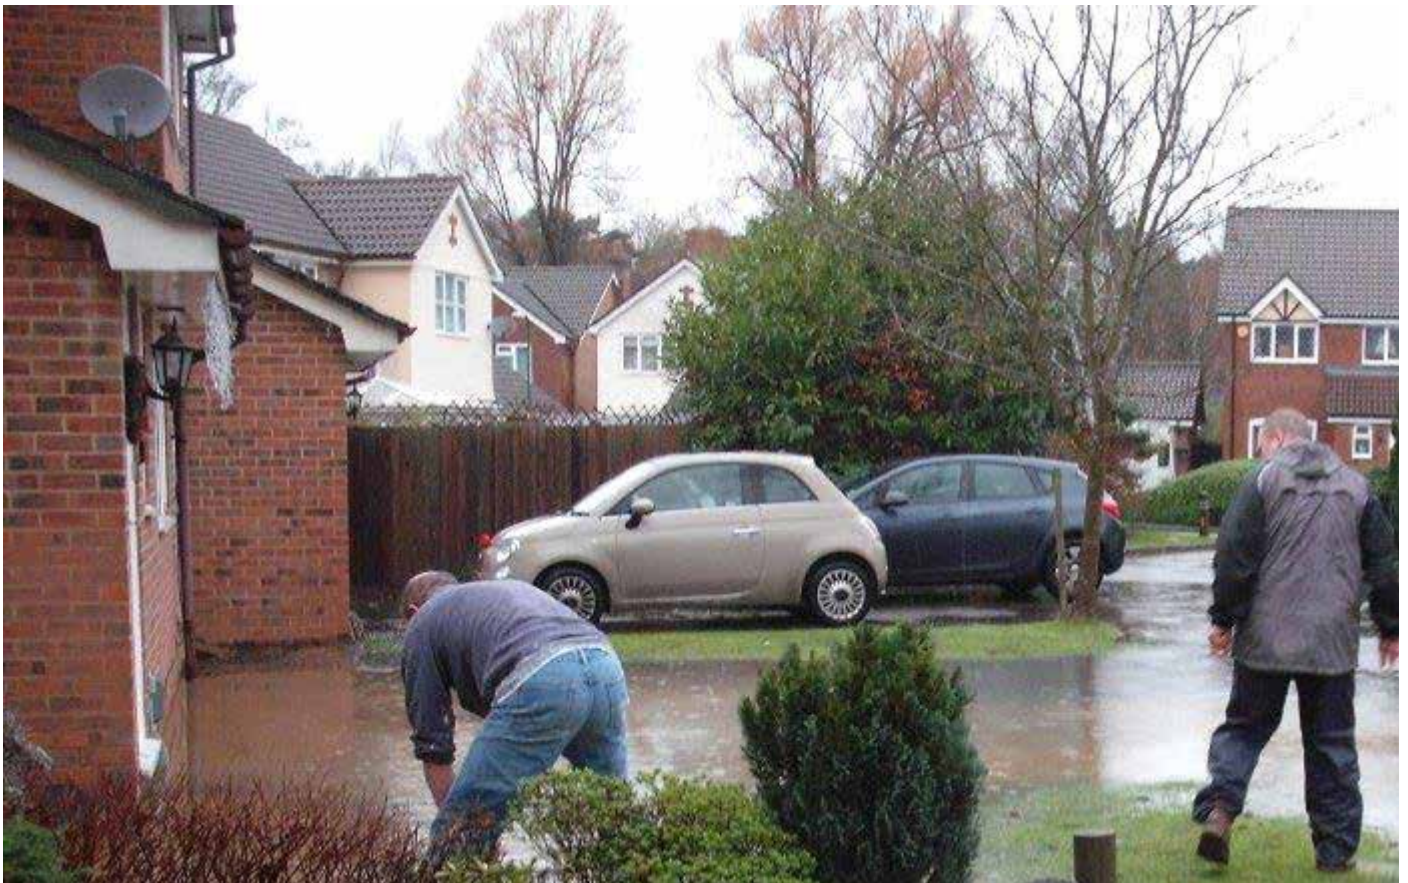
Flood in Nether Vell Mead 4 Jan 2014

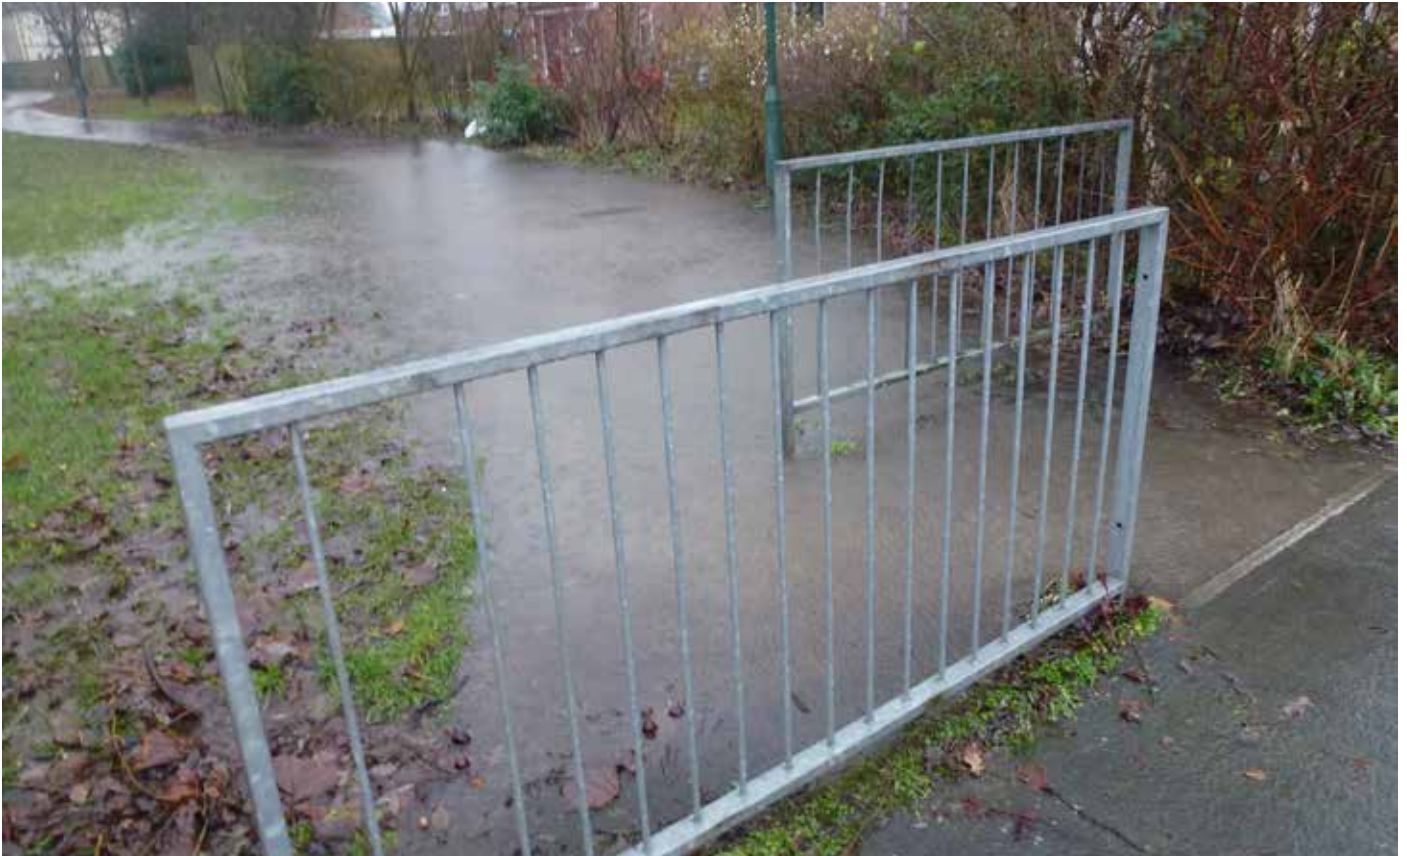
Once again the pathway from Ewshot Lane junction to Nether Vell Mead was inundated, resulting in water ingress at 100 Nether Vell Mead.

Flooded pathway opposite 100 Nether Vell Mead at 12:30pm 4 Jan 2014 after waters had receded

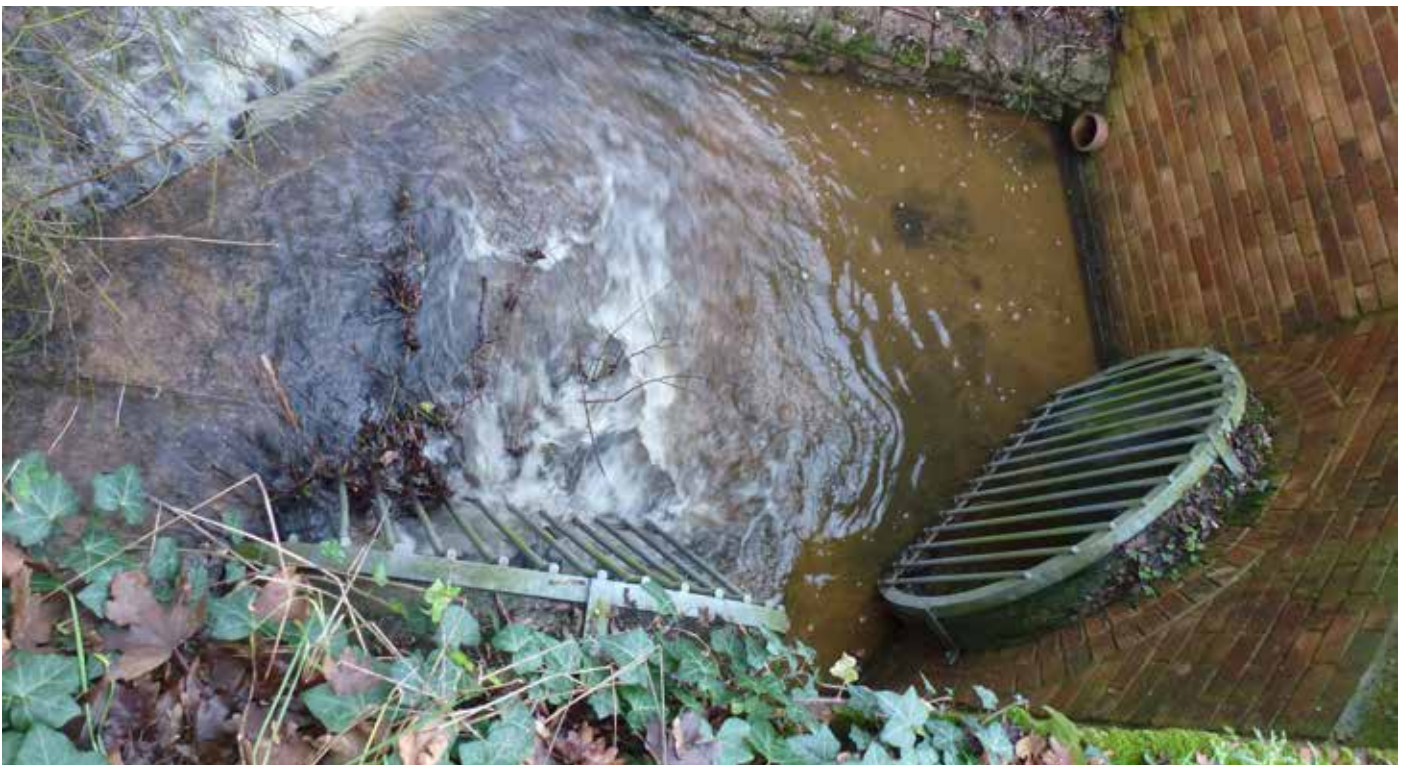
The flow from the Norththerly of the two inlets into the head of the Brandon Road ditch opposite the Redfields roundabout seems to have been obstructed somewhere upstream, resulting in negligible flow from that feed where it joins the active feed from the Watery Lane direction.

Culvert (R) into Brandon Road ditch appears blocked upstream 2:30pm 6 Jan 2014

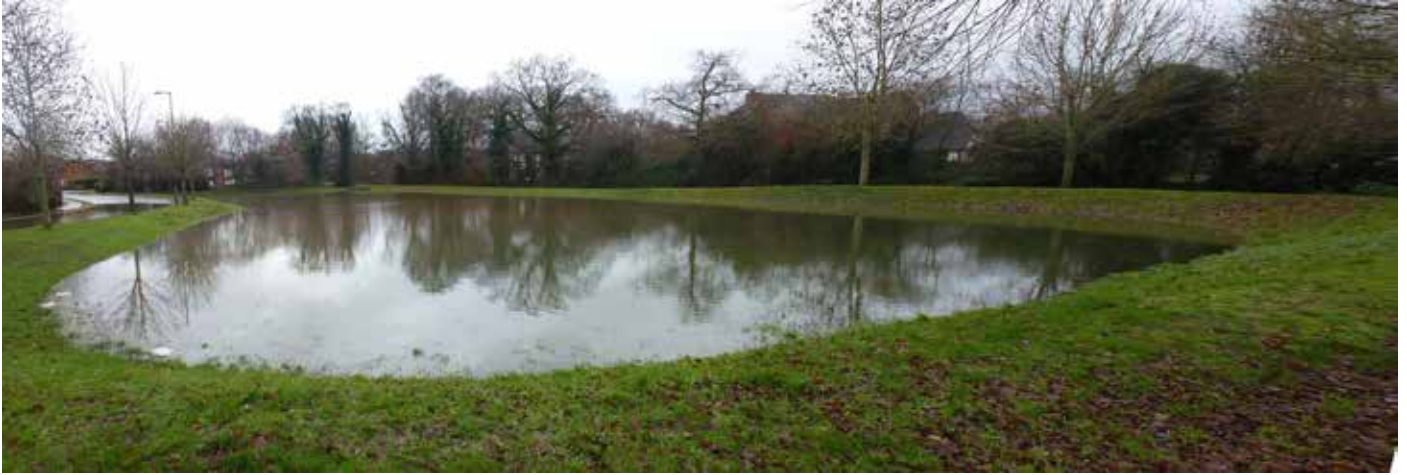
Although the main balancing pond on Brandon Road became very full, it did not overflow this time.

Main Brandon Road balancing Pond 12:30 pm 4 Jan 2014

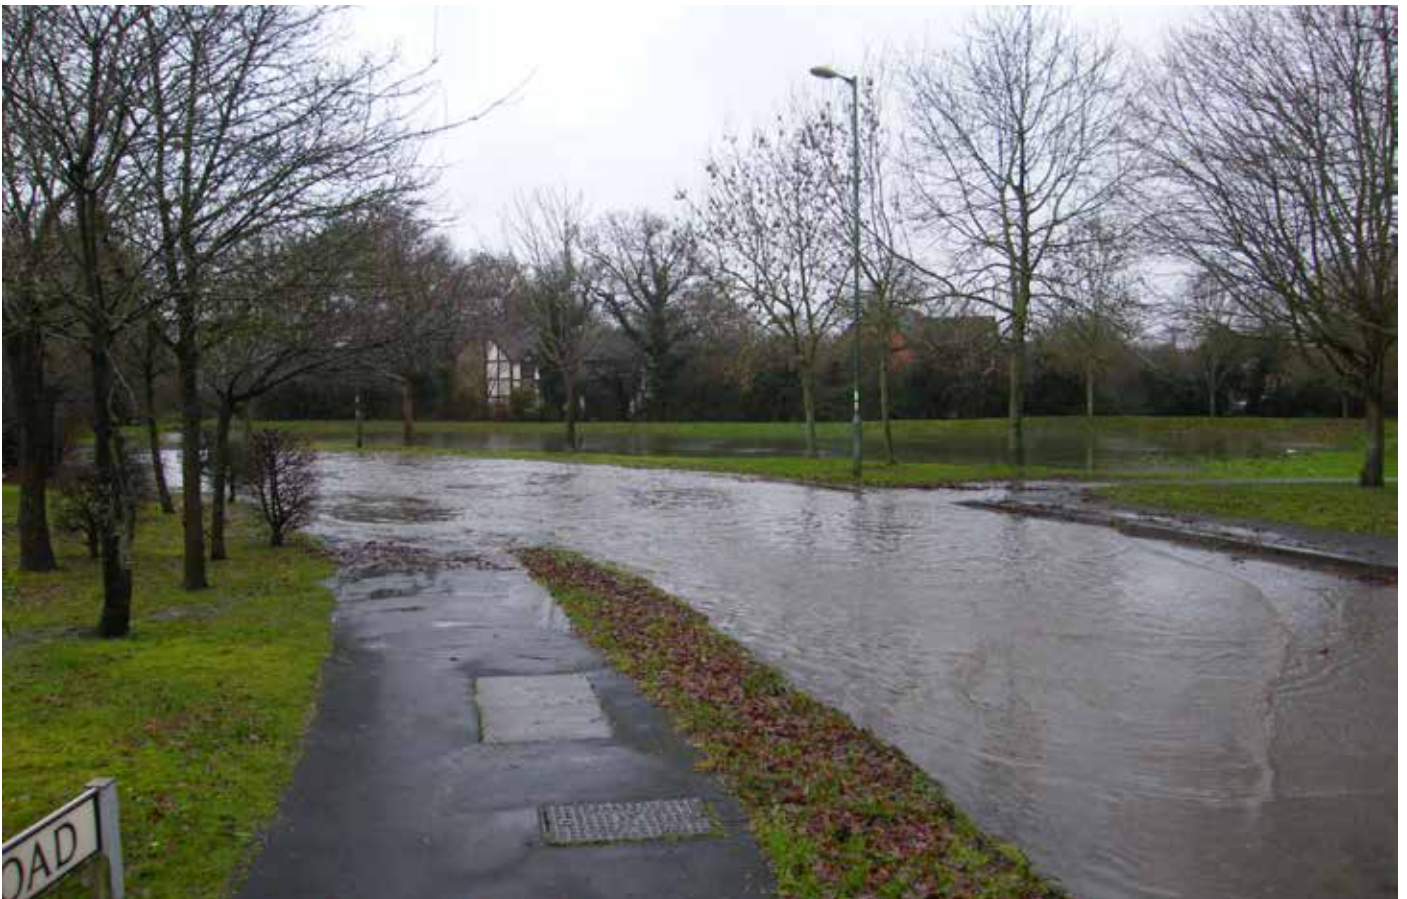
However, Brandon Road itself became flooded adjacent to the balancing pond due to roadside drains being unable to cope with water suspected of originating in Nether Vell Mead. Detritus on Nether Vell Mead after waters there had subsided there pointed to a significant flow from that source onto Brandon Road. This water also spilled onto the path alongside the Daphne Drive end of the balancing pond, which then formed a deep pond adjacent to the litter bin at the top of Rebecca Close; this water did not go any further.

Brandon Road at 11am 4 Jan 2014

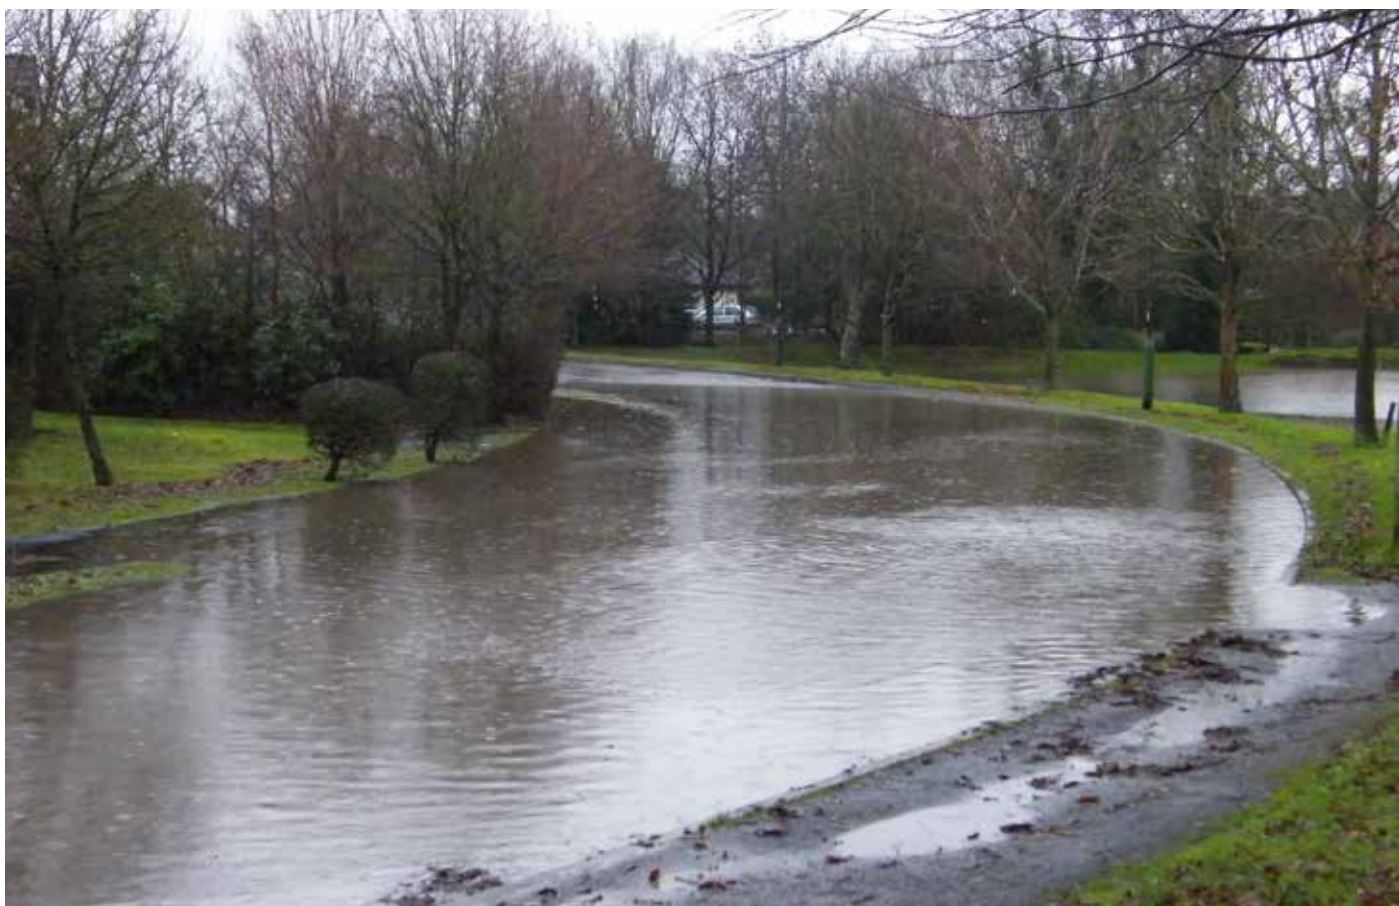
Water flowing from Brandon Road onto the path towards Rebecca Close 11am 4 Jan 2014

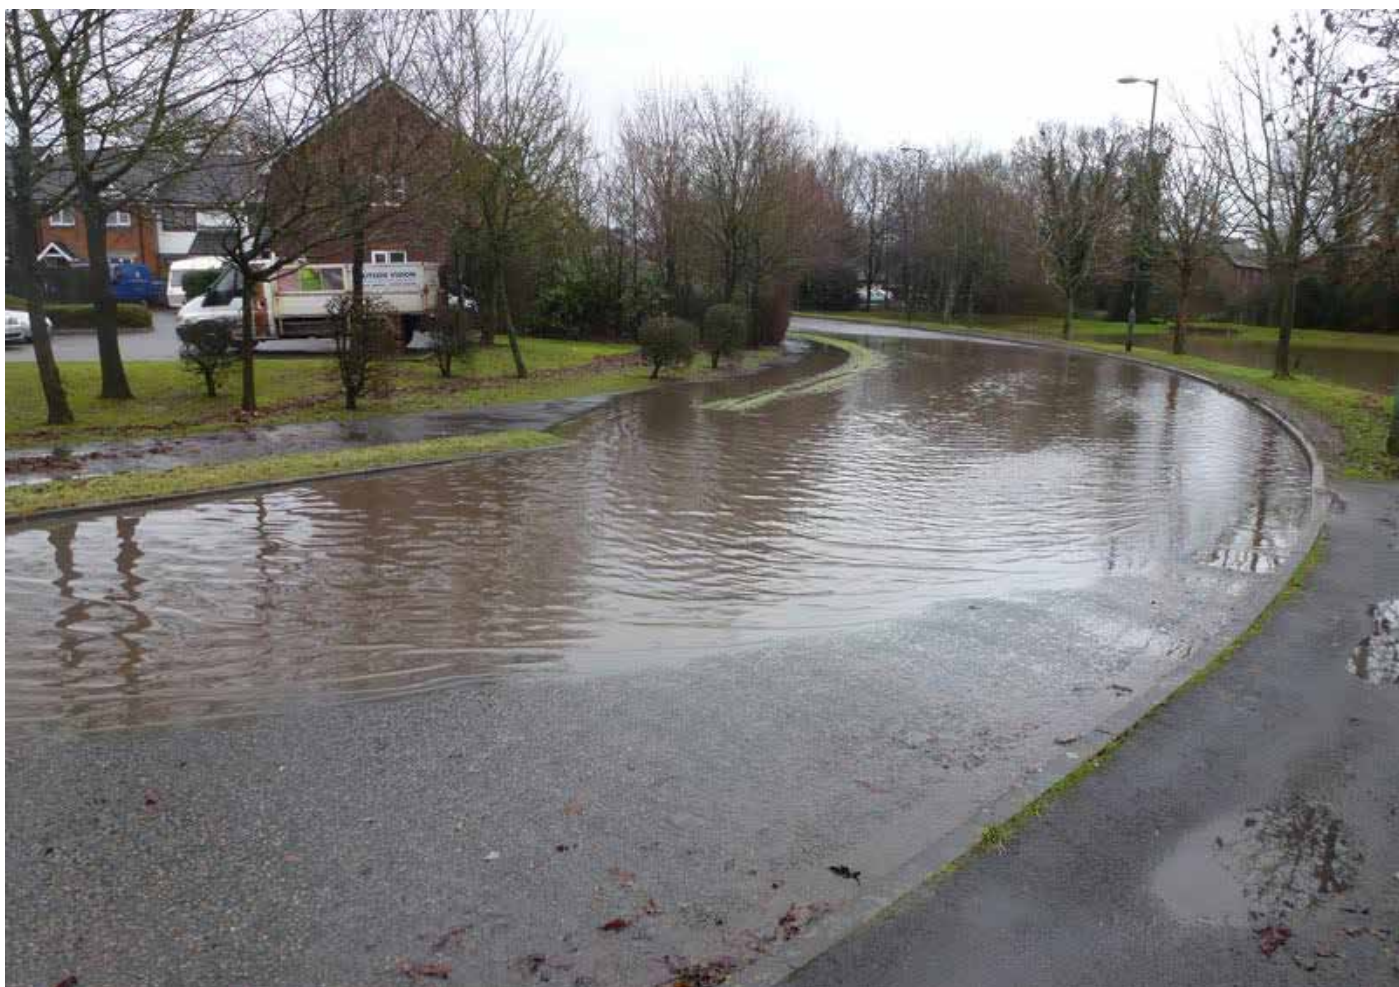
Area of deepest water on Brandon Road after much had subsided 12:30pm 4 Jan 2014

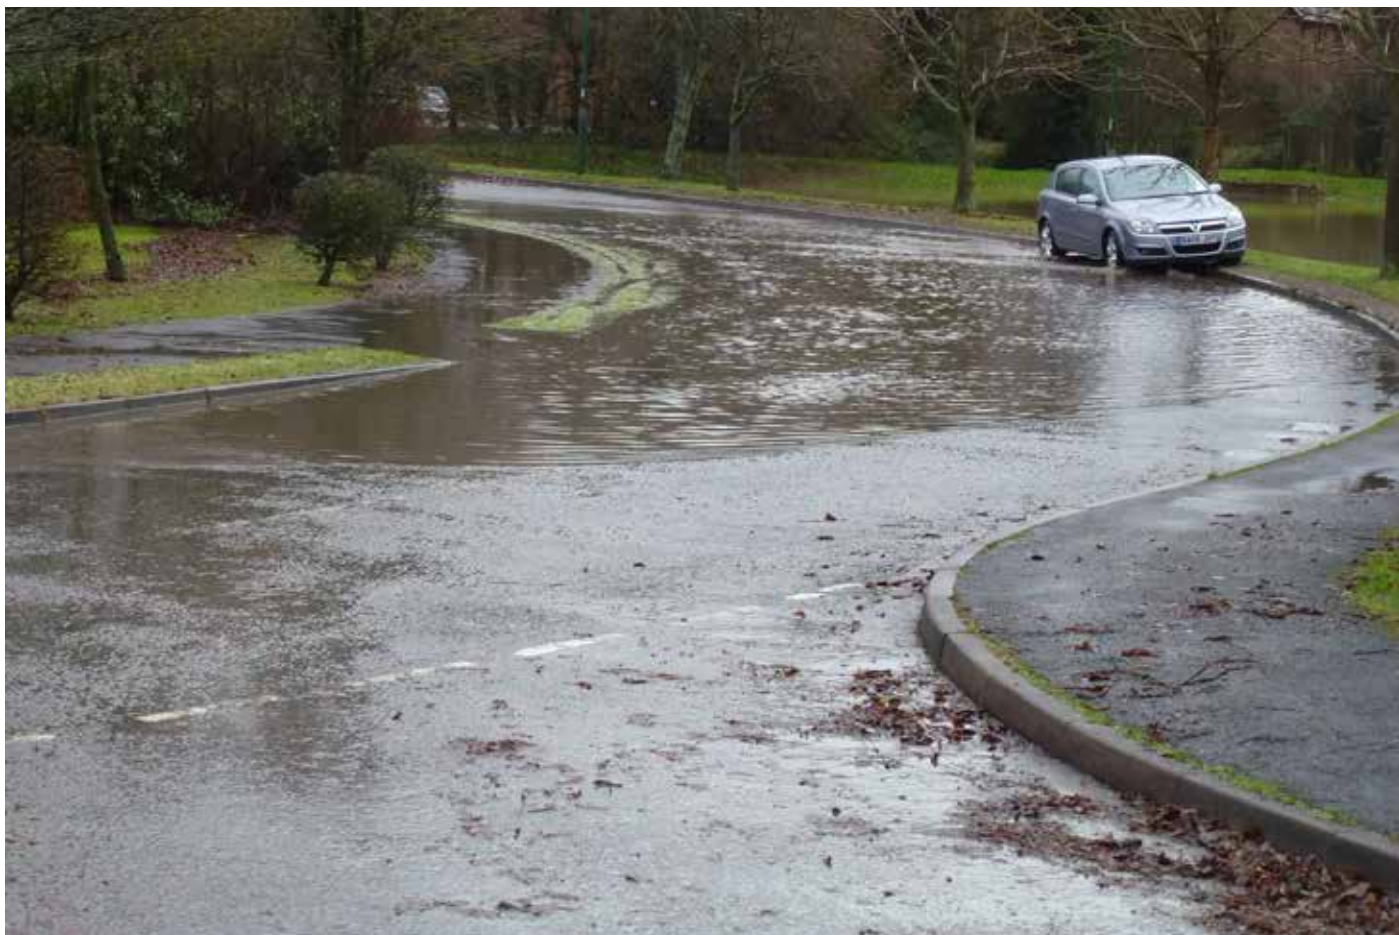
Some vehicles damaged the grass verge 12:30pm 4 Jan 2014

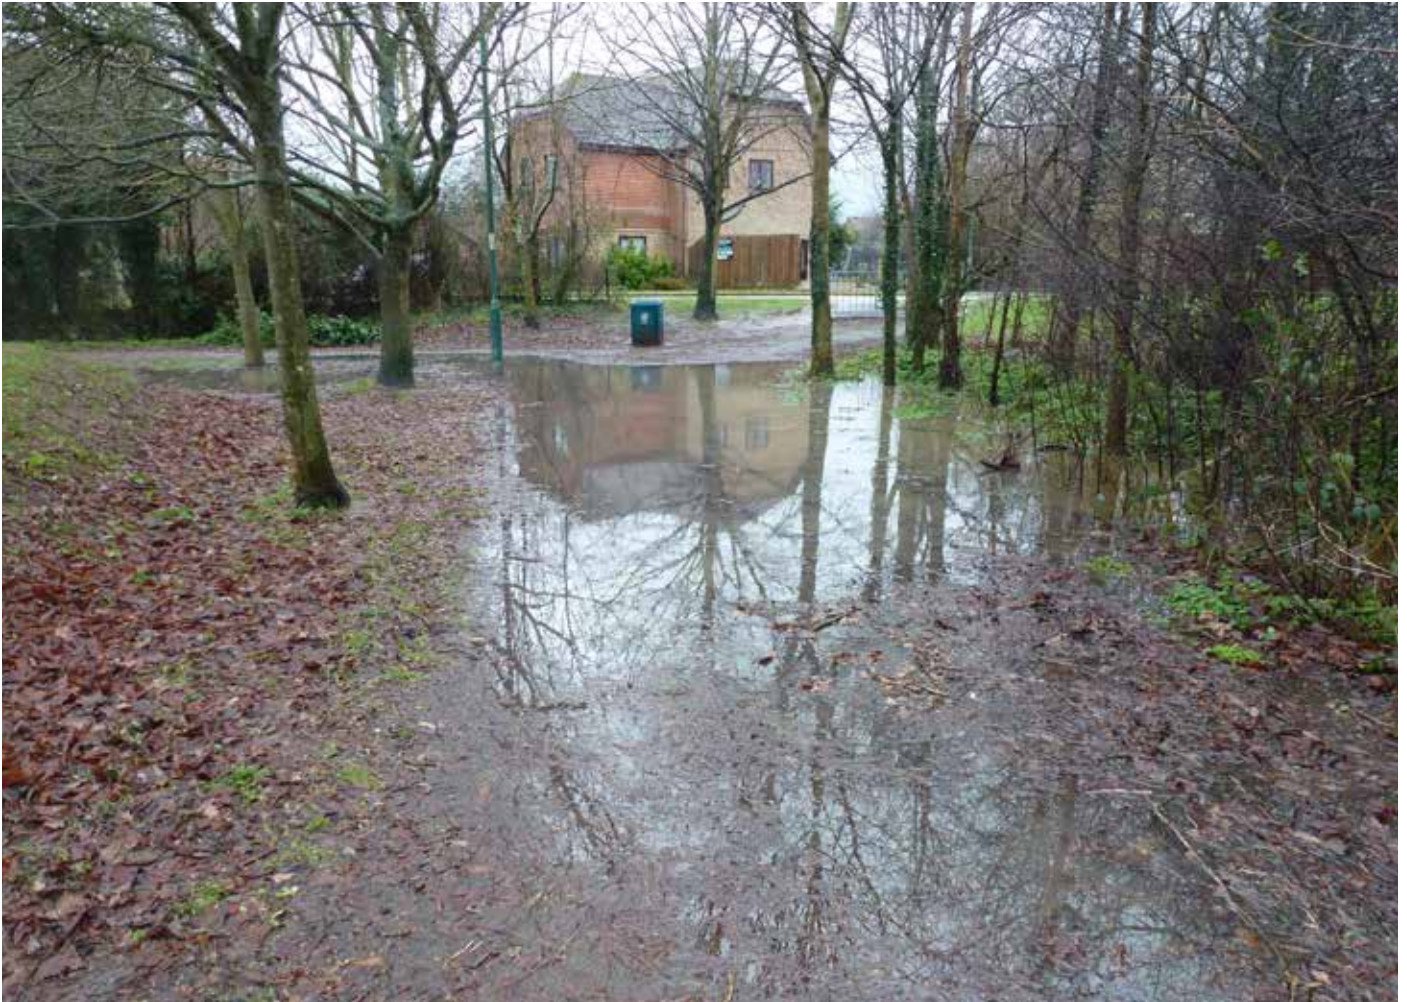
Flooded path adjacent to balancing pond near Rebecca Close after much had subsided 12:30pm 4 Jan 2014

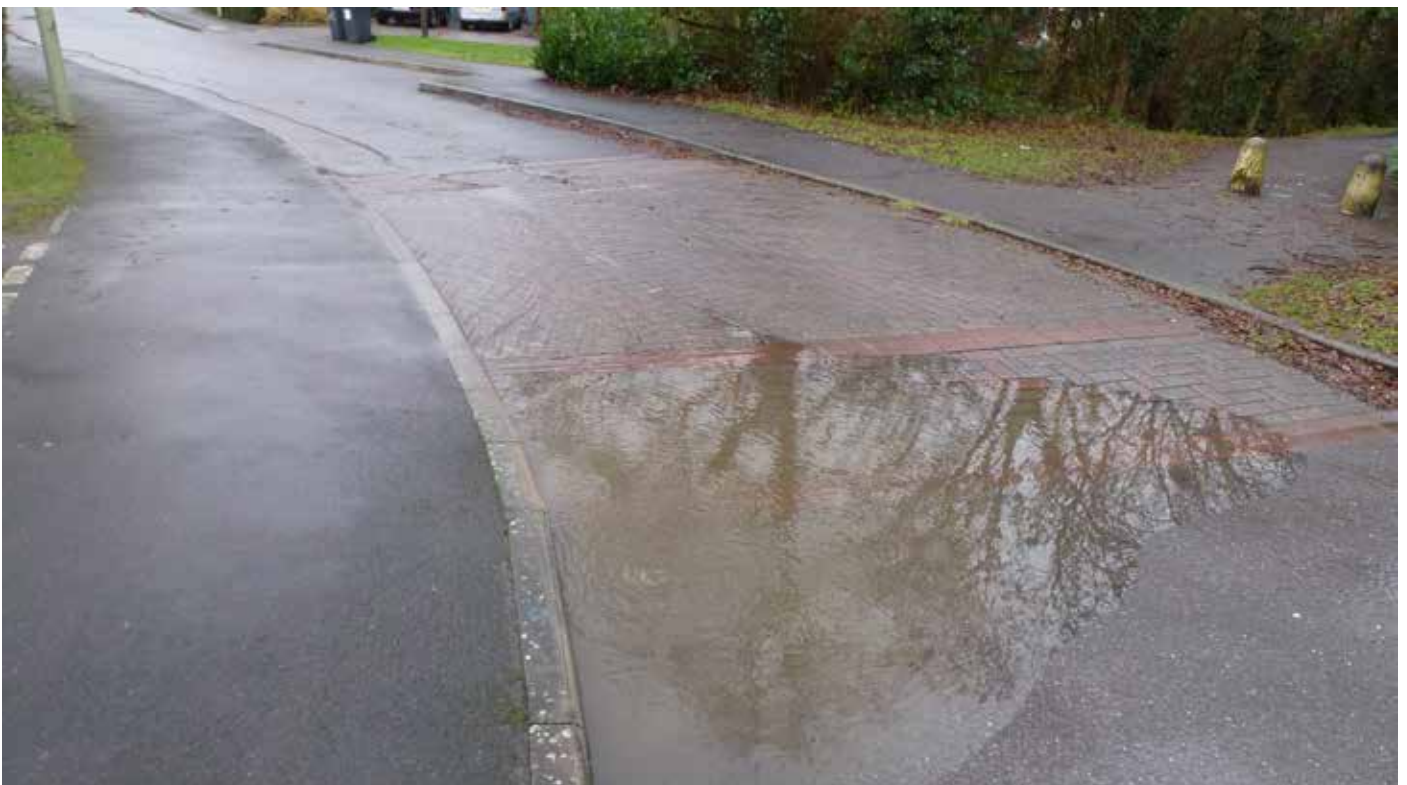
The drain on Browning Road just above the road hump just below the junction with Rebecca Close was spewing water, which ran down to the next drain below, whilst the road hump acted as a dam.

Browning Road drain output after most water had subsided 12:30pm 4 Jan 2014

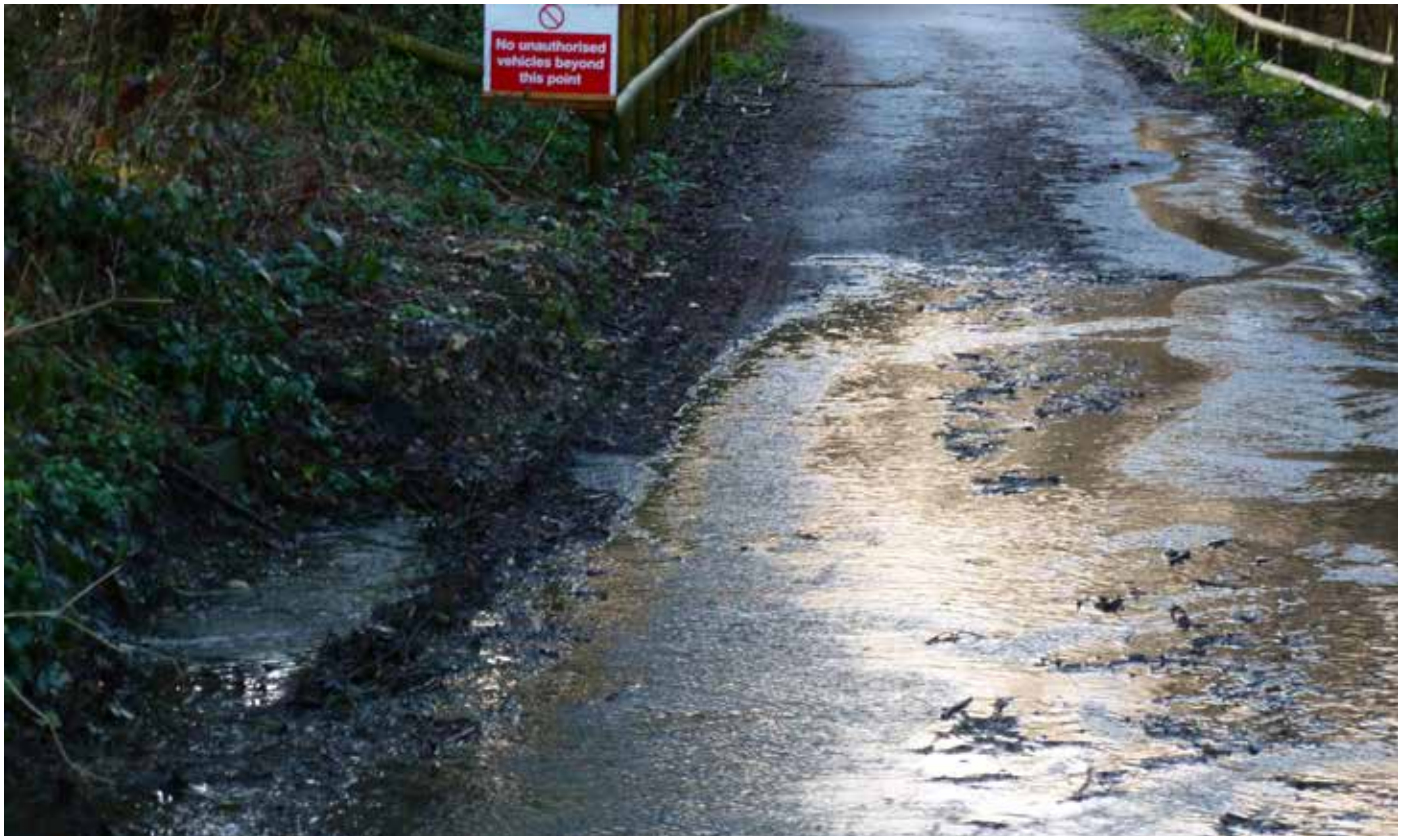
Once again there was very significant run-off from the open fields adjacent to Watery Lane resulting in a major flow North along the roadway into the main stream to the just short of the bridge into Tryplets.

Showing the route of water from the roadway into the main stream (after the main flow had subsided)
