# **Flooding around Zebon Copse Estate**

**Church Crookham**

**January 2014**

**prepared by  
David Jackson  
Chairman Zebon Copse Residents' Association**

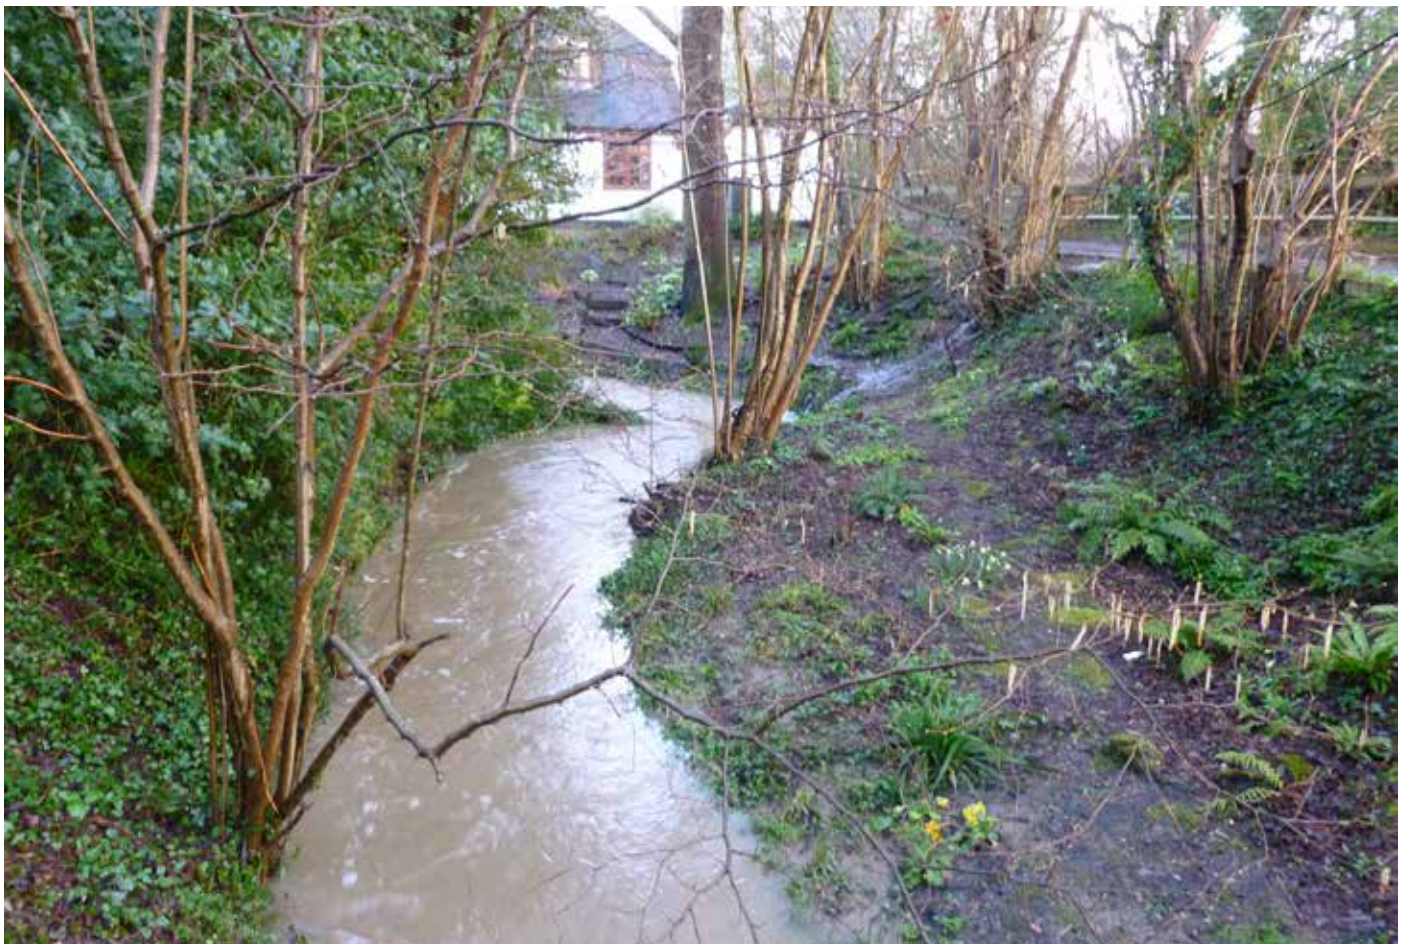
The main stream beside Watery Lane was still very full after the main flow had subsided somewhat

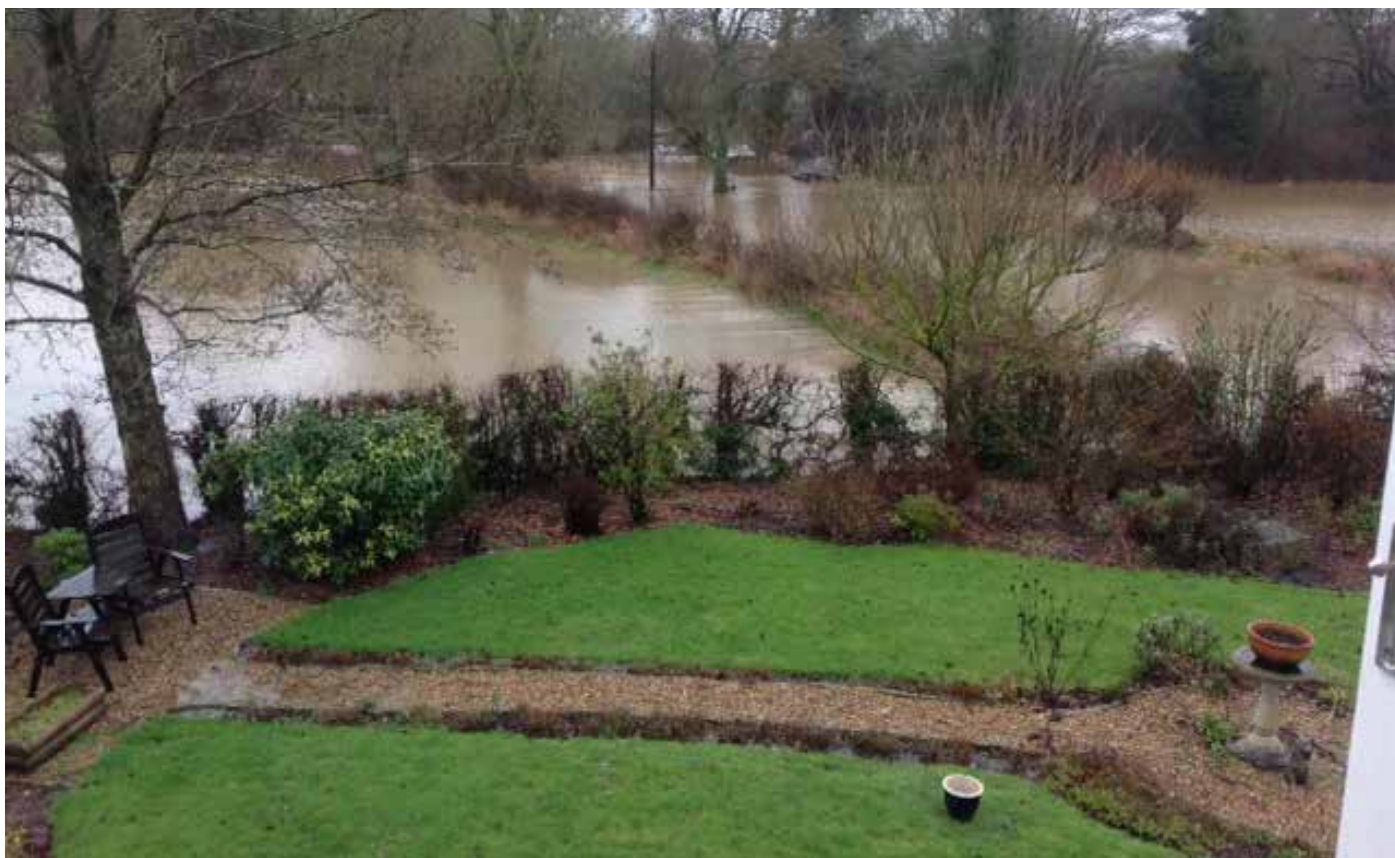
It was reported that Zephon Common Lane was flooded to a depth of 2.5 feet, making it impassable to normal vehicles and thus cutting off properties from Poulters Bridge Cottage to Riverside Cottage.

View from Burnt House of flooded fields on Zephon Common Lane

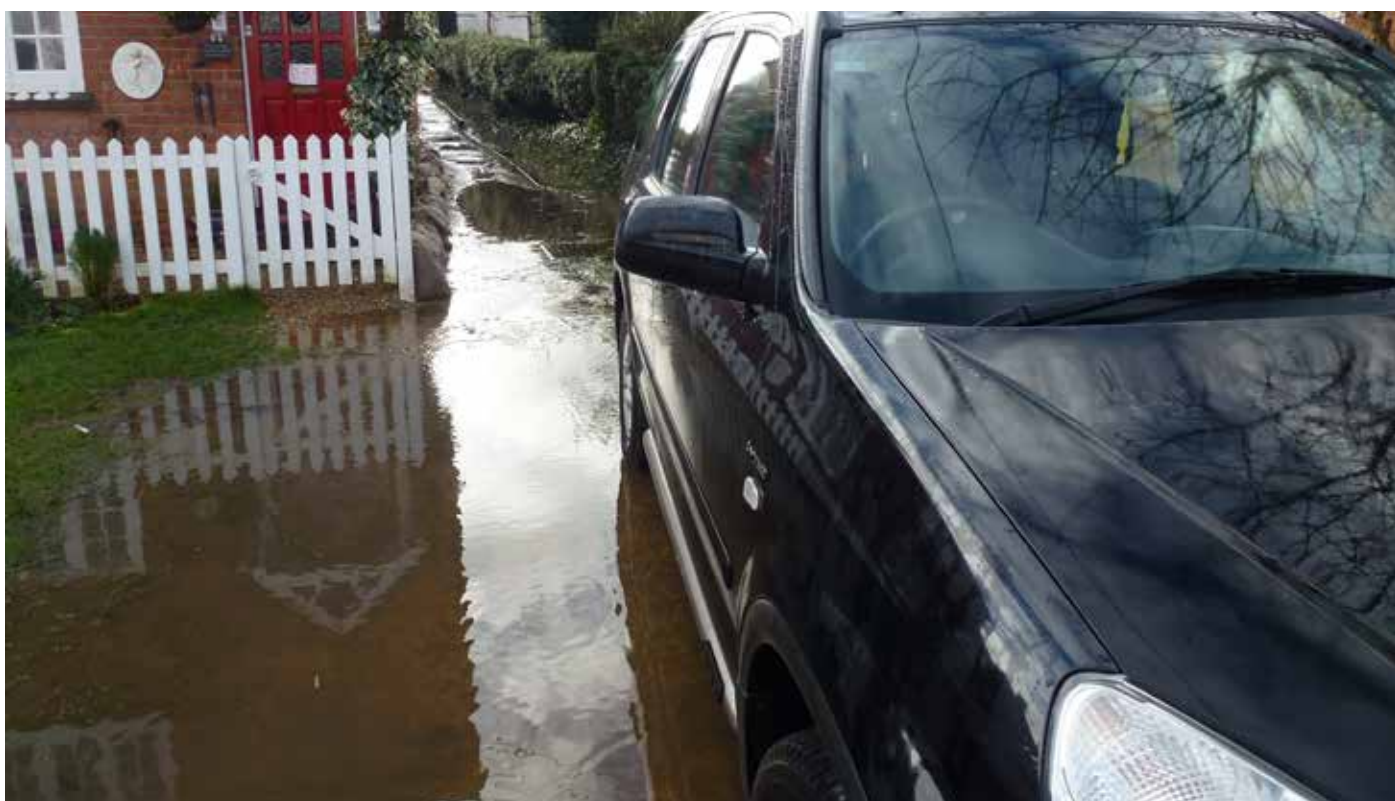
The ditch beside Footpath 1 backed up due to blockages downstream and flooded 2 Forge Cottages.

Flooded footpath 1 next to 2 Forge Cottages after most had subsided 6pm 17 Jan 2014

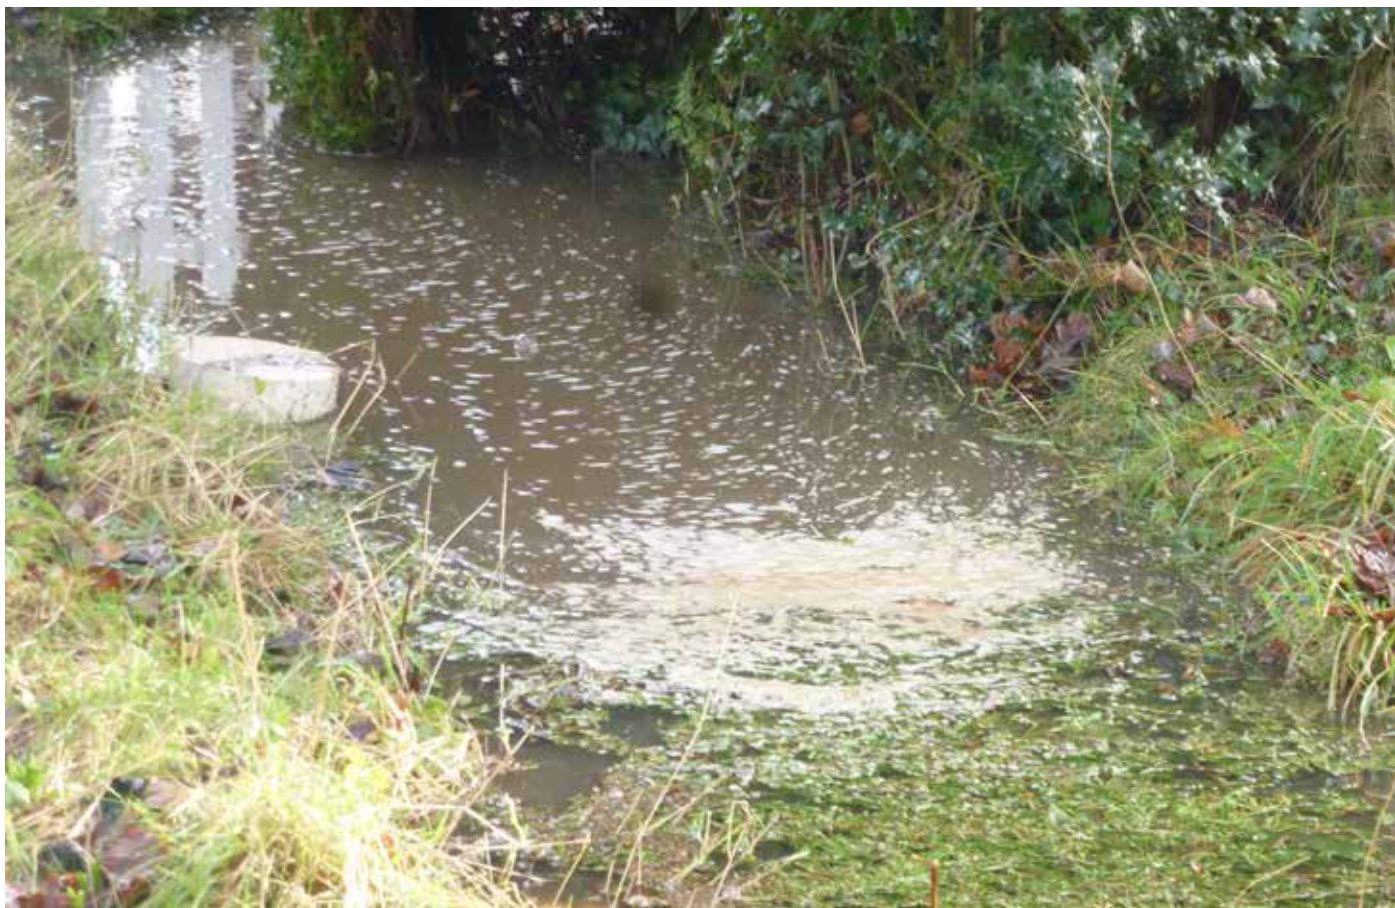
Looking towards Forge Cottages from the culvert under the driveway to Old Forge 6pm 17 Jan 2014
