the play inspection company

Annual Inspection

Recreation Ground (Cheriton PC)

Inspection Ref: 3102797 Site Ref: 33741

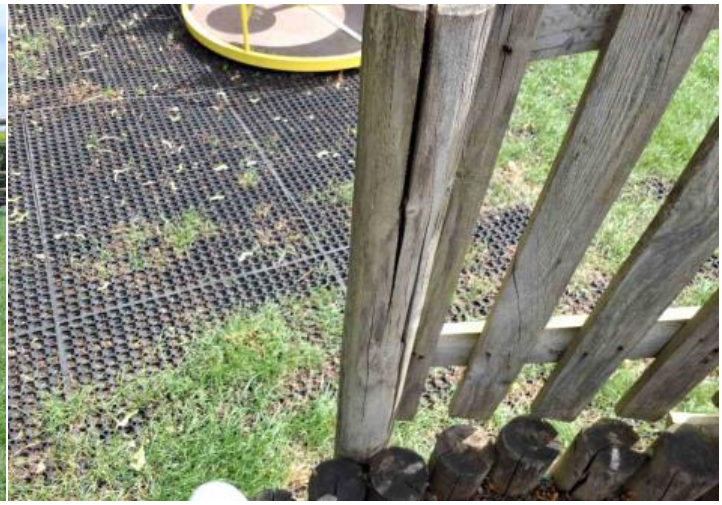
8 - Low Risk (Finding 3)

Item: Other - Slide Unit
Manufacturer: Obra
Risk Level: L - Low Risk
Surface: Grass Matrix Tiles

Finding: The timber has a number of splits/shakes or air cracks and this may affect the stability or allow water ingress which will accelerate the rotting process. Timber splits may also create rough / splintering edges.

Action: Monitor, sand down any rough edges and ensure the splits do not cross through fixing points of the structure and/or cause any instability

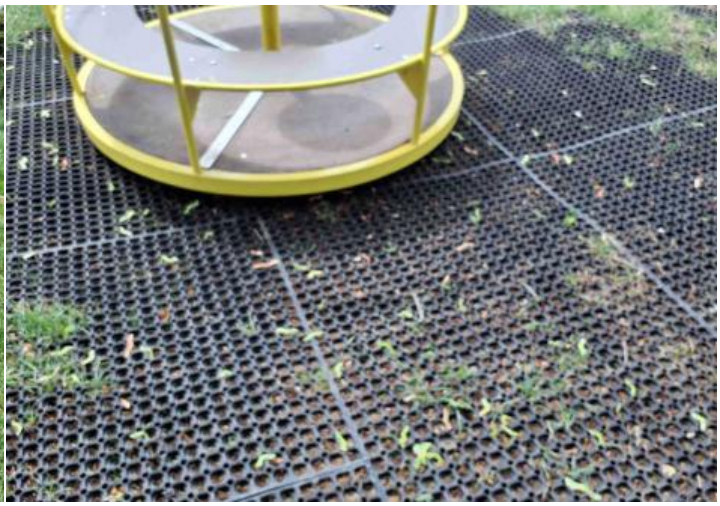
6 - Low Risk (Finding 5)

Item: Rotor Play - Roundabout
Manufacturer: Obra
Risk Level: L - Low Risk
Surface: Grass Matrix Tiles

Finding: The surface has subsided in some areas

Action: Monitor for any further deterioration and repair as required

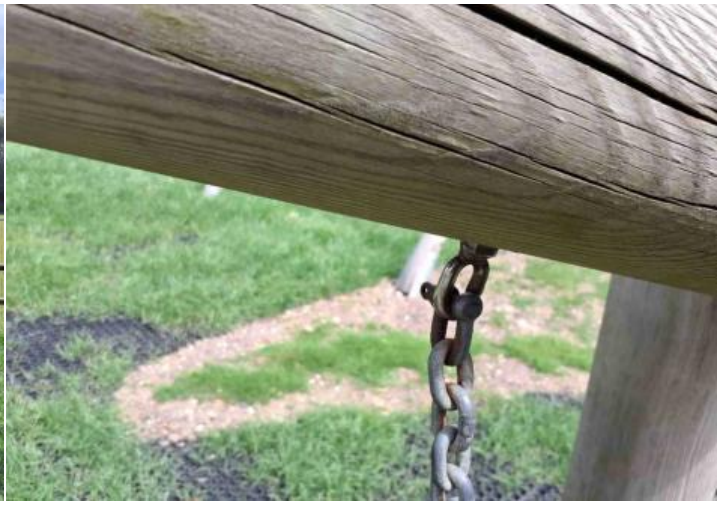
6 - Low Risk (Finding 8)

Item: Activity Equipment - Multi Play (Junior)
Manufacturer: Obra
Risk Level: L - Low Risk
Surface: Grass Matrix Tiles

Finding: There is some wear to the shackles

Action: Monitor for any further deterioration and replace when 40% worn
