the **play inspection** company

Annual Inspection

Winchester City Council

Recreation Ground (Cheriton PC)

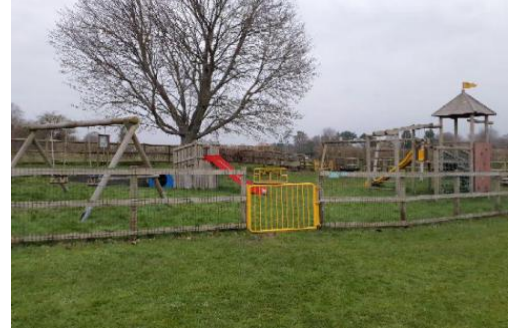
Item: Site General
Manufacturer: Owner/Operator
Surface Type: N/A
Item Quantity: 1
Equipment Compliance: N/A
Surface Area Compliance: N/A

It is recommended that signage, with information including the site address, contact information for maintenance issues and emergency contact details are provided for the facility - Provide in accordance with the recommendations

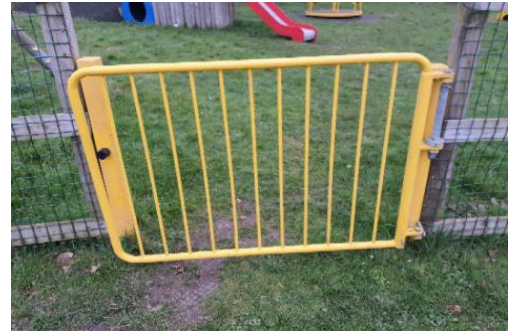
Item: Gate - Self Closing
Manufacturer: I.A.E. Fencing
Surface Type: Grass Matrix Tiles
Item Quantity: 2
Equipment Compliance: N/A
Surface Area Compliance: N/A

There is a missing fixing and a bracket has slipped out of place with sharp edges - Repair

i 6 - Low Risk

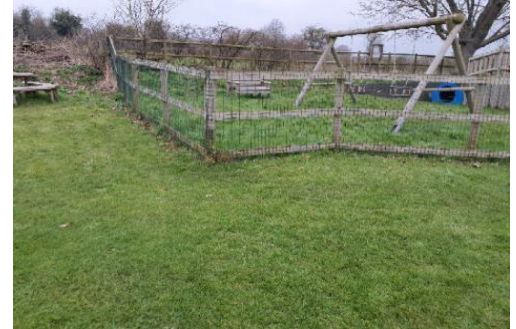
Item: Fence - Timber & Mesh Infill
Manufacturer: Not Identified
Surface Type: Grass
Item Quantity: 1
Equipment Compliance: N/A
Surface Area Compliance: N/A

There is some evidence of rot in the timber - Monitor for any further deterioration and replace as required

Cable ties have been used on the item and there are sharp projecting ends - Remove if not required or replace with a more appropriate alternative fixing method if used as a fixing

i 8 - Low Risk

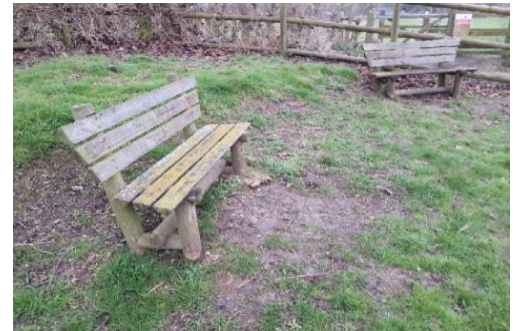
Item: Bench
Manufacturer: Not Identified
Surface Type: Grass
Item Quantity: 2
Equipment Compliance: N/A
Surface Area Compliance: N/A

The surface has eroded and the foundations are exposed - Reinstate surrounding surfaces to cover the foundations

There is some evidence of rot in the timber - Monitor for any further deterioration and replace as required

i 8 - Low Risk

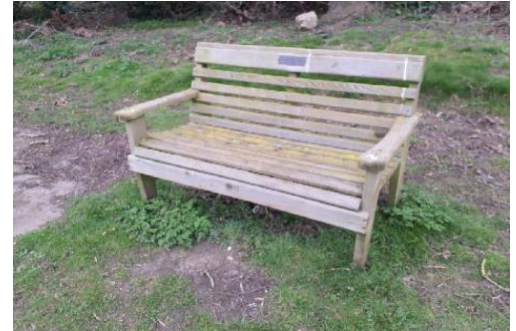
Item: Bench
Manufacturer: Not Identified
Surface Type: Grass
Item Quantity: 3
Equipment Compliance: N/A
Surface Area Compliance: N/A

i 8 - Low Risk

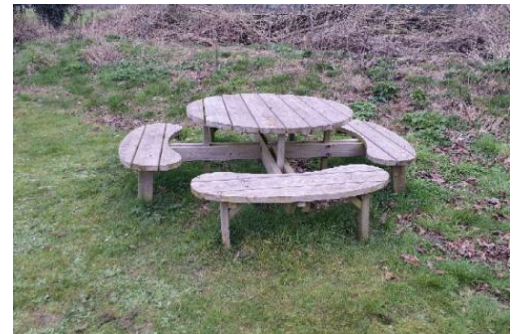
Item: Picnic Table
Manufacturer: Not Identified
Surface Type: Grass
Item Quantity: 2
Equipment Compliance: N/A
Surface Area Compliance: N/A

i 6 - Low Risk

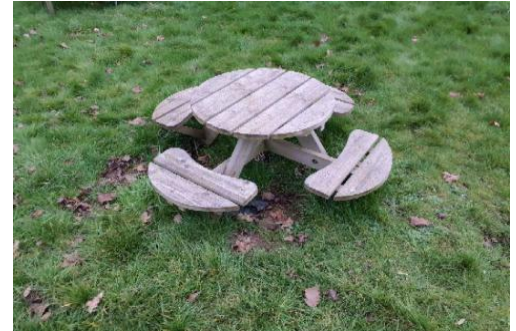
Item: Picnic Table
Manufacturer: Not Identified
Surface Type: Grass
Item Quantity: 1
Equipment Compliance: N/A
Surface Area Compliance: N/A

i 8 - Low Risk

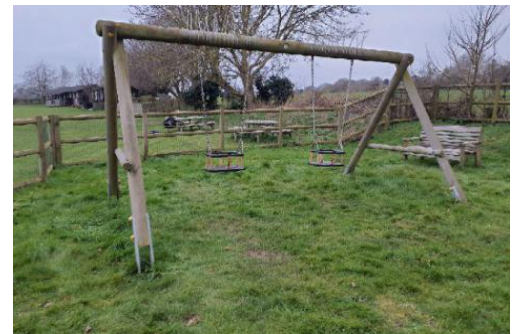
Item: 1 Bay 2 Seat (Cradle)
Manufacturer: Oبرا
Surface Type: Grass Matrix Tiles
Item Quantity: 1
Equipment Compliance: No
Surface Area Compliance: Yes

The timber has a number of splits/shakes or air cracks and this may affect the stability or allow water ingress which will accelerate the rotting process - Monitor to ensure the splits do not cross through fixing points of the structure and/or cause any instability

The fixings have corroded excessively - Replace all corroded fixings

The chain openings are in excess of the 8.6mm as recommended by BS EN 1176 - Monitor - No remedial work recommended

There is some notable evidence of chain wear - Monitor for any further deterioration and replace when 40% worn

i 9 - Low Risk

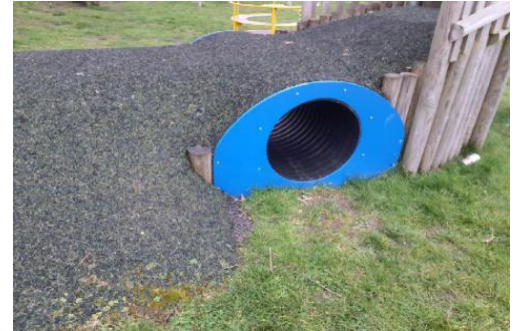
Item: Crawling Tunnel
Manufacturer: Obra
Surface Type: Grass Matrix Tiles
Item Quantity: 1
Equipment Compliance: No
Surface Area Compliance: Yes

This design / configuration of tunnel mound is well established and has been successfully included in large quantities of playgrounds throughout the UK. Whilst the design does not fully meet the requirements of BS EN 1176 with regards to falls in excess of 600mm over the edge of the tunnel to the surface below, it has been risk assessed as fit for purpose in this regard and no changes are recommended to the design unless otherwise stated in additional findings - Monitor - No remedial work recommended

There are significant gaps (over 30mm) between the surface and the edging or between the joints in the surface; these are large enough for a small foot to enter - Repair surfacing

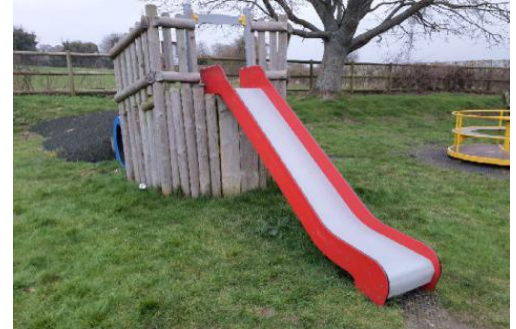
Item: Multi Play (Junior)
Manufacturer: Obra
Surface Type: Grass Matrix Tiles
Item Quantity: 1
Equipment Compliance: No
Surface Area Compliance: Yes

The slide start section incline is not in the direction of travel; it should slope towards the direction of the sliding surface to meet the requirements of BS EN 1176 Part 3 - Monitor - No remedial work recommended

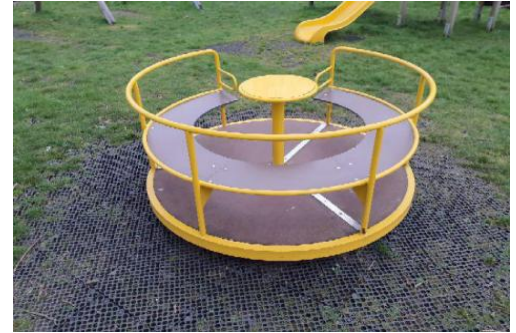
Item: Roundabout
Manufacturer: Obra
Surface Type: Grass Matrix Tiles
Item Quantity: 1
Equipment Compliance: No
Surface Area Compliance: Yes

The distance between the underside of the roundabout platform and the playing surface is less than 60mm and contravenes the requirements of BS EN 1176 Part 5 which requires that the distance be maintained between 60mm-110mm for the entire circumference of the roundabout - Monitor - No remedial work recommended

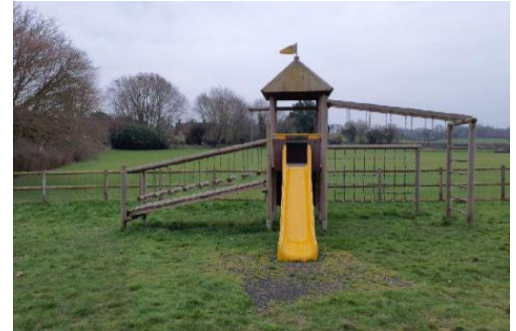
Item: Multi Play (Junior)
Manufacturer: Obra
Surface Type: Grass Matrix Tiles
Item Quantity: 1
Equipment Compliance: No
Surface Area Compliance: Yes

The fixings have corroded excessively - Replace all corroded fixings

i 6 - Low Risk
