## Annual Inspection

Winchester City Council

Meonwara PA (West Meon PC)

Meonwara Crescent, West Meon, Winchester, Hampshire

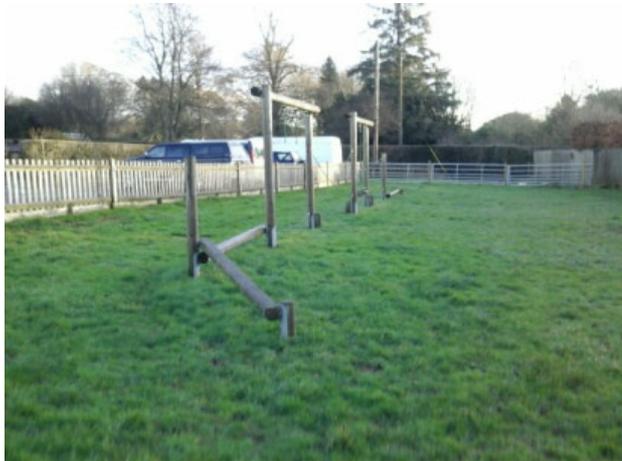
Finding 1

It is recommended that information signs with emergency contact details are installed at each entrance/exit point to the playground - Provide in accordance with the recommendations set out in BS EN 1176

Finding 2

The grass is overgrown within the play area and may hide hazards - Reduce the length of grass to an acceptable height and maintain

<b>Finding:</b>	It is recommended that information signs with emergency contact details are installed at each entrance/exit point to the playground	<b>Action:</b>	Provide in accordance with the recommendations set out in BS EN 1176
-----------------	---	----------------	--

<b>Finding:</b>	The grass is overgrown within the play area and may hide hazards	<b>Action:</b>	Reduce the length of grass to an acceptable height and maintain
-----------------	--	----------------	---

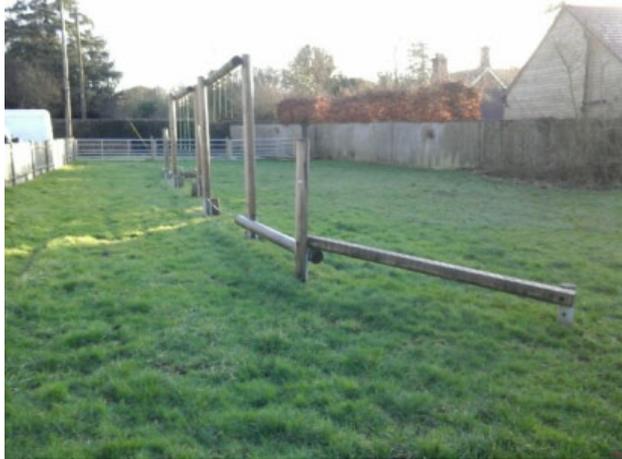
**Finding 1**

The timber has a number of air cracks apparent, the splits will have penetrated the preservative applied to the timber and allow water ingress to the unprotected areas - Monitor for any deterioration (rot) and replace as required

The connecting links are in excess of 8.6mm and less than 12mm and fail the requirements of BS EN 1176:2008 Part 1; clause 4.2.13, Chains - Monitor use and replace with compliant links at the next maintenance cycle

The timber is damaged - Monitor use and replace if required

**Finding:** The timber has a number of air cracks apparent, the splits will have penetrated the preservative applied to the timber and allow water ingress to the unprotected areas

**Finding:** The connecting links are in excess of 8.6mm and less than 12mm and fail the requirements of BS EN 1176:2008 Part 1; clause 4.2.13, Chains

**Finding:** The timber is damaged

**Action:** Monitor for any deterioration (rot) and replace as required

**Action:** Monitor use and replace with compliant links at the next maintenance cycle

**Action:** Monitor use and replace if required
