## Annual Inspection

Winchester City Council

West Meon Village Hall RG (West Meon PC)

Annual Inspection - 16 January 2018 at 09:20 Inspector: Matt Clay (RPII Annual Inspector)

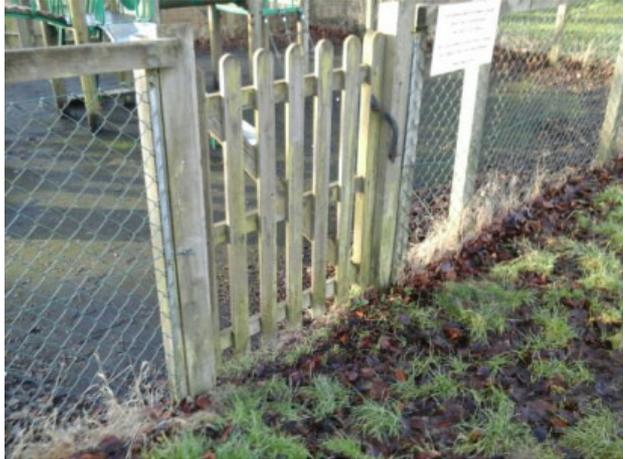
**Item:** Ancillary Items - Gate  
**Manufacturer:** Owner/Operator  
**Surface Type:** Grass  
**Equipment Compliance:** N/A  
**Surface Area Compliance:** N/A  
**Ref/Part Number:**  
**Total Findings:** 1

The opening between the gate and the post is less than 12mm and could trap users fingers - Adjust gate to ensure a 12mm opening all around

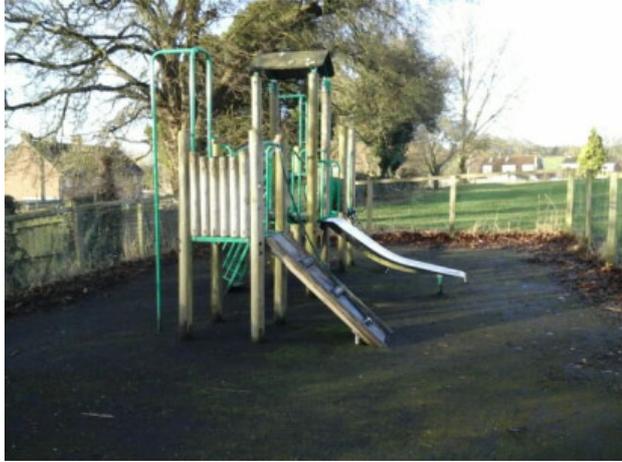
**Item:** Activity Equipment - Multi Play (Toddler)  
**Manufacturer:** A.E.Evans  
**Surface Type:** Wet Pour  
**Equipment Compliance:** No  
**Surface Area Compliance:** Yes  
**Ref/Part Number:**  
**Total Findings:** 12

There is some tree debris on the surfacing - Remove and maintain

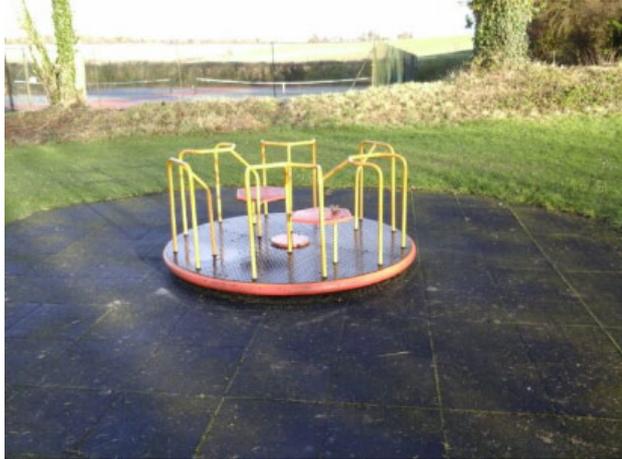
**Item:** Rotor Play - Roundabout  
**Manufacturer:** Wicksteed Playgrounds  
**Surface Type:** Rubber Tiles  
**Equipment Compliance:** Yes  
**Surface Area Compliance:** Yes  
**Ref/Part Number:**  
**Total Findings:** 1

This item is satisfactory - no work required

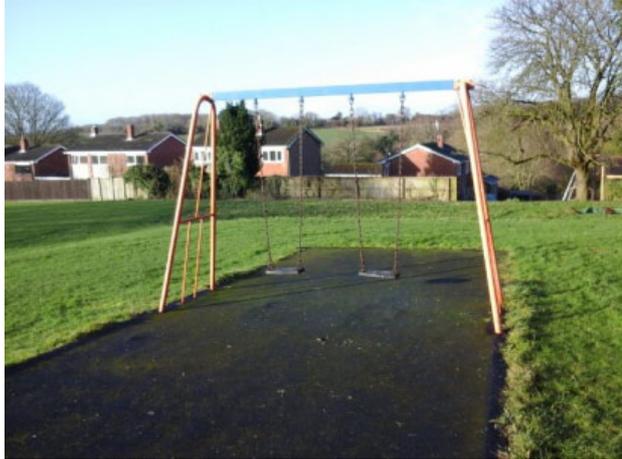
**Item:** Swings - 1 Bay 2 Seat (Flat)  
**Manufacturer:** Wicksteed Playgrounds  
**Surface Type:** Wet Pour  
**Equipment Compliance:** No  
**Surface Area Compliance:** Yes  
**Ref/Part Number:**  
**Total Findings:** 5

There is some graffiti present - Remove the graffiti

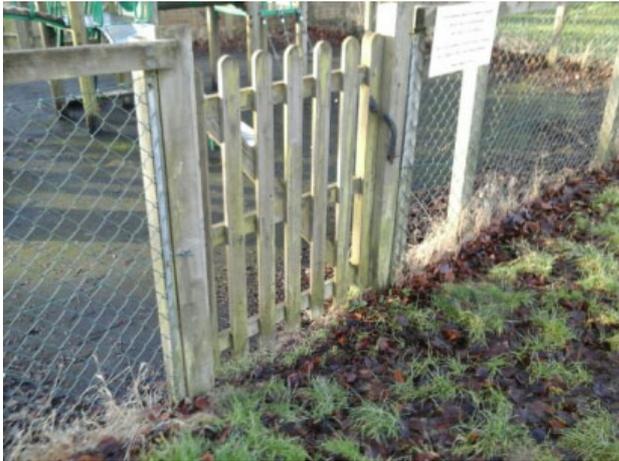
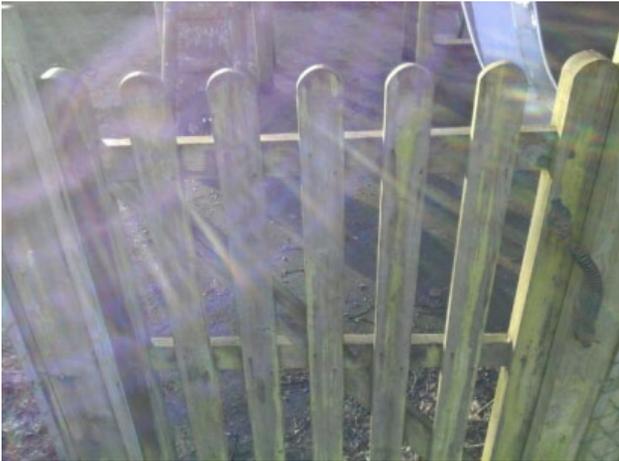
<b>8 - Low Risk (Finding 1)</b>			
<b>Item:</b>	Ancillary Items - Gate	<b>Risk Level:</b>	L - Low Risk
<b>Manufacturer:</b>	Owner/Operator	<b>Surface:</b>	Grass

<b>Finding:</b>	The opening between the gate and the post is less than 12mm and could trap users fingers		<b>Action:</b> Adjust gate to ensure a 12mm opening all around

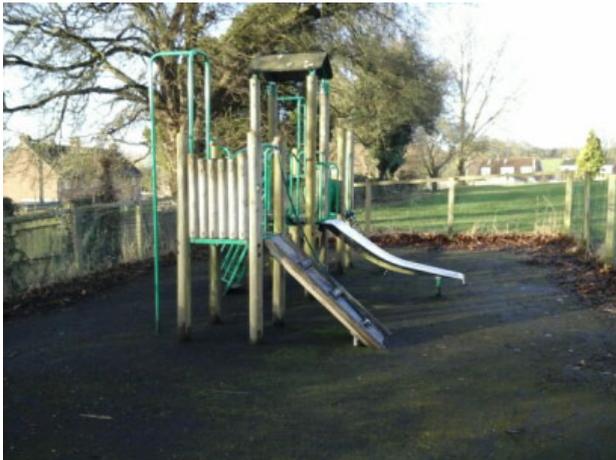
**Finding:** The unit is easily accessible and should have the appropriate barriers installed as the height of the unit exceeds 600mm

**Action:** Monitor use

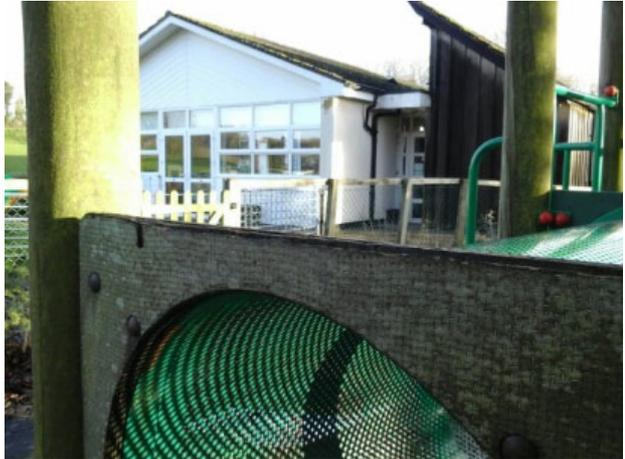
**Finding:** Parts of the timber are rough or splintered

**Action:** Remove all rough or sharp edges

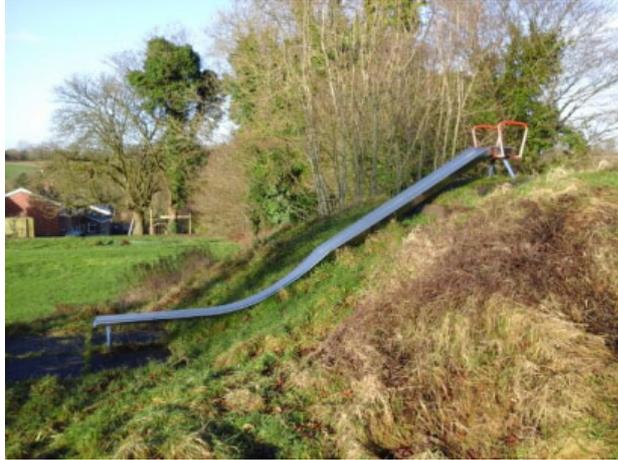
**Item:** Other - Embankment Slide  
**Manufacturer:** Unknown

**Finding:** The slide start section incline is not in the direction of travel; it should slope towards the direction of the sliding surface

**Action:** Monitor use

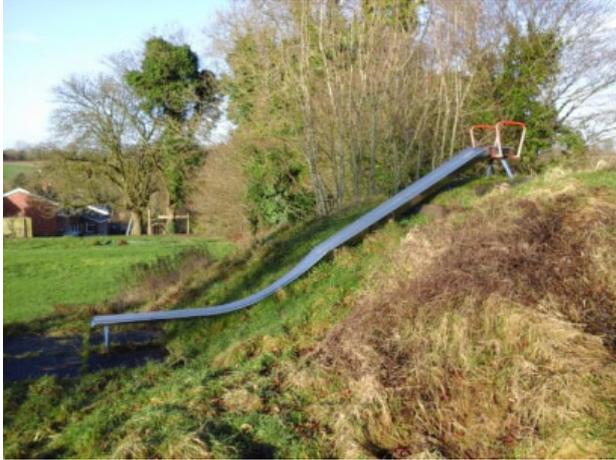
**Item:** Other - Embankment Slide  
**Manufacturer:** Unknown

**Finding:** There is a toggle entrapment at the top of the slide

**Action:** Monitor Use

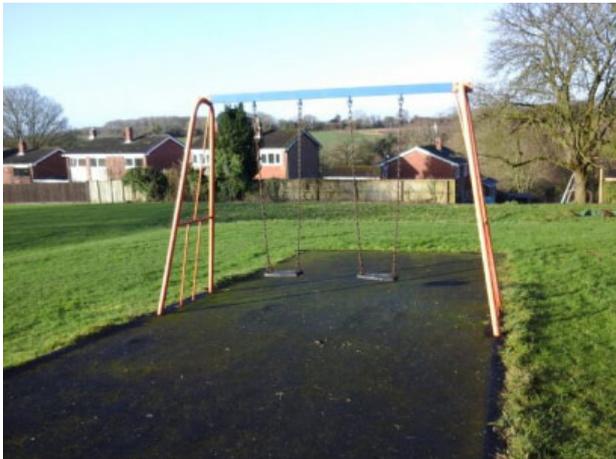
**Item:** Swings - 1 Bay 2 Seat (Flat)  
**Manufacturer:** Wicksteed Playgrounds

**Finding:** There is some graffiti present

**Action:** Remove the graffiti

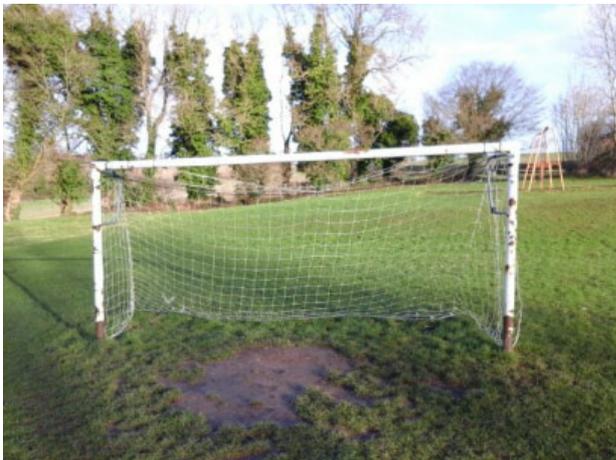
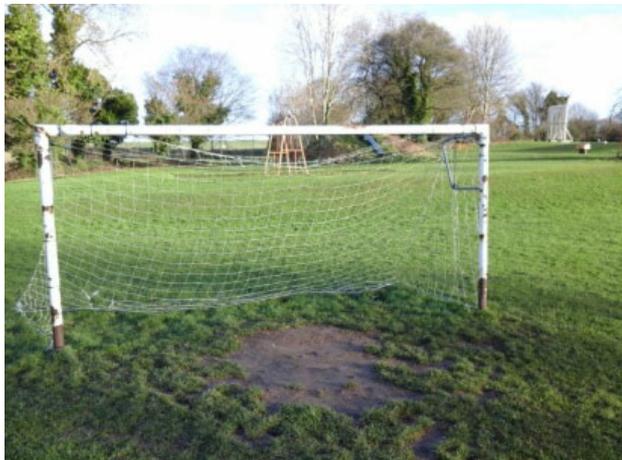
0 - Risk Assessment not Undertaken (Finding 2)

**Item:** Multi Use Games Area - Football Goal **Risk Level:** N - Risk Assessment not Undertaken  
**Manufacturer:** Unknown **Surface:** Grass

**Finding:** NB: We have undertaken a maintenance inspection only of the football goal(s); full load testing fall outside the scope of our inspection. **Action:** Implement load testing as required
